August 5, 2021

Mr. Ron Lunday
15215 – 162nd Avenue Southeast
Renton, Washington
ronlunday@earthlink.net
(425) 254-0537

Critical Areas Report – Geologic Hazard Areas
Clearing and Grading Within a Landslide Hazard
Buffer
15215 – 162nd Avenue Southeast
King County, Washington
PN: 7806450070
Doc ID: Lunday.162ndAveSE.GHA

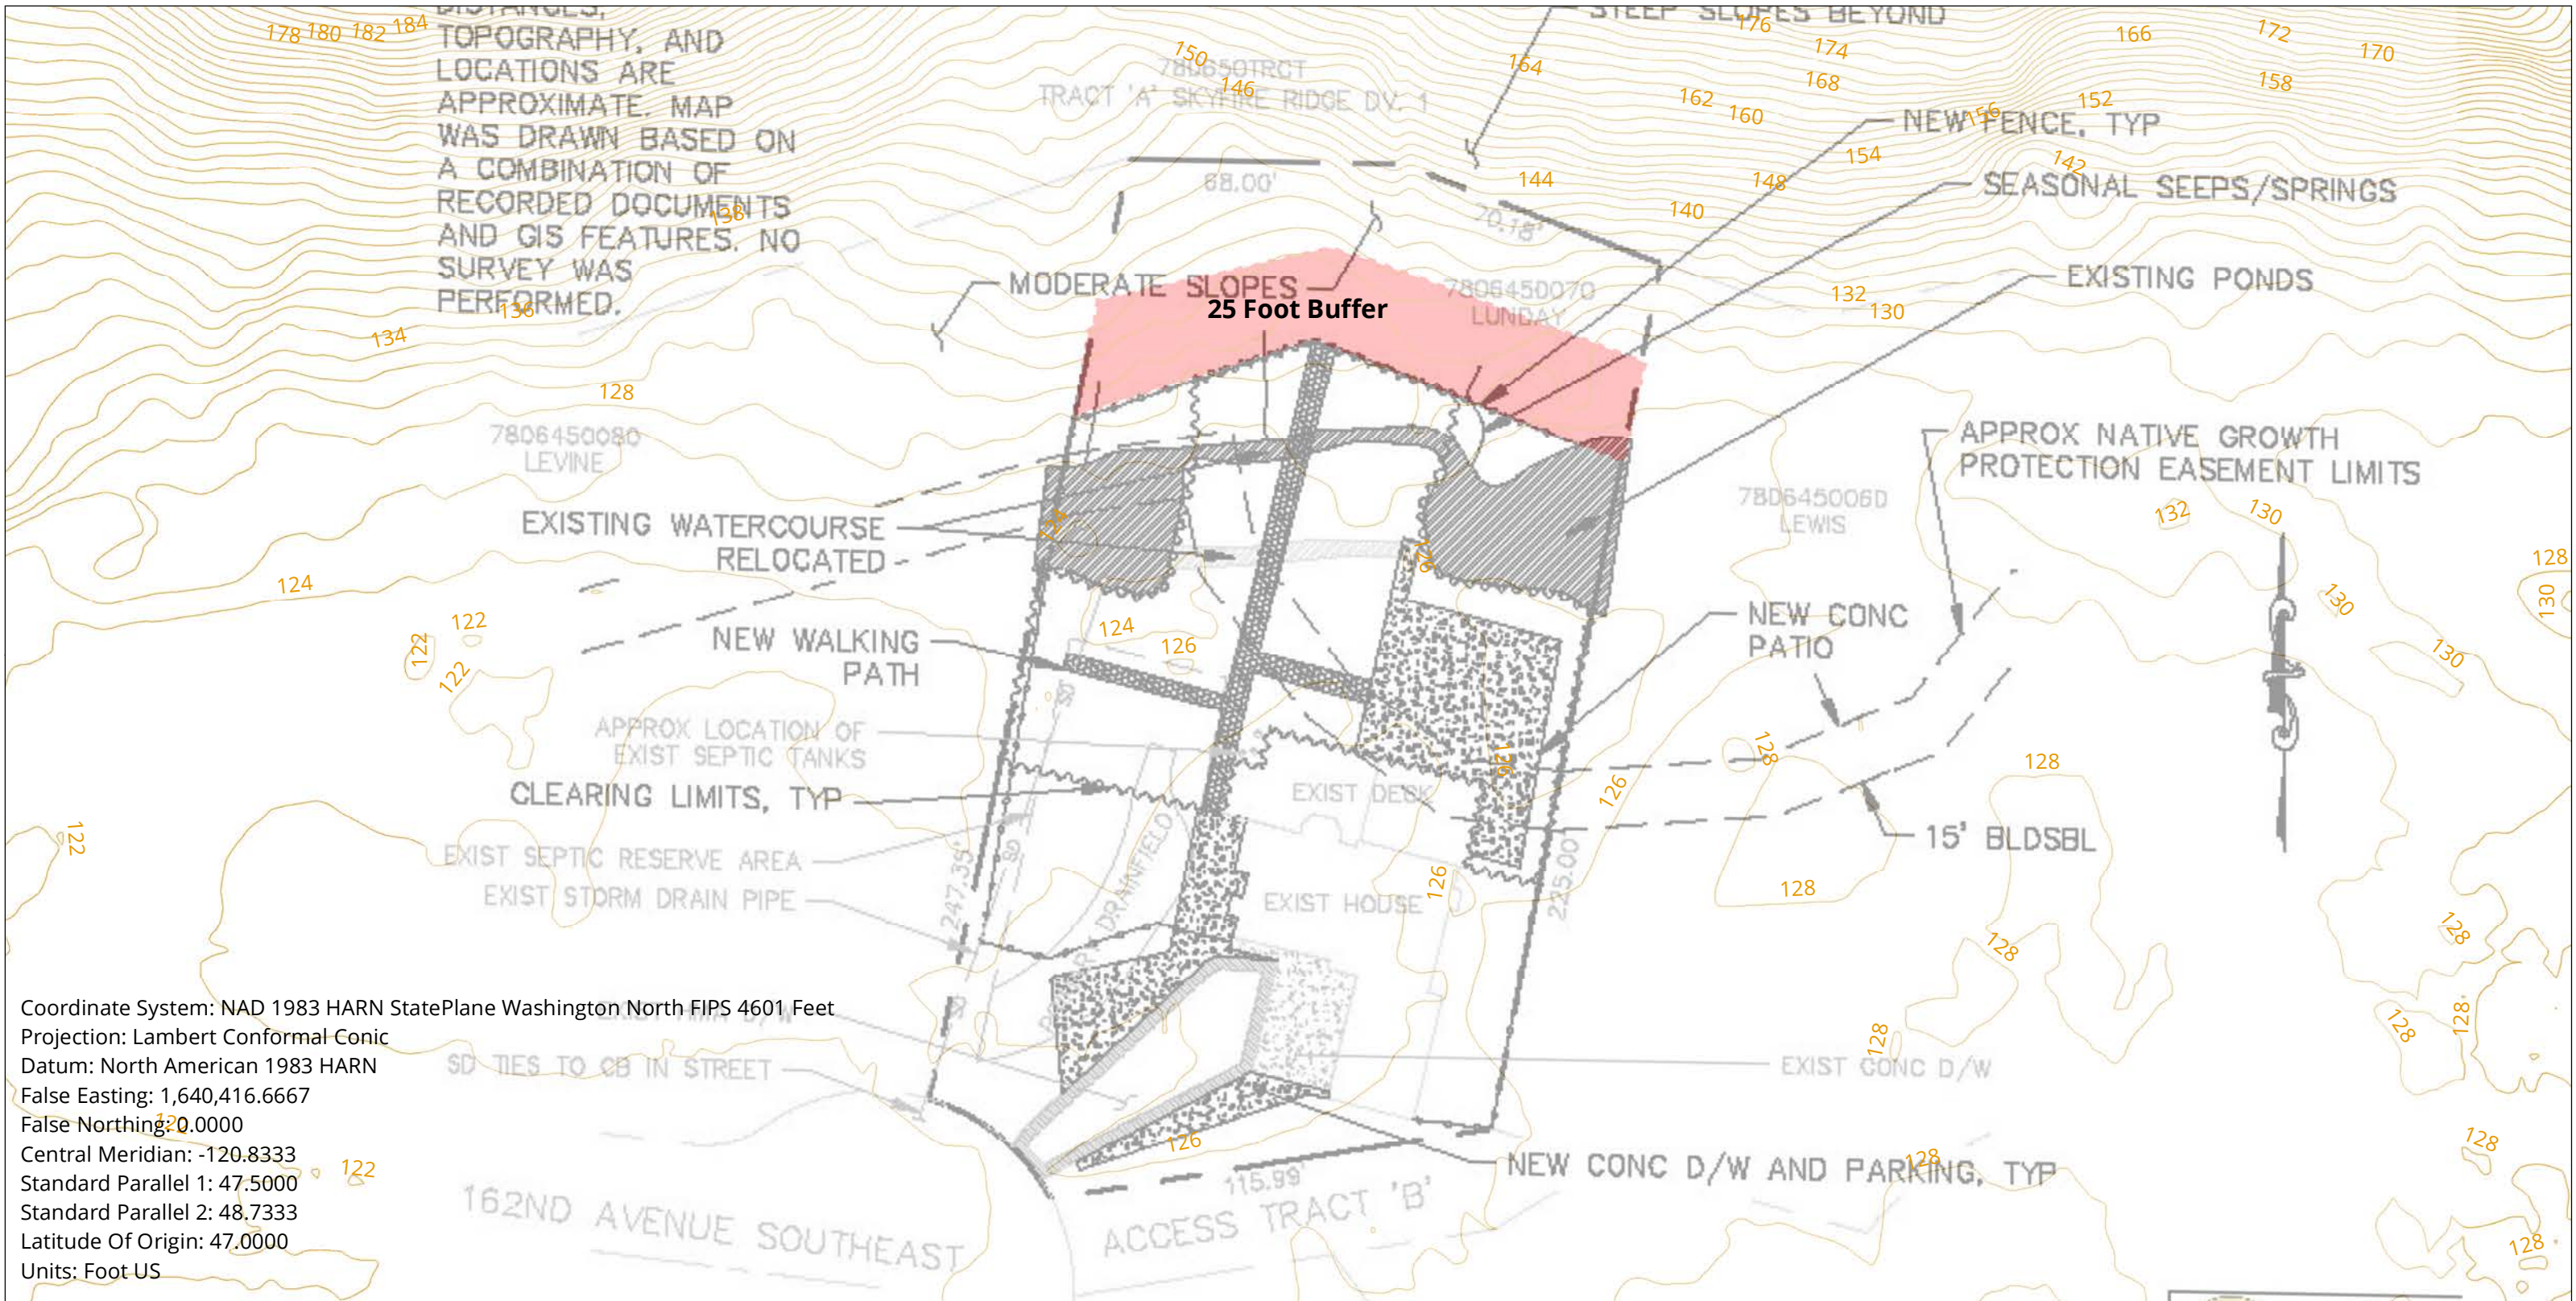
DocID:Lunday.162ndAveSE	August 2021	Figure 2
-------------------------	-------------	----------

Our understanding of the project is based on our email and phone conversations with Mr. Ron Lunday; our review of the available geologic and soil literature for the site; our June 22, 2021 site visit; our review of the King County Permitting Division *PREA20-0252-EnFR20-0444, parcel 7806450070 Critical Area Requirements*; our understanding of the King County Code Critical Areas and Resource Land Ordinance 180, Section 08, Geologically Hazardous Areas; our review of the provided residential site plan by Valor Civil Engineering, and our experience in King County. The violation was from unpermitted 2019 landscaping and drainage adjustments completed in a mapped landslide buffer zone located in the northern to central portions of the site. The landscaping alterations included adding new plants, replacing the existing pathways, and adding a gazebo and fence. Some trees and brush were removed to keep leaves and other brush from clogged the existing drainage ditch. Two existing ponds were also dredged of sludge. A copy of the site plan prepared by Valor Engineering is included as Figure 2.

The vegetation across the site generally consists of landscaped perennials and shrubs with scattered ferns and blackberries. The most common tree at the valley slope toe located adjacent to the northern site boundary is birch, with scattered fir and maple. The understory vegetation at the valley slope toe is very dense and consistent with a wet environment, with the most common plants being ivy, ferns, horsetails, and blackberries. The site configuration and existing topography are shown on the Site Plan, Figure 2 and the Site Vicinity Map, Figure 3.

As described above, it is our opinion that the valley slope that extends along the northern site boundary and steepens to the north is a landslide hazard area. The valley slope is also considered a steep slope hazard area. We recommend that a 25-foot buffer of native vegetation be established from the landslide hazard and steep slope hazard area. Based on our site observations and measurements, it appears a dense zone of vegetation is currently established in the recommended buffer zone. The approximate buffer distance is labeled on the Site Plan, Figure 2.

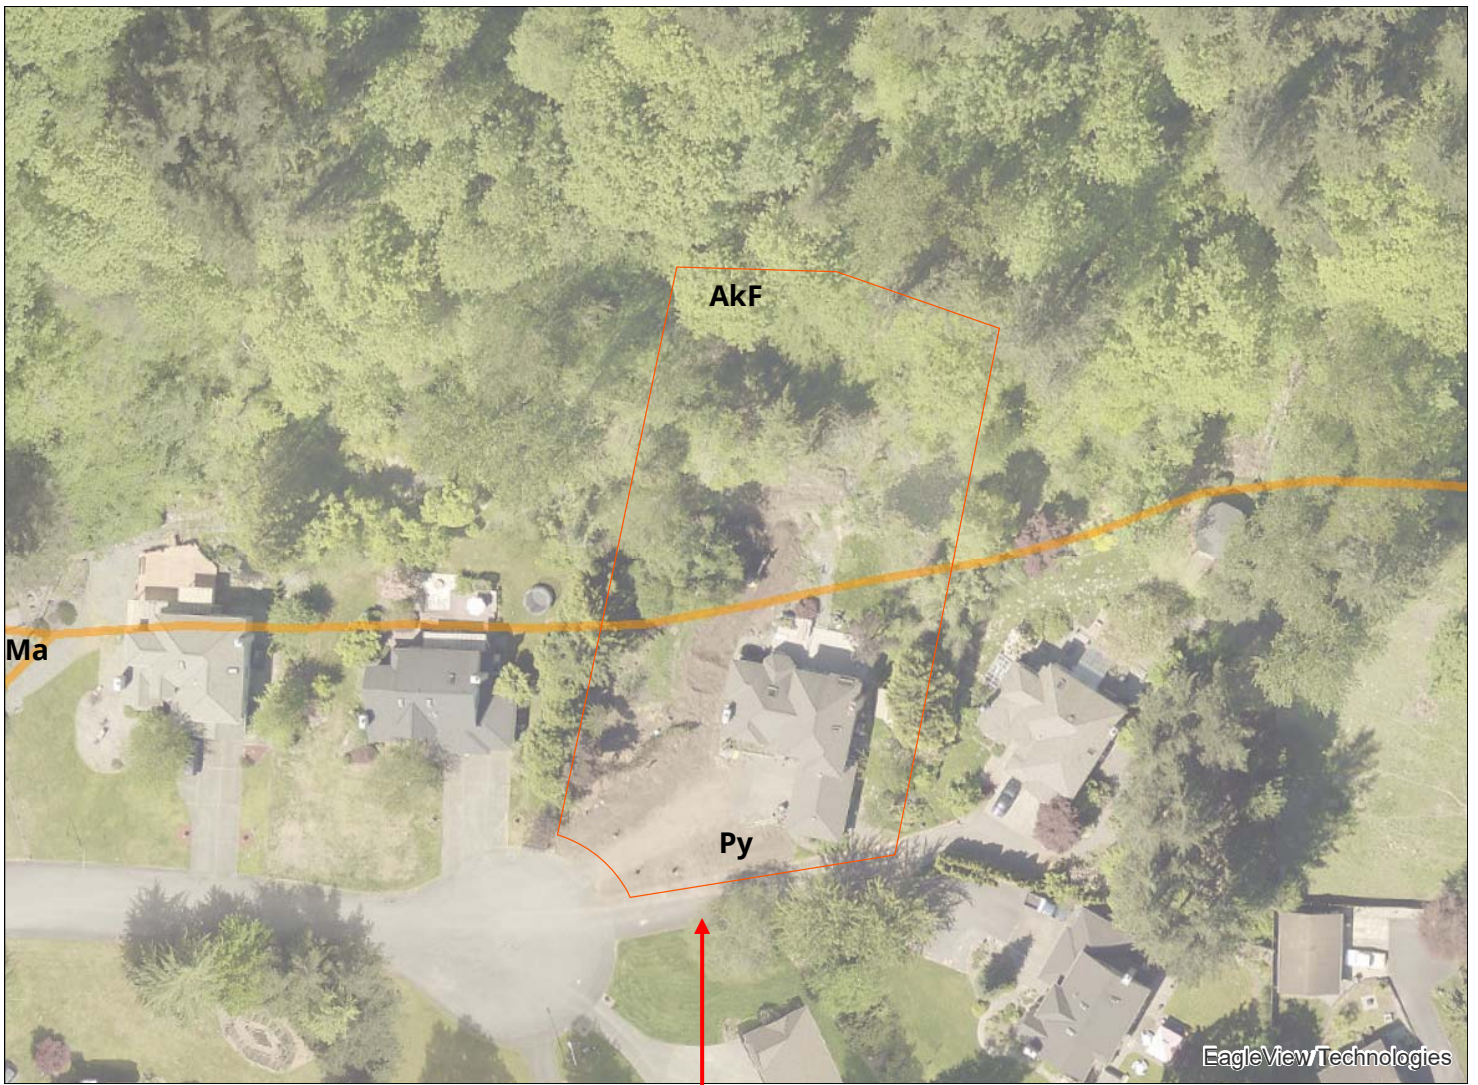
Figure 4

The USDA Natural Resource Conservation Service (NRCS) Web Soil Survey maps the soils underlying the site as Alderwood and Kitsap soils, very steep (AkF) and Puyallup fine sandy loam (Py). A copy of the NRCS Web Soil Survey for the site and surrounding area is attached as Figure 4.

- Alderwood and Kitsap soils, very steep (AkF): Alderwood and Kitsap soils, very steep are derived from basal till with some volcanic ash, has a severe erosion hazard when exposed and is included in hydrologic soils group B. This soil is mapped to underlie central to northern portions of the site.
- Puyallup fine sandy loam (Py): The Puyallup fine sandy loam is derived from alluvium, has a slight erosion hazard when exposed, and is included in hydrologic soils group A. This soil is mapped to underlie the level to slightly sloping southern portion of the site.

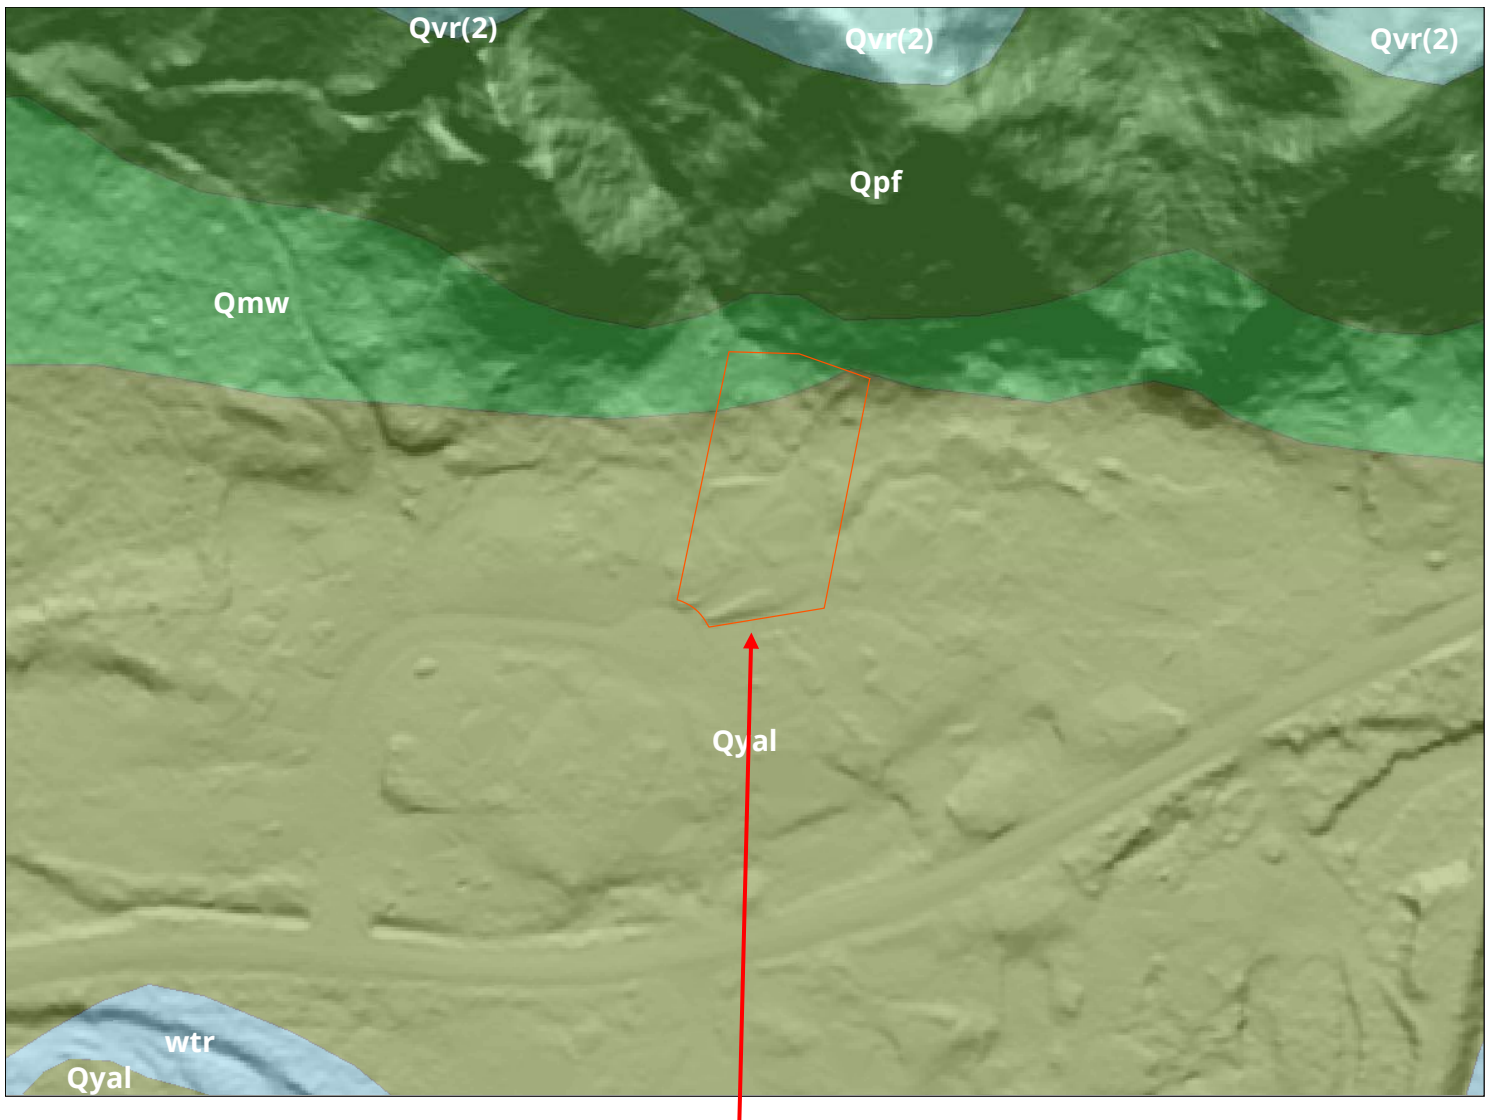
DocID: Lunday.162ndAveSE.F	August 2021	Figure 5
----------------------------	-------------	----------

The 1:24000 scale *Surficial Geologic Map of the Maple Valley Quadrangle, King County, Washington* by D.B. Booth (1995) maps the geology of the site as younger alluvium deposits (Qyal) and mass wasting deposits (Qmw). An excerpt of the digitized referenced geologic map is attached as Figure 5.

- Younger Alluvium Deposits (Qyal): The alluvium deposits generally consist of clay, silt, sand, and gravel deposited in streambeds and floodplains. Younger alluvial soils are recent deposits that were generally deposited along major rivers and stream. Because of the depositional environment, the alluvium soils are generally in a normally consolidated state and exhibit low to moderate strength and moderate to high compressibility characteristics, depending on grain size. The younger alluvium deposits are mapped to underlie the site to northwestern corner.

- Mass Wasting Deposits (Qmw): Mass wasting deposits generally are Holocene age (previous 10,000 years) colluvium consisting of a poorly sorted mix of clay, silt, sand, and gravel with scattered to abundant organics deposited from landslide failures. These deposits have an indistinct geomorphology and are found along the Cedar River valley. The mass wasting deposits are generally encountered in a normally to loosely consolidated state and exhibit low strength and compressibility characteristics where encountered. This geologic unit is mapped to underlie the northwest corner of the site.

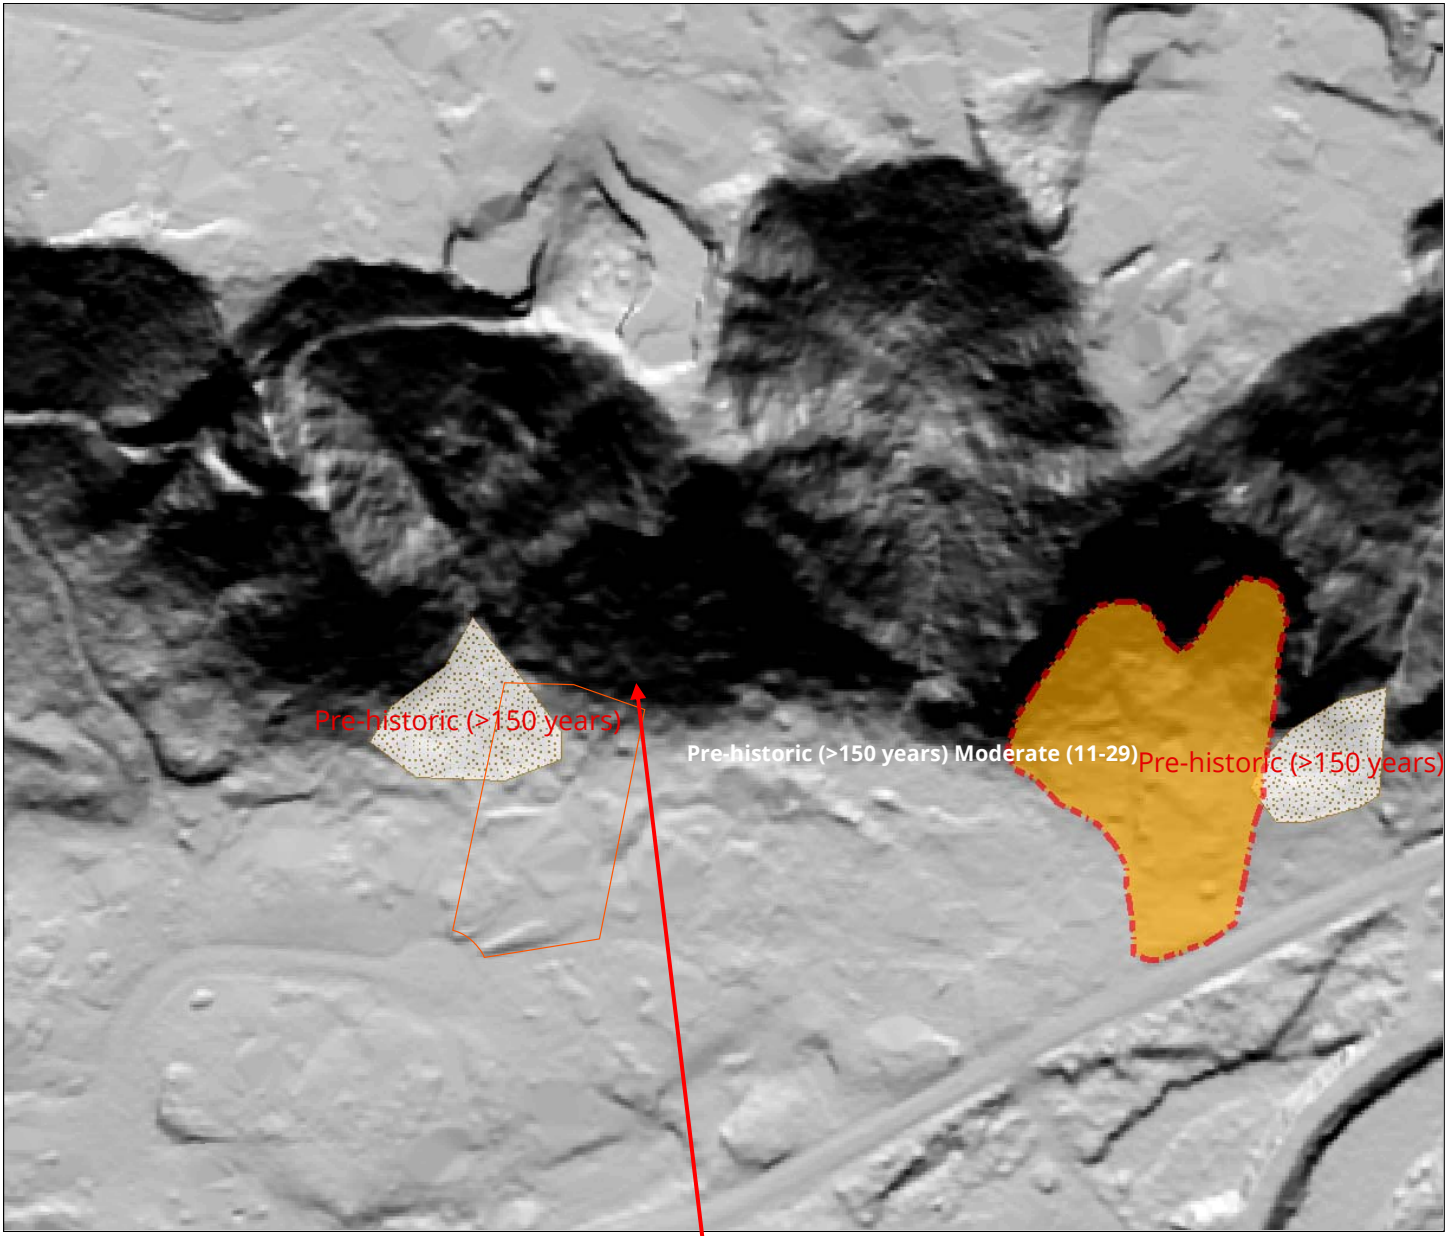
The WA DNR Landslide Inventory maps a landslide deposit with “moderate” confidence (confidence is on a 1 to 10 scale, with 1 being lowest and 10 being highest) about 680 feet to the east of

the site. The deposit is mapped to have a failure depth of about 82 feet and a head scarp height of 100 feet. The deposit is considered prehistoric in age (greater than 150 years) and was not confirmed in the field. No landslides are mapped by the WA DNR Landslide Compilation to within 300 feet of the site. An alluvial fan is mapped with "moderate" confidence to fan out across the northwest portion of the site. The WA DNR Landslide Inventory for the site and surrounding area is included as Figure 6.
