# COUNTYLINE LEVEE SETBACK PROJECT

## YEAR 3 MONITORING REPORT (2020)

Constructed: Summer 2017  
Planted: Winter 2017, Fall 2018, Fall 2019  
USACE Reference No. NWS-2011-211

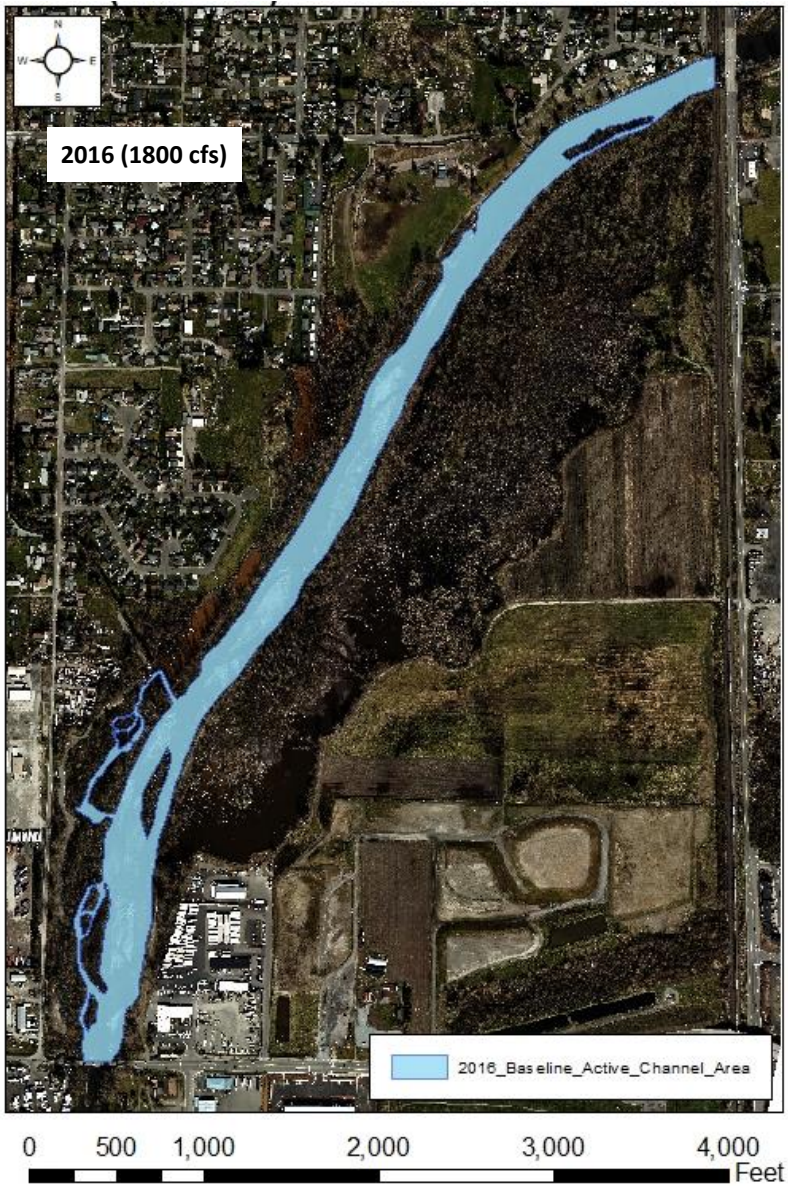
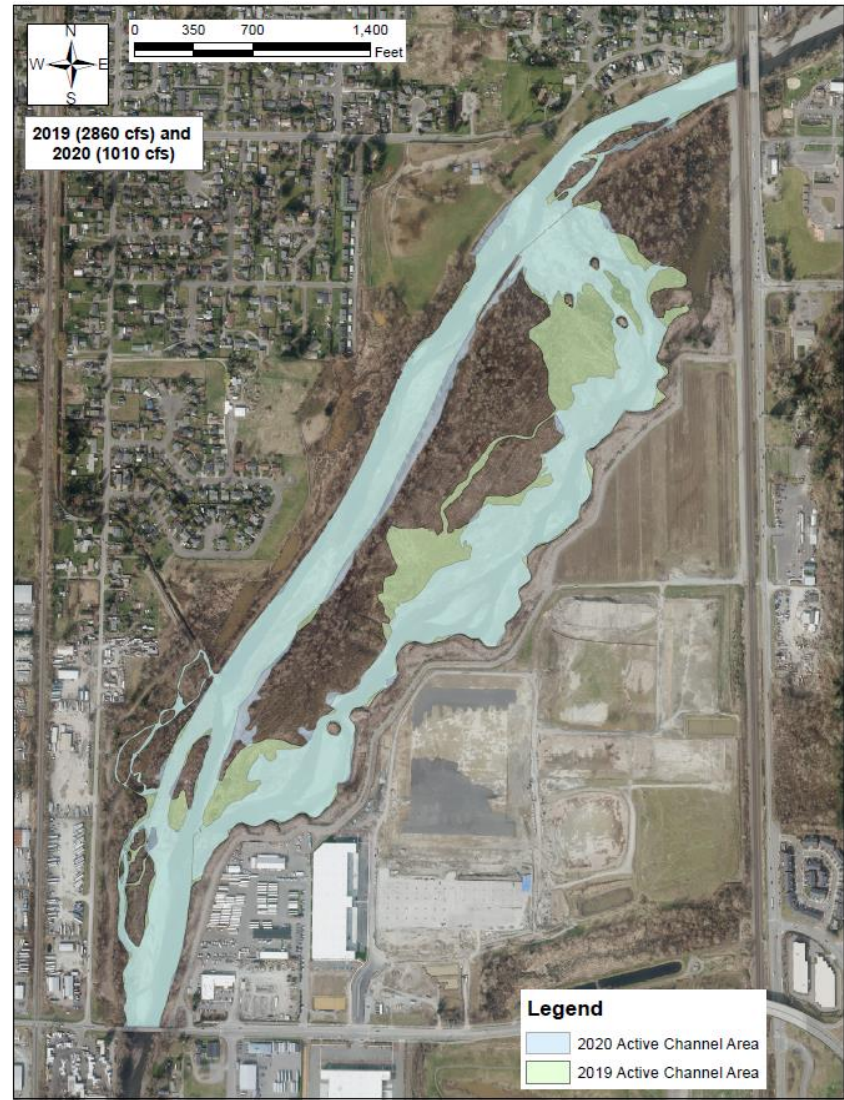
In 2020, the active channel location and planform of the mainstem were similar to 2019 and pre-project conditions (Figure 5). Active channel area in the project area (both mainstem and floodplain) decreased from 2019 to 2020 as the side channel has become more simplified, however across the reach the active channel remained 39.2 acres greater than at baseline (Table 4).

Figure 5. Change in active channel area between baseline (2016), Year 2 (2019), and Year 3 (2020).

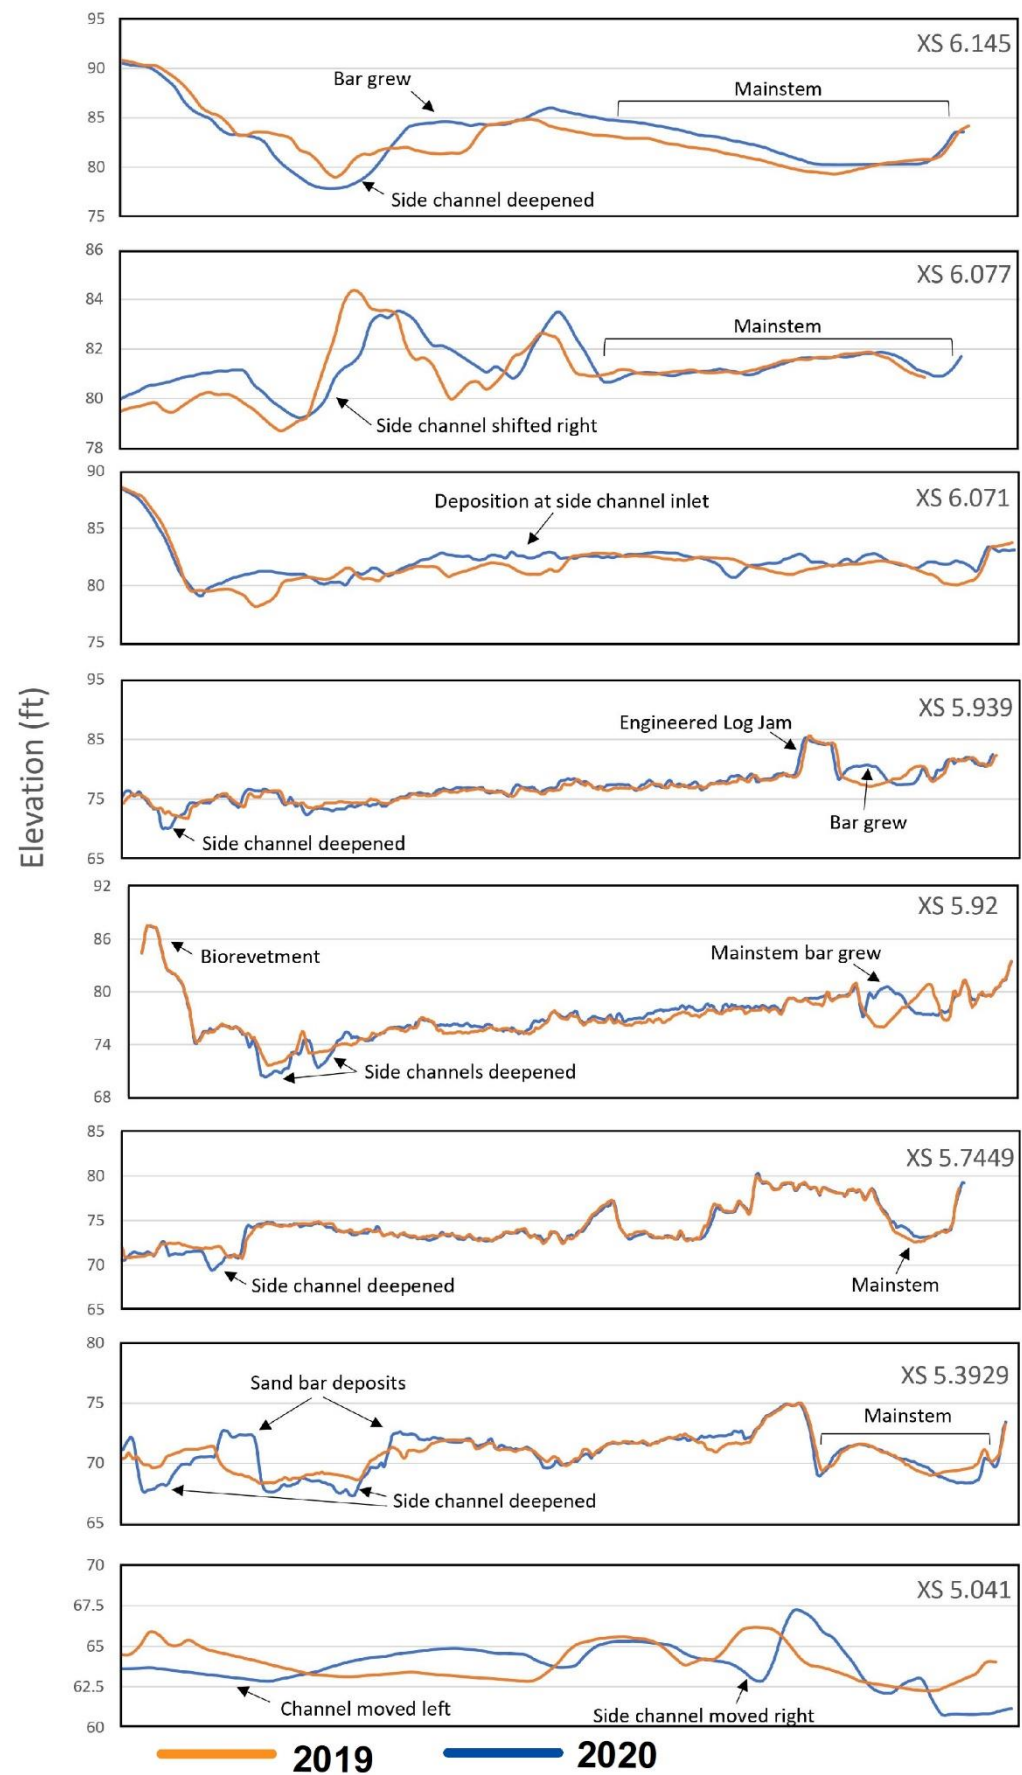
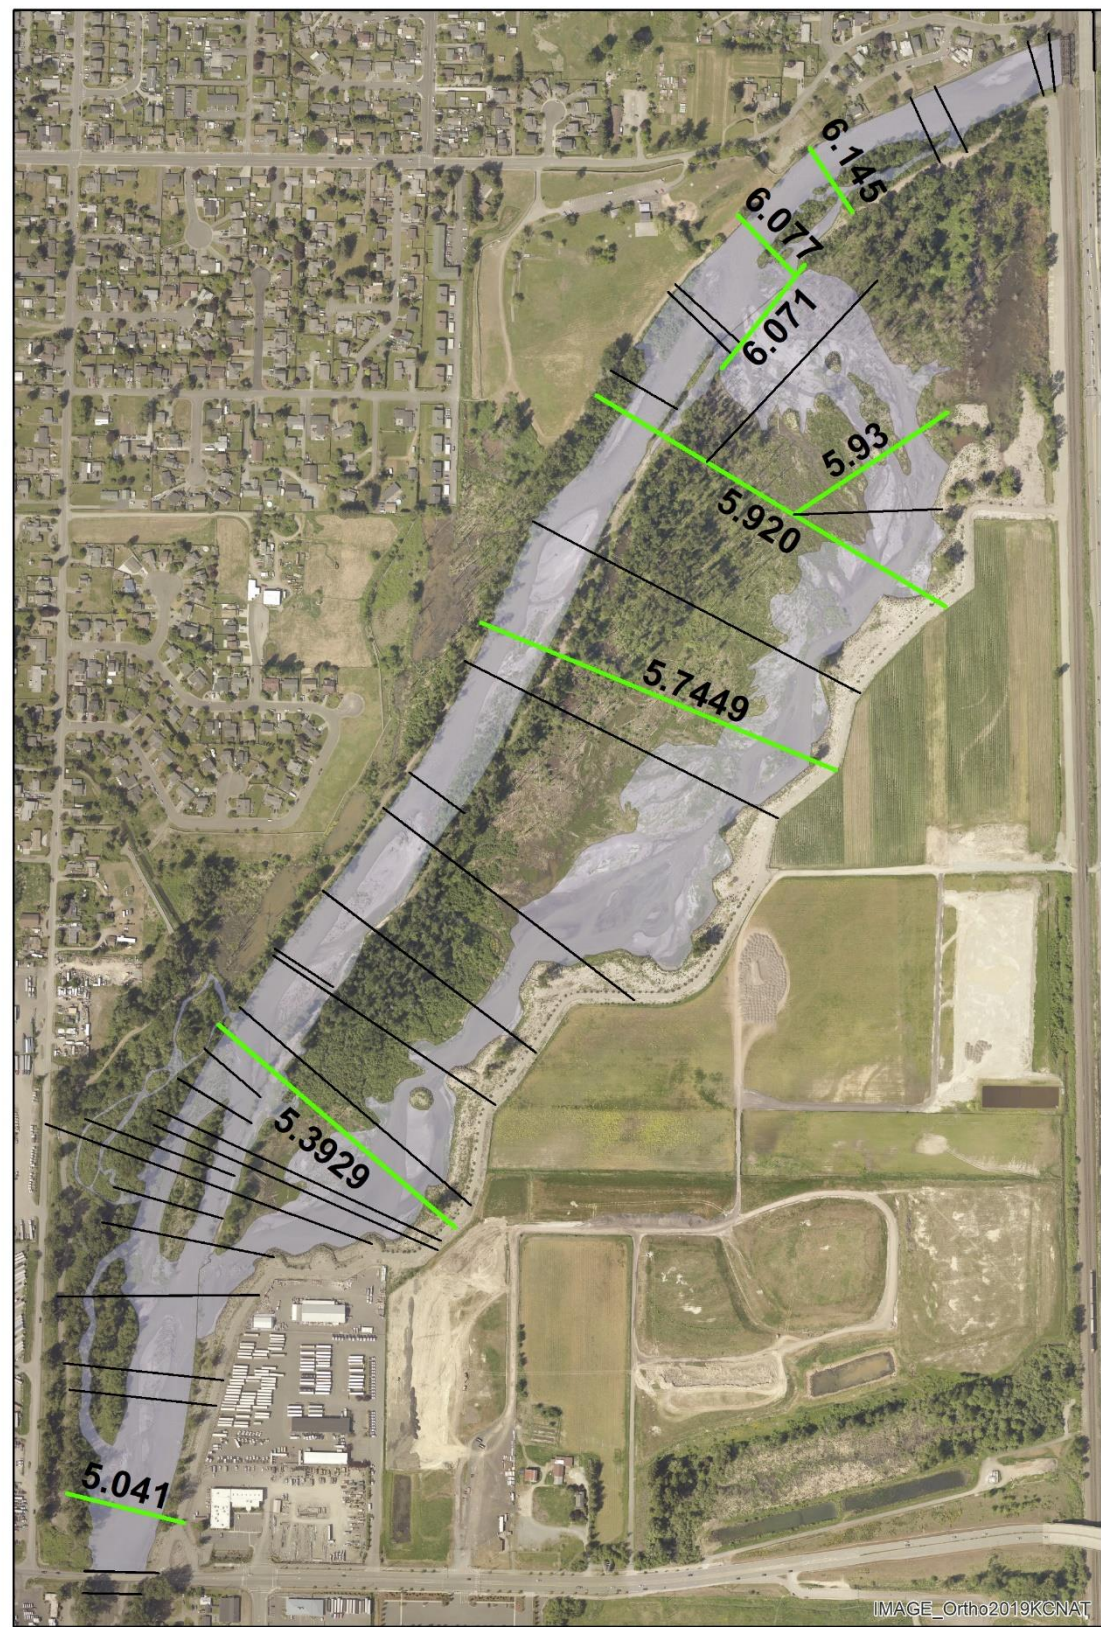
Figure 7. Cross sections comparing 2019 and 2020 channel bed elevations. Selected cross sections highlighted in green, and active channel shown in pale purple in the map on right. Lateral extent of each cross section was determined by channel extents, so levees and revetments are not shown.

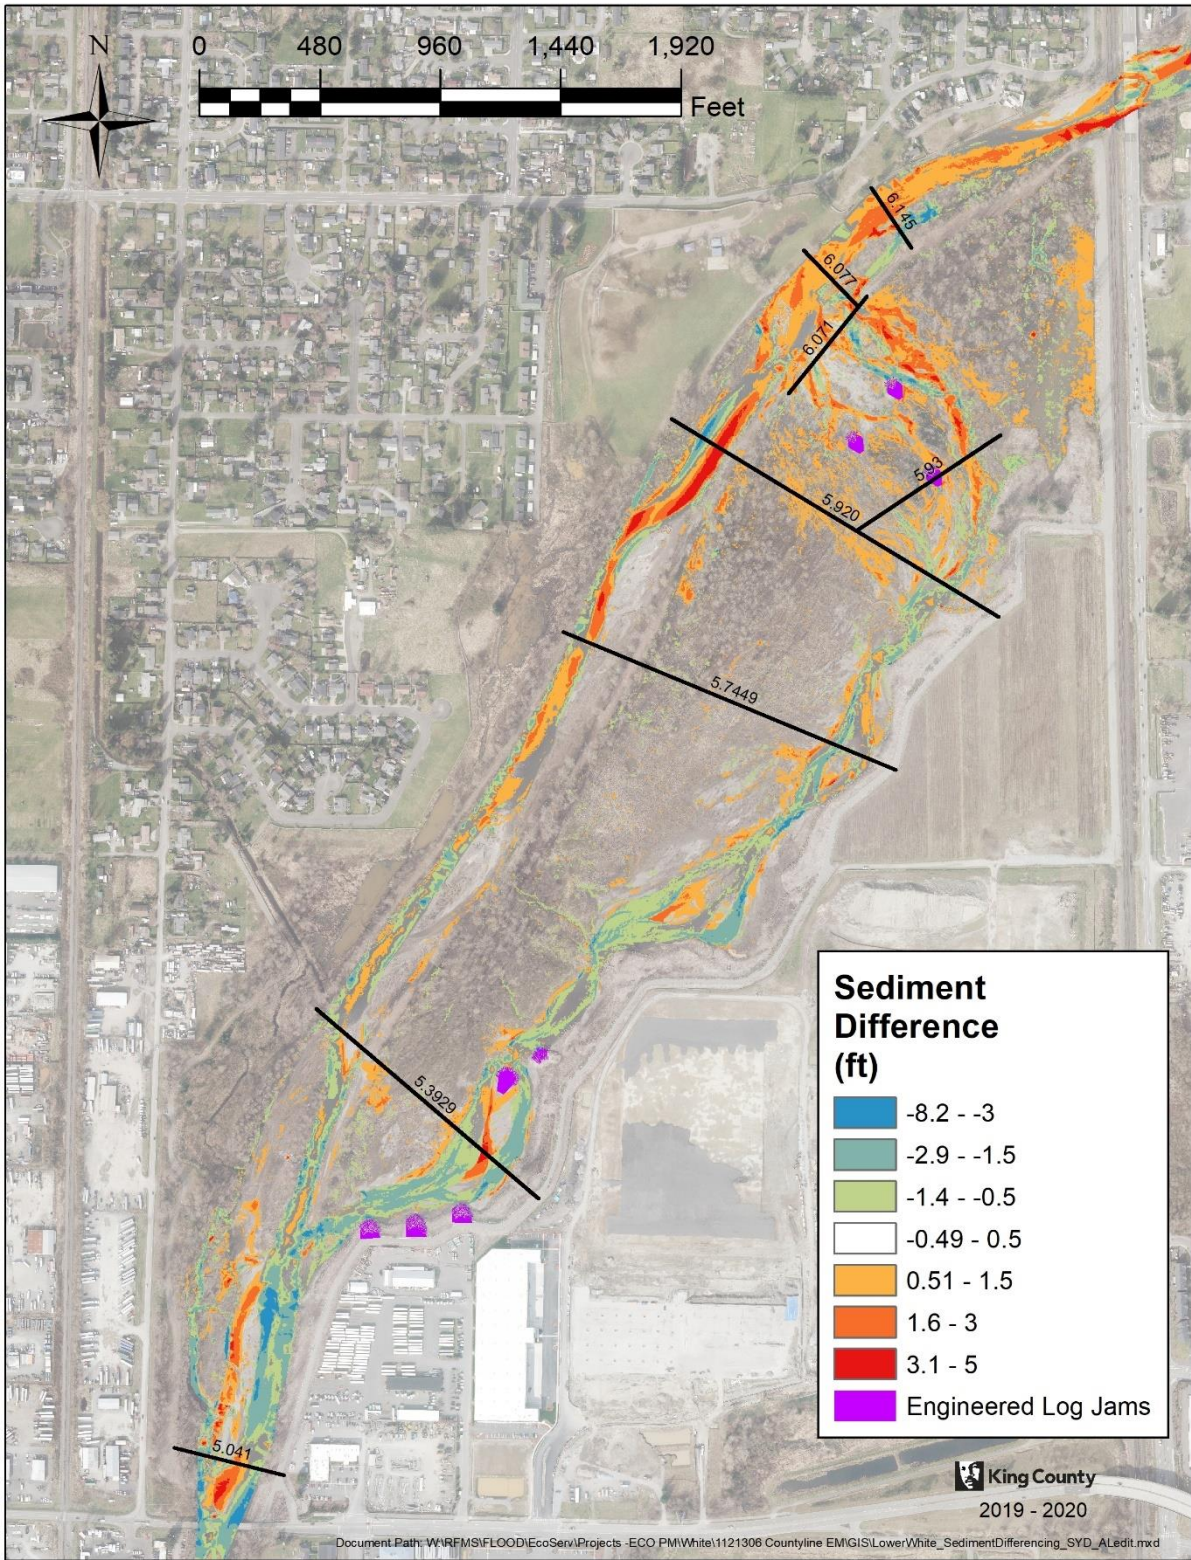
Between 2019 and 2020, a net loss of 2,137 cubic yards of sediment was estimated in the reach between the A Street and Stewart Street bridges. Most of the net erosion was observed in the downstream sections of mainstem and floodplain (Figures 8 and 9, Table 6); as calculated from LiDAR, a net 3,806 cubic yards of sediment moved out of the floodplain while 1,669 cubic yards of sediment was deposited throughout the mainstem. This is a different pattern than was observed in the first year post-construction, when large amounts of sediment were deposited throughout the floodplain, but especially in the downstream sections of floodplain where large volumes of sand-sized material were deposited. In Year 3, some floodplain sandbars enlarged (downstream from mid-project vegetated islands and downstream of the southern engineered log jam), while adjacent channels eroded sediment and deepened. Continued monitoring of sediment changes will increase our understanding of these channel responses; one explanation for sediment mobilization in downstream project areas is that deposition where the channel widens at the side channel inlet could have increased channel slope and resulted in increased water velocity and sediment export downstream.

Figure 8. Elevation change in the project area between 2019 and 2020.

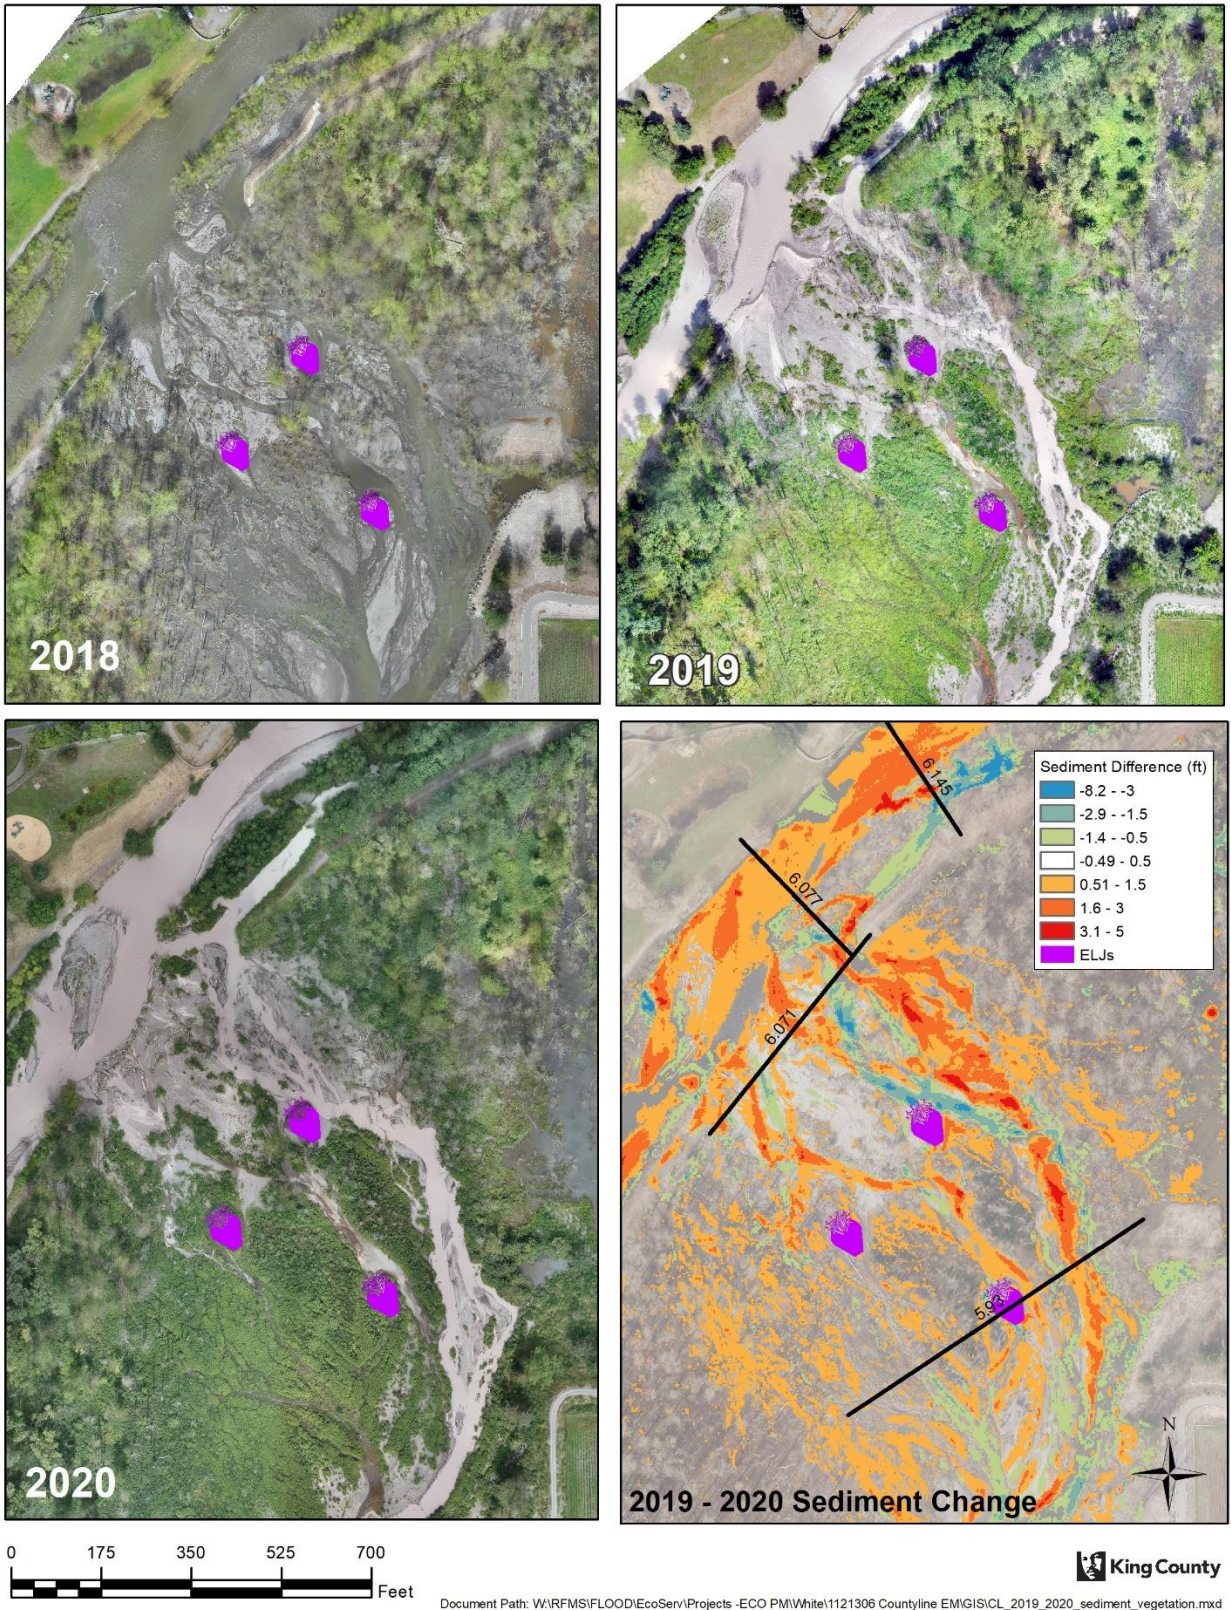
Figure 10. Aerial imagery and sediment differencing in the side channel inlet area between 2018 - 2020.

Vegetation growth may be contributing to patterns of channel development and aggradation at the inlet area. Portions of areas that were previously braided channel in 2018 have increased in vegetative cover over time (Figure 10), which may have slow flows and induced sediment deposition in these areas, resulting in concentrated flow in fewer braided channels. Concentrated flow may have contributed to the channel deepening observed along cross section 5.939 (Figure 7).

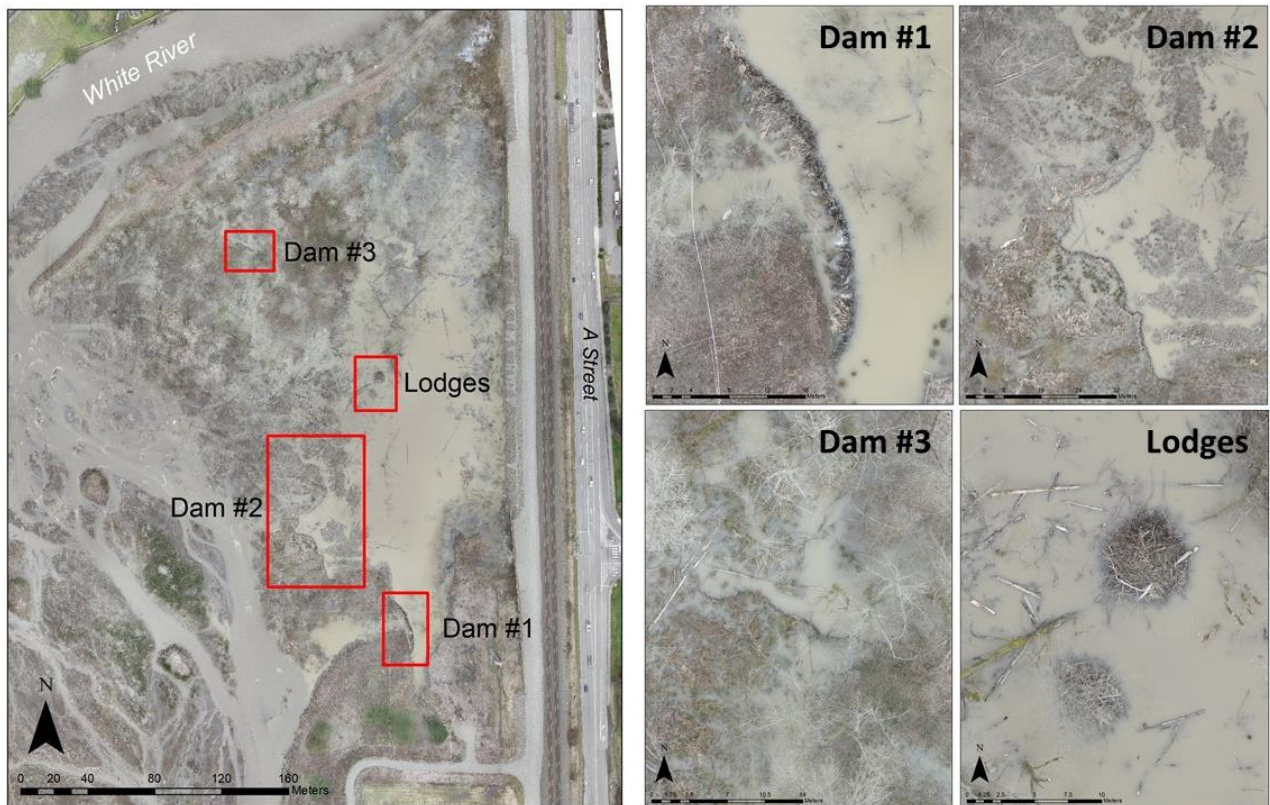
Figure 11. A complex of three beaver dams and 2 lodges visible in high resolution aerial imagery collected on February 23, 2021 (4,920 cfs at R Street gage).

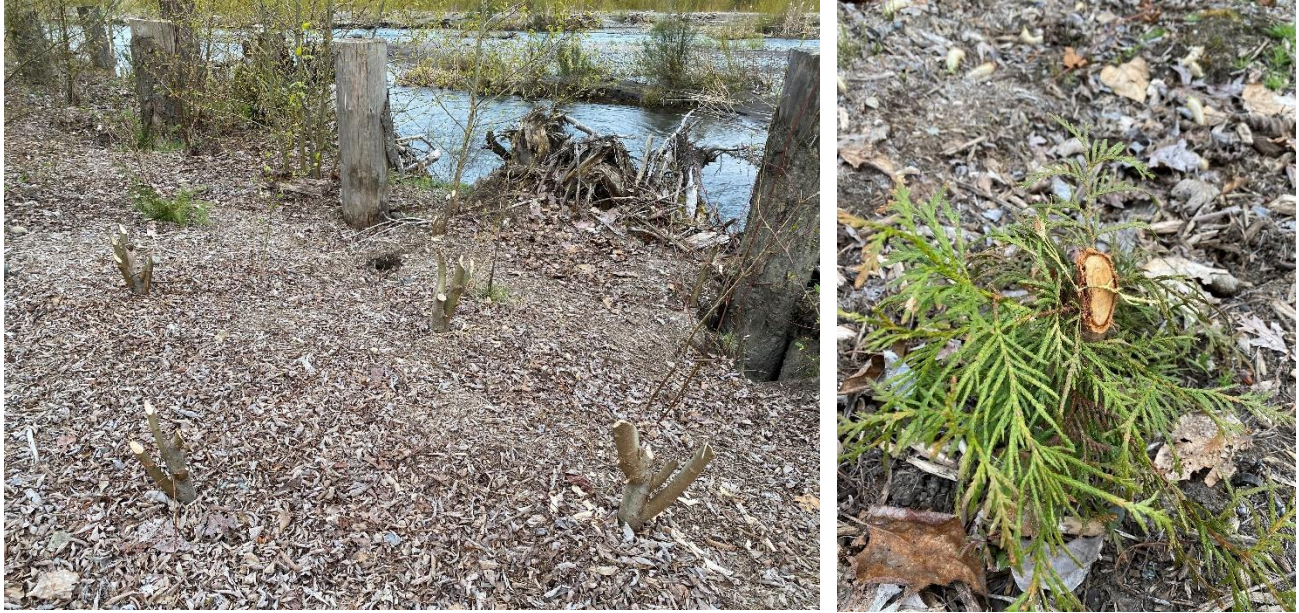
Figure 12. Beaver browsed willow (left) and western red cedar (right) observed April 2021.

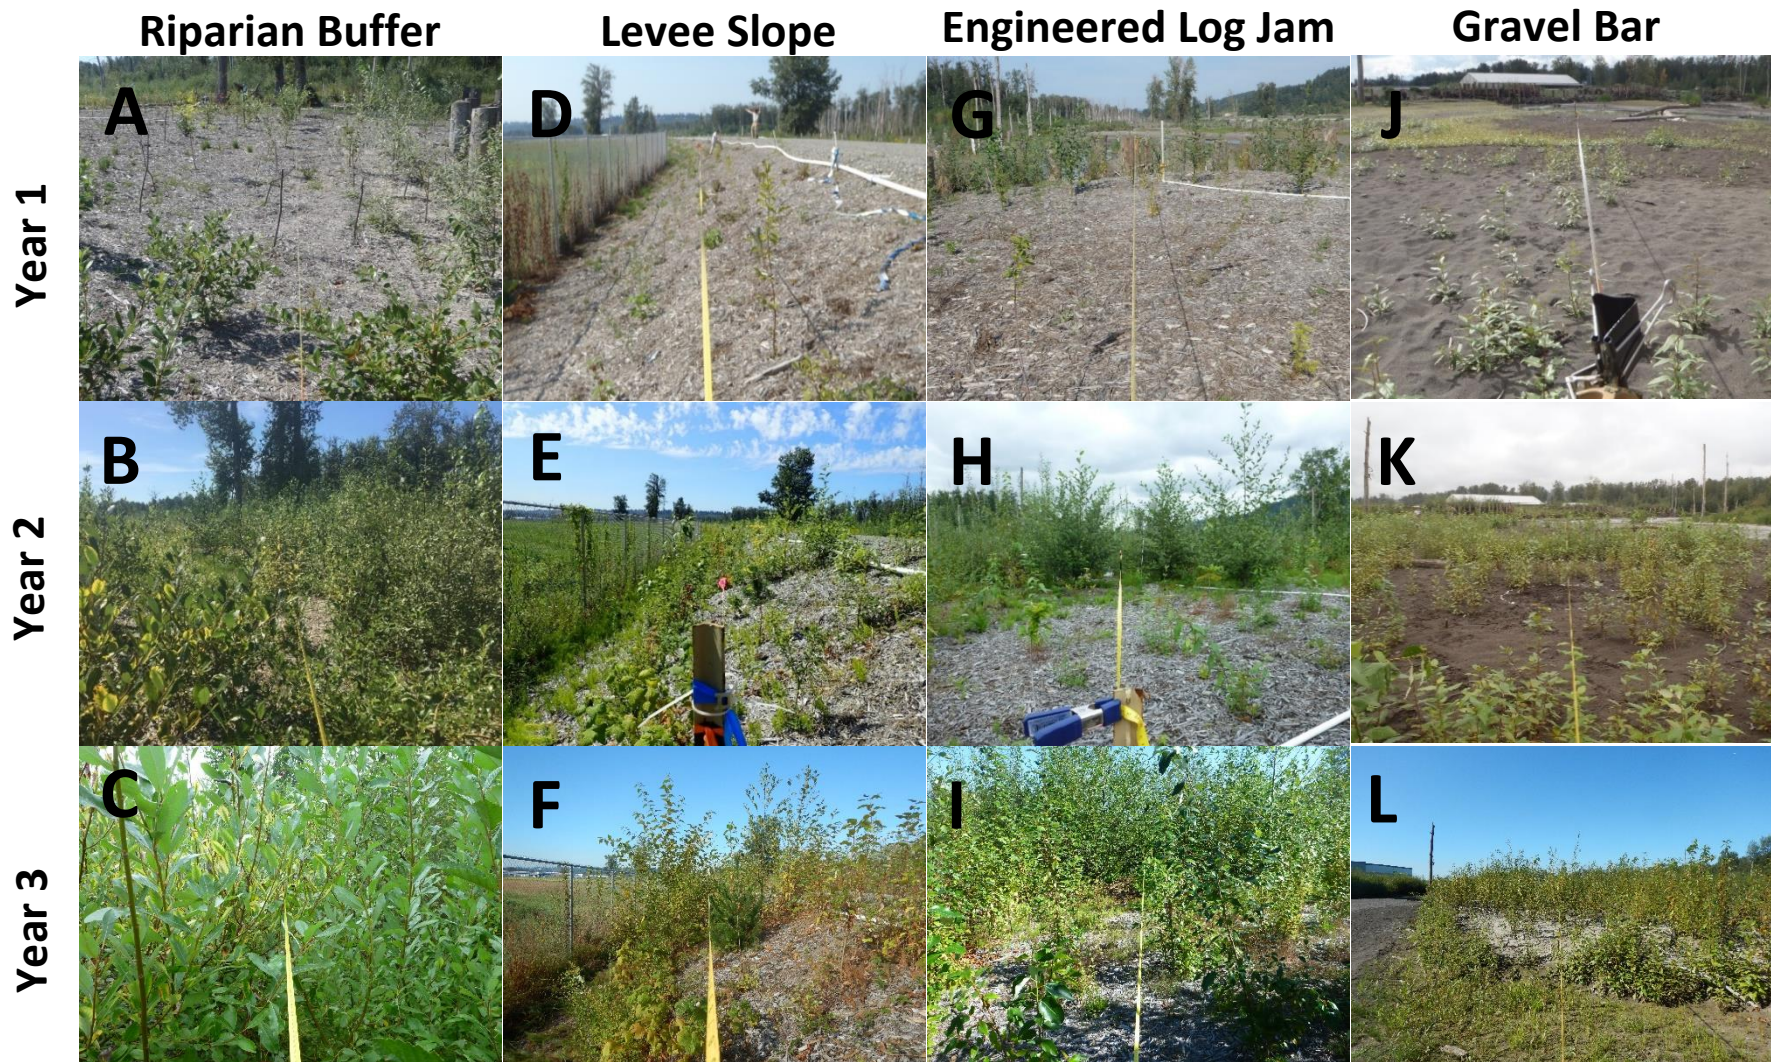
Figure 14. Photos of vegetation transects in riparian buffer, levee slope, engineered log jam, and unplanted gravel bar areas at Year 1, 2, and 3. Panels A,B,C show transect RB-3 (at 0-m), D,E,F show transect LS-1 (at 0-m), G,H,I show transect ELJ-2 (at 15-m), and J,K,L show transect GB-2 (at 0-m).

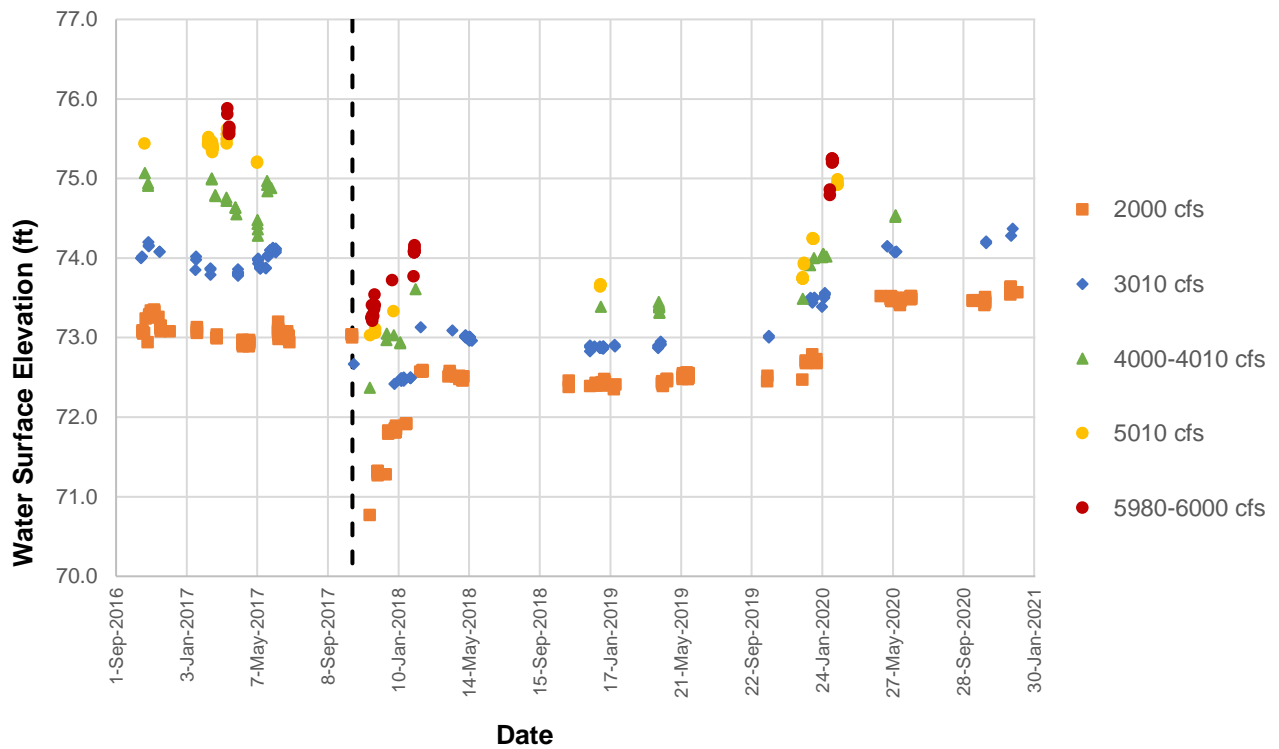
Figure 22. Water surface elevation at USGS 12100498 White River at Pacific, WA. The river initially breached the lowered levee on October 21 2017 (dashed line).

Flood flows since October 2017 and through 2020 were conveyed through the Countyline project area, as expected, and water surface elevations in the mainstem White River at USGS gage 12100498 at Pacific decreased at a given discharge, particularly at higher flows (Figure 22). Substantial reductions in water surface elevation in the mainstem White River were observed immediately after the river initially breached the levee and inundated the floodplain in October 2017; a larger proportion of flow was directed into the floodplain than the mainstem during the first flood season. Subsequent patterns of sediment deposition in the floodplain through the end of 2019 redirected the majority of flow back into the mainstem White River. The aggradation at the side channel inlet following the flood event in February 2020 resulted in another change in water surface elevations in the mainstem White at a given discharge; at lower flow, less water appears to be entering the left bank floodplain than in 2019, as inferred by higher water elevations in the mainstem (Figure 22). At higher flows (e.g., 5000-6000 cfs) mainstem water surface elevations remained lower than pre-project conditions, indicating that the project continues to provide improved flood conveyance in the Countyline reach.
