**King County Department of Natural Resources and Parks
Wastewater Treatment Division**

Equity and Social Justice Review of Facilities

November 2013

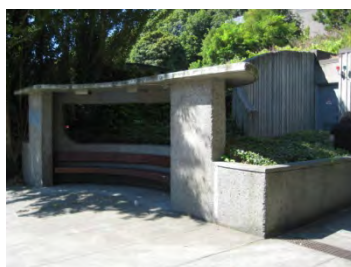
It is recommended that maintenance frequency be increased in facilities that are heavily used by the public. Overall, the maintenance of all the facilities observed was good but facilities such as Dexter Regulator Station and University Regulator Station should be put on a tighter schedule for general litter and pressure washing. These facilities have popular amenities that provide seating and shelter for people waiting for buses.

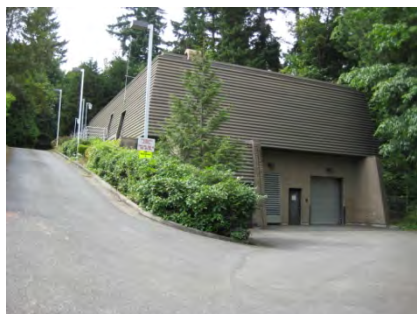
Heathfield Pump Station

It is recommended that densely planted masses of shrubs and groundcovers for landscaping should be used whenever possible. This type of landscaping was found to be attractive and gave the appearance of being well maintained while out competing the weeds and reducing the maintenance needed. The shrubs can also provide attractive screening to buffer our facilities.

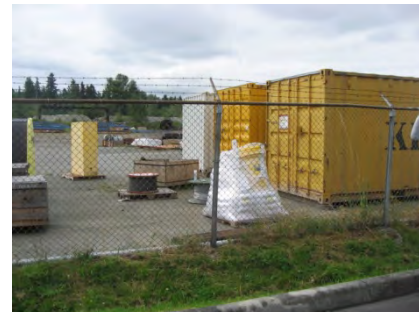
Adjacent view of Kenmore Pump Station

It is recommended that all facilities should be visited to note dramatic changes in the adjacent land uses. This is to evaluate the changes and determine if any modifications might be needed to our facilities or the landscaping. For example, the Kenmore Pump Station is currently in a heavily industrial area, but there are future plans to build a large condominium complex adjacent to that facility. When that construction happens, it would be recommended that additional landscape screening be placed to buffer the facility and a more “friendly” fencing be designed and installed.

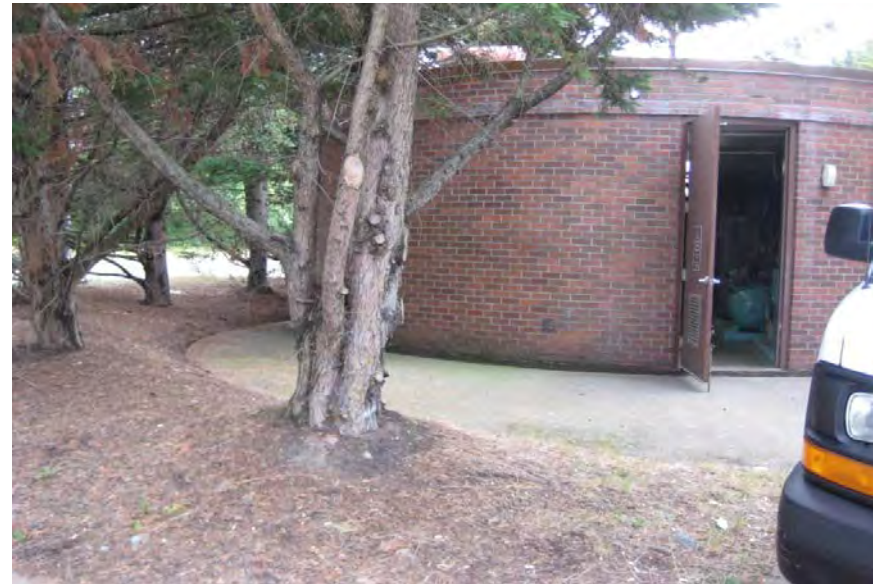
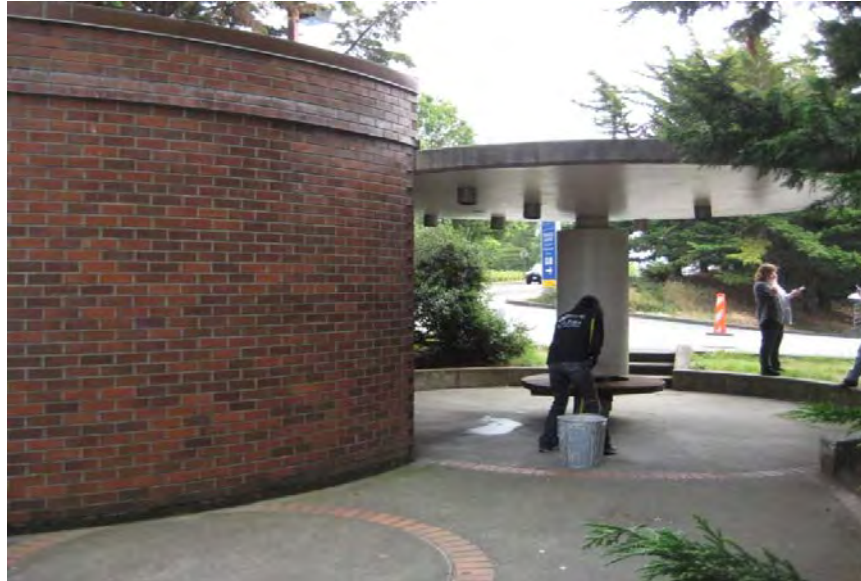
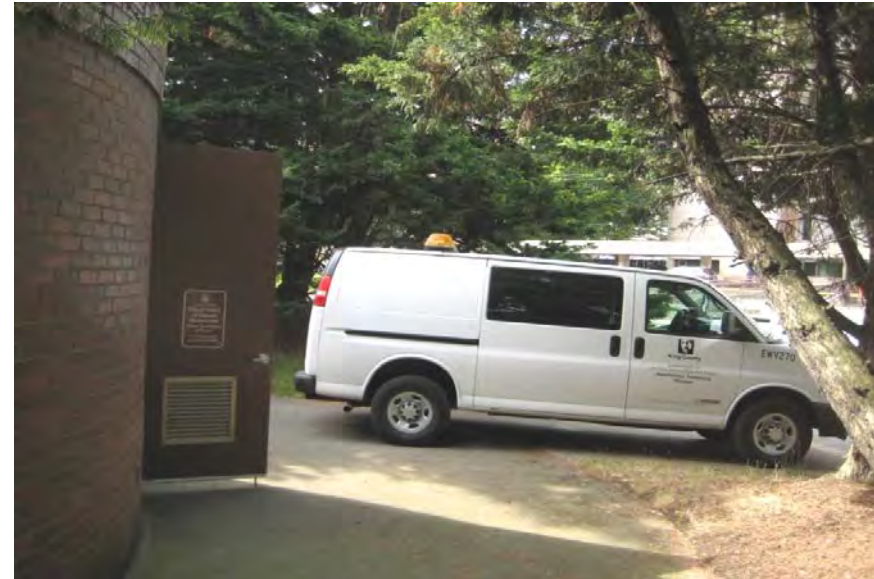
Log-boom Regulator Station

Odor control standards were found (of the three characteristics measured) to meet the highest standards across all land use categories with only one, our Logboom facility, falling below standard in odor control at the time that site visits were completed for this study.

It is recommended that odor control at the Logboom Regulator Station be addressed. WTD has done a very good job with odor control overall. It was found that, at least during the time of site visits, all but one of WTD's facilities had slight to no odor present. The exception was found to be the Logboom Regulator Station, whose odor was quite noticeable. Logboom Regulator Station odor control should be dealt with on a priority basis, because of its prominent location next to a heavily used trail, public park, and playground.
