JUNE 2015

**EQUITY AND SOCIAL JUSTICE
REVIEW OF FACILITIES:**
ASSESSMENT OF RESIDENTIAL-AREA
PUMP STATIONS

King County

Department of Natural Resources and Parks
Wastewater Treatment Division

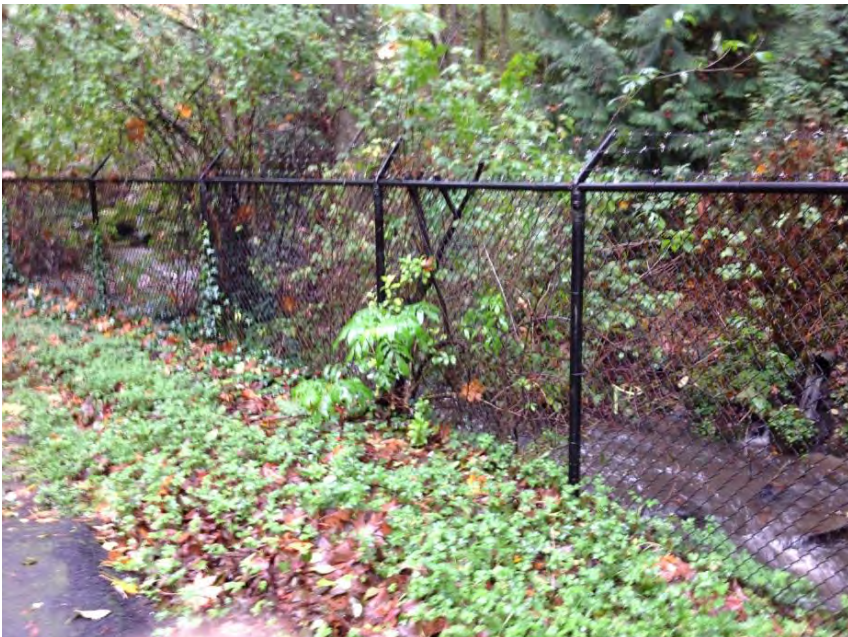
View of the property line. Note the barbed wire fence.

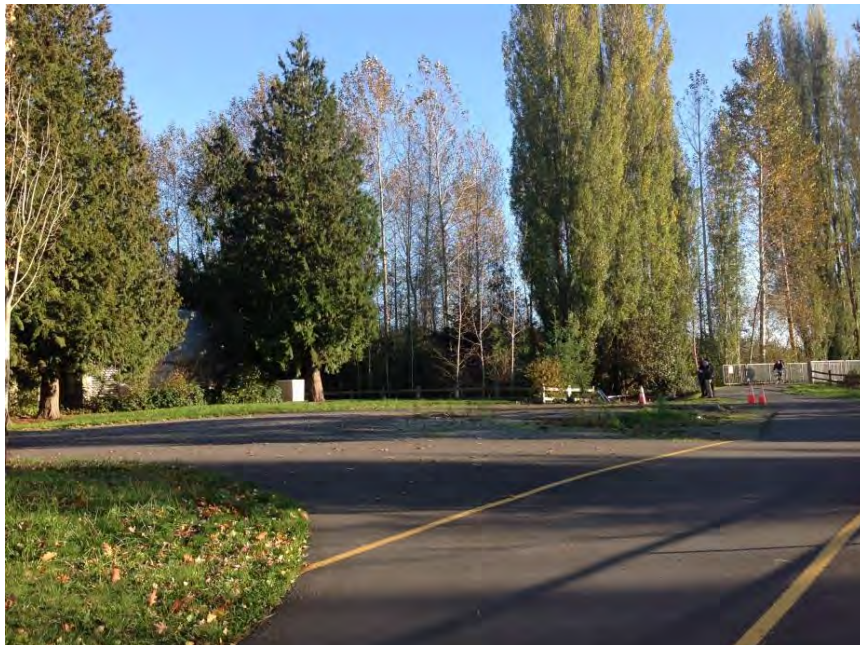
From the Sammamish River trail, view of buffer, odorous manholes and wetland mitigation area; pump station to the left side of the photograph

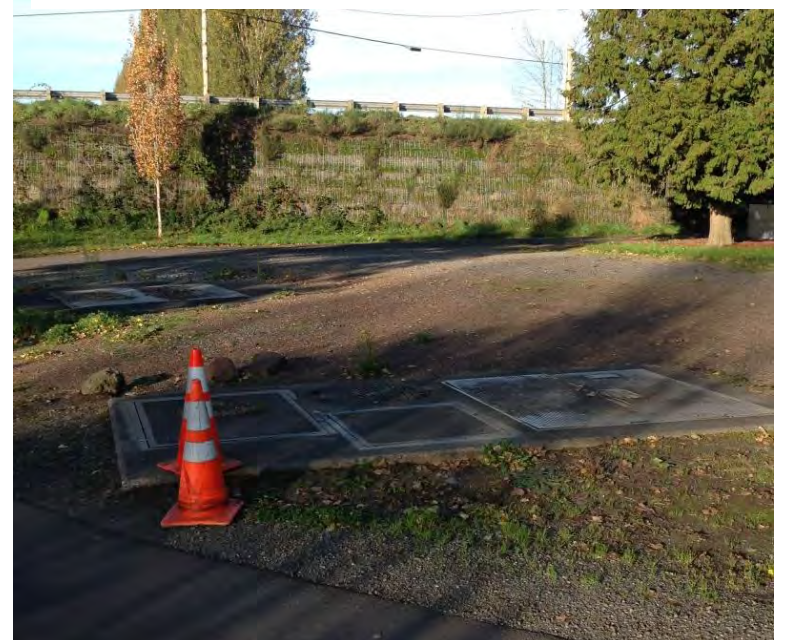
Manholes on pump station property adjacent to the Sammamish River trail emitting strong odors

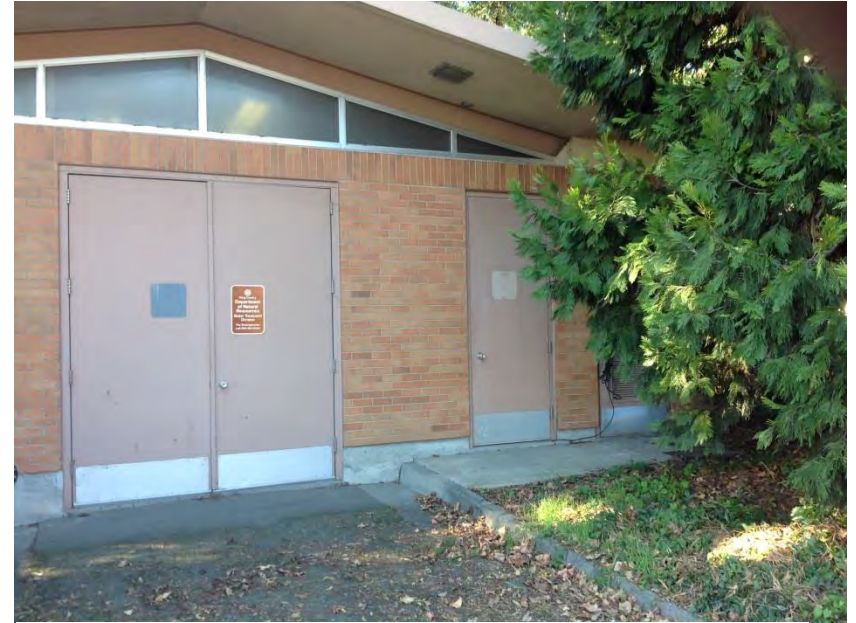
Front entry to Juanita Bay (East) Pump Station.

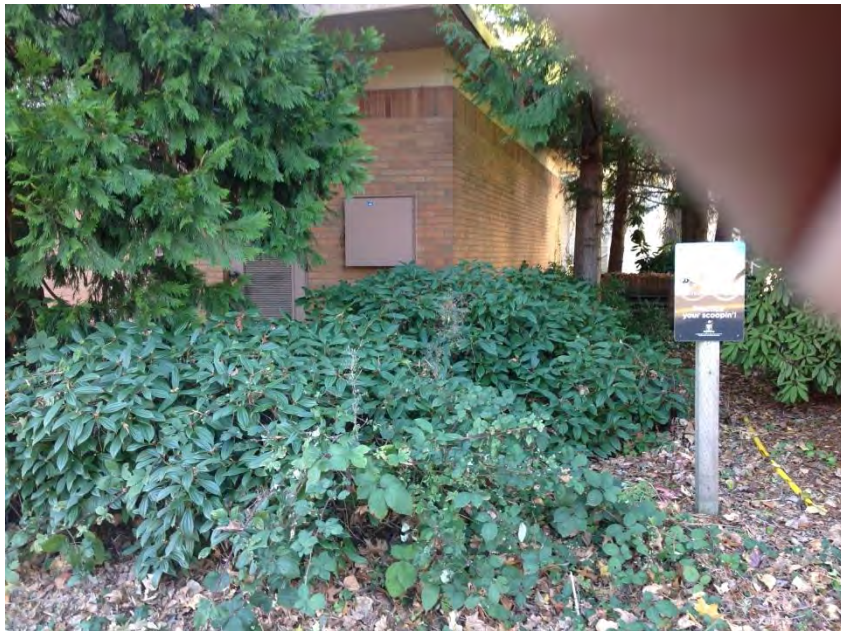
Side view of Juanita Bay (East) Pump Station.

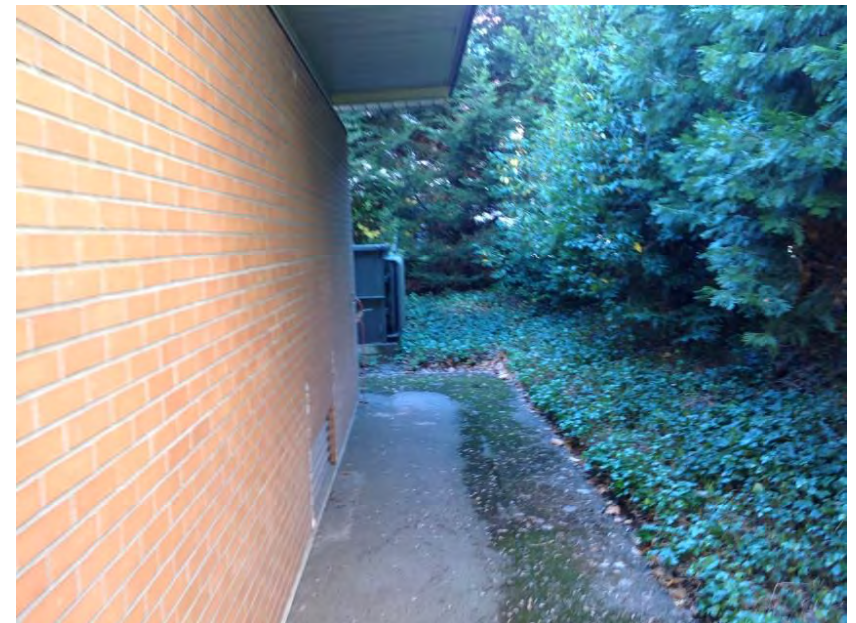
Rear of Juanita Bay (East) Pump Station.

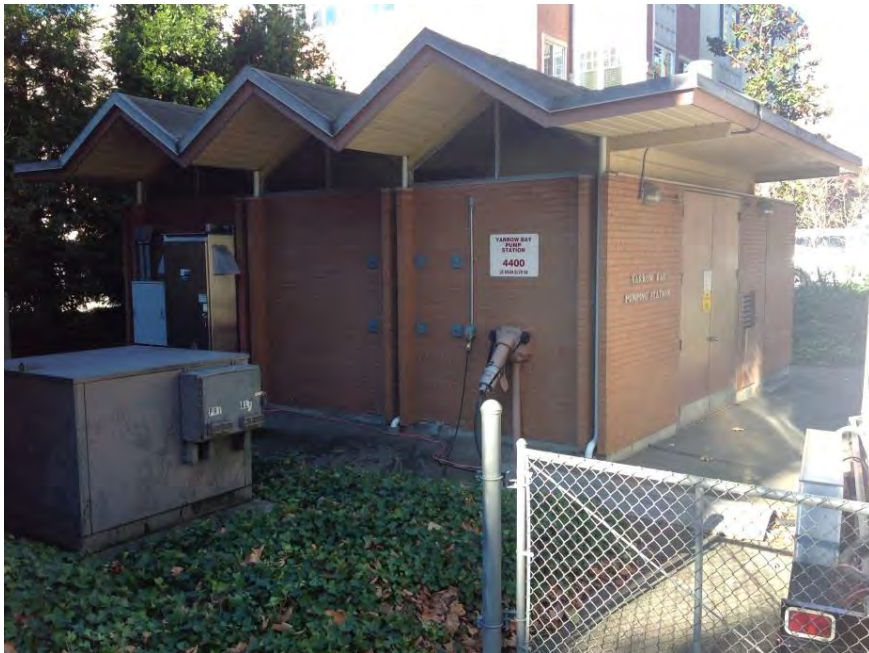
Side of Yarrow Bay, view of invasive ivies

English Ivy is a Class C Noxious Weed, and should be removed from any facility where it cannot be kept to strictly confined areas. When replaced, ivy should be replaced with a non-invasive ground cover.

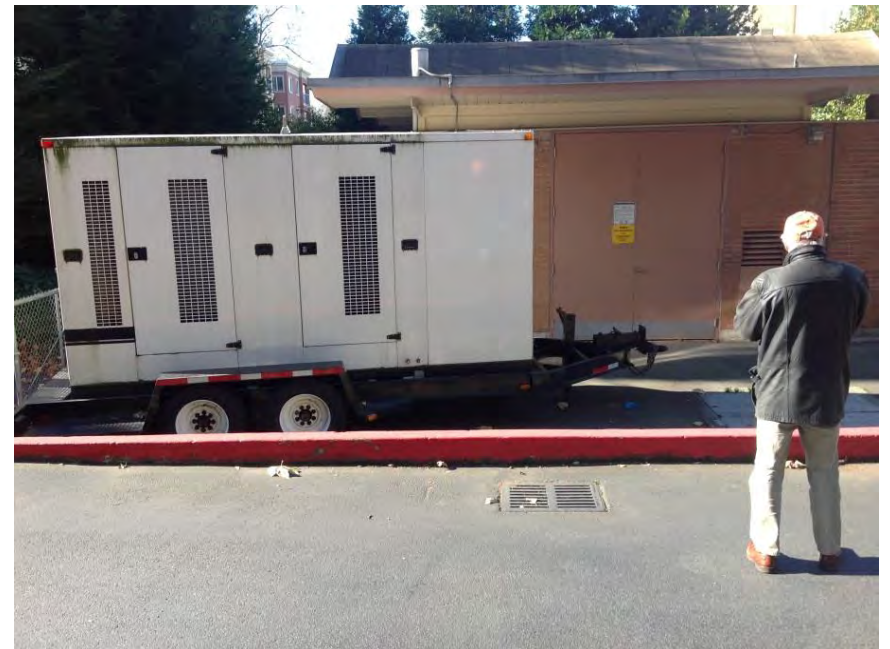
Emergency generator placed in front of Yarrow Bay

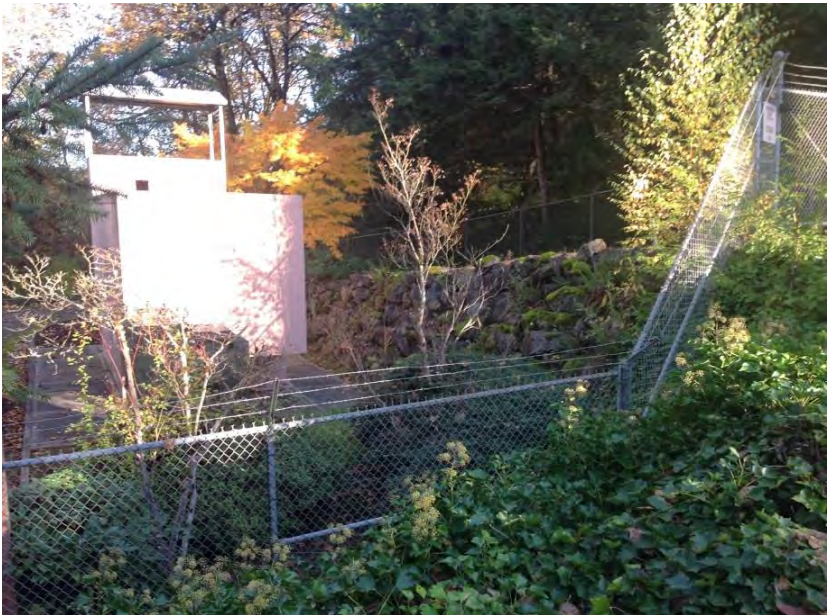
Note invasive species and extensive use of barbed wire fencing

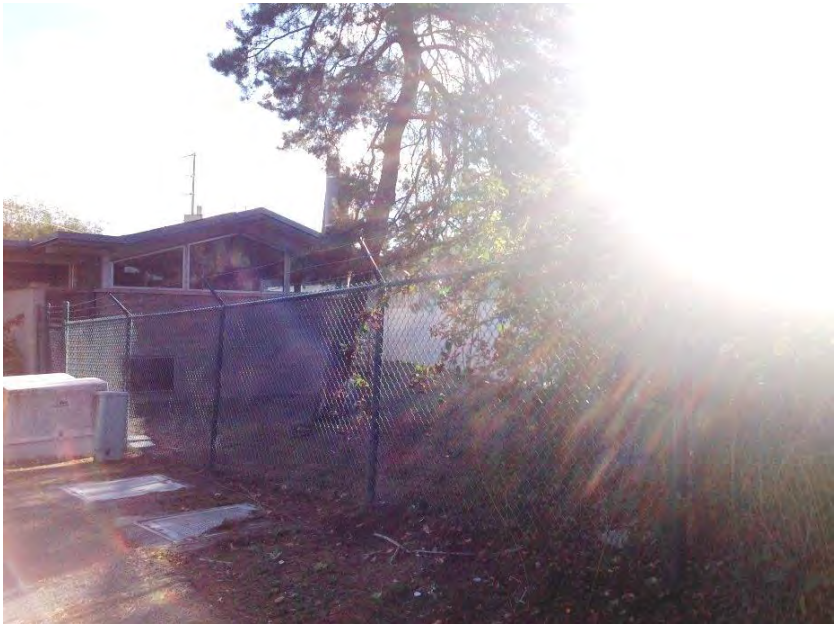
Adjacent yard space, surrounded by barbed wire fencing on the north side of the pump station.

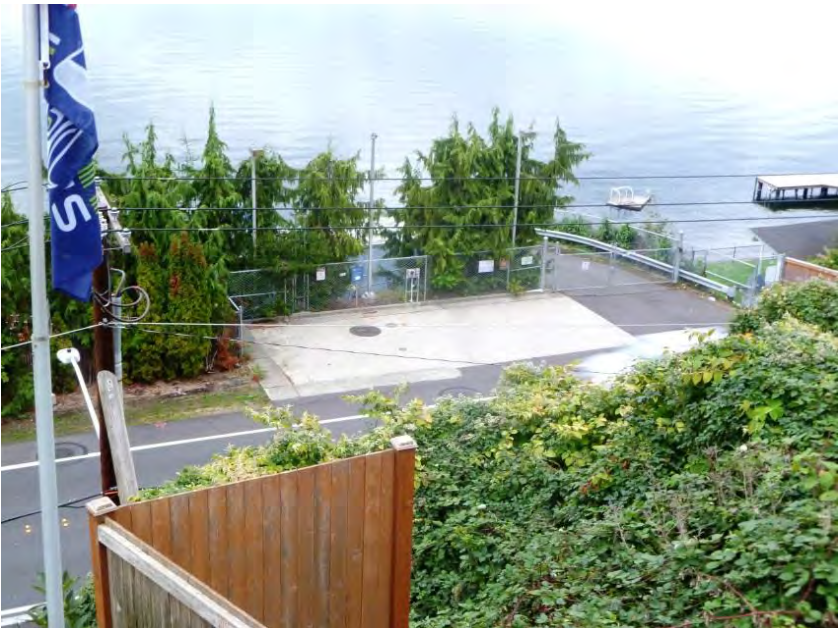
View from uphill residence, looking on to the entry roof to the pump station. Note extensive barbed wire fencing.
