Subject: North Beach Force Main Evaluation

**TETRA TECH, INC.
KING COUNTY WTD
NORTH BEACH FORCE MAIN
CONDITION ASSESSMENT PROJECT
FINAL REPORT**

Norton Corrosion Limited (NCL) was retained by Tetra Tech, Inc. to assist with a condition assessment of King County WTD North Beach Force Main located in Seattle, Washington. NCL developed an inspection/sampling program to be conducted at select excavation sites with field activities to collect necessary data and laboratory analysis to support formation of a professional opinion on present conditions. Authorization was by Consulting Services Agreement dated September 5, 2012. The field portion of the inspection/sampling occurred during the week of August 17, 2012.

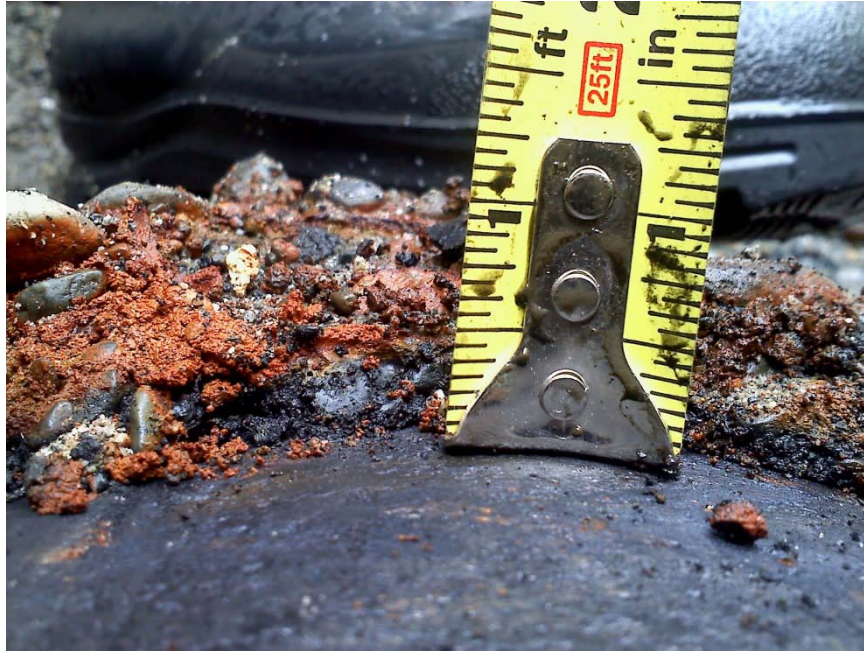
Picture 1-5: Thickness of the Carbonation/Corrosion Product Layer of 1"

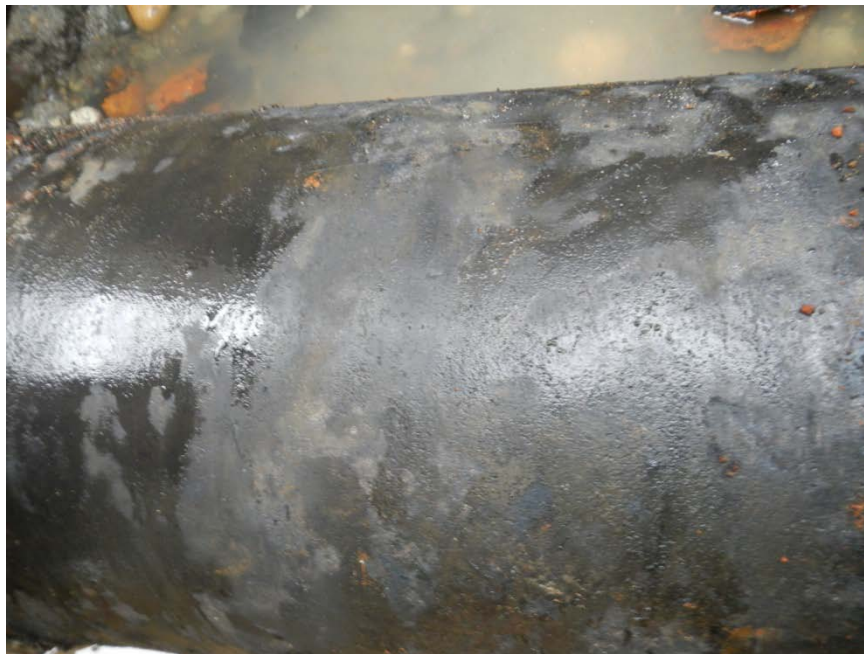
Picture 1-6: Profile Cleaned Cast Iron

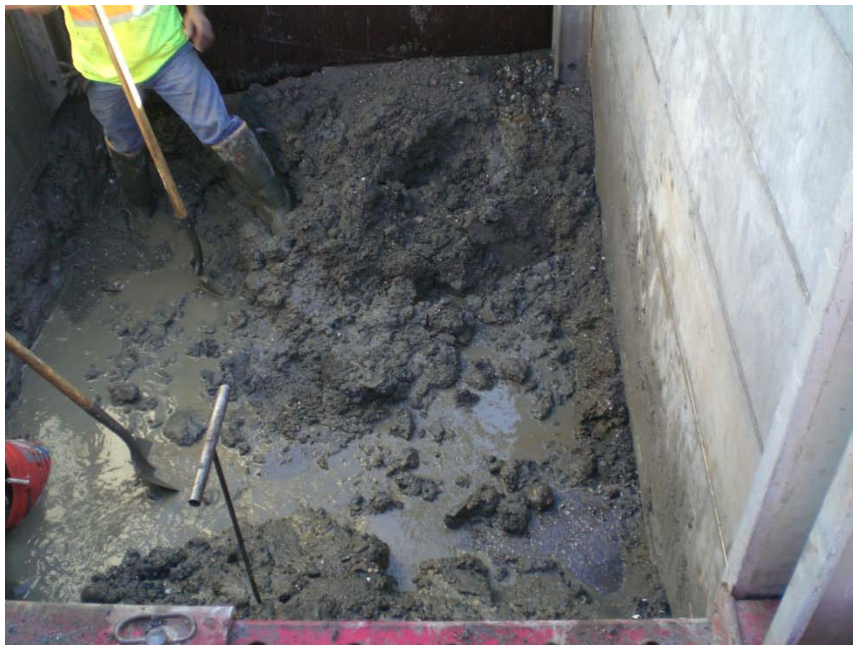
Picture 2-2: General Soil Conditions Surrounding Pipe

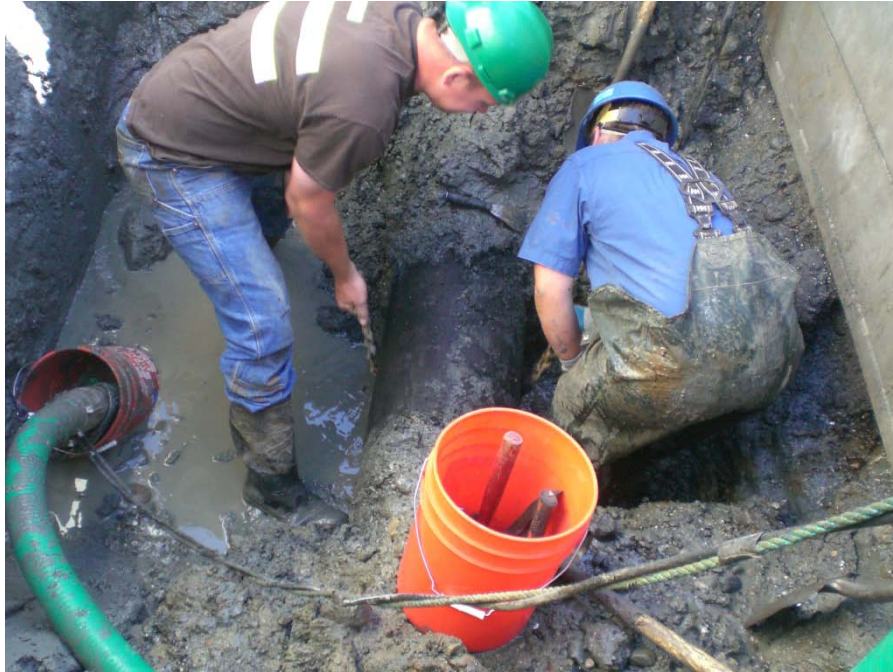
Picture 2-3: Carbonation/Corrosion Layer Being Removed by Tapping Crew

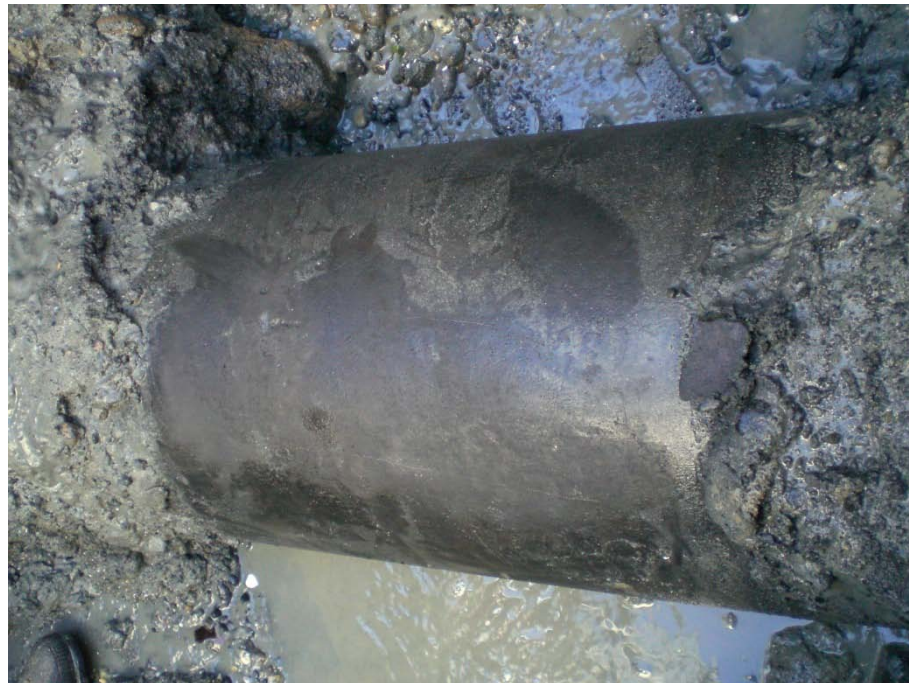
Picture 2-4: General Profile of Pipe with Carbonation Layer Removed

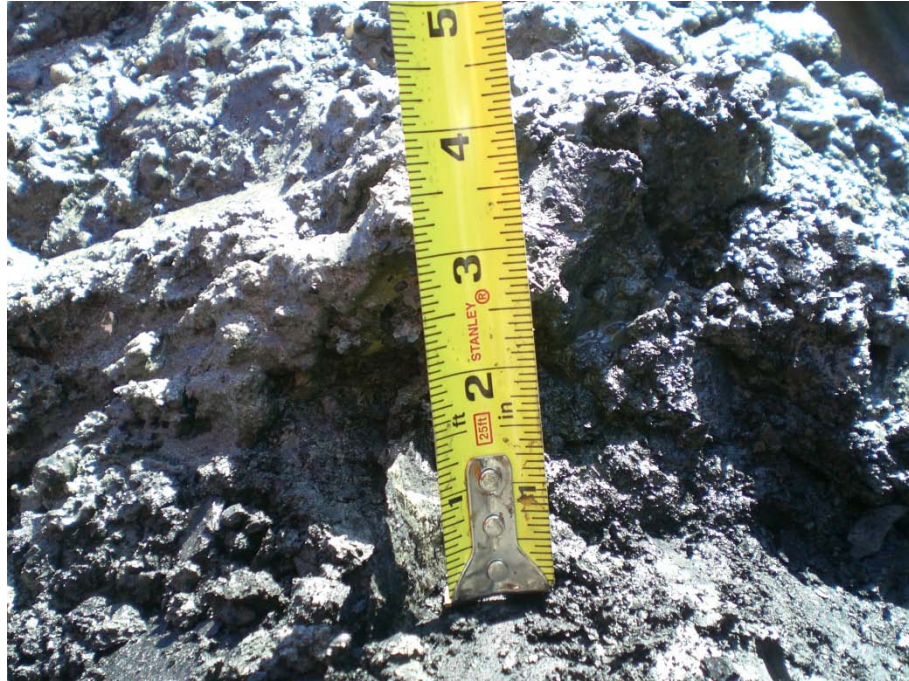
Picture 3-3: Carbonization/Corrosion Layer Shown of Approximately 4" Thickness

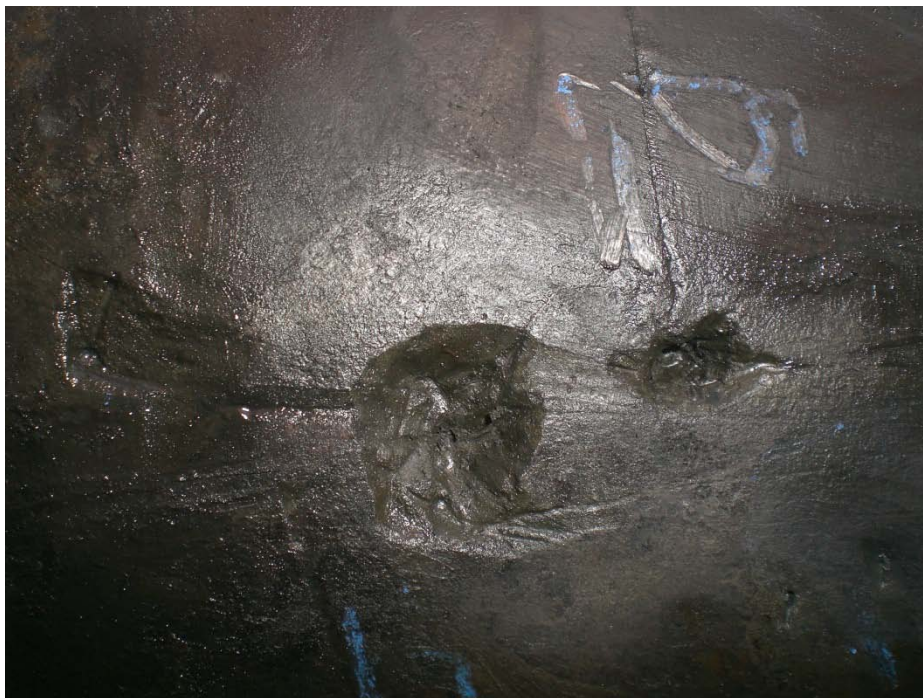
Pit locations 10 and 11 appeared to be associated with some prior damage to the pipe. The damage may have occurred at the time of installation. When the corrosion cell was initiated in these locations, the damage allowed the pitting to become more significant.

Picture 3-6: Depths of Pits 10 and 11
These pits appeared to be initiated by slight damage most likely from installation.

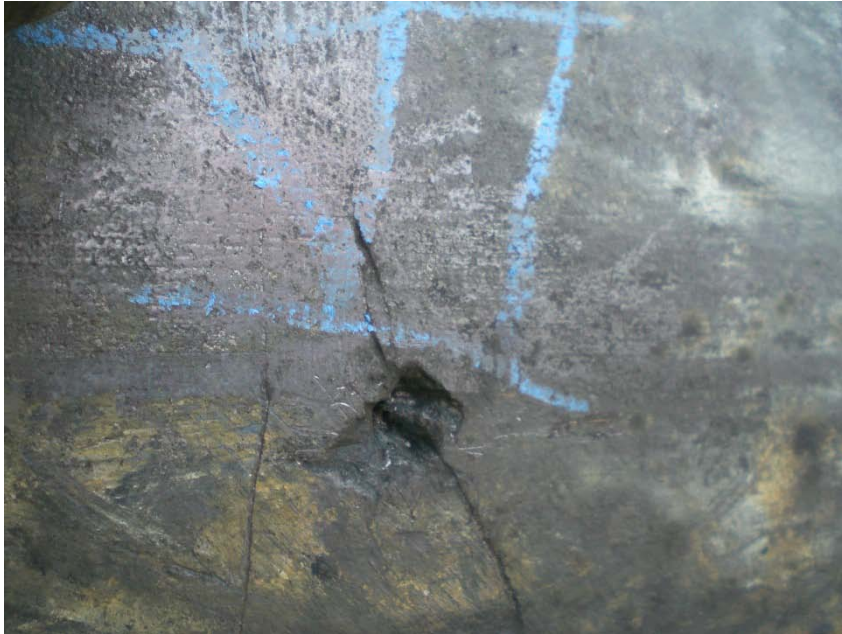
Picture 3-7: Profile of Pit 6

The scrape marks through the pit are from the knife used to dig out the soft graphite layer that filled the pit.

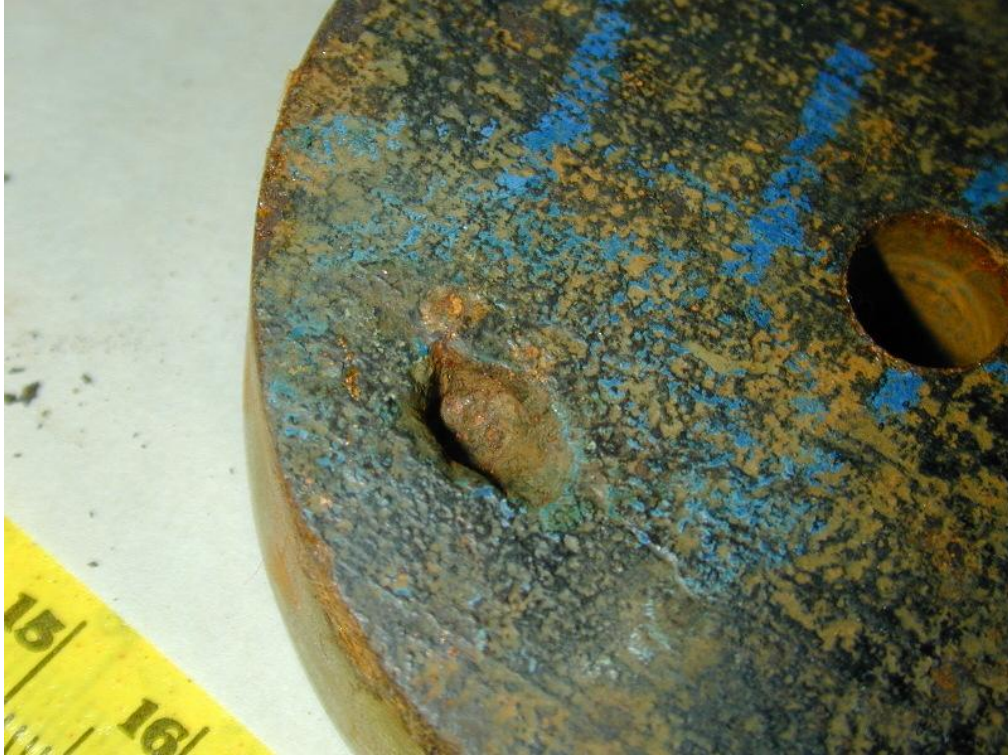
Fig. 9: Close-up of the deep pit on the OD of sample #3.

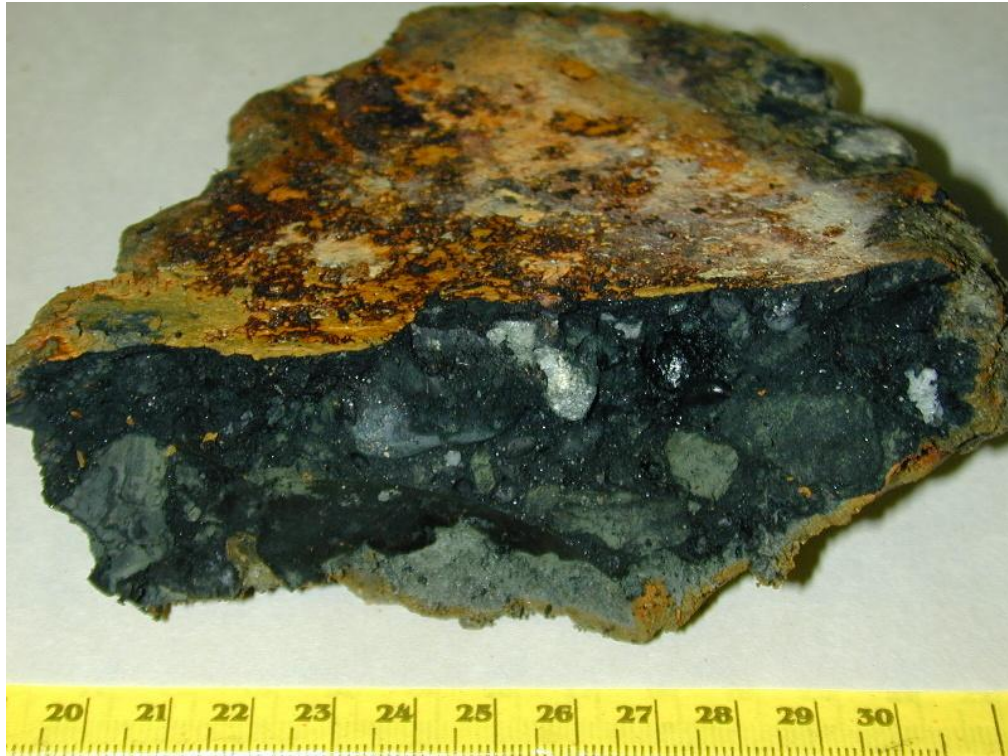
Fig. 13: Close-up of one half of sample #4. Note, the rocks in the corrosion scale.

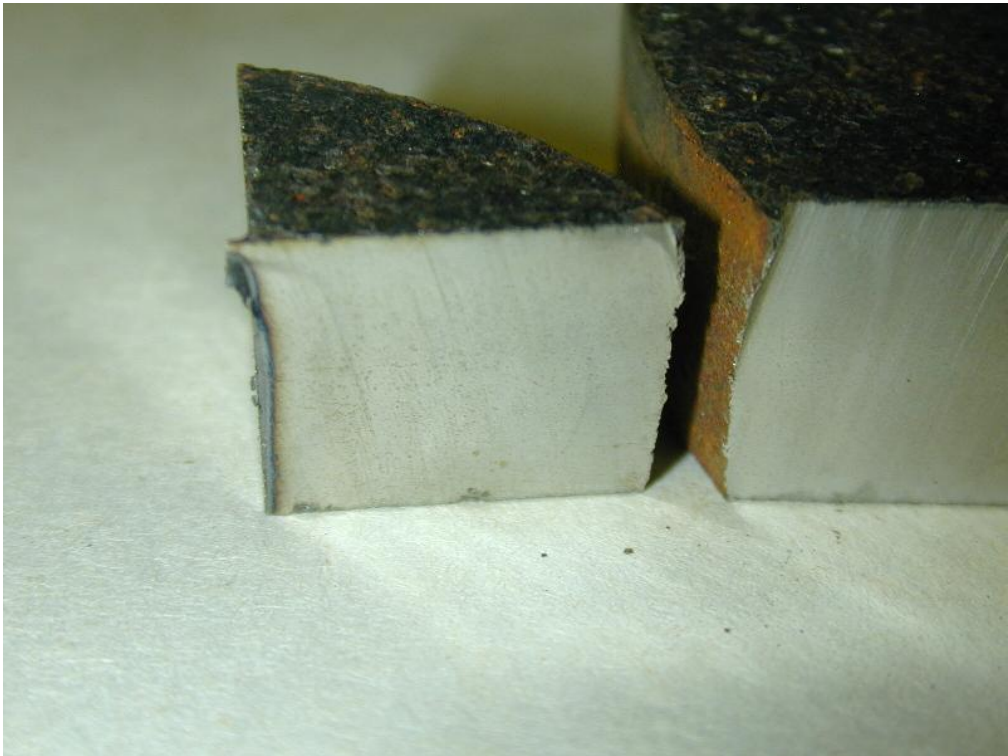
Fig. 20: Close-up of the cross-sectioned piece. Note, the pitting at the ID.

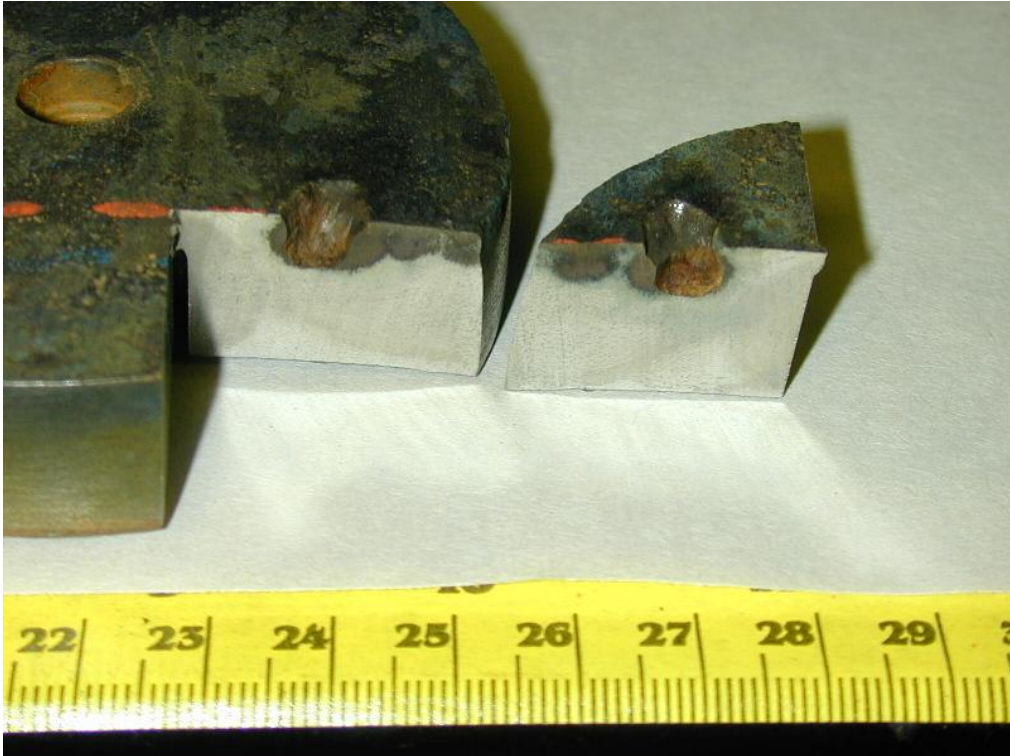
Fig. 22: Cross-sectional view of the pitting and graphitic corrosion.

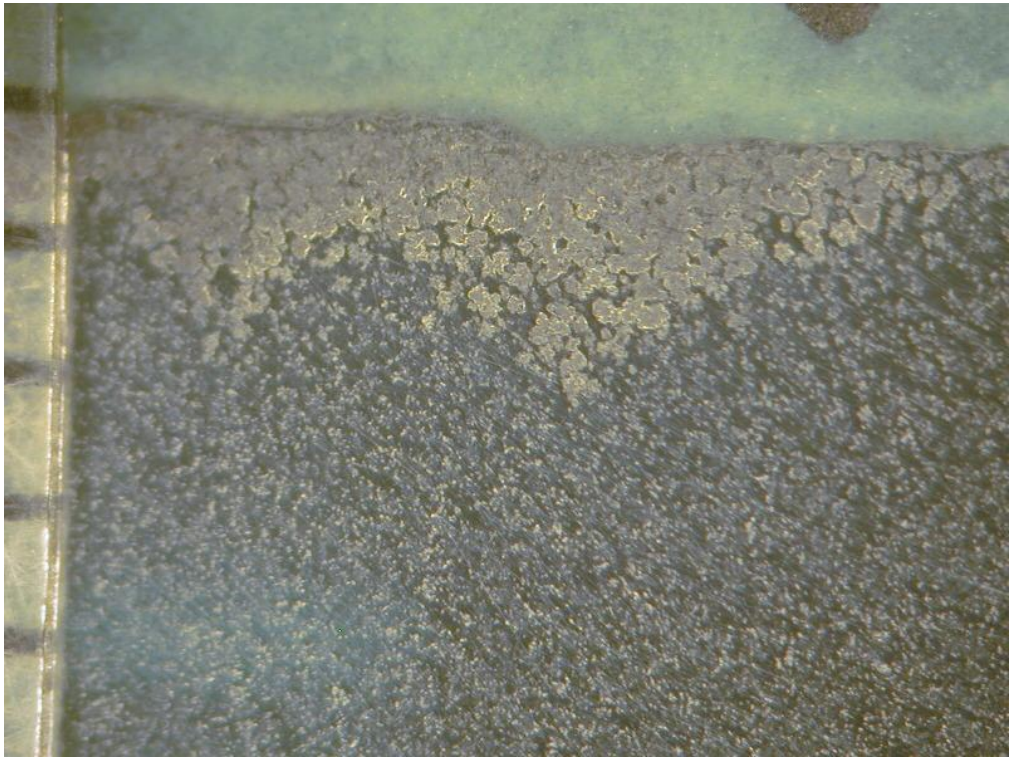
Fig. 27: 7x cross-sectional view of the depth of graphitic corrosion from the OD. Note, the demarcations on the scale are 1mm.

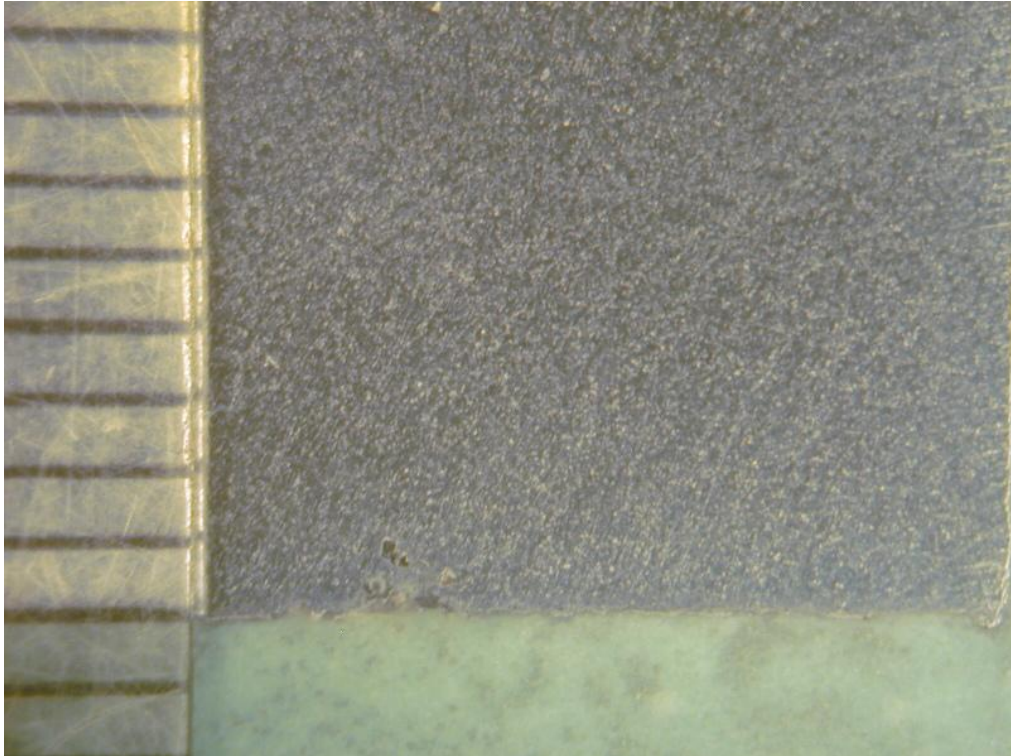
Fig. 29: 7x cross-sectional view of the corrosion at the OD of sample #2.

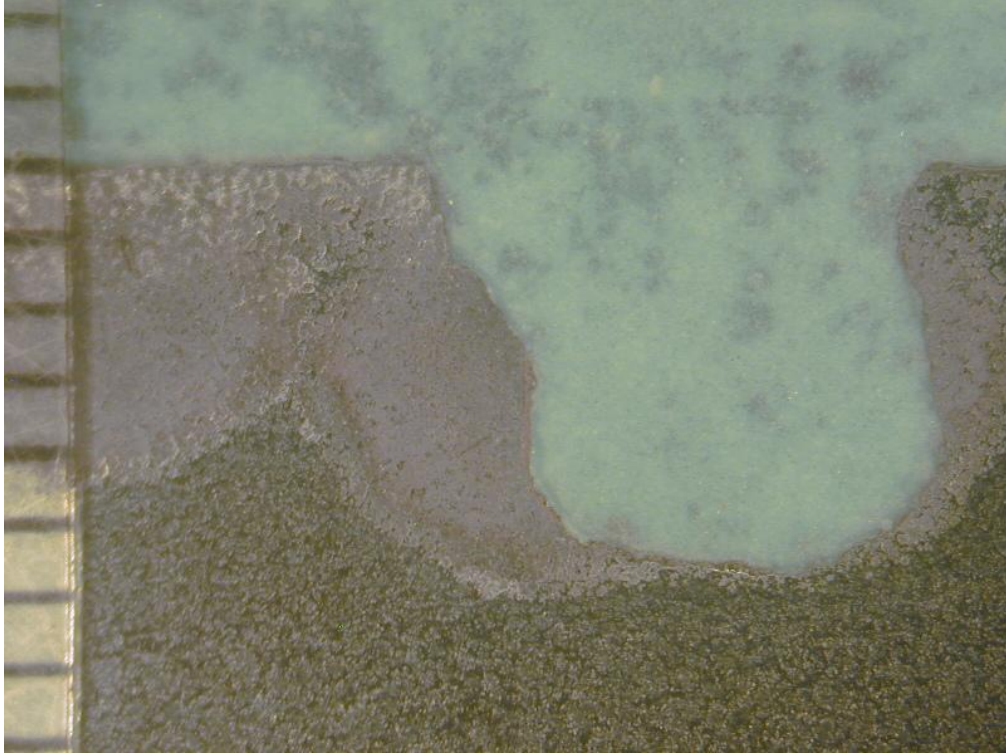
Fig. 30: 7x view of the pitting at the ID of sample #2.

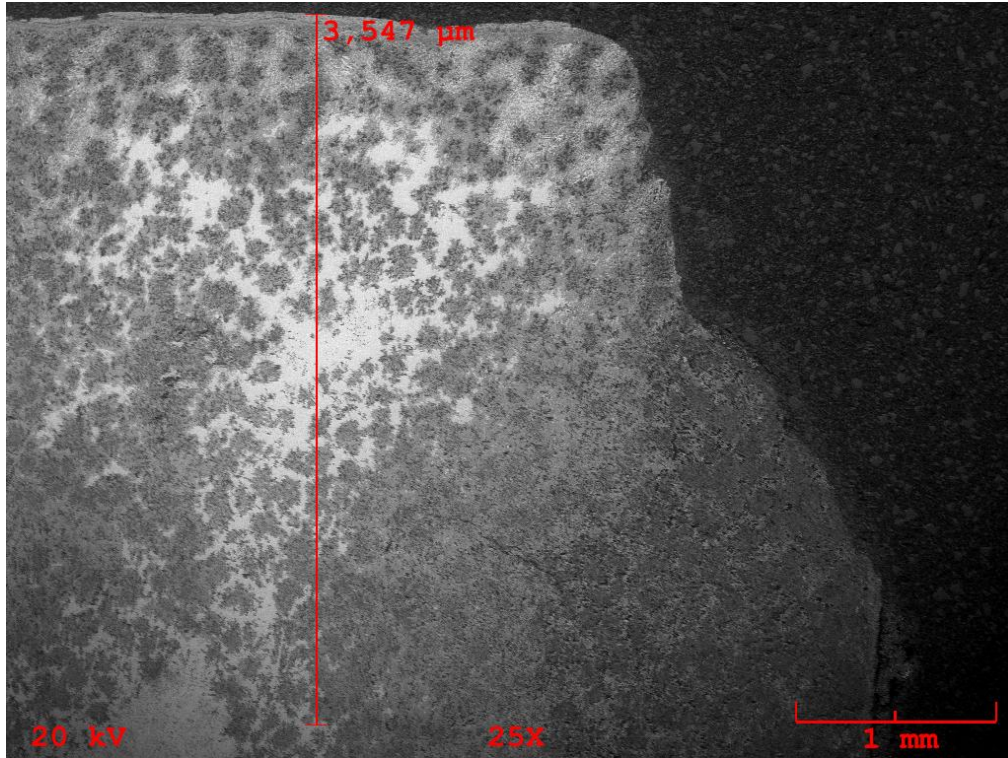
Fig. 66: 25x SEM cross-sectional image of the pit on sample #3. Note, the entire pit could not be captured in one image. Therefore, the pitting depth was determined by combining this measurement with the subsequent one.
