PILOT PROJECT REPORT

Regional Infiltration and Inflow Control Program King County, Washington

October 2004

Prepared for King County by
Earth Tech Team, Seattle, WA

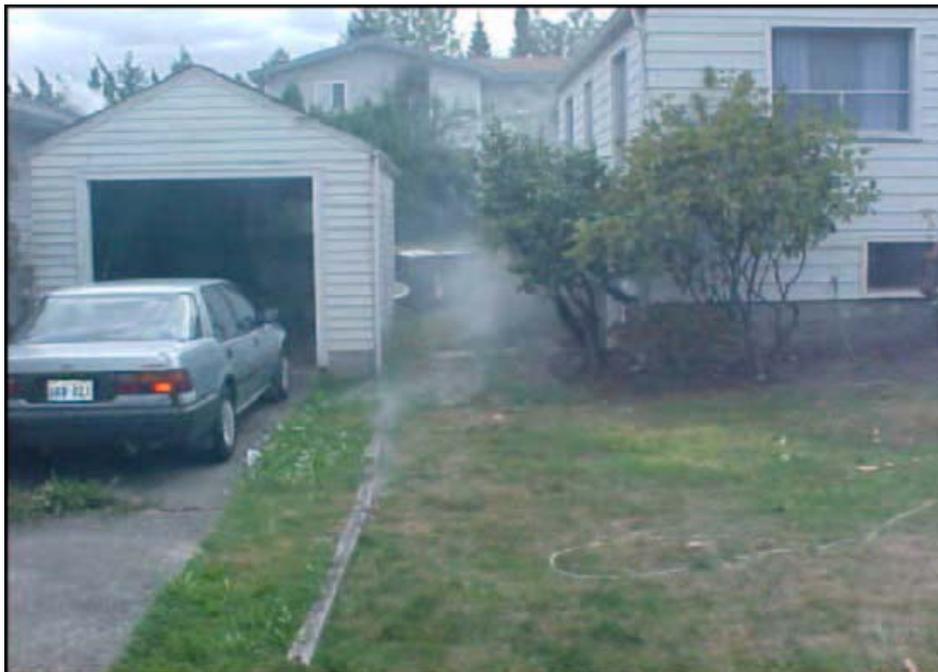
Figure 7-2. Smoke Testing 1

Smoke emanating from ground during smoke testing indicating cracks or defects in the buried side sewer.

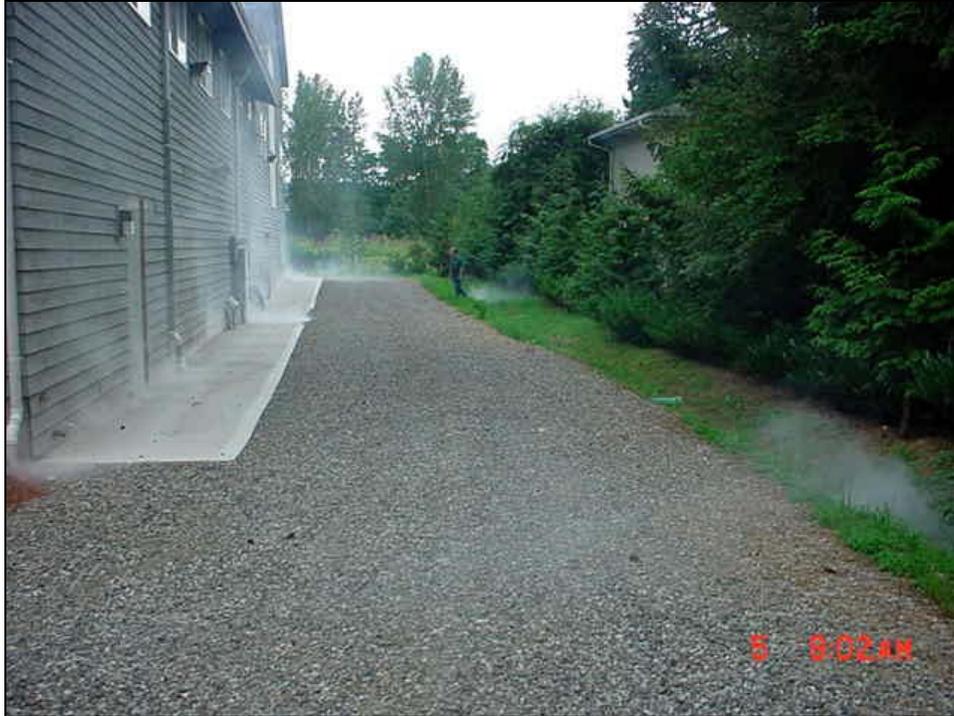
Figure 7-3. Smoke Testing 2

Smoke emanating from ground during smoke testing.

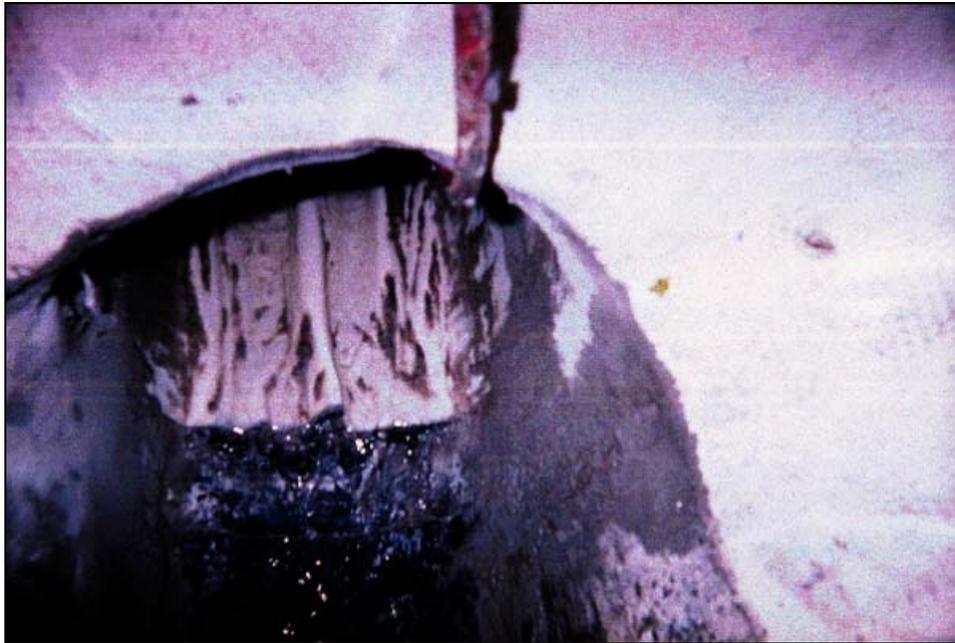
Figure 7-10. Cured-in-Place Pipe 6

Liner failed to fully inflate in this 12-inch-diameter sewer main at downstream manhole. Wrinkles extended several feet up the pipe and were not fully cured. Last run of pipe was re-pressurized and additional steam was applied. Short section of liner was then removed and a spot repair installed.

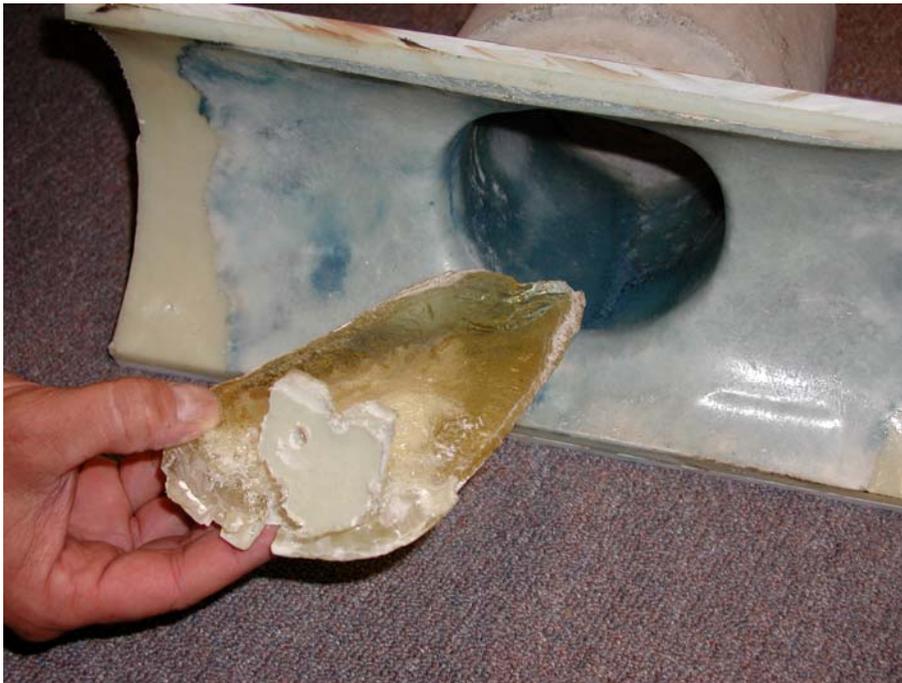
Figure 7-12. Cured-in-Place Pipe 8

Epoxy resin slug that pooled in a lateral connection to a sewer main during the installation of the CIPP in the sewer main. The slug is held adjacent to a sample pipe section with a lateral connection to illustrate the location of the slug in the field. The slug was removed during the reinstatement of the lateral connection.

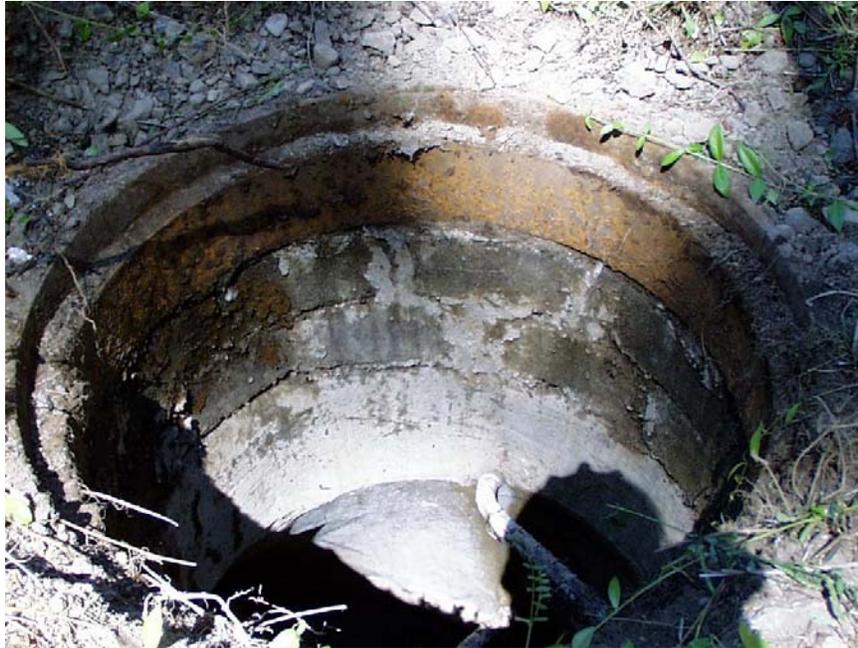
Figure 7-25. Manhole 1

Manhole chimney in need of repair.

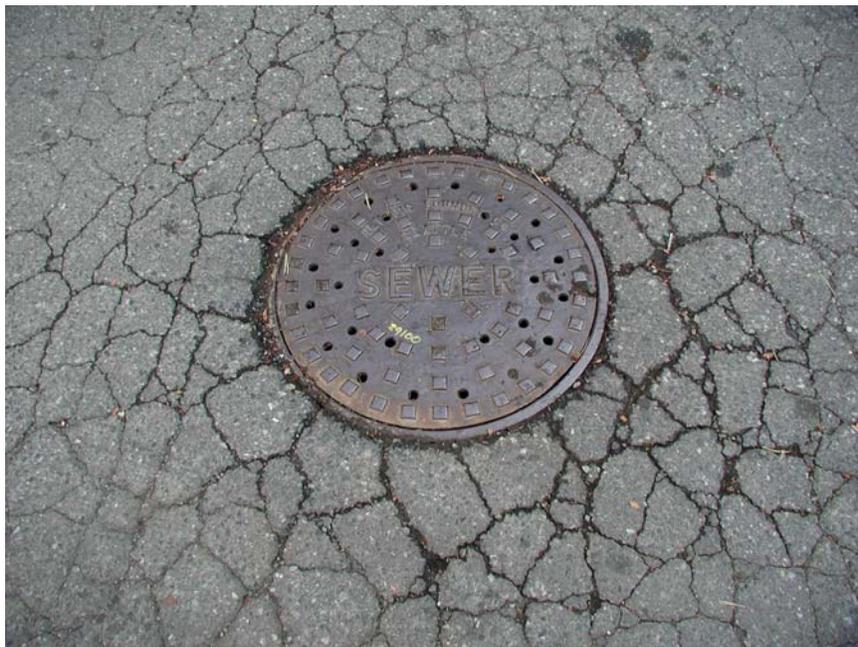
Figure 7-26. Manhole 2

Manhole with indications of settlement in the pavement that likely subject the cover to inundation during rainfall. The large number of pick holes in the lid also allows free flow of surface water into the manhole.

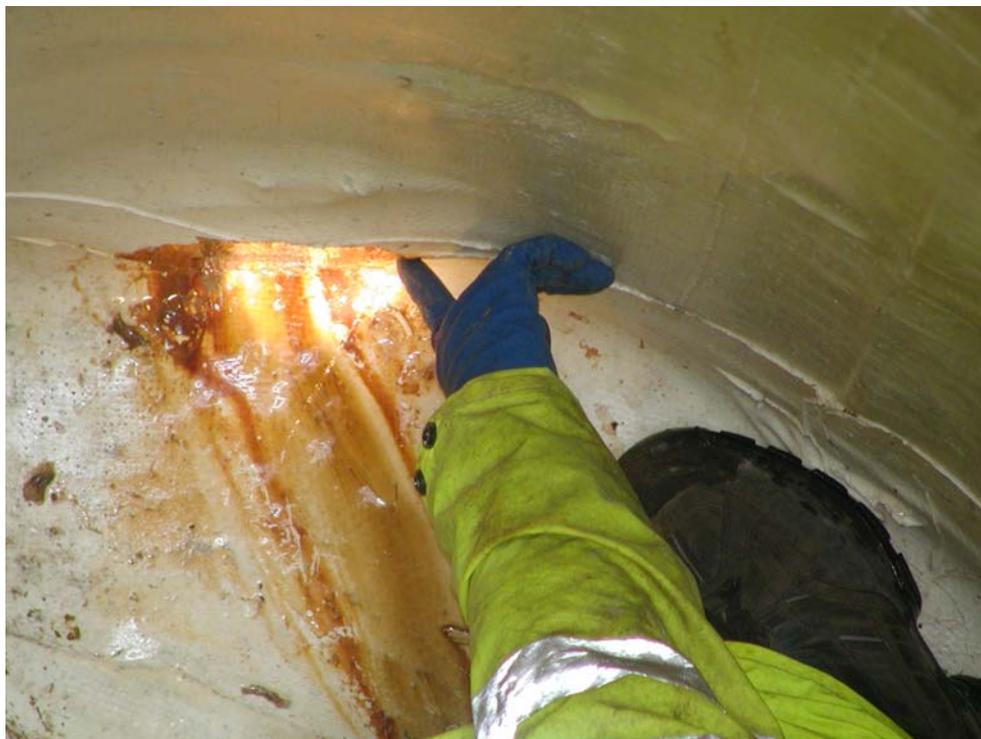
Figure 7-34. Manhole 10

Leak in a cured fiberglass manhole liner.

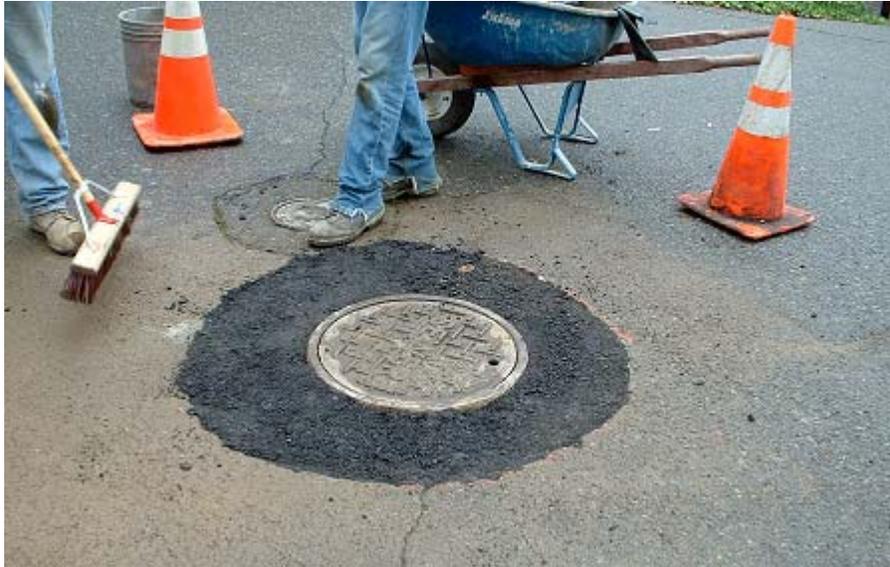
Figure 7-35. Manhole 11

Manhole that has been raised slightly above grade to prevent surface inundation.

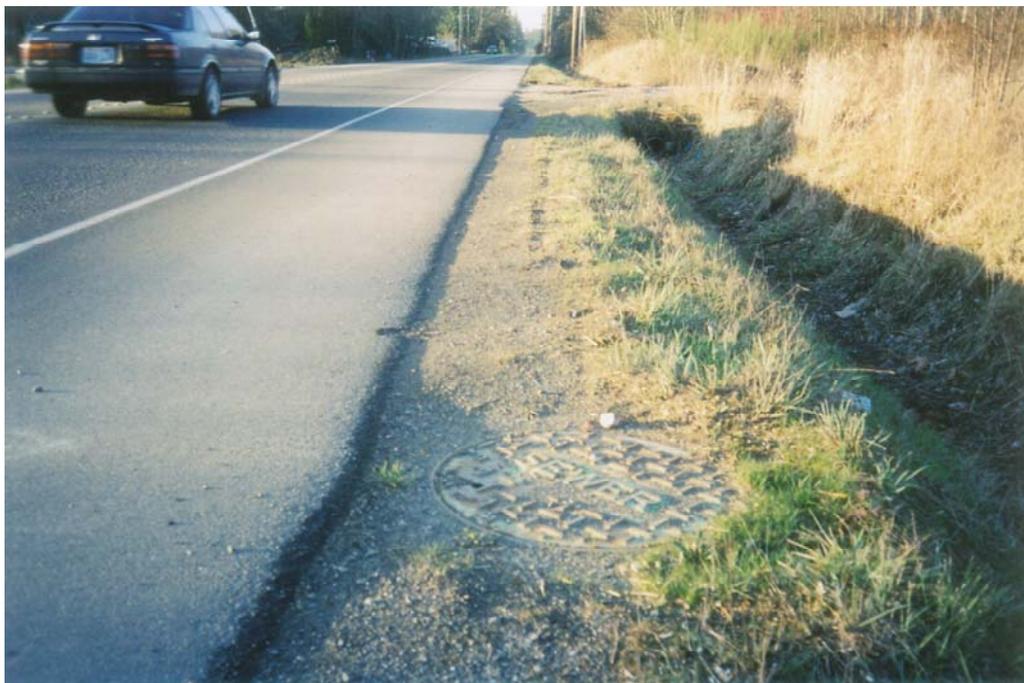
Figure 7-38. Manhole 14

Manhole lid below grade and subject to inundation from surface water running off the roadway.

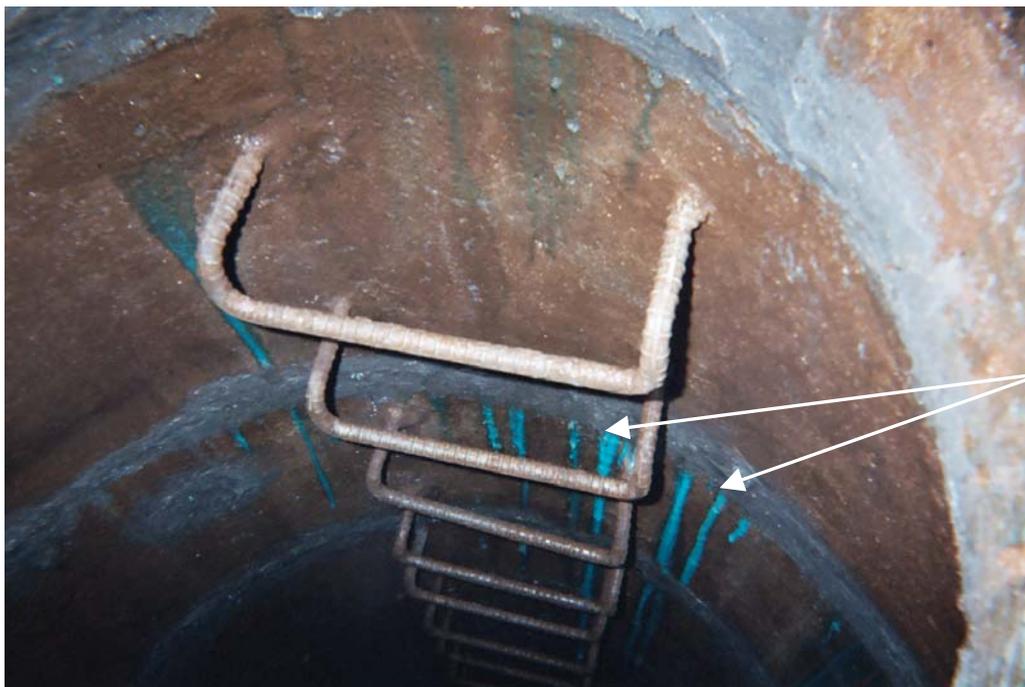
Figure 7-42. Manhole 18

Drips are chemical grout leaking back into manhole through defects.

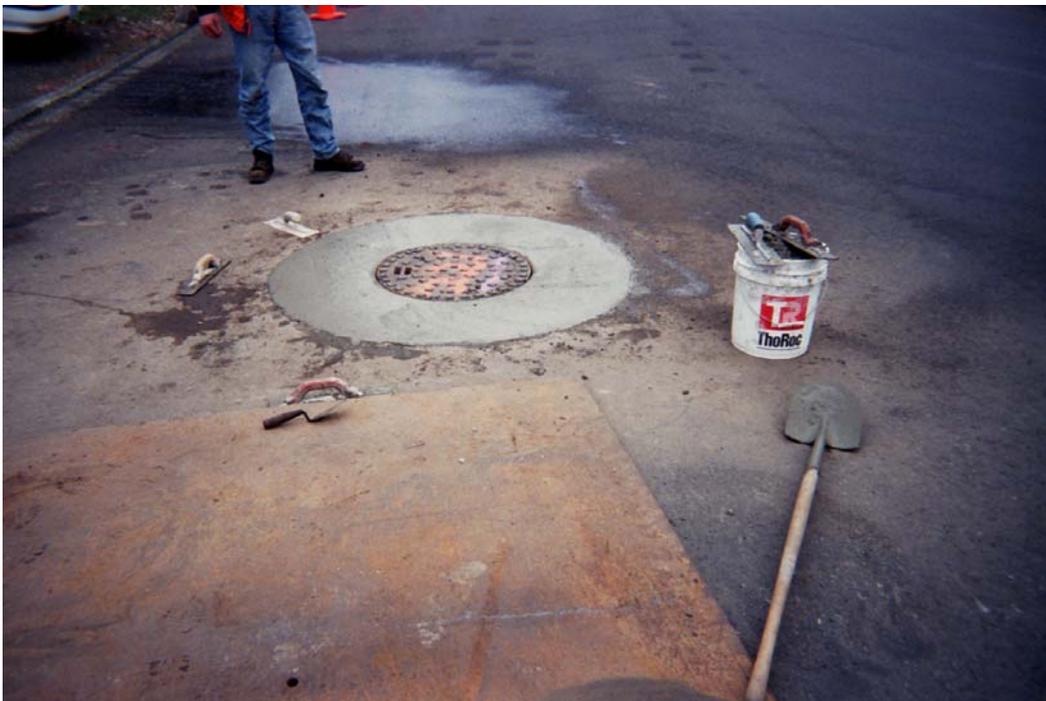
Figure 7-48. Manhole 24

Completed concrete collar. Steel plate is required to protect fresh concrete and must be blocked up to avoid touching concrete. This may preclude allowing cars to drive over the plate.
