RED BRICK ROAD CONDITION ASSESSMENT, 196TH AVENUE NE, KING COUNTY, WASHINGTON

December 22, 2015

King County Department of Transportation Project Number 1126665

RED BRICK ROAD CONDITION ASSESSMENT
196TH AVENUE NE, KING COUNTY, WASHINGTON

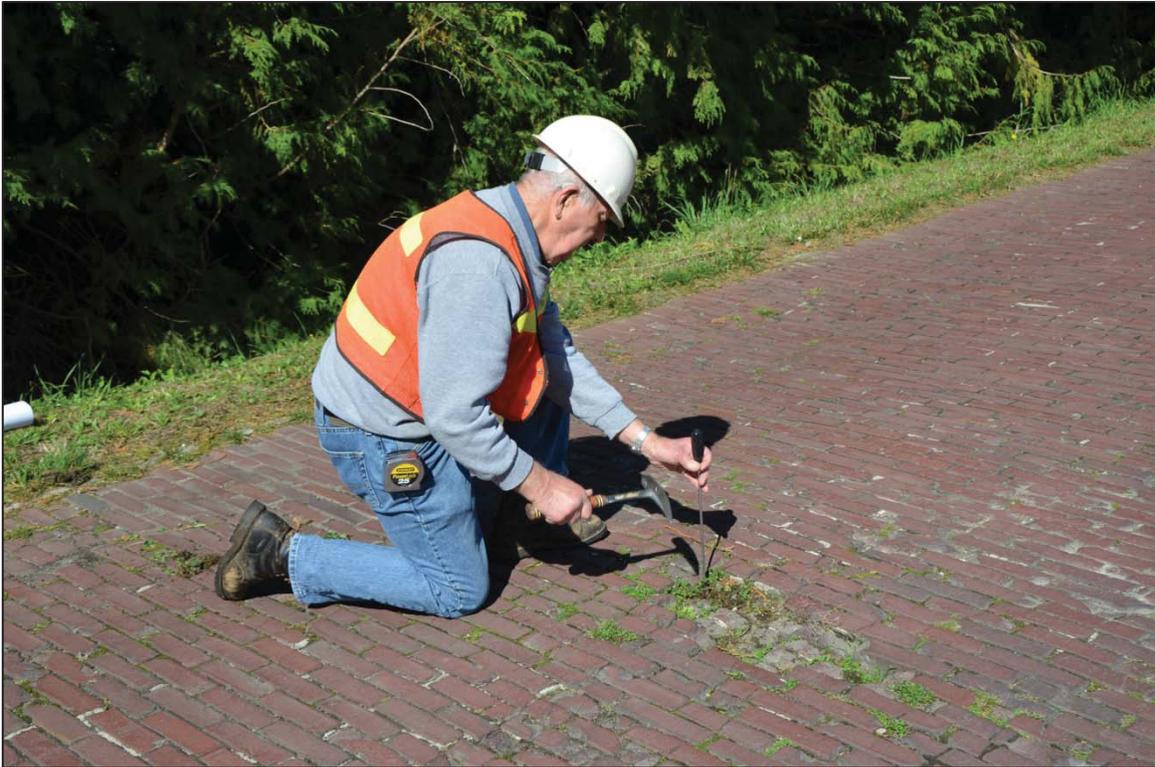
The team conducted test probes to provide a quick, low-tech method for assessing the sub-base condition. Plans indicate that the brick is 4 inches deep with a 1- to 2-inch sand layer cushion between the brick and the concrete sub-base. The probe consisted of a ¼-inch-diameter pointed steel rod that was driven through cracks in the roadway surface until it encountered resistance or reached the maximum depth of the probe at 15.5 inches (Figure 7). Based on the size of the brick and the amount of sand that plans indicate is between the brick and the sub-base, it was determined that the test probe would terminate at approximately 5 to 6 inches if the sub-base was solid. Test probes were assigned the following condition rankings based on surface condition and depth of probe:

- Rank 1 (poor) – broken/crushed brick, probe goes through sub-base
- Rank 2 (fair) – broken brick, solid sub-base
- Rank 3 (good) – no brick cracking or depressions

Figure 7. Test probe with Rank 2 conditions.

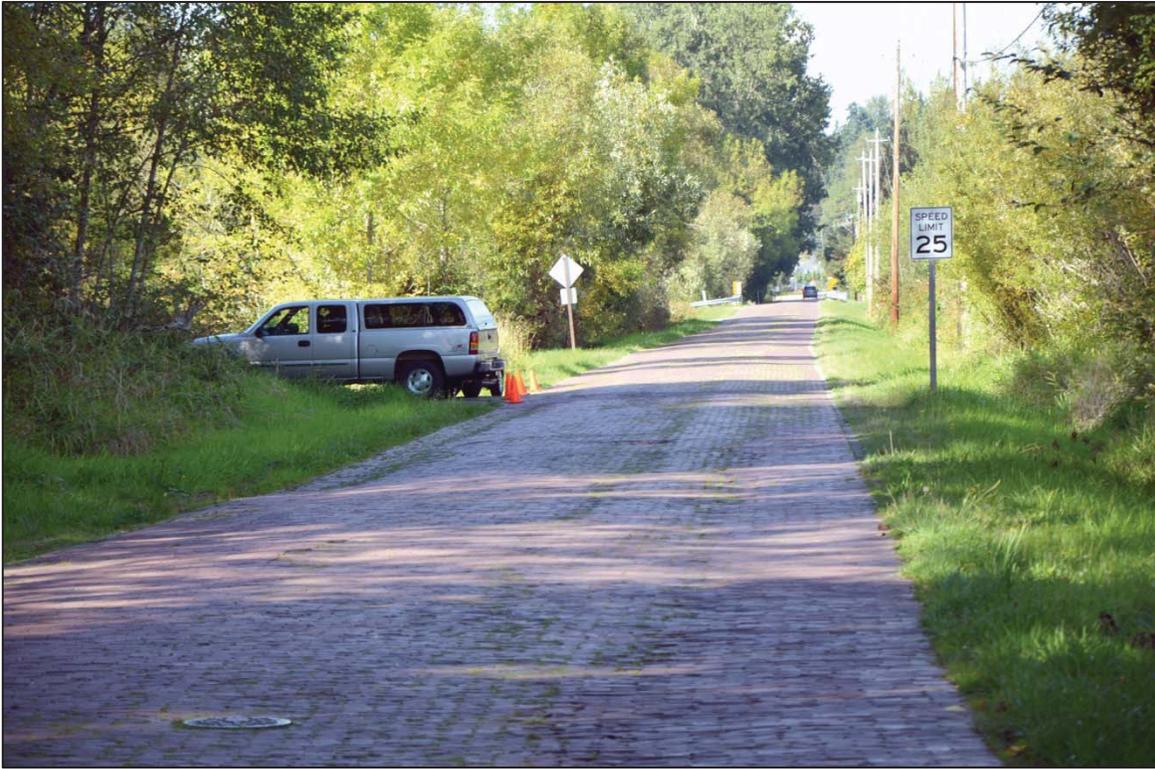
A long segment of the Red Brick Road lies within the wetlands referred to as the Evans Creek Flood Basin. This 3,100-foot section of road generally extends from the north of the Evans Creek North Bridge to NE 61st Place in the south. The subgrade (the section of roadway below the concrete sub-base) within this segment of road has been described by previous geotechnical evaluations as being in “poor” condition. SWCA’s visual inspection of the road in this segment showed major cracks, as well as heaving,

severe surface settlements, fractures of brick, and sagging, which are all indications of apparent subgrade bearing failure (Figure 8).

Included with the KCM's Conditions Assessment Report of June 1986 was a Geotechnical Engineering Evaluation in an appendix. This report addressed the structural features of the roadway subgrade, particularly within the wetland segment. The most critical areas identified were between Stations 20 and 43 (approximately 0.5 mile in length). The road in this area was described as having a very thin subgrade fill over the soft and wet native soils. Further, the report stated that the severe surface settlement and potholing were likely caused by insufficient thickness of the subgrade layer.

Figure 8. Surface settlement showing apparent subgrade bearing failure (note sag in road on left side of photograph).

Further deterioration of the sub-base will continue unless the subgrade is rebuilt following the recommendations in the 1986 Geotechnical Report. However, these repairs will require complete reconstruction of the road through these sections, which will, in turn, affect the integrity of the road under the NRHP and KCRHP guidelines. Since it has been nearly 30 years since the previous study, a new geotechnical review may be warranted and may suggest alternative methods to assess and repair or replace the subgrade. All of the ramifications of subgrade replacement and the effects on future uses of the road merit further discussion by King County, the Landmarks Commission, area residents, and other involved parties.

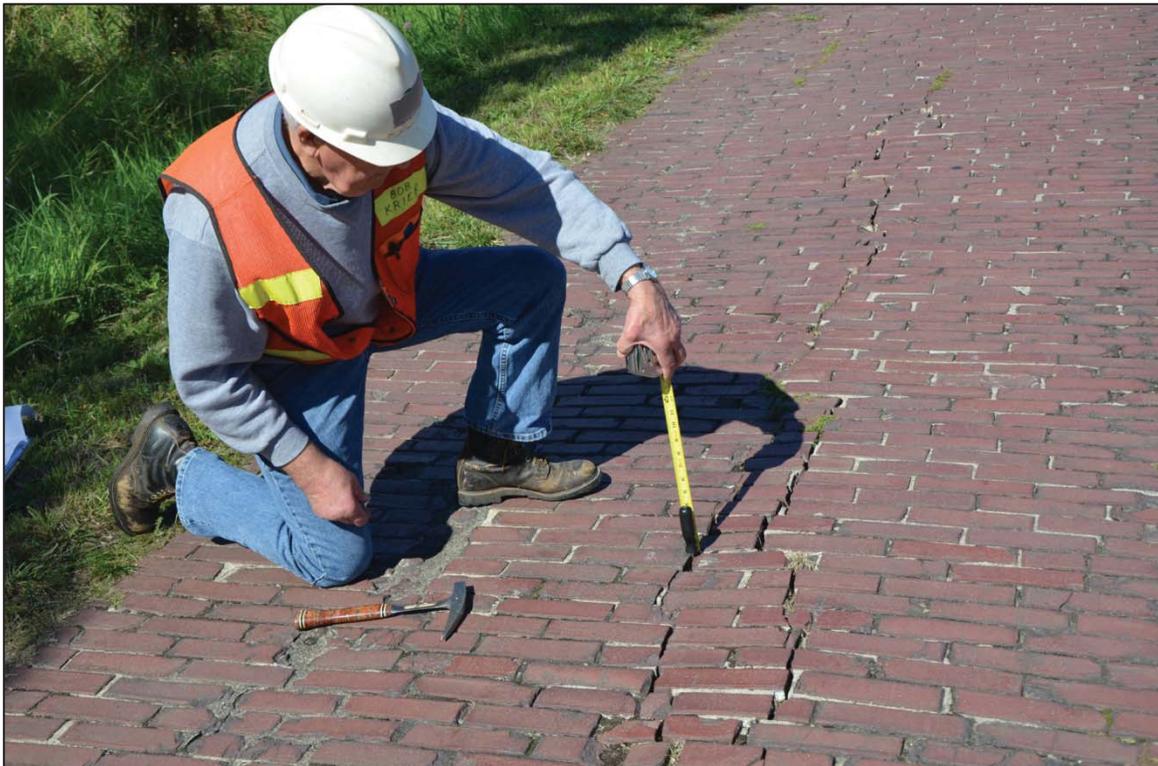
These concerns prompted the SWCA field personnel to check the concrete sub-base by using a probe. Field results and comparison to road plans show that a test probe with normal sub-base conditions would include 4 inches for the depth of the brick and one to two inches for the depth of the original sand cushion for a total of 5 to 6 inches of penetration. From the attached field notes it is seen that out

Figure 9. Test probe showing failure of sub-base.

Taking core samples of the concrete slab is recommended to obtain additional information about the quality and strength of the concrete. Additional historical research may also result in a better understanding of concrete composition. Although the results of the test probes are encouraging, they should not be considered a reliable demonstration of the actual condition of the base slab. Where potholes, heaving, cracks, depressions or raised sections are affecting the surface conditions, it is a sign of a structural defect. Bricks and the sand cushion around those areas should be temporarily removed and the concrete slab should be inspected for damage. In order for the road to continue to be used for automobile traffic, the cause of the sub-base damage needs to be identified and addressed, and the sub-base and edge restraints should be rebuilt in these locations.

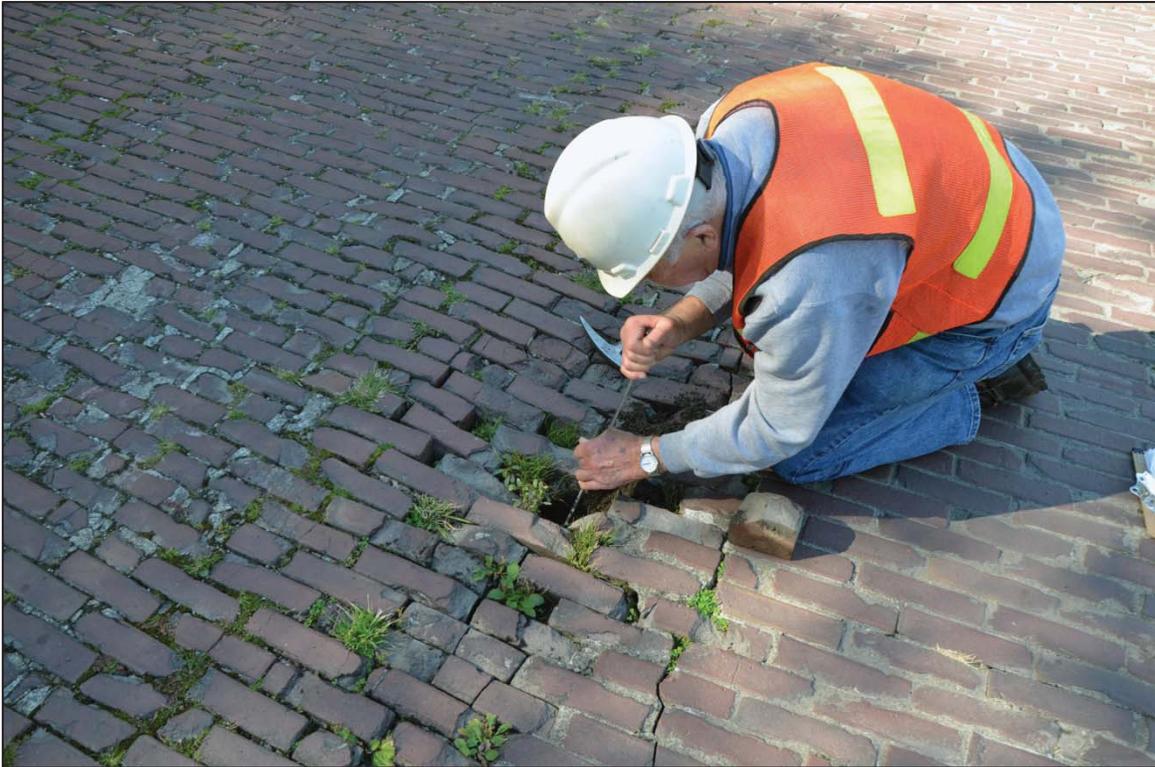
Test probes were disproportionately placed in areas that were visibly damaged on the surface, such as low spots, cracks, or places with loose or crushed brick, in order to test the sub-base in these locations. Fewer probes were placed in areas where the road surface showed more limited signs of deterioration. This methodology was partially due to a lack of readily available probe locations, such as surface cracks or areas of loose or missing mortar.

Figure 10. Test probe 46 with loose brick.

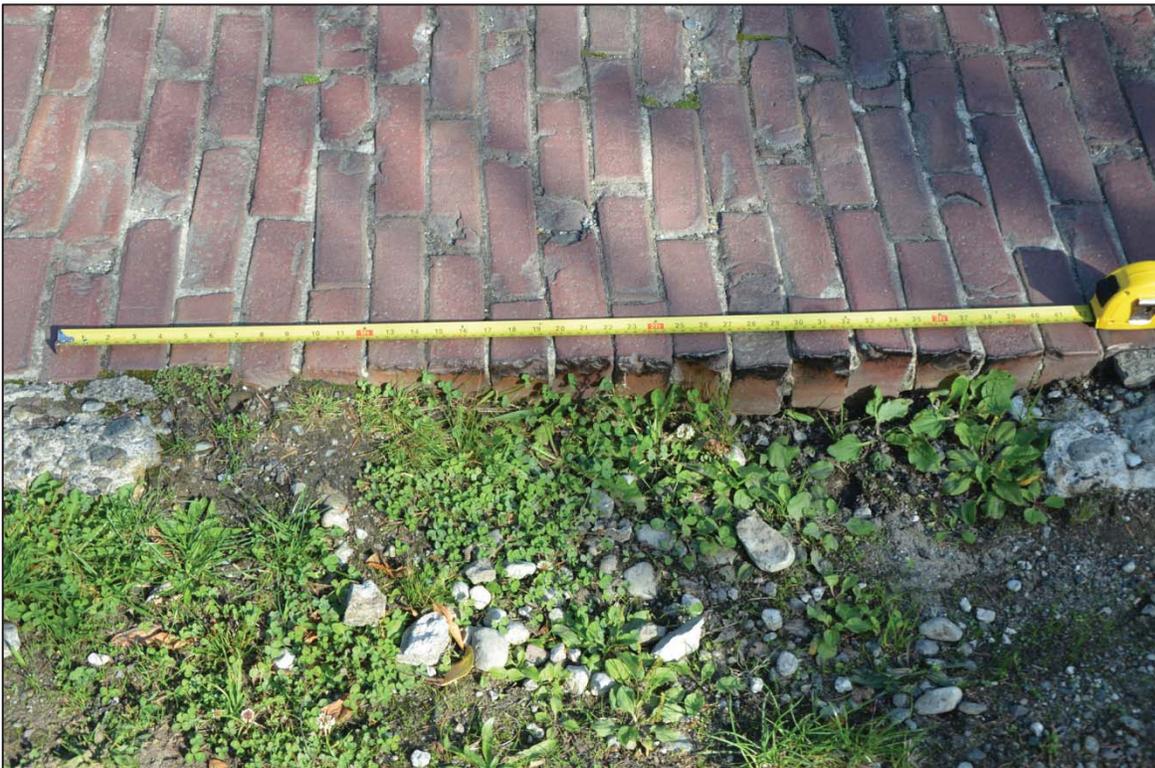
The roadway “curbs” are not standard curbs as commonly referred to in sidewalk and street configurations. Rather, they are considered edge restraints that are necessary along the sides of the pavement to prevent lateral movement of the bricks and loss of the bedding material on which the bricks are set. Curb construction is an integral part of the concrete sub-base slab, and is approximately level with the top of the bricks. In some areas there are portions that are completely missing (Figure 11). Many areas are covered by vegetation, while other parts of the curb have deteriorated to the point that they are no longer effective as edge restraints.

Figure 11. Missing edge restraint segment.

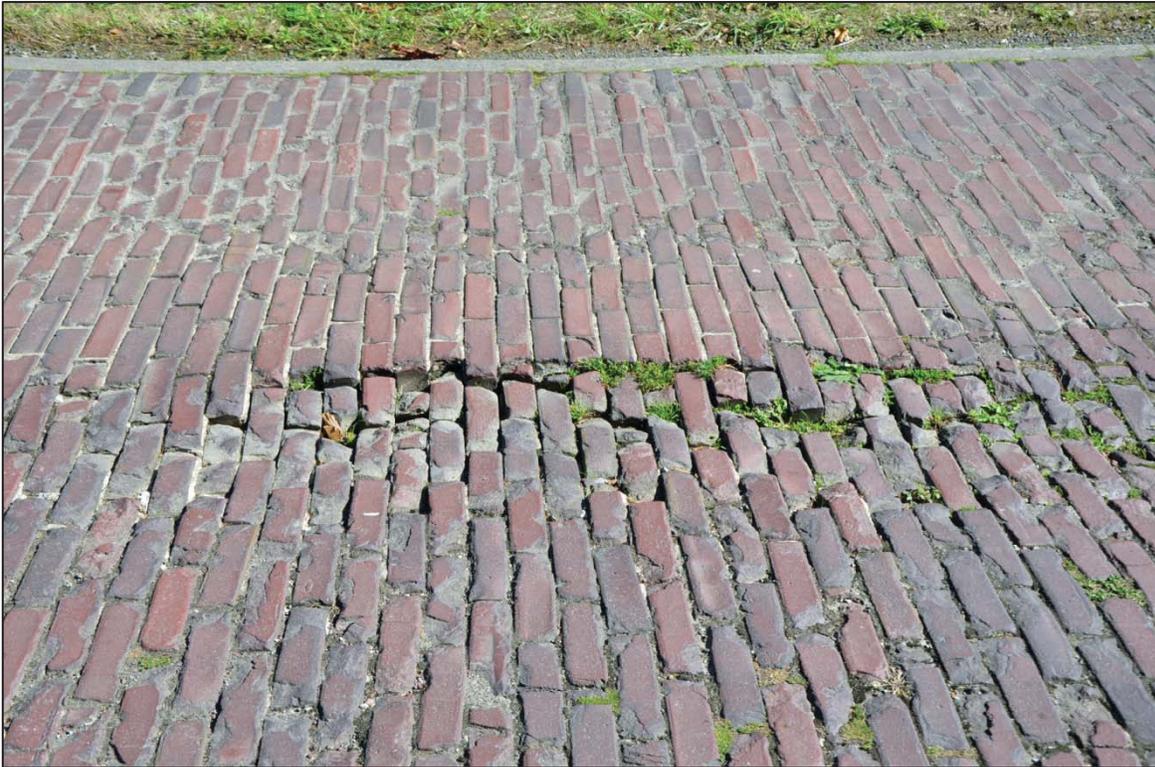
There are many locations where fractures, breaking, and misalignment of the bricks, both vertically and horizontally, occur (Figure 12). These areas still serve as a functional surface along with the adjacent brick pavement, but will eventually need to be replaced. These conditions are similar to those that were repaired in the 1988 renovation. Several methods of repair were used at that time, although not all were successful. One of those methods involved two strips of damaged bricks, each 18 inches wide, that ran nearly the full longitudinal length of the brick pavement. The strips were approximately 10 feet apart and parallel to each other. These strips were identified as the place where a heavy, metal-wheeled steam tractor traveled down the road shortly after it had been built. The wheels left fractured and broken brick, and over the years the heavy trucks and speeding traffic continued to aggravate the condition (Figure 13). The joints between the broken and fractured bricks were cleaned to make spaces that were filled with cement grout flush with the top of the bricks. However, the broken fragments and fractured pieces of bricks were not removed. This process did not maintain the original integrity of the brick construction, particularly the joints between the bricks and the retention of the fractured and broken pieces. The historic appearance was compromised, and future repairs should not be made using this procedure.

Figure 12. Road segment with fractured brick.

Although many areas of crushed brick are relatively stable, damaged bricks will eventually need to be replaced in kind. Areas with loose or fractured brick should be repaired with bricks salvaged from Union Hill Road, which appears to be the same type of brick used for the original wear surface on the Red Brick Road. When repairing or replacing brick the use of mortar that is harder than the brick should be avoided, as this situation will lead to further brick damage.

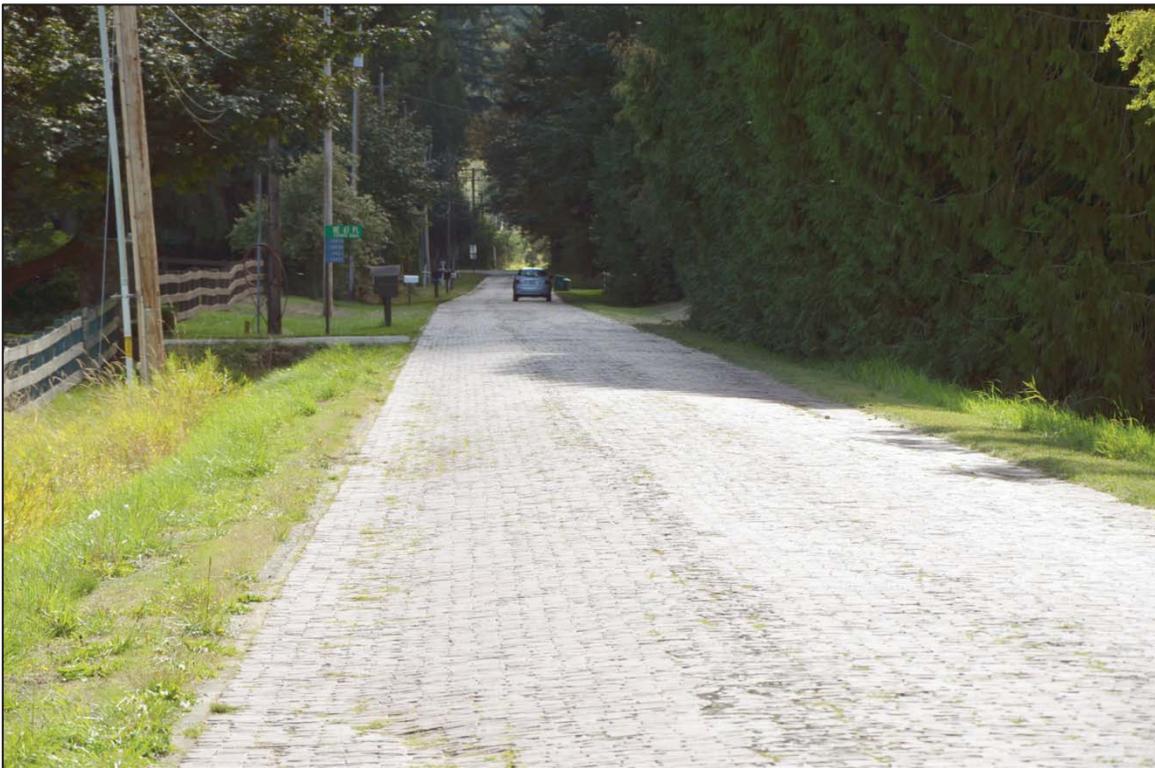
Figure 13. Parallel tracks with crushed and fragmented brick.

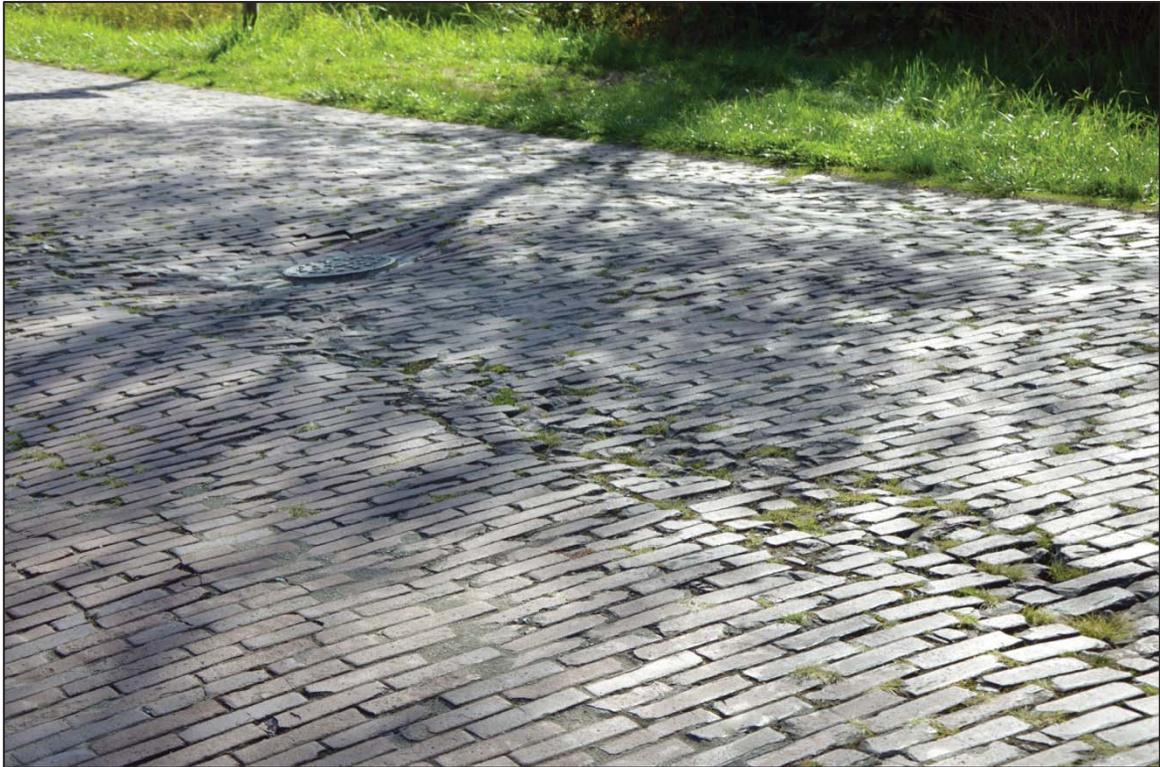
Depressions and severe pot holes were noted in the vicinity of several monument cases (Figure 14). Similar issues were noted in the 1988 repairs; these cases and covers were adjusted to grade in that contract.

Figure 14. Sagging in vicinity of monument case.

Monument cases with sagging and depressions in the immediate vicinity will need to be reset at grade in a similar manner to the 1988 repairs.

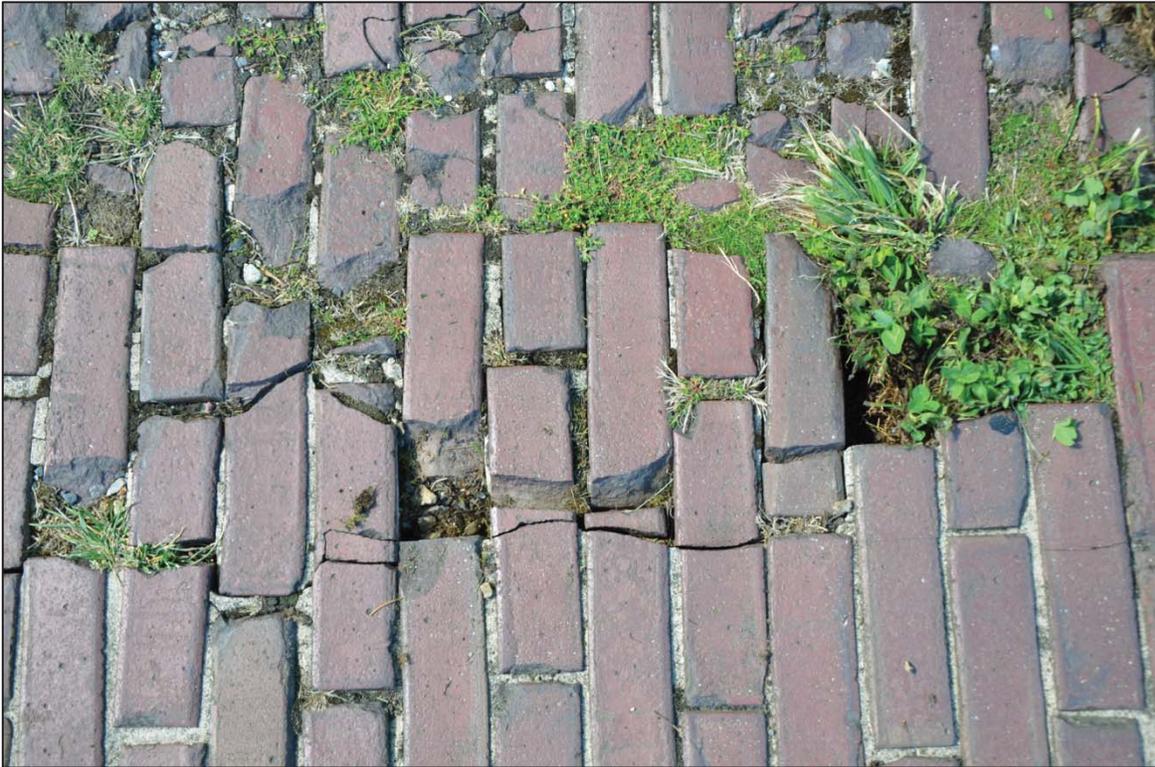
Figure 15. Vegetation in road.

bricks most closely match the type originally used on the Red Brick Road. The maintenance plan should also address annual removal of vegetation in and around the road (Figure 15). Removal methods should be non-intrusive and non-destructive. Assigning a trained maintenance crew of two to three people may help to ensure that the maintenance plan is being followed when repairs are conducted.
