**Subject: Geologic Hazards Assessment, Preliminary Soil Design Information,
and Conceptual Drainage Plan Review**
Holub Property, Parcel #3125079010, Redmond, Washington

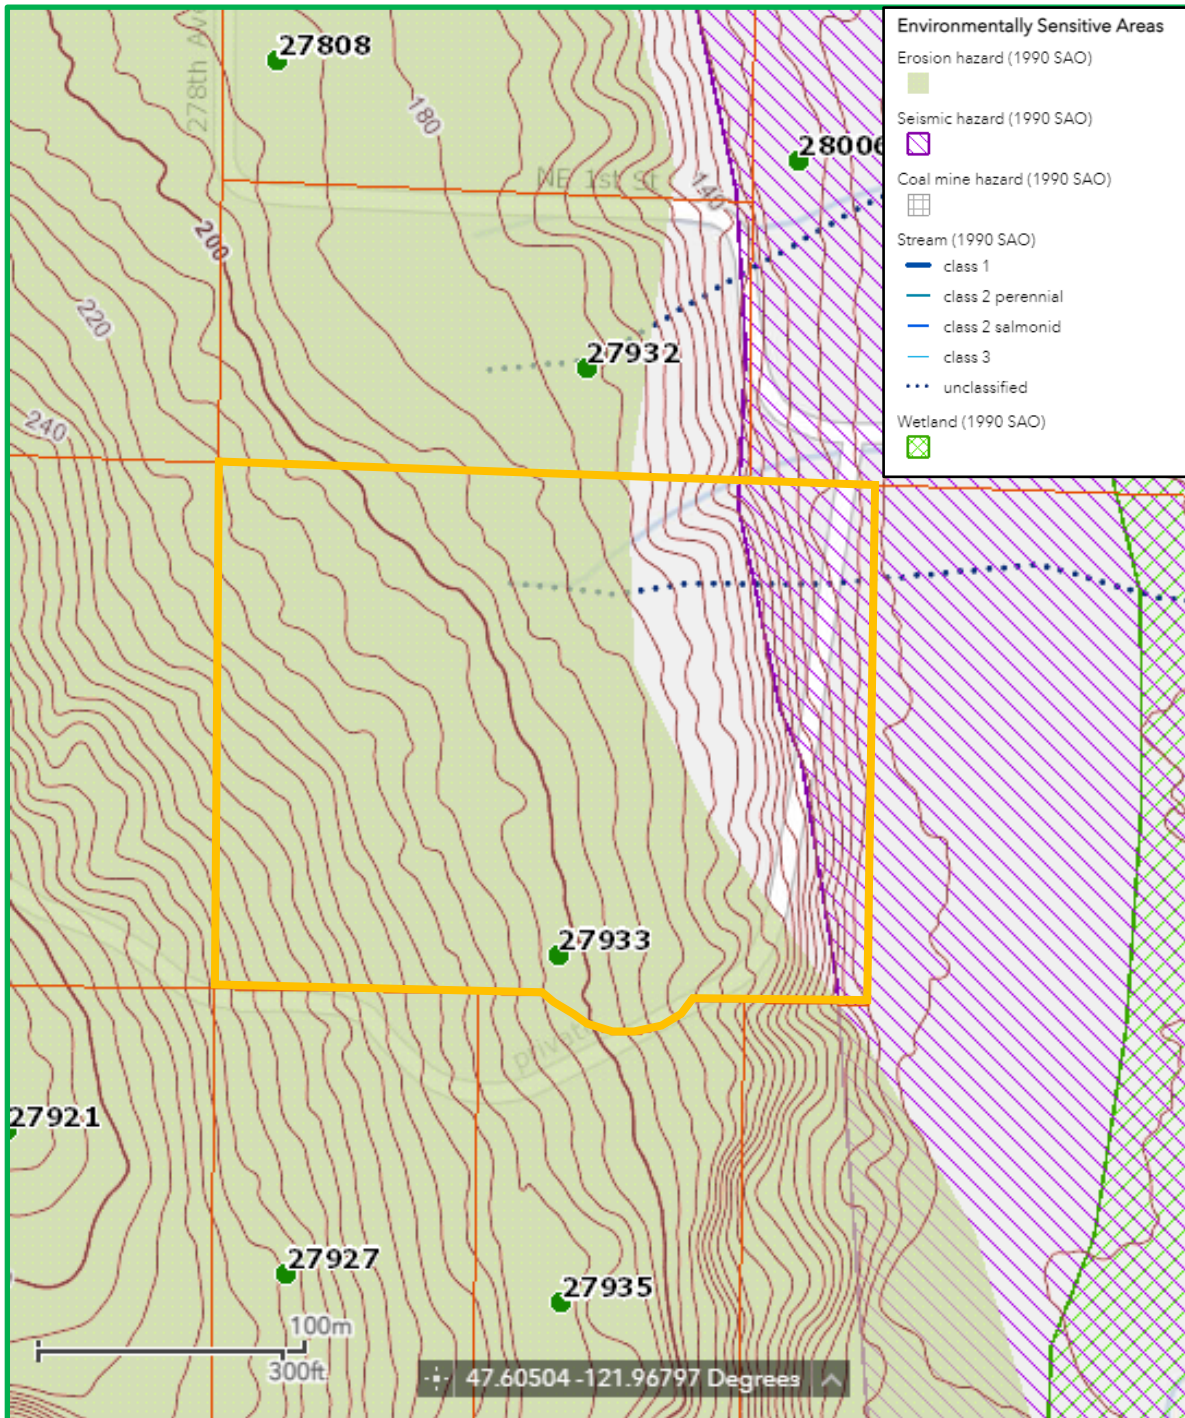
Typical Mapped Geologic Hazard Layers

The following discussion of potential geologic hazards is based on the visual reconnaissance of the site, reviews of aerial photographs and regional topographic and geologic maps of the area, and review of the information available on the King County Interactive Mapping Tool (iMap). The iMap information indicates the following geologic hazards: Erosion Hazard Area, Potential Steep Slope Hazard Area, Critical Aquifer Recharge Area (Category 2), Seismic Hazard Area and a Landslide Hazard Area that was within the “Stormwater Services” map layer tree, which is not a typical GIS layer for determining geologic hazards. We will address these items in the following subsections:

The eastern portion of the property is mapped as a seismic hazard area. This is due to the presence of Quaternary peat deposits in the bog to the east of the property. These soils do not underlie the area to be developed and as such the proposed development should not be encumbered by seismic hazard areas. Liquefaction is a condition where loose, saturated, fine sands lose their shear strength due to rapid pore pressure build-up when subjected to high intensity cyclic loads that can occur during earthquakes. Based on the native, moderately to well-graded sediments underlying the area to be developed and the lack of adverse groundwater conditions (minor perched water rather than a static groundwater table), it is our opinion the liquefaction potential of this site is low, and no mitigations are necessary.

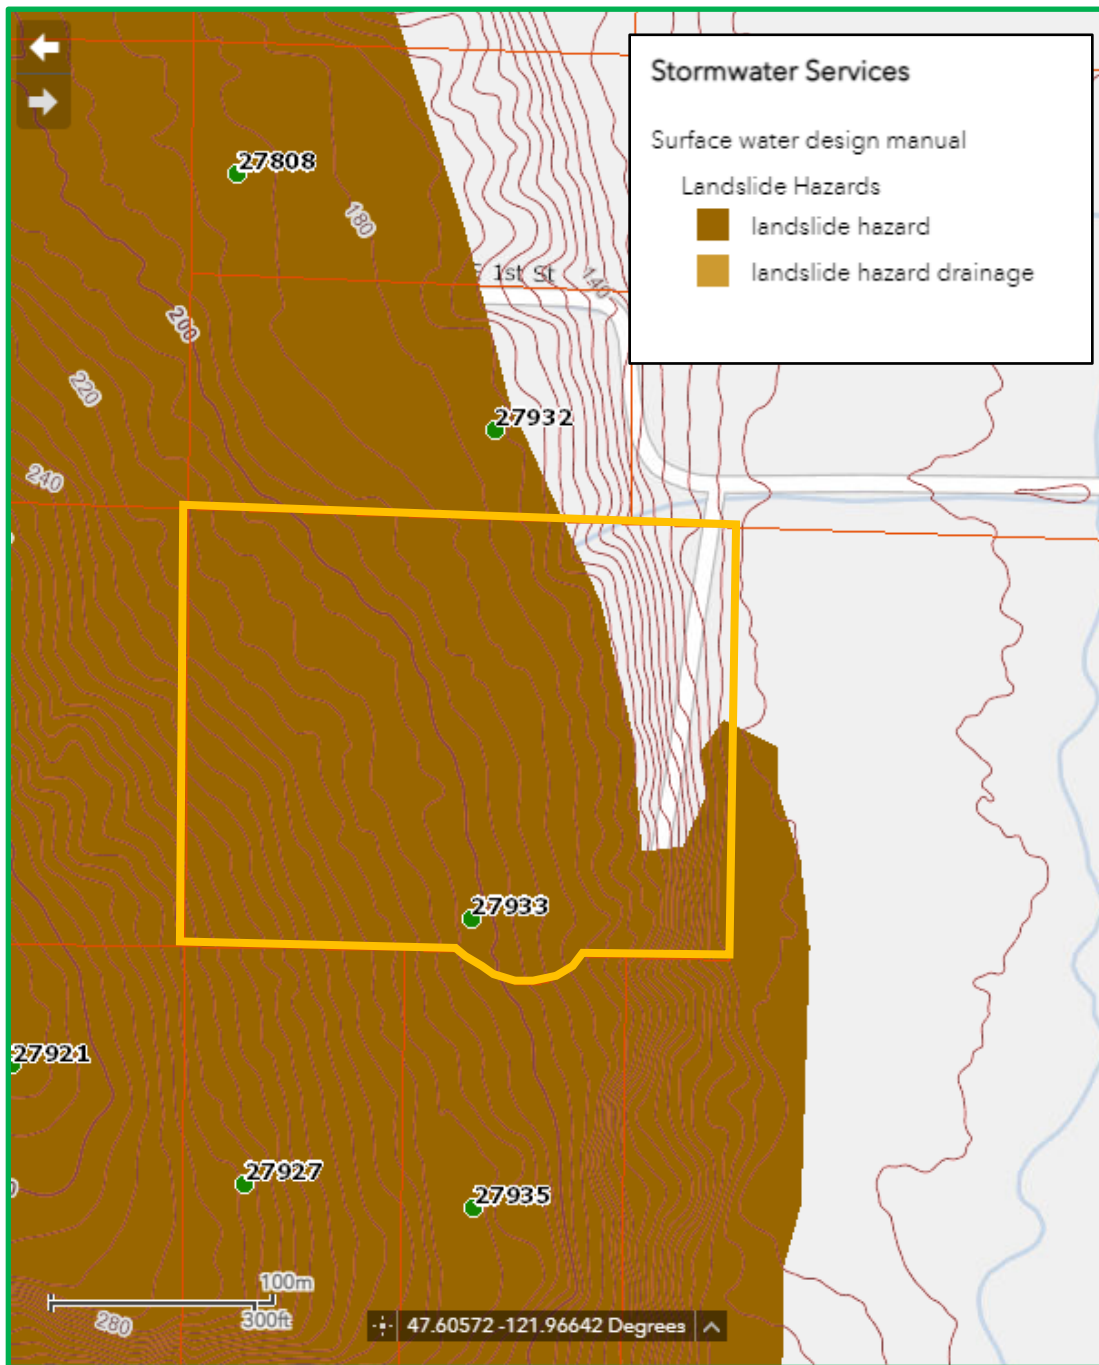
Surface Water Design Manual Mapped Landslide Hazard Layers

Based upon our site reconnaissance, the topographic and geologic conditions present, and the lack of geomorphic evidence of past landslide activity, it is our opinion that the site conditions do not fulfill the codified definition/criteria of a landslide hazard area (KCC 21A.06.680). However, King County staff brought the Stormwater Services landslide hazard area mapping layer to Mr. Holub's attention. It appears that this mapping layer was designed to flag sensitive drainage basins and natural slopes with respect to stormwater drainage design, but we could not determine from the iMap layer source information what data or interpretation this mapping was based on. We have attached images of the landslide hazard area related iMap layers, the typical layer from the "Environmentally Critical Areas" map tree, which does not indicate the presence of landslide hazard areas, and the "Stormwater Services" map tree mapping layer that shows landslide hazard areas. South Fork Geosciences has reached out to King County staff for clarification with respect to this mapping layer discrepancy, but we have not received a response at the time this letter was prepared.

We presume that the code definition/criteria for a landslide hazard area would dictate the development standards for the property, and the property clearly does not constitute a landslide hazard area per KCC 21A.06.680. Upon clarification of the implications of this "Stormwater Services" mapping layer by King County staff, South Fork Geosciences will provide additional assessment or supplemental information, as required.
