Vashon Island - Colvos Passage Site  
**2022 UNDERWATER SEABED AND SAV SURVEY**

**Vashon Kelp Forest, LLC**  
January 31, 2022

# **Vashon Island – Colvos Passage Site 2022 UNDERWATER SEABED AND SAV SURVEY REPORT**

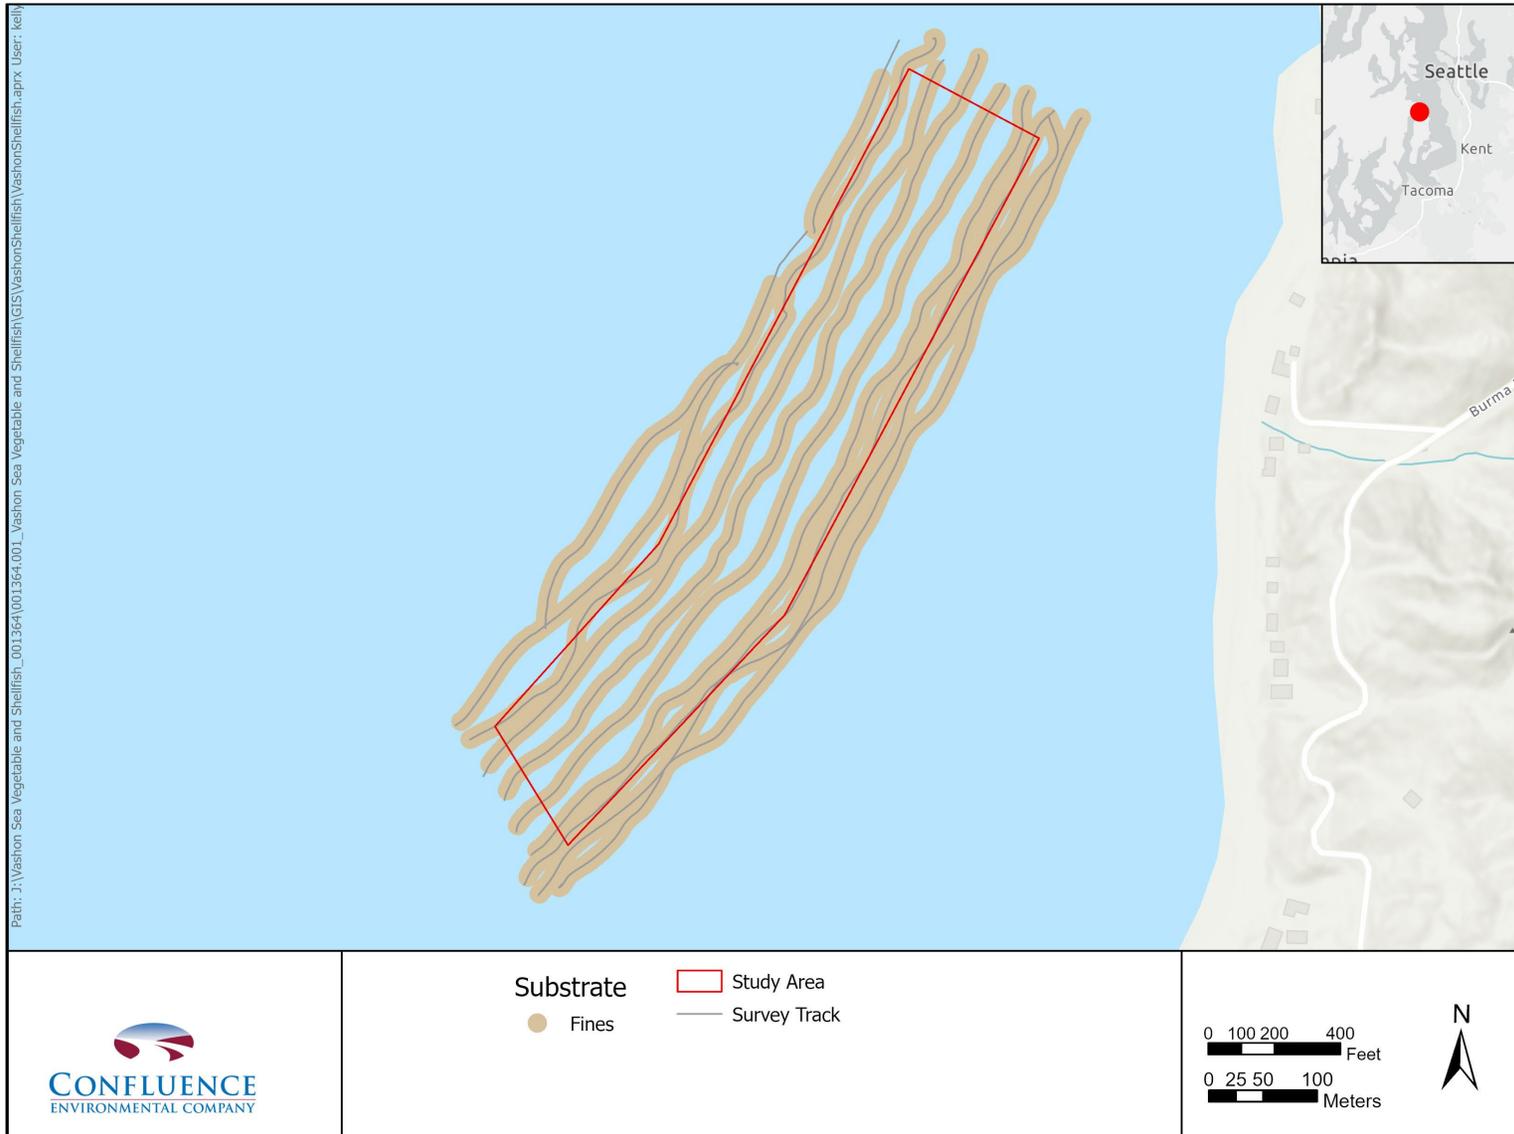
**Figure 3. Substrate Types Observed During 2022 Field Survey**

The surveyed area lies between approximately 50 feet below MLLW and 120 feet below MLLW. The substrate surveyed was uniformly composed of fine-grained soft sediments with scattered empty shells of bivalves (primarily oysters and medium-sized clams). There was no evidence of larger grained sediments, rocky outcrops, or other hard substrate.

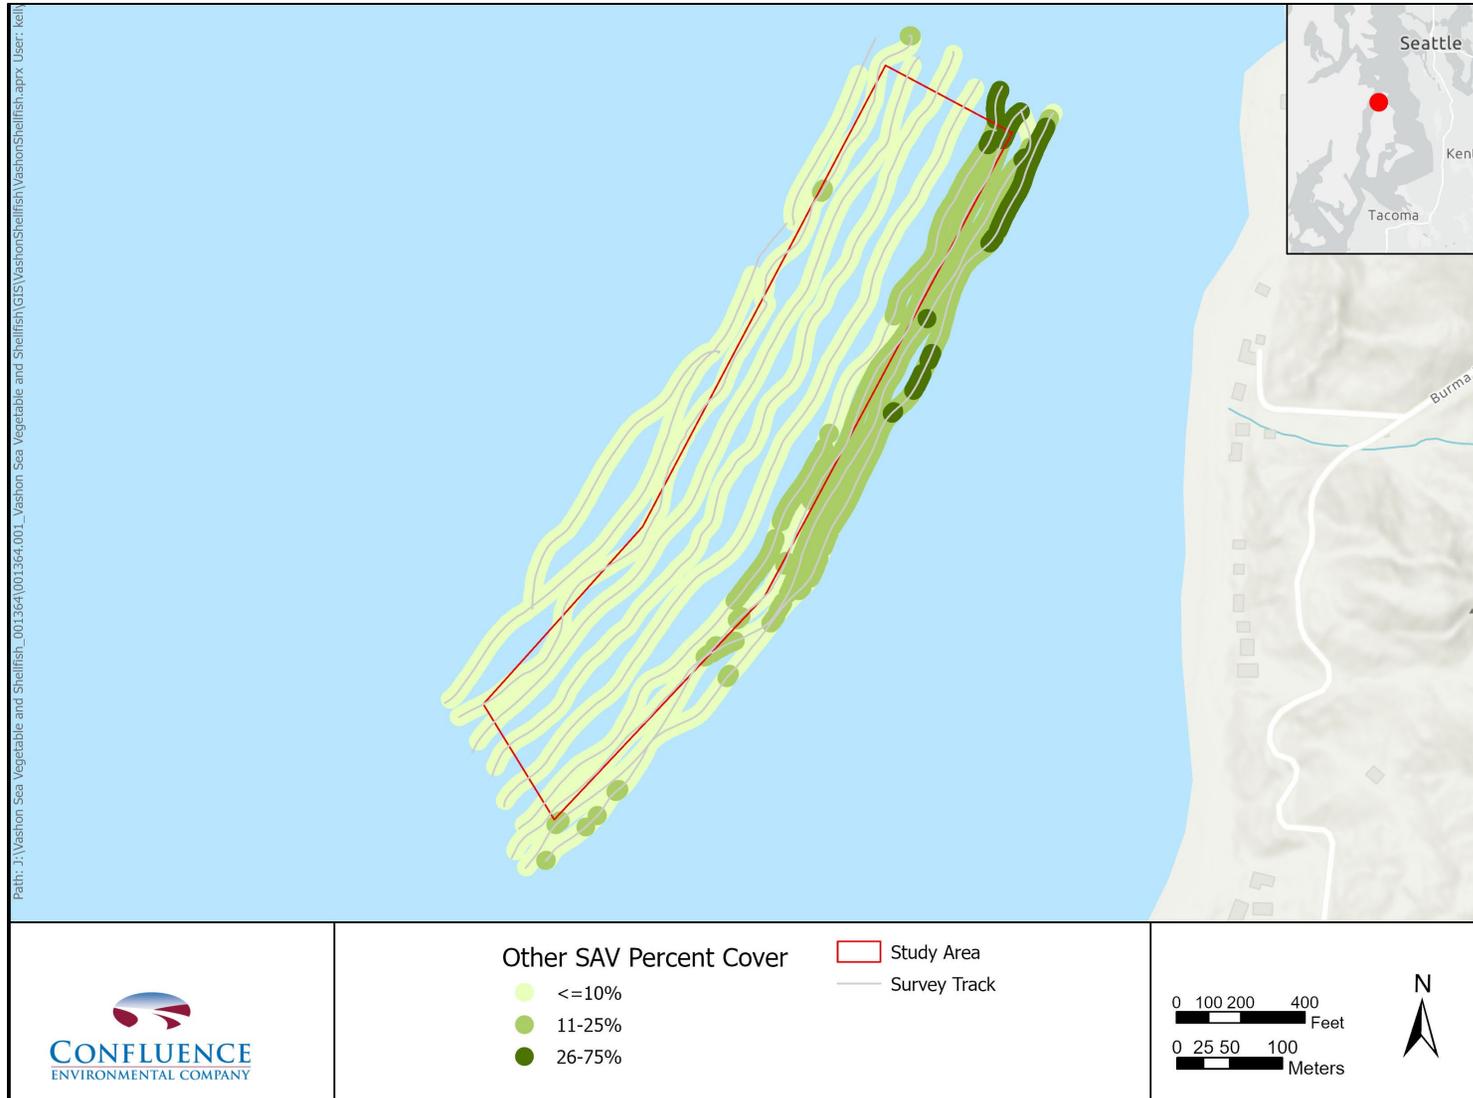
Figure 4. Submerged Aquatic Vegetation (SAV) Observed During 2022 Field Survey

Attached eelgrass or order Laminaria kelp was not observed in the surveyed area. No areas or specimens of Laminariales (kelp) or eelgrass were observed anywhere in the surveyed area. Much of the observed SAV was patches of detached or loosely aggregated macroalgae. Detached algal material is comprised of fragments that break off of algal blades or stipes. Many algae and kelp species die back in the winter and vegetative material drifts along the seabed before decomposing. The vegetation observed is comprised of detached kelp detritus that has likely drifted to the site from adjacent shallow subtidal areas. Much of the detached material is in clumps or waves along the seabed. From the condition of the algal specimens observed and the quality of video, it was not possible to positively identify any observed algae. Based on visual observations, substrate type, and habitat (depth and location), it was possible to determine that neither large kelps nor eelgrass are present in the surveyed area. Apart from occasional debris, no suitable material for kelp attachment was observed on the seabed.

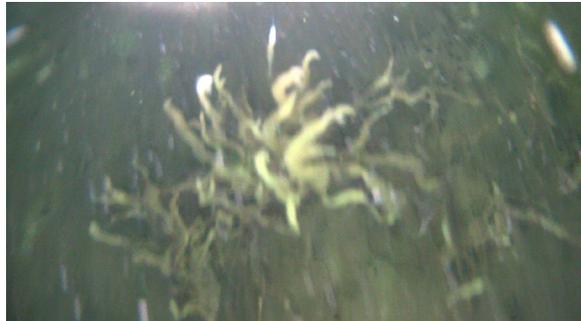
**Unidentified algae fragments (Vashon Site)**

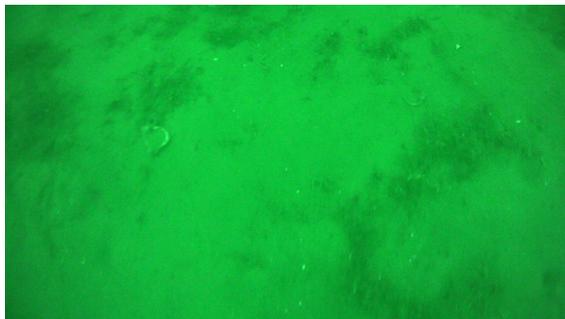
**Fine substrate and red or brown algae(Vashon Site)**

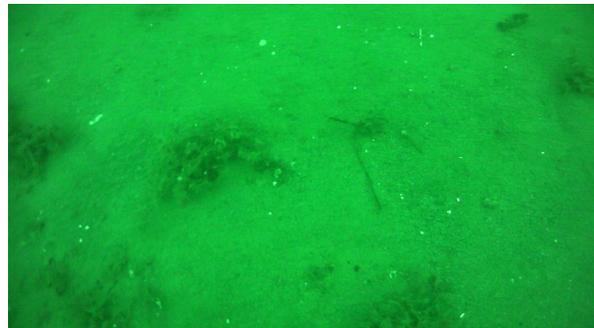
**Fine substrate and unattached SAV example (Vashon Site)**
