Technical Information Report

Reserve Inert Waste Landfill Expansion Project

DRAFT
February 28, 2025

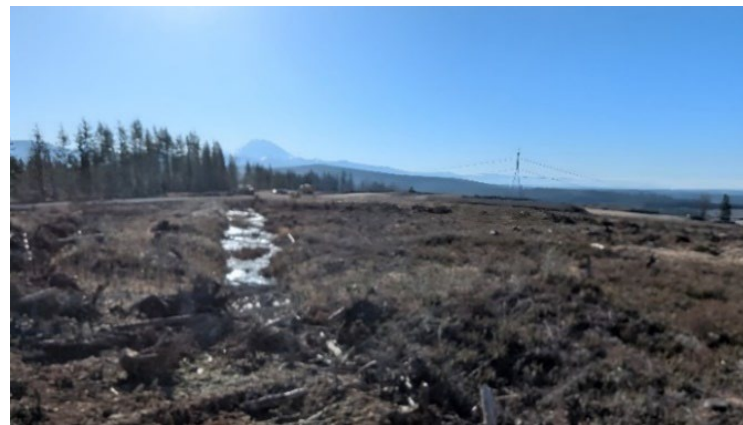
Figure 2. Area 6 Fill Location Drainage.

Notes: Runoff drains southeast towards two culverts under the eastern haul road.

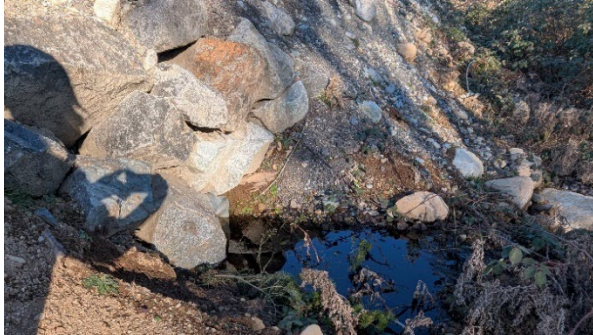
Figure 3. Upstream 12-inch Culvert Outlet into Coal Mine Depression.

Notes: Outflow from 12-inch corrugated metal pipe flows toward coal mine depression.

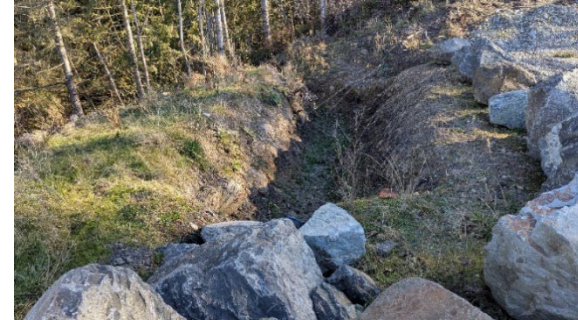
Figure 4. Downstream 12-inch Culvert Outlet into Drainage Swale.

Notes: Drainage swale conveys culvert (12-inch smooth wall polyethylene pipe) outflow east towards coal mine depression.

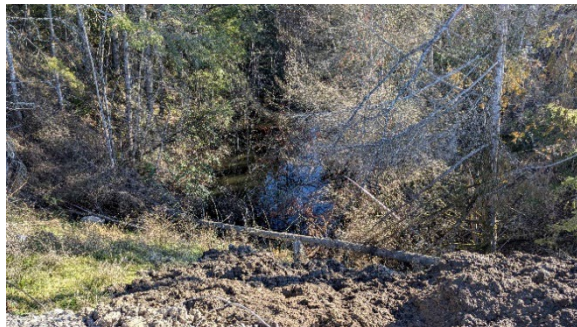
Figure 5. Eastern Coal Mining Remnant

Notes: Historical coal mine seam has become a surface water body and downstream drainage point for portions of Area 6 runoff.

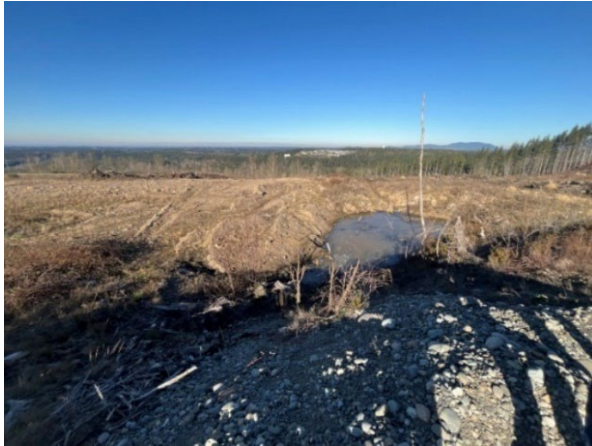
Figure 7. Area 6 Temporary Stormwater Pond

Notes: Depression where Area 6 runoff collects.

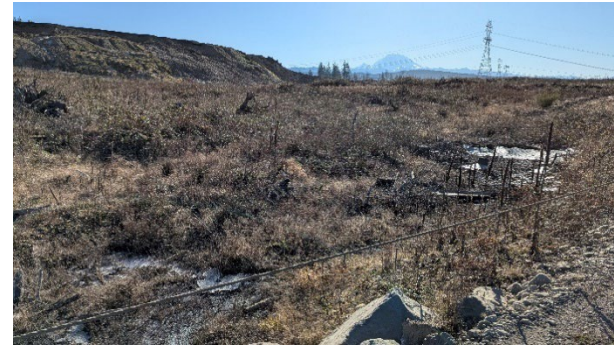
Figure 8. Western Downhill Side of the Area 6 Plateau

Notes: Runoff from Area 6 flows northwest to an 18" smooth wall polyethylene culvert beneath the eastern haul road, which directs it toward either the temporary storage pond or across vegetated cover into ditches along the eastern side of the main haul road.

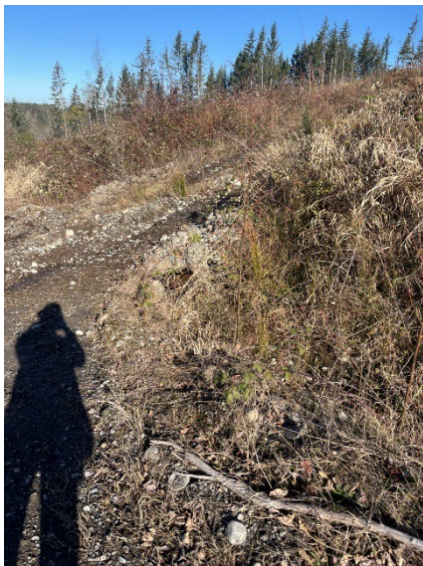
Figure 9. Access Road Culvert

No conveyance system nuisance problems were identified downstream of the Site during the resource review process or during the field reconnaissance. Some ditches on the Site have deteriorated due to vegetation overgrowth and sediment accumulation but are generally oversized and have sufficient capacity to convey the 100-year event. All existing culverts appear free flowing and non-obstructed. Off site, the ditches along Black Diamond-Ravensdale Road Southeast appear to have sufficient capacity based on visual inspection, but the 18-inch culvert (managed by King County) under Black Diamond – Ravensdale Road Southeast is reported to periodically cause minor flooding of the road. Runoff from the Areas 5 and 6 is not routed to this culvert.

Notes: Culvert appears free flowing, but there is evidence of vegetation overgrowth and sediment accumulation at culvert inlet and outlet.

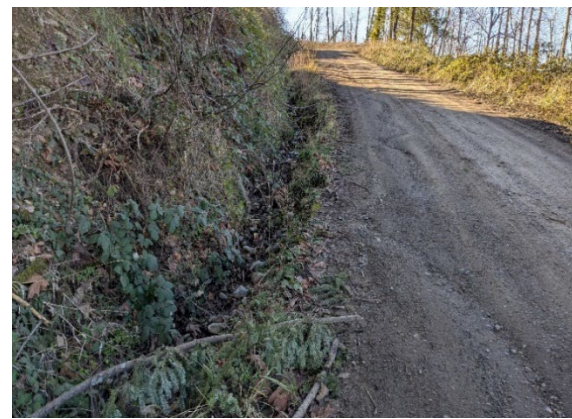
Figure 10. Roadside Ditch Network Along East Side of Main Haul Road

Notes: Downstream of the culvert, a long stretch of ditch remains intact and typically has a 6' top width, 2' bottom width, and 2.25' depth.

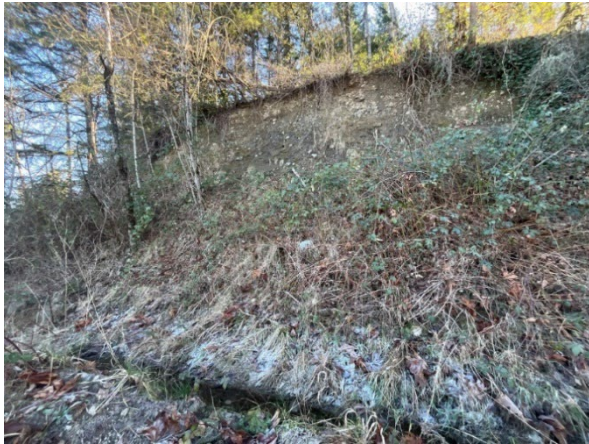
Figure 11. Steep Slopes on Downhill Side of Landfill Along East Side of Main Haul Road

The Fill Site is predominately classified as a potential steep slope hazard area, particularly along the downhill sides of Areas 1 through 4. During the downstream field analysis, no severe erosion issues were identified. However, steep slopes on the east (uphill) side of the main haul road could pose potential hazards to the haul road ditch at the toe of the slope, which will convey runoff from Area 6. In the event of a slope failure or landslide, these ditches could become obstructed. Mitigation strategies to prevent hillside impact are detailed in Section 4.1.5.

Notes: Slopes of approximately 39% along the uphill side of road.

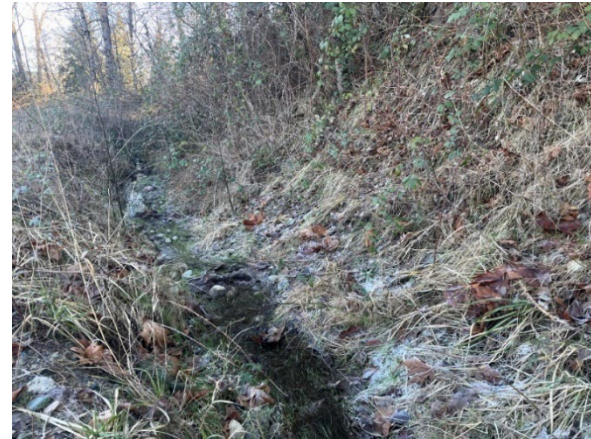
Figure 12. TDA 1 Existing Discharge Location

Notes: Ditch flow line appears to continue onto adjacent property (Discharge Point 1).

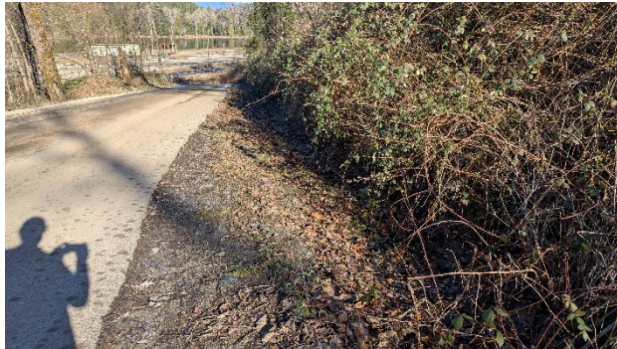
Figure 13. TDA 1 Proposed Discharge Location

Notes: Majority of runoff will infiltrate within the forested area or collect in ditches along Black Diamond-Ravensdale Road SE (Figure 13).

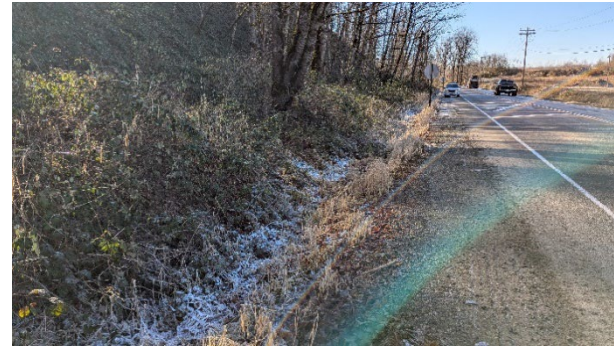
Figure 14. Downstream Flowpath of TDA 1 Runoff Under Proposed Conditions

Notes: TDA runoff which reaches the roadway will collect in roadside ditches, draining north.

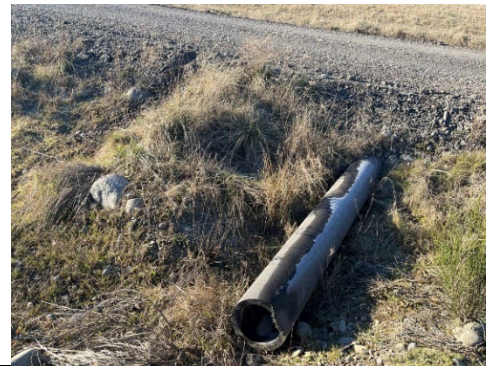
Figure 16. 8-inch HDPE Culvert Draining East Under Main Haul Road.

Notes: Culvert appears to collect runoff from Dale Strip Pit area.

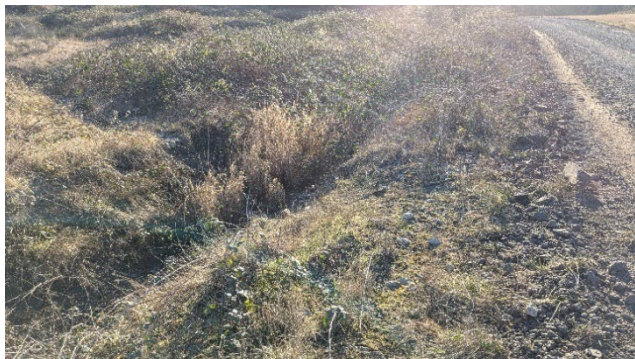
Figure 17. Main Haul Road Drainage Ditch

Notes: Ditch centerline become more apparent downstream of culvert, and typical dimensions are 8' top width, 2' bottom width, and 2' depth.

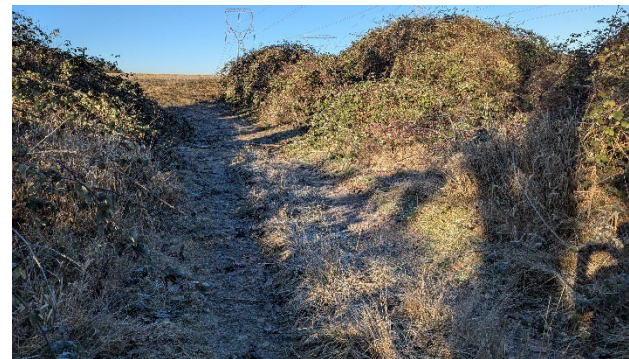
Figure 18. Low Point Located on Small Access Road

Notes: No culvert observed under access road, but thick vegetation may have obscured a pipe, ditch appears to drain towards low point in road.

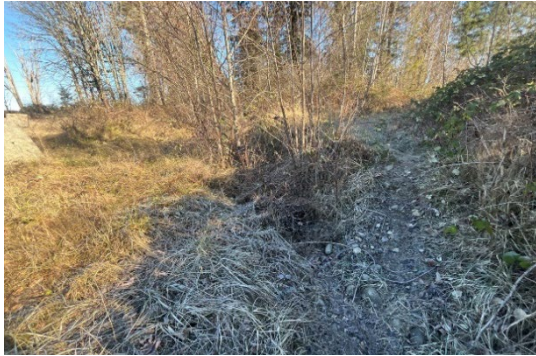
Figure 19. Drainage Ditch Obstruction

Notes: Drainage ditch appears to pick up south of the gravel trail, but ditch geometry was obscured by vegetation. Flow path appears obstructed by gravel trail transecting the ditch from the east. However, soil erosion along across the trail indicates that runoff continues draining south.

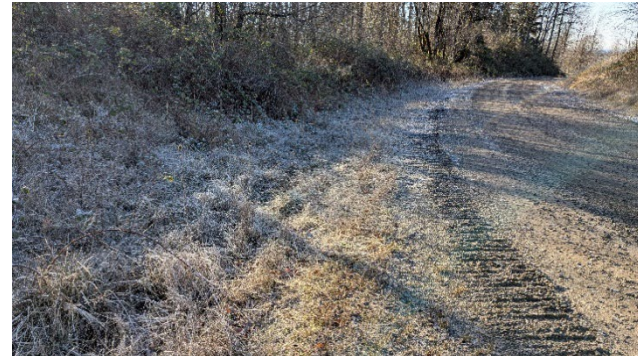
Figure 20. Continued Flowline Along eastern side of Main Haul Road

Notes: South of the trail, there is no clear ditch geometry due to vegetation, but approximately 100' downstream, a more defined and recently maintained ditch is established (Figure 20)

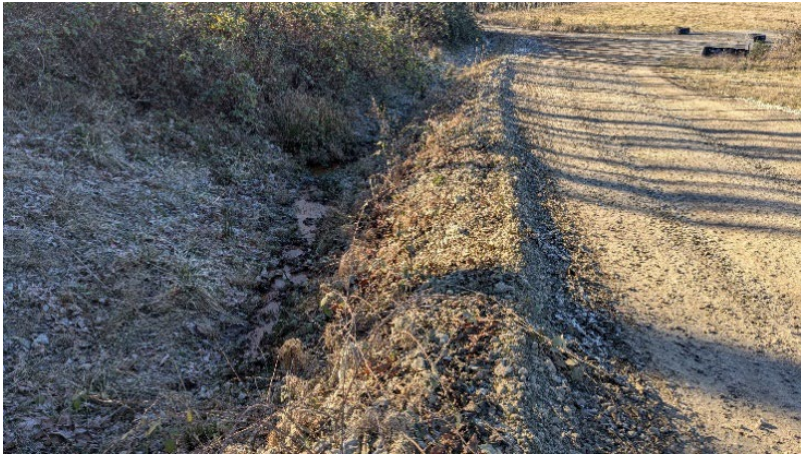
Figure 21. Ditch Establishment

Notes: Gravel thickened edge keeps haul road runoff from draining into ditch. A ditch geometry becomes more clearly visible, approximate 8' top width, 2' bottom width and 3' depth.

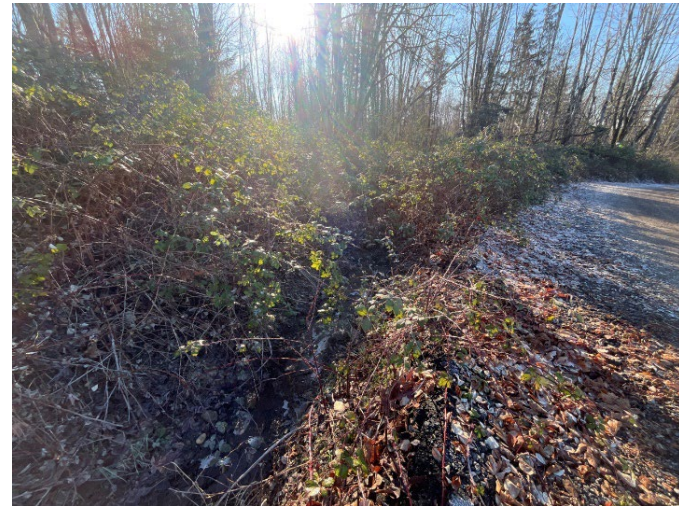
Figure 22. Existing TDA 2 Discharge Location

Notes: Ditch flow line ends, draining towards adjacent forest. (Discharge Point 2).

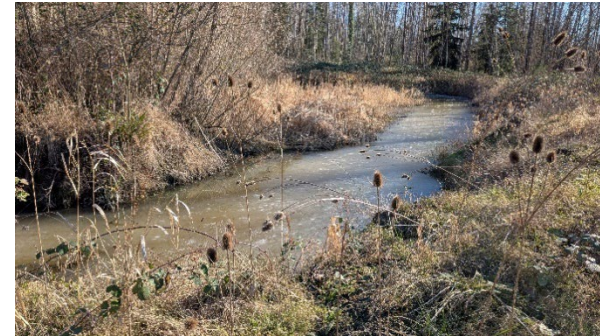
Figure 24. Existing Infiltration Pond

Notes: Soft, damp soils were observed near the pond.

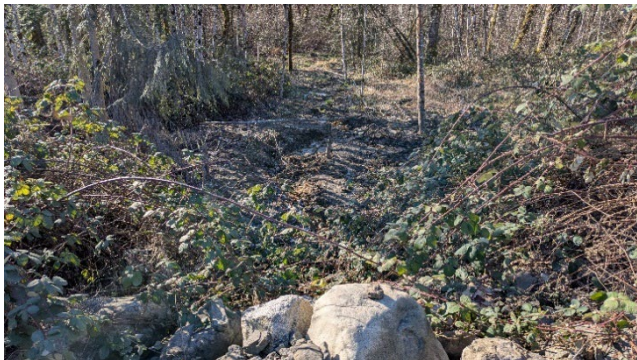
Figure 25. Rock Dispersion at Infiltration Pond Outlet/TDA 3 Existing Discharge Point

Notes: Runoff that does not infiltrate, is dispersed into the forest to the west.

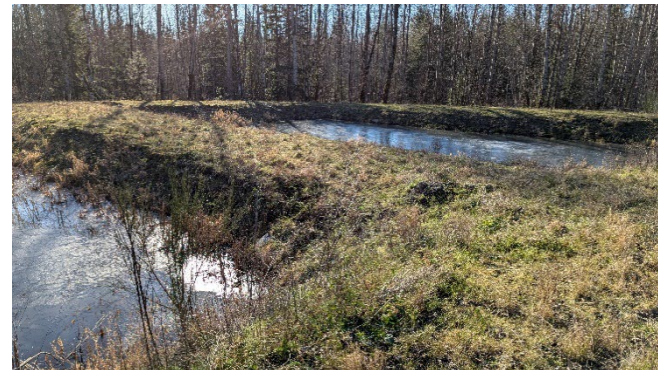
Figure 26. TDA 3 Wet pond under Construction

Notes: Runoff from the central portion of the inert waste landfill will be routed to the new wet pond designed by Aspect Consulting. Construction of the wet pond began in 2023.

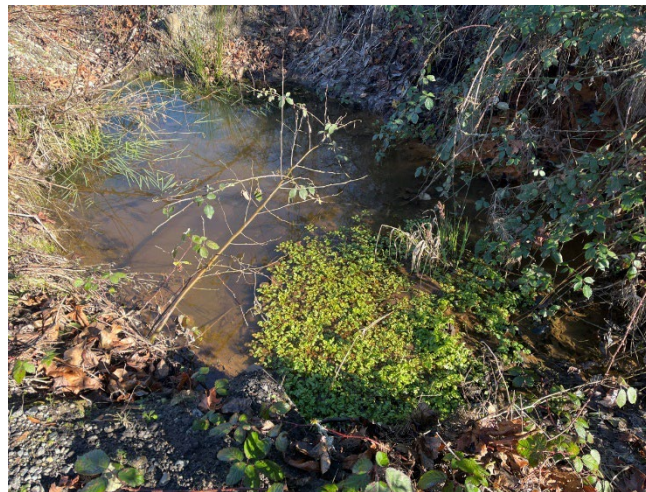
Figure 28. Culvert Inlet at Ditch Along Lower Haul Road.

Notes: An 18-inch smooth wall polyethylene pipe conveys runoff from the haul road ditches west under the haul road at the Y towards forested cover upstream of Black Diamond-Ravensdale Road SE. Ponded water was observed upstream of culvert in ditch.

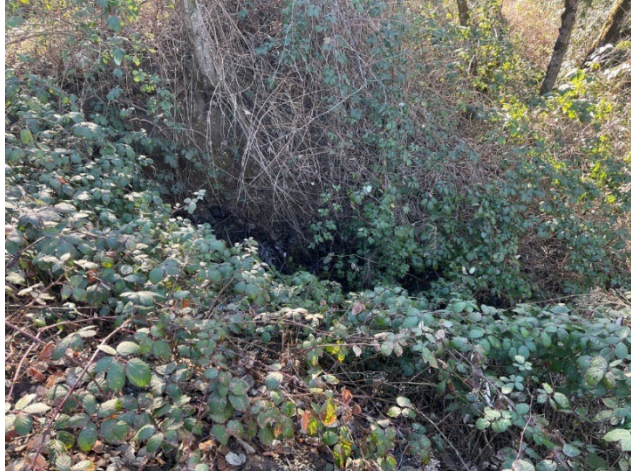
Figure 29. Culvert Outlet into Drainage Swale

Notes: Culvert outlet discharges runoff into a drainage swale which directs runoff towards Black Diamond-Ravensdale Road SE.

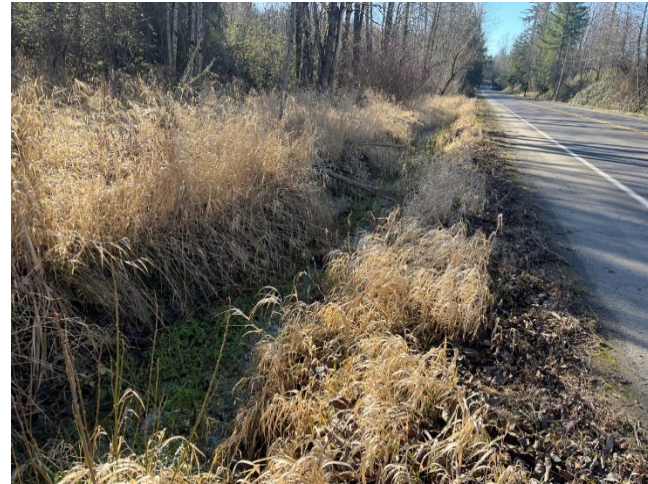
Figure 30. Roadside Ditch Network Along South Side of Black Diamond-Ravensdale Road SE.

Notes: Ditch geometry was typically 4' top width, 2' bottom width, and 2.5' depth.

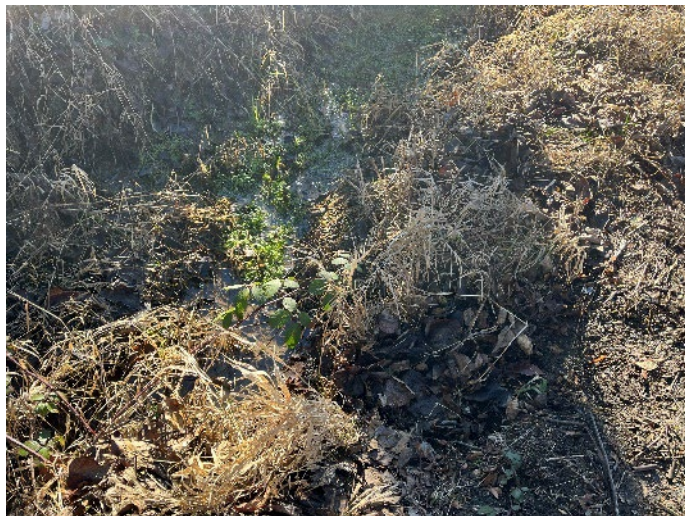
Figure 31. Evidence of Culvert Inlet under Black Diamond-Ravensdale Road SE.

Notes: Runoff from ditch appears to drain under road, but culvert inlet was not located.

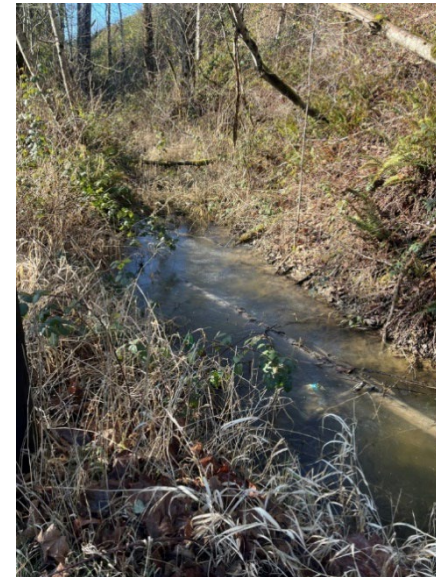
Figure 32. Roadside Ditch Network Along North Side of Black Diamond-Ravensdale Road SE.

Notes: Ditch geometry on north side of road is typically a 12' top width, 4.5' bottom width and 3.5' depth. Evidence of ponding water indicates stormwater pools upstream before discharging onto Plant Site (Figure 32)

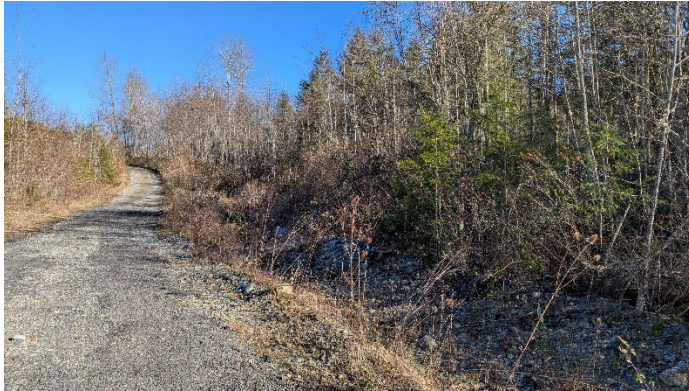
Figure 33. North Side Ditch Turnout onto Plant Site

Notes: The roadside ditch along the north side of Black Diamond-Ravensdale Road SE turns onto the Plant Site and continues draining in ditches along the south side the Plant Site perimeter road towards an excavated closed depression (Figure 33).

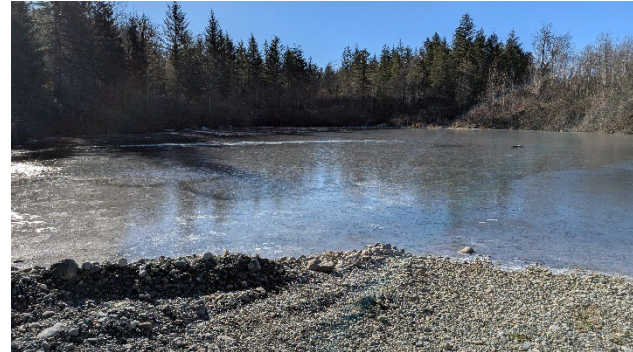
Figure 34. Closed Depression at Western End of Plant Site.

Notes: Stormwater from a portion of the perimeter road on the Plant site currently drains towards an excavated closed depression. There was no evidence of a flow path leaving the closed depression and surficial soils appeared to be coarse sand and gravel indicating water likely flows subsurface from the depression.
