RE: Coal mine hazard on PCCC Enumclaw-Franklin Road Properties Inquiry Number L06SA435

SENSITIVE AREA NOTICE

Geological Engineering Services Preliminary Assessment of Coal Mine Hazards, Landslide/Steep Slope Hazards and Landslide Hazard Drainage Areas PCCC Enumclaw-Franklin Road Properties Section 19-T21N-R7E and Section 30-T21N-R7E Black Diamond (King County), Washington

> May 2, 2006 Project No. 0102-010

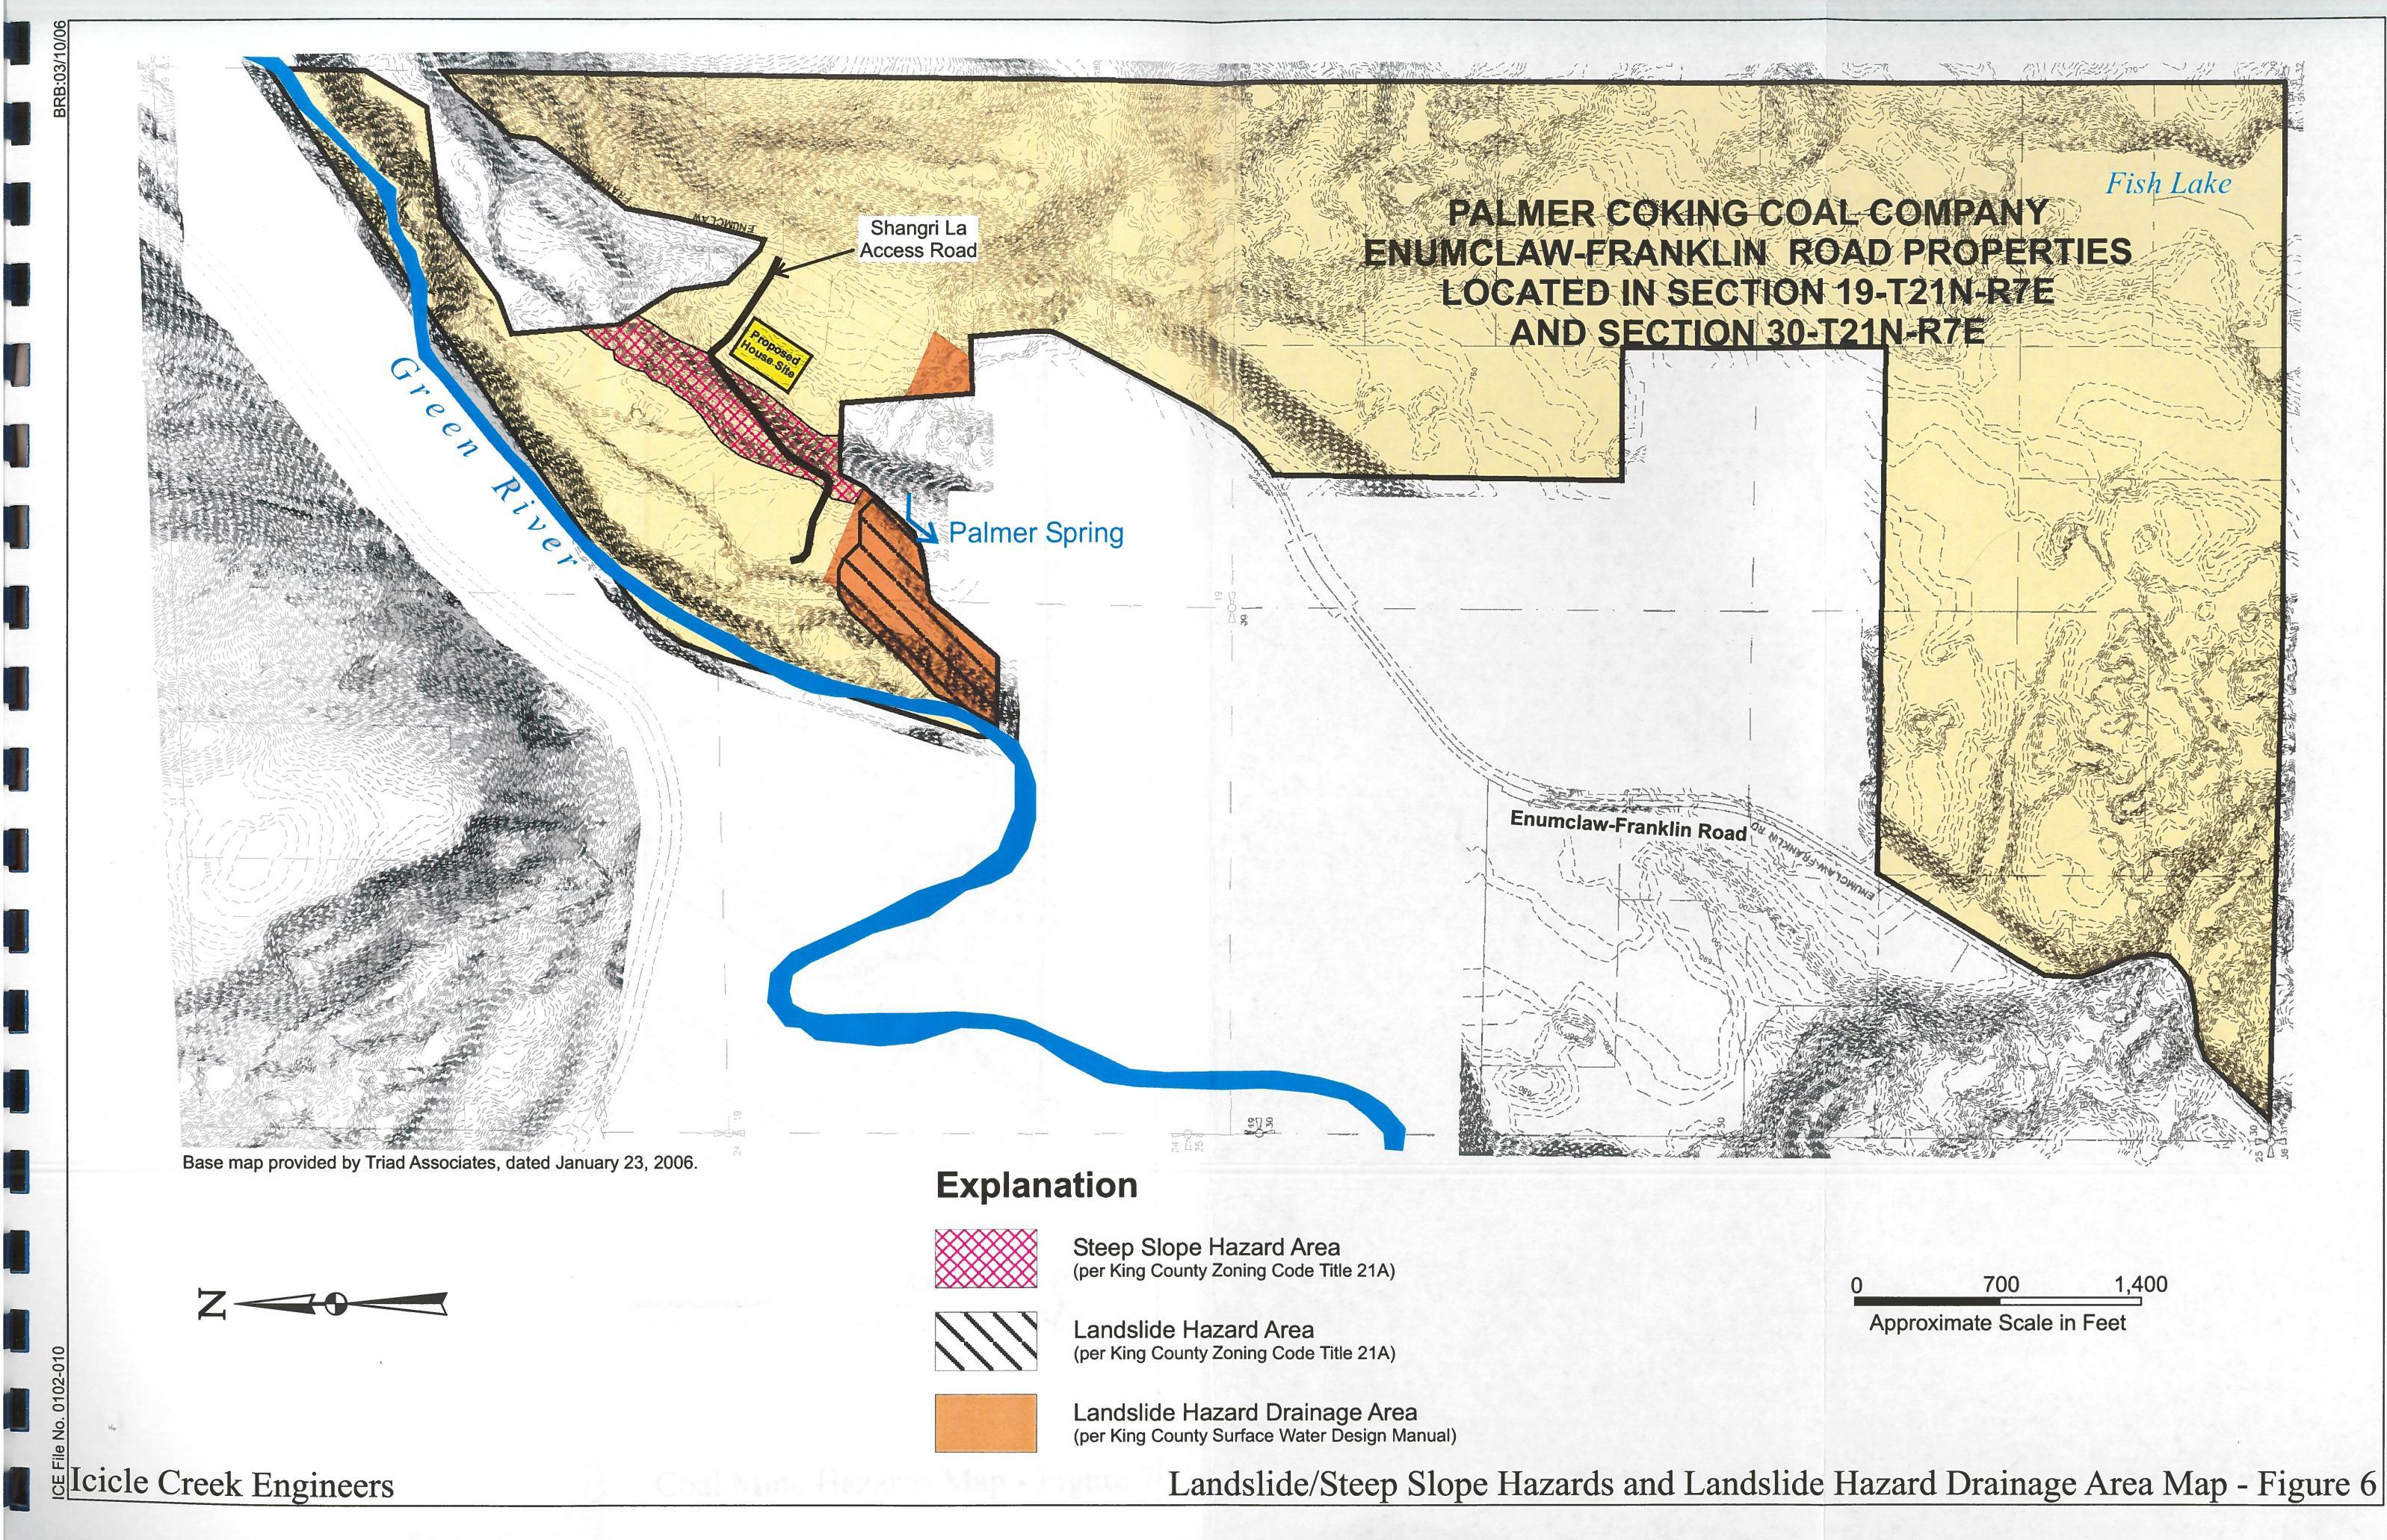
Figure 6 - Landslide/Steep Slope Hazards and Landslide Hazard Drainage Area Map

We did not observe surficial physical evidence of active deep-seated (more than 5 feet deep) landsliding within the Landslide and Steep Slope Hazard areas (shown on Figure 6) within or adjacent to

According to King County DDES mapping, an area southwest of the proposed house site is within a regionally-mapped Landslide Hazard area as shown on Figure 6. We did not observe surface evidence of deep-seated (more than 5-feet deep) landsliding within the Landslide Hazard Area. Surficial (less than 5-feet deep) ground movement, referred to as soil creep is likely active, and is typical of most steep slope areas in the Puget Sound lowlands.

A Landslide Hazard Drainage Area, according to King County DDES, exists in the area shown on Figure 6. Development in this area (none is proposed at this time) will require special drainage review by King County DDES. Mitigations for development within a Landslide Hazard Drainage Area are focused on controlling stormwater runoff from new impervious surfaces, and routing this stormwater in a tightline to the base of slope areas or other approved discharge point.

Based on our knowledge of the geologic and soil conditions at the site, and our geologic reconnaissance, we recommend that foundation elements of structures and new access driveways/roads should be set back at least 40 feet from the top of the Steep Slope Hazard Area. The 40-foot wide setback includes a 25-foot wide buffer (reduced from the King County DDES standard 50 feet) for a Steep Slope Hazard area. It is possible that the buffer width could be reduced to a King County DDES minimum of 10 feet provided that subsurface exploration was completed to further evaluate subsurface soil and ground water conditions on a site-specific basis.

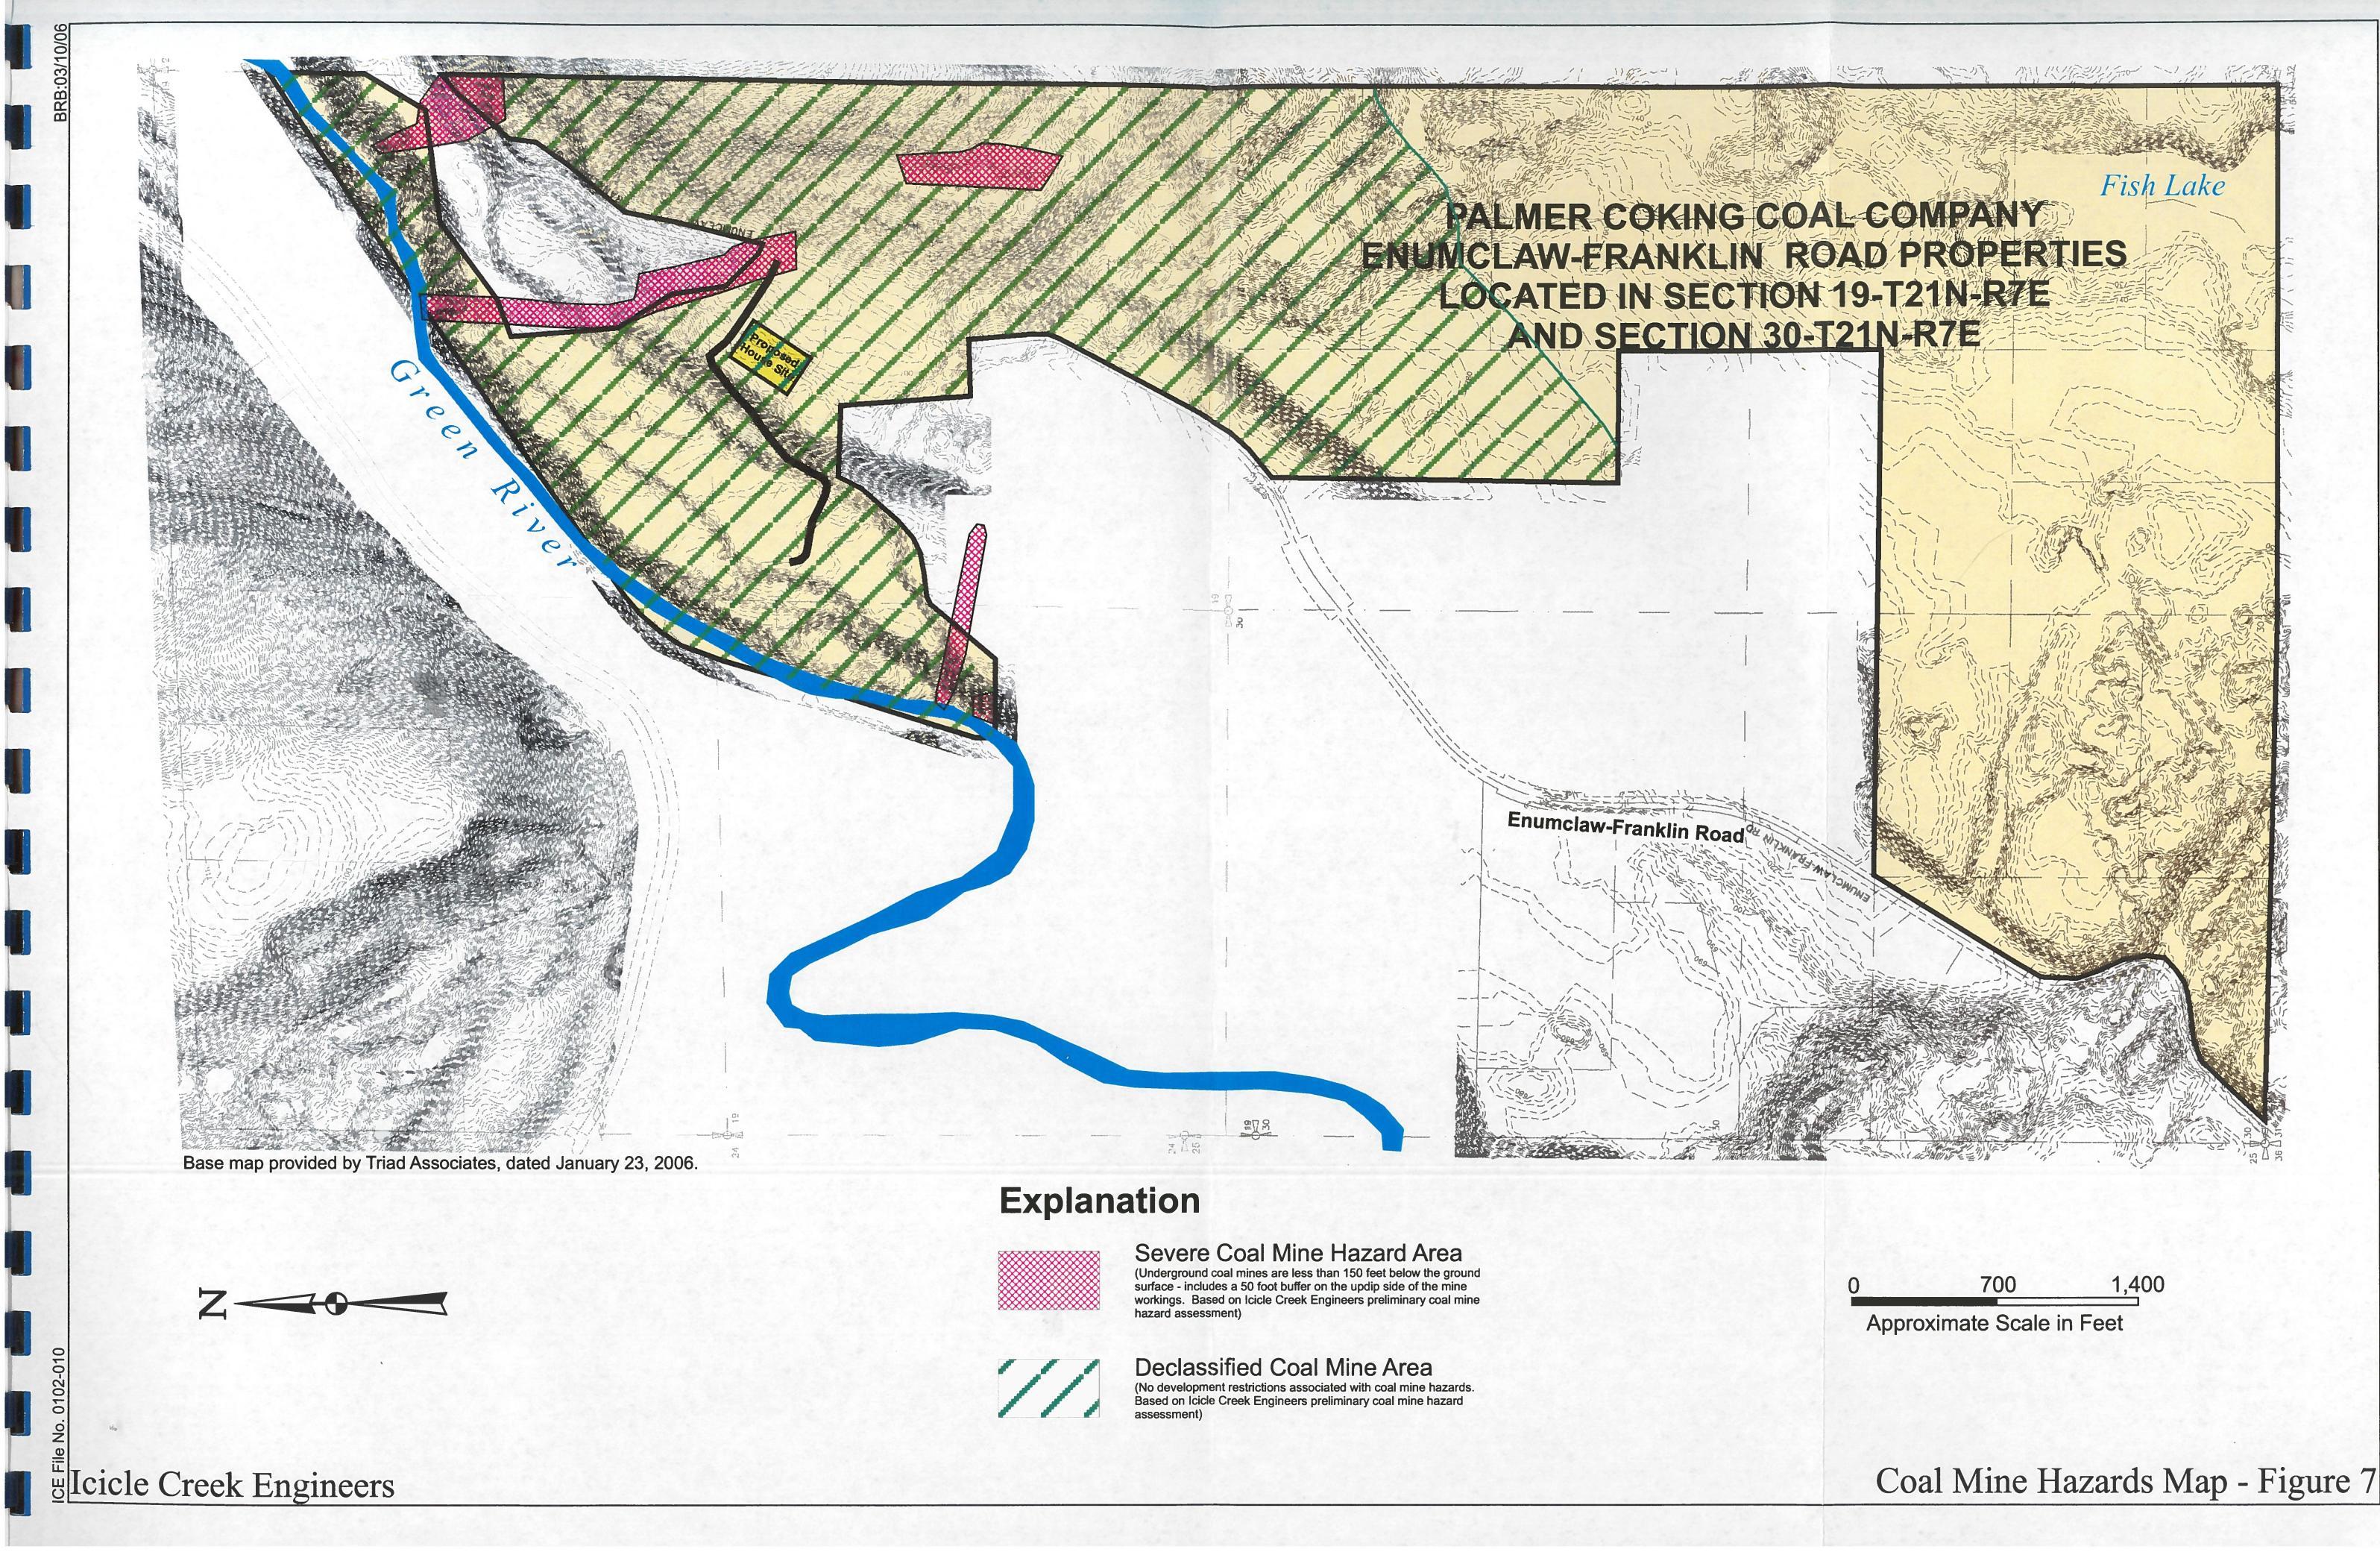
Figure 7 - Coal Mine Hazards Map

The Severe Coal Mine Hazard areas are underlain by abandoned underground coal mines at a depth of less than 150 feet and are shown on the Coal-Mine Hazards Map, Figure 7. We added a 50-foot wide buffer to the updip side of the Severe Coal Mine Hazard area as a conservative means to compensate for possible funneling of caved materials along the longitudinal axis of the subcrop of the mined out area of the coal seam.

Based on our evaluation, area classified as a "Coal Mine Hazard" by King County DDES that are outside of ICE classified Severe Coal Mine Hazard areas within the PCCC Enumclaw-Franklin Road properties should be designated as a Declassified Coal Mine Area as shown on Figure 7.

- No surface manifestation of regional ground subsidence was observed during our geologic reconnaissance.
- Portions of the PCCC Enumclaw-Franklin Road properties are underlain by abandoned underground mine workings that are less than 150 feet below the ground surface. These areas are Severe Coal Mine Hazard Areas as shown on Figure 7.

- An existing access road and portions of the Enumclaw-Franklin Road are located within the Severe Coal Mine Hazard area. Both roads have existed in their current locations for over 60 years. Given the lack of surface evidence of past subsidence of these road areas, these roads should be maintained in their present condition.
