Critical Areas Report and Buffer Averaging Plan

White Center HUB

10821 8th Avenue SW

Prepared for Community Roots Housing

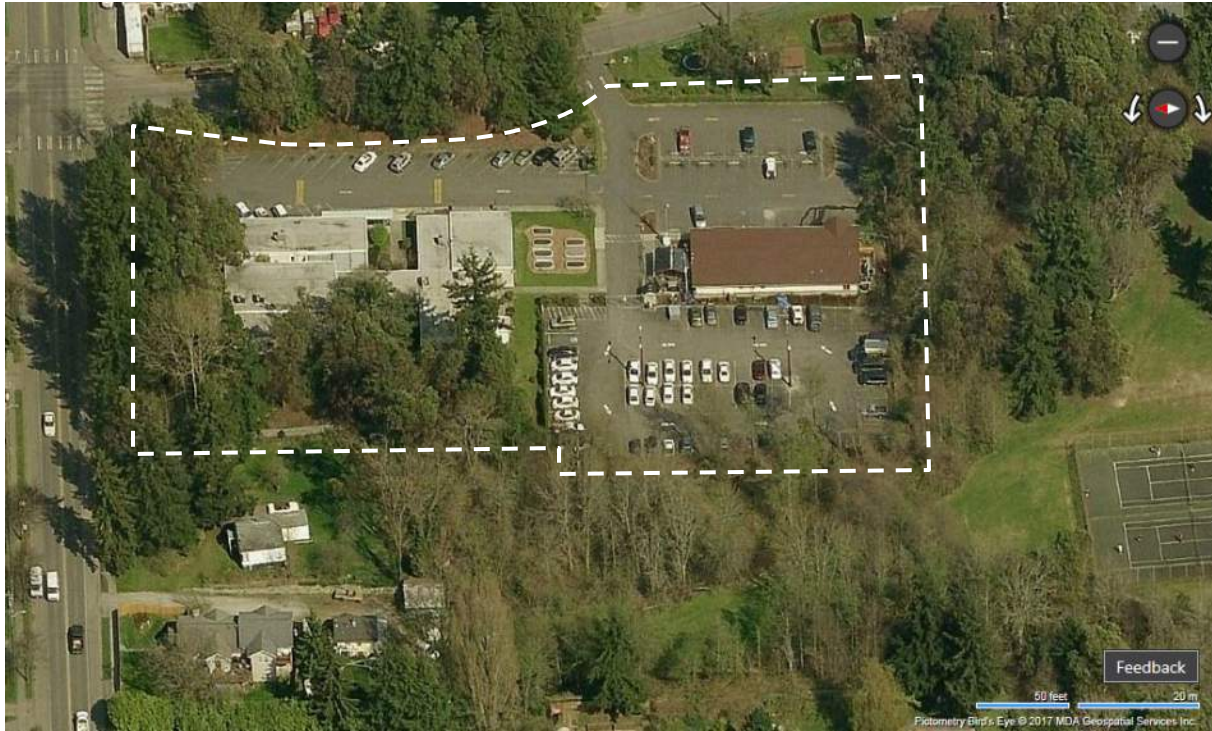
Photo 1. Birds-eye view of the property facing east.

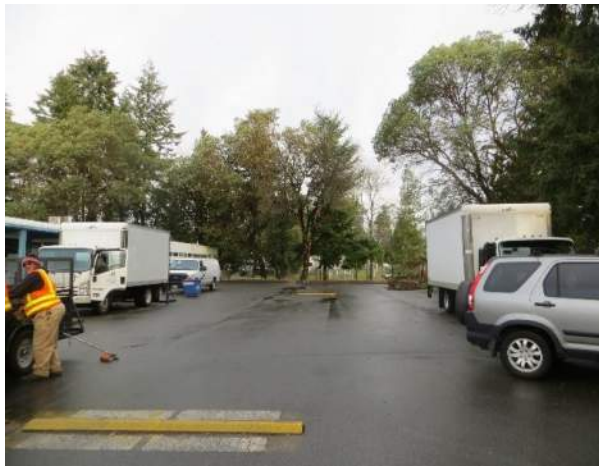
Photo 2. View to north of parking lot east of buildings. A large madrone tree is visible on the right.

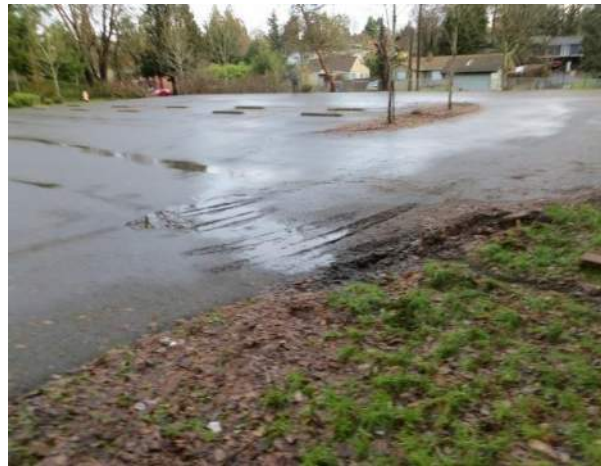
Photo 3. View to north of southeastern parking lot.

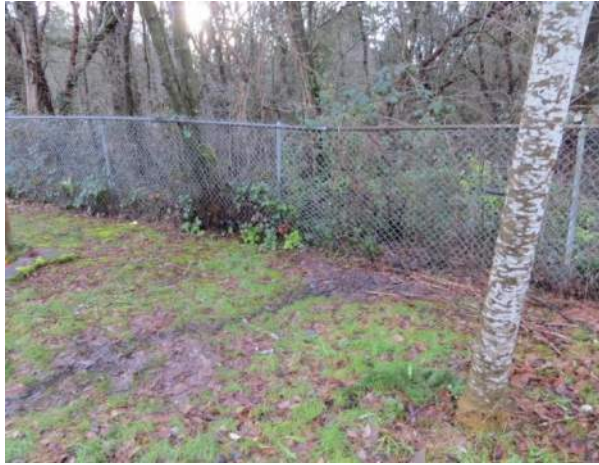
Photo 4. Runoff from the parking lot currently flows under the fence and downhill to the park property to the south.

The property is in the Salmon Creek/South Puget Sound watershed in the Duwamish-Green River Water Resource Inventory Area (WRIA 9). The property sits near the watershed divide between the Duwamish waterway to the east and Puget Sound to the west. Salmon Creek is shown on most maps as having its headwater tributaries beginning approximately 0.5 mile to the west. Hydrology at the site comes primarily from direct precipitation. Runoff from the buildings and parking lots is discharged to the south and west.

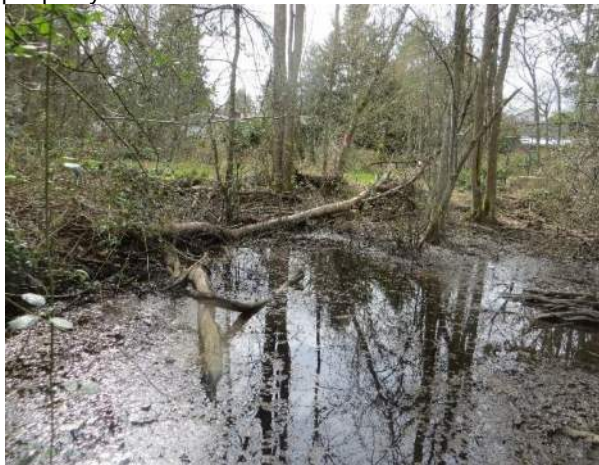
Photo 6. View to the northwest of wetland showing ponding.

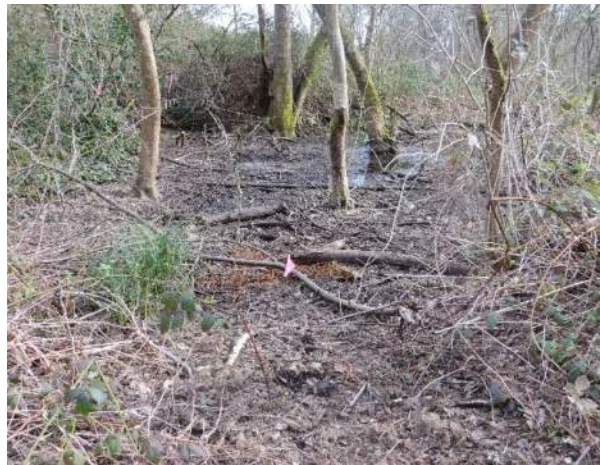
Photo 7. View to southwest of wetland showing slough sedge, ash trees, woody debris, and ponding.

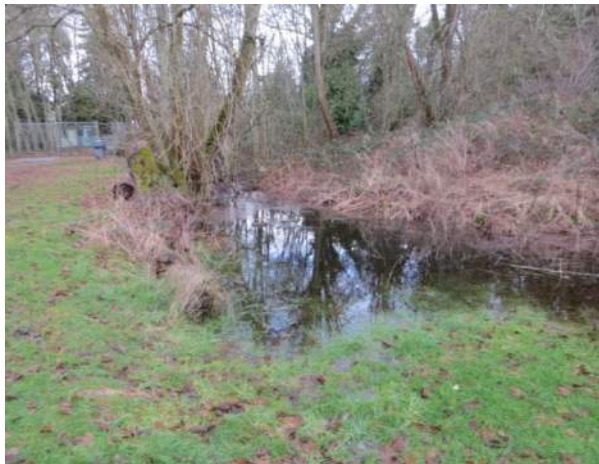
Photo 8. View to north of south end of wetland showing ponded water during high water.

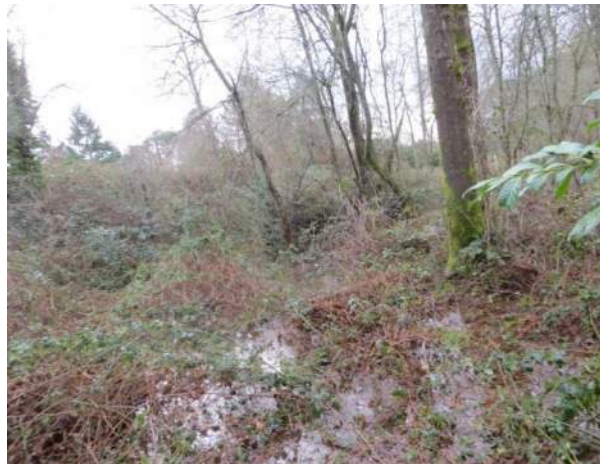
Photo 9. View to south from north end of wetland showing heavy infestation by blackberry.

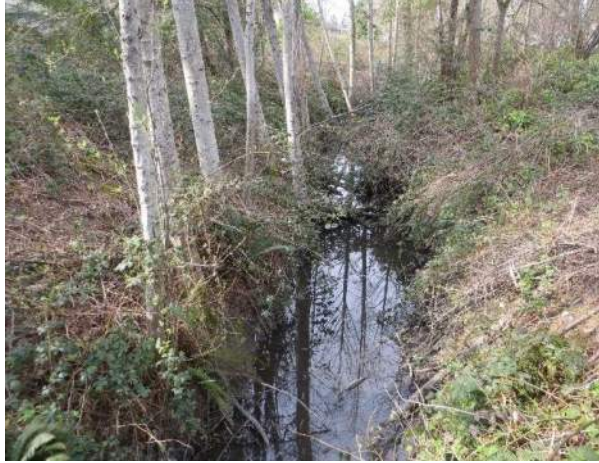
Photo 10. Stream due west of subject property, the stream channel appears constructed.

Just west of the property, a small stream flows out of a culvert on the north edge of King County park property and flows south through the park into Hicklin Lake. The stream is fed by a series of wetlands and small ponds to the north, and by stormwater runoff from the surrounding neighborhoods. Earlier topographic maps show a culvert connection from the High School just south of the park to the Salmon Creek tributaries but there is currently no apparent outflow from the Lake except for a constructed overflow pipe. This drainage is considered part of the Salmon Creek watershed, despite the lack of a surface connection to the creek, and Salmon Creek flows into Puget Sound.

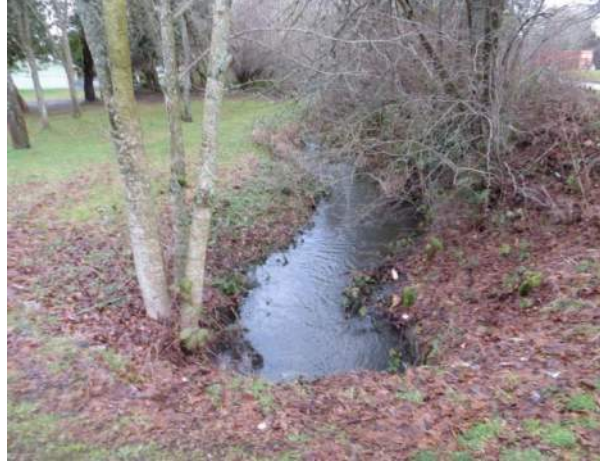
Photo 11. Stream just north of park drive entering culvert under driveway.

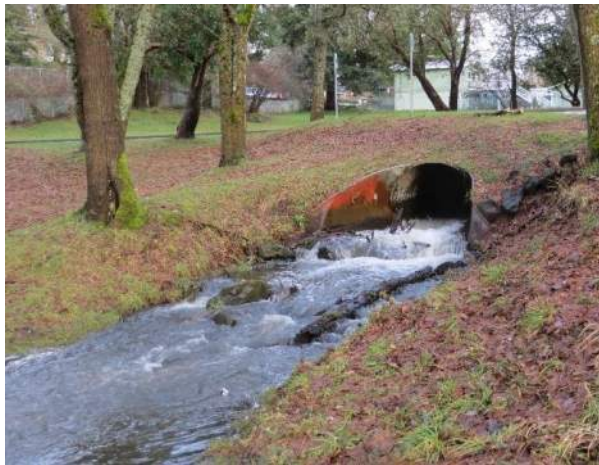
Photo 12. Stream flowing out of culvert south of park drive.

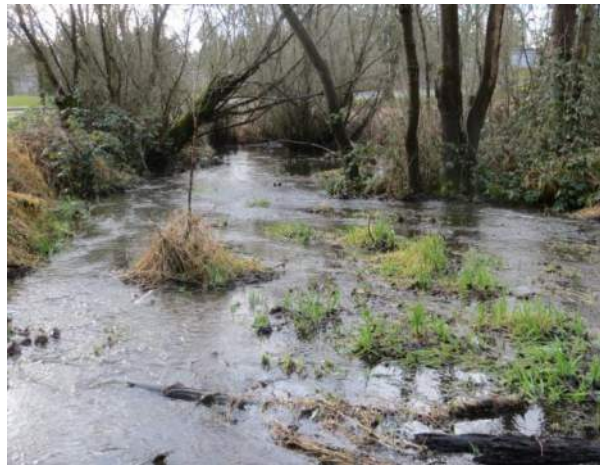
Photo 13. Stream flowing south through the park towards Hicklin Lake during high water.

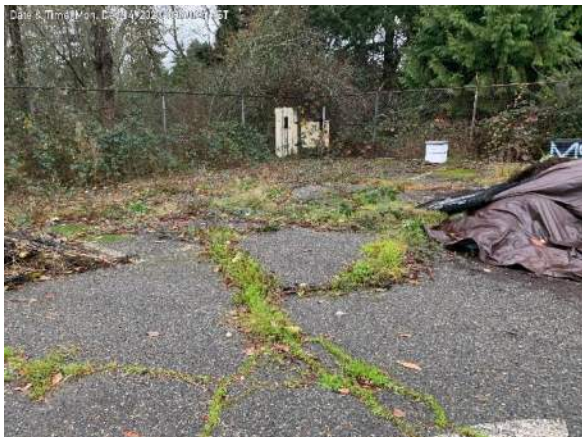
Photo 14. Existing wetland buffer on property.

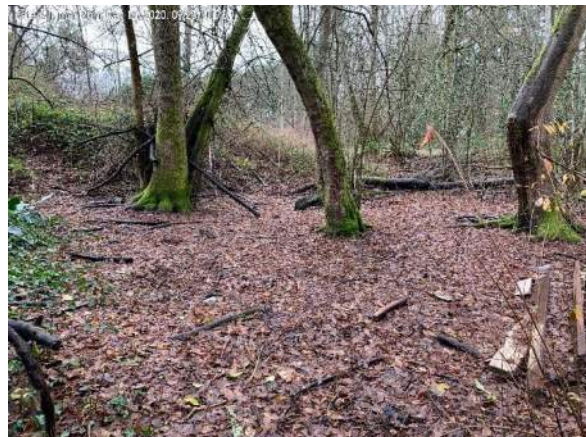
Photo 15. Wetland A off-site.

PBS conducted a waters/wetland delineation in the vicinity of the Community Roots Housing property. No wetlands were found on the subject property, but we identified Wetland A on the adjacent parcel to the west. Wetland A sits in a slight depression between the fill slope at the edge of the subject property and the small stream to the west (Figure 4). It is possible that material was excavated from this area to create the level surface on the subject parcel or that it was constructed as a stormwater pond. The wetland does not appear to have a direct hydrologic connection to the stream. Wetland data sheets can be found in Appendix A. Wetland rating forms can be found in Appendix B.

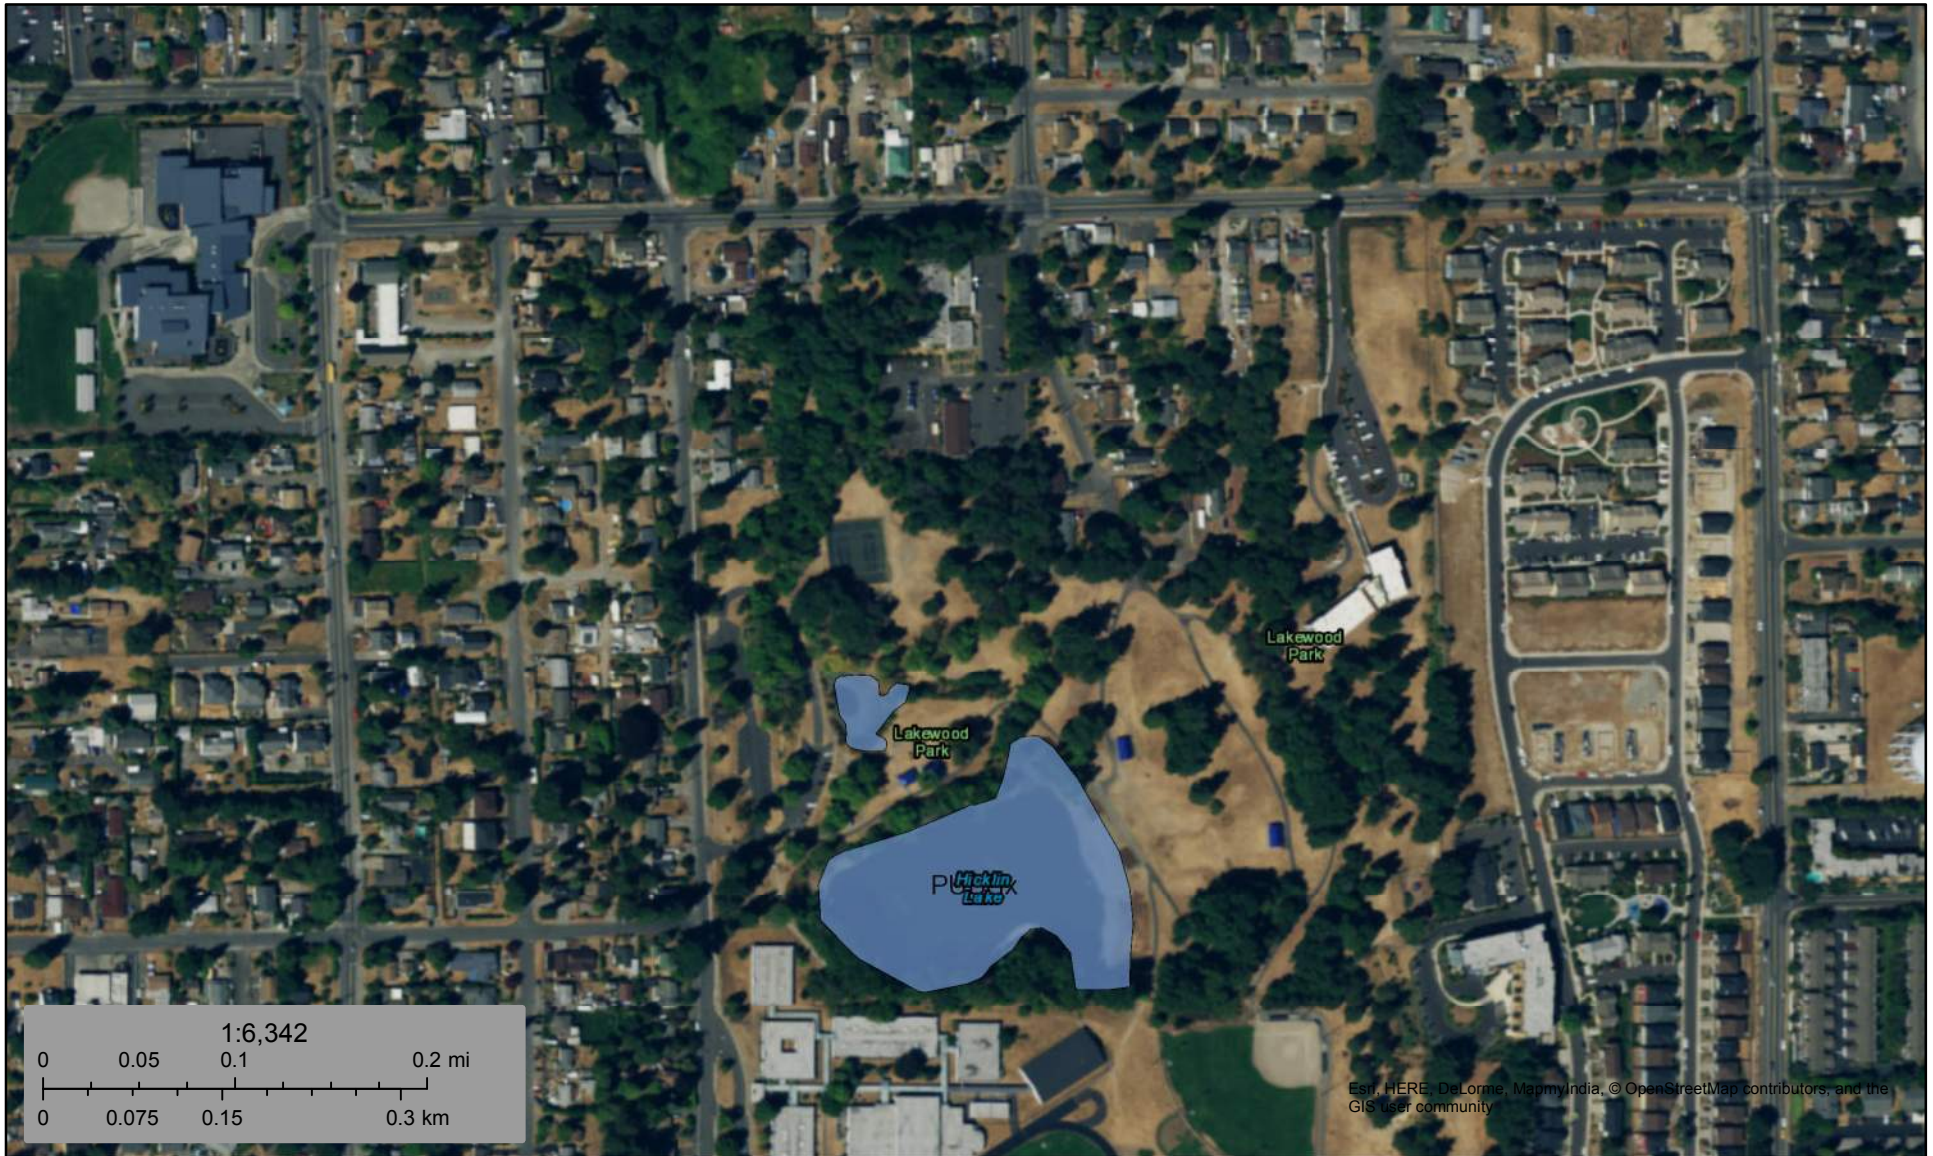
This map is for general reference only. The US Fish and Wildlife Service is not responsible for the accuracy or currentness of the base data shown on this map. All wetlands related data should be used in accordance with the layer metadata found on the Wetlands Mapper web site.

The National Wetland Inventory (NWI) website shows two palustrine unconsolidated bottom, permanently flooded ponds (Figure 2). The larger pond is known as Hicklin Lake or Garrett Lake. The smaller pond is just north and west of Hicklin Lake. No other wetlands are mapped in the vicinity. King County also maps a Category II wetland that includes the two ponds and some of the surrounding area (Figure 3). No critical areas are mapped on the subject property.

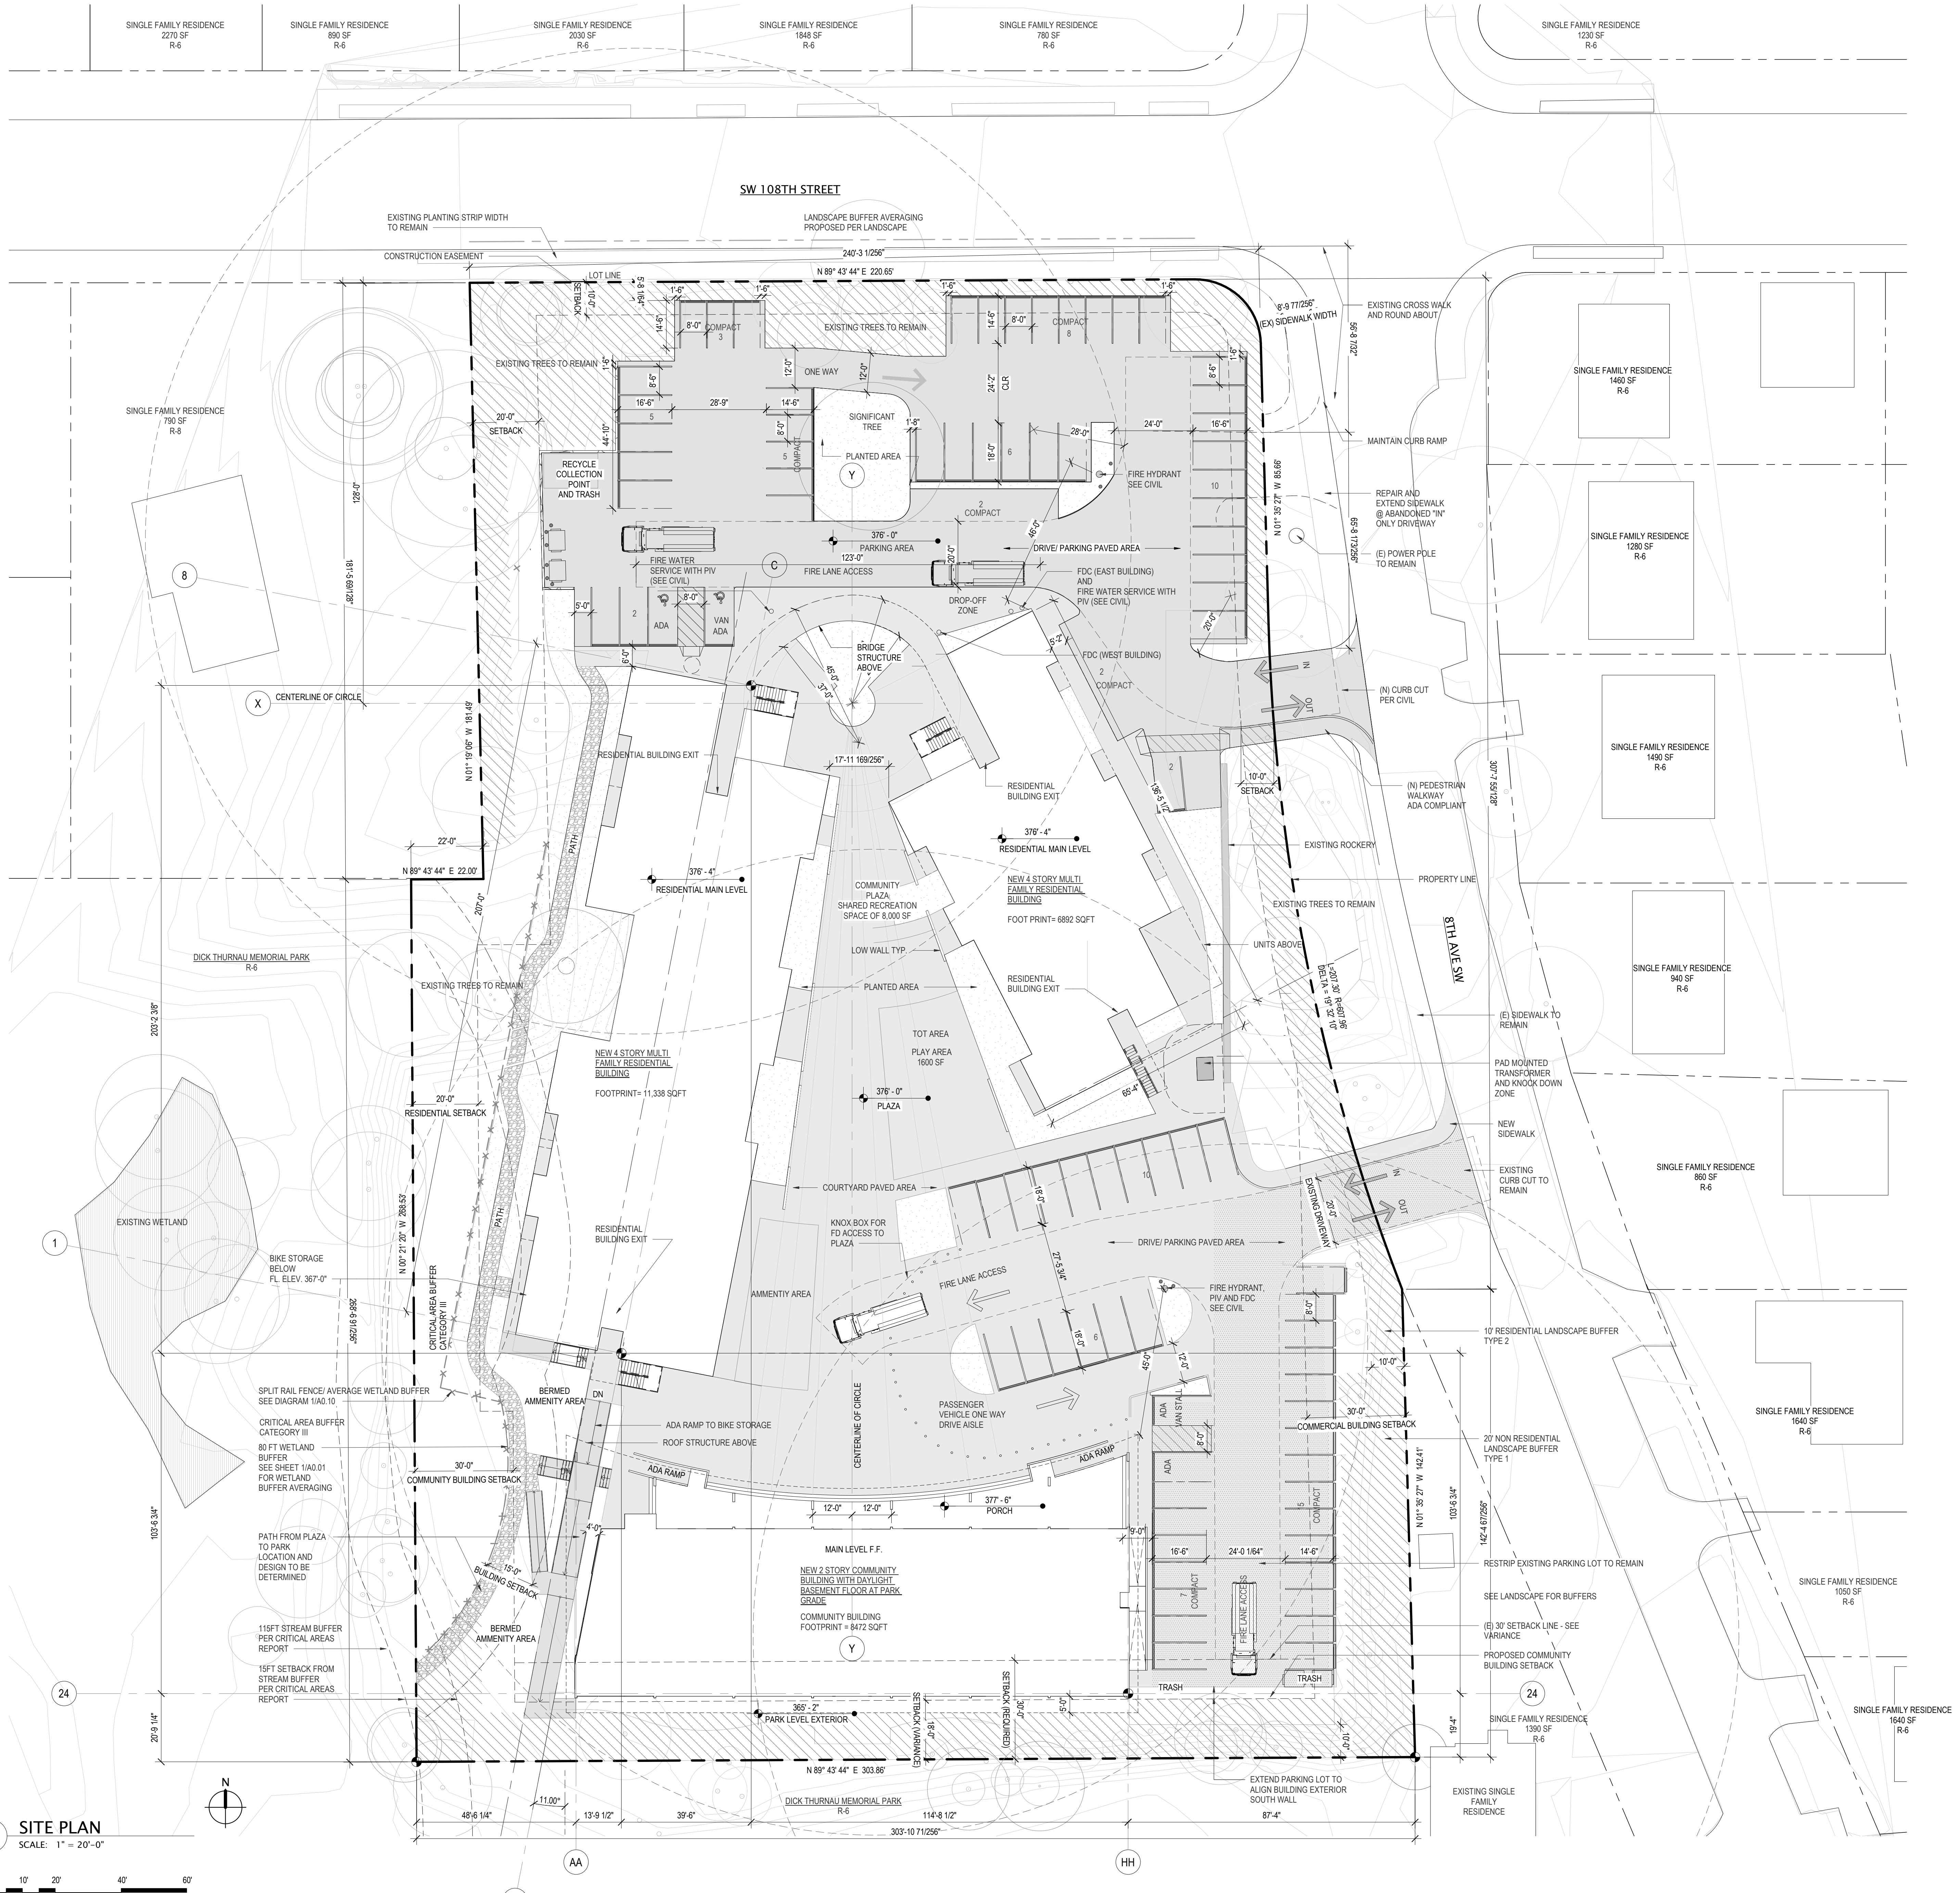
1 SITE PLAN
SCALE: 1" = 20'-0"

PROJECT SCOPE: THE PROPOSAL IS A 70,000 SQFT, 4- STORY MULTI- FAMILY HOUSING STRUCTURE WITH 76 LOW INCOME UNITS. UNITS INCLUDE MOSTLY 2 AND 3 BEDROOMS CATERING TO FAMILIES. PROPOSED HEIGHT IS 40FT.
