SEPA ENVIRONMENTAL CHECKLIST

West Seattle Mixed Use

FivePoint Capital Management

Geotechnical Report

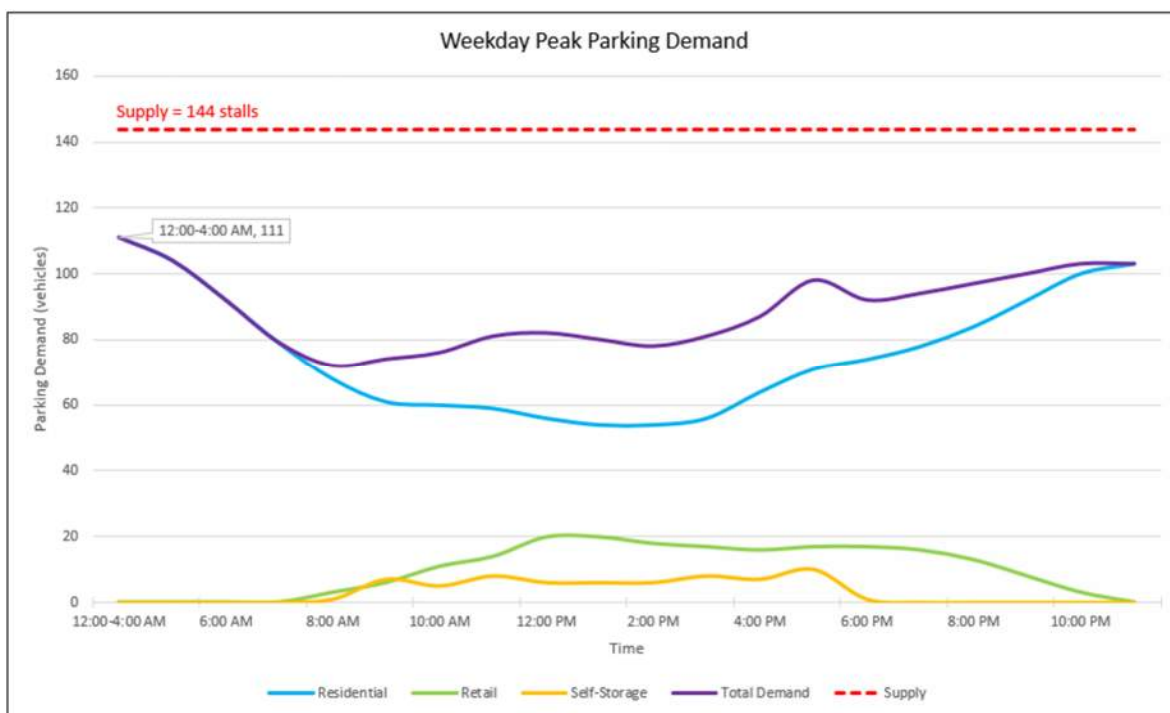
The estimate peak parking demand of 111 vehicles is estimated to occur between 12:00 and 4:00 AM, which is expected to be accommodated by the proposed on-site parking supply (144 stalls). The cumulative peak parking demand calculations are included in **Attachment G**.

Due to the mixed-use nature of the proposed West Seattle Mixed-Use project and uses that are anticipated to peak at different times, a shared parking analysis was completed to compare the estimated cumulative peak parking demand to the proposed supply. The hourly variation of peak parking demand for each of the proposed uses was based on studies documented in the ITE *Parking Generation Manual*, 5th Edition. The estimated cumulative peak parking demand estimates compared to the proposed supply is shown graphically below.

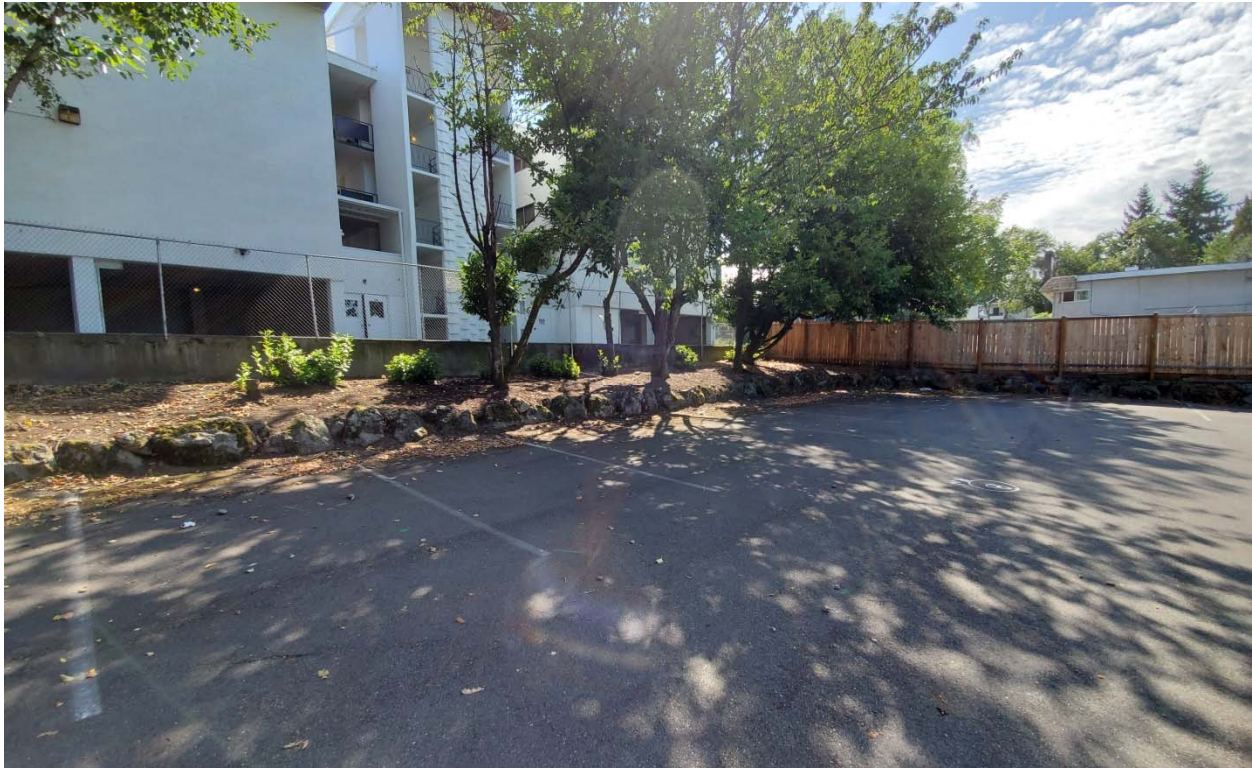
Concrete Cast-in-place Wall: An approximately 2 foot tall concrete cast-in-place (CIP) wall runs along the southern perimeter of the site. It supports the paved access road to the apartment building to the south, which is higher in elevation relative to the site. The wall is approximately 6 inches thick. A chain link fence is built over the wall. The wall appears stable and near vertical.

Southwestern Rockery: The ground surface in front of the CIP wall along the southern perimeter is maintained as a raised landscaping bed approximately 8 to 12 feet wide. It is planted with deciduous trees approximately 6 to 18-inches in diameter. The bed is supported by a 12 to 18-inch high rockery at the edge of the parking lot. The rockery runs along the southern perimeter of the site then runs north between the law office and the site, and terminates near the funeral home. The CIP wall, rockery, and landscaping bed together appear to form a low-profile tiered wall system supporting an approximate 4 foot total rise in ground surface. The system appears stable, and is shown in **Photo 2**. At the southeast corner of the site, the walls terminate at a paved ramp connecting the parking lot to the access road of the apartment to the south. Access to the ramp is restricted by the chain-link fence.

Photo 2: CIP wall and rockery along the southern perimeter of the site, looking southwest.

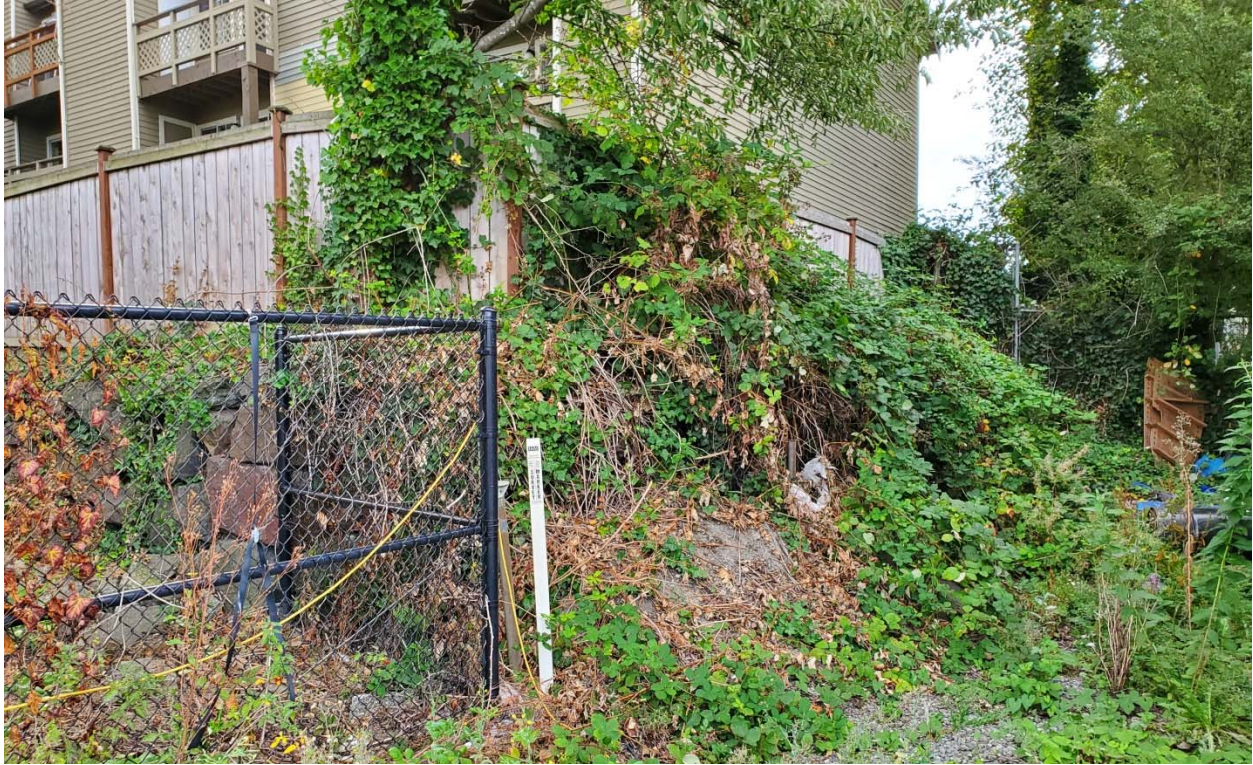
Eastern Rockery: Another rockery begins near the paved ramp at the southeast corner of the site and runs parallel to the eastern site perimeter. The rockery retains a grade change from the site up to the apartment complex to the southeast of the site. It appears that the entire rockery is off the subject property, but runs parallel to the property line. The rockery increases from 1 foot in height near the southeast corner of the site up to 6 feet in height behind the autoglass building. The rockery then turns east perpendicular to the perimeter of the site. The face of the rockery on site is obscured by blackberry brambles, but appears to consist of rocks 1.5 to 3-feet in diameter. The portion of the rockery following the site perimeter is shown in **Photo 3**. The portion of rockery perpendicular to the perimeter is shown in **Photo 4**, as it better reveals the stacking of the rockery face. The rockery appears stable.

Photo 3: Rockery along eastern perimeter of site, looking southeast.

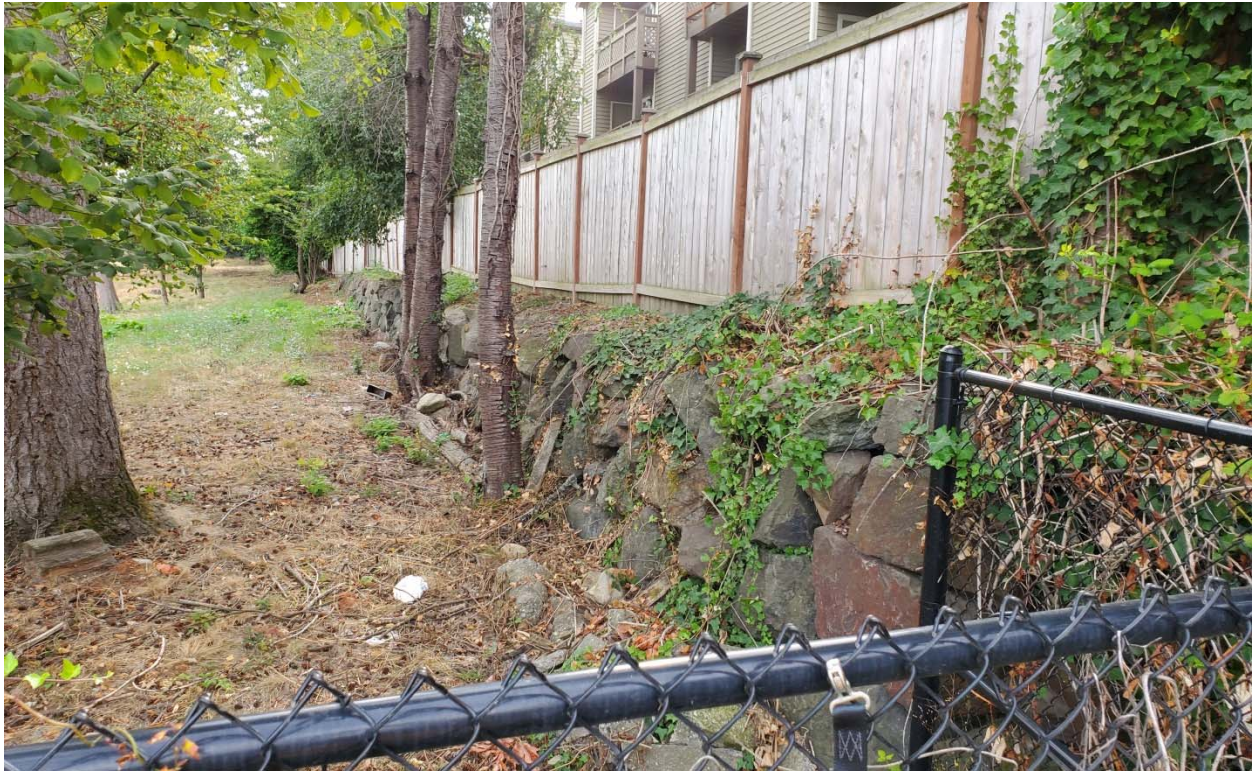
Photo 4: View of rockery off site showing the rock stacking obscured by blackberries on the portion of the rockery parallel to the site perimeter.

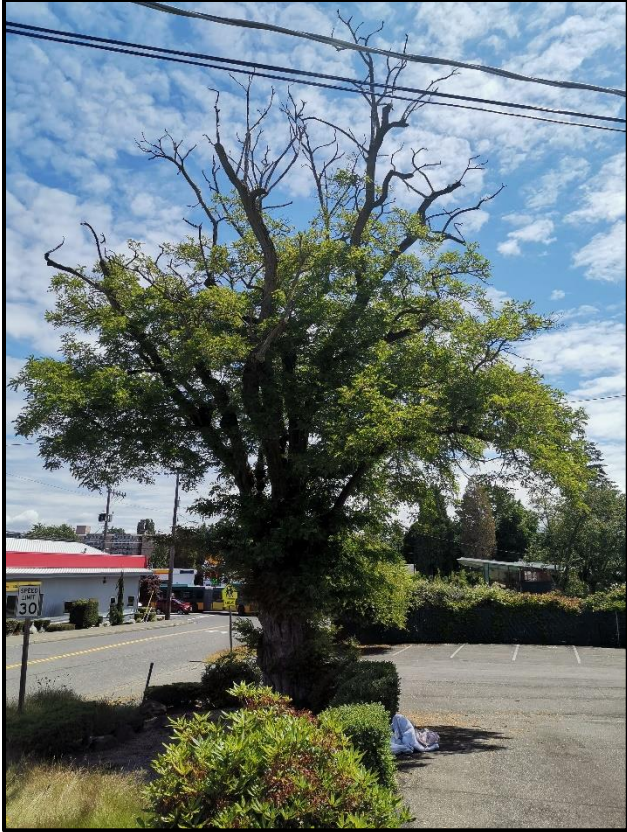
Photo 5. Tree 740 located along the northern property line exhibiting significant canopy decline.
