**CRITICAL AREAS REPORT AND CONCEPTUAL MITIGATION  
PLAN**

**GUNSHY MANOR PRELIMINARY PLAT  
KING COUNTY, WASHINGTON**

28 February 2018  
(Revised 28 May 2019)

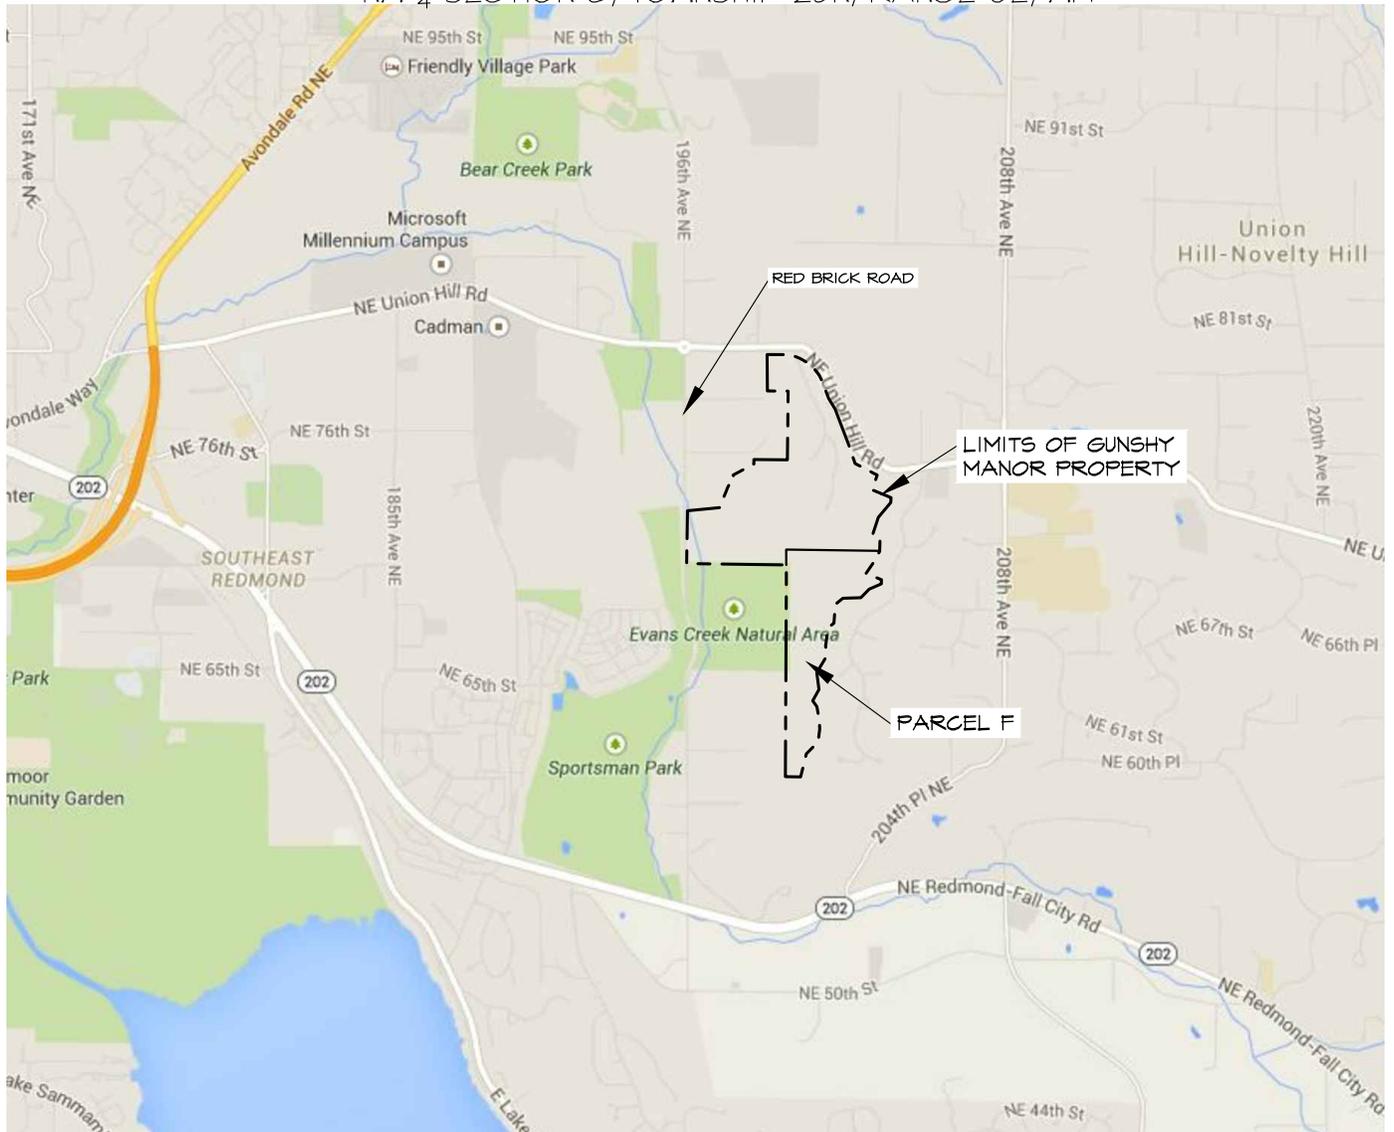
**Figure 4.** National Wetlands Inventory Map

NOTE: EVANS CREEK LOCATION DOES NOT REFLECT FIELD CONDITIONS

feature is mapped on the NWI mapper as a split stream, which is not consistent with field conditions.

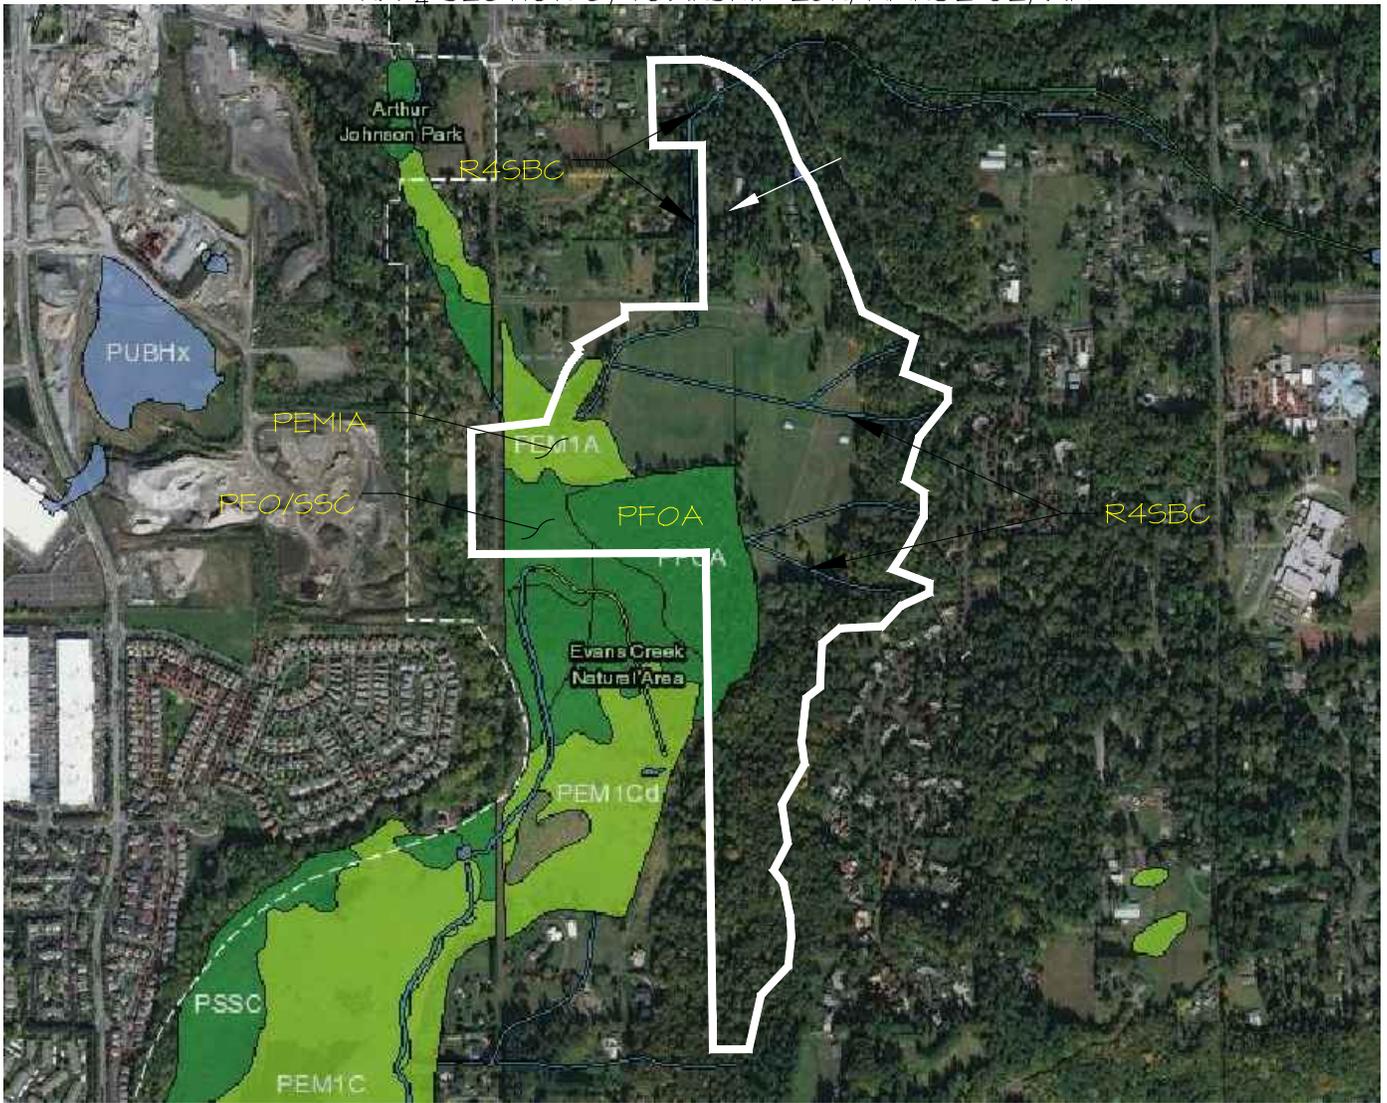
NW ¼ SECTION 8, TOWNSHIP 25N, RANGE 6E, WM

TYPE	DESCRIPTION
PEMIA	PALUSTRINE EMERGENT, PERSISTENT TEMPORARY FLOODED
PFOA	PALUSTRINE FORESTED, TEMPORARY FLOODED
PFO/SSC	PALUSTRINE FORESTED, SCRUB-SHRUB, SEASONALLY FLOODED
R4SBC	RIVERINE INTERMITTENT, STREAMBED, SEASONALLY FLOODED

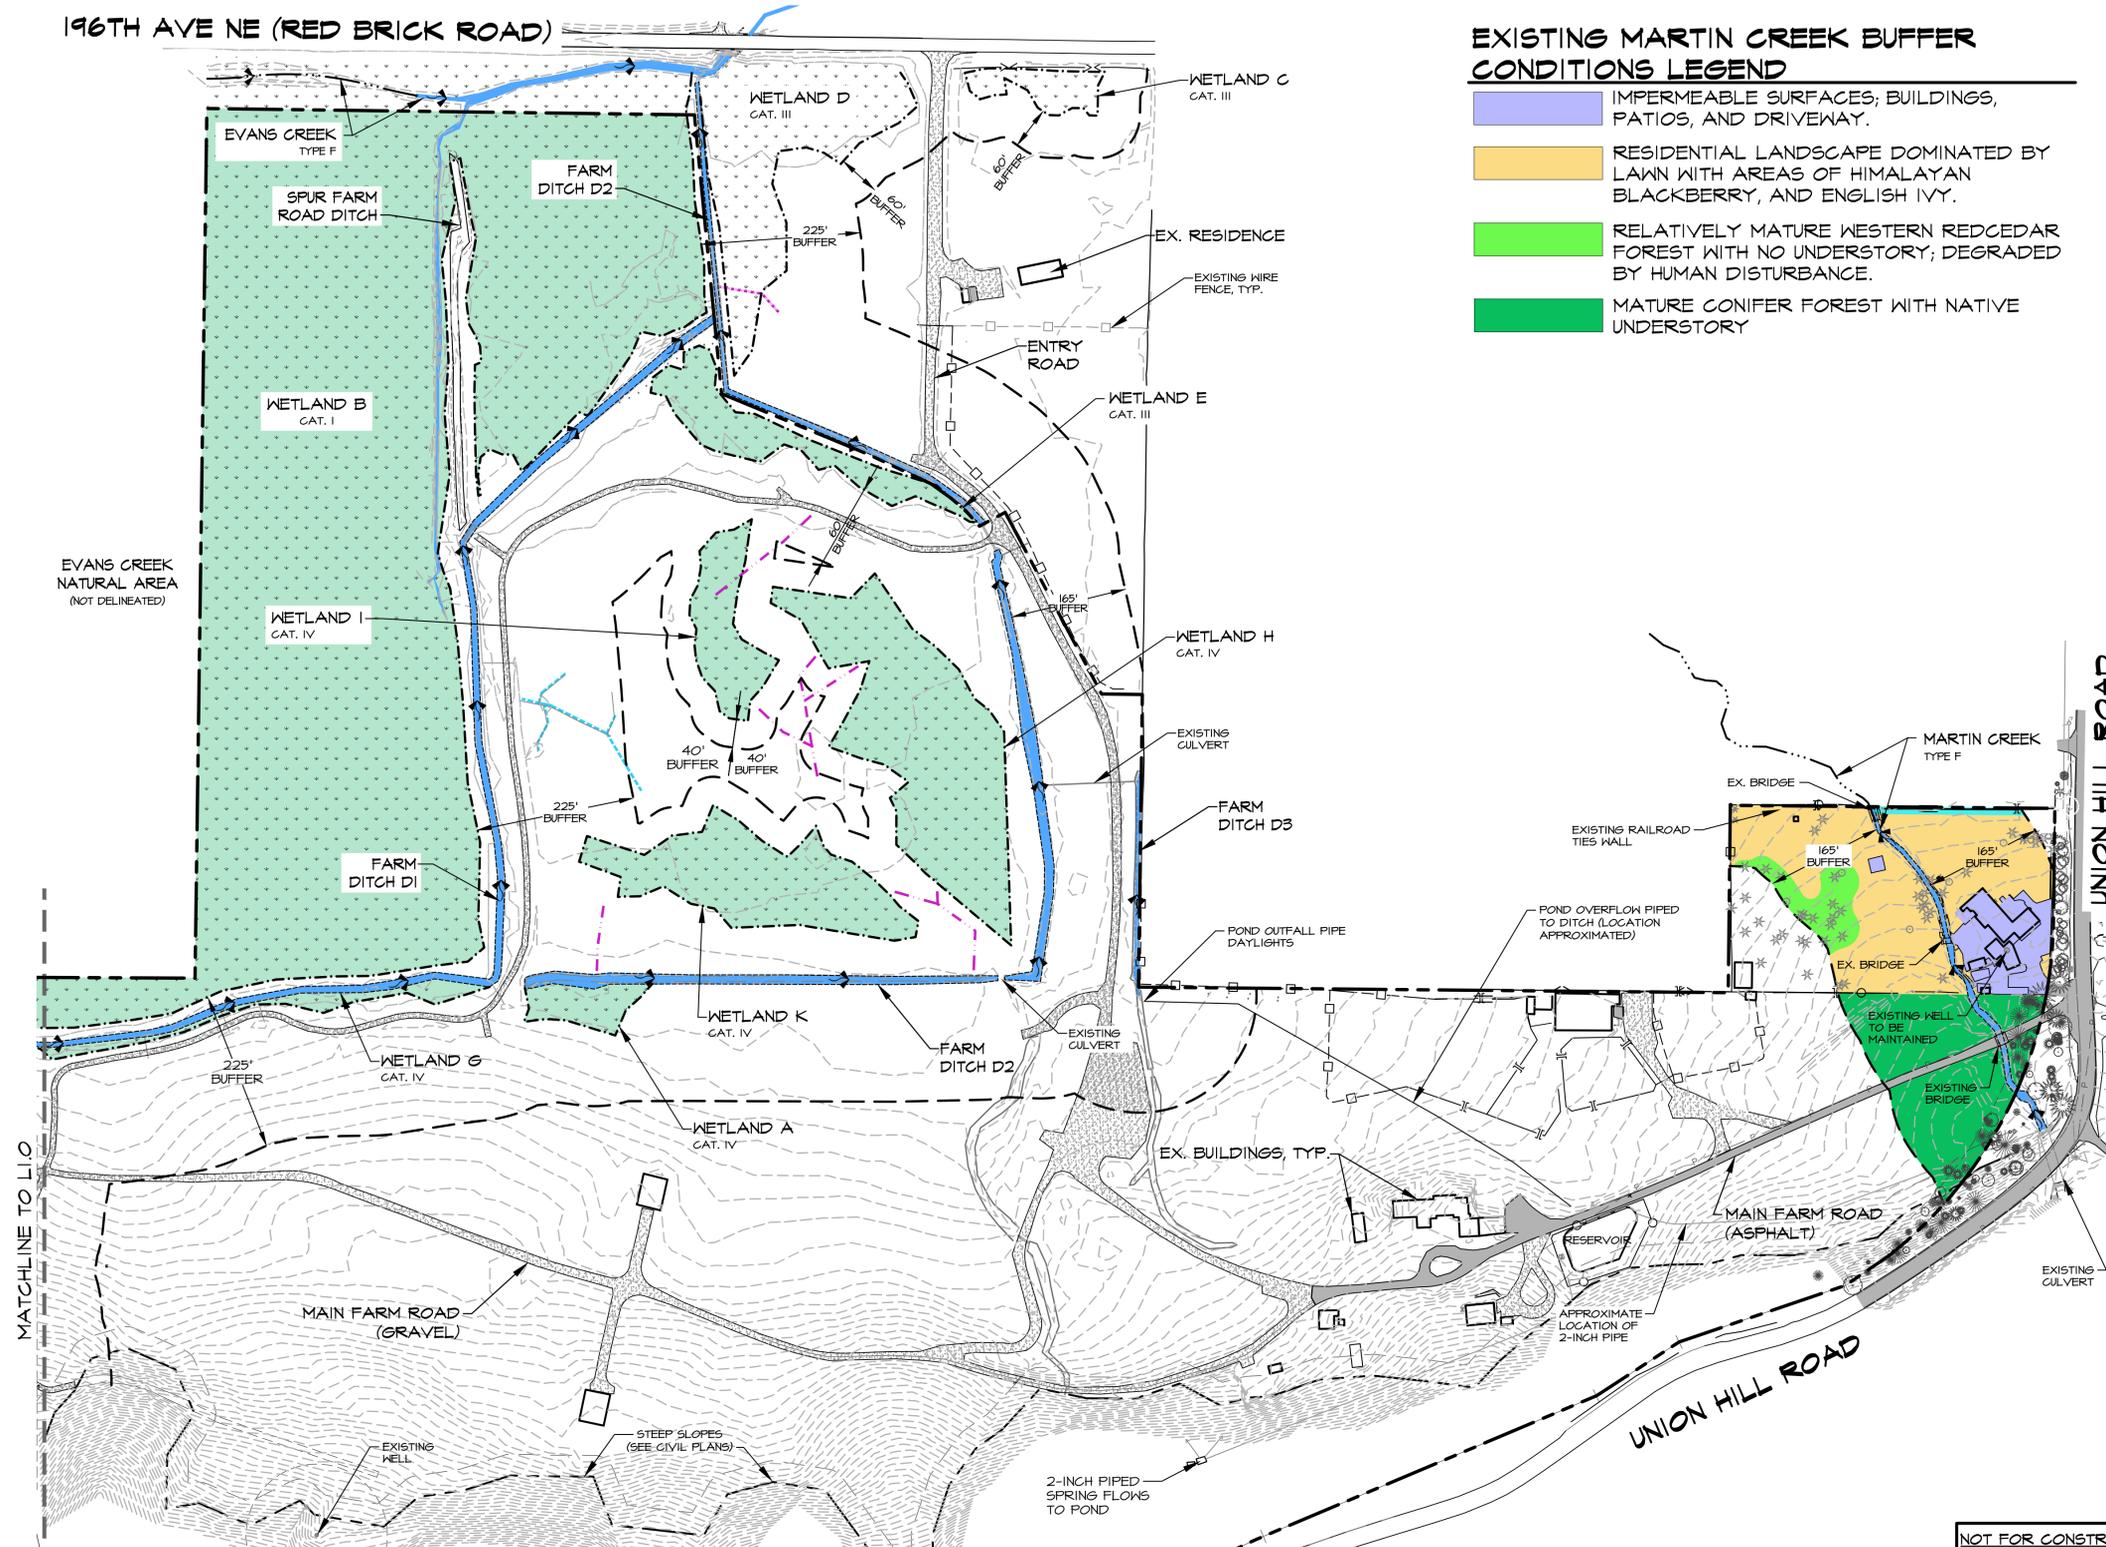
**EXISTING CONDITIONS PLAN**

RELATIVELY MATURE WESTERN REDCEDAR FOREST WITH NO UNDERSTORY; DEGRADED BY HUMAN DISTURBANCE.
-

MATURE CONIFER FOREST WITH NATIVE UNDERSTORY

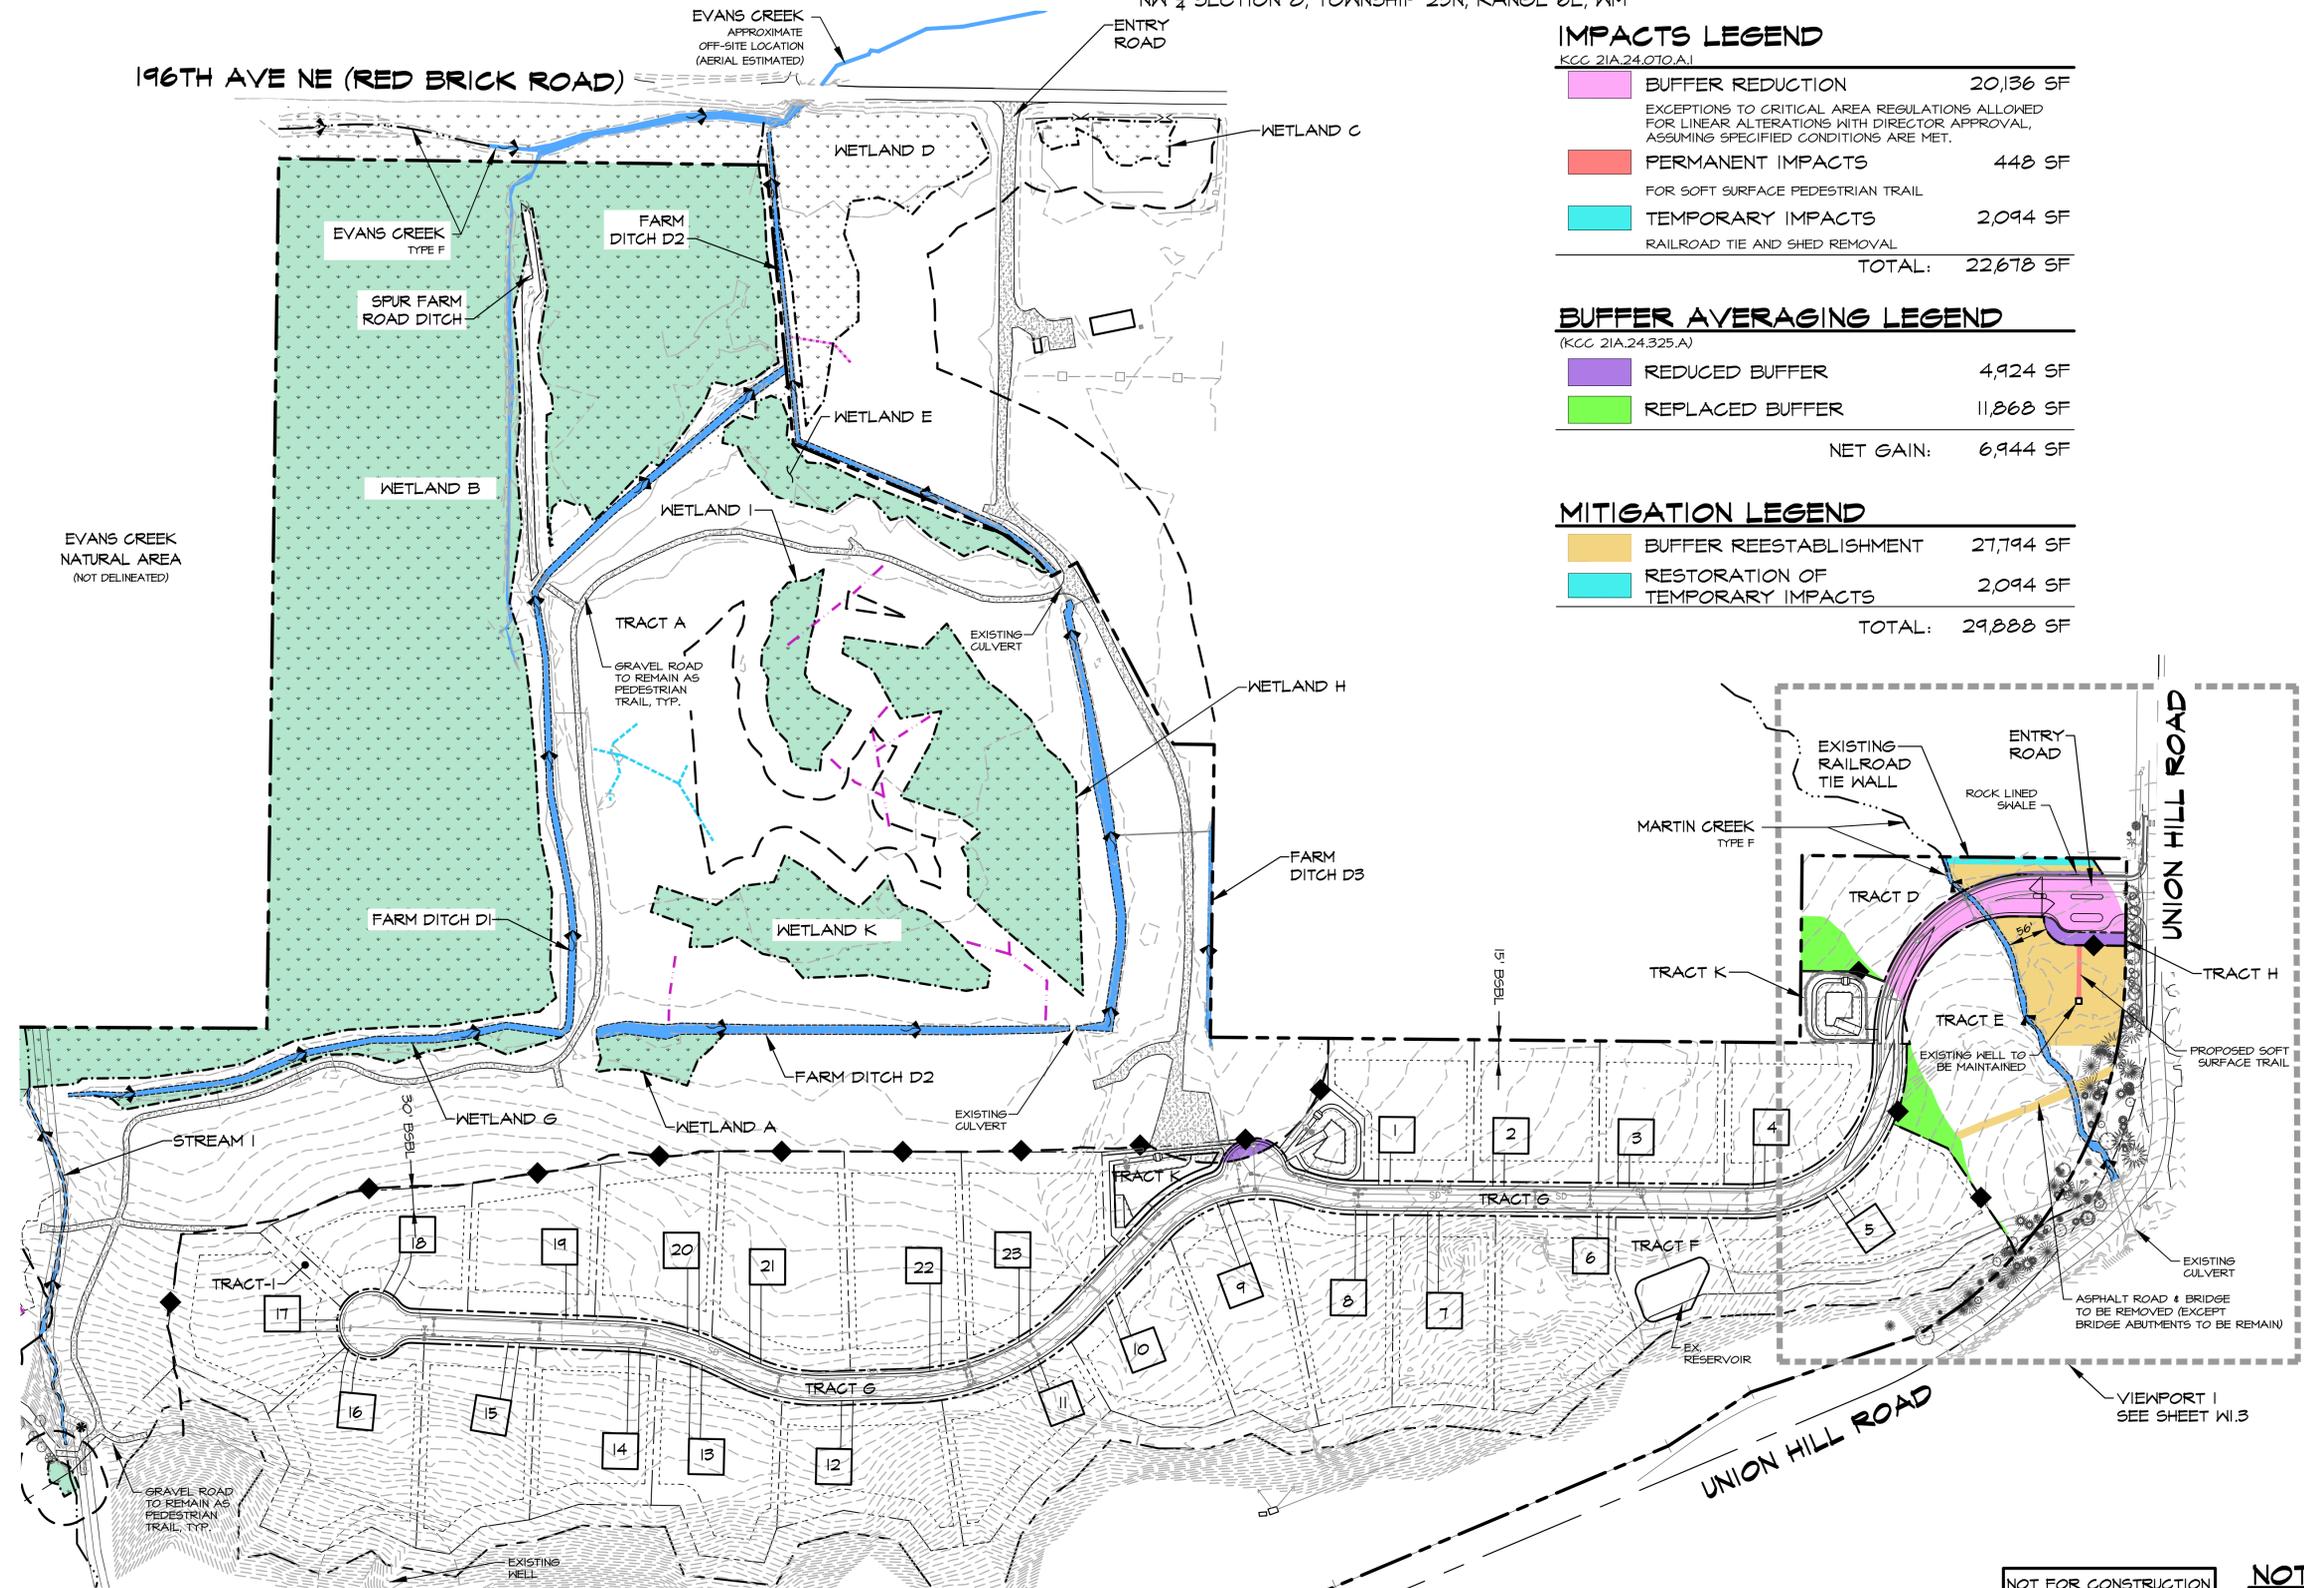
**IMPACTS LEGEND**  
(KCC 21A.24.010.A)

<span style="display:inline-block; width:15px; height:15px; background-color: #FFC0CB; border: 1px solid black;"></span> BUFFER REDUCTION	20,136 SF
EXCEPTIONS TO CRITICAL AREA REGULATIONS ALLOWED FOR LINEAR ALTERATIONS WITH DIRECTOR APPROVAL, ASSUMING SPECIFIED CONDITIONS ARE MET.	
<span style="display:inline-block; width:15px; height:15px; background-color: #FF6347; border: 1px solid black;"></span> PERMANENT IMPACTS	448 SF
FOR SOFT SURFACE PEDESTRIAN TRAIL	
<span style="display:inline-block; width:15px; height:15px; background-color: #00CED1; border: 1px solid black;"></span> TEMPORARY IMPACTS	2,094 SF
RAILROAD TIE AND SHED REMOVAL	
<b>TOTAL:</b>	<b>22,678 SF</b>

Compensation for the Martin Creek buffer intrusion necessary for the new Union Hill Road entrance will be provided by removing the existing house and associated structures within the Martin Creek buffer and restoring these areas with native vegetation. Temporary impacts to the stream buffer will be necessary in conjunction with the removal of these existing structures, though these areas will be regraded and planted after removal of existing structures. The remainder of the Martin Creek buffer that does not contain structures will remain in its current vegetated condition. A native canopy exists that will be maintained where present. Native understory species will recruit into these areas once regular maintenance ceases. Other areas not contained within the post-development critical areas will be maintained by the Homeowner's Association for the development, once established. Vegetative enhancement is proposed over 29,888 square feet of Martin Creek buffer to restore those areas covered by structures.

There are three areas adjacent to the primary access point from NE Union Hill road that will be averaged out of the stream buffer. These areas include an entryway landscape tract (Tract H) along the east edge of the access point, a rock-lined swale along the west edge, and a surface trail extending eastward from the access point that will provide access to an existing groundwater well. The project proposes to reduce the Martin Creek stream buffer by 4,924 square feet for these three elements combined. The buffer will be replaced adjacent to the existing Martin Creek buffer within areas that are, at a minimum, equivalent to the structure and function provided by the stream buffer to be reduced. This 11,868 square foot buffer replacement area is being provided consistent with KCC 21A.24.358.E.1.a for no net loss of total buffer area, and ultimately will provide a net gain of 6,944 square feet of Martin Creek buffer.
