COUNTYLINE LEVEE SETBACK PROJECT

YEAR 5 MONITORING REPORT (2022)

USACE Reference No. NWS-2011-211

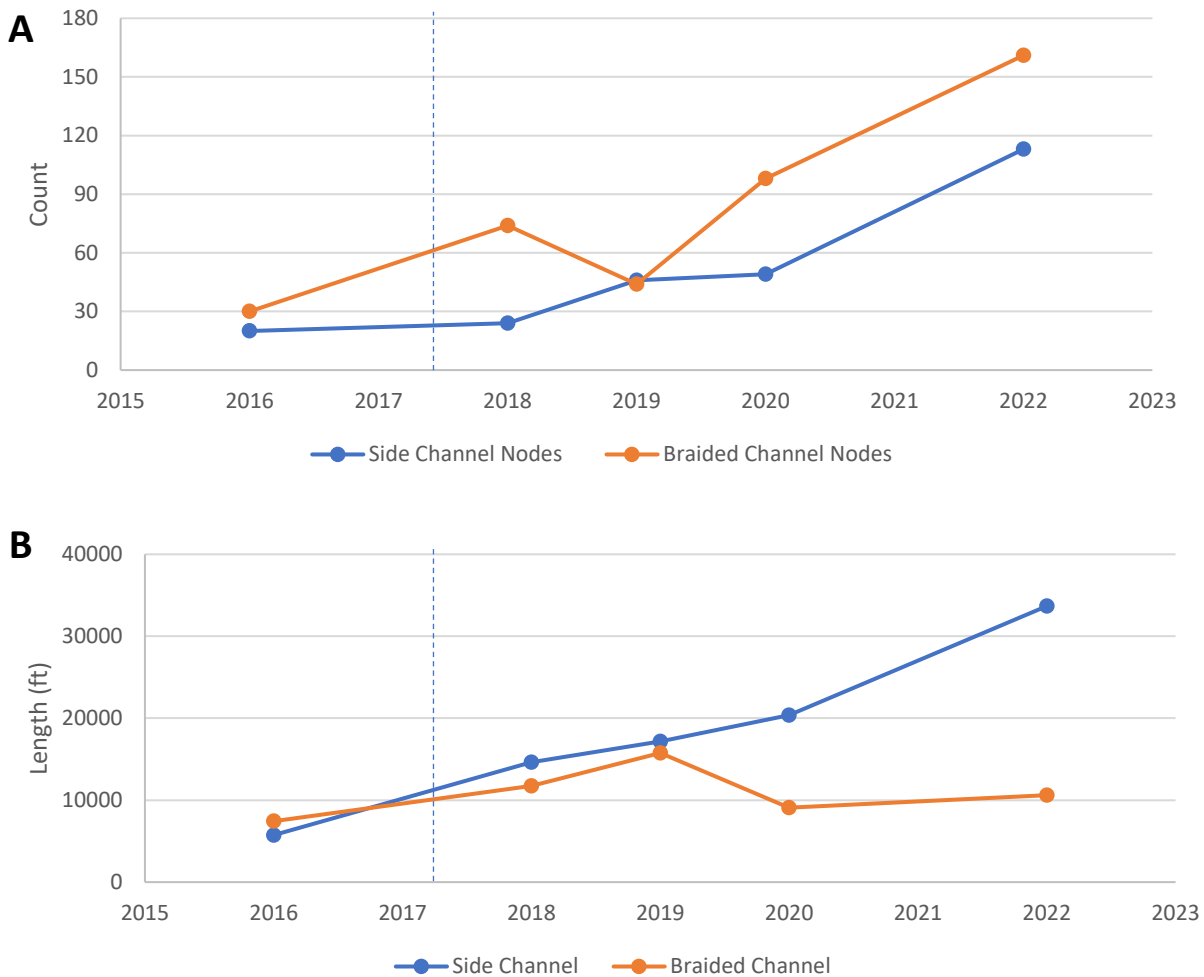
Figure 5. Side channel and braided channel nodes (A) and total length (B) across the project area over time. 2016 Data represents pre-project conditions, dotted line shows timing of project construction.

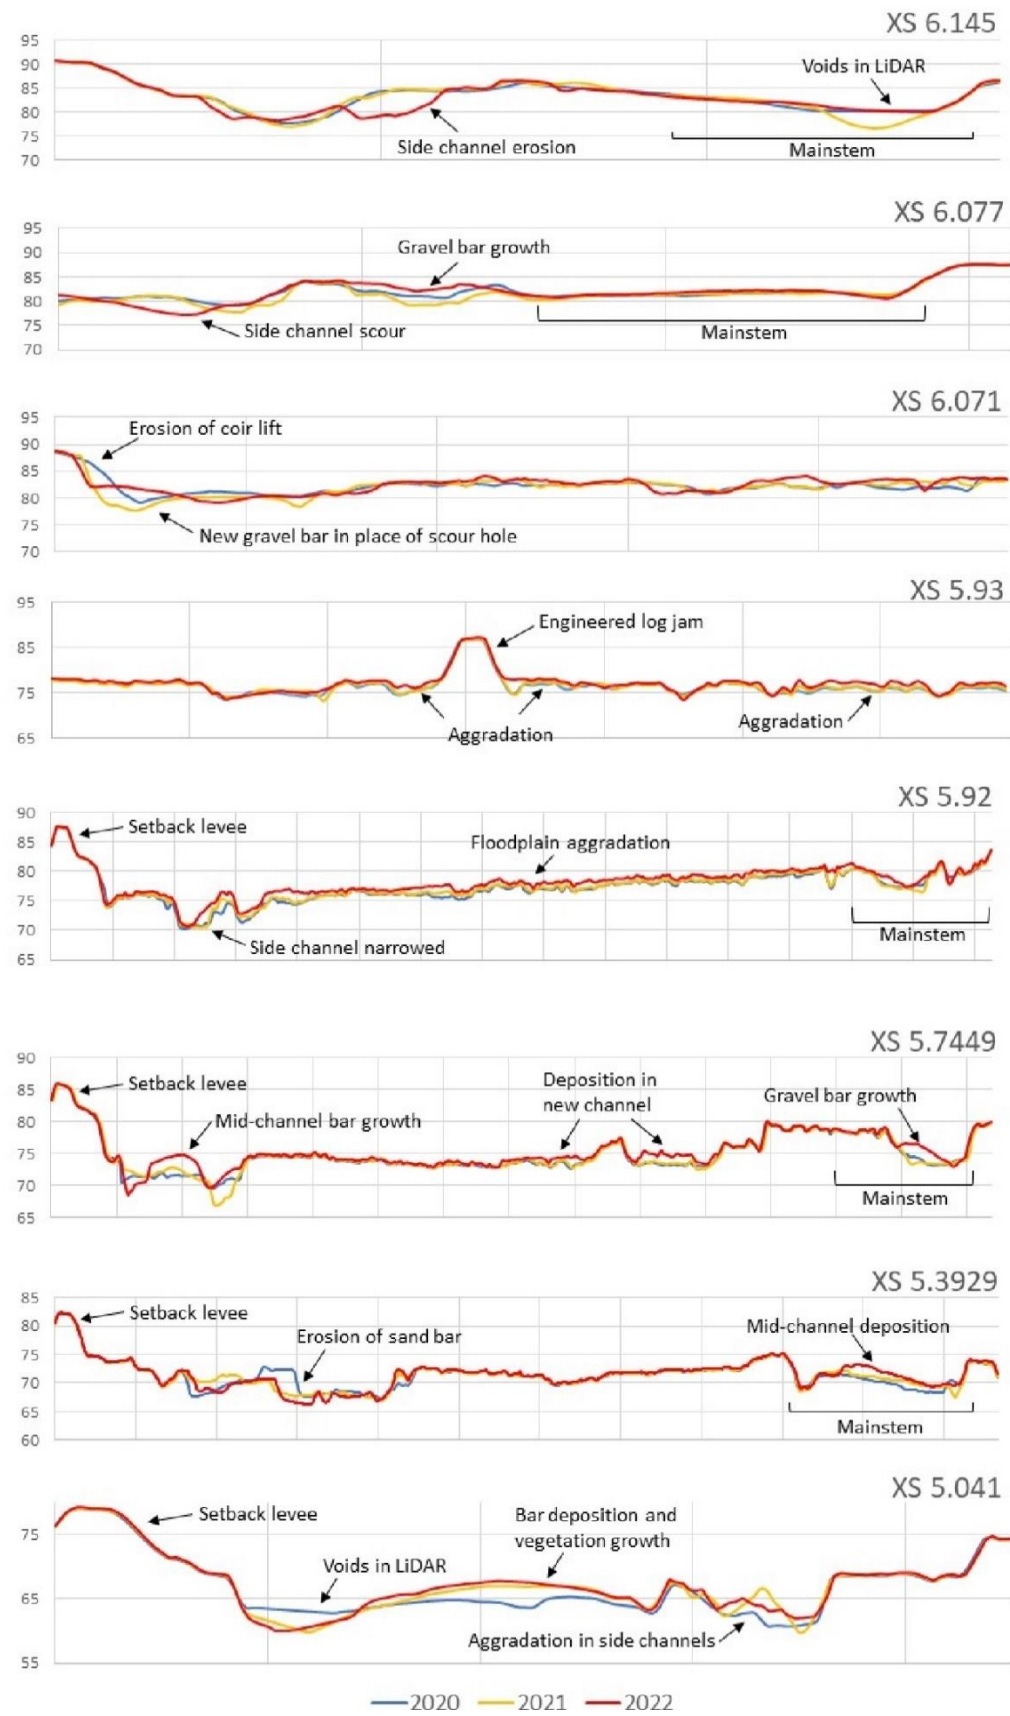
Figure 6. Cross sections comparing 2020, 2021 and 2022 channel bed elevations, viewed looking downstream with mainstem on the right side of cross sections. Scaling varies in order to accentuate features, vertical grid lines along x-axis represent 100-foot increments. At right, selected cross sections highlighted in green, active channel shown in blue polygon.

Cross-section	Year 3 (2020)	Year 5 (2022)	Difference (ft)
XS 6.145	83.23 (83.64)	82.96 (83.15)	-0.27 (-0.49)
XS 6.077	81.84	81.89	+0.06
XS 6.071	82.18	82.33	+0.14
XS 5.93	76.50	77.23	+0.72
XS 5.920	77.31	78.12	+0.81
XS 5.7449	74.86	75.43	+0.57
XS 5.3929	71.38	71.52	+0.14
XS 5.041	66.96 (67.24)	67.44	+0.48 (+0.20)

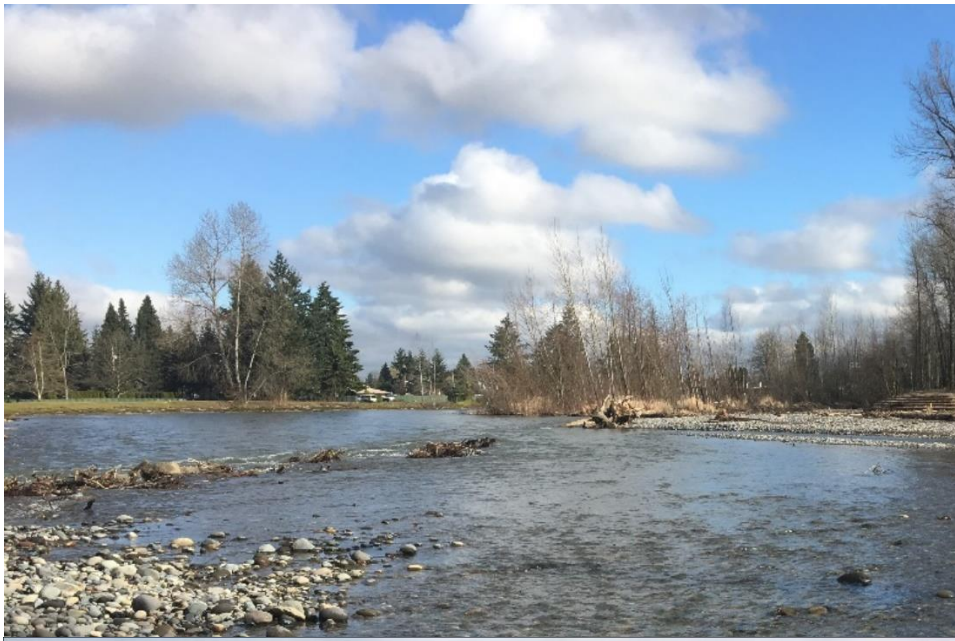
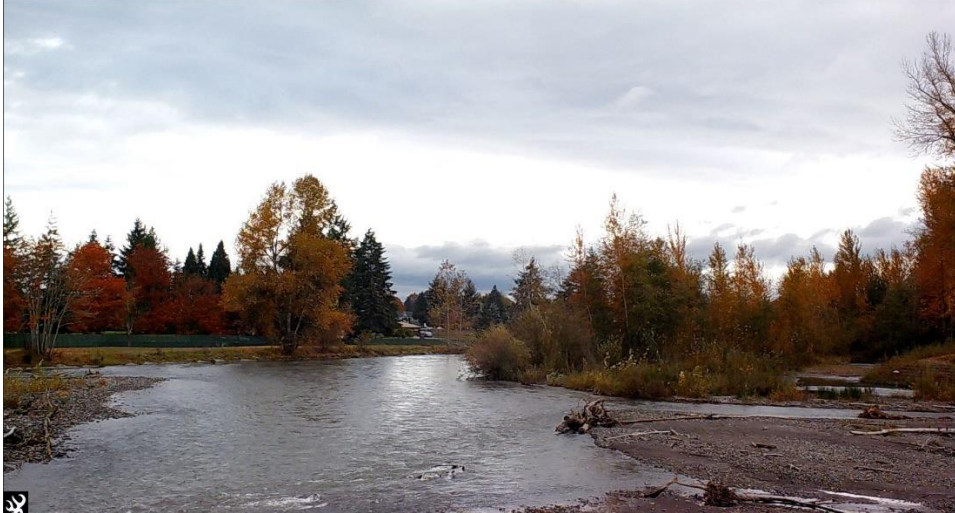
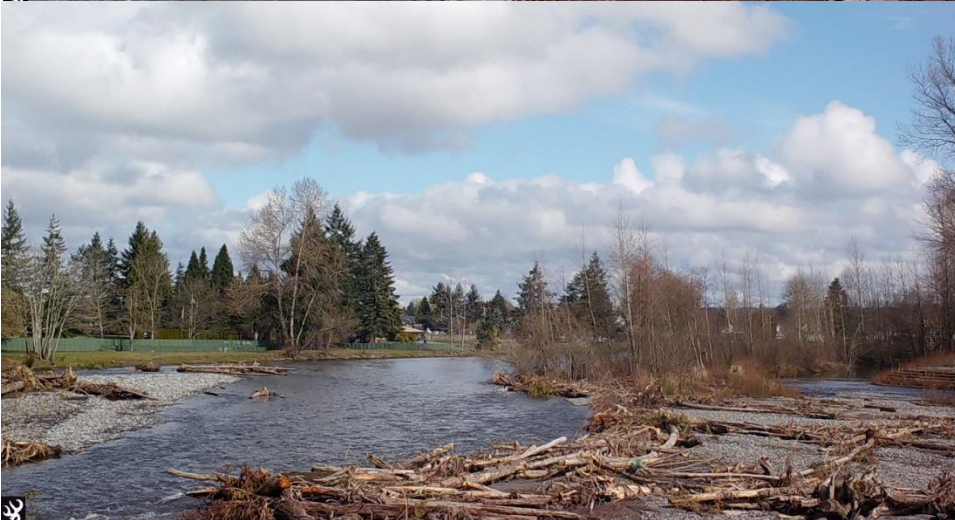
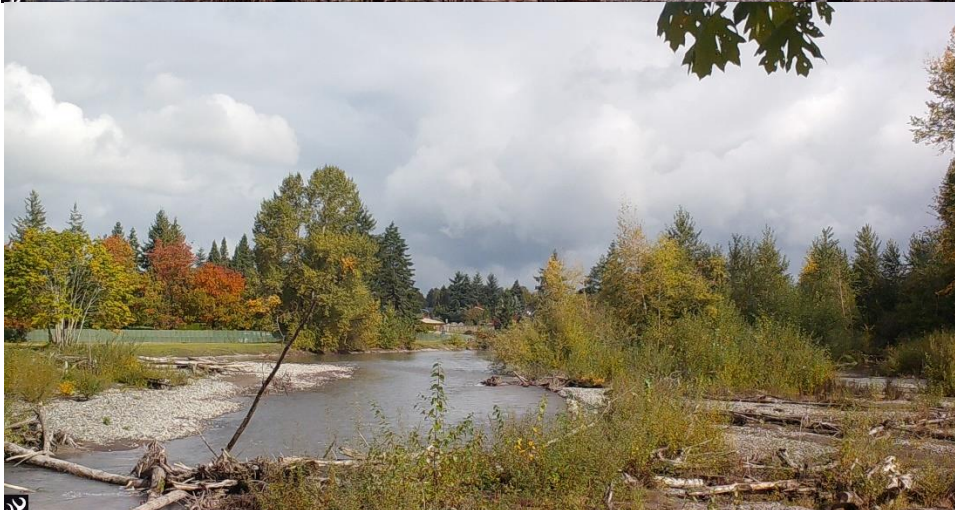
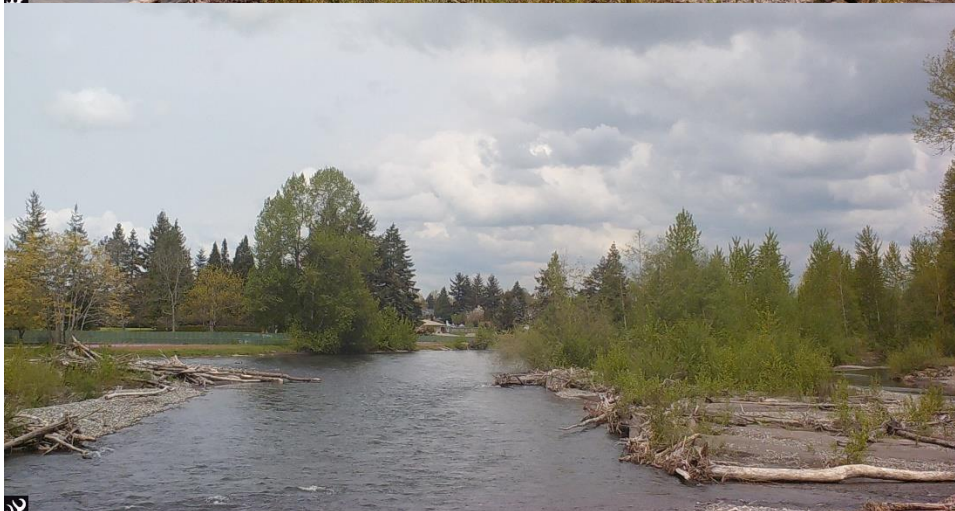
Figure 7. Side channel inlet, looking north.

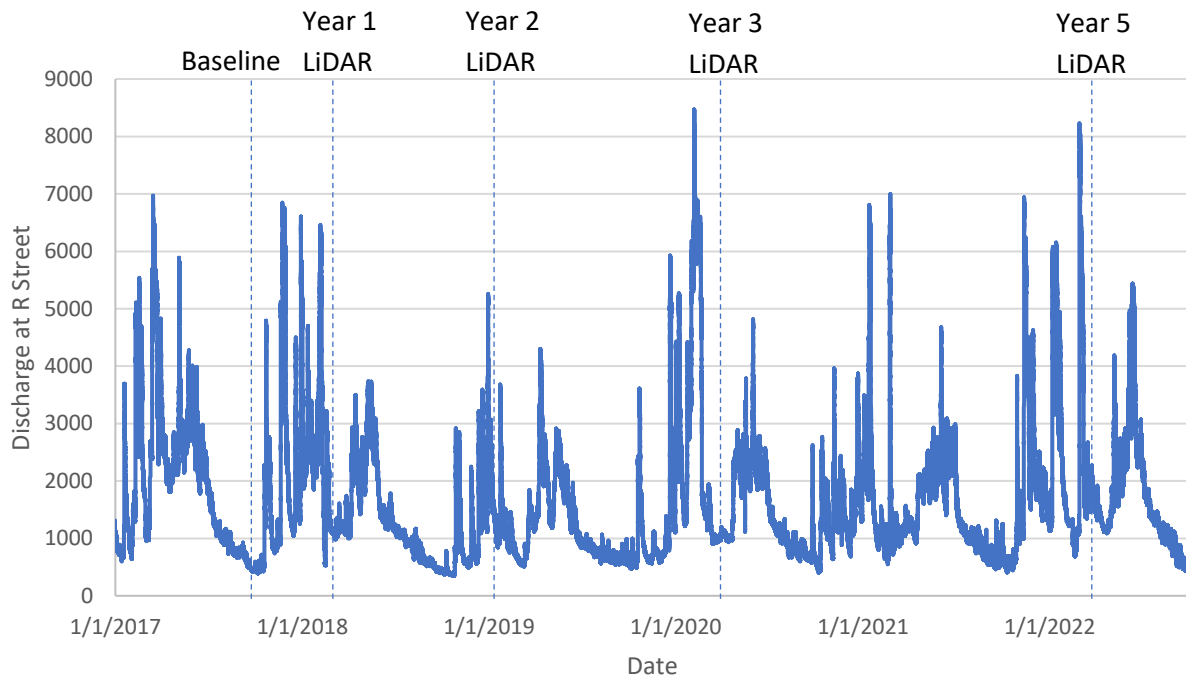
Figure 8. Hydrology (USGS White River at R Street) since January 2017. Dates of LiDAR flights (which provided digital ground models used in analyses) are shown with dotted lines.

Observed sediment deposition and erosion patterns are consistent with channel response predictions made during project design. These observations also are consistent with mechanisms of bedload sediment transport involved in the process of incremental head-cutting where the low area at the tail of a headcut (pool) will be filled from sediment mobilized at the nick point at the top of the headcut slope (Fryirs and Brierley, 2013). Anderson and Jaeger (2019) demonstrated through sediment flux analysis that the lower Canyon Reach (RM 12 to 17) is the source of sediment deposited in the Countyline Reach and that the nick point where erosion changes to deposition is at about RM 9. Multiple high flow events occurred between LiDAR flights that would have mobilized upstream sediments (Figure 8) and contributed to patterns of overall deposition observed at the project.

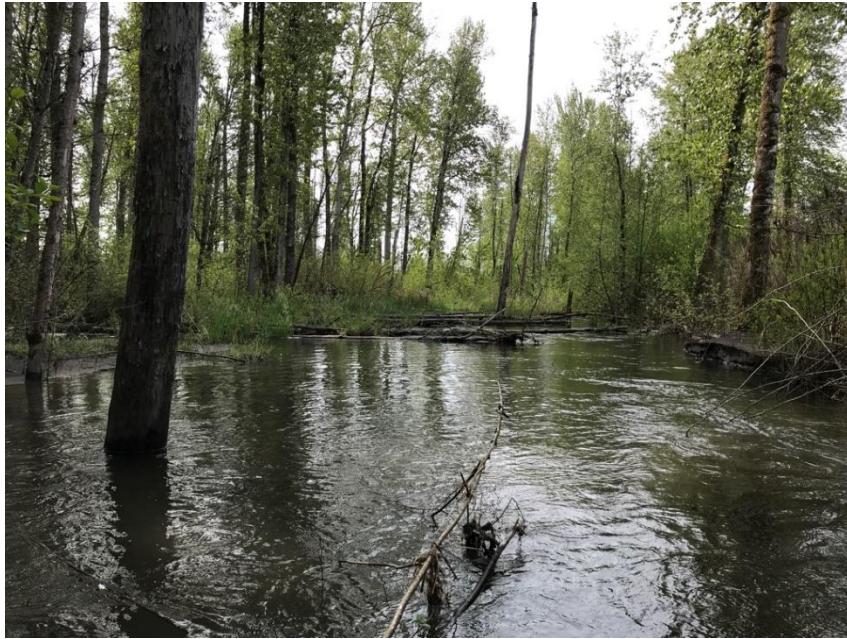
Figure 12. New channel between mainstem and side channel floodplain (May 2022).

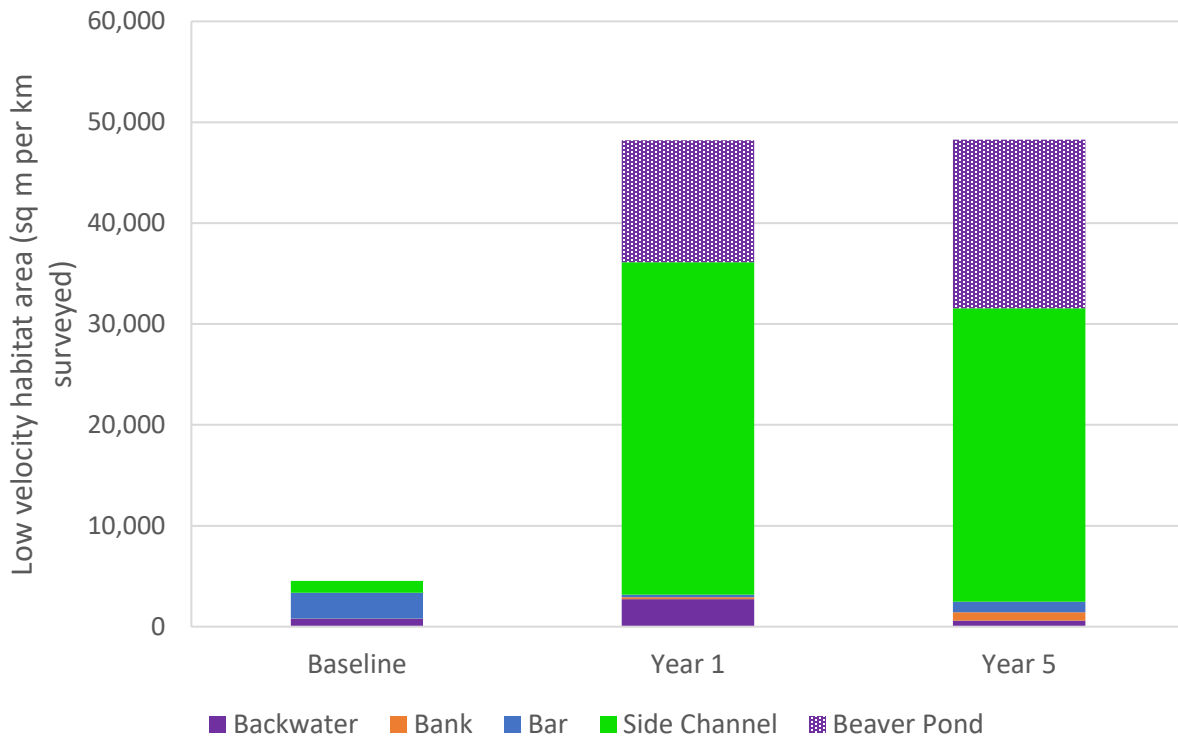
Figure 13. Slow-water habitat by type at baseline (3/19/2015), Year 1 (11/5/2018), and Year 5 (7/18/2022) at approximately 1400-1500 cfs. Side channel habitat in Year 1 includes bar and bank habitat within the floodplain side channel.

The total area of low velocity habitat is very similar to that observed at a similar flow in Year 1 (2018), though the spatial distribution is different as the site has evolved (Figure 14). Flow around the area near the side channel inlet has become more concentrated in more defined channels, and so less low velocity habitat is found in this area. While some channel braids and side channels have become inundated less frequently in the primary side channel through the floodplain, a new connection point between the mainstem and floodplain side channel has formed, creating a large new patch of side channel habitat that runs through a wetland complex at the center of the site (Figure 12, Figure 14). This new side channel remains connected at summer low flow. The beaver pond at the north end of the site has also enlarged from 6.3 acres in 2018 to 8.8 acres in 2022. Similar to Year 1, most low velocity habitat is side channel, though less backwater habitat was present in Year 5 compared to Year 1 (Figure 13, Table 6).

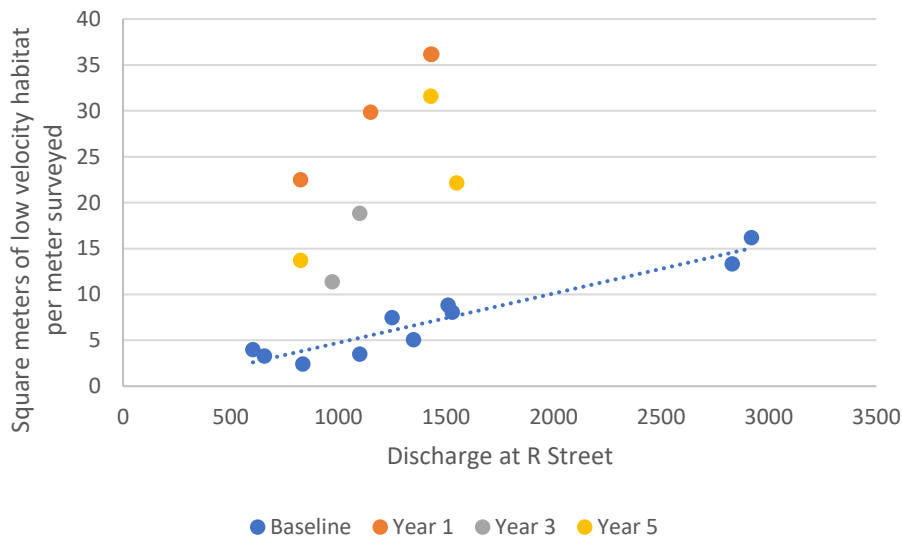
Figure 15. Low velocity habitat area versus discharge at R Street gage. All habitat types combined. Linear trend for baseline data shown.

Plotting low velocity habitat area versus discharge at the USGS R Street gage revealed a positive relationship under both baseline and post-project conditions (Figure 15), likely because side channels and backwater habitats became engaged at higher flows but were dry or disconnected at lower flows. Plotting post-project habitat data by habitat type supports this explanation, as only side channel habitat showed a positive relationship with discharge (Figure 16). Across all post-construction years, more low velocity habitat was present at low flows compared to baseline, indicating the project has created habitat that has persisted over time. Very high flood flows were not sampled due to safety and so the nature of the relationship between habitat area and discharge at higher flows than sampled is unknown; as discharge increases further we hypothesize that low velocity habitat availability would increase as floodplain inundation increases, but would eventually decrease after floodplain inundation was complete since the river remains confined between levees. Low velocity area at these very high flows would still likely be higher than at low flows.

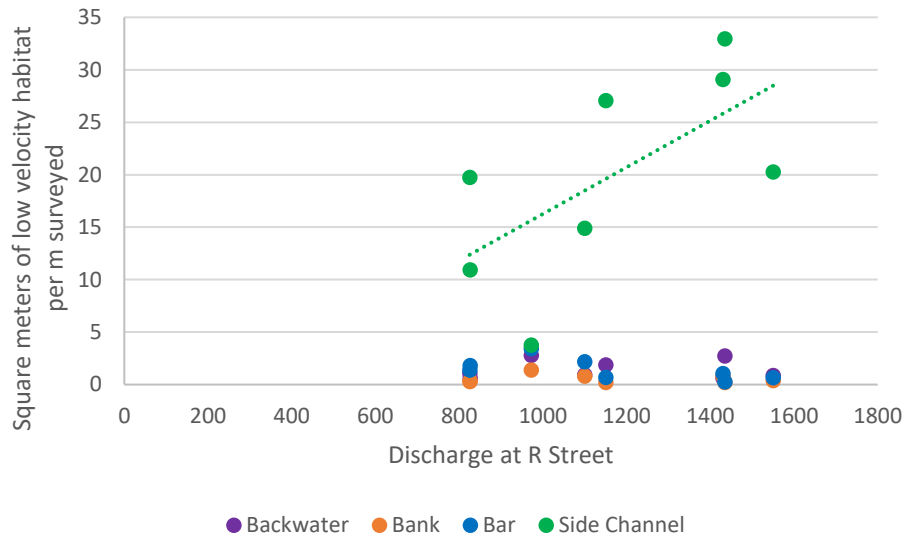
Figure 16. Post-project low velocity habitat area by type versus discharge at the R Street gage. All post-project surveys shown. Linear trend for side channel habitat shown.

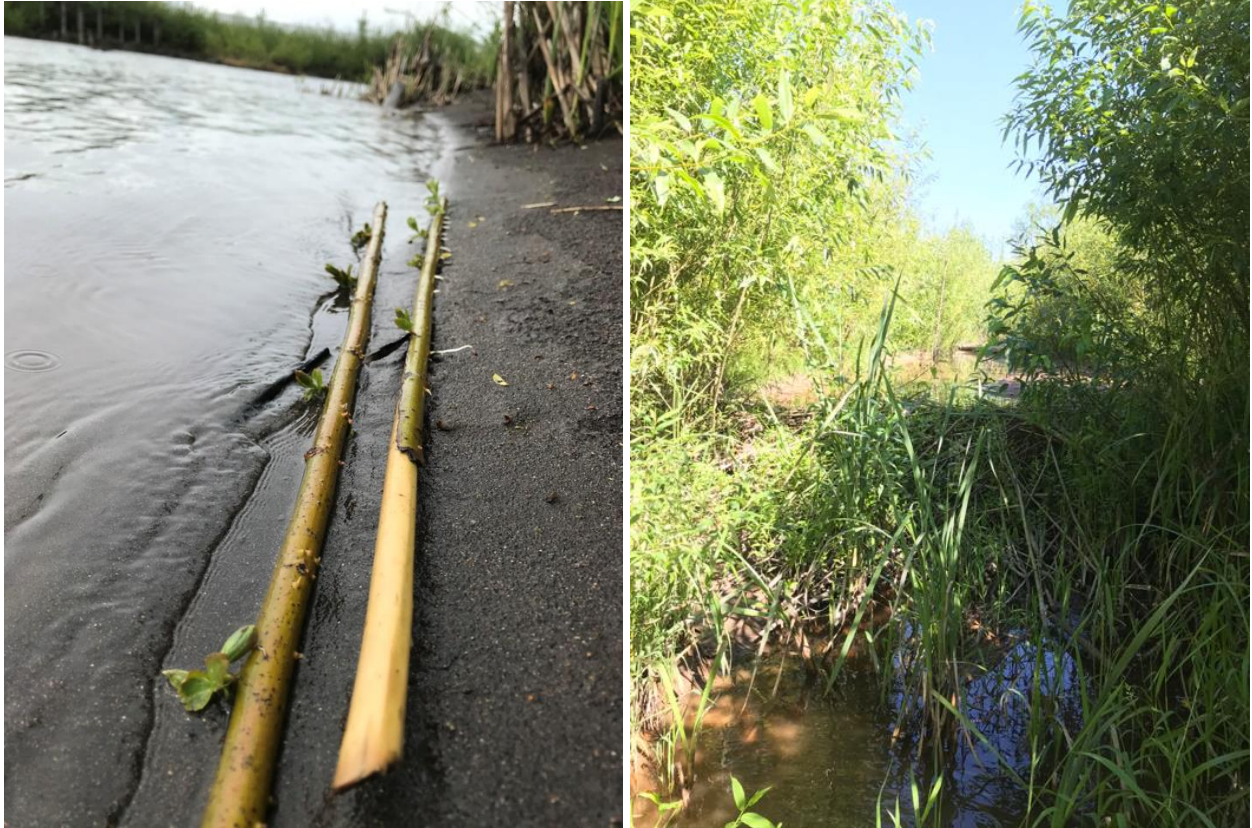
Figure 21. Beaver browsed willow sending out roots along a floodplain sand bar (left; May 2022). One of several small beaver dams in the floodplain (right; July 2022).

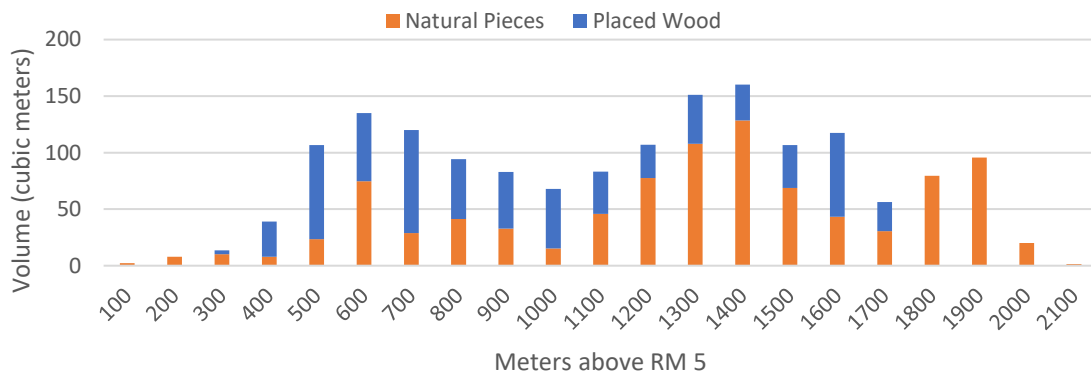
Figure 24. Volume of naturally occurring and placed large wood pieces in 2021. Data does not include pieces found within jams.

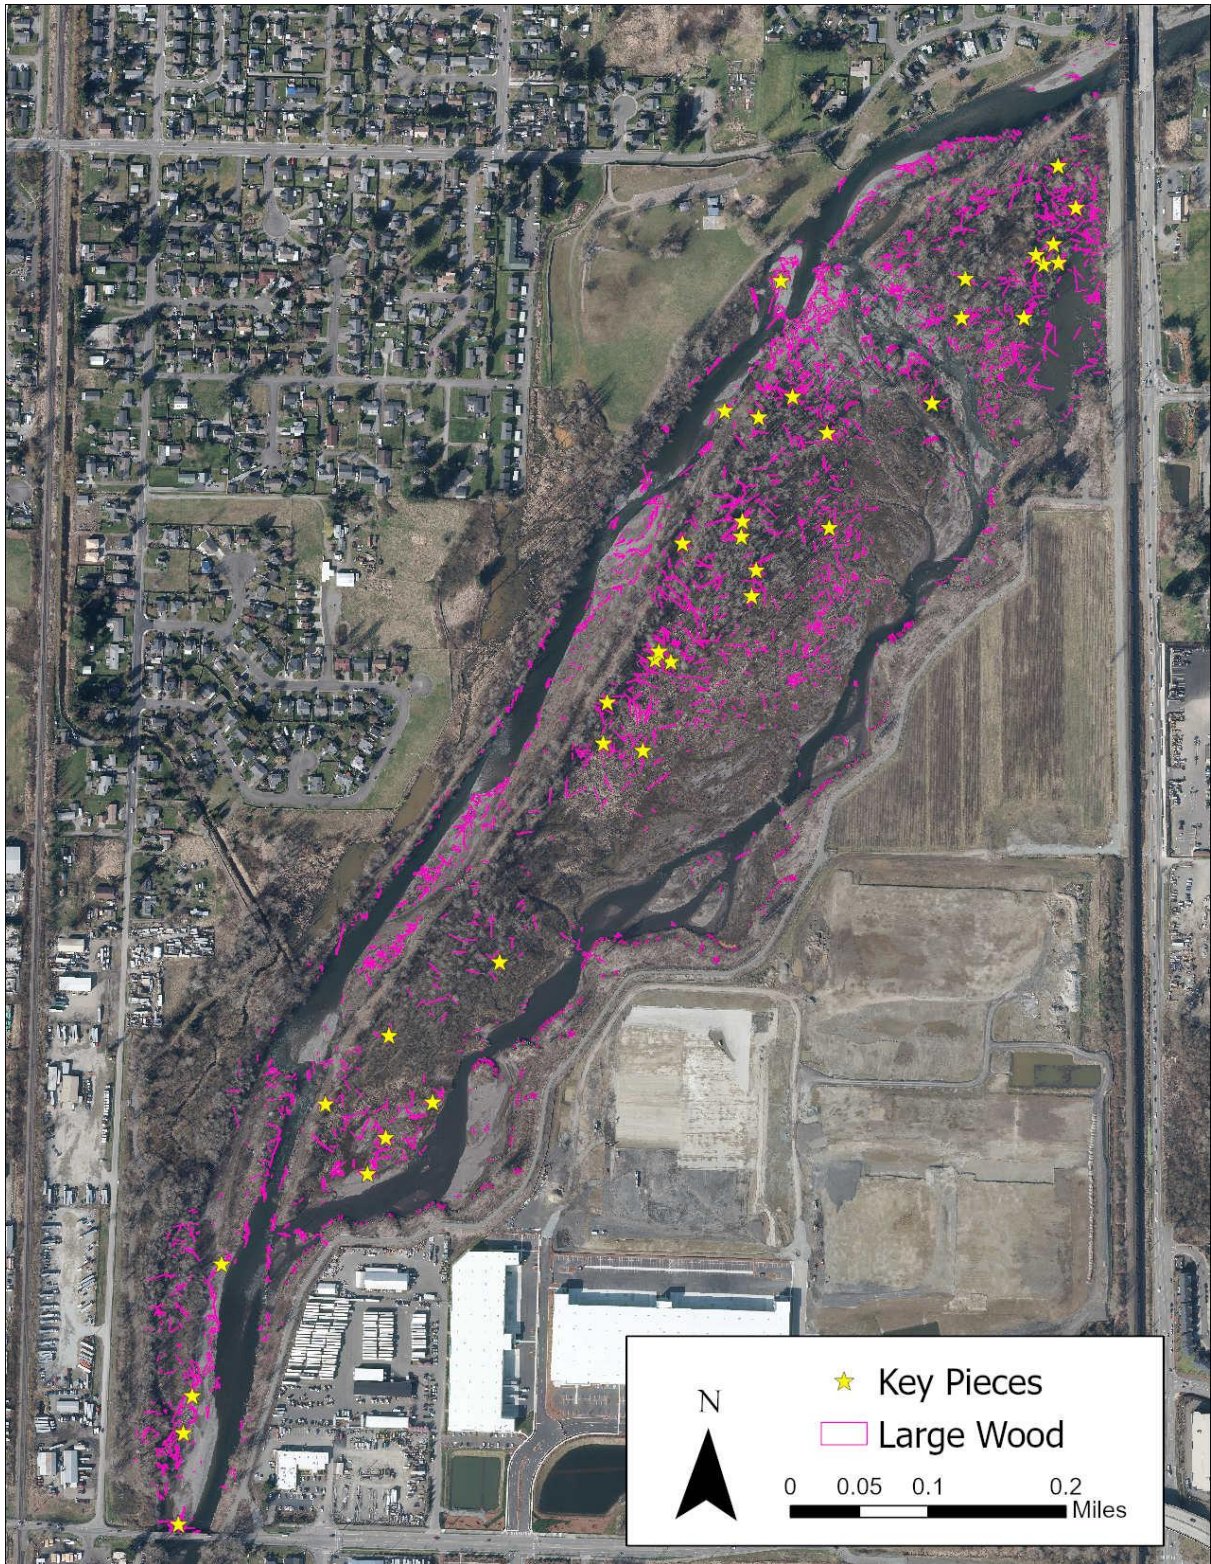
Figure 26. Map of all large wood (pieces and jams, naturally occurring and placed) in the project reach in 2021. See Table 10 for Key Piece definition.

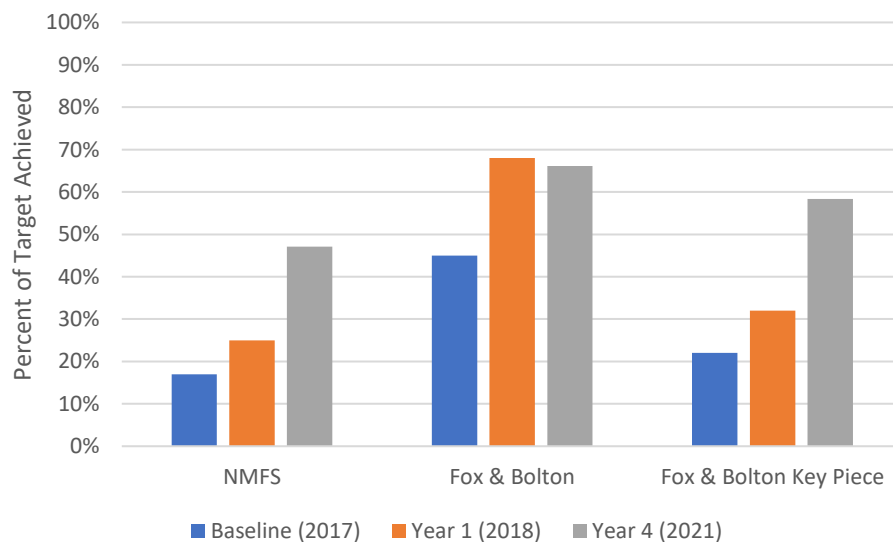
Figure 27. Percent of large wood target guidelines achieved at baseline, Year 1, and Year 5. Placed wood pieces are included in the Fox & Bolton target, but not the NMFS or Fox and Bolton Key Piece targets.

Large wood abundance in the project area continues to fall short of the targeted 80 pieces per mile (15.2 m long and 0.6 ft diameter), likely because high flow conditions that recruit and transport wood have largely not occurred since construction. Wood targets for the project were based on study results that suggested on average 79 pieces meeting this size threshold would be transported to the project area annually (King County 2011). However, this analysis assumed flow conditions would remain similar into the future; instead, flow releases from Mud Mountain Dam have been limited to less than 7,000 cfs since 2009 (compared to 17,600 cfs authorized under the Water Control Manual, and a flow target of 12,000 cfs when feasible). Wood recruitment to the project area is likely to continue to be limited by water management practices.

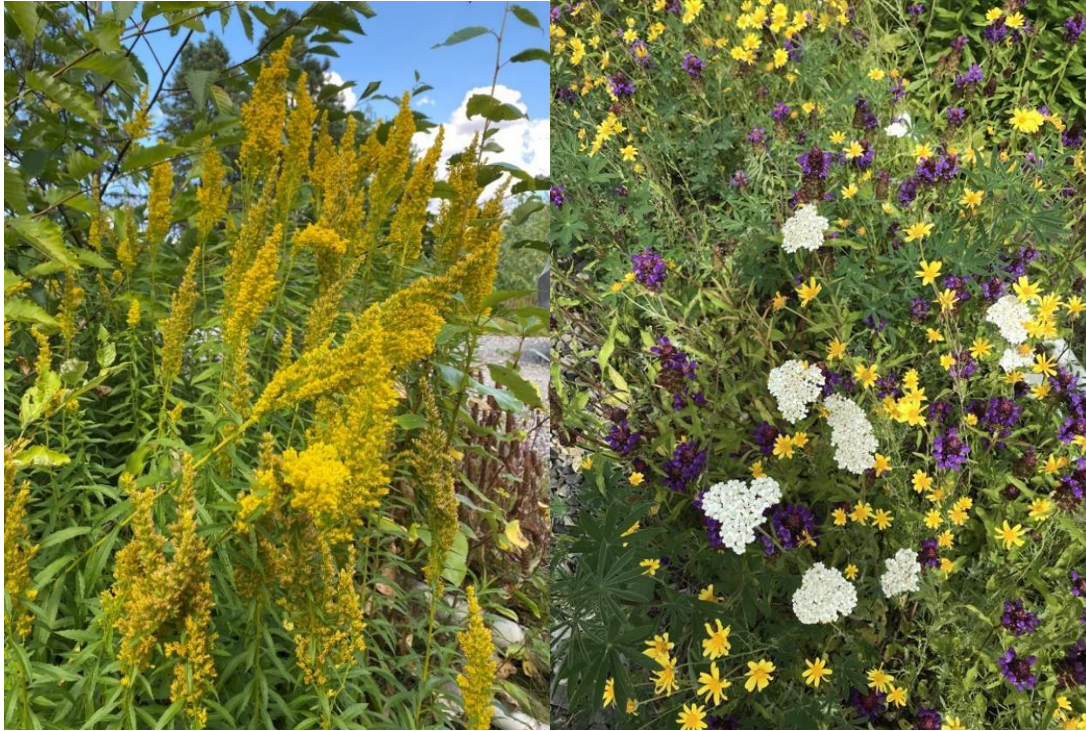
Figure 29. Canada goldenrod (left) and yarrow, self heal, woolly sunflower, and riverbank lupin (right) in 2020.

A native wildflower seed mix was spread along the top couple feet of the levee slopes in 2018; riverbank lupine (*Lupinus rivularis*) has been particularly successful, with most species establishing in 2019 and 2020 during the second or third growing season. Successful perennial wildflowers included self heal (*Prunella vulgaris*), western yarrow (*Achillea millefolium*), Canada goldenrod (*Solidago canadensis*), riverbank lupine, bigleaf lupine (*Lupinus polyphyllus*), fireweed (*Chamaenerion angustifolium*), western columbine (*Aquilegia formosa*), and woolly sunflower (*Eriophyllum lanatum*) (Figure 29). Several annual species have also re-seeded and persisted over time, including Douglas meadowfoam (*Limnathes douglasii*) and wine cup clarkia (*Clarkia purpurea*).

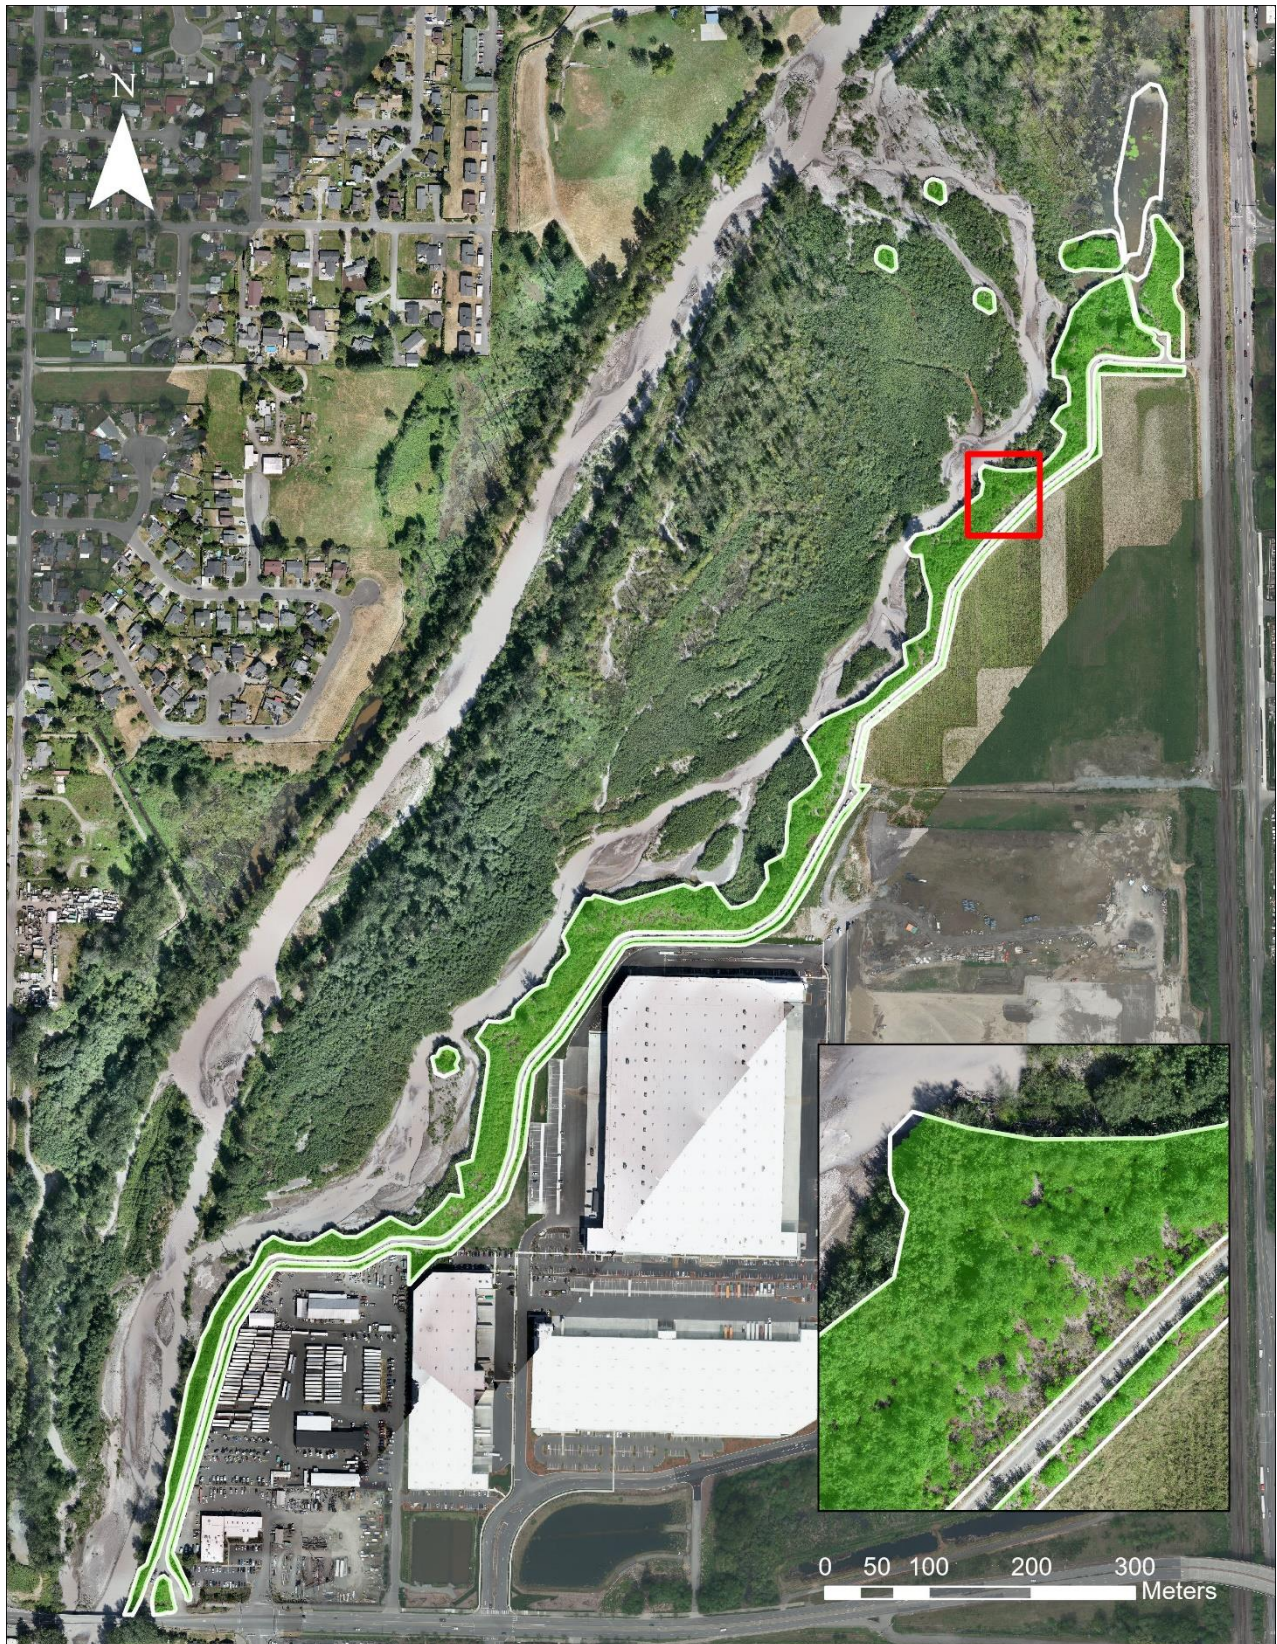
Figure 30. Remotely sensed vegetation in planted areas (bright green) as calculated by NDVI. Boundary of planted areas shown in white polygons.

Remote sensing analysis using a Normalized Difference Vegetation Index (NDVI) found that across the entire planted area, percent cover was 82%, up from 63% in Year 3 (Figure 30). The NDVI method uses multispectral imagery to characterize vegetation, and a field verification exercise done at this site in 2021 found that the NDVI method may produce greater estimates of cover compared to transect data collected in the field. We did not expect that the NDVI method and transect sampling would produce identical or directly comparable estimates of percent cover, since the NDVI estimate includes all vegetation, (including non-native species, whereas data reported above from transects separate out native and non-native cover and include woody species only), and methodology limitations differ (e.g., cover class bins for field collected data, soil color influences on spectral reflectance for remotely sensed data) which may under or overestimate cover in some areas.

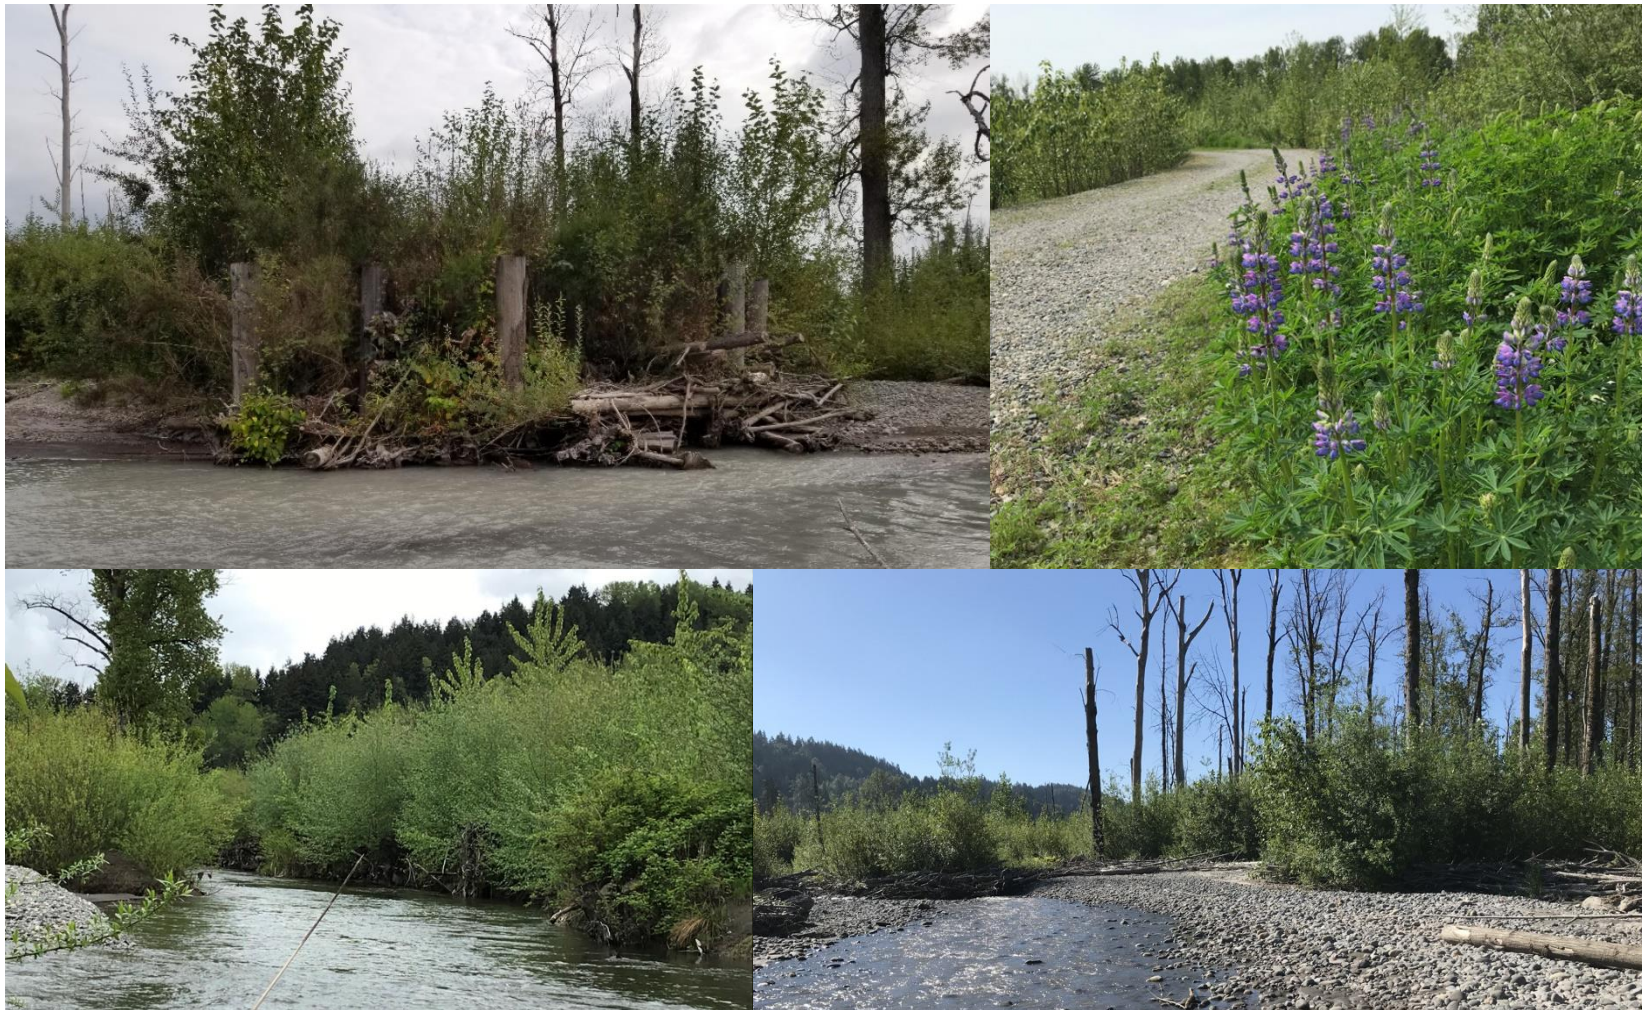
Figure 33. Vegetation establishment on top of an apex engineered log jam (top left), along levee slopes (top right), within riparian buffers (bottom left), and along unplanted gravel bars (bottom right) in 2022.

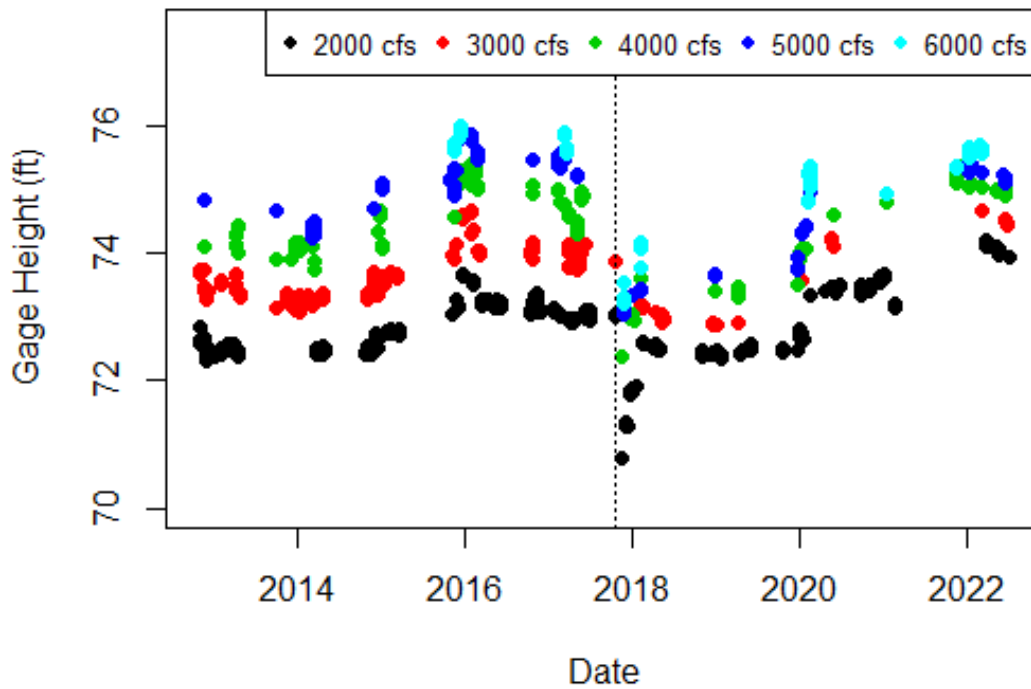
Figure 34. Water surface elevation at USGS 12100498 White River at Pacific, WA. The river initially breached the lowered levee on October 21 2017 (dashed line).

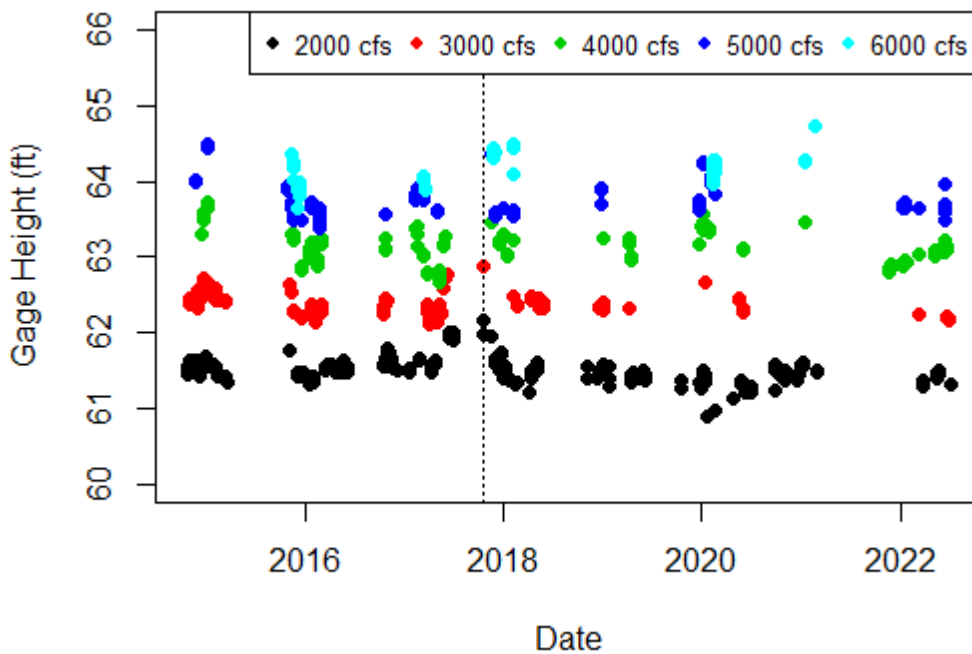
Figure 35. Water surface elevation at USGS 12100500 White River near Sumner, WA (at the 8th Street bridge). The river initially breached the lowered levee on October 21 2017 (dashed line).

As of October 2022, at higher flows (i.e., 6000 cfs) mainstem WSEs have returned to approximately the same elevation as pre-project elevations at the same discharge, however the range of WSEs across discharges was reduced in 2022 compared to pre-project (Figure 34); this indicates that at higher flows water is still being conveyed through the floodplain rather than increasing mainstem stage, therefore the project continues to provide reduced flood risk.

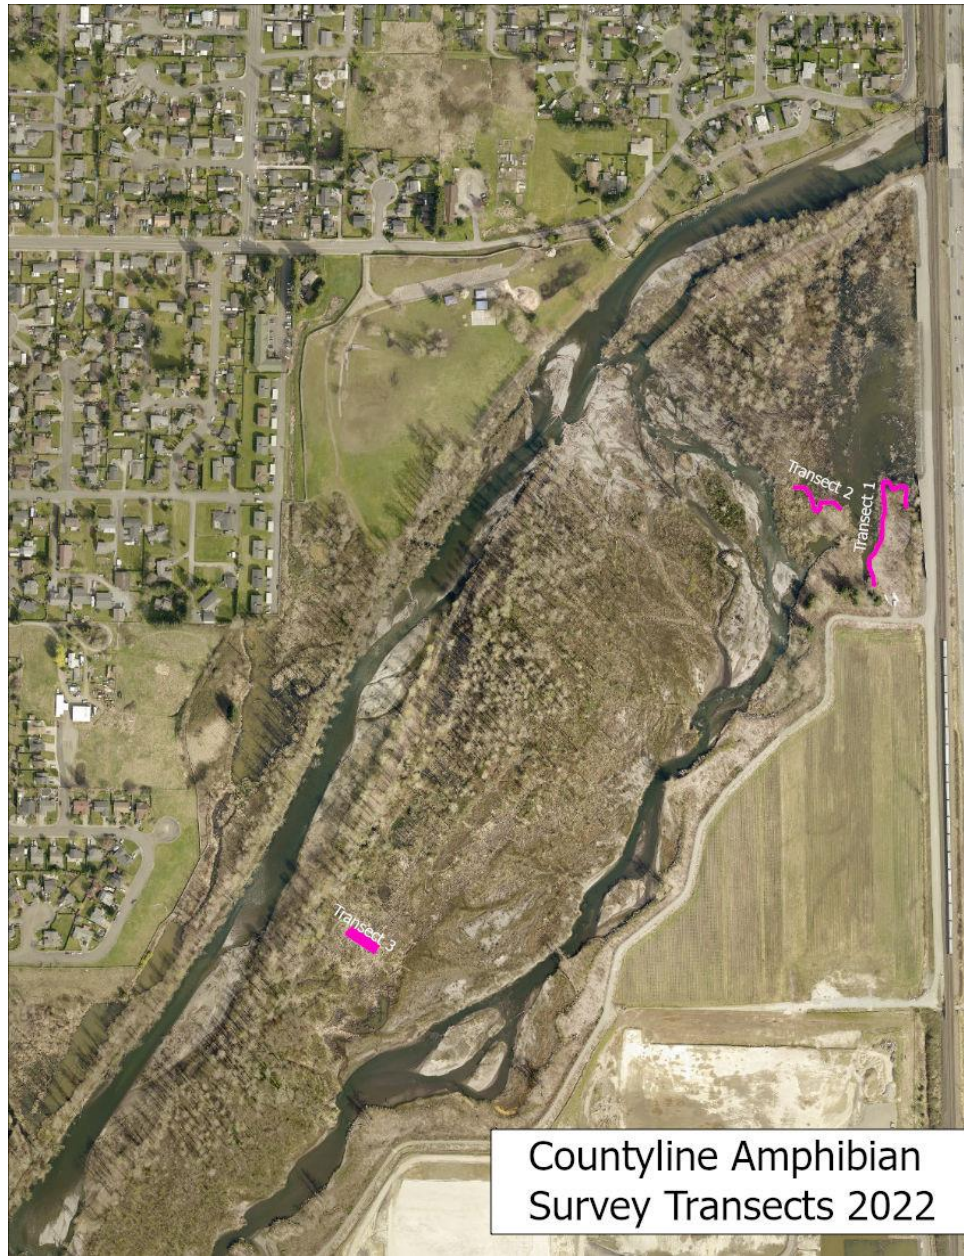
Figure B1. Amphibian breeding survey transects.

Amphibian breeding surveys were conducted monthly during the breeding season (on Feb 11, Mar 24, Apr 22, and May 19 2022) by a team of three to four biologists. Two transects were established in the large beaver pond at the northernmost area of the project, along the pond edge where shallower water provided suitable breeding habitat (Transect 1 and 2; Figure B1). An additional transect was established in a floodplain wetland near the center of the project (Transect 3; Figure B1). Transects were generally shallow (<1 m deep) and a 2-m wide area along the transect was surveyed for egg mass presence. Surveys were conducted on foot by wading along the transects, and also walking along the shore in the case of the beaver pond transects. Surveys were not conducted in rain or high winds to maximize visibility. Egg masses were identified by species and egg mass locations were marked with a GPS.
