GEOTECHNICAL DATA REPORT Levee Breach Analysis Mapping and Risk Assessment, Lower Raging River KING COUNTY, WASHINGTON

Subject: GEOTECHNICAL DATA REPORT, LEVEE BREACH ANALYSIS MAPPING
AND RISK ASSESSMENT, LOWER RAGING RIVER, KING COUNTY,
WASHINGTON

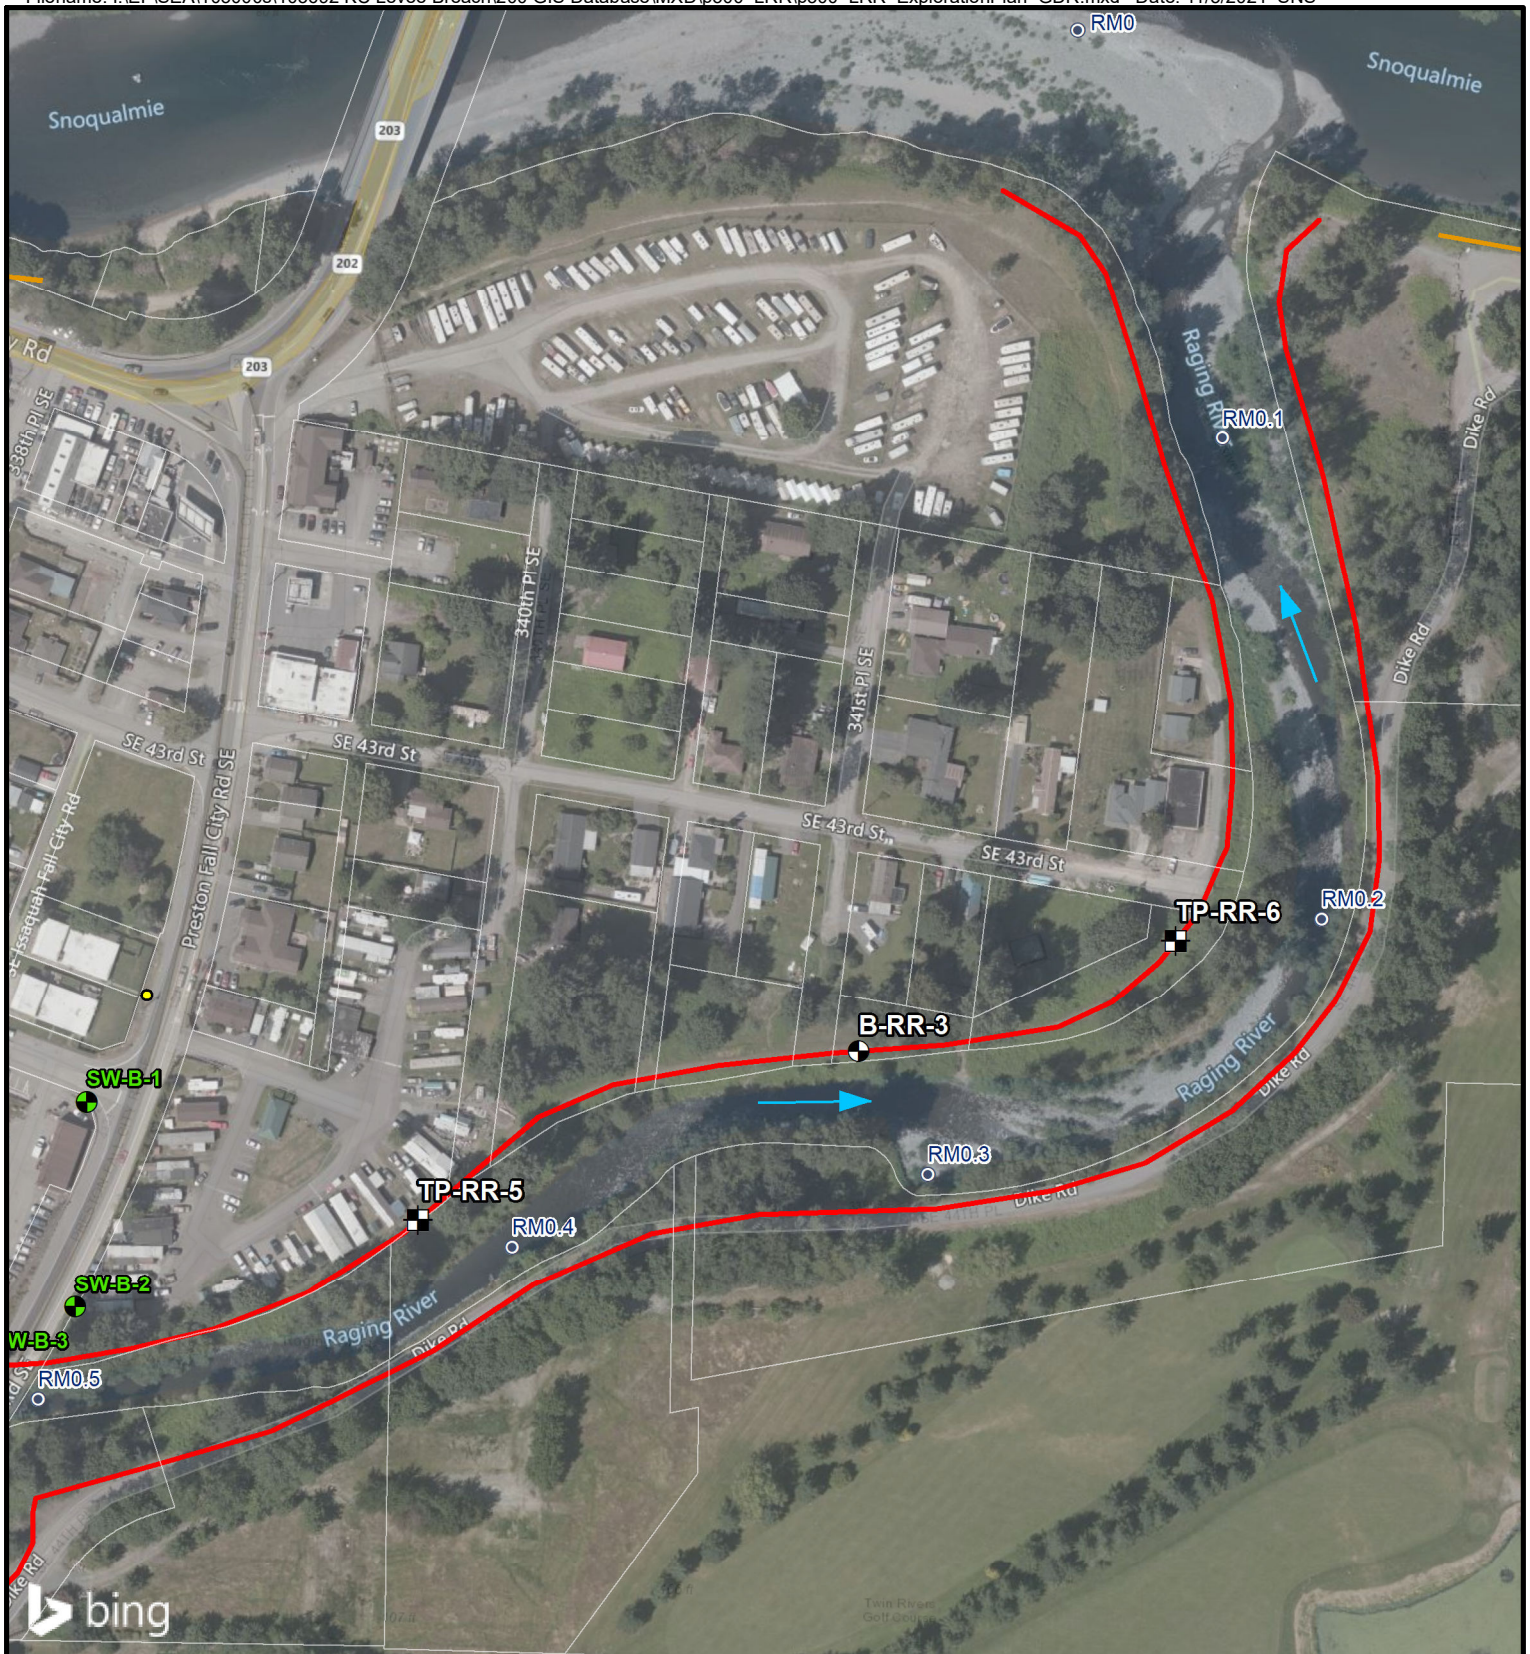
FIG. 2
Sheet 3 of 4

We designated our explorations using the exploration method (i.e., “B-RR” for Raging River borings and “TP-RR” for Raging River test pit) and a number (i.e., “B-RR-1” and “TP-RR-01”). 1 Alliance Geomatics surveyed the boring and test pit locations and elevations after completion. The locations of the Lower Raging River subsurface explorations are shown in Figure 2.

The historic Shannon & Wilson explorations along Lower Raging River consist of borings and test pits associated with the Raging River Bridge Replacement Project (Shannon & Wilson, 1997). The approximate boring locations are shown in Figure 2. The Shannon & Wilson boring logs, test pit logs, and associated lab testing records are provided in Appendix B as Figures B-1 through B-19.

The historic King County DOT boring and test pit logs are associated with the Smith-Parker Bridge Replacement Geotechnical Engineering Report (GeoEngineers, 1996). The approximate boring locations are shown in Figure 2. The legend for the GeoEngineers exploration location is provided in Appendix B, Figure B-20. The boring logs, test pit logs, and lab testing records are provided in Appendix B as Figures B-21 through B-35.

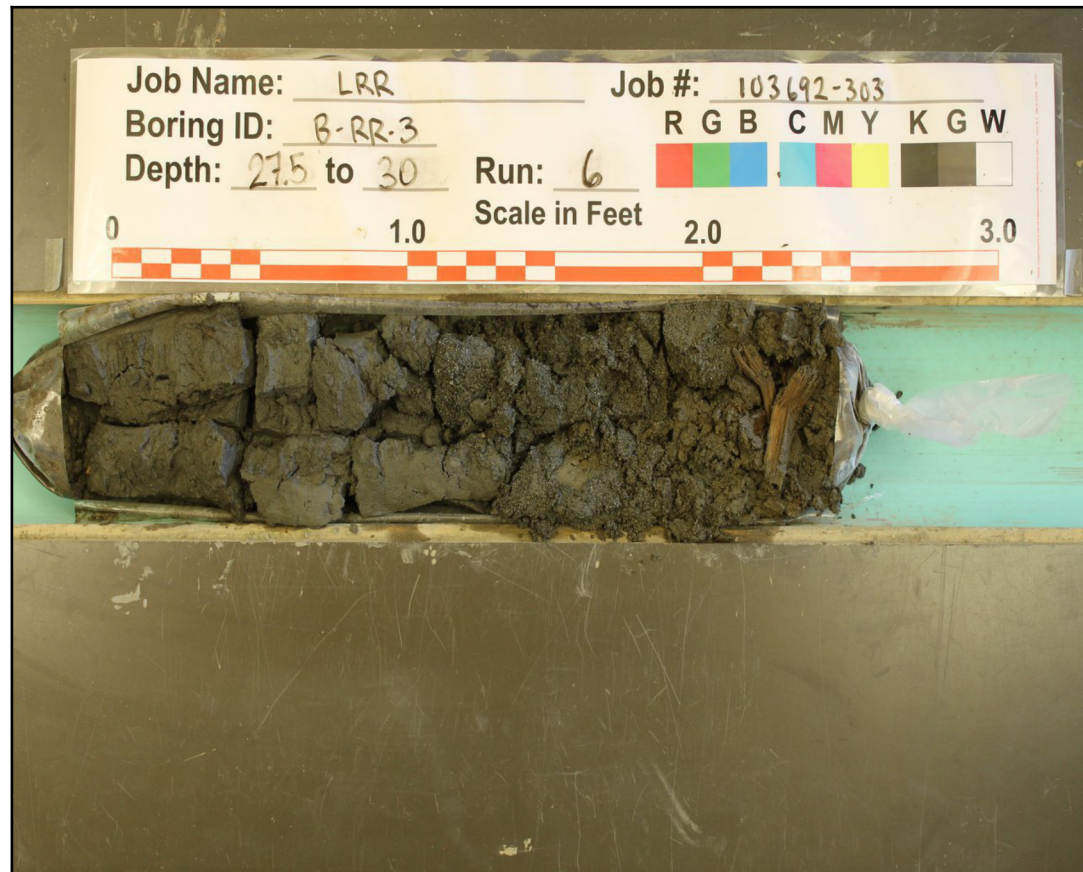
FIG. A-7
Sheet 7 of 14

Medium dense, brown to gray, interbedded, Poorly Graded Sand with Silt (SP-SM), Poorly Graded Sand (SP), and Silty Sand (SM); wet; trace to few fine gravel; fine to medium sand; nonplastic; iron-oxide staining around 27 feet; few wood fragments.

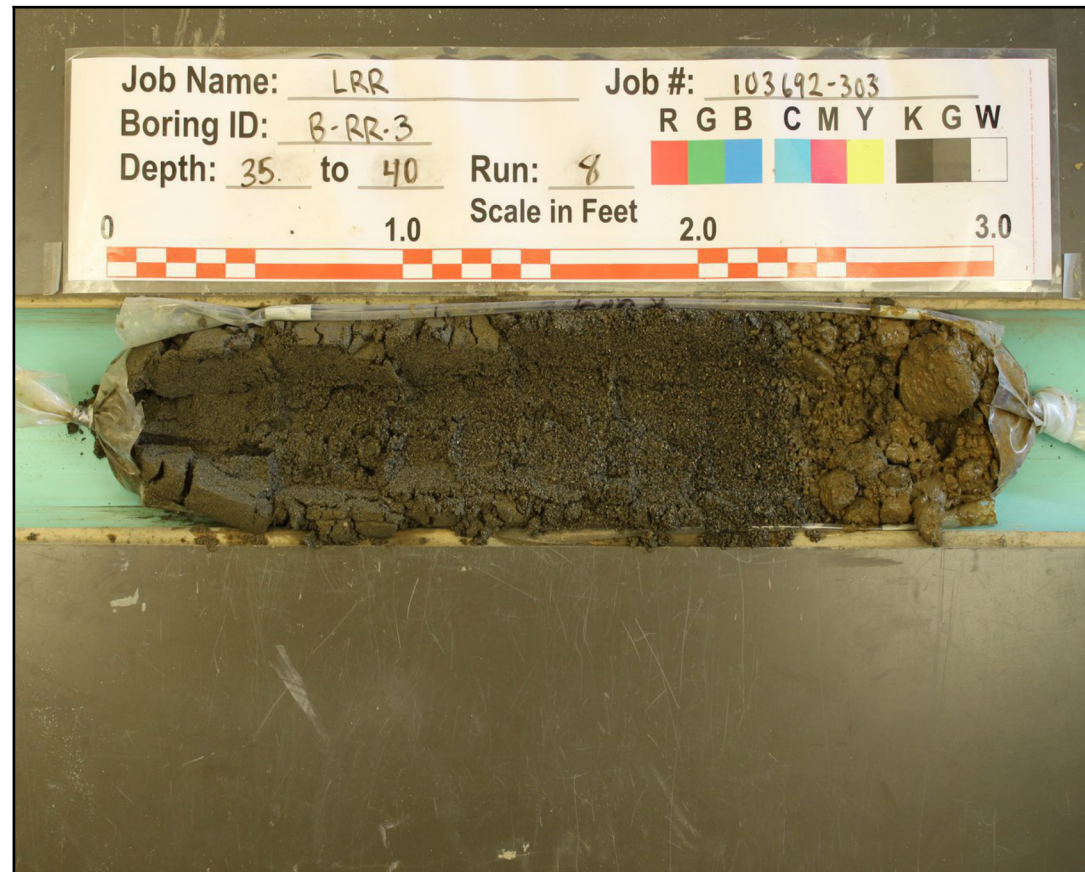
FIG. A-7

Very loose, gray, Silty Sand (SM) to Poorly Graded Sand with Silt (SP-SM) and Poorly Graded Sand (SP); wet; fine to medium sand, grading to coarse sand with depth; nonplastic.

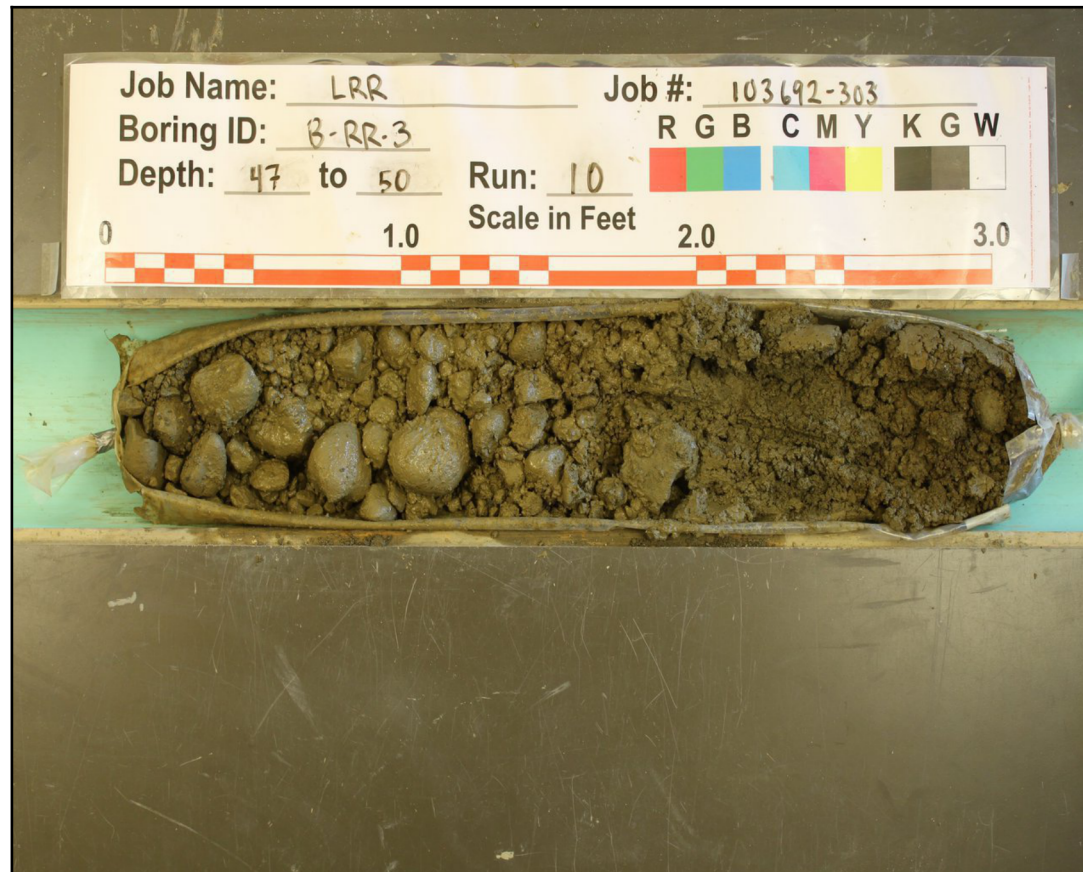
FIG. A-7
Sheet 13 of 14

Very loose, gray-brown, Silty Sand (SM) grading to Poorly Graded Sand with Silt (SP-SM); wet; trace fine gravel; fine to medium sand, grading to coarse sand; nonplastic.

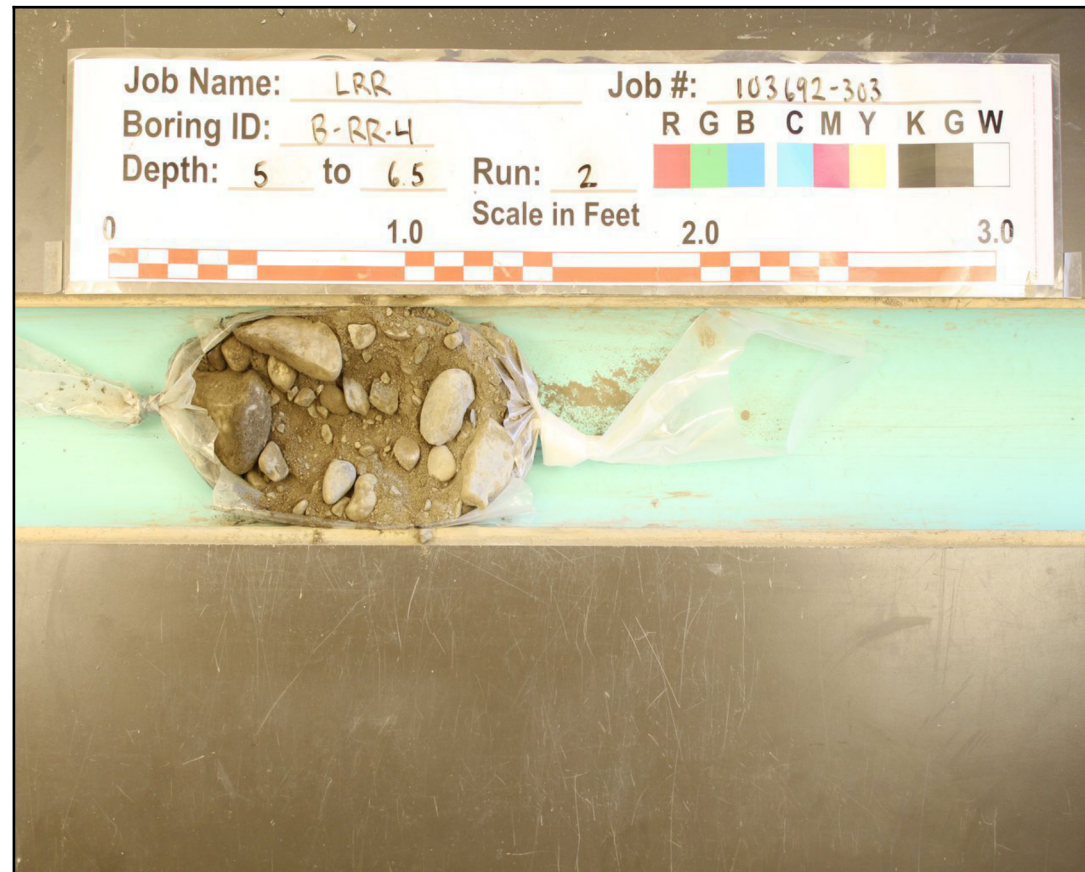
FIG. A-9
Sheet 1 of 15

Medium dense, brown to gray-brown, Poorly Graded Gravel with Silt and Sand and Cobbles (GP-GM) to Poorly Graded Gravel with Sand and Cobbles (GP); moist; few cobbles; fine to coarse, subangular to rounded gravel; fine to coarse sand; nonplastic.

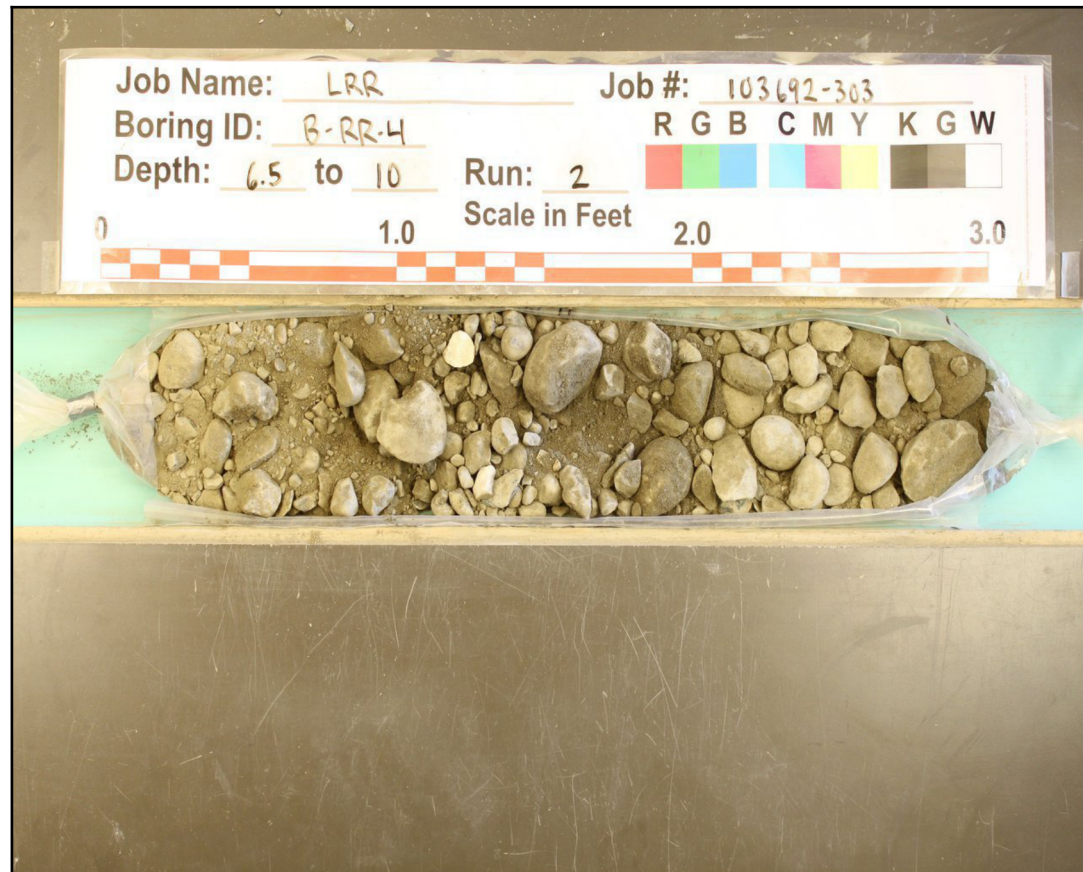
FIG. A-9
Sheet 2 of 15

Medium dense, brown to gray-brown, Poorly Graded Gravel with Silt and Sand and Cobbles (GP-GM) to Poorly Graded Gravel with Sand and Cobbles (GP); moist; few cobbles; fine to coarse, subangular to rounded gravel; fine to coarse sand; nonplastic.

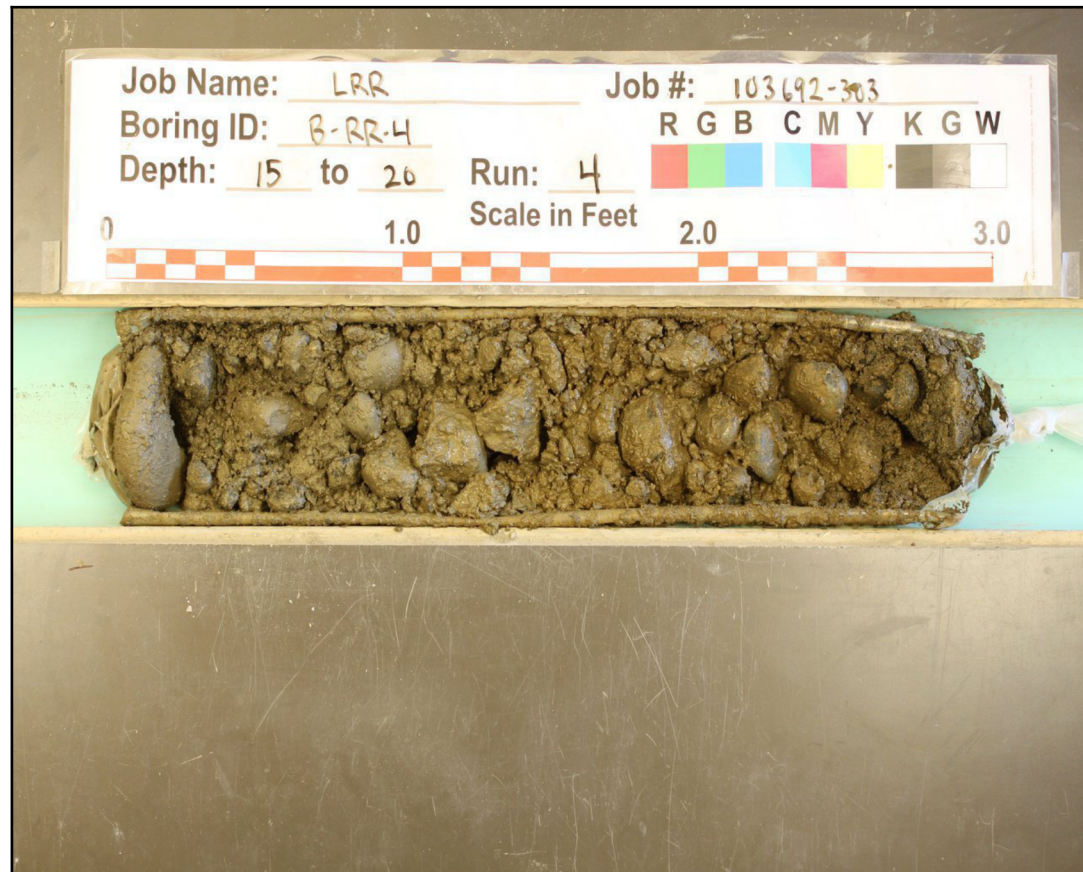
Sheet 4 of 15

Medium dense, brown to red-brown, Poorly Graded Gravel with Sand and Cobbles (GP); moist to wet; few cobbles; fine to coarse, subangular to rounded gravel; fine to coarse sand; nonplastic.

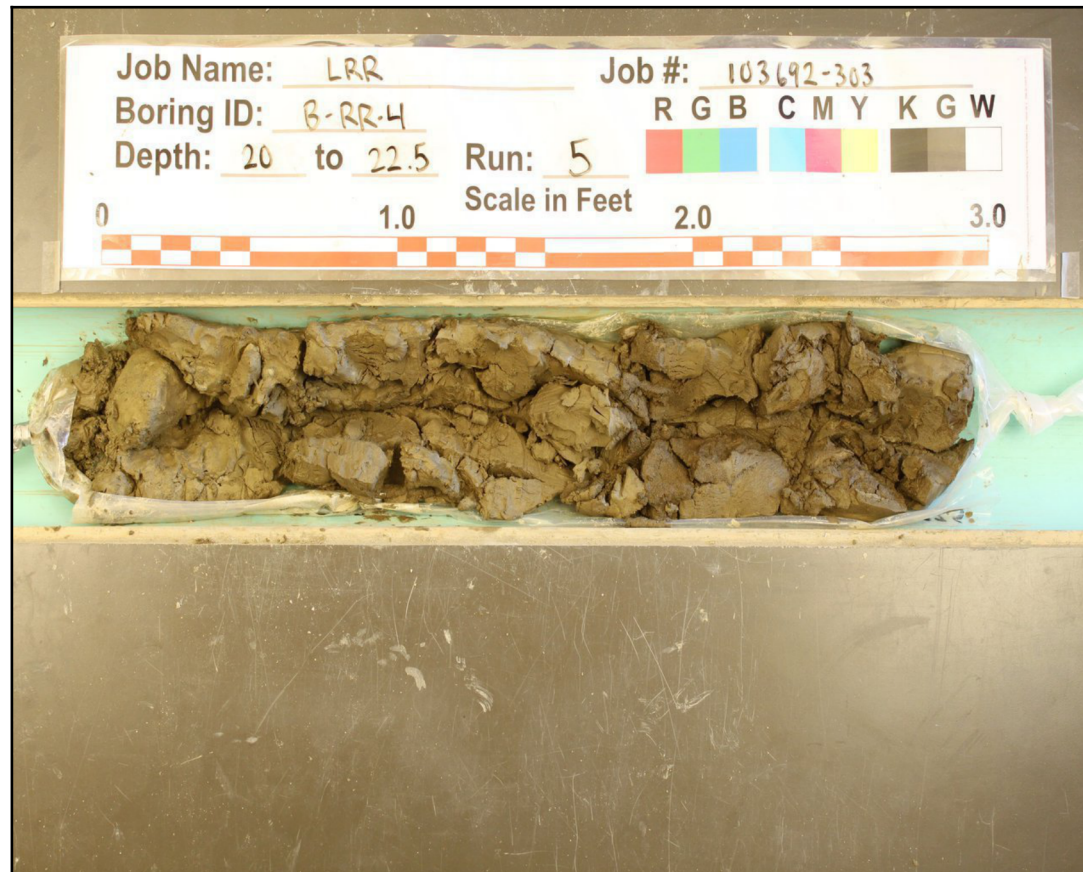
FIG. A-9
Sheet 5 of 15

Soft, brown, Lean Clay (CL); moist to wet; few cobbles and gravel above about 22 feet; low plasticity to medium plasticity.

Brown, Sandy Silt (ML); wet; fine to medium sand; nonplastic; few iron-oxide stained seams.

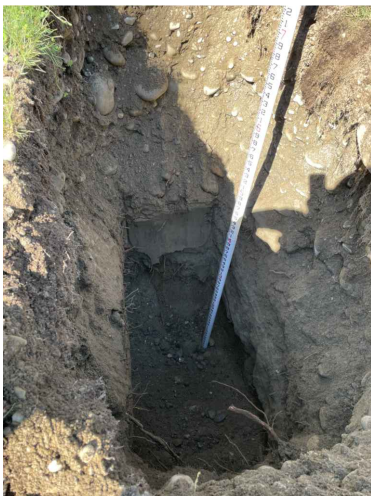
LOG OF TEST PIT TP-RR-2

SOIL DESCRIPTION	Ground Water	% Water Content	Samples	Depth, Ft.	Sketch of Southeast Pit Side	Surface Elevation: Approx. 142 Ft.					
					Horizontal Distance in Feet						
					0	2	4	6	8	10	12
<div>① Topsoil and grass.</div> <div>② Brown, <i>Well-Graded Gravel with Silt and Sand and Cobbles (GW-GM)</i>; moist; subrounded to rounded cobbles; fine to coarse gravel; fine to coarse sand; nonplastic fines. - Few roots from about 3 to 4 feet.</div> <div>③ Brown, <i>Silty Sand (SM) and Sandy Silt (ML)</i>; moist; few fine to coarse, subrounded gravel; fine to coarse sand; low plasticity fines.</div> <div>④ Gray to brown, <i>Poorly Graded Sand with Gravel (SP) to Poorly Graded Gravel with Sand (GP)</i>; moist; fine to coarse, subrounded gravel; fine to coarse sand; trace nonplastic fines.</div>	None Observed			0							
			S-1	2

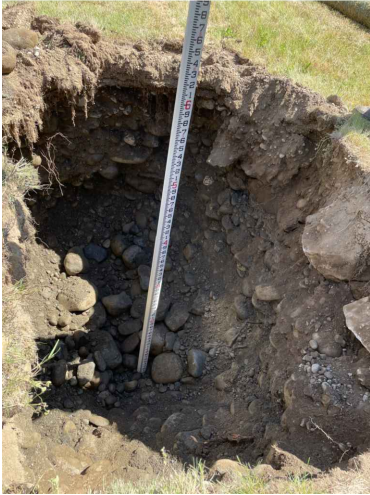
SOIL DESCRIPTION	Ground Water	% Water Content	Samples	Depth, Ft.	Sketch of East Pit Side	Surface Elevation: Approx. 136 Ft.					
						Horizontal Distance in Feet					
				0	0	2	4	6	8	10	12
<div>① Topsoil and grass with crushed gravel.</div> <div>② Angular boulders observed on east edge of test pit to about 6 feet west of the eastern edge of the levee.</div> <div>③ Brown, <i>Well-Graded Gravel with Sand and Cobbles (GW)</i>; moist; subrounded cobbles; fine to coarse, subrounded to rounded gravel; fine to coarse sand; trace nonplastic fines.<div>- Few roots from about 3 to 4 feet.</div></div>	None Observed		S-1	0							
2											
4											
6											
8											
10											
12

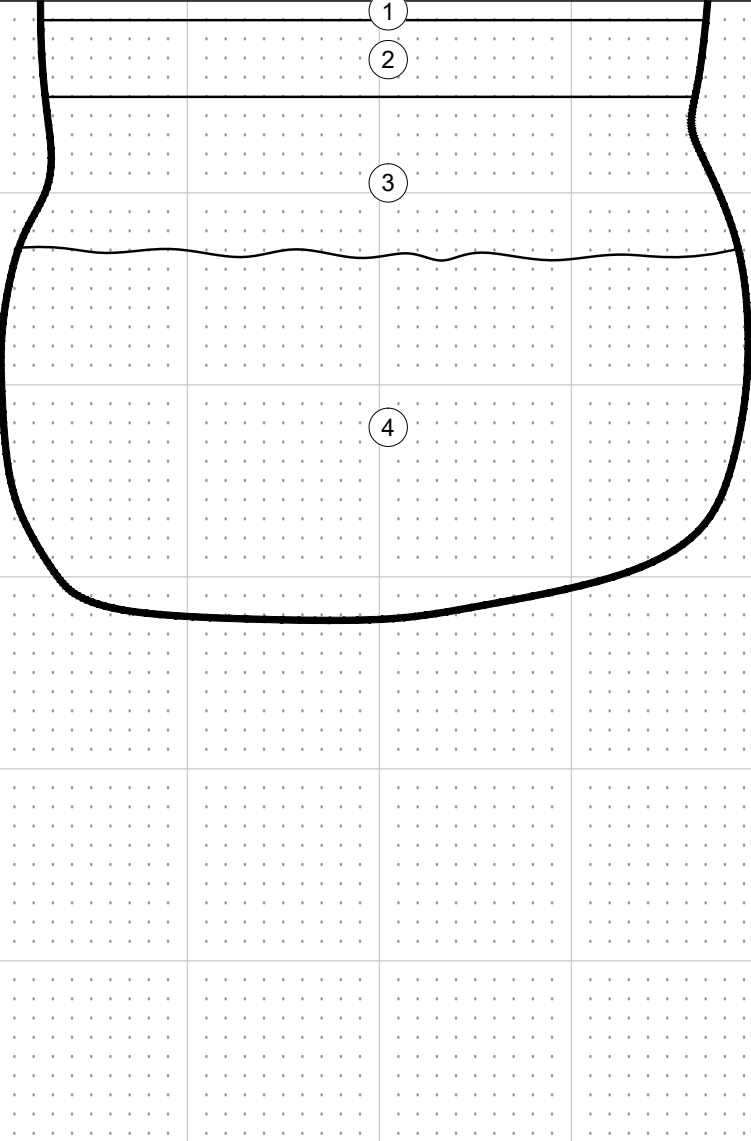
LOG OF TEST PIT TP-RR-3

SOIL DESCRIPTION	Ground Water	% Water Content	Samples	Depth, Ft.	Sketch of East Pit Side	Surface Elevation: Approx. 125 Ft.					
						Horizontal Distance in Feet					
					0	2	4	6	8	10	12
① Topsoil and grass.	None Observed		S-1	0

② Gray-brown crushed gravel mixed with topsoil. - Grass roots at about 1 foot.				2							
③ Gray-brown, angular Boulders and Cobbles mixed with <i>Poorly Graded Gravel with Sand (GP)</i> ; moist; angular boulders; subrounded gravel; fine to coarse sand; trace nonplastic fines.				4							
④ Brown and gray, <i>Poorly Graded Gravel with Silt and Sand and Cobbles (GP-GM)</i> ; moist; subrounded cobbles; fine to coarse, subrounded to rounded gravel; fine to coarse sand; nonplastic fines.				6							
			S-2	8							
				10							
				12

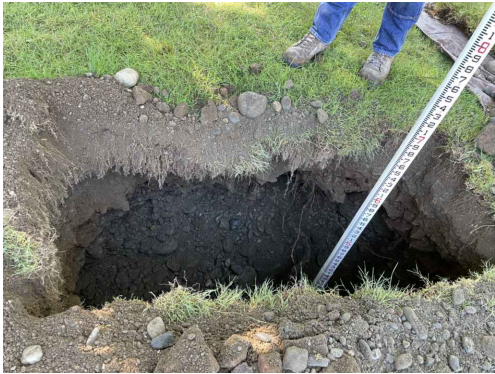
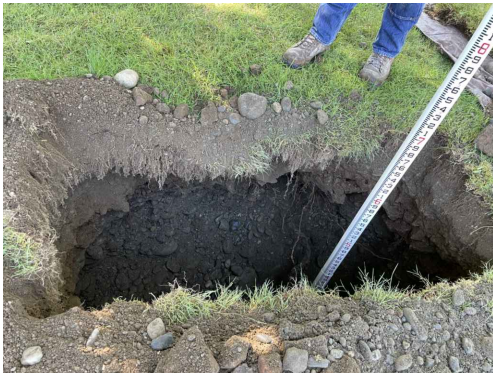
LOG OF TEST PIT TP-RR-4

SOIL DESCRIPTION	Ground Water	% Water Content	Samples	Depth, Ft.	Sketch of East Pit Side	Surface Elevation: Approx. 121 Ft.										
					Horizontal Distance in Feet											
					0	2	4	6	8	10	12					
<div>① Topsoil and grass.</div> <div>② Brown and gray crushed gravel.</div> <div>③ Brown, <i>Poorly Graded Gravel with Silt and Sand and Cobbles (GP-GM)</i>; moist; subrounded cobbles; fine to coarse gravel; fine to coarse sand; nonplastic fines. - roots from about 3 to 4 feet.</div>	None Observed		<div>S-1</div>	0												
				2												
				4												
				6												
				8												
				10												
				12

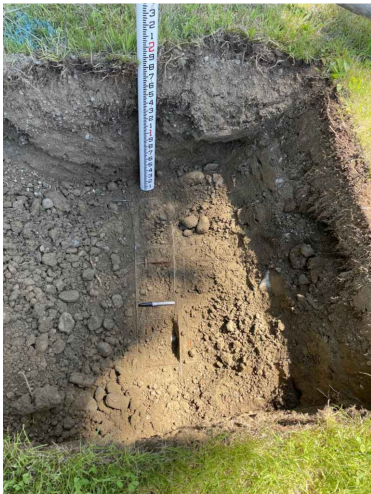
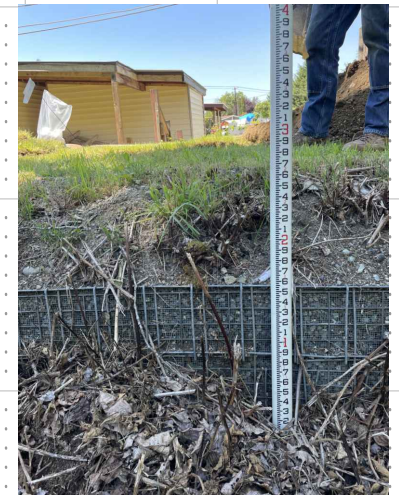
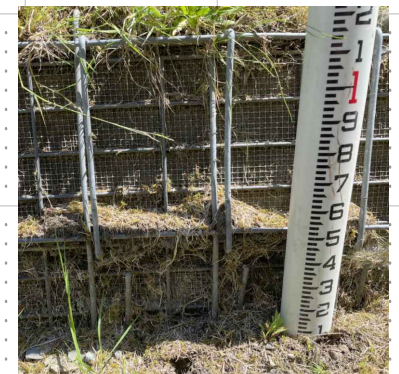
LOG OF TEST PIT TP-RR-6

SOIL DESCRIPTION	Ground Water	% Water Content	Samples	Depth, Ft.	Sketch of East Pit Side	Surface Elevation: Approx. 107 Ft.														
						Horizontal Distance in Feet														
				0	0	2	4	6	8	10	12									
① Topsoil and grass.	None Observed	12.3	<div>S-1</div>	0																
② Brown, <i>Silty Gravel with Sand and Cobbles (GM)</i> ; moist; trace subrounded cobbles; fine to coarse, subangular to rounded gravel; fine to coarse sand; low plasticity fines. - 3-inch chunk of asphalt.				Gabion Basket - Water Side																
③ Gabion basket encountered at 2 feet with overlapping grids filled with material similar to that described above, but with higher plasticity and less gravel. - Gabion baskets on water side of levee filled with coarse rounded gravel (see photo). - Gabion basket on land side of levee utilized fabric (see photo).				Gabion basket encountered at 2 feet.

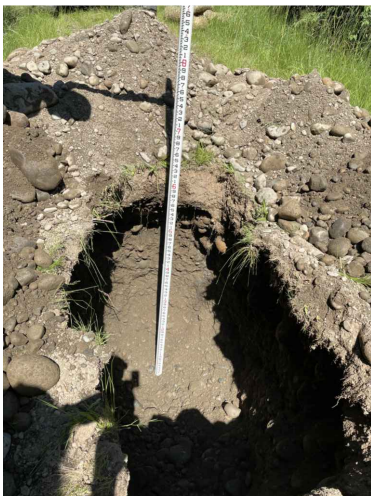
LOG OF TEST PIT TP-RR-7

SOIL DESCRIPTION	Ground Water	% Water Content	Samples	Depth, Ft.	Sketch of East Pit Side	Surface Elevation: Approx. 105 Ft.					
					Horizontal Distance in Feet						
<p>① Topsoil and grass over crushed gravel.</p> <p>② Brown, <i>Poorly Graded Gravel with Sand and Cobbles (GP)</i>; moist; subrounded cobbles; fine to coarse, subrounded to rounded gravel; fine to coarse sand; trace nonplastic fines.</p>	None Observed	4.0	S-1	0							
				2							
				4							
				6							
				8							
				10							
				12
