**DRAFT GEOTECHNICAL REPORT
Green To Cedar Rivers Trail
Maple Valley, Washington**

HWA Project No. 2021-163-21

**Prepared for
Parametrix, Inc.**

May 26, 2023

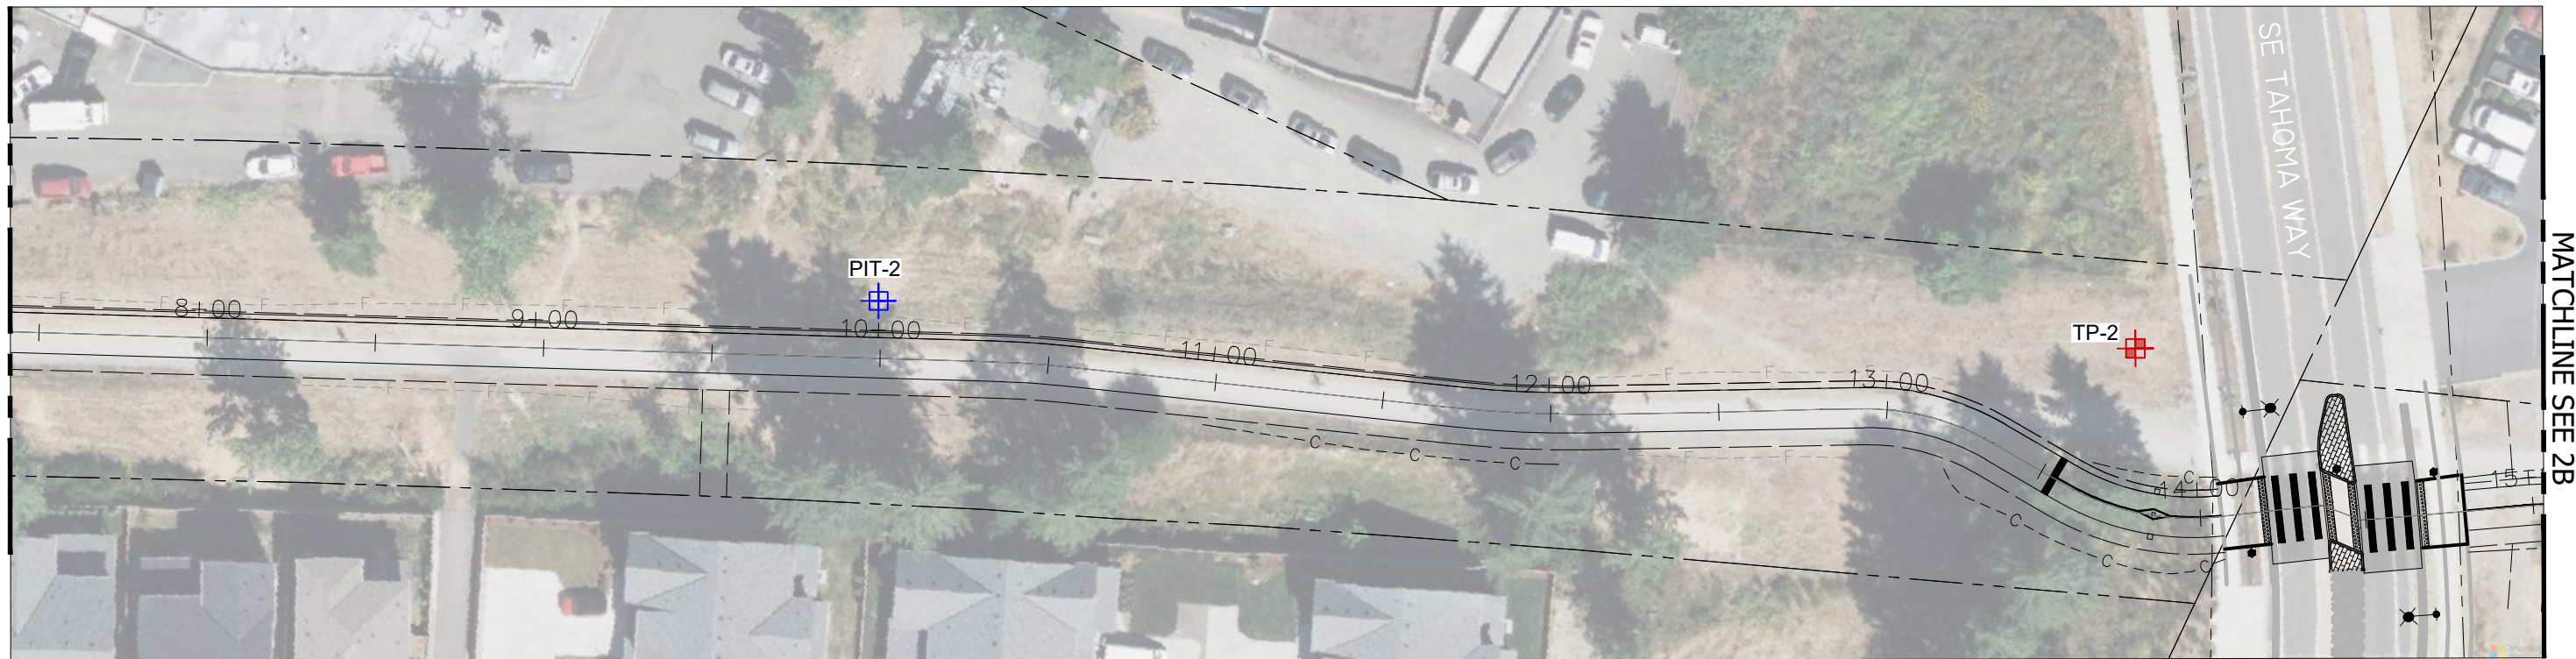
DRAWN BY: CF	FIGURE NO.: 2A
CHECK BY: MAB/JTW	PROJECT NO.: 2021-163-21

SE KENT KANGLEY RD
Scale: 1" = 50'-0"

SE 271ST PL
Scale: 1" = 50'-0"

At each test location, an approximately 19 to 24 square foot excavation was advanced to the proposed infiltration receptor depths, approximately 3 to 4.5 feet below ground surface. Water was introduced in the excavation via fire hoses into a 6-inch diameter, perforated diffuser pipe from a water truck provided by Kelly's Excavating, or directly from a fire hydrant. Using a flow meter to control the flow rate, water was added to the PITs at a rate that maintained a water depth of approximately 1 foot for the pre-soak period. Due to the high permeability of the on-site soils, in some of the tests we were unable to achieve a constant head flow rate. Each test was run until the water truck (approximately 3,000 gallons) was empty. Following the constant head test, a falling head test was performed in each pit. For the falling head test, the water was shut off and the rate at which the water infiltrated into the pit was recorded until all of the water had infiltrated. The locations of the PITs are shown on the Site and Exploration Plan, [Figures 2A through 2E](#).

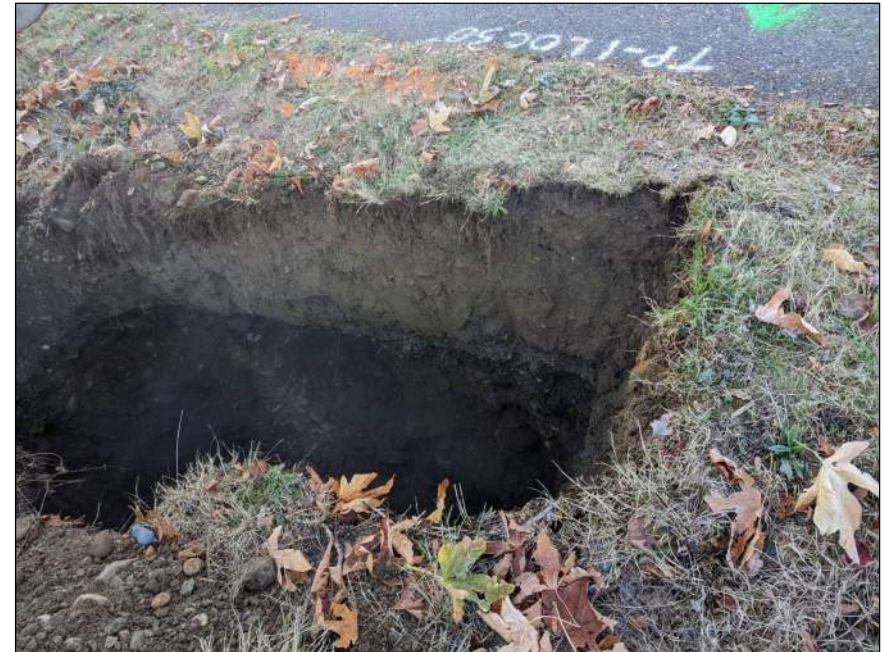
TEST PIT PHOTO

DEPTH (feet)	SYMBOL	USCS SOIL CLASS	DESCRIPTION	SAMPLE TYPE	SAMPLE NUMBER	MOISTUE CONTENT (%)	OTHER TESTS
0	GM		Loose to medium dense, dark brown, silty, sandy GRAVEL, moist. Abundant roots. (TOPSOIL)	○	S-1	3	GS
	GP		Loose to medium dense, grayish-brown, sandy GRAVEL, moist. Gravel subangular. (FILL)	○	S-2	3	GS
5			Loose to medium dense, slightly rust-mottled dark grayish-brown, sandy GRAVEL, moist. Scattered cobbles, boulders. (RECESSIONAL OUTWASH)				
	GW	GM	East and west side walls caving in towards existing path and adjacent sewer trench. Soil becomes dark grayish-brown.				
10				○	S-3		
15			TP-1 terminated at about 12 feet below ground surface due to refusal as walls caved in. No groundwater encountered during the exploration. Test pit abandoned with native cuttings.				
20

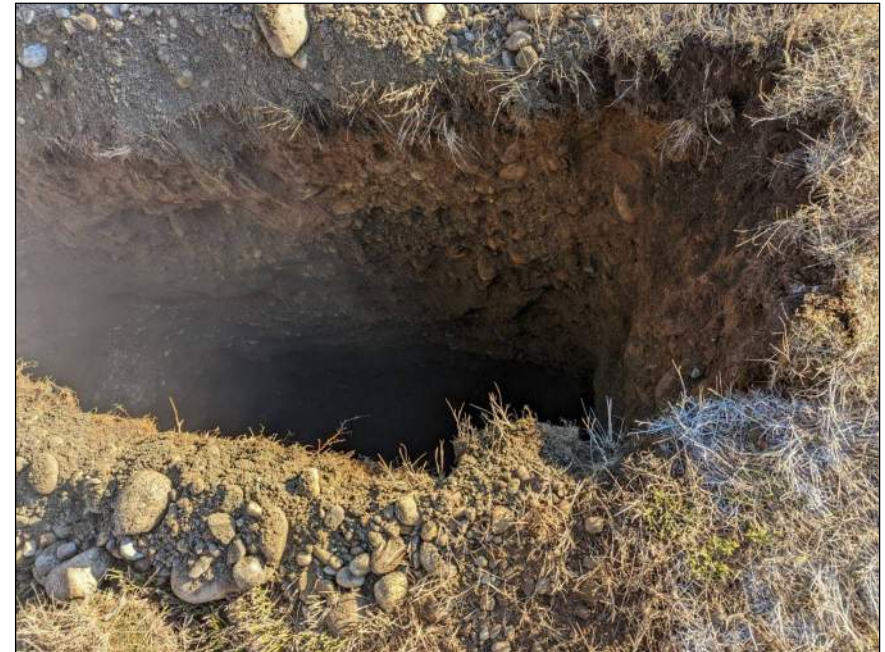
TEST PIT PHOTO

DEPTH (feet)	SYMBOL	USCS SOIL CLASS	DESCRIPTION	SAMPLE TYPE	SAMPLE NUMBER	MOISTUE CONTENT (%)	OTHER TESTS
0	GM		Loose to medium dense, dark brown, silty, sandy GRAVEL, moist. Abundant roots. (TOPSOIL)				
	GM		Loose to medium dense, dark brown, silty, sandy GRAVEL, moist. Scattered to adundant roots. (FILL)				
5			Loose to medium dense, dark olive brown, very sandy GRAVEL, moist. Scattered cobbles. (RECESSIONAL OUTWASH) Minor side wall caving.				
10	GP						
15	GW		Gravel becomes coarser with depth, sand fraction decreases. Loose to medium dense, dark olive brown, very sandy GRAVEL, moist. Scattered cobbles.	S-2	2	GS	
20			TP-2 terminated at about 14.5 feet below ground surface (bgs). No groundwater encountered during the exploration. 1.25 inch PVC well installed to 9.5 feet bgs. Test pit abandoned with native cuttings.

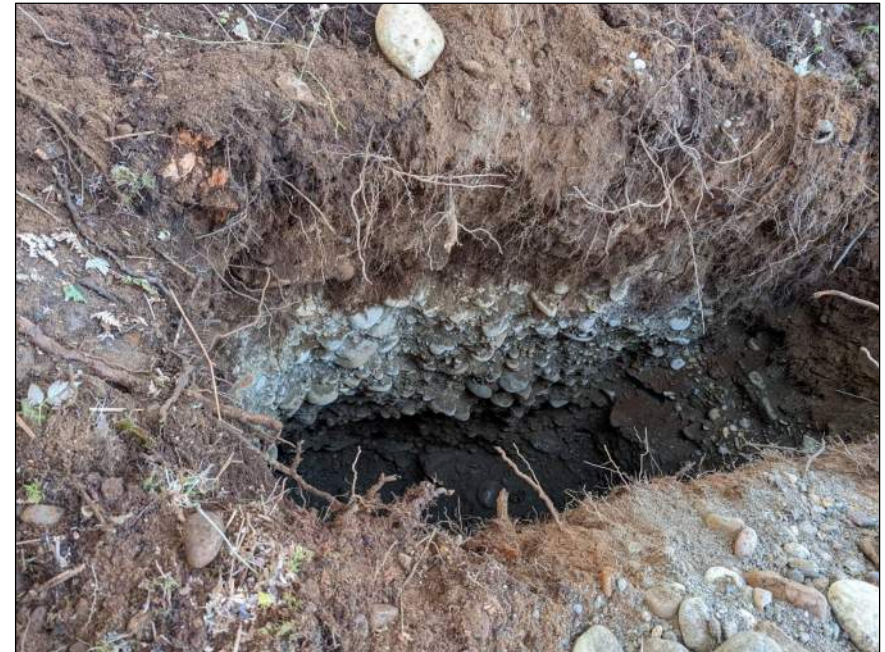
TEST PIT PHOTO

DEPTH (feet)	SYMBOL	USCS SOIL CLASS	DESCRIPTION	SAMPLE TYPE	SAMPLE NUMBER	MOISTUE CONTENT (%)	OTHER TESTS
0		SM	Loose to medium dense, dark brown, silty, very gravelly SAND, moist. Abundant roots. (TOPSOIL)				
		SM	Loose to medium dense, dark brown, silty, very gravelly SAND, moist. Scattered to abundant roots. (FILL)				
5		GW	Loose to medium dense, grayish-brown, sandy GRAVEL, moist. Abundant cobbles, boulders. (RECESSIONAL OUTWASH)	○ S-1	1	GS	
10		GP	Loose to medium dense, dark grayish-brown, sandy GRAVEL, moist. Abundant cobbles, boulders. (RECESSIONAL OUTWASH)	○ S-2	3	GS	
15			TP-4 terminated at about 14 feet below ground surface. No groundwater encountered during the exploration. Test pit abandoned with native cuttings.	○ S-3			
20

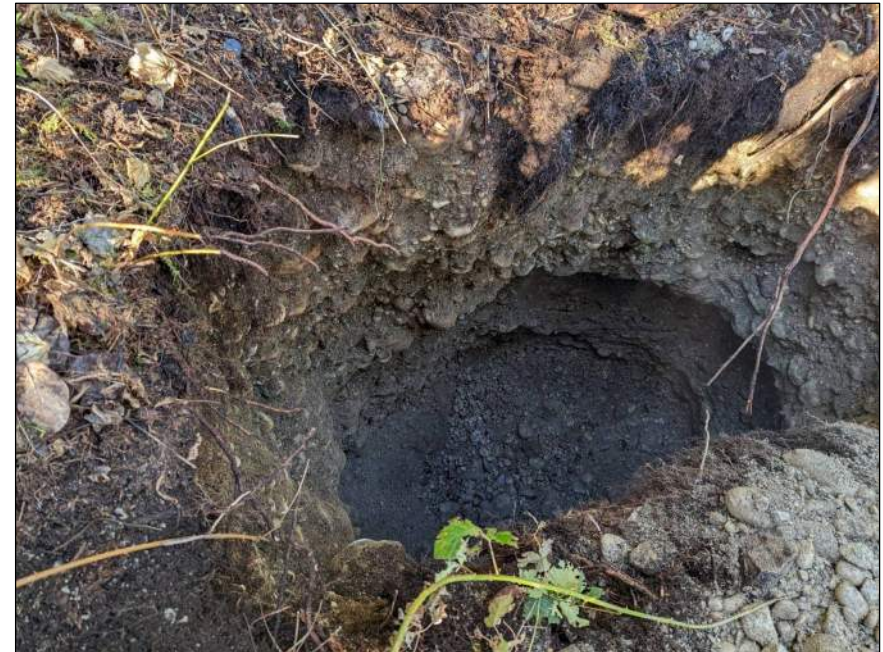
TEST PIT PHOTO

DEPTH (feet)	SYMBOL	USCS SOIL CLASS	DESCRIPTION	SAMPLE TYPE	SAMPLE NUMBER	MOISTUE CONTENT (%)	OTHER TESTS
0		SM	Loose to medium dense, dark brown, gravelly, silty SAND, moist. Abundant roots. (FILL)	○	S-1	4	GS
			Loose to medium dense, reddish-brown, sandy GRAVEL, moist. Scattered cobbles, boulders. (RECESSIONAL OUTWASH)				
5		GP	Loose to medium dense, dark brown, silty, sandy GRAVEL, moist. Scattered cobbles, boulders.				
10		GW	Loose to medium dense, dark grayish-brown, sandy GRAVEL, moist. Scattered cobbles.	○	S-2	3	GS
15			TP-12 terminated at about 14 feet below ground surface (bgs). No groundwater encountered during the exploration. 1.25 inch PVC well installed to 9 feet bgs. Test pit abandoned with native cuttings.				
20

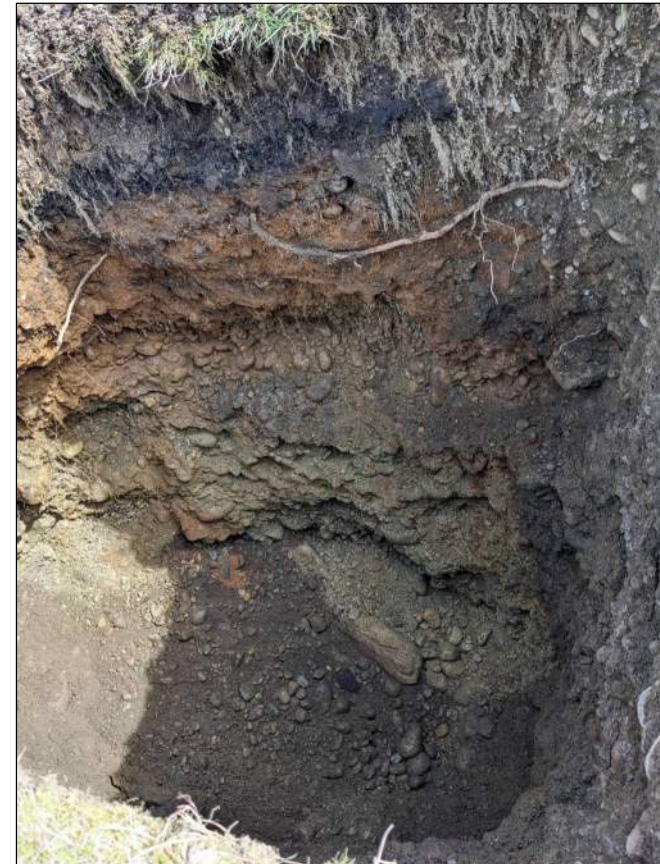
TEST PIT PHOTO

DEPTH (feet)	SYMBOL	USCS SOIL CLASS	DESCRIPTION	SAMPLE TYPE	SAMPLE NUMBER	MOISTUE CONTENT (%)	OTHER TESTS
0		GM	Loose to medium dense, dark brown, silty, sandy GRAVEL, moist. Abundant roots. (TOPSOIL)				
		GM	Loose to medium dense, reddish-brown, silty, sandy GRAVEL, moist. Scattered cobbles and black charcoal. (FILL)	■	S-1	14	GS
5		GW	Loose to medium dense, gray, sandy GRAVEL, moist. Scattered cobbles and sparse boulders. (RECESSIONAL OUTWASH)	■	S-2		
10			TP-16 terminated at about 9.1 feet below ground surface due to refusal as walls caved in. No groundwater encountered during the exploration. Test pit abandoned with native cuttings.				
15							
20

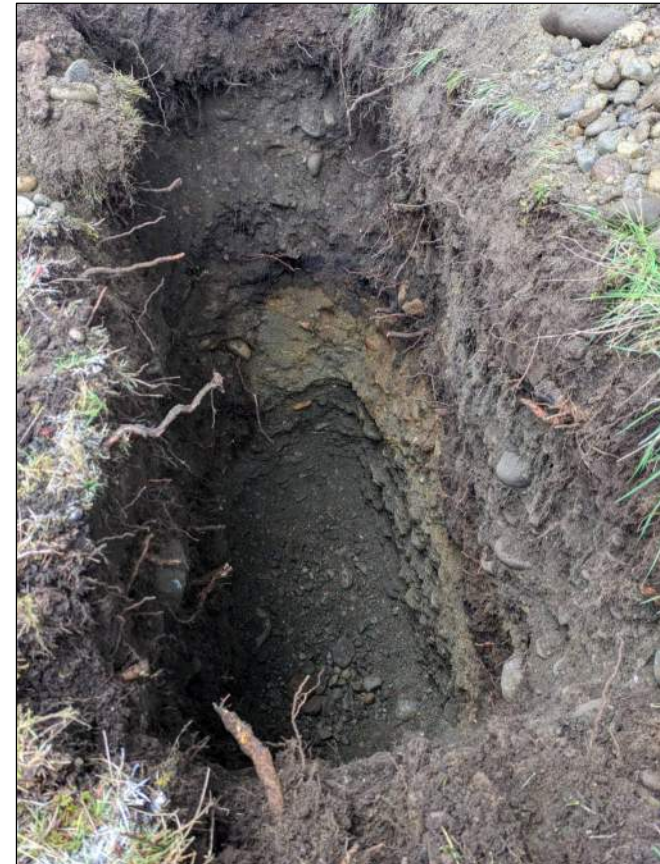
TEST PIT PHOTO

DEPTH (feet)	SYMBOL	USCS SOIL CLASS	DESCRIPTION	SAMPLE TYPE	SAMPLE NUMBER	MOISTUE CONTENT (%)	OTHER TESTS
0		SM	Loose to medium dense, dark brown, silty. gravelly SAND, moist. Scattered cobbles. (TOPSOIL)				
		SM	Loose to medium dense, gray, silty, very gravelly SAND, moist. Minor roots. (FILL)				
		GM	Loose to medium dense, dark brown, silty. sandy GRAVEL, moist. Scattered cobbles.				
5			Loose to medium dense, gray, sandy GRAVEL, moist. Scattered cobbles. (RECESSIONAL OUTWASH)	■	S-1	3	GS
		GP					
10				■	S-2		
15			TP-17 terminated at about 10 feet below ground surface due to refusal as walls caved in. No groundwater encountered during the exploration. Test pit abandoned with native cuttings.				
20

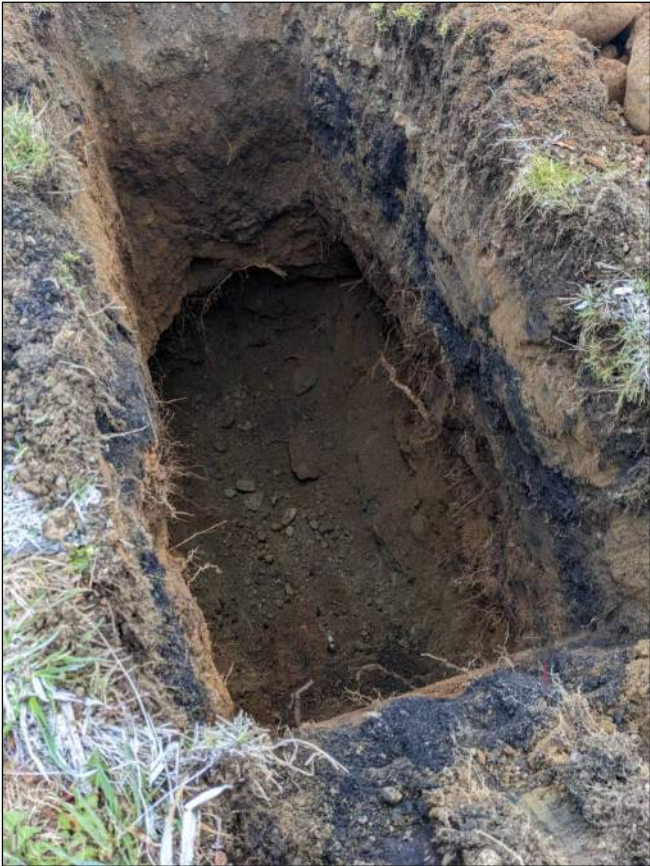
TEST PIT PHOTO

DEPTH (feet)	SYMBOL	USCS SOIL CLASS	DESCRIPTION	SAMPLE TYPE	SAMPLE NUMBER	MOISTUE CONTENT (%)	OTHER TESTS
0		GM	Loose to medium dense, dark brown, silty, sandy GRAVEL, moist. Abundant roots. (TOPSOIL)				
		SW SM	Loose to medium dense, reddish-brown, slightly silty, gravelly SAND, moist. Scattered cobbles and roots. (WEATHERED RECESSONAL OUTWASH)		S-1		
			Loose to medium dense, grayish-brown, sandy GRAVEL, moist. Scattered cobbles. (RECESSONAL OUTWASH)		S-2	5	GS Infiltration test - 3.5' bgs
5		GP					
					S-3		
10							
15

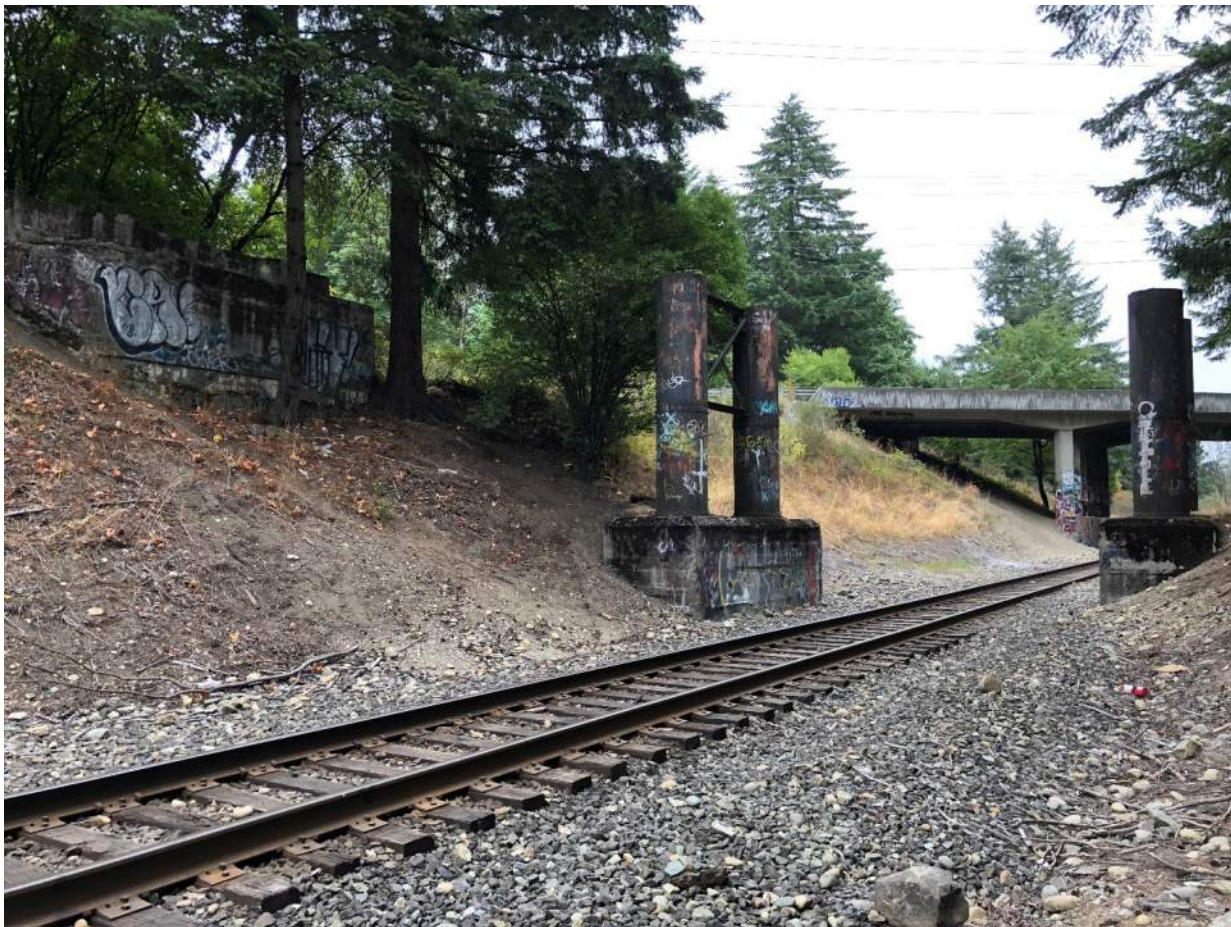
Photo 1: Active east-west BNSF rail line extending through the cut. Existing north-south railway bridge footings and abutment visible in background. View facing east toward the Highway 169 bridge.

At the location of the proposed pedestrian bridge, we observed that the east-west BNSF rail line lies within an approximately 20-foot-deep cut, shown in Photo 1. Bridge footings and abutments for the abandoned north-south BNSF rail line are still present at the site, but we understand that no existing bridge structures will be used in the construction of the proposed pedestrian bridge. We observed gravel and cobbles on the surface near the east-west tracks; the slopes on either side or the east-west rail line primarily consisted of brown sand with silt and gravel.
