January 19, 2022

RE: CRITICAL AREA REVIEW AND WETLAND INVESTIGATION, LITTLE LAKE FOREST
PARK TRAILHEAD FACILITY, KING COUNTY, WASHINGTON

- Enc. References (2 pages)
 Figure 1 – Vicinity Map
 Figure 2 – Site Review Map
 Appendix A – Wetland Delineation Methodology
 Appendix B – Wetland Determination Data Forms
 Appendix C – Site Photographs
 Important Information About Your Wetland Delineation/Mitigation and/or Stream
 Classification Report

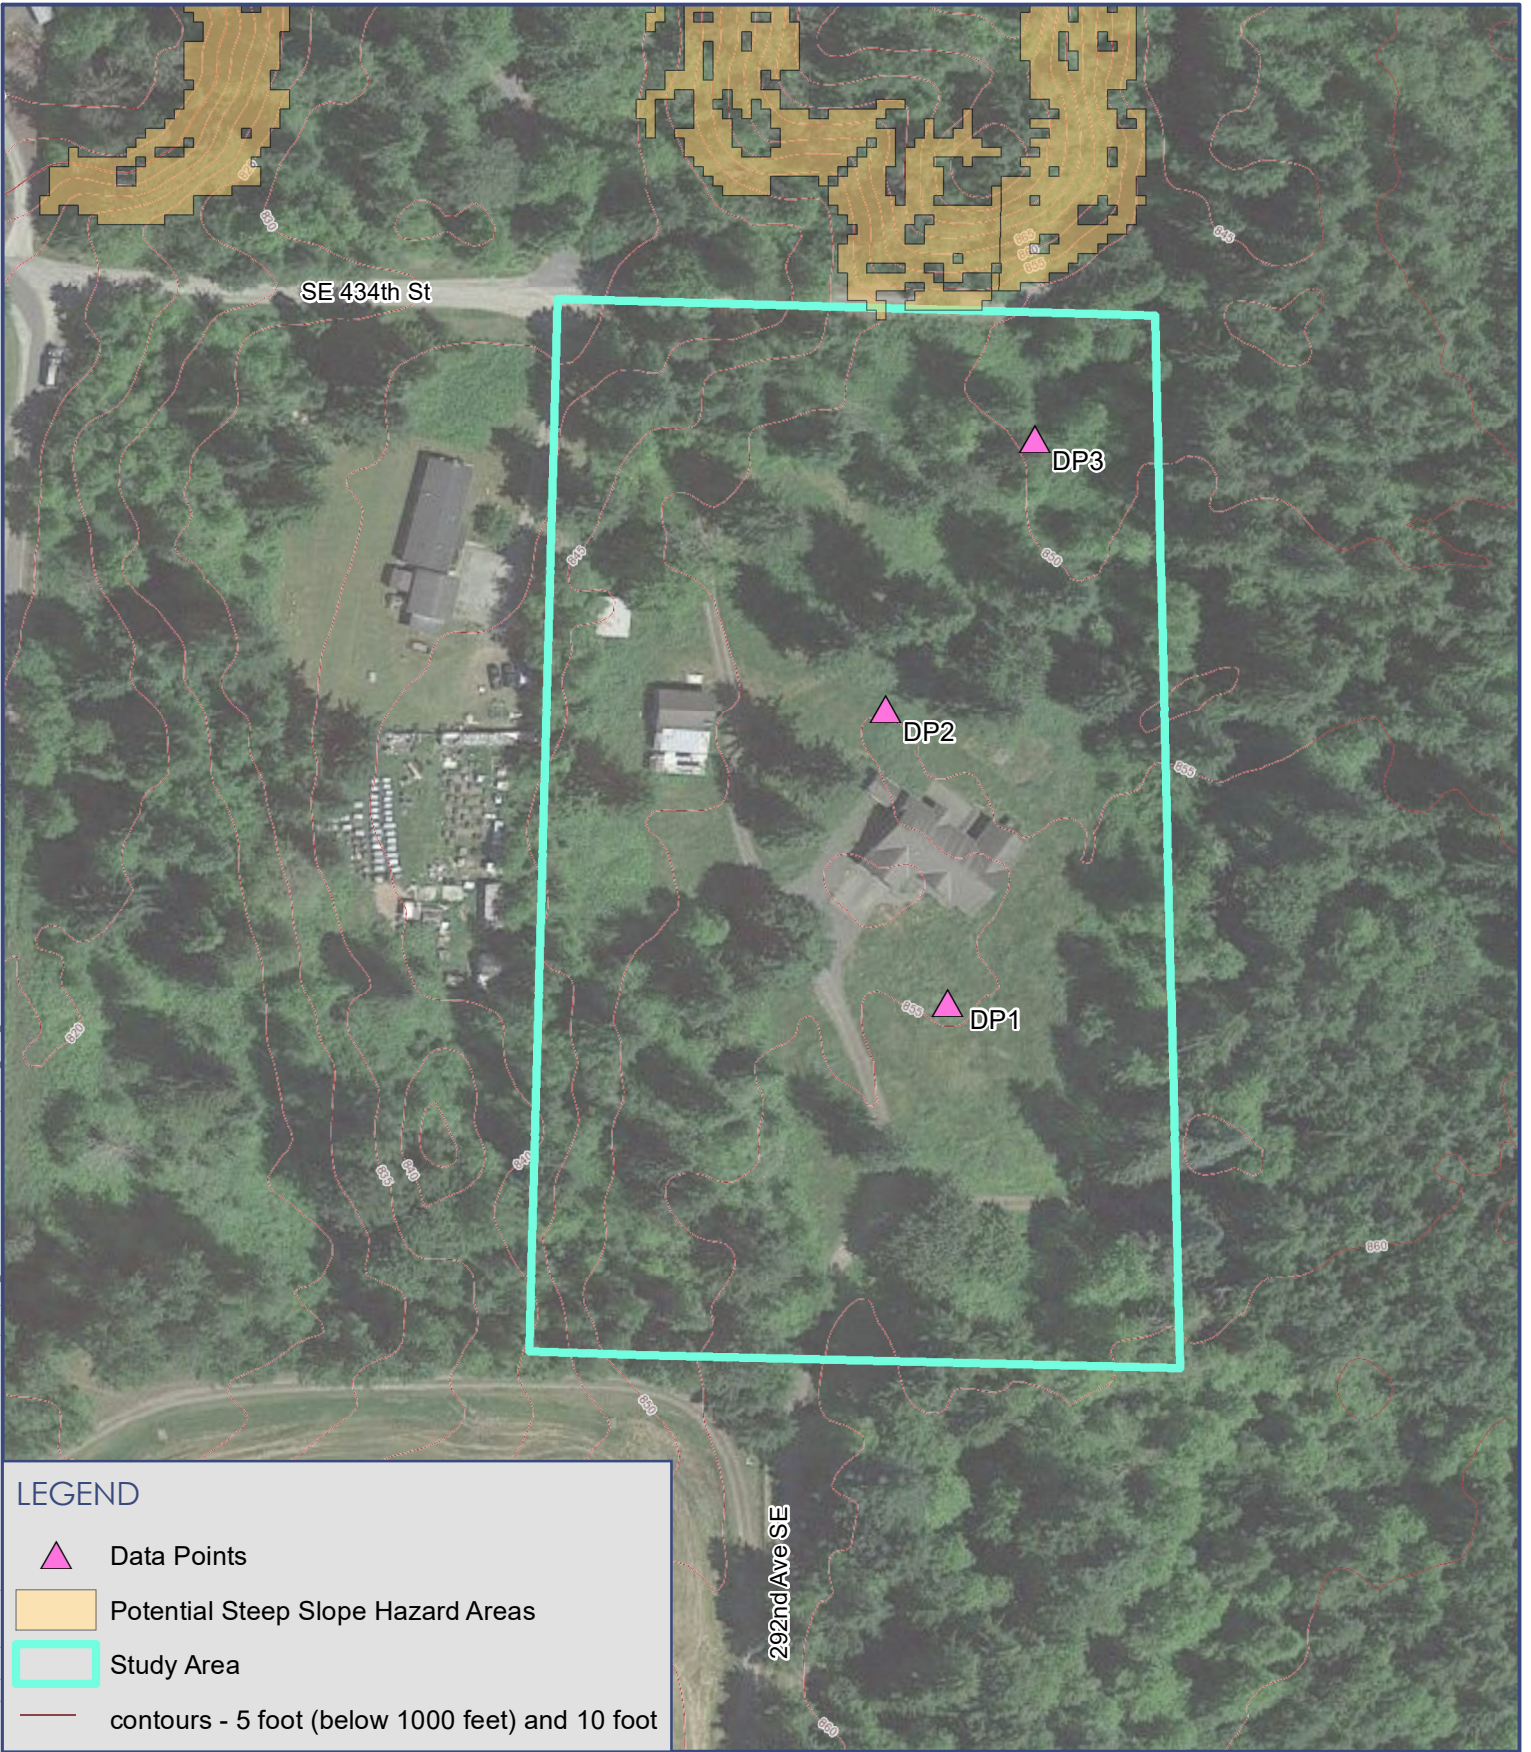
King County iMap does not display any streams, waterbodies, wetlands, wildlife habitat areas, or flood-prone areas within the Study Area. Potential steep slope hazard areas are displayed just north and northwest of the property boundary, as represented in Figure 2.

- Data Points
- Potential Steep Slope Hazard Areas
- Study Area
- contours - 5 foot (below 1000 feet) and 10 foot

- Notes:
1. Potential steep slopes hazard areas downloaded from King County GIS.
 2. Data points were collected using a hand-held GPS device with accuracy of approximately 5 feet.

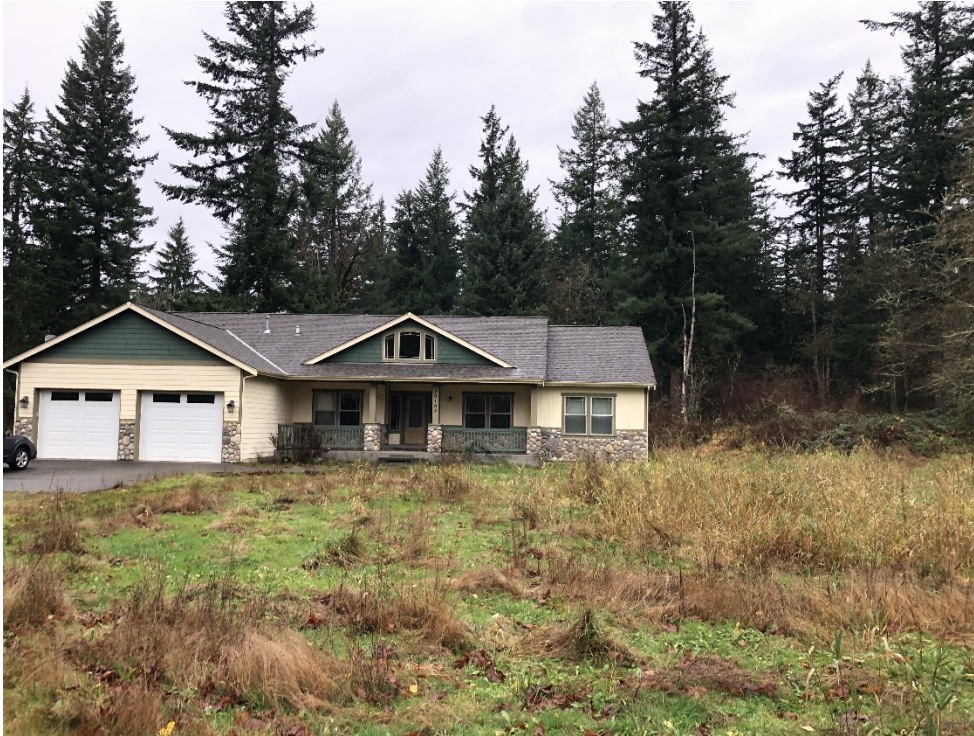
A data point was collected south of the existing SFR within an overgrown lawn (DP1). Vegetation in this area included common pasture grasses, reed canarygrass (*Phalaris*

Exhibit C-1: Southern portion of Property and General Location of DP1, Facing North (11/30/2021)

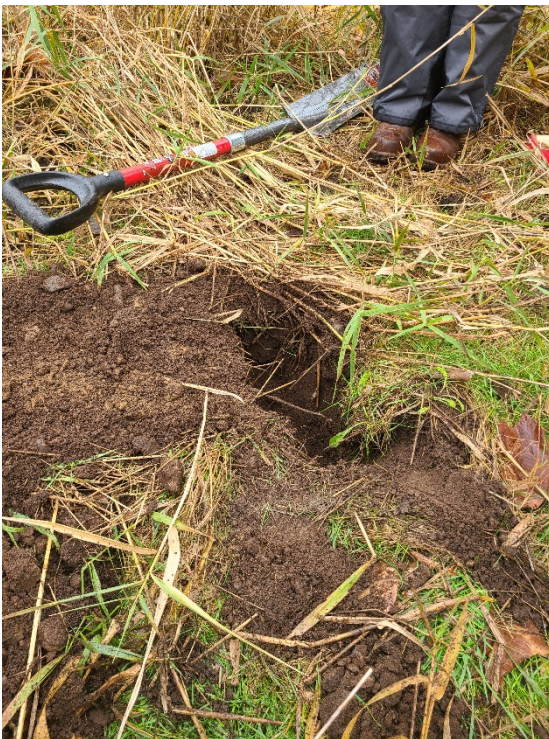
arundinacea), and dandelion (*Taraxacum officinale*). The soil profile ranged from moist to dry to a depth of more than 16 inches. From 0 to 16 inches, soils were very dark brown (10YR 2/2) loam mixed with large cobbles. Below 16 inches, a mixed matrix of brown (10YR 4/3) and very dark grayish-brown (10YR 3/2), gravelly loam was present. No hydric soil or wetland hydrology indicators were present.

Exhibit C-2: Soil Pit Associated with DP1 (12/10/2021)

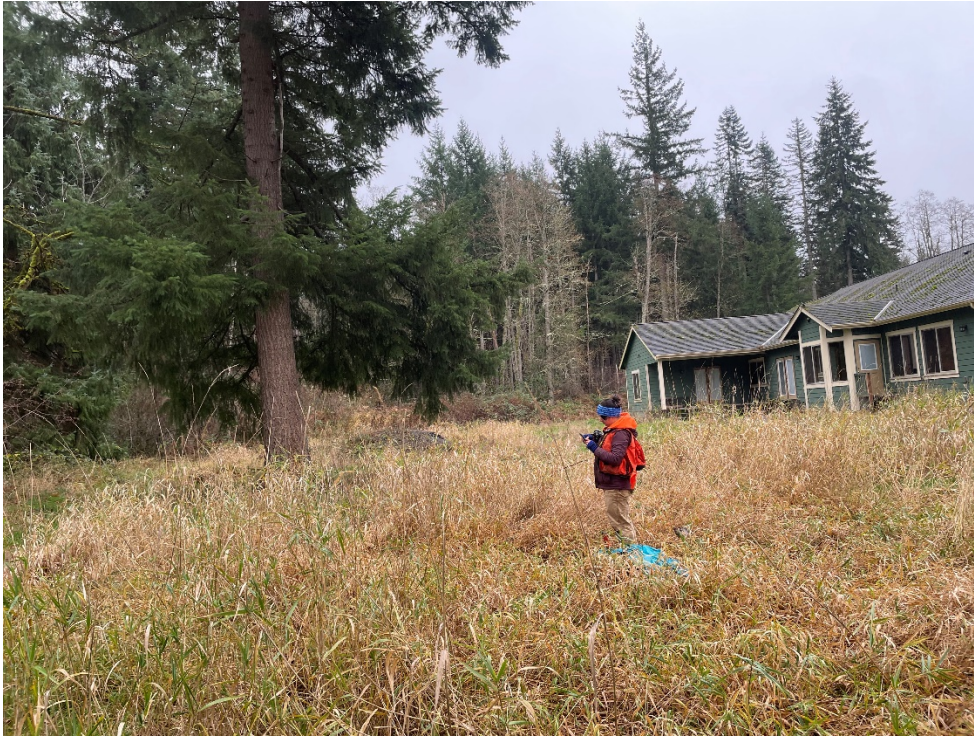
The second data point (DP2) was collected north of the SFR within an unmaintained and disturbed lawn area. Vegetation was composed of reed canarygrass, and mosses were also present on the soil surface. The soil profile was dry to a depth of more than 14 inches, and it appeared disturbed. A large amount of gravel and cobble fill material appeared mixed into the surface and subsurface layers. From 0 to 10 inches, soils were very dark brown (10YR 2/2) loam mixed with large cobbles and gravel. From 10 to 14 inches, soils were very dark grayish-brown (10YR 3/2), gravelly clay loam with 5% depletions (10YR 5/2) within the matrix. Below 14 inches, soils were very dark brown (7.5YR 2.5/2), gravelly loam. No hydric soil or wetland hydrology indicators were present.

Exhibit C-3: Facing East from DP2 (12/10/2021)

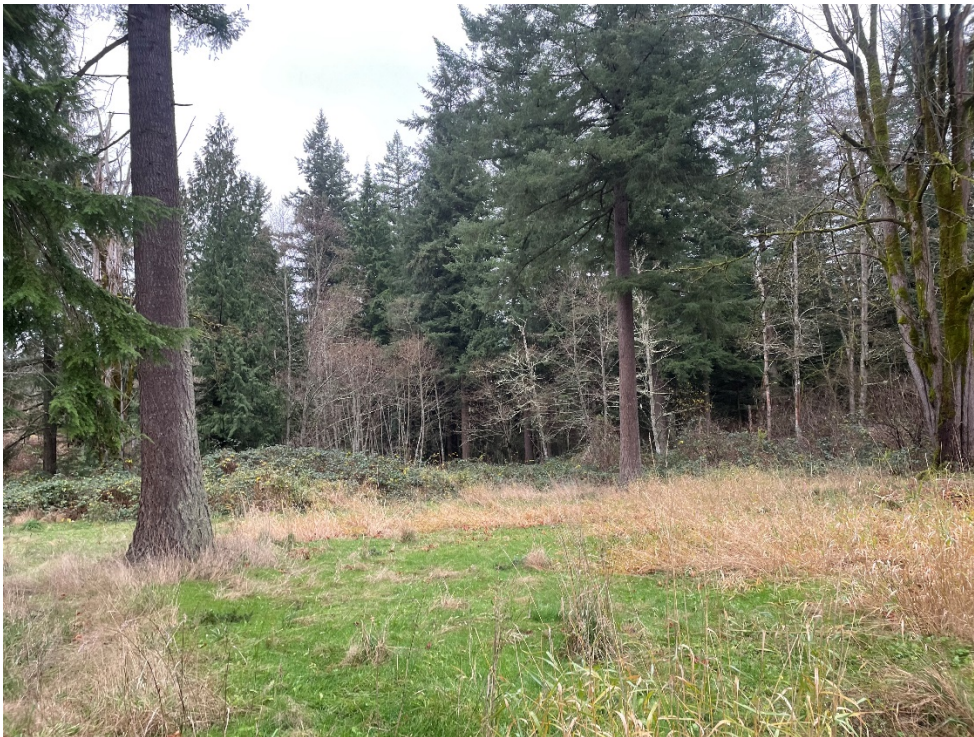
Exhibit C-4: Northern Portion of Property, Facing North from DP2 (12/10/2021)

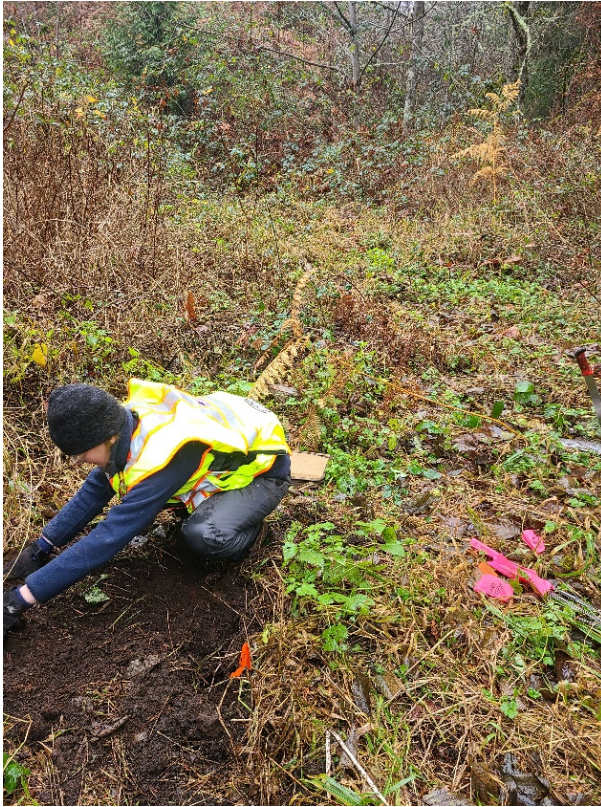
A third data point (DP3) was collected in the northeast corner of the property within a depression. Vegetation in this area was composed of red alder (*Alnus rubra*), western red cedar (*Thuja plicata*), salmonberry (*Rubus spectabilis*), stinging nettle (*Urtica dioica*), reed canarygrass, and stickywilly (*Galium aparine*). Soils were dry to a depth of below 13 inches. From 0 to 8 inches, soils were black (7.5YR 2.5/1), sandy clay loam with large pieces of wood. A charcoal layer was present between 8 and 9 inches. From 9 to 13 inches, soils were black (7.5YR 2.5/1) clay loam with dark brown (7.5YR 3/4) redoximorphic concentrations within the matrix. Below 13 inches, soils were black (7.5YR 2.5/1) clay loam with very dark brown (7.5YR 2.5/3) redoximorphic concentrations. No hydric soil or wetland hydrology indicators were present.

Exhibit C-5: Facing North at DP3 (12/10/2021)

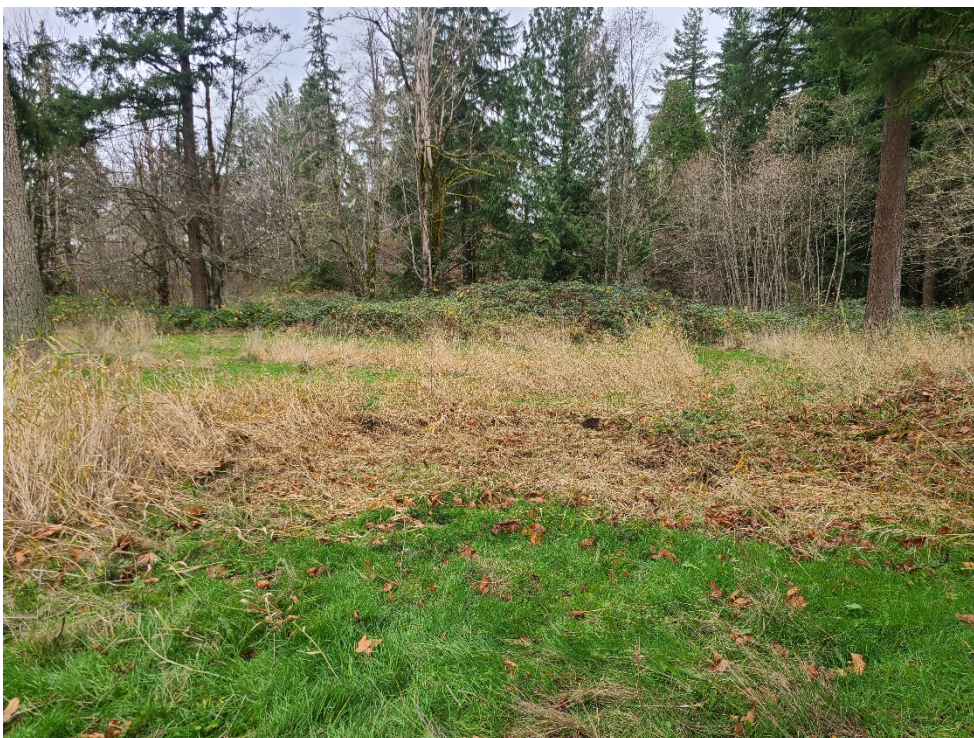
Exhibit C-6: Northern Portion of Property, Facing North (12/10/2021)
