PILOT PROJECT REPORT

APPENDICES

Regional Infiltration and Inflow Control Program King County, Washington

Prepared for King County by
Earth Tech Team, Seattle, WA

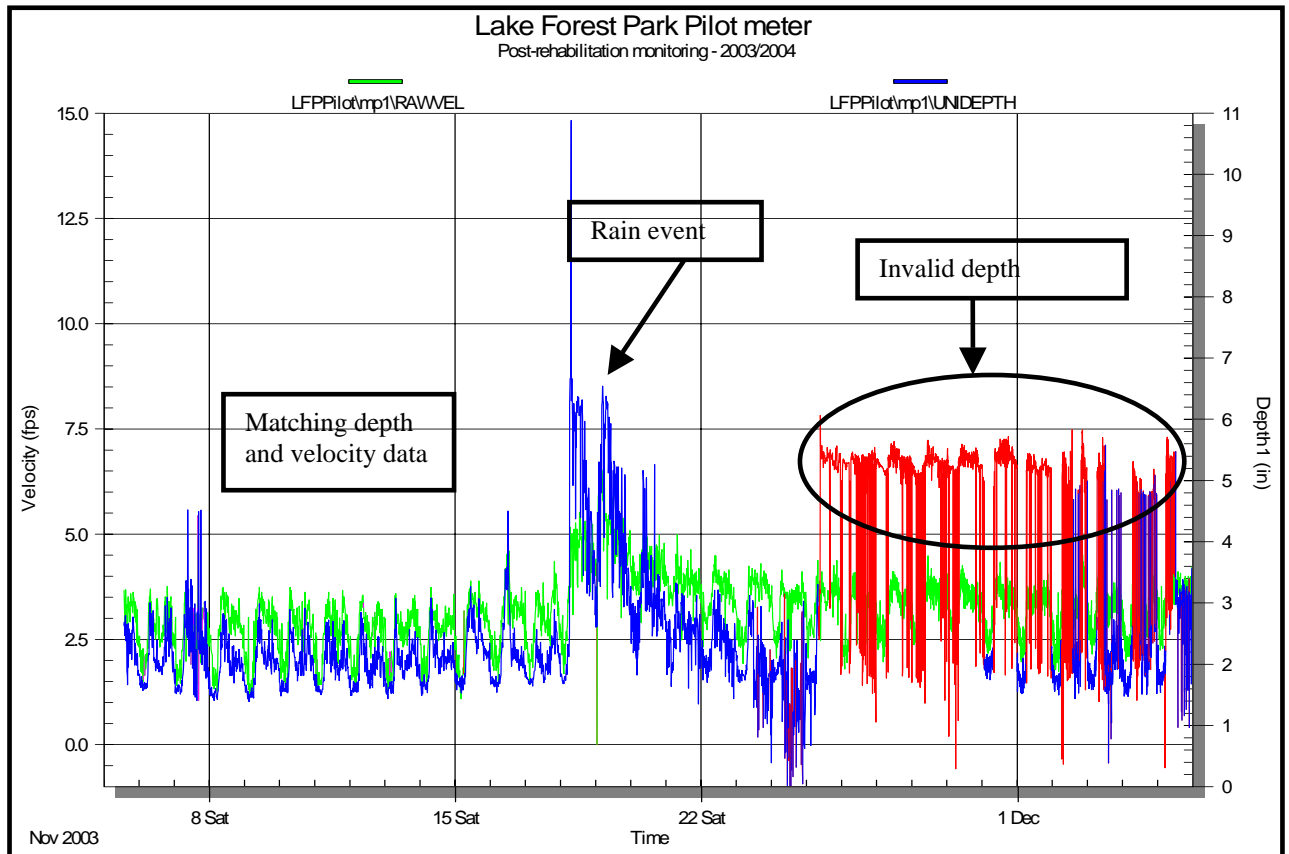
Figure 4.1- Hydrograph of Invalid Depth Data Due to Sensor Fouling

Figure 4.1 illustrates how invalid depth was identified and flagged on a hydrograph. Depth and velocity showed repeated diurnal patterns with velocity increasing with an increase in depth. Around 11/25/03, depth values spiked without any significant and matching increase in velocity. There were no rain events on 11/26 and 11/27, but the depth of flow spiked to depths of flow close to that observed during the significant rain events on 11/18 and 11/19/03. Although there was a rain event on 11/28, the effect was masked by the invalid depth data before and after this rain event. The invalid data were flagged and were not used for flow quantity calculation.

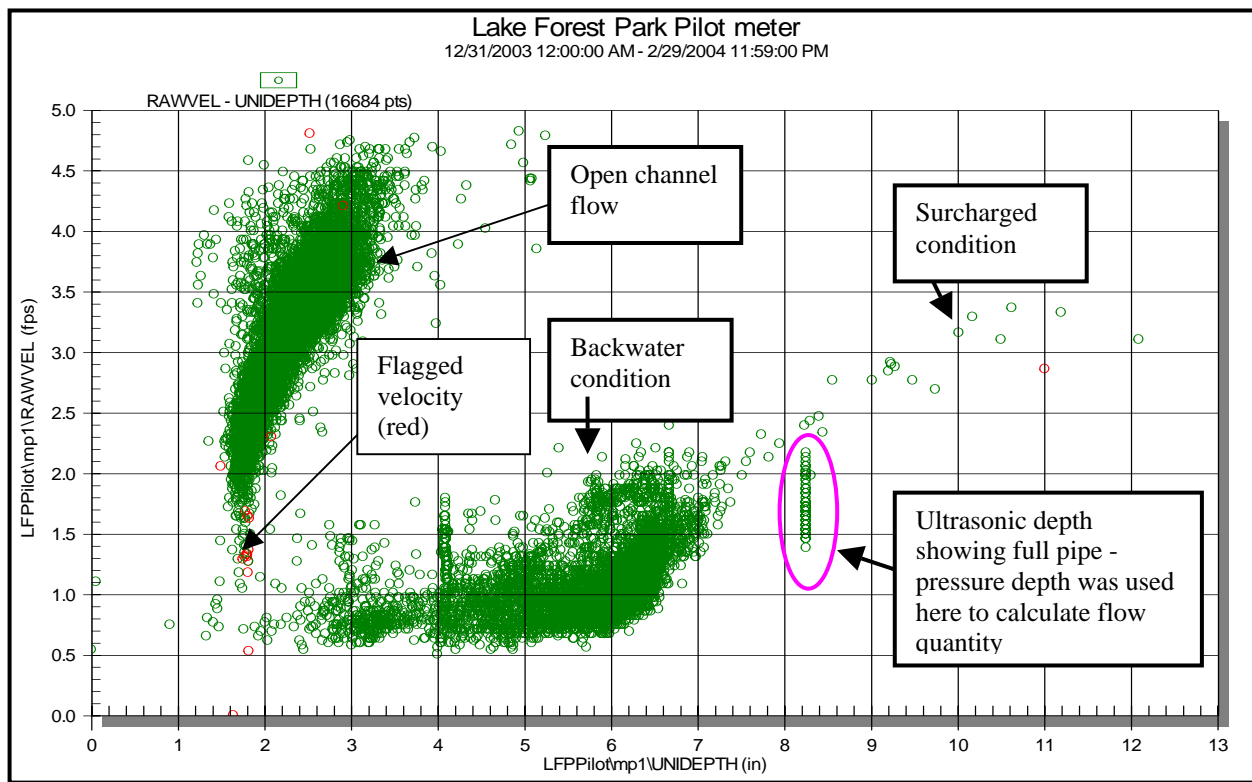
Figure 4.2 - Scattergraph of Invalid Velocity Showing Open Channel Flow and Backwater and Surcharged Conditions

Figure 4.2 is a scattergraph showing invalid and flagged velocity data. In this graph there are some depth data that show ultrasonic depth values at full or near full pipe heights. During such periods where the ultrasonic depth sensor indicated surcharge conditions, depth data from the pressure sensor was used to calculate flow quantity. Figure 4.3 is a scattergraph plot with velocity on the x-axis and depth on the y-axis, showing the flagged depth data illustrated in Figure 4.1. Field verification data are also plotted on this scattergraph.

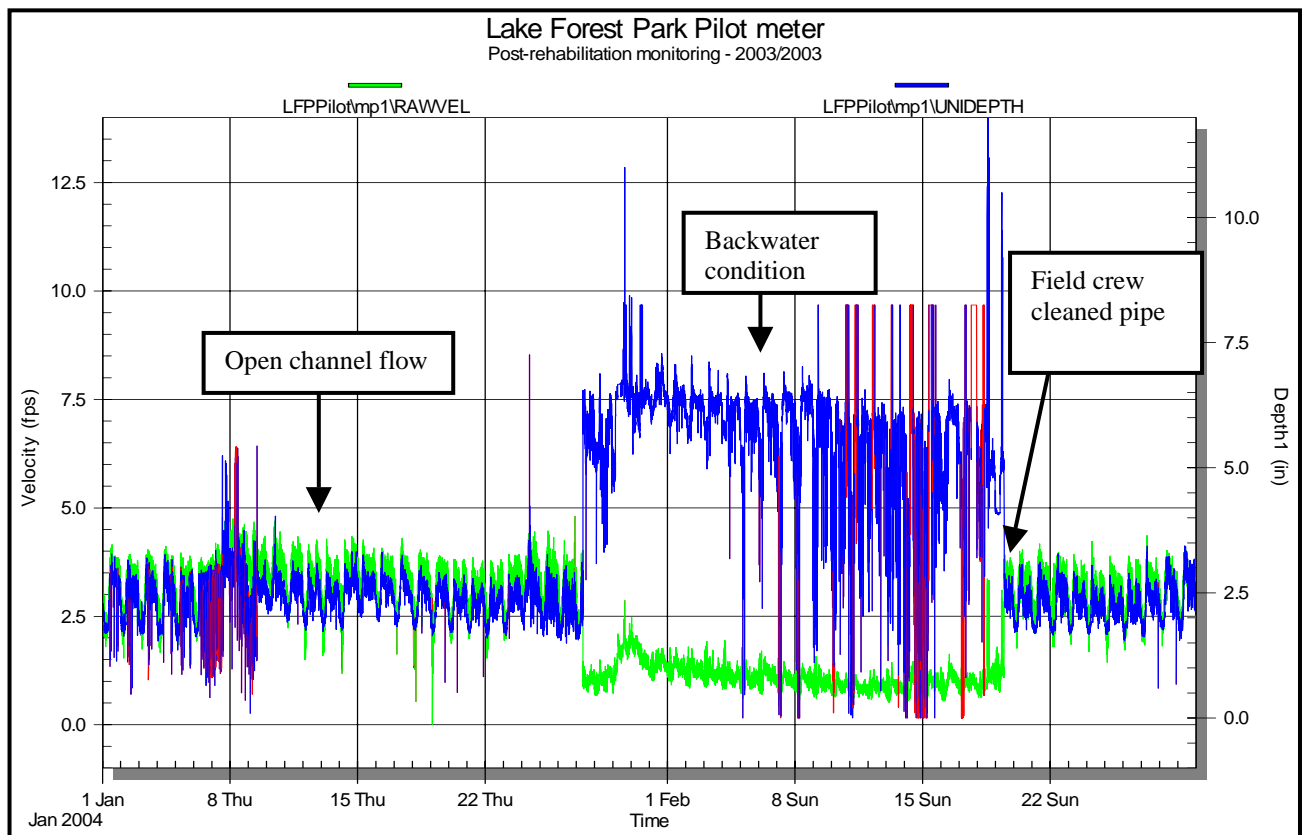
Figure 4.8 - Hydrograph Illustrating Backwater Conditions due to Temporary Debris Blockage and Invalid Depth Data (In Red)

When the raw flow data from the Lake Forest Park Pilot Project site were reviewed, it was noted that the flow changed significantly around 1/27/04. Prior to 1/27/04, depth and velocity patterns showed a regular and repeatable pattern where increase or decrease in depth was accompanied by increase or decrease in velocity. Depth values ranged from 1.5 to 2 inches and velocity varied from about 2 to 4 ft/sec during the dry day periods. After 1/27/04, the site became deeper (4 to 7.5 inches) and slower (velocity less than 2 ft/sec). Depth and velocity varied inversely. The field crew performed a manhole investigation on 2/19/04 and found that there was a huge accumulation of trash and rags blocking the flow in the downstream side of the pipe. This temporary blockage backed up the flow, increasing the depth and decreasing the velocity. Field verification was performed during the high flow condition, then the crew removed the blocking debris. Flow returned to normal open channel flow. Figures 4.8 and 4.9 illustrate how changes in hydraulic conditions were identified using a combination of hydrograph and scattergraph plots.

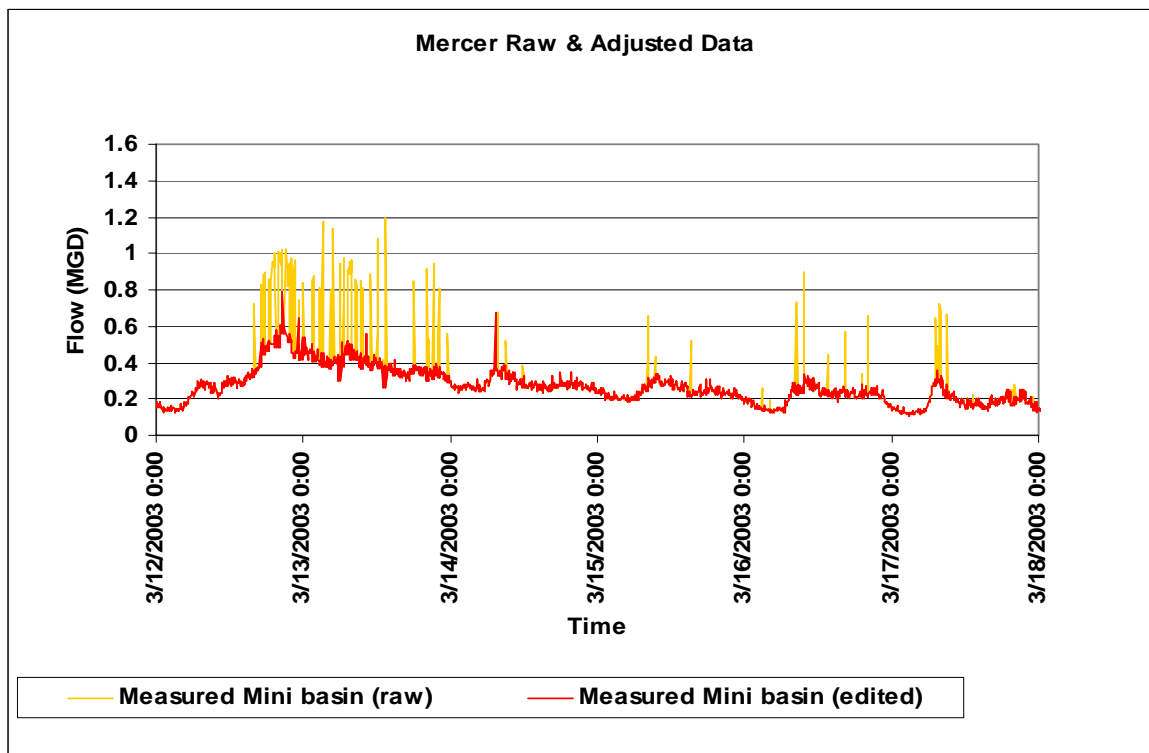
Figure 4.10 - An Example of Data Scrubbing

A scrubbing routine was established based on the results of the flow test conducted on 3/19/03 and the peak-to-minimum-value ratios in a 50- to 60-minute span during rain events when the system surcharged. This routine established an empirical limit of 150 percent to make the peak flow data consistent with what was observed/measured during the calculation window. If the measured peak was greater than the minimum value (in the 1-hour span) by more than 150 percent, it was rejected and substituted with the minimum value. Otherwise, the recorded value was kept as valid data. Figure 4.10 illustrates the results of this procedure. This approach was used to edit spikes of shorter duration (less than 1 hour) during the 2002/2003 and 2003/2004 flow monitoring periods.

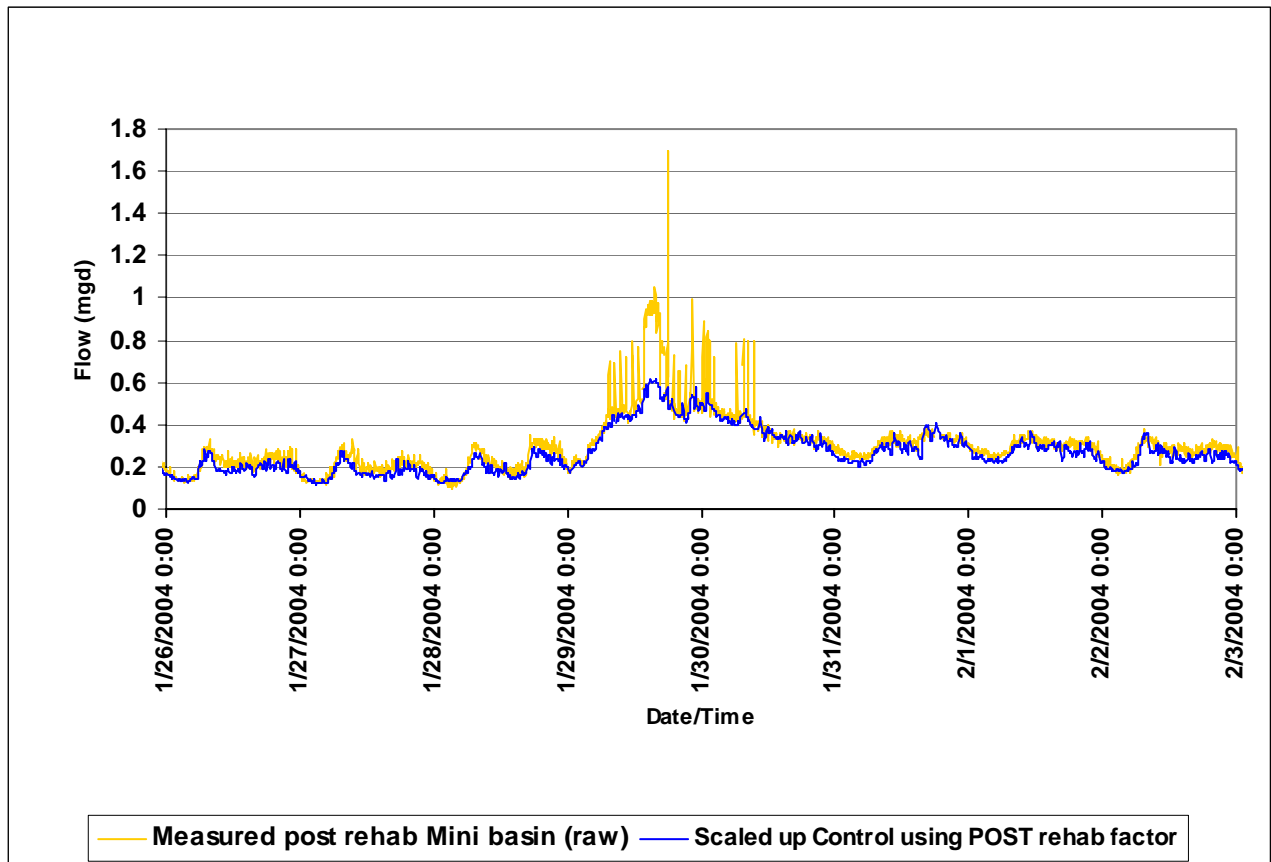
Figure 4.11 - Mercer Mini-Basin Data Scaled Up Using the Post-Rehabilitation Control Site Data and Post-Rehabilitation Scaling Factor

Due to rehabilitation work done in the Mercer mini-basin during the 2003/2004 post-rehabilitation monitoring period, the scaling factor was recalculated (3.069) using post-rehabilitation flow data. The scaled-up control site data were used to replace mini-basin peak flow data only during rain events when the pipe was in a surcharged condition and the peaks were of longer duration (more than 1 hour). For smaller duration peaks, the scrubbing approach was used. Figure 4.11 shows a comparison of the raw mini-basin data and the mini-basin flow data generated by using the scaling approach.

The scaling factor approach was used to estimate the peak flows (during surcharged conditions) at the Mercer Island mini-basin meter (MRC012 2001/2002) using measured flow from the Mercer Island control basin. The flow from the control basin made up about 26 percent of the total flow measured at the mini-basin (for the 3/5 to 4/11/03 time period used to generate the scaling factor). Using this relationship, the measured control basin flow was scaled up to simulate the mini-basin flow and was then compared with the measured mini-basin flow. The measured mini-basin flow was edited to remove erroneous/invalid data prior to comparison. An average scaling factor of 4.28 was calculated using this approach. This scaling factor was a better fit for wet weather than dry weather flow data.

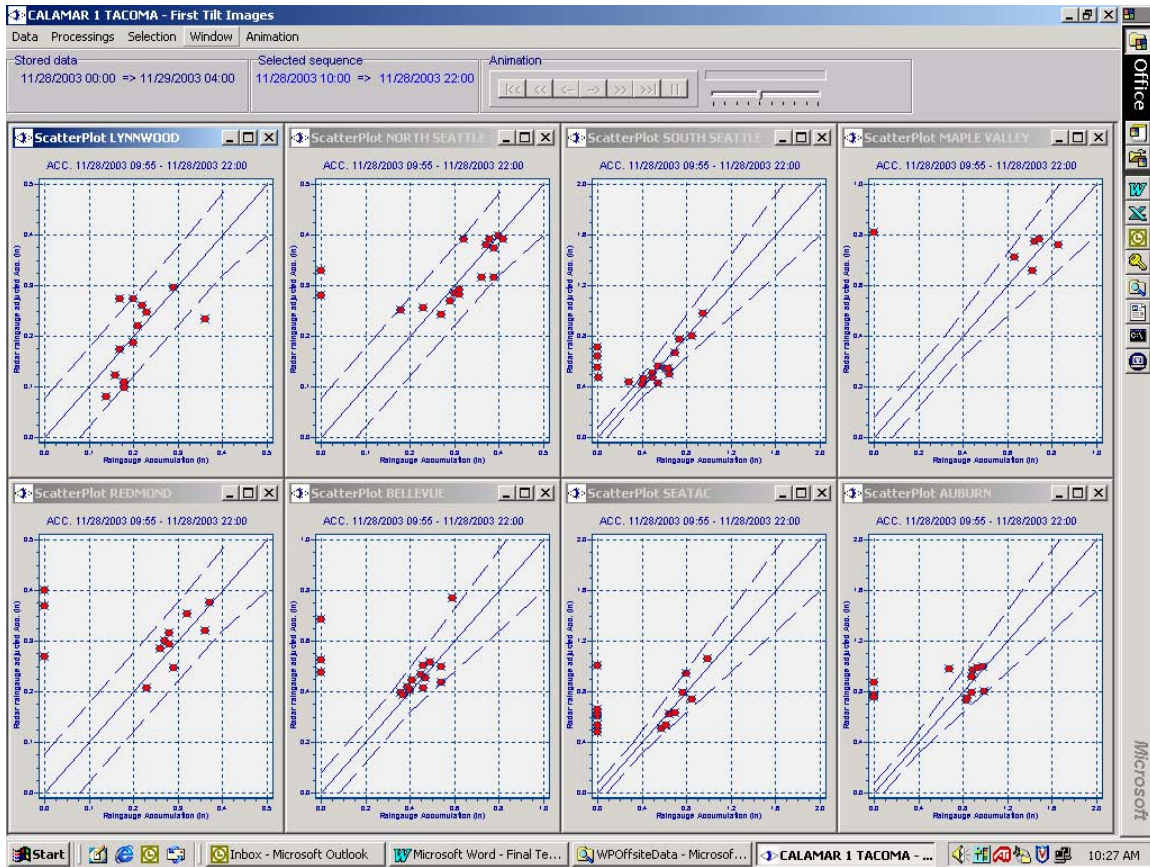
Figure 2
CALAMAR Scatterplots for 11/28/03

The basic tool for evaluating the calibration of each zone is a scatterplot displaying the rain gauge accumulation versus the radar rainfall accumulation for each rainfall event. These scatterplots allow dysfunctional rain gauges to be identified so that they can be disregarded during the calibration of the zone in which they reside. Figure 2 shows an example of the scatterplots for all of the calibration zones for Post-Rehabilitation Storm 3 that occurred on 11/28/2003.

As shown on the scatterplots, the rain gauges that fell along the y-axis were measuring zero and not functioning properly. These gauges were disregarded from the calibration.
