Comprehensive Sediment Quality Summary Report for CSO Discharge Locations

November 2018

King County

Wastewater Treatment Division

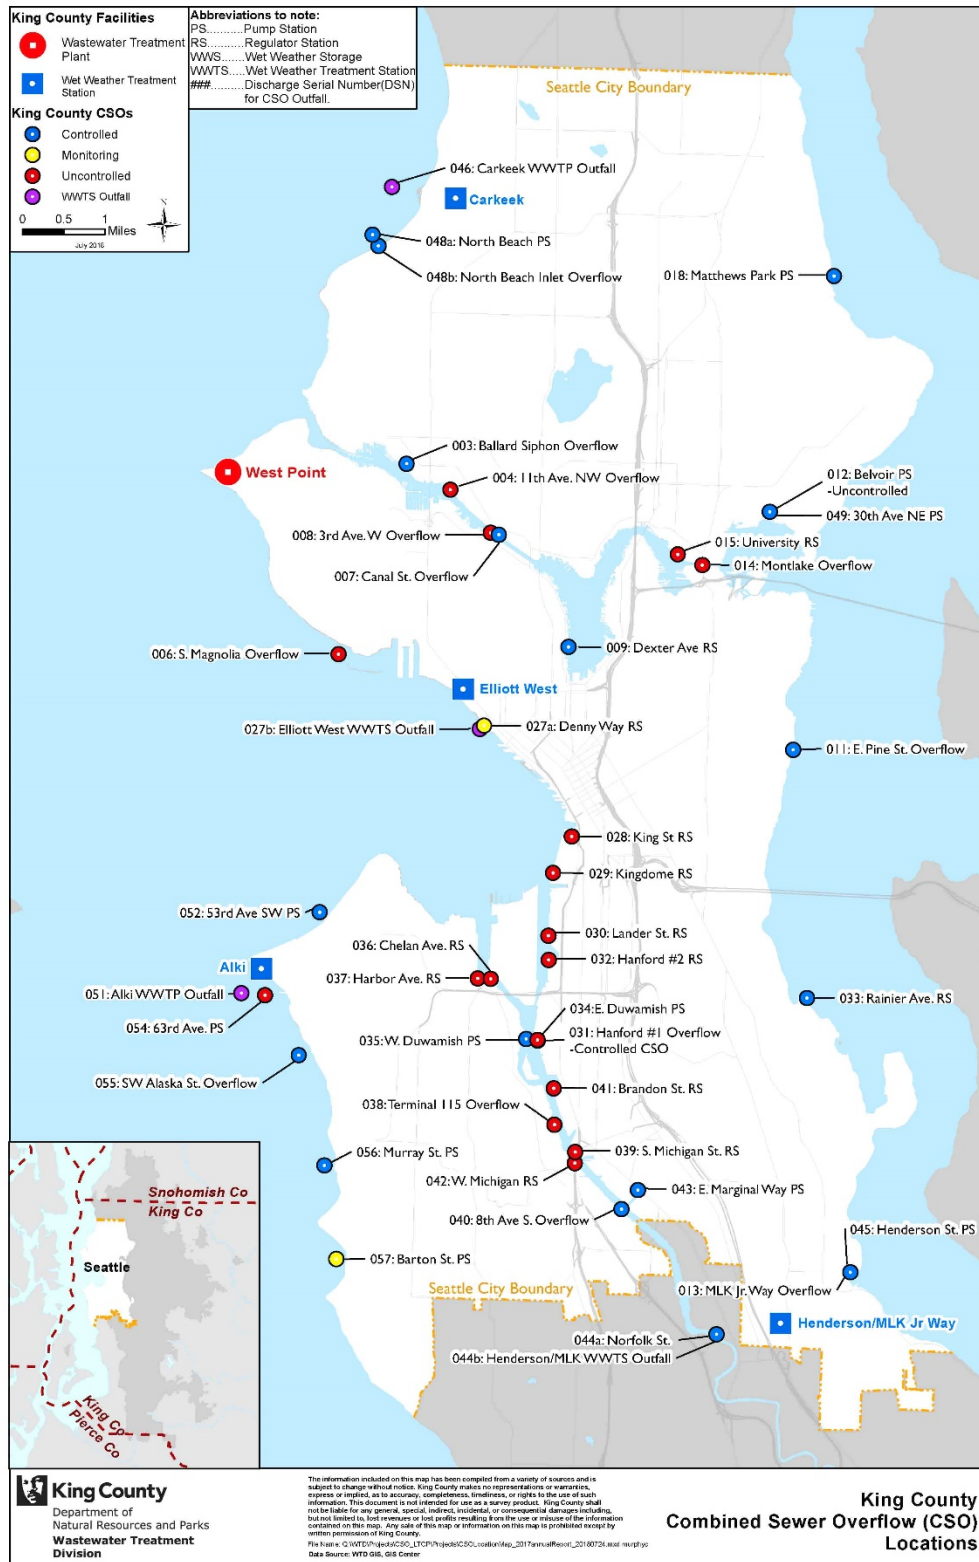
Figure 1-1. King County CSO Locations

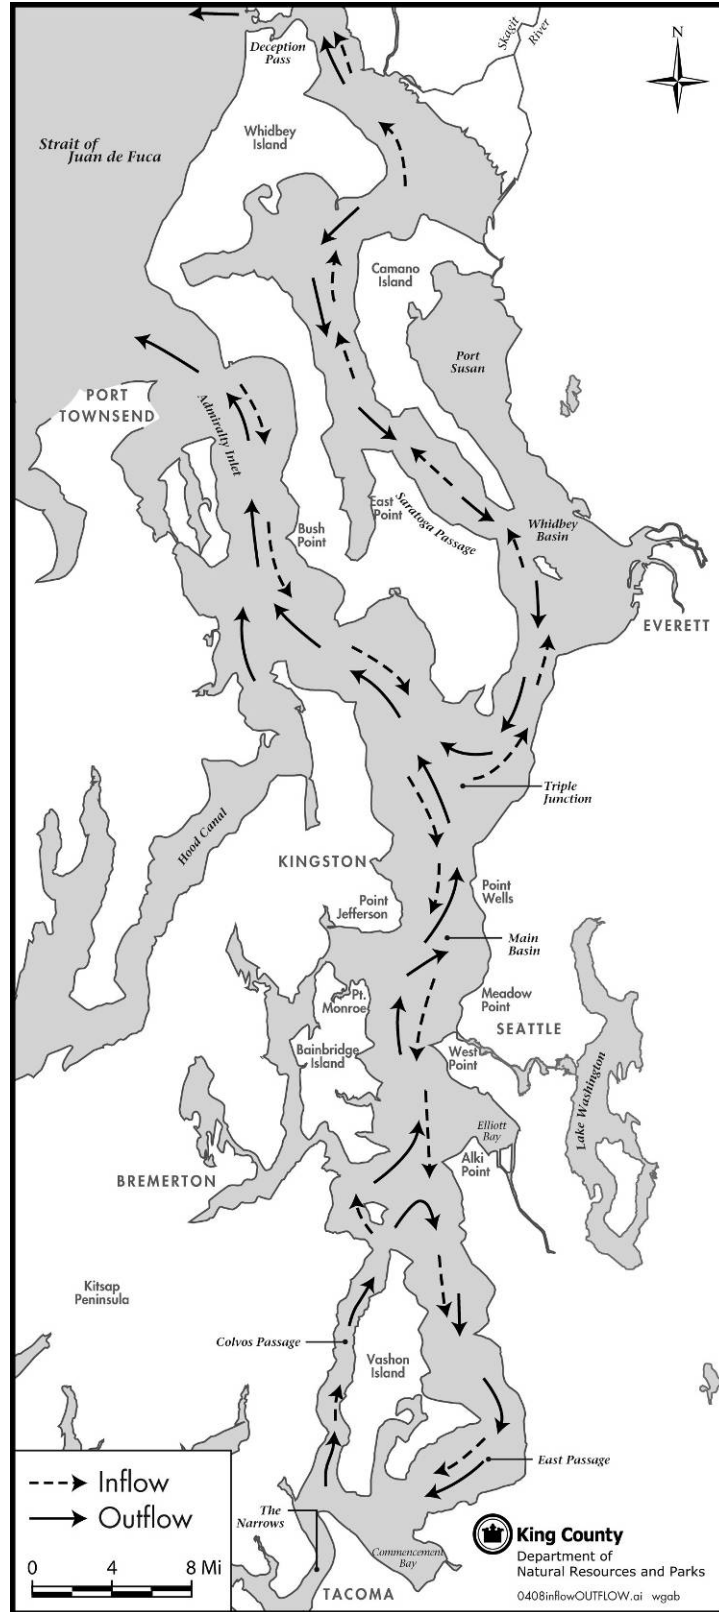
Figure 2-1. Generalized Puget Sound Circulation (from King County, 2002)

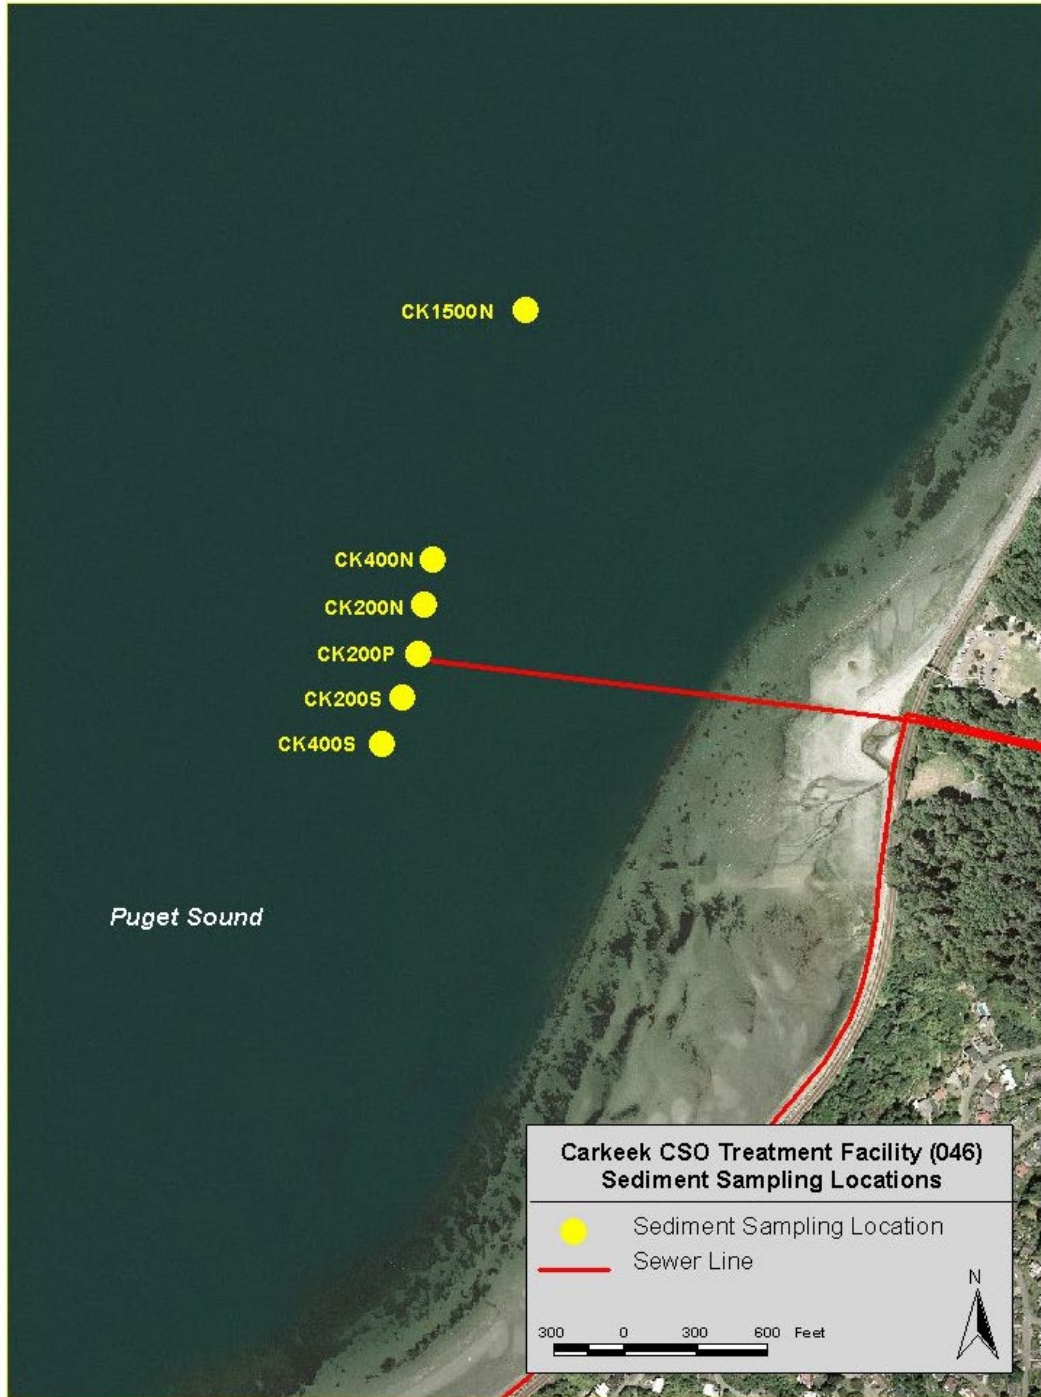
Figure 2-3. Carkeek Wet Weather Treatment Station (046) Sediment Sampling Locations

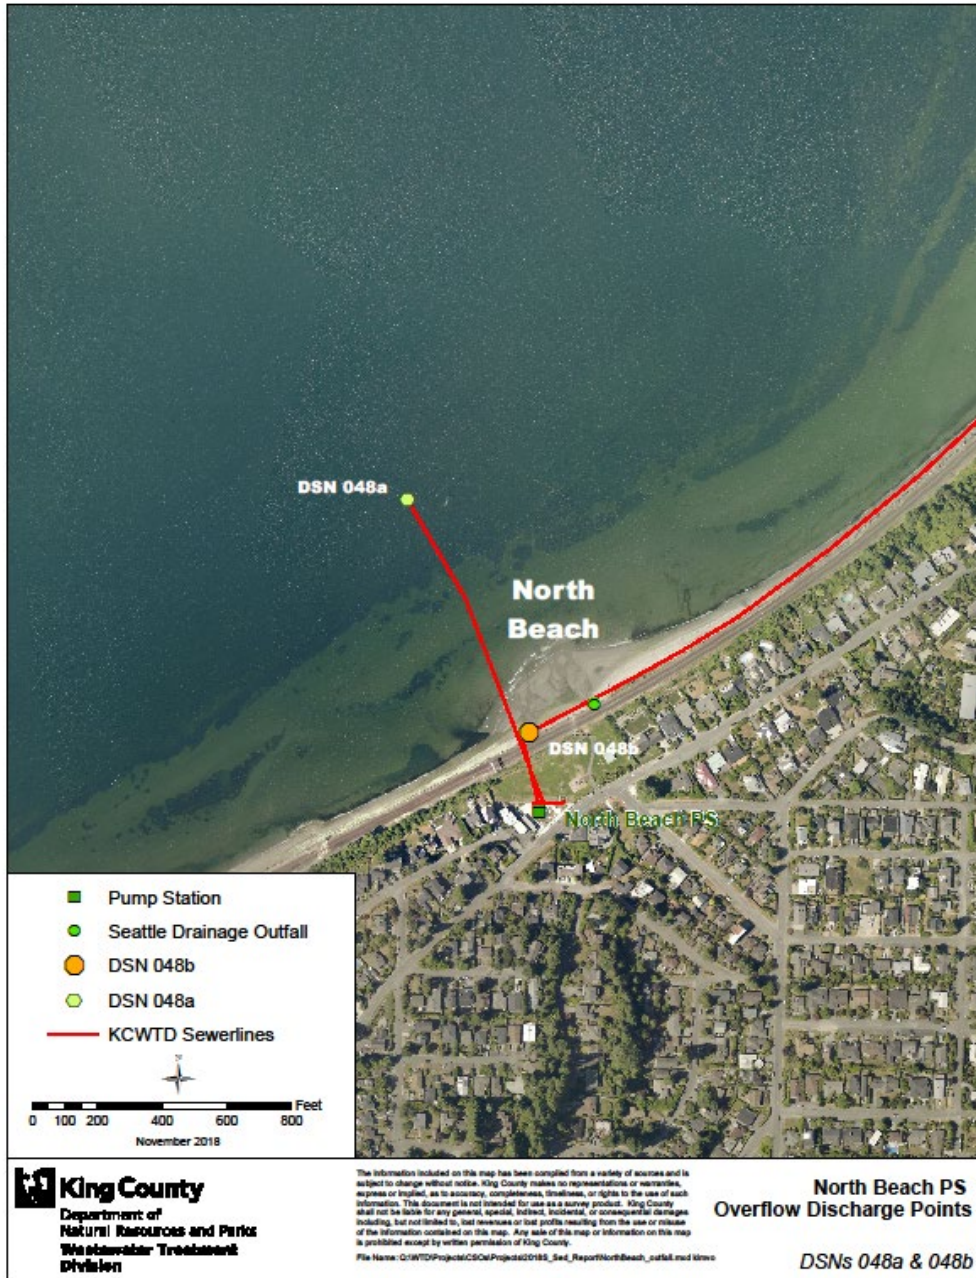
Figure 2-4. North Beach Pump Station CSO Discharge Point

Discharge Location: Inlet overflow to storm drain and beach at latitude 47° 42' 7.710" N and longitude -122° 23' 26.735" W; wet well overflow via old plant outfall 1,000 feet offshore at latitude 47° 42' 14.424" N and longitude 122° 23' 33.229" W (Figure 2-4).

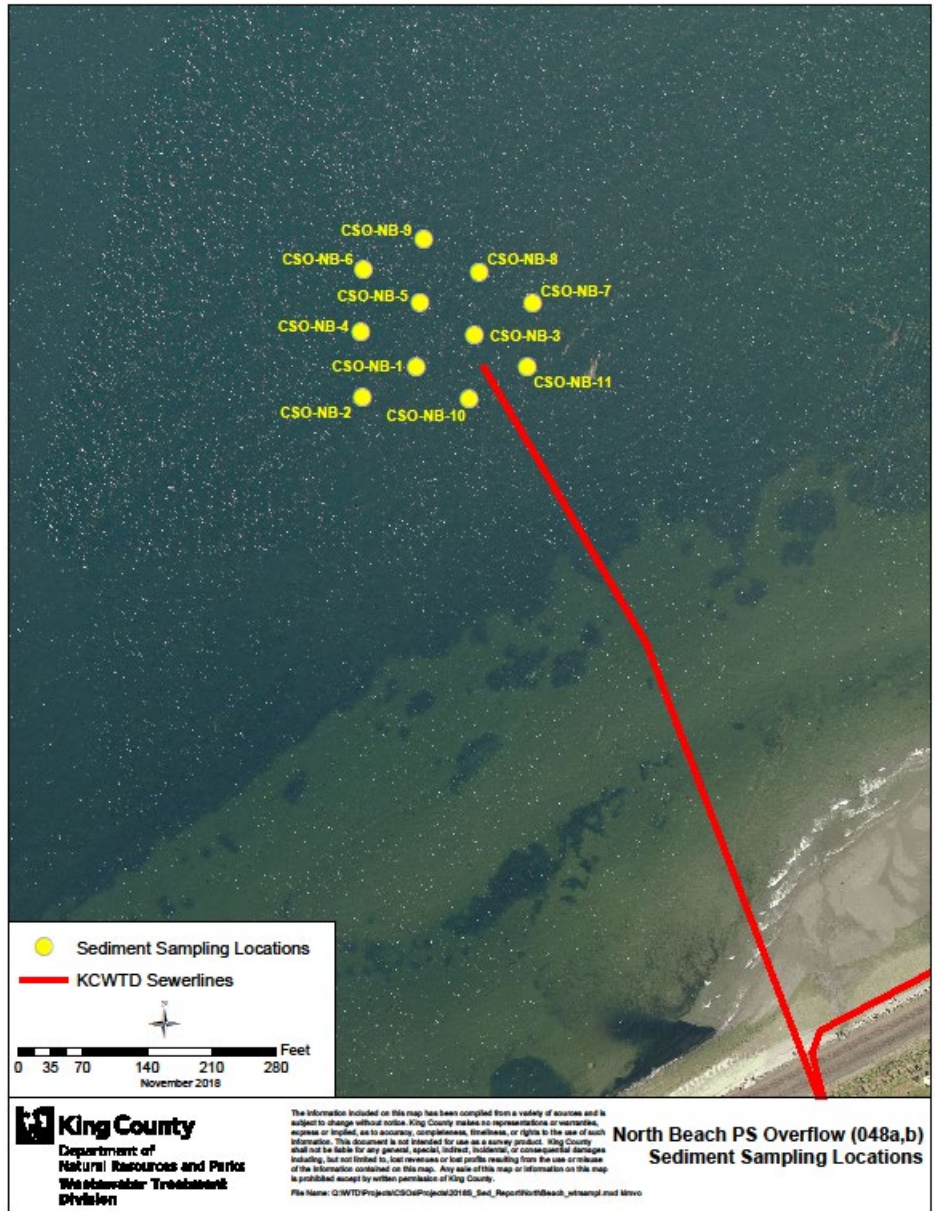
Figure 2-5. North Beach Pump Station (048a,b) Sediment Sampling Locations

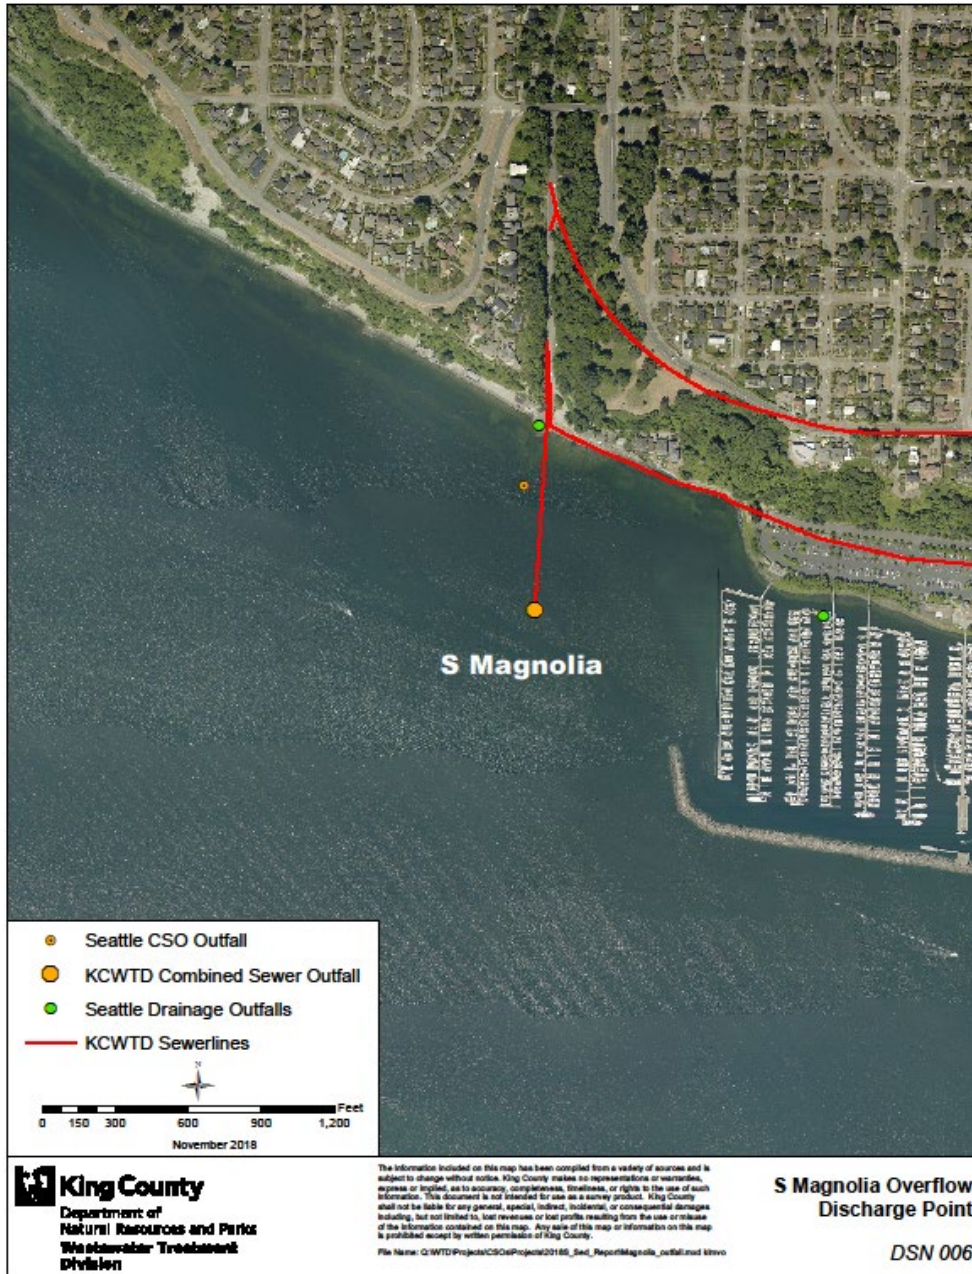
Figure 2-6. South Magnolia CSO Discharge Point

Discharge Location: Submerged offshore outfall discharges 780 feet offshore in Puget Sound at latitude 47° 37' 48.663" N and longitude -122° 23' 56.476" W; twin outfalls replaced by a single outfall in 1999 (Figure 2-6).

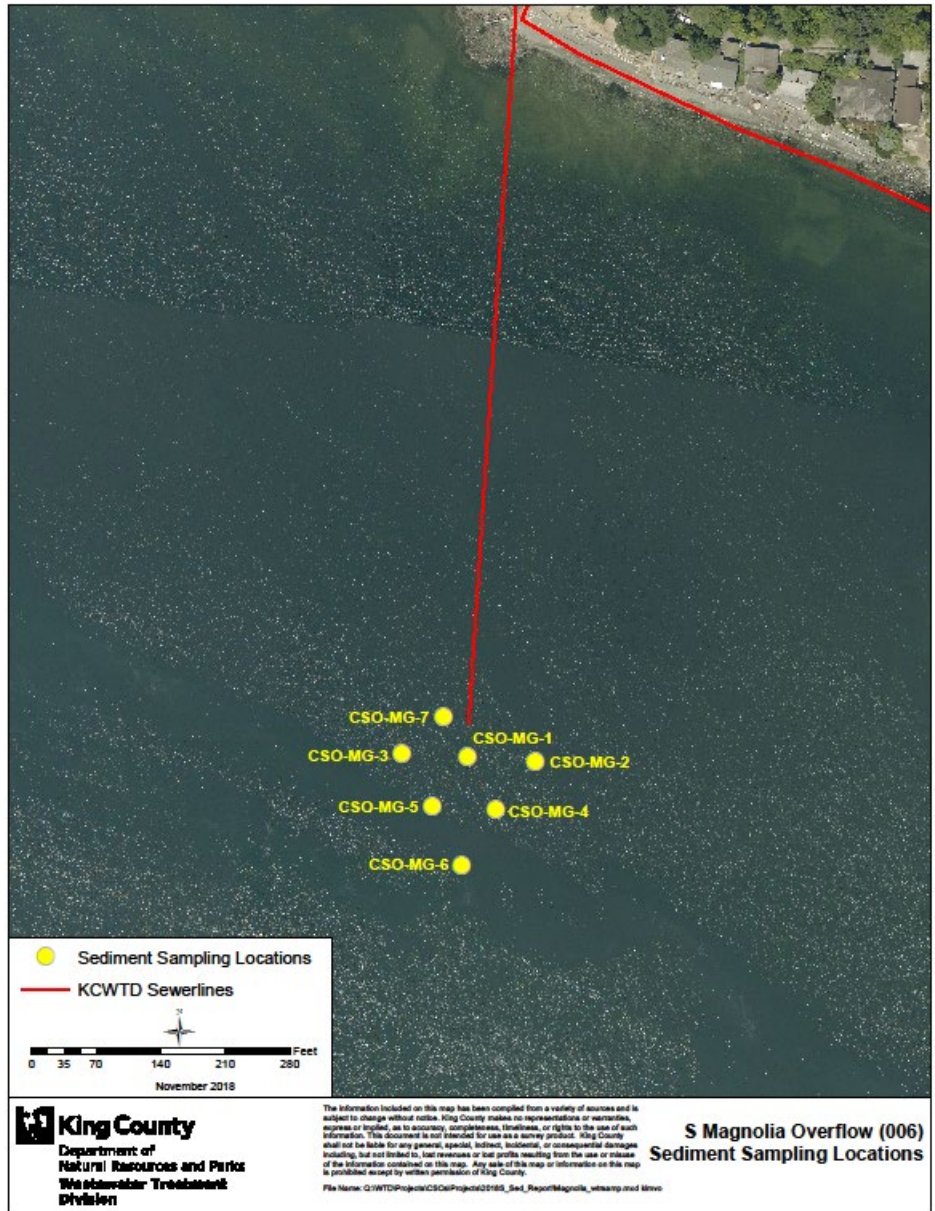
Figure 2-7. South Magnolia Overflow (006) Sediment Sampling Locations

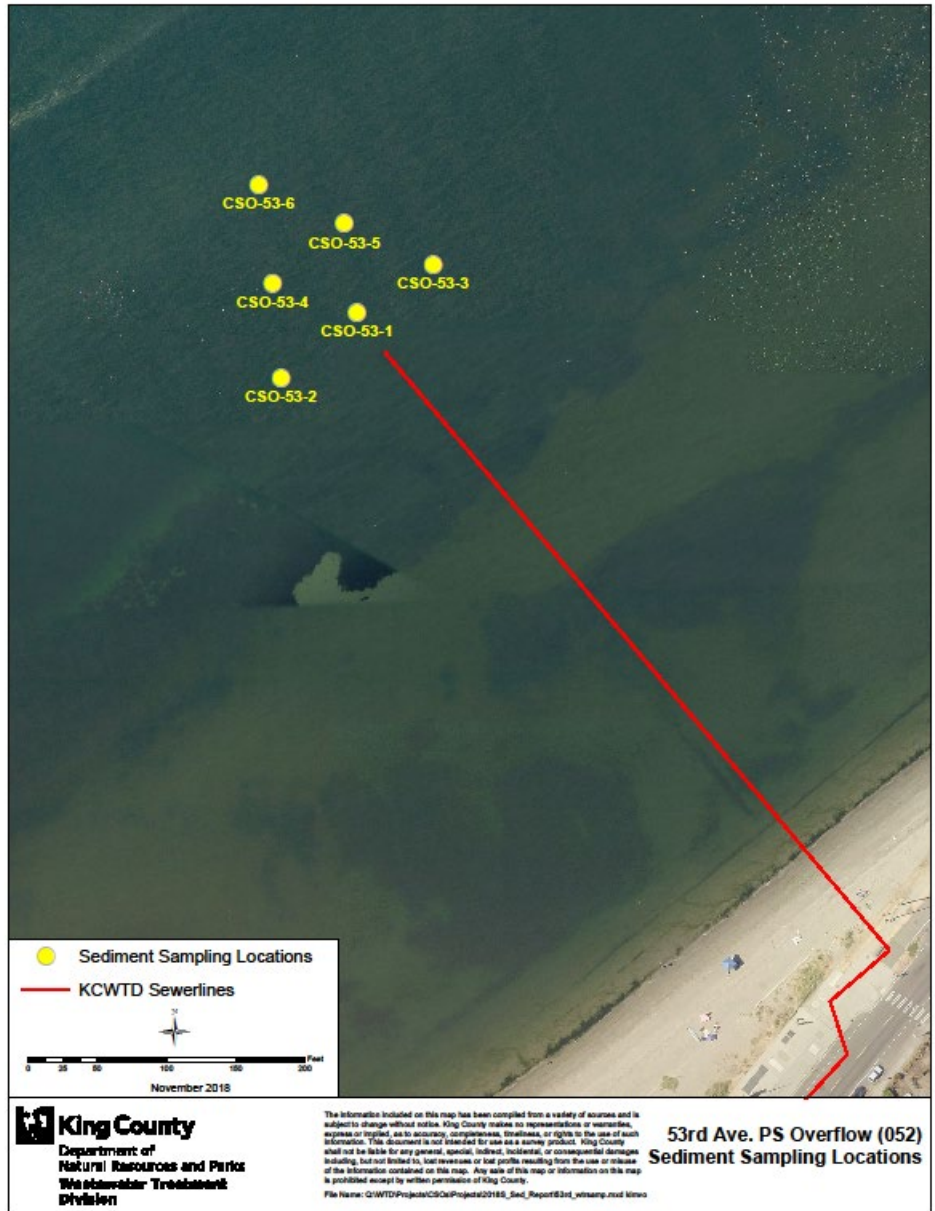
Figure 2-9. 53rd Avenue Pump Station (052) Sediment Sampling Locations

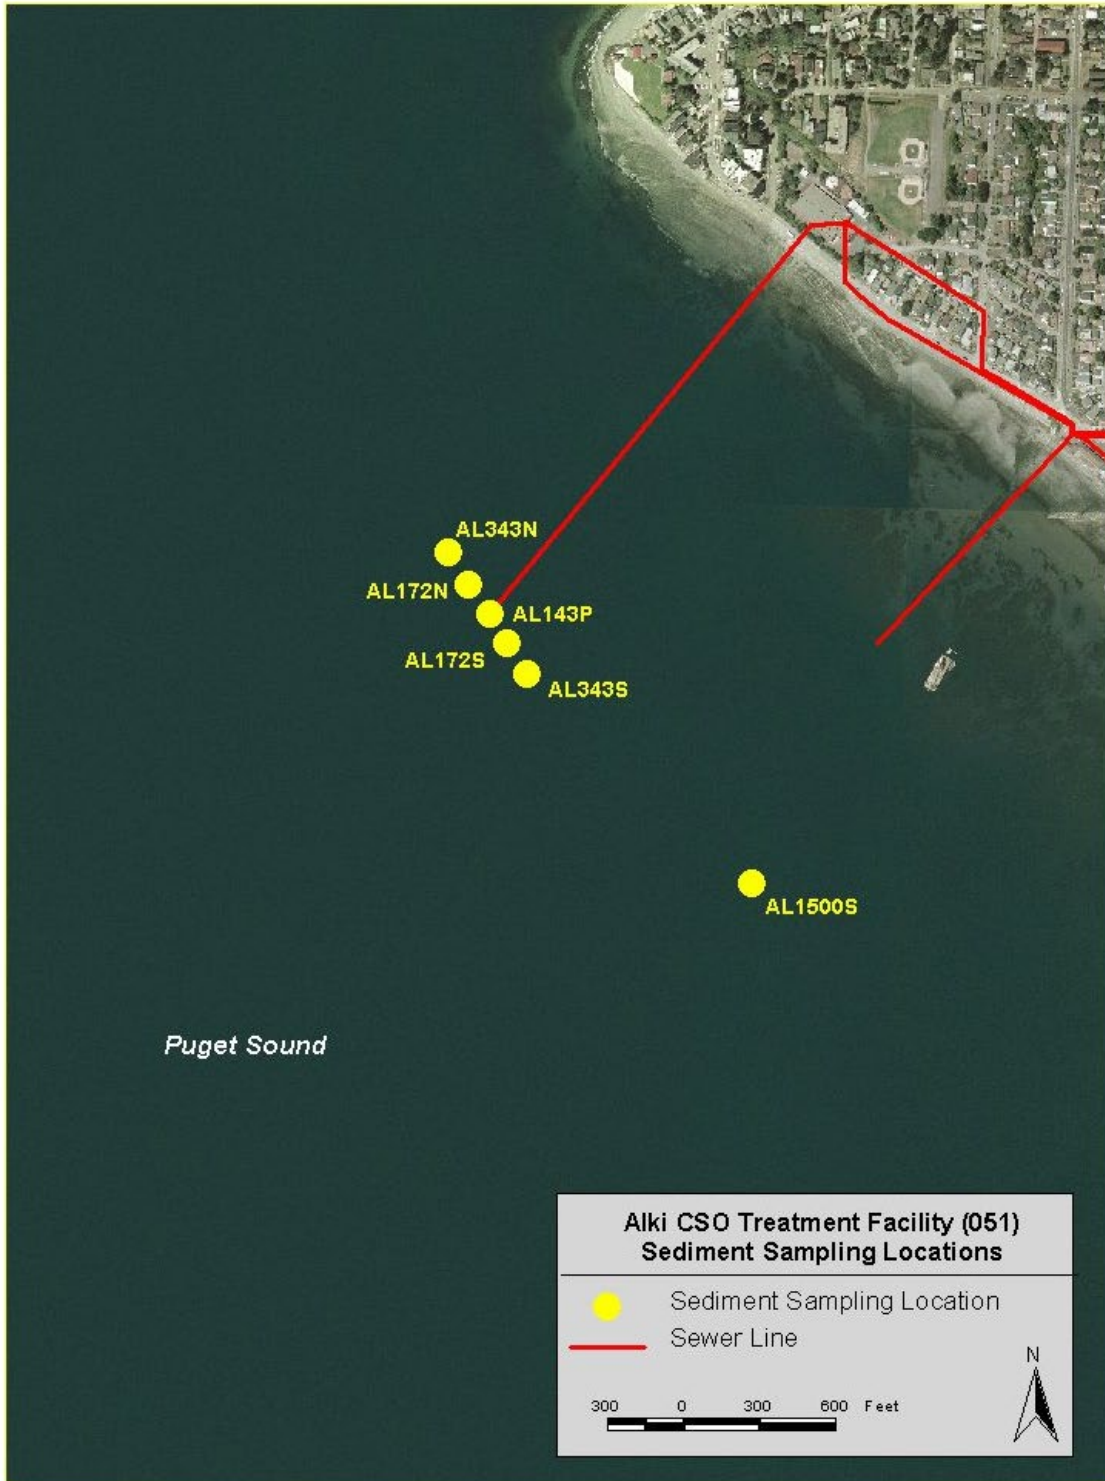
Figure 2-11. Alki CSO Treatment Plant (051) Sediment Sampling Locations

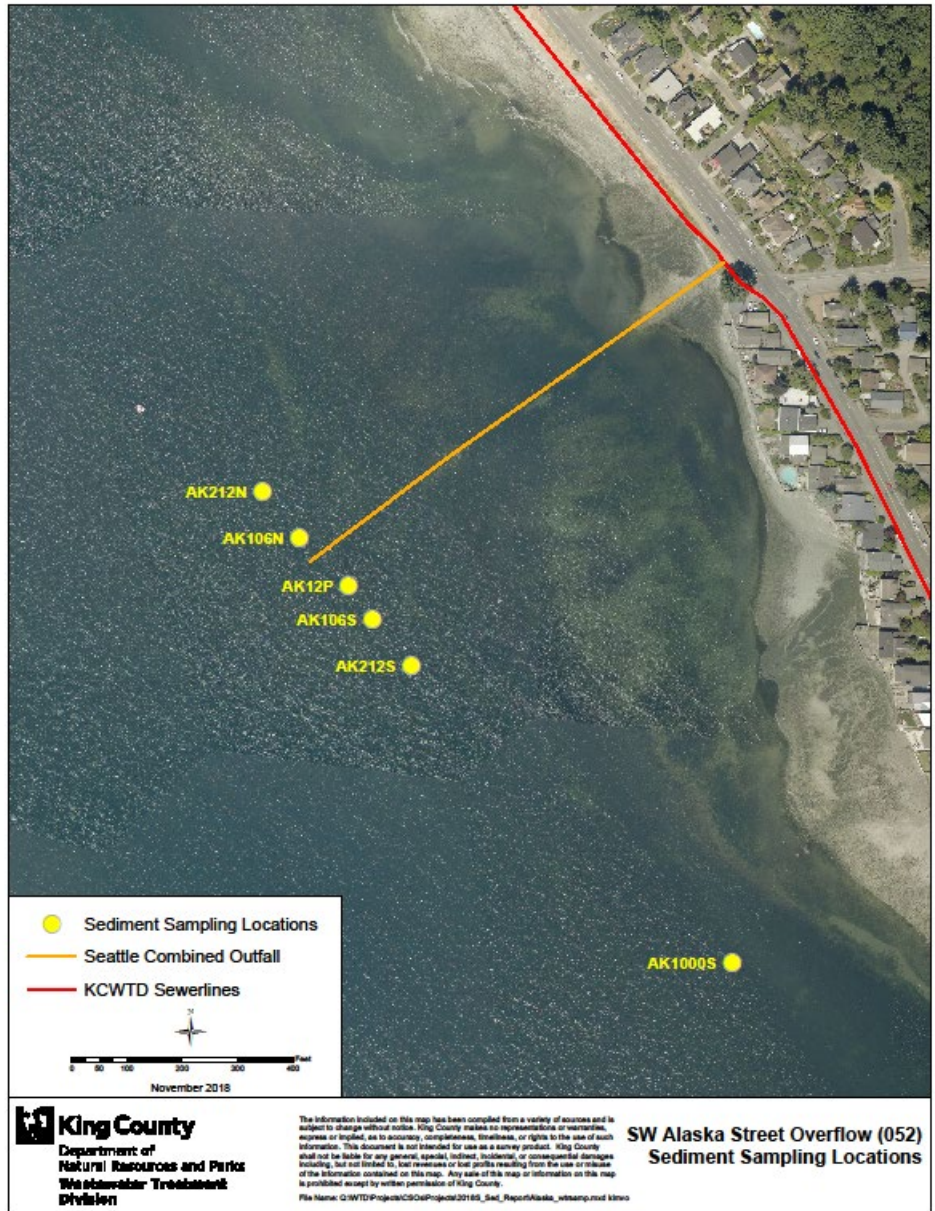
Figure 2-15. Southwest Alaska Street Overflow (052) Sediment Sampling Locations

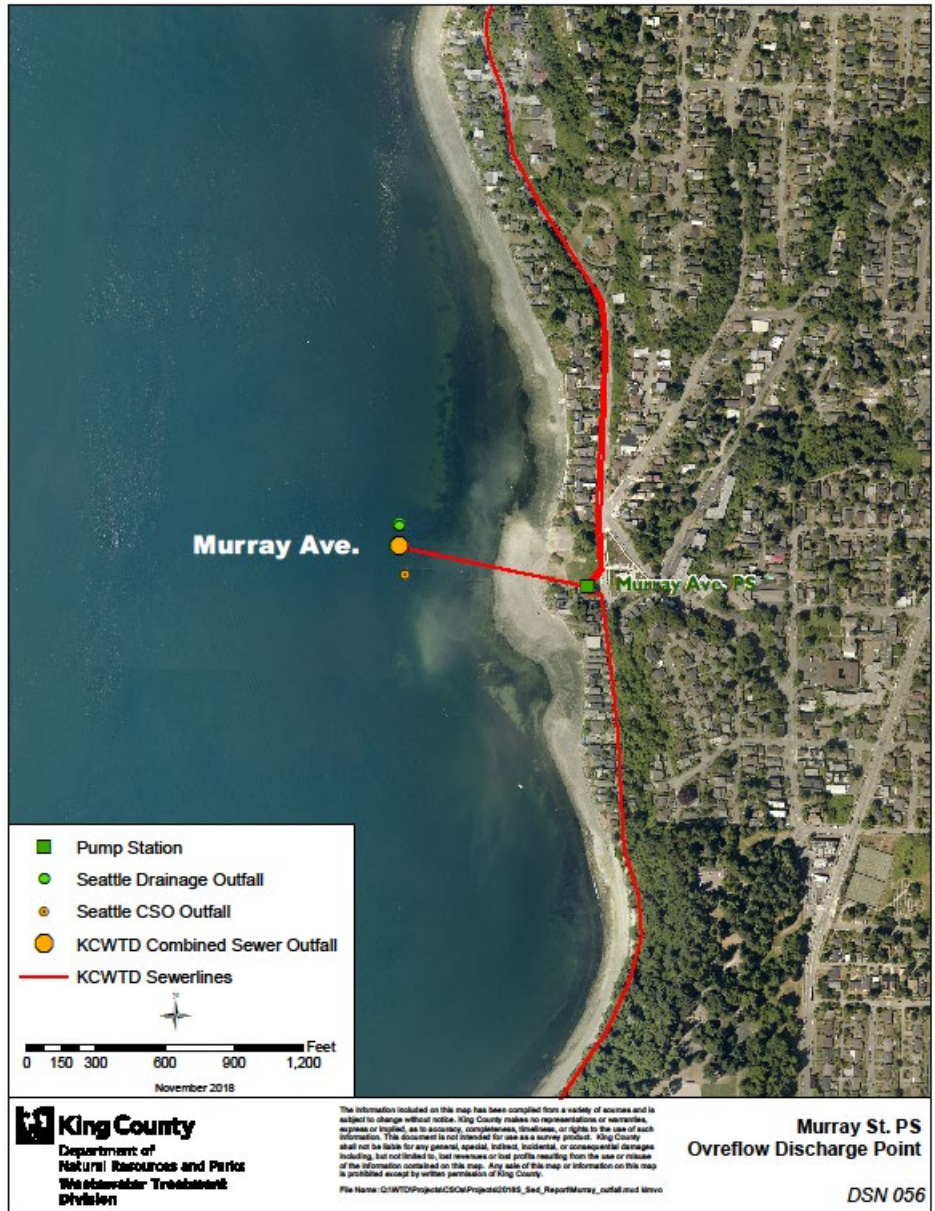
Figure 2-16. Murray Avenue Pump Station CSO Discharge Point

Discharge Location: 72-inch-diameter submerged outfall, 800 feet offshore of Lowman Beach Park in West Seattle into Puget Sound at latitude 47° 32' 24.991" N and longitude -122° 24' 0.009" W (Figure 2-16).

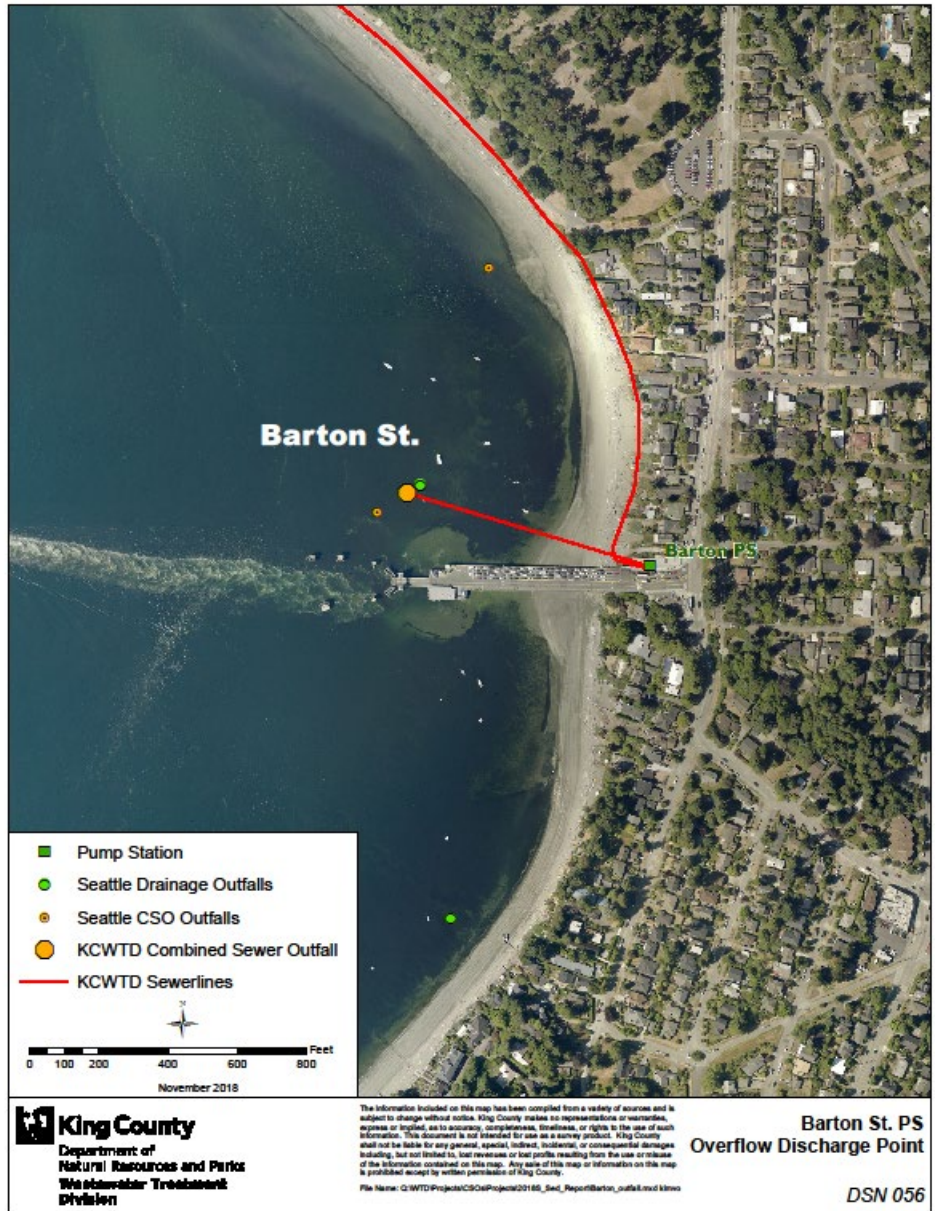
Figure 2-18. Barton Street Pump Station CSO Discharge Point

Discharge Location: 60-inch-diameter submerged outfall, 620 feet offshore of the Fauntleroy Ferry Terminal in West Seattle into Puget Sound at latitude 47° 31' 25.991" N and longitude - 122° 23' 47.014" W (Figure 2-18).

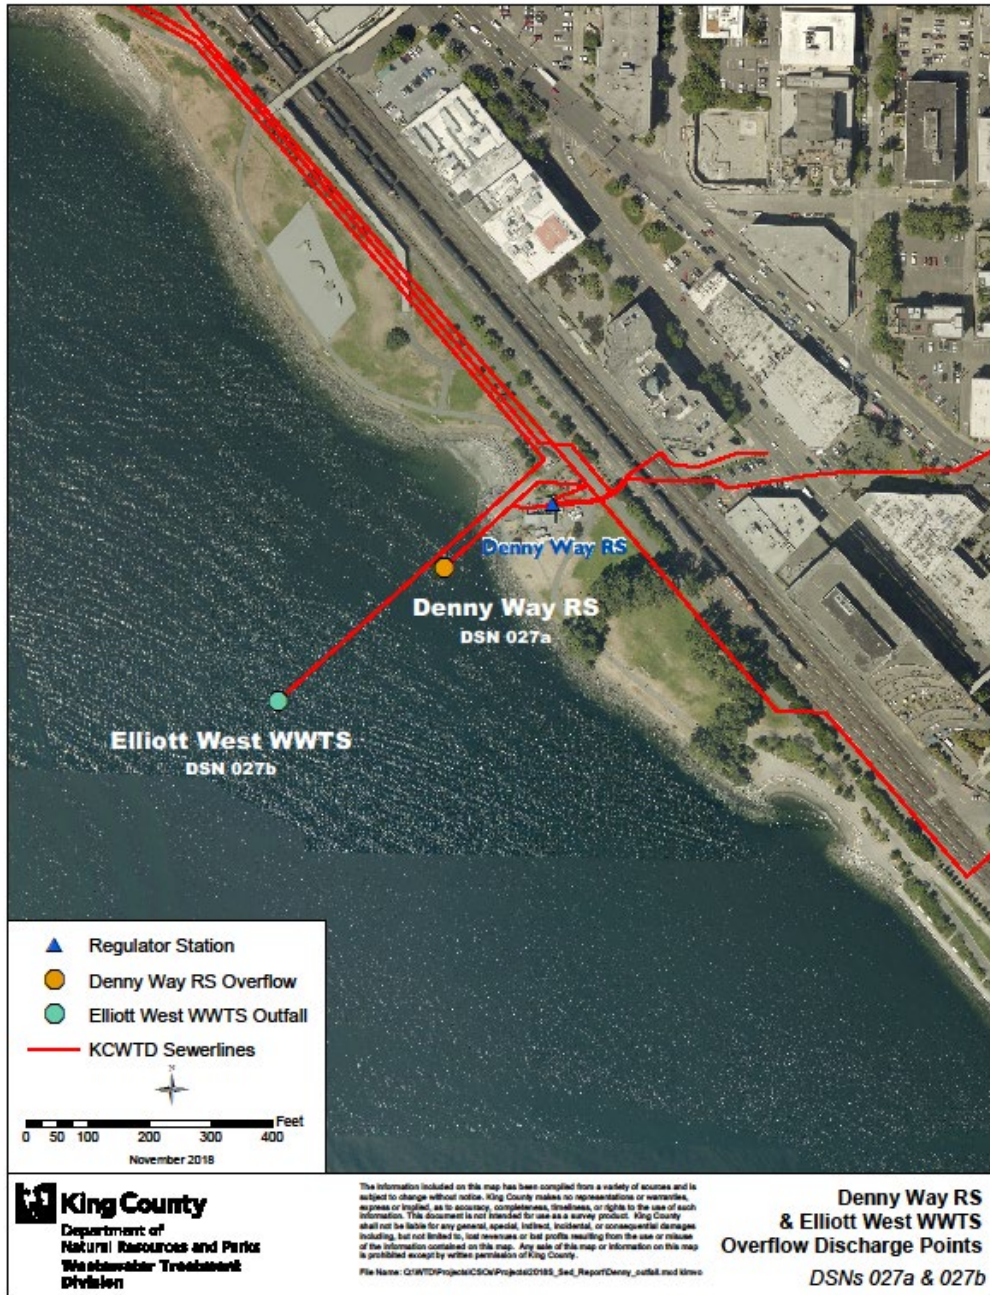
Figure 3-1. Denny Way Regulator Station and Elliott West Wet Weather Treatment Station CSO Discharge Point

Discharge Location: Untreated overflow on surface at northeast side of Elliott Bay until replaced in 2005 as part of the Denny Way/Lake Union CSO control project with a new submerged outfall 100 feet offshore at a 10-foot depth; also as part of the project, the new Elliott West WWTS started discharging treated CSO at latitude 47° 37' 3.18" N and longitude -122° 21' 42.68" W through a 90-inch-diameter submerged outfall 490 feet offshore at a 60-foot depth (Figure 3-1). The treated discharge outfall provides 7.8:1 dilution at the zone of acute criteria exceedance and 11:1 dilution at the chronic mixing zone boundary.

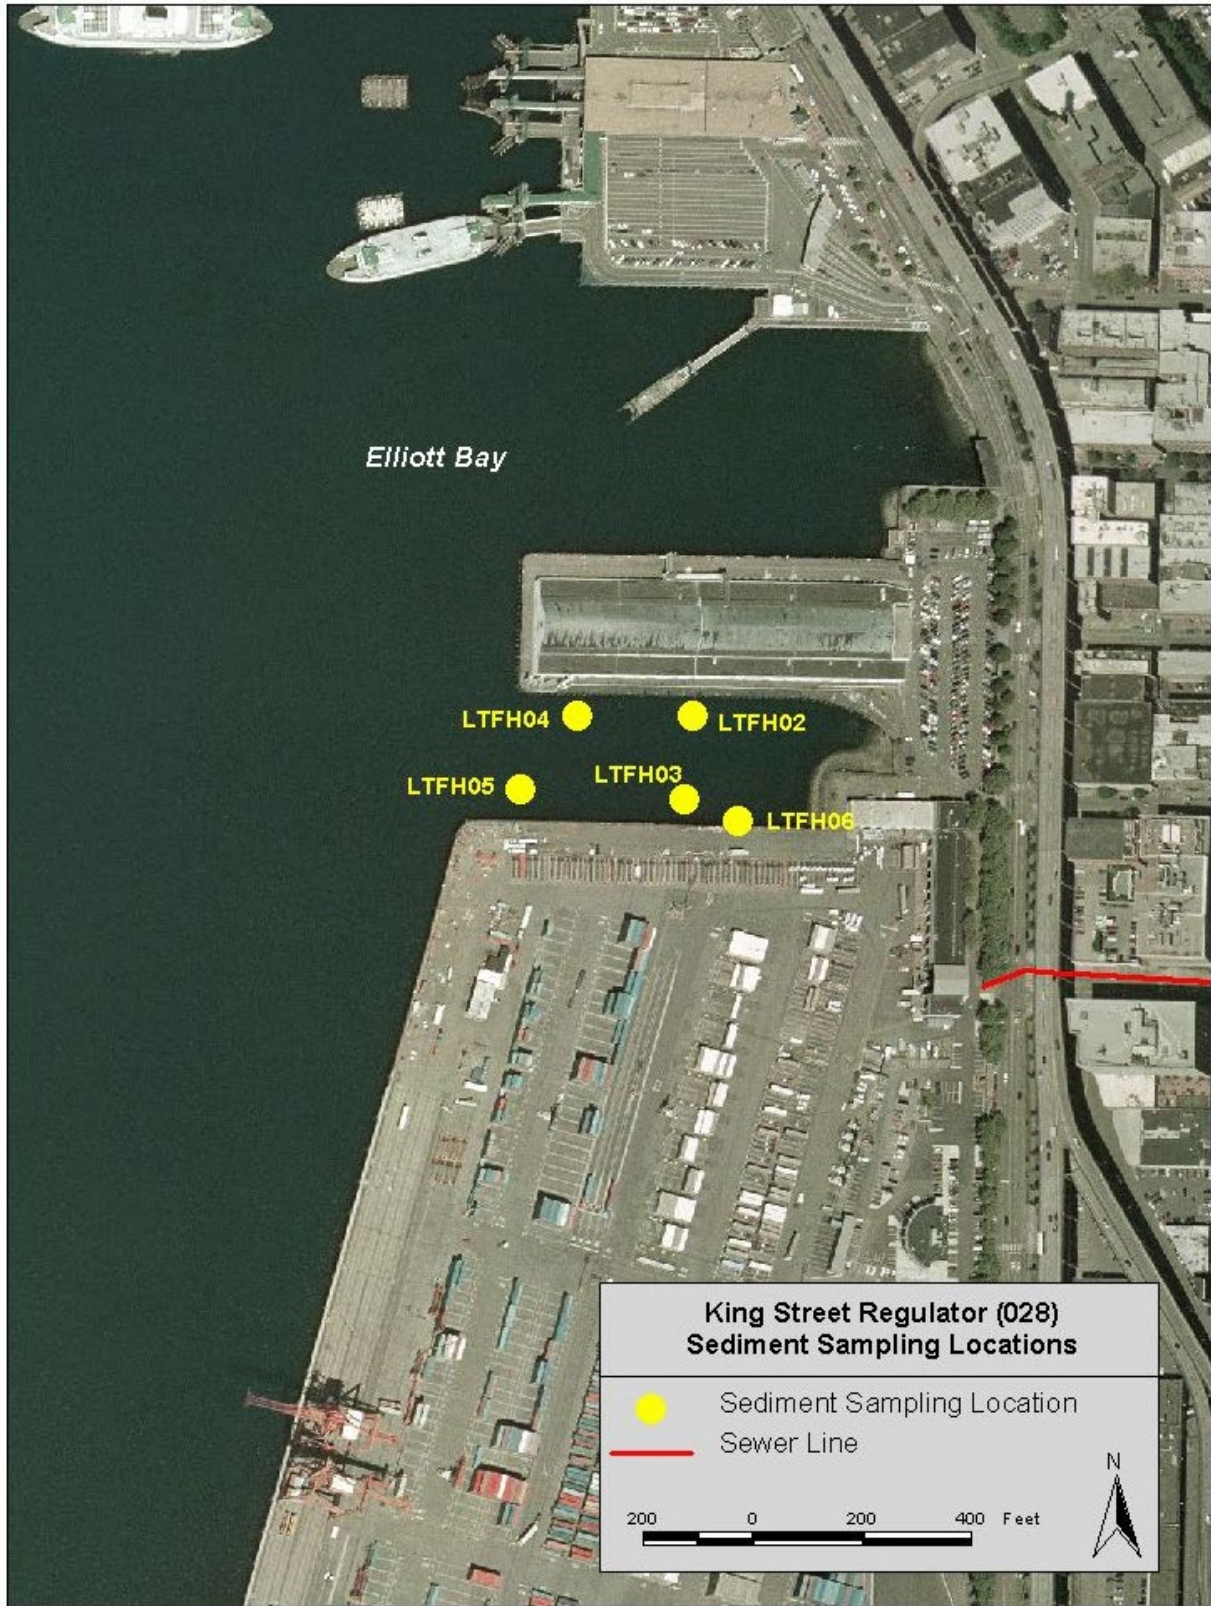
Figure 3-5. King Street Regulator Station (028) Sediment Sampling Locations

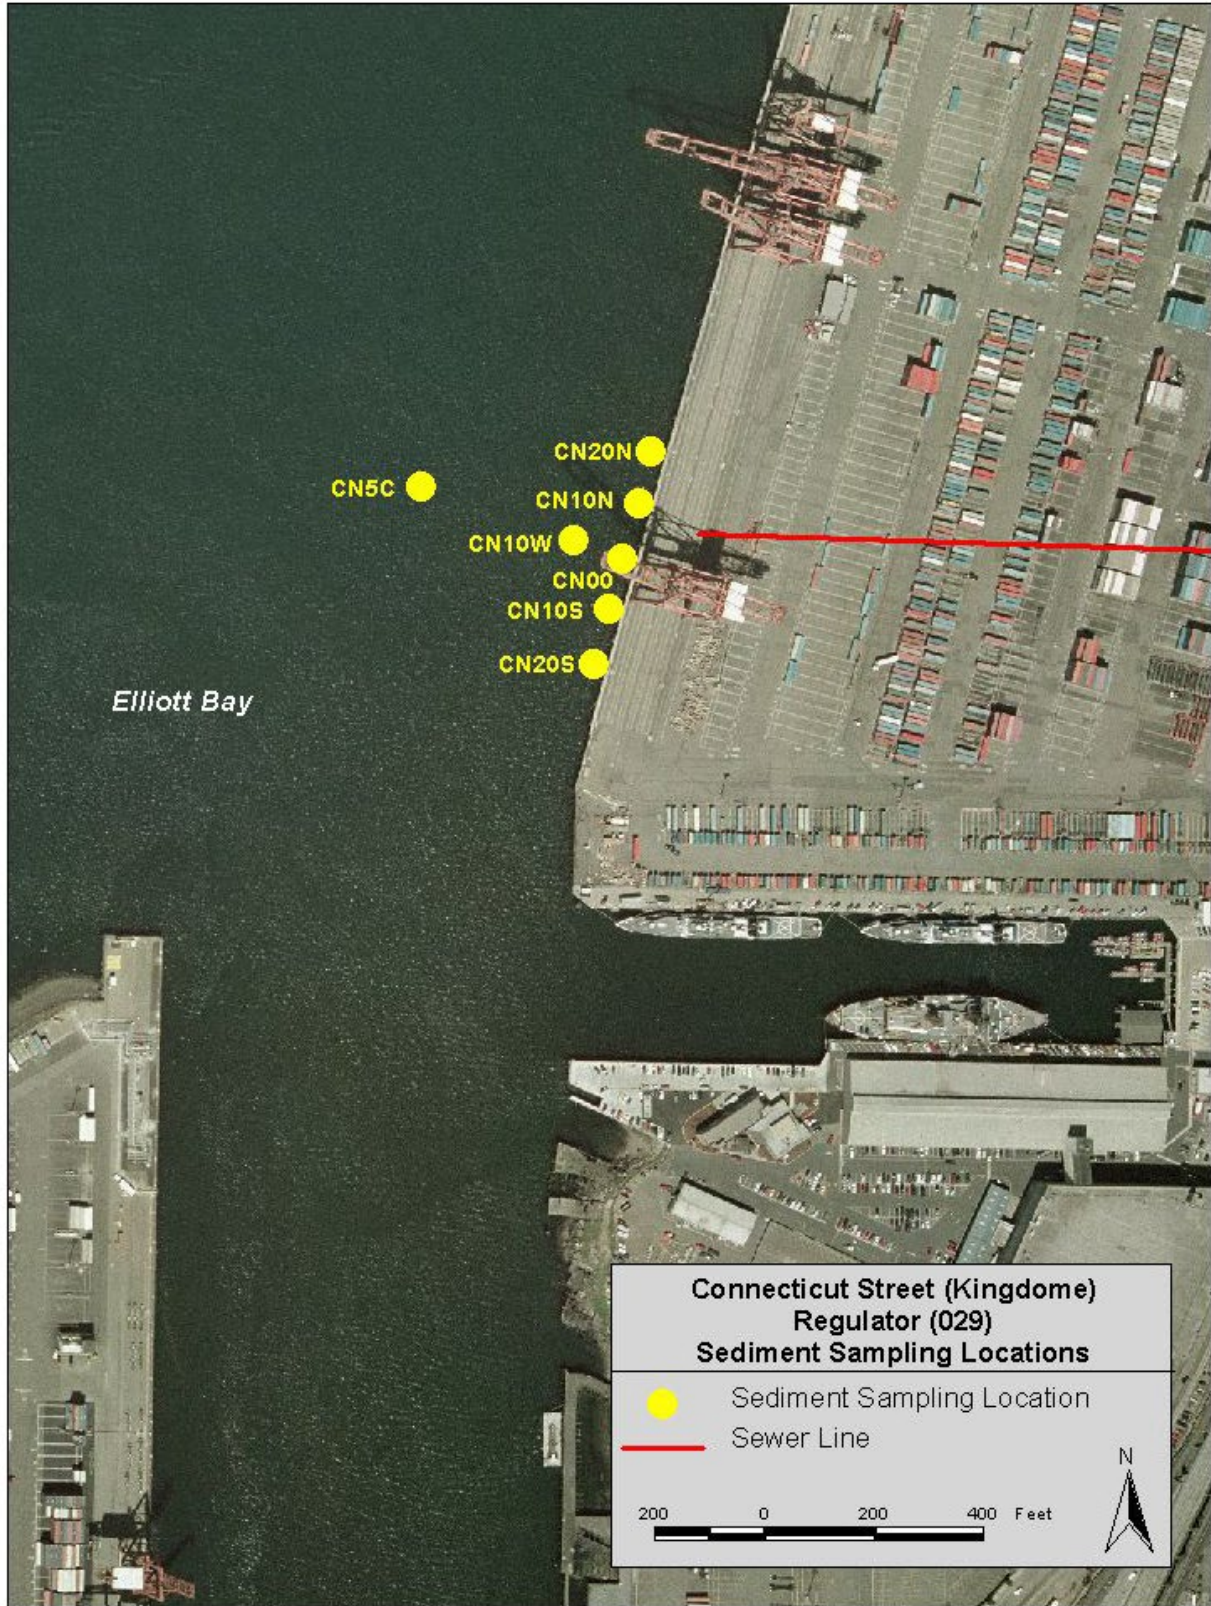
Figure 3-7. Kingdome (Connecticut Street) Regulator Station (029) Sediment Sampling Locations

Sediment Remediation Activity: Berth area maintenance along Pier 48 removed several feet of surface sediments in front of the outfall. The area was evaluated under the East Waterway Superfund Remedial Investigation to determine if it needed to be within the cleanup site boundaries (Windward and Anchor, 2014). Based on the sediment data collected in the vicinity, the area was not included in the site, suggesting no further action is needed.

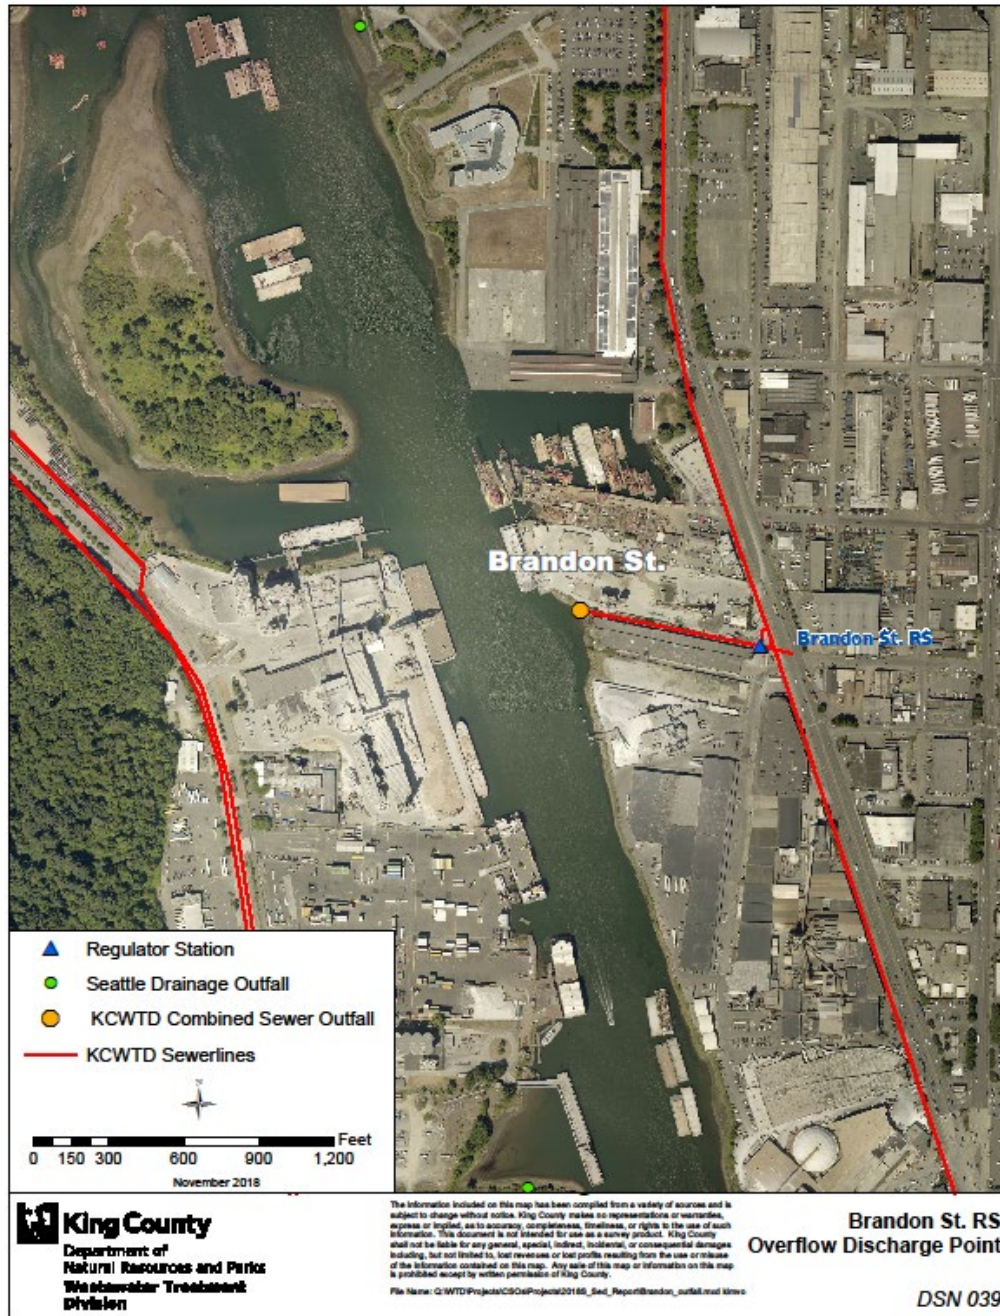
Figure 4-8. Brandon Street Regulator Station CSO Discharge Point

Discharge Location: Outfall station discharges at east bank of Duwamish at latitude 47° 33' 16.781" N and longitude -122° 20' 26.996" W (Figure 4-8).
