Comprehensive Sediment Quality Summary Report for CSO Discharge Locations

November 2018

King County

Wastewater Treatment Division

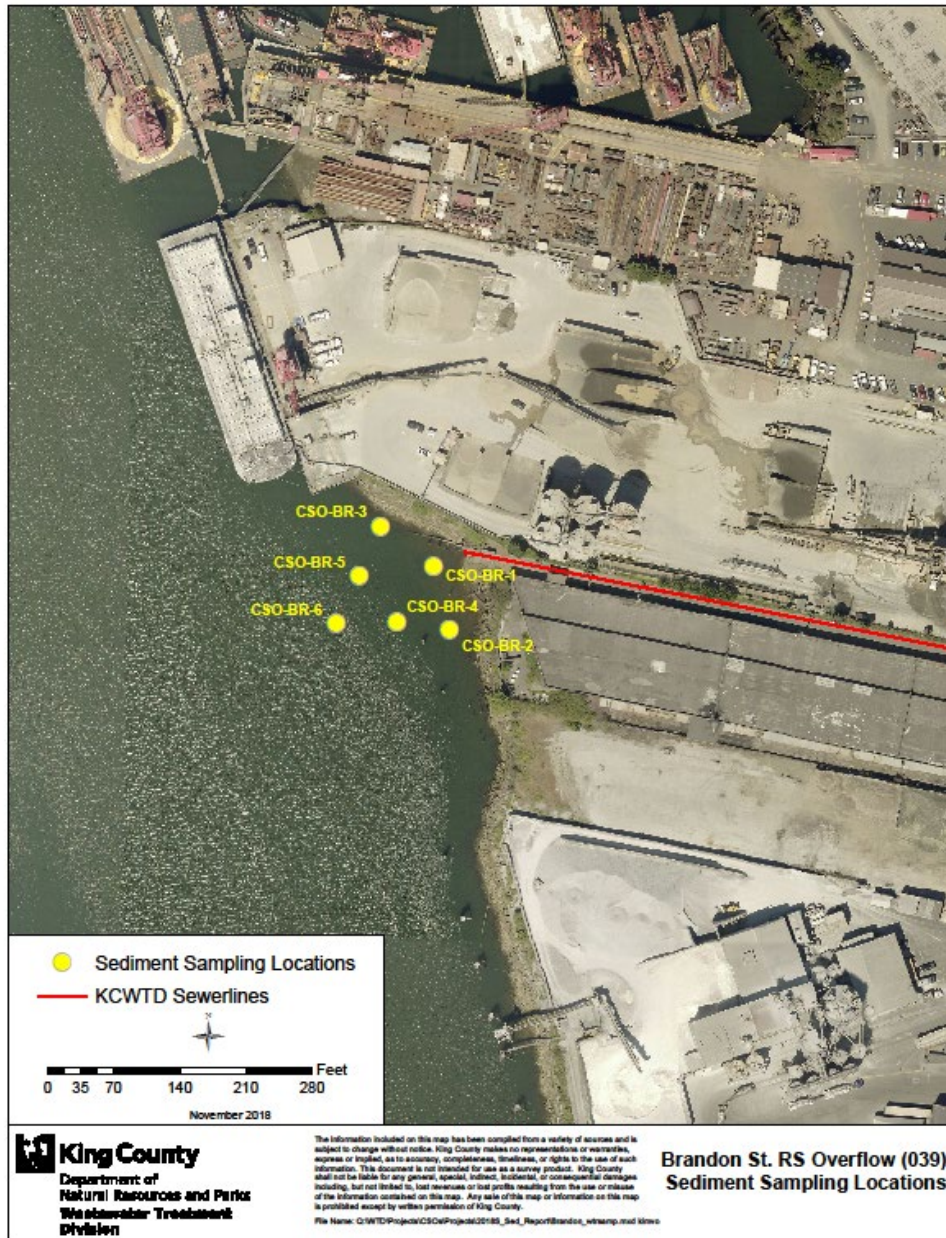
Figure 4-9. Brandon Street Regulator Station CSO Sediment Sampling Location

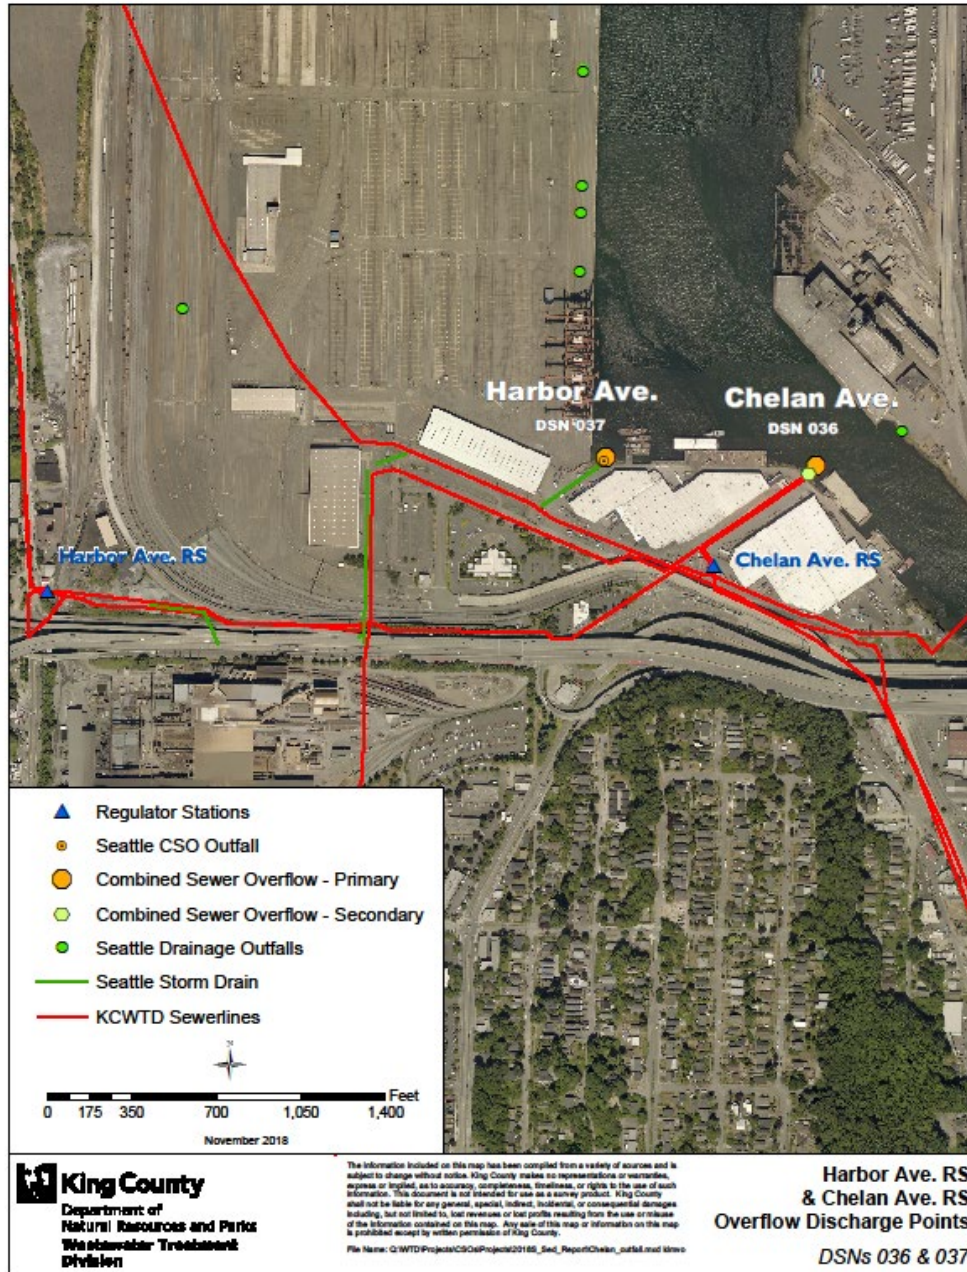
Figure 4-11. Harbor Avenue Regulator Station CSO Discharge Point

Discharge Location: Duwamish West Waterway via a 96-inch-diameter Seattle storm drain that also carries Seattle CSOs and Longfellow Creek at latitude 47° 34' 25.341" N and longitude - 122° 21' 40.174" W (Figure 4-11).

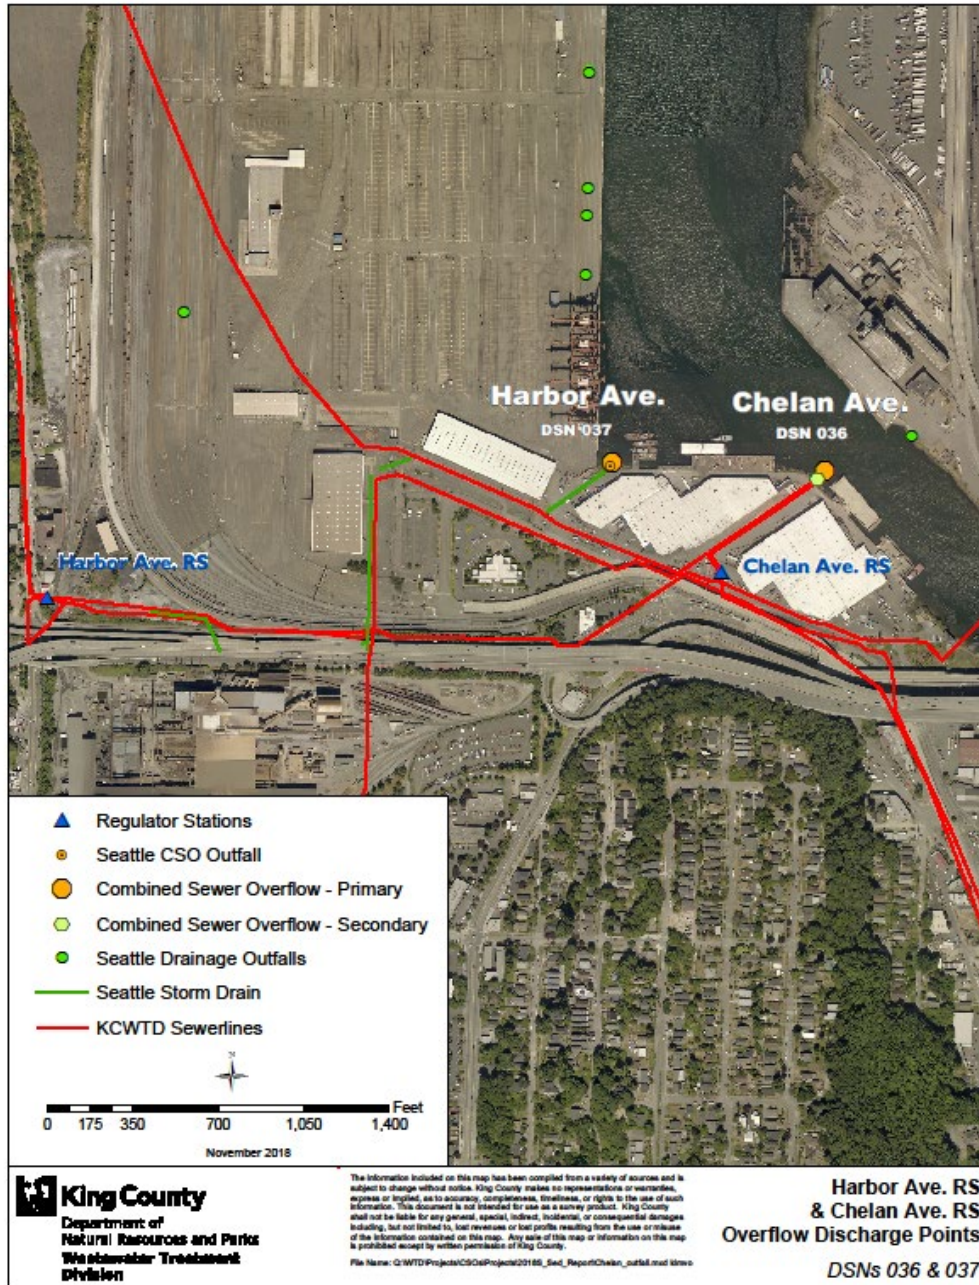
Figure 4-12. Chelan Avenue Regulator Station CSO Discharge Point

Discharge Location: West side of Duwamish West Waterway below Port of Seattle facilities via parallel submerged 30- and 48-inch outfalls at latitude 47° 34' 25.201" N and longitude -122° 21' 28.004" W (Figure 4-12).

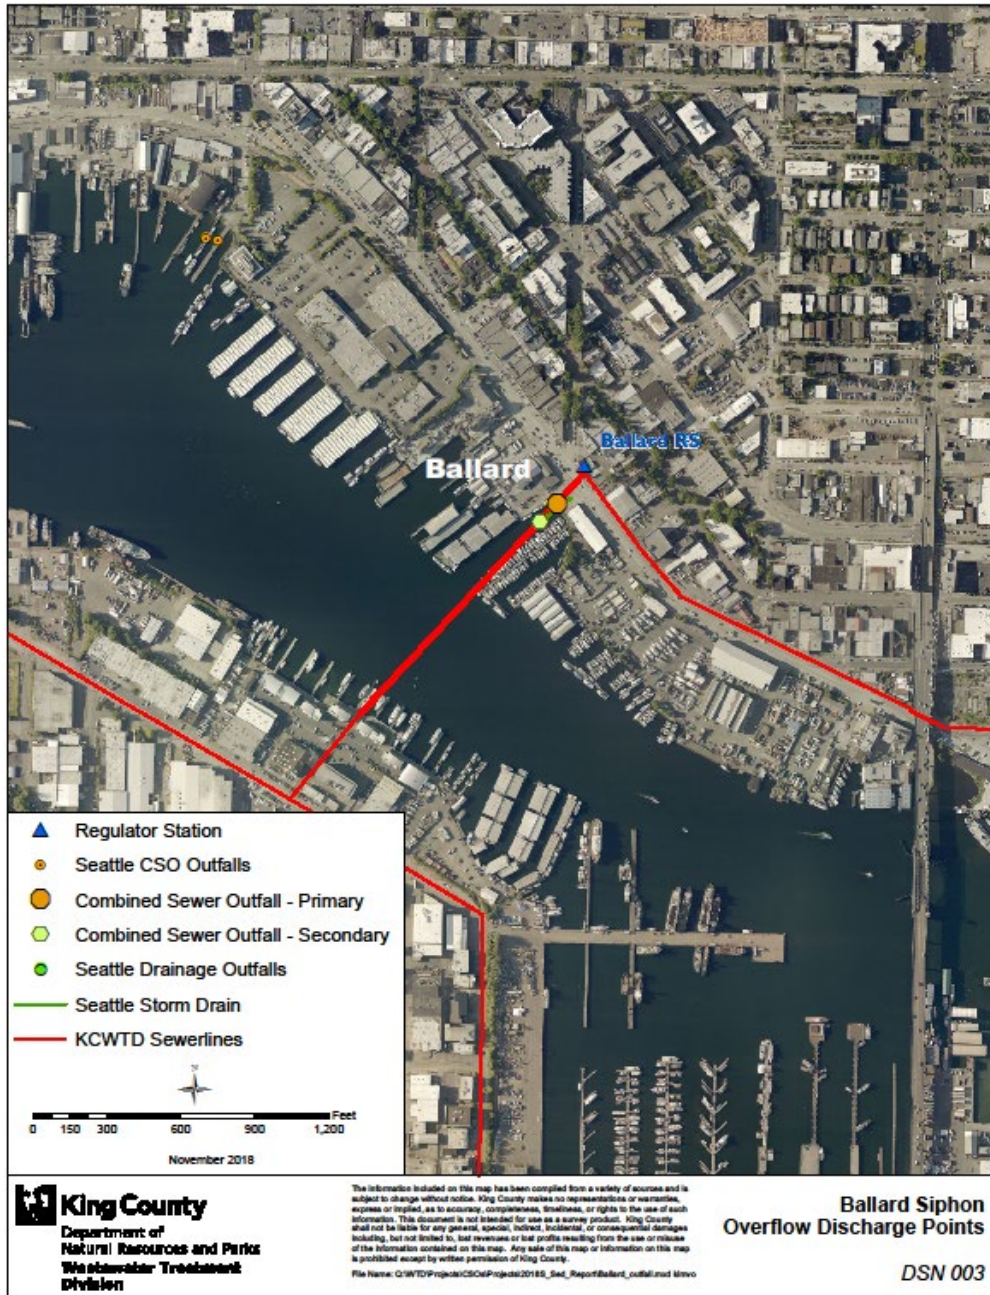
Figure 5-1. Ballard Siphon CSO Discharge Point

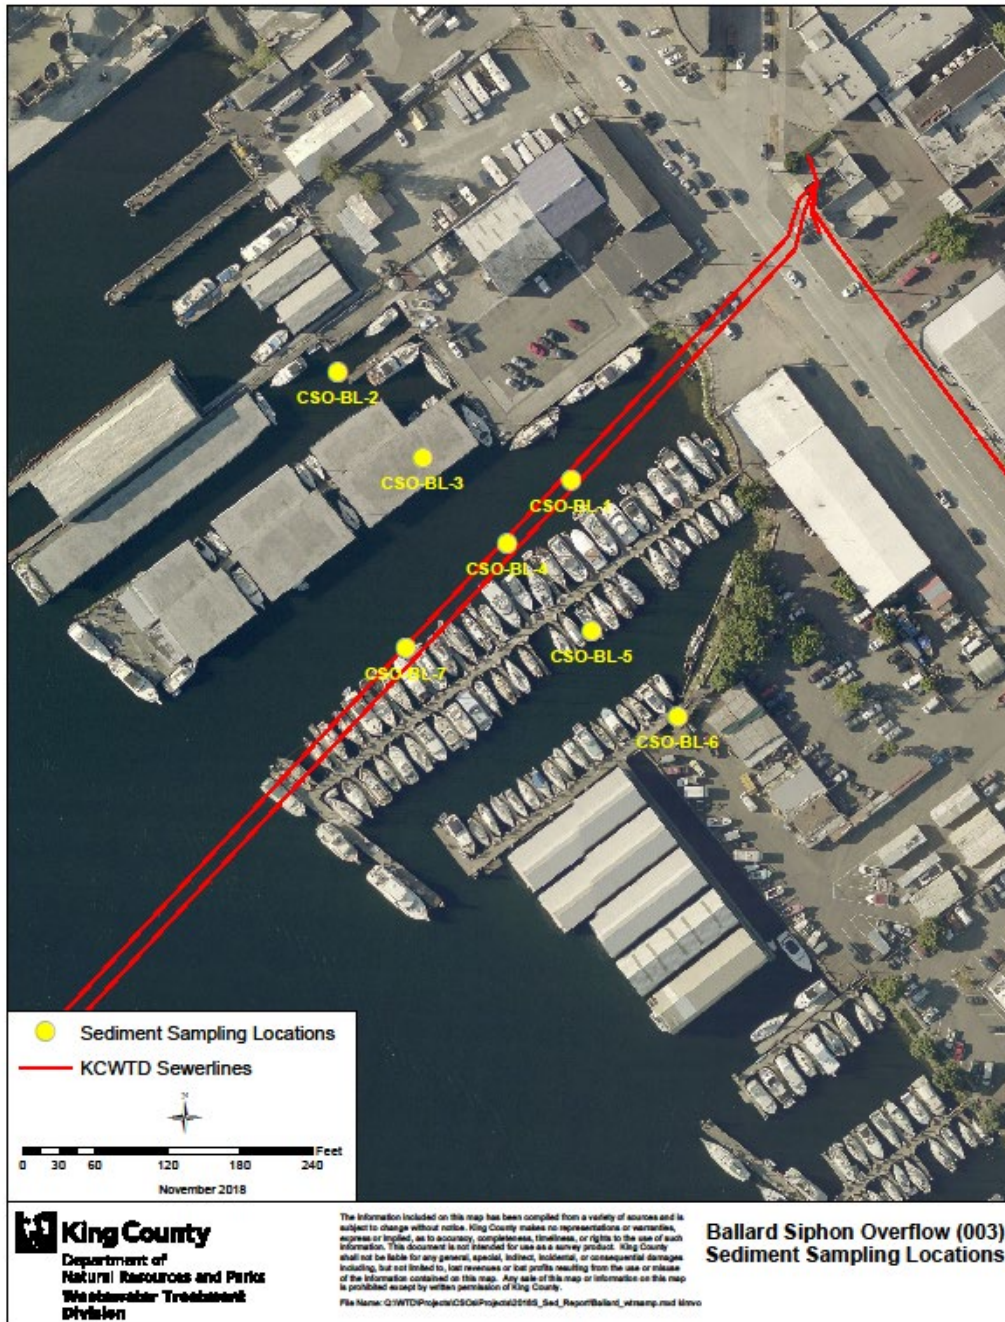
Figure 5-2. Ballard Siphon Regulator (003) Sediment Sampling Location

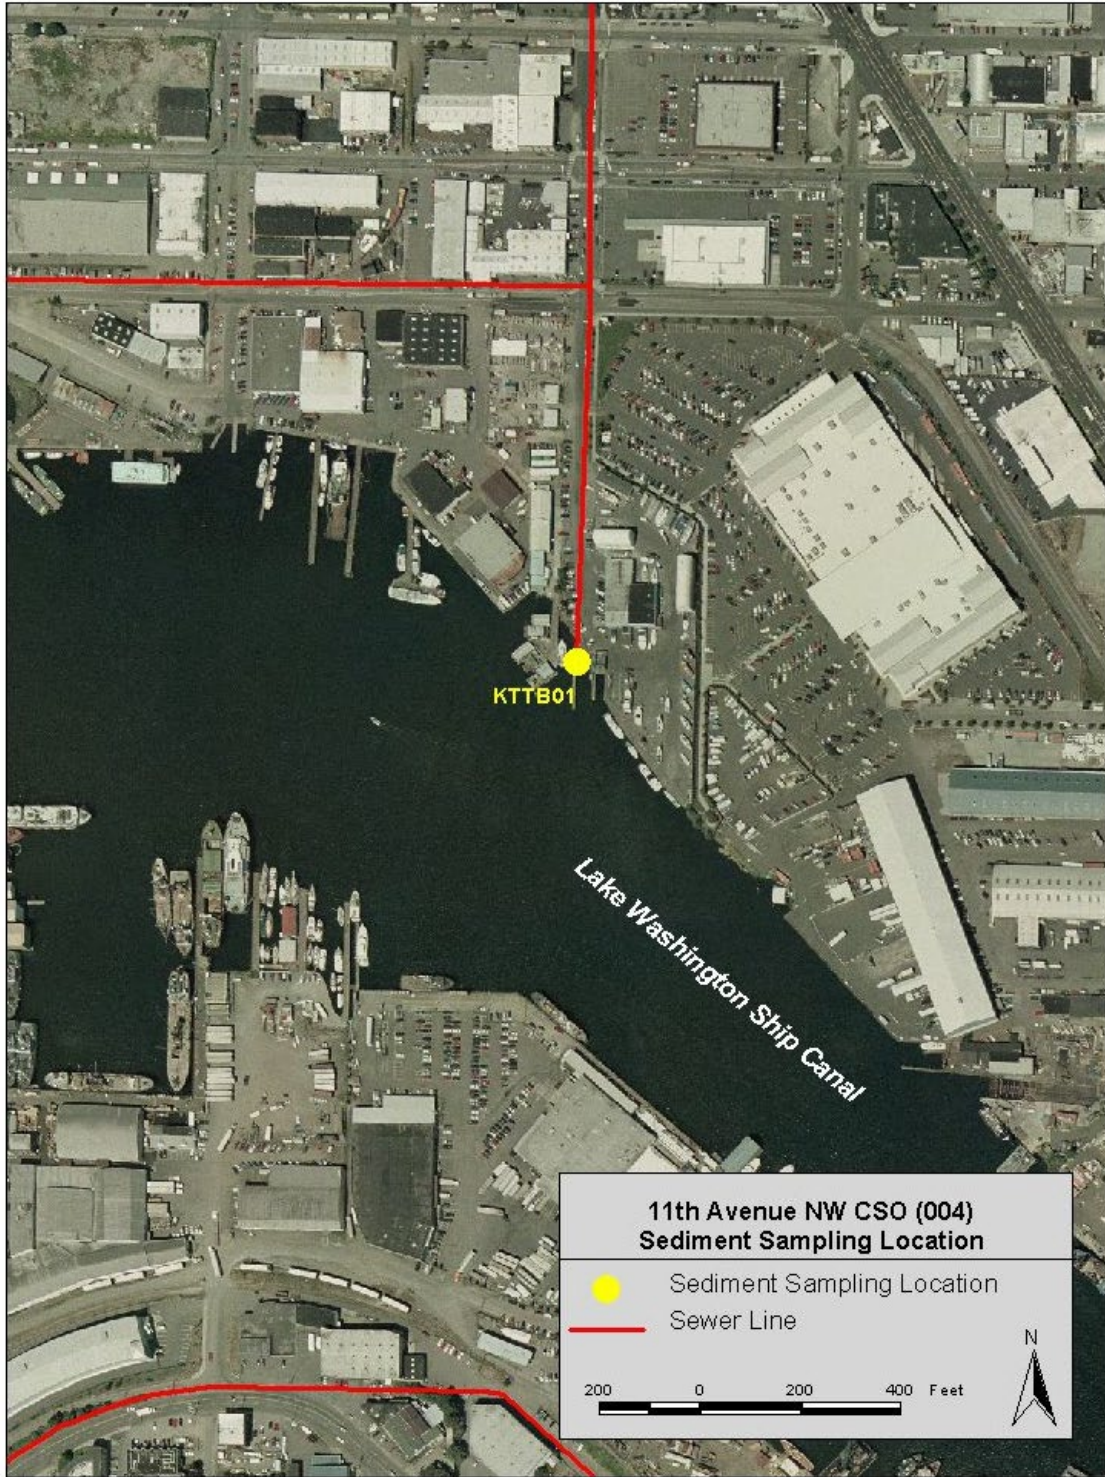
Figure 5-4. 11th Avenue Northwest CSO (004) Sediment Sampling Location

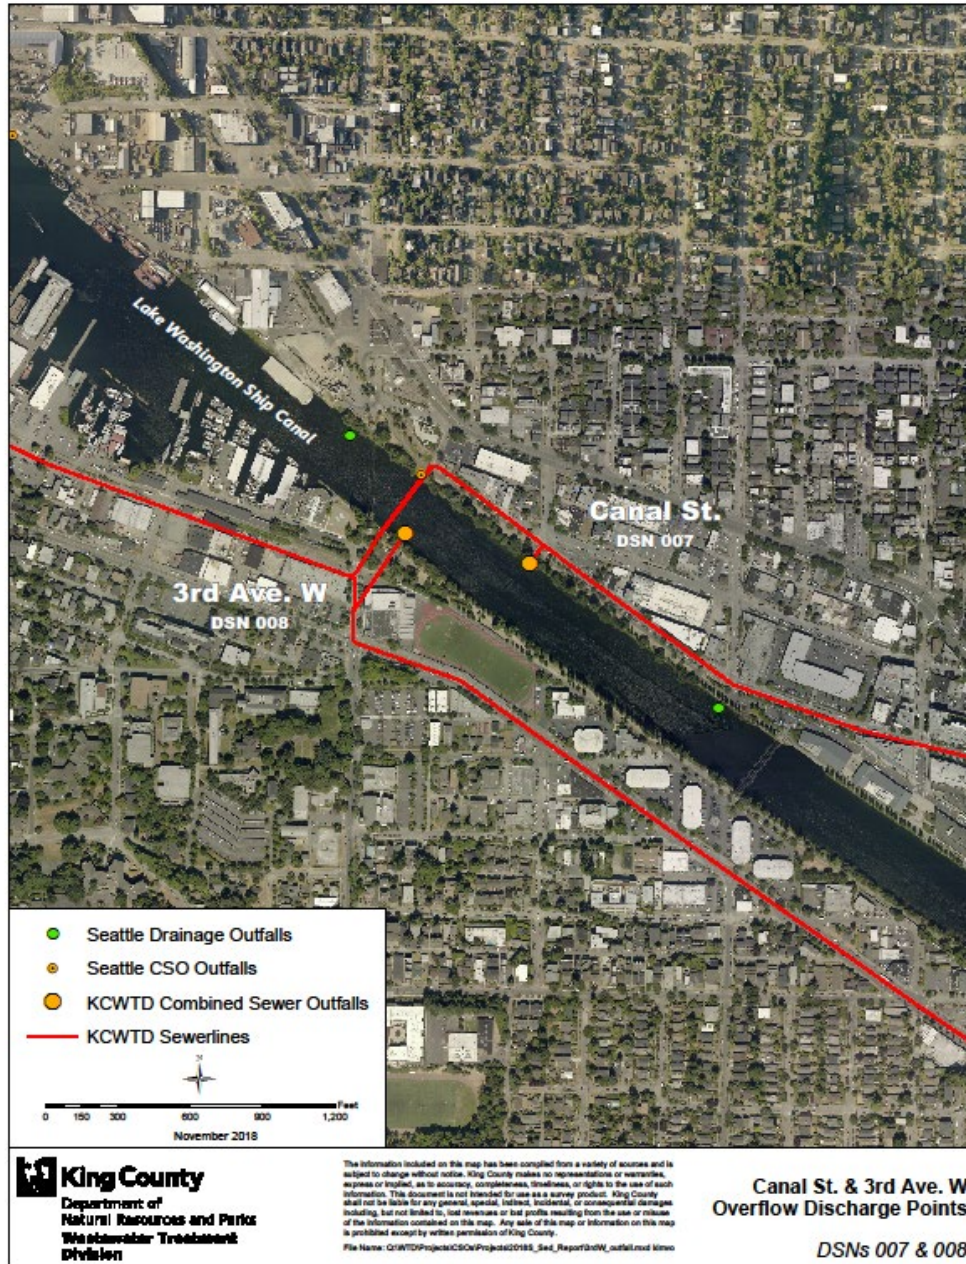
Figure 5-5. 3rd Avenue West CSO Discharge Point

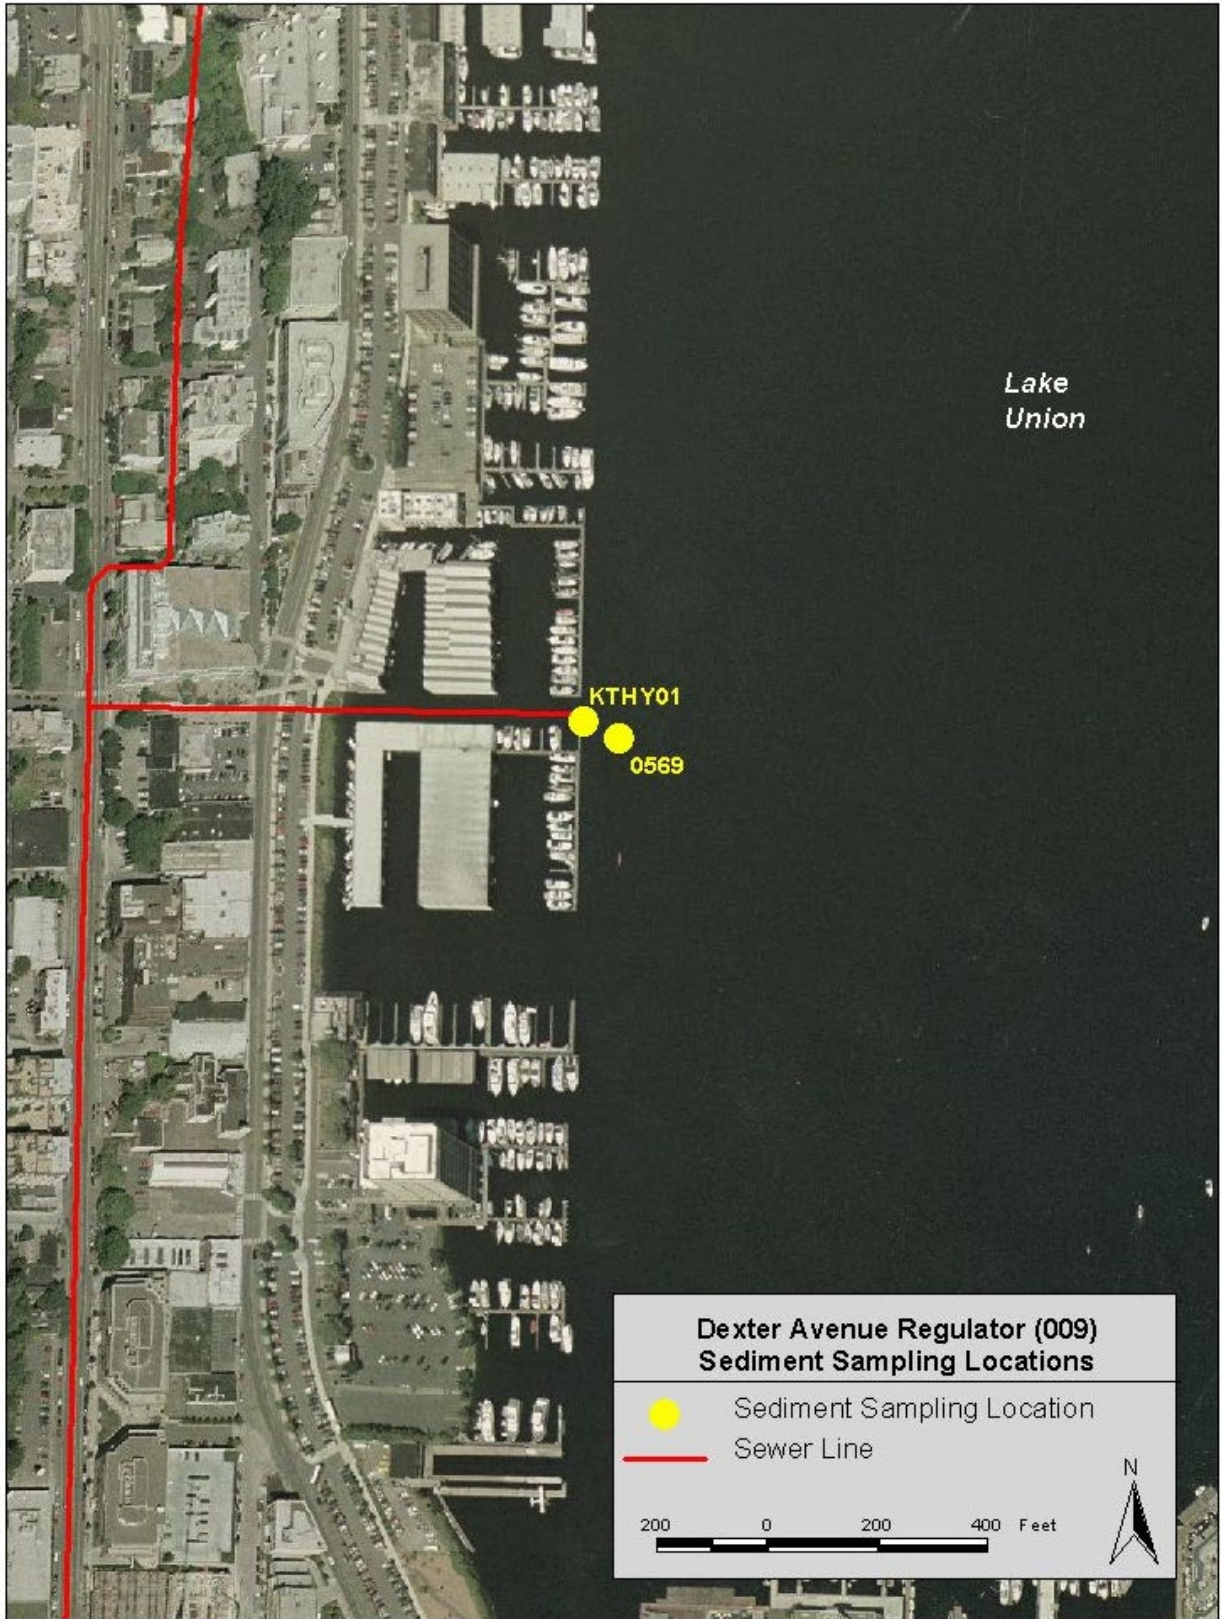
Figure 5-9. Dexter Avenue Regulator Station (009) Sediment Sampling Locations

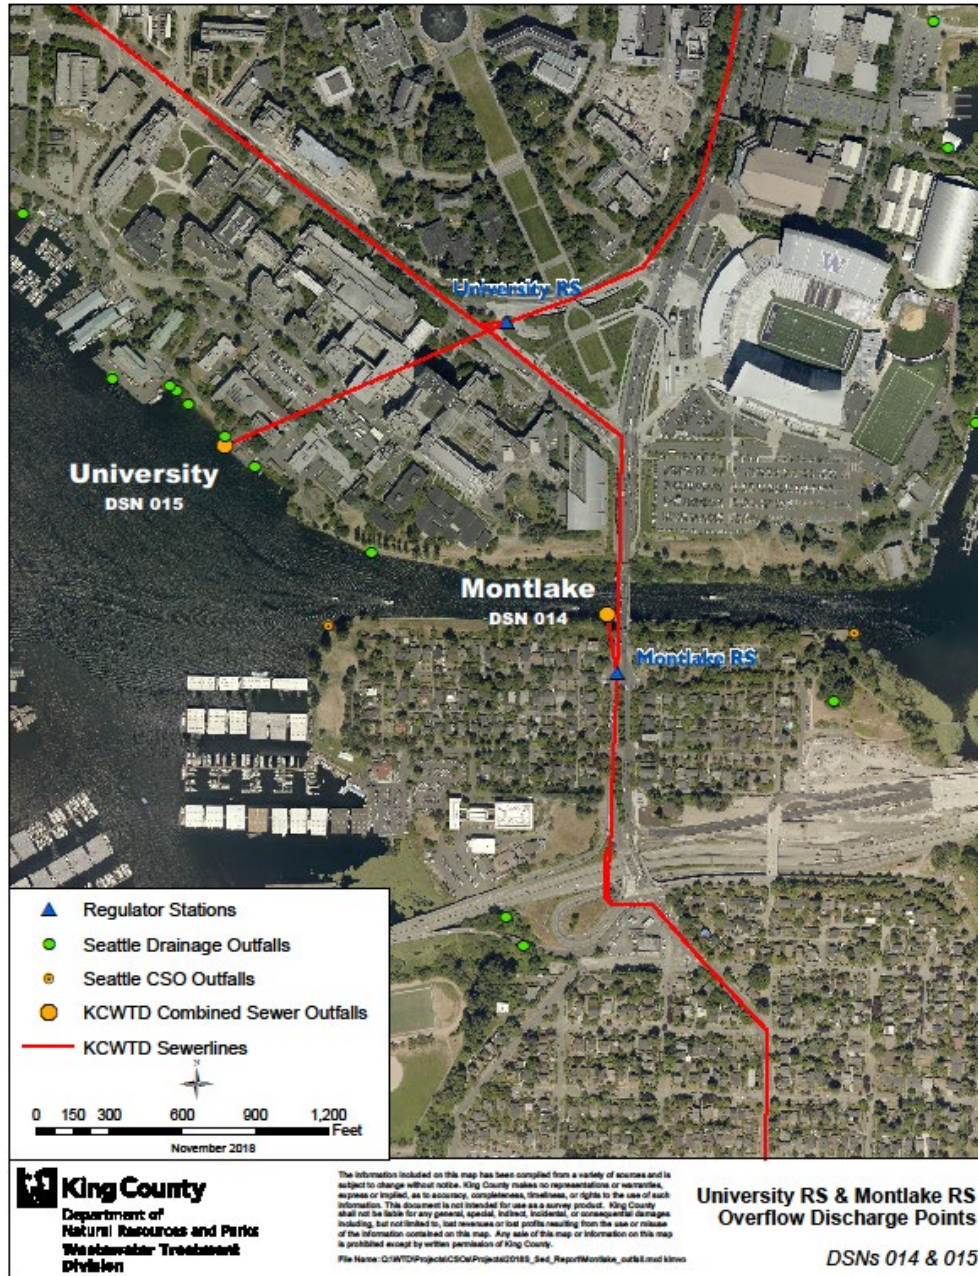
Figure 5-10. University Regulator Station CSO Discharge Point

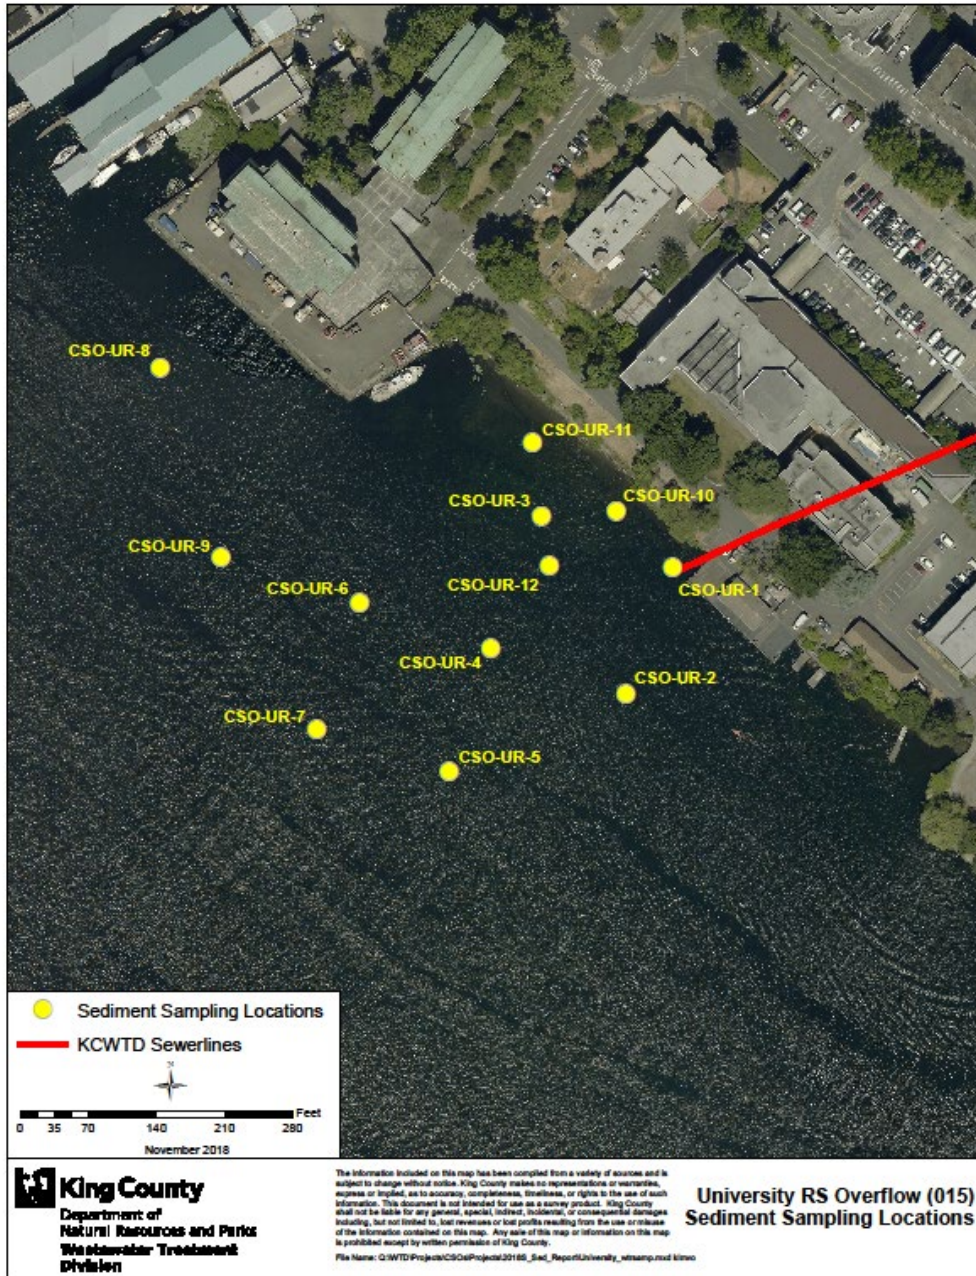
Figure 5-11. University Regulator Station (015) Sediment Sampling Location

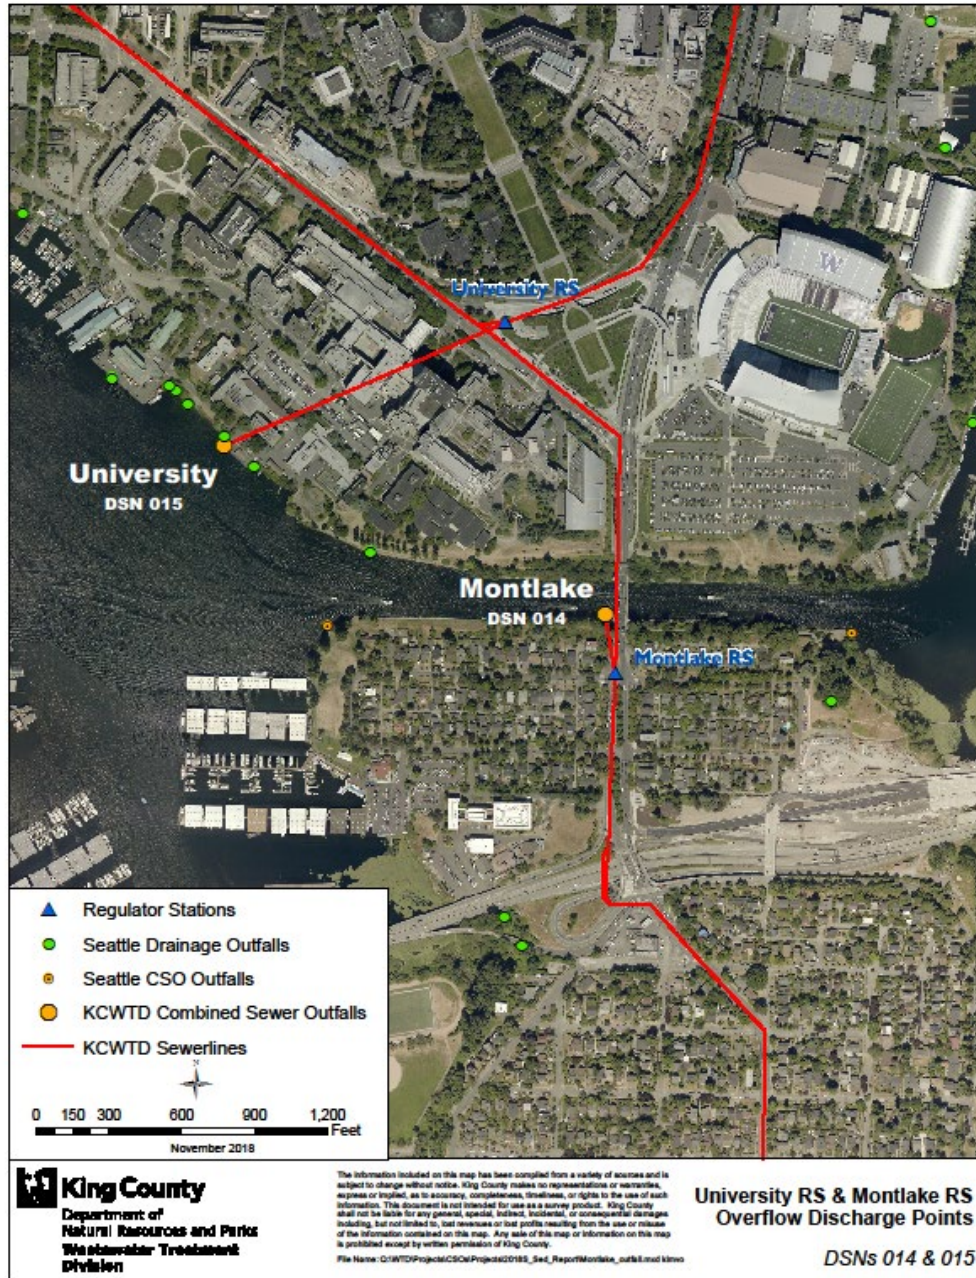
Figure 5-12. University and Montlake CSOs Discharge Points

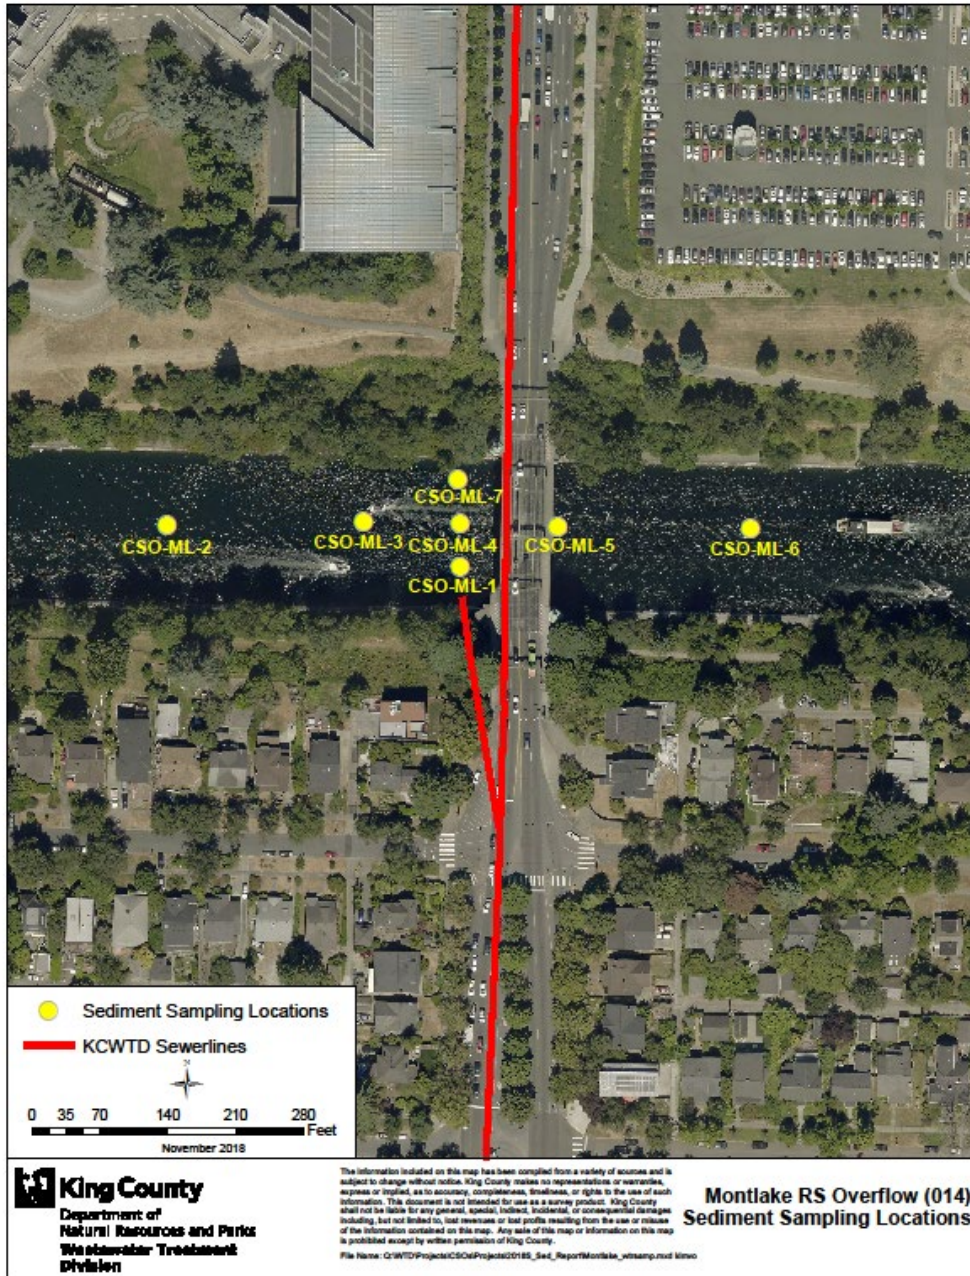
Figure 5-13. Montlake Regulator Station CSO (014) Sediment Sampling Location

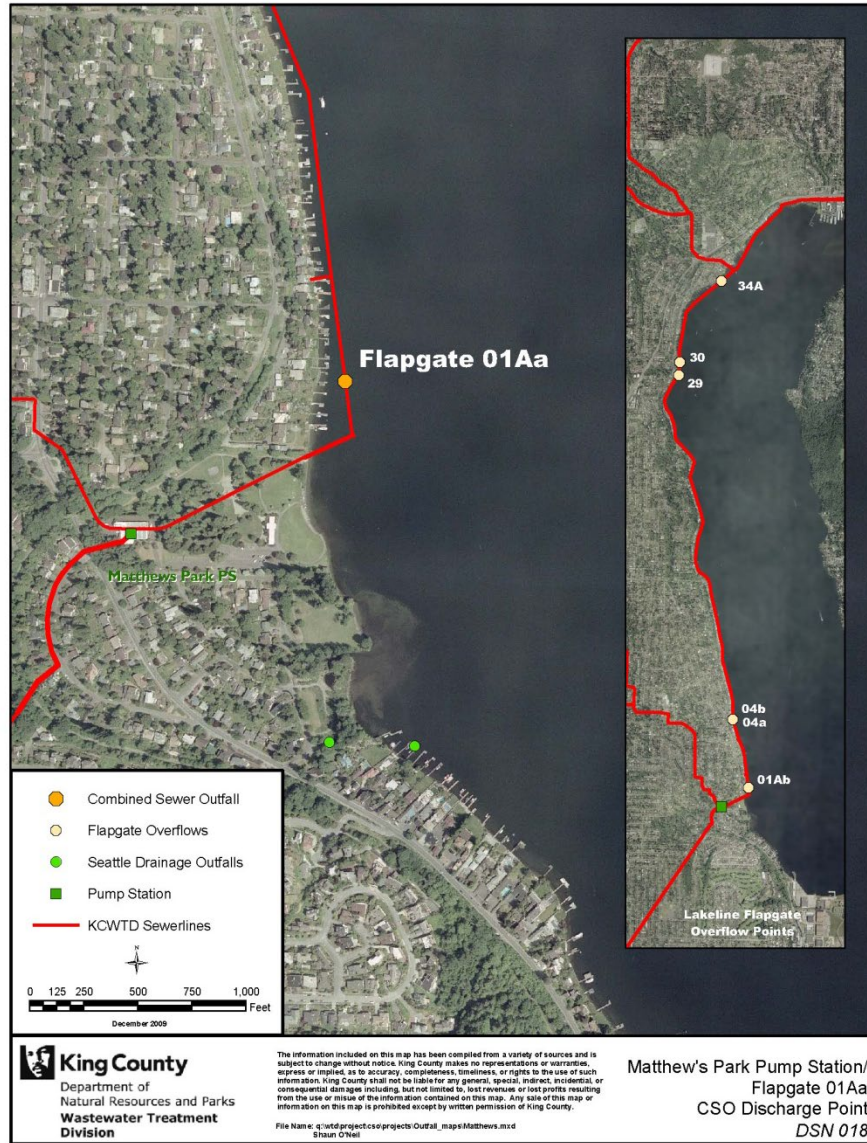
Figure 6-1. Matthew's Park Pump Station CSO Discharge Point (Flapgate 01Aa)

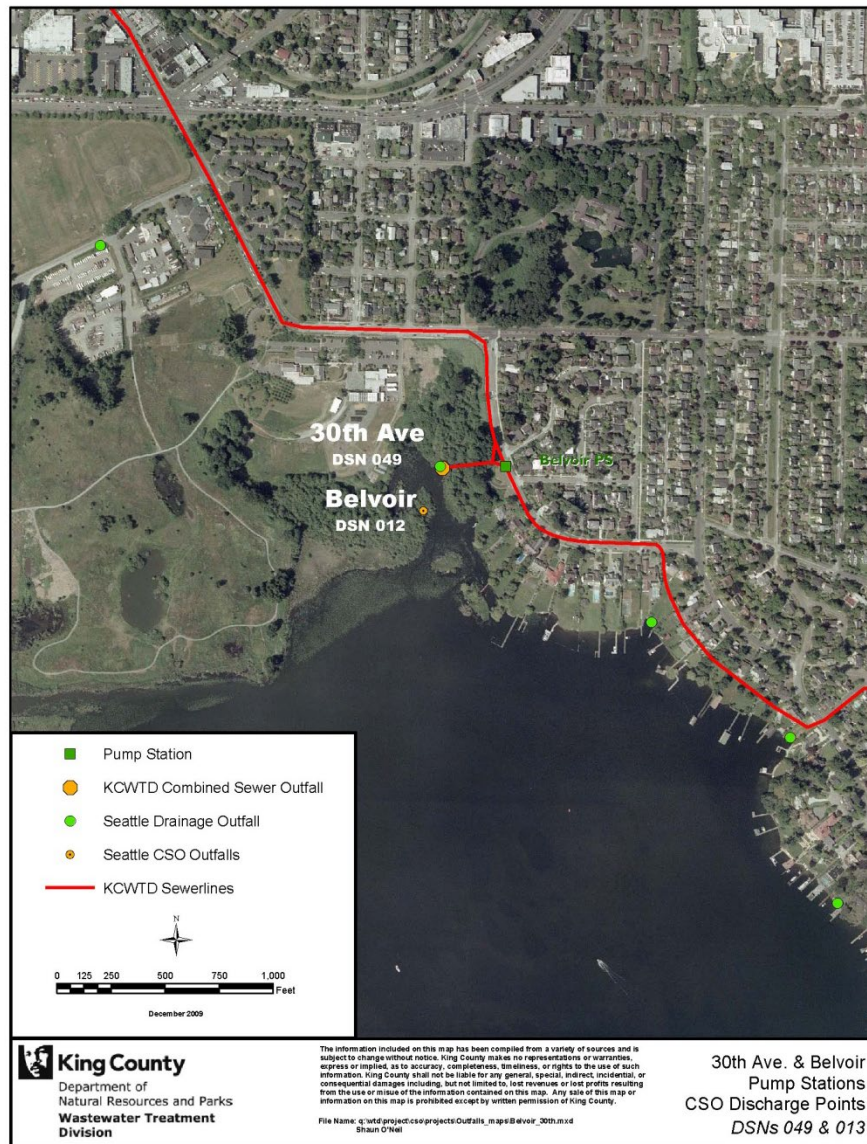
Figure 6-2. 30th Avenue Northeast CSO Discharge Point

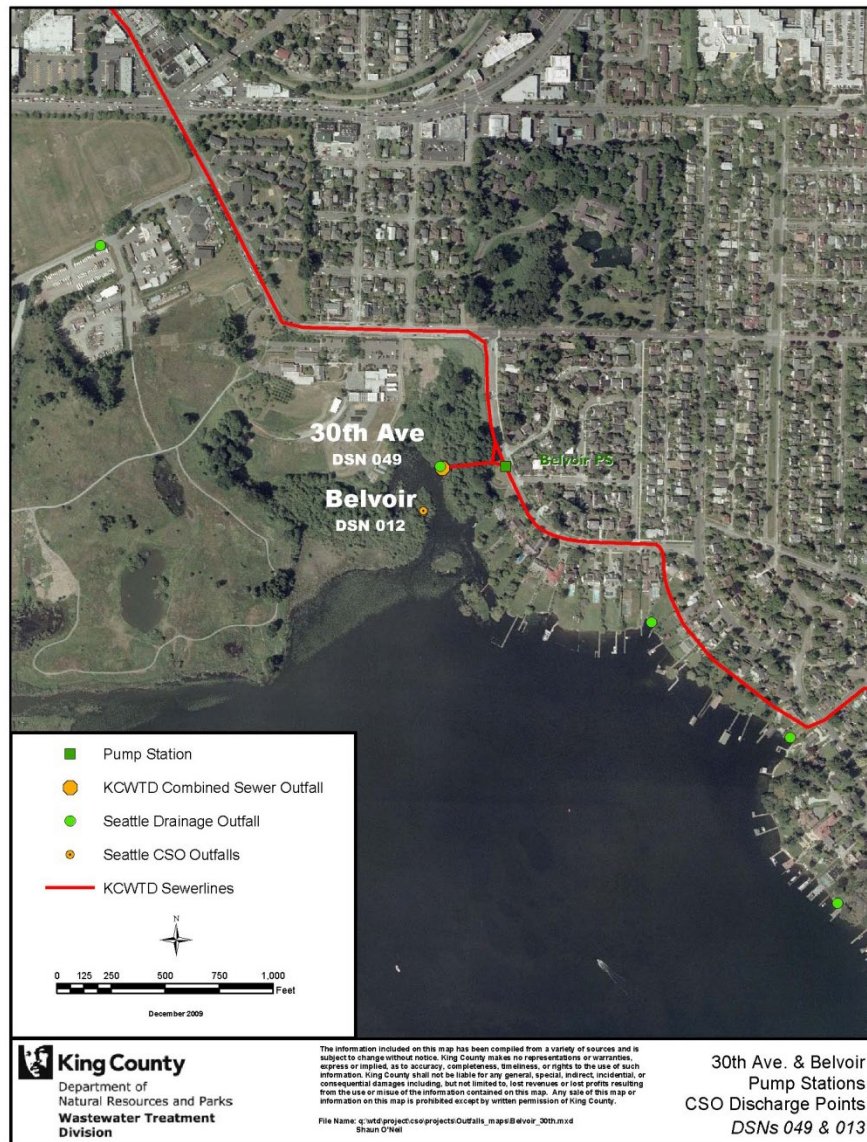
Figure 6-3. Belvoir Pump Station CSO Discharge Point

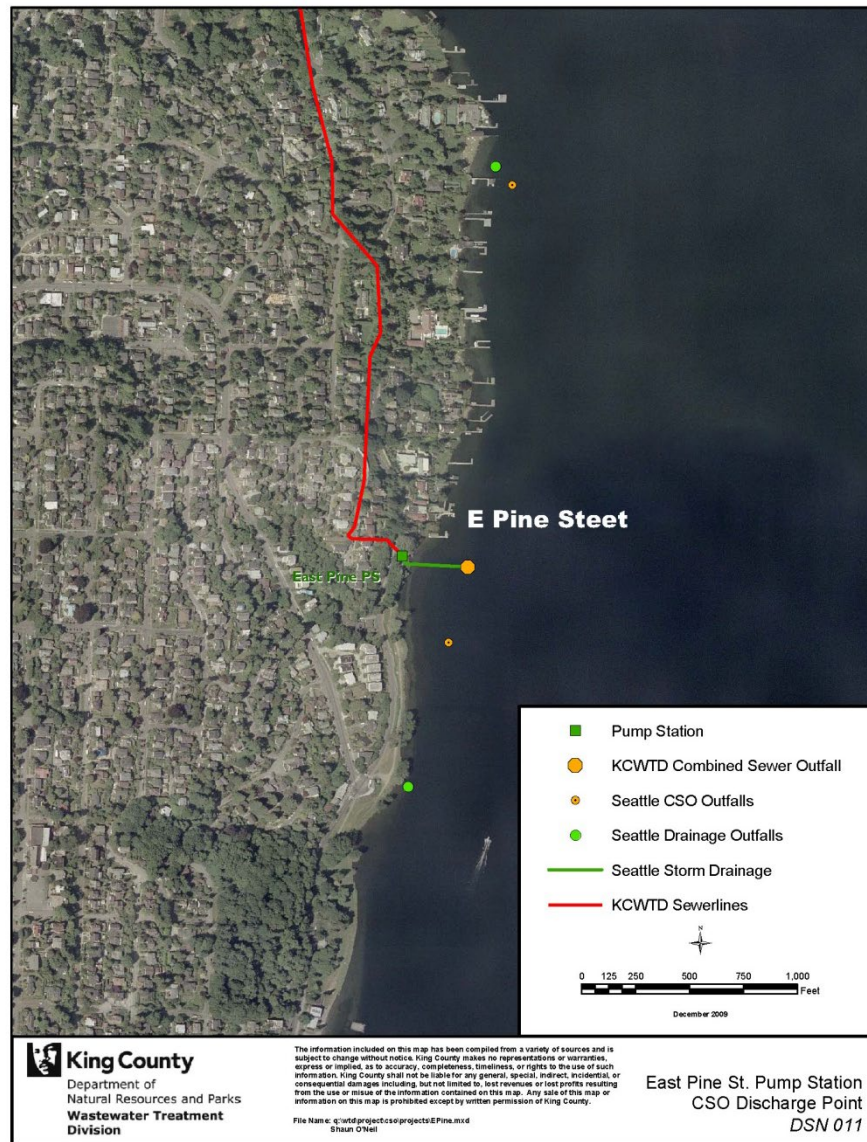
Figure 6-5. East Pine Street CSO Discharge Point

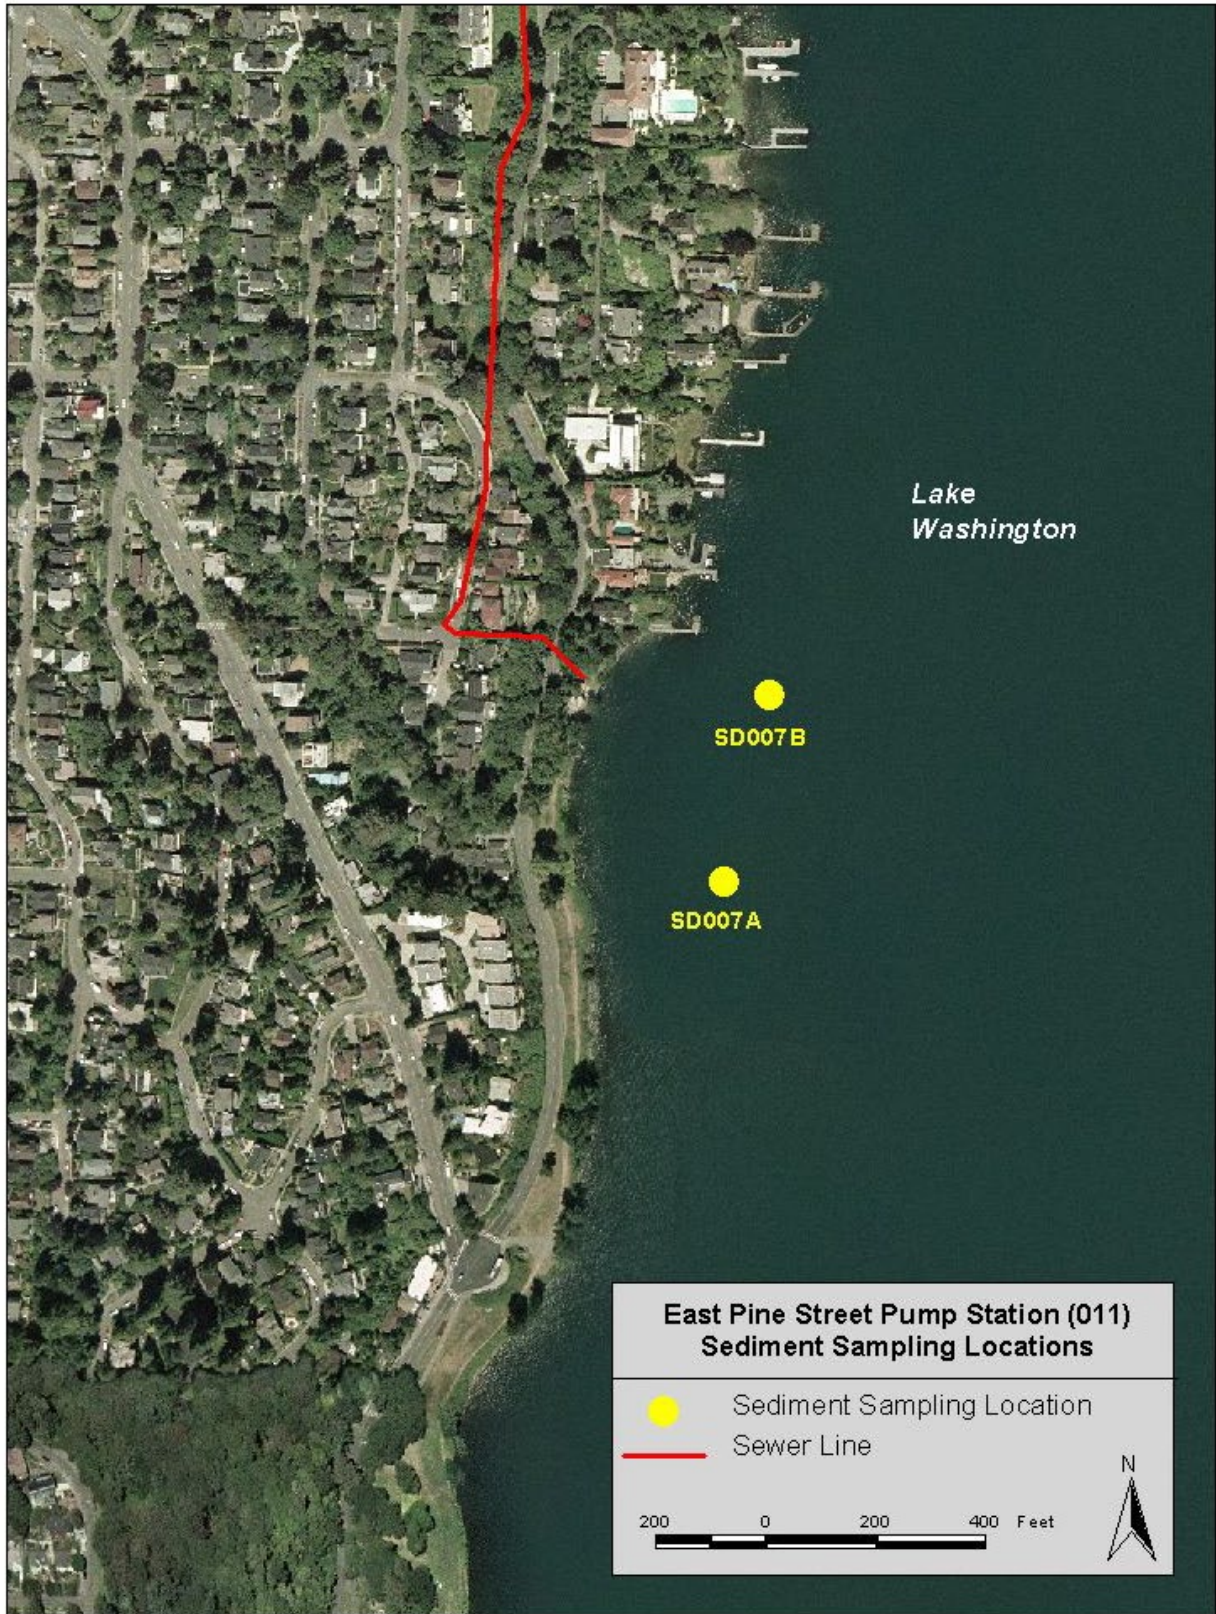
Figure 6-6. East Pine Street (011) Sediment Sampling Locations
