Comprehensive Sediment Quality Summary Report for CSO Discharge Locations

November 2018

King County

Wastewater Treatment Division

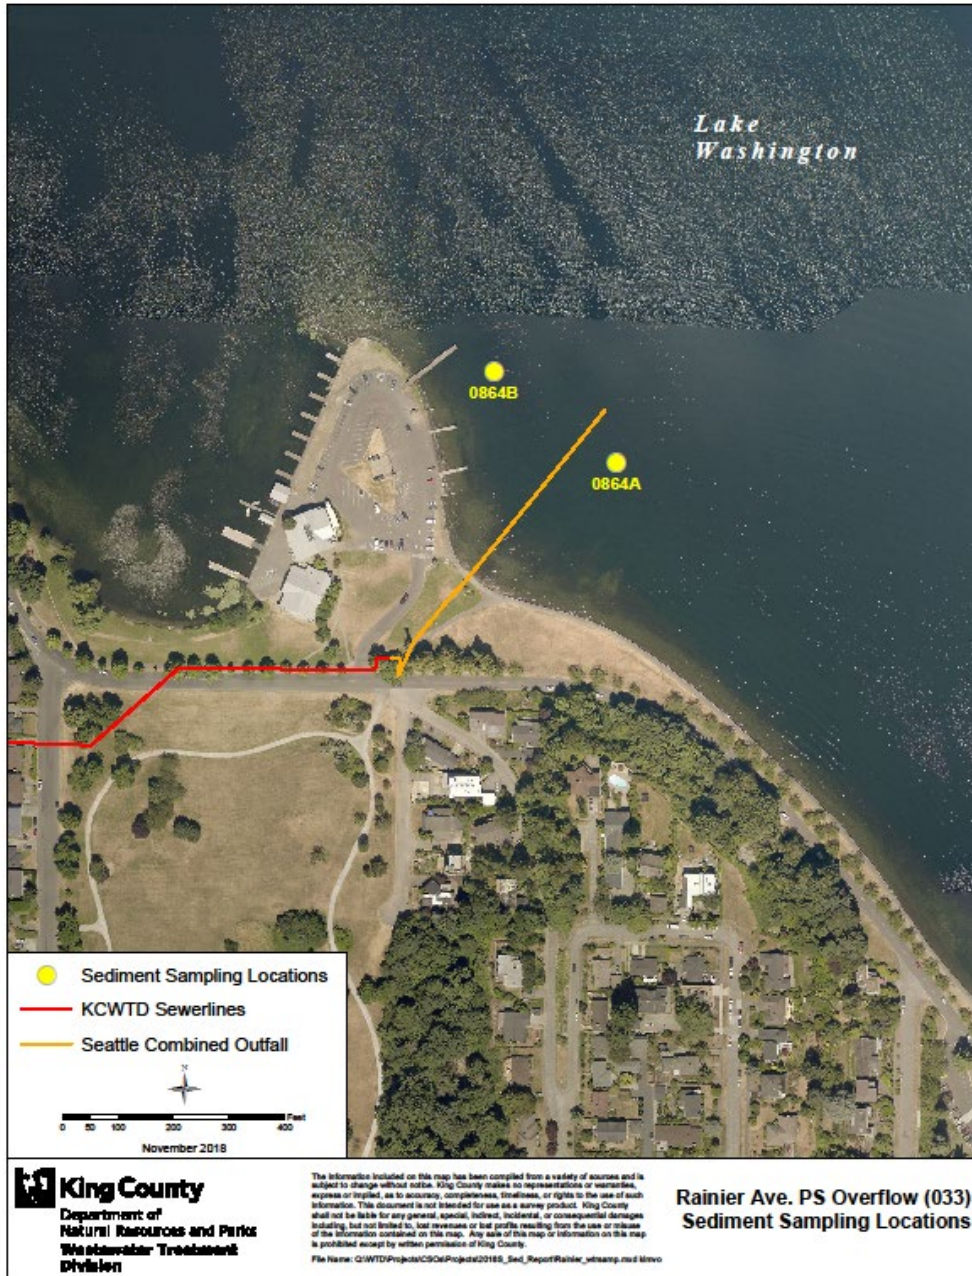
Figure 6-8. Rainier Avenue Pump Station (033) Sediment Sampling Locations

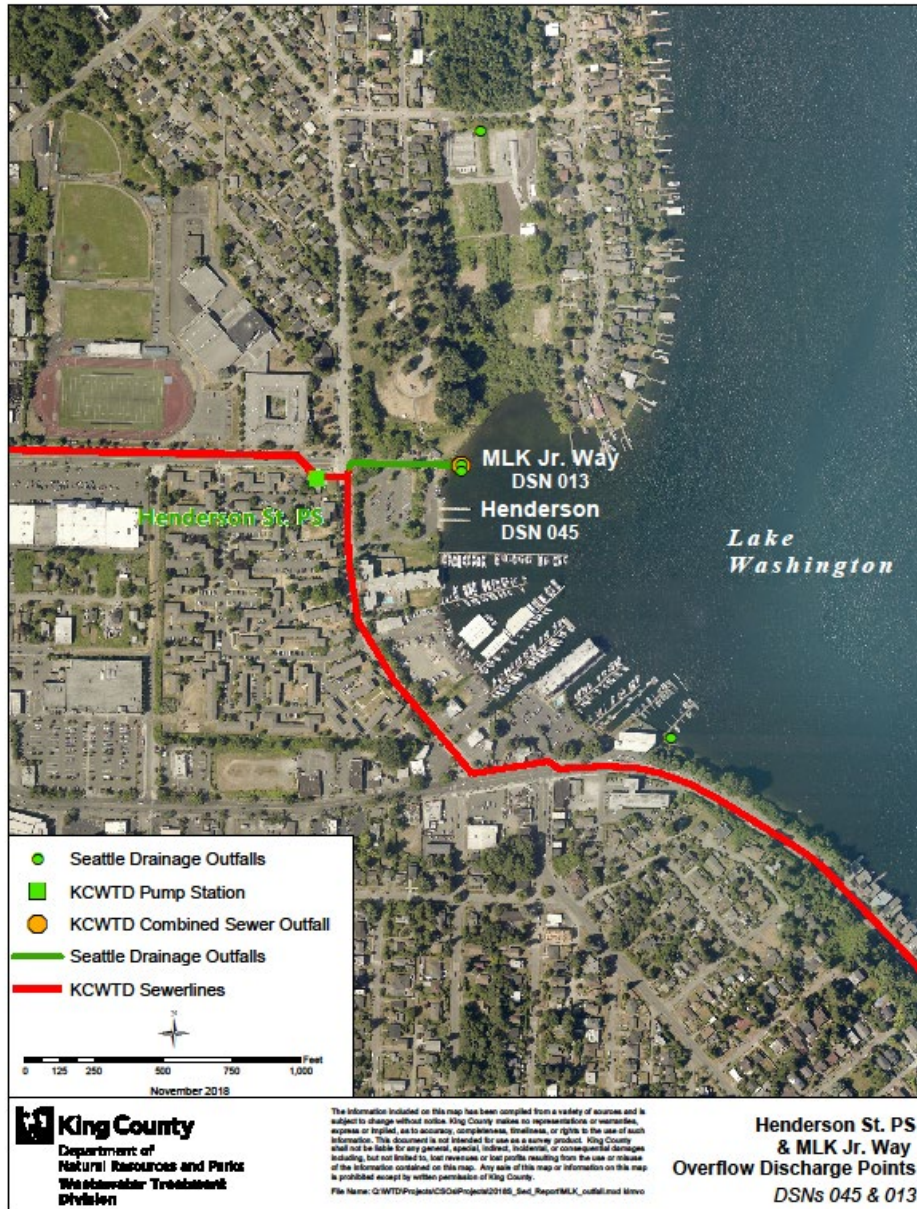
Figure 6-9. Henderson Street Pump Station/Martin Luther King Jr. Way CSOs' Discharge Point
