KING COUNTY PARCEL No. 9353300590

CRITICAL AREA REPORT & BUFFER MITIGATION PLAN

PETERMAN CONSULTING, LLC
12450 80TH AVE S
SEATTLE, WA 98178
(206) 666-8736

REVISED SEPTEMBER 30TH, 2025

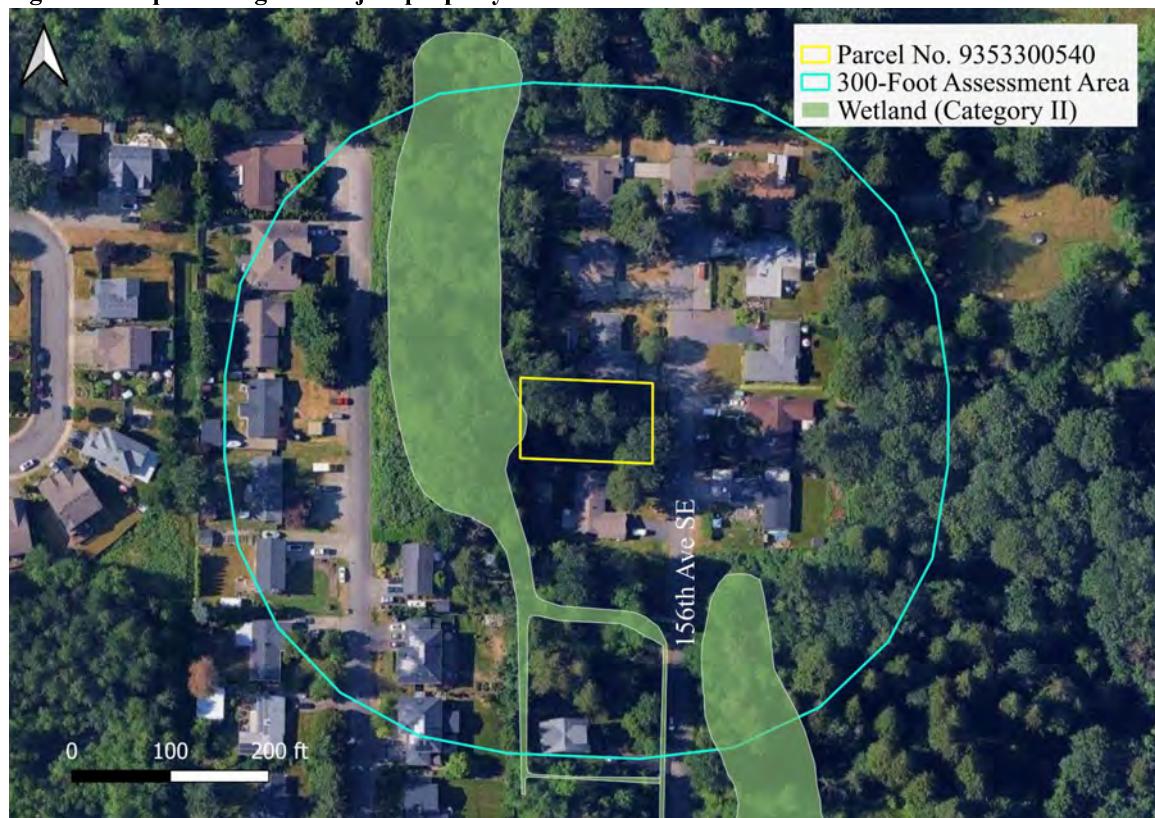
Figure 2. Map showing the subject property and the wetlands.

Peterman Consulting identified one wetland feature (WA) that was found to be partially located on the subject property (Figure 2) and another (WB) that was located entirely offsite but within 300 feet. The onsite wetland contained all three wetland criteria defined in the U.S. Army Corps of Engineers' (USACE) *Federal Wetland Delineation Manual* (1987), and the USACE's *Regional Supplement to the Corps of Engineers Wetland Delineation Manual: Western Mountains, Valleys, and Coast Region (Version 2.0)* (2010). The wetlands were rated according to King County Code (KCC) 21A.24.318 and the Washington State Department of Ecology's (Ecology) *Washington State Wetland Rating System for Western WA – 2014 Update* (Hruby 2014). A delineation summary, field

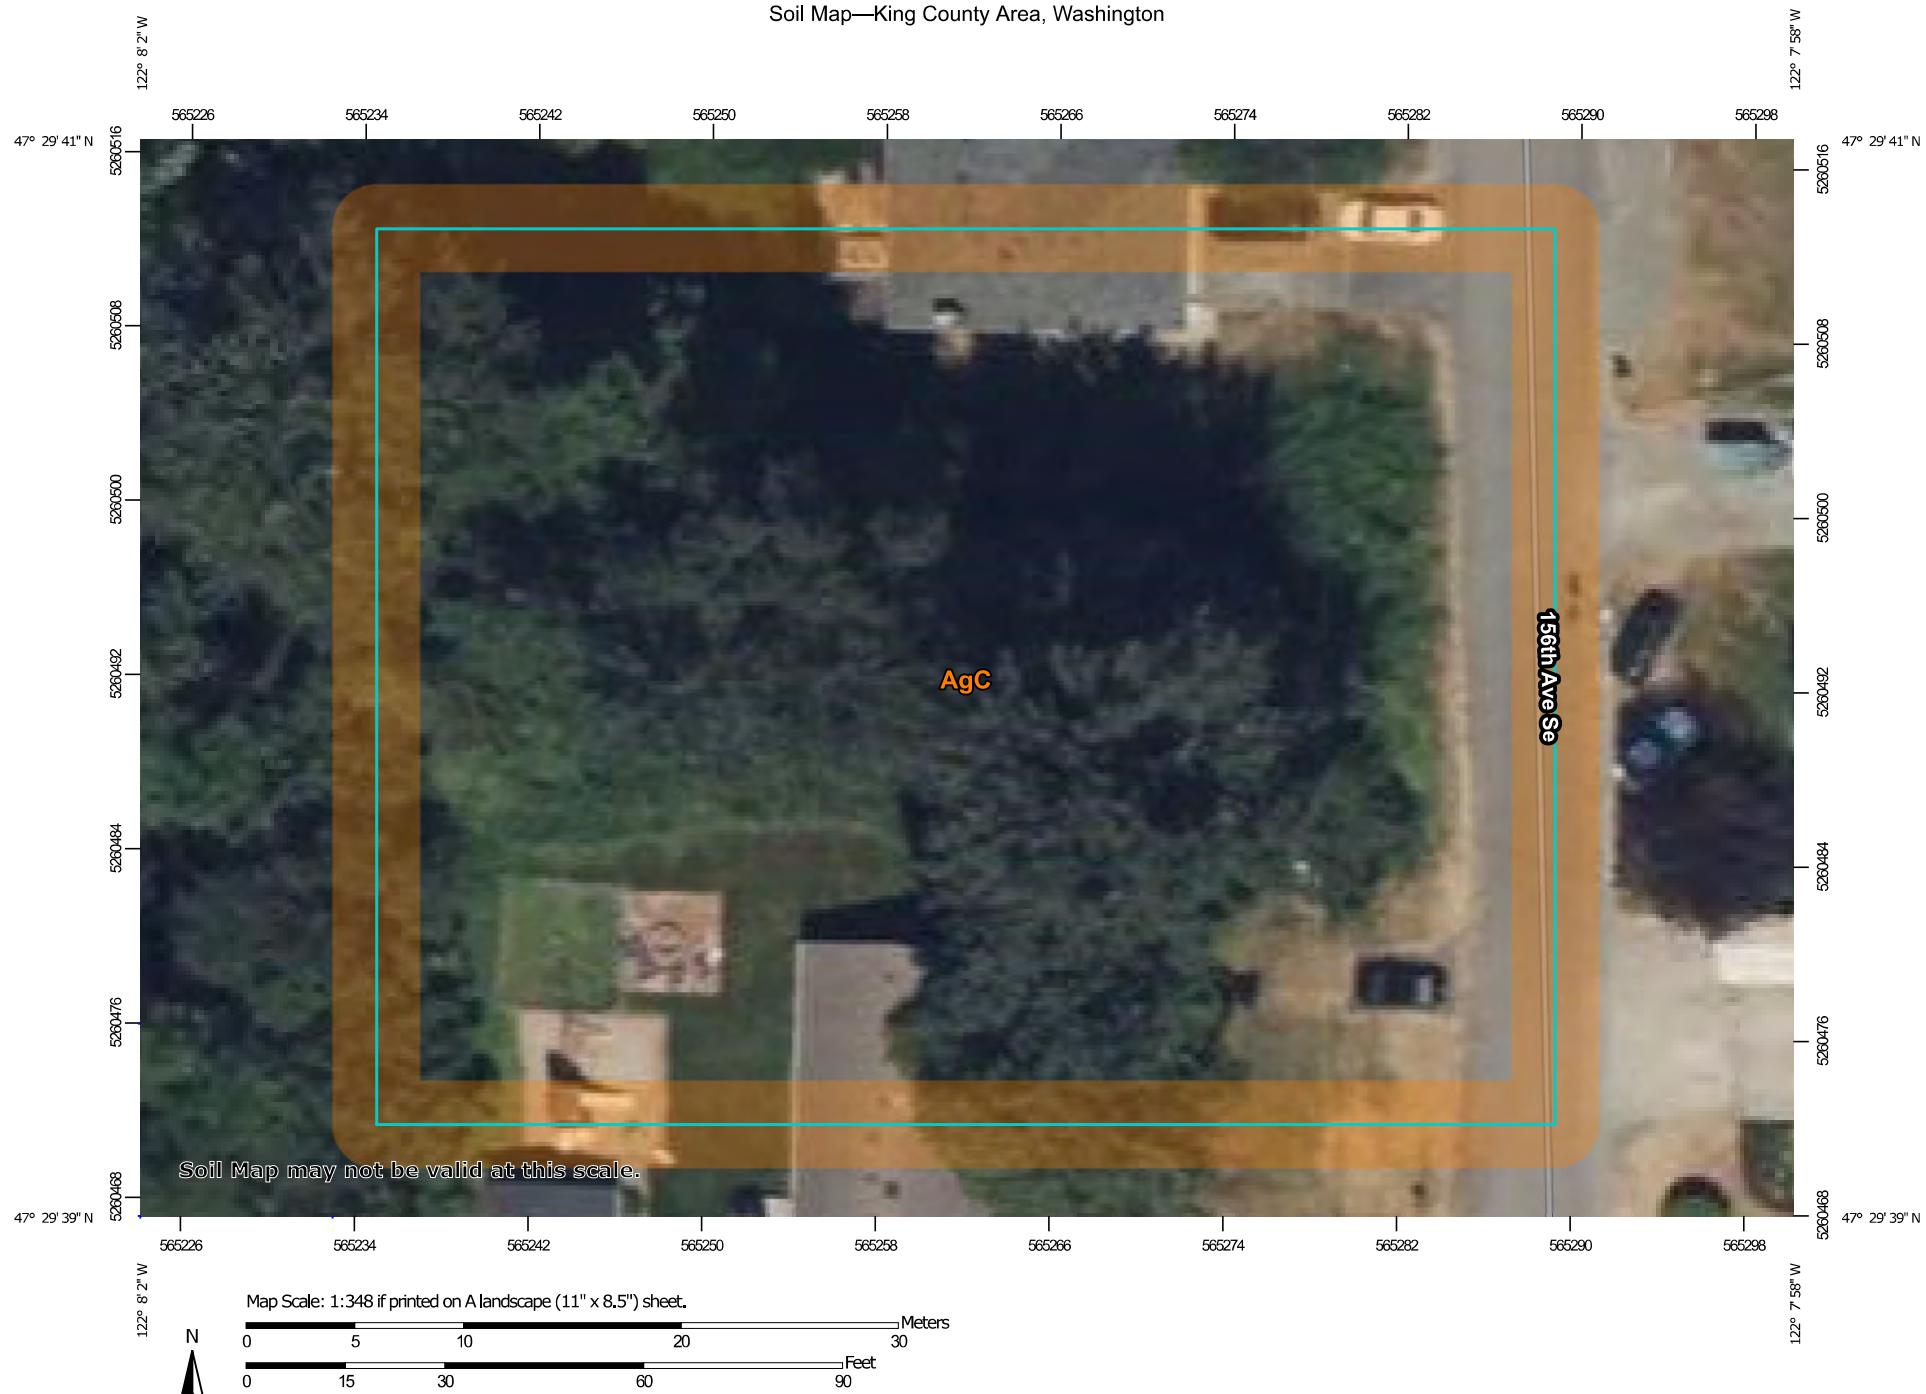
Soil Map—King County Area, Washington

According to the Natural Resources Conservation Service's (NRCS) Web Soil Survey (NRCS 2024), the soils on the subject property are listed as being 85 percent Alderwood gravelly sandy loam and 15 percent minor components. Alderwood gravelly sandy loam is not designated as a hydric soil (Appendix E). The other minor component soils on the property are Everett and Indianola both at 5 percent and neither is listed as a hydric soil. Also listed are 3 percent of Shalcar and 2 percent of Norma, both of which are designated as hydric soils.

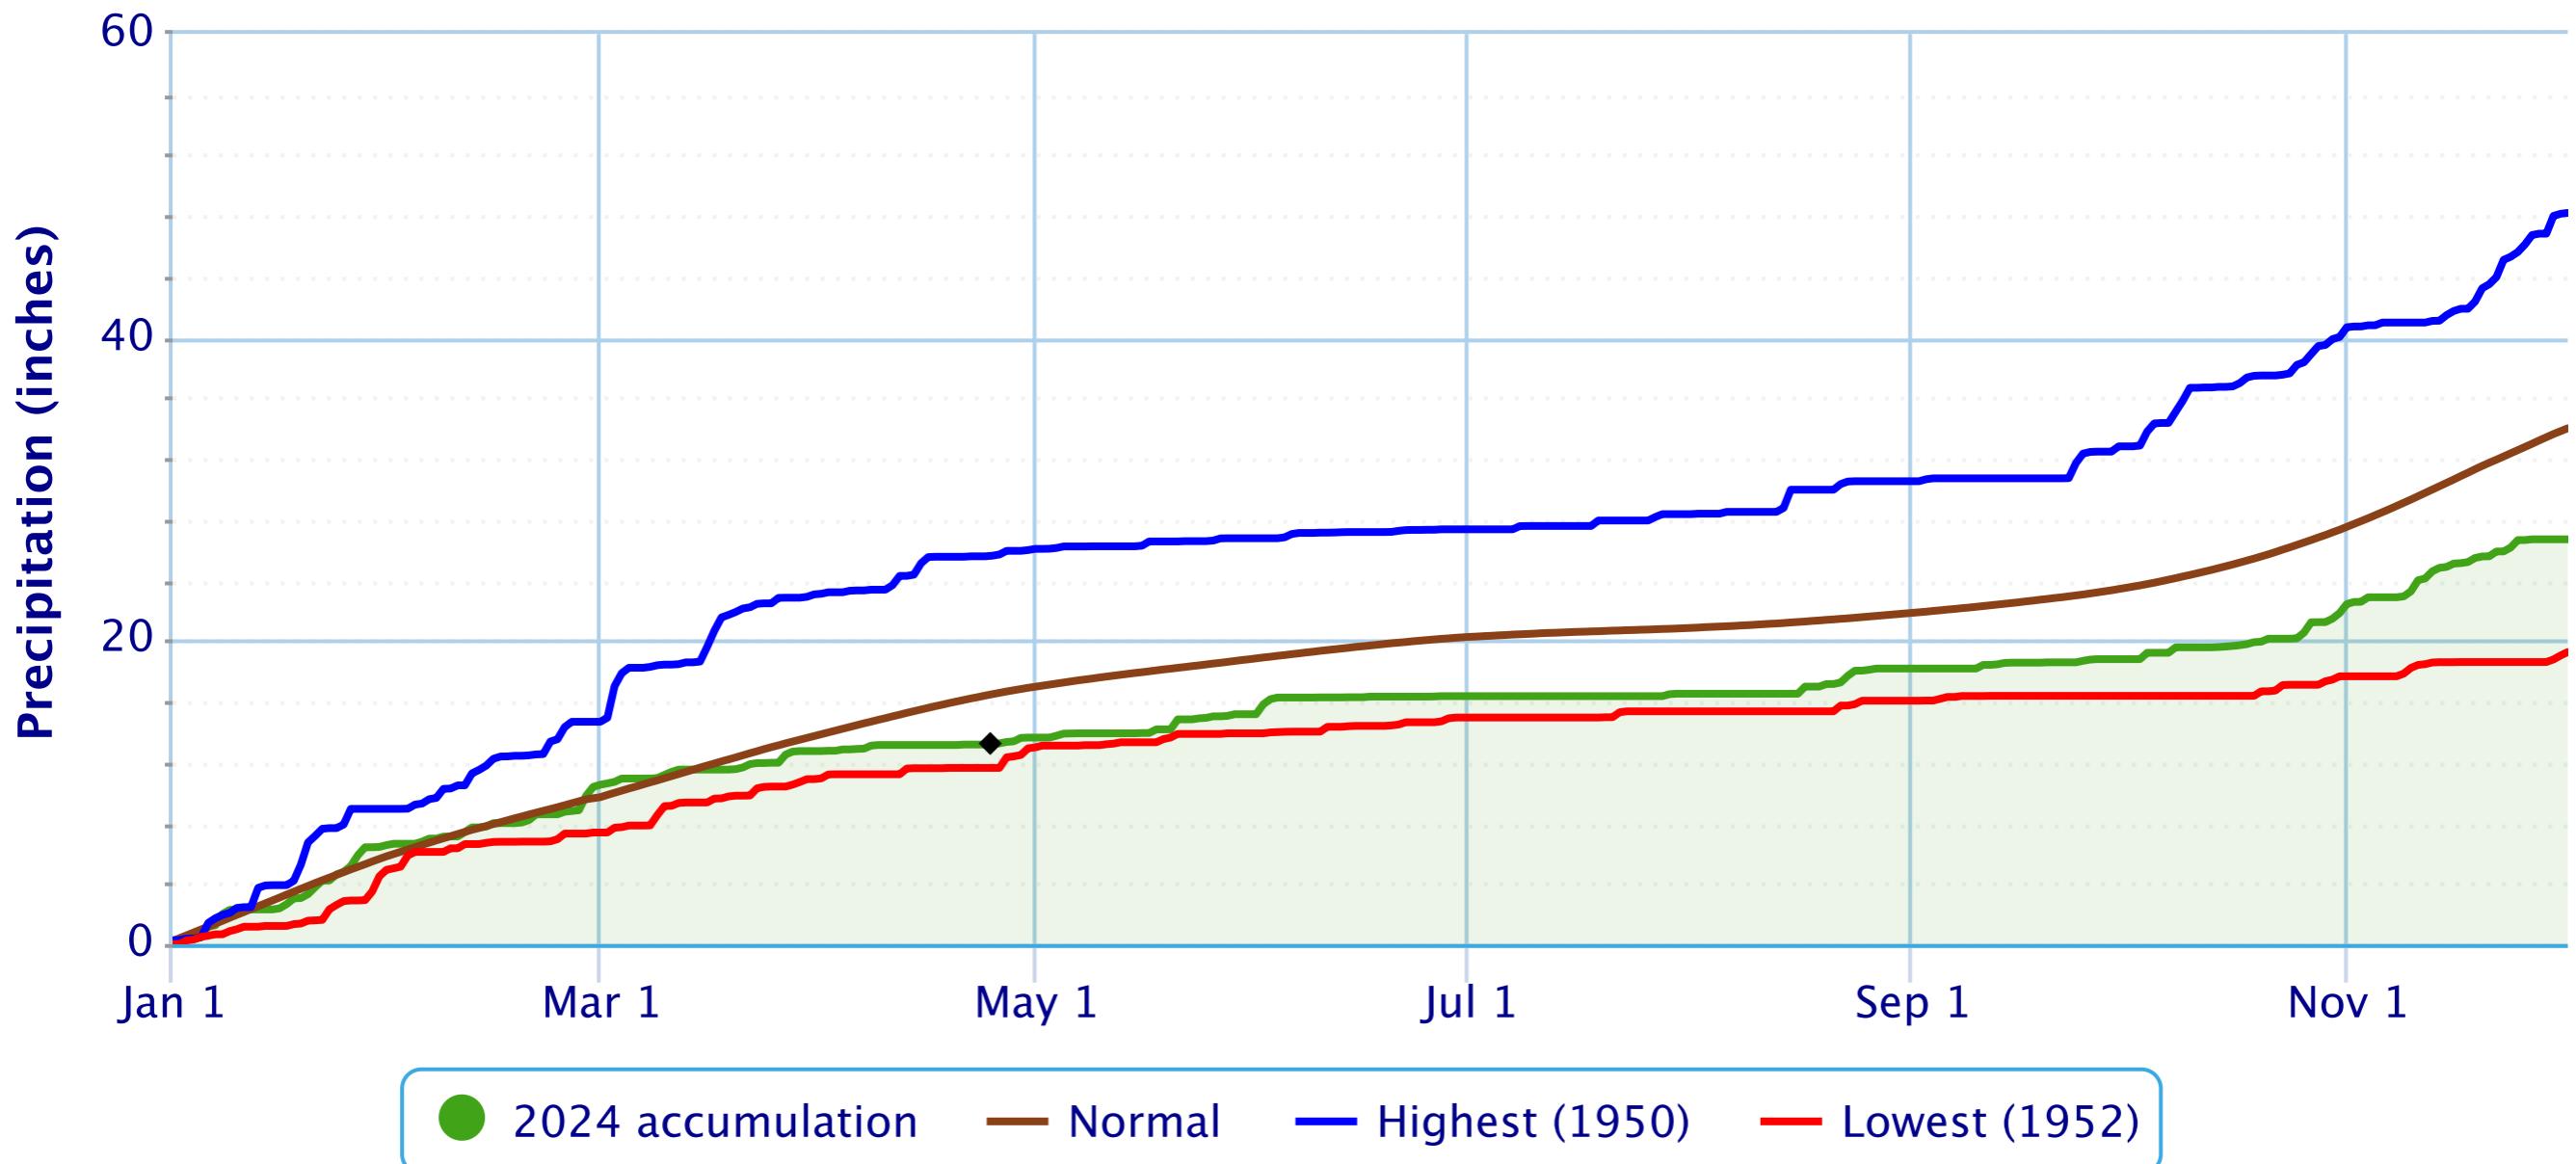
Accumulated Precipitation – SEATTLE TACOMA AIRPORT, WA

Bins were established to evaluate the overall rainfall period during the field investigation; drier (sum in 6-9), normal (sum is 10-14), wet (sum is 15-18). A sum of 11 indicates that hydrologic conditions are normal. Data from the start of the year for the accumulated precipitation for that weather station shows that it has remained below the normal average since the end of March (Appendix E).

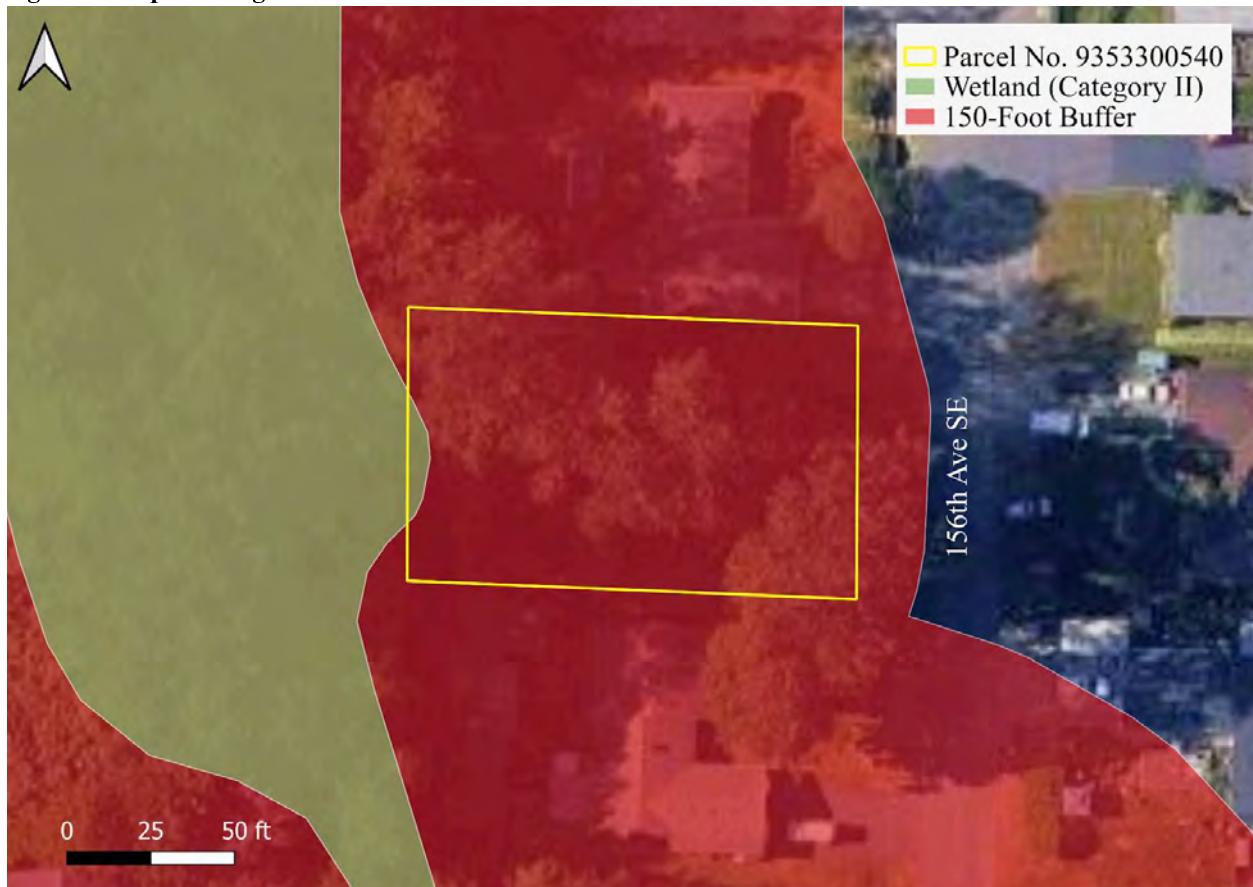
Figure 1. Map showing the wetland and buffer.

The wetland's buffer is defined according to King County Code (KCC) 21A.24.325. The wetland is rated as a Category II feature (Table 1). According to KCC 21A.24.325, the wetland buffer is 150-feet for Category II wetlands with moderate habitat scores within the Urban Growth Area. The entire subject property is situated within the wetland's buffer.
