**CRITICAL AREAS REPORT
&
MITIGATION PLAN**

**King County Tax Parcel 935330-0870
King County, Washington**

Report Title: Critical Areas Report & Mitigation Plan
King County, Washington

Project Number: EE-475

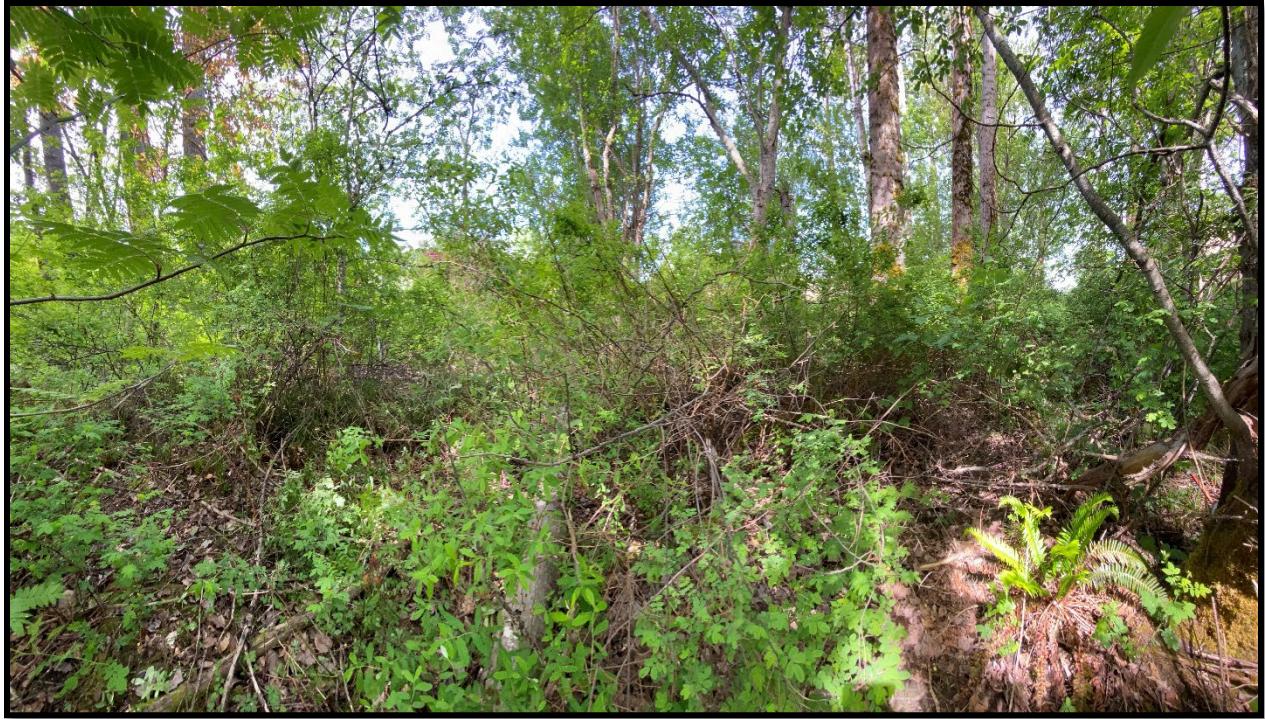
Wetland A is a 5,256-sf wetland located in the southern portion of the Site and continues offsite to the south (**Photo 1**). This wetland has a depressional hydrogeomorphic classification (Brinson, 1993) and palustrine forested Cowardin classification (Cowardin *et al.* 1979).

Photo 1. Photo of Wetland A facing to the south.

Vegetation within Wetland A includes black cottonwood (*Populus trichocarpa*), red alder (*Alnus rubra*), cluster rose (*Rosa pisocarpa*), cutleaf blackberry (*Rubus laciniatus*), English hawthorn (*Crataegus monogyna*), Himalayan blackberry (*Rubus bifrons*), English holly (*Ilex aquifolium*), salmonberry (*Rubus spectabilis*), hardhack (*Spiraea douglasii*), English ivy (*Hedera helix*), and slough sedge (*Carex obnupta*).

Soils within Wetland A are characterized by a black (7.5YR 2/1) sandy loam surface layer from 0-17 inches, underlain by a brown (10YR 4/2) sandy loam with prominent dark yellowish brown (10YR 4/4) redoximorphic concentrations from 17-20+ inches below the surface. These characteristics meet the criteria for the *Thick Dark Surface* (A12) Hydric Soil Indicator. Hydrology within Wetland A is supported by groundwater and precipitation. Hydrologic indicators observed during the Site visit include *High Water Table* (A2) and *Saturation* (A3).

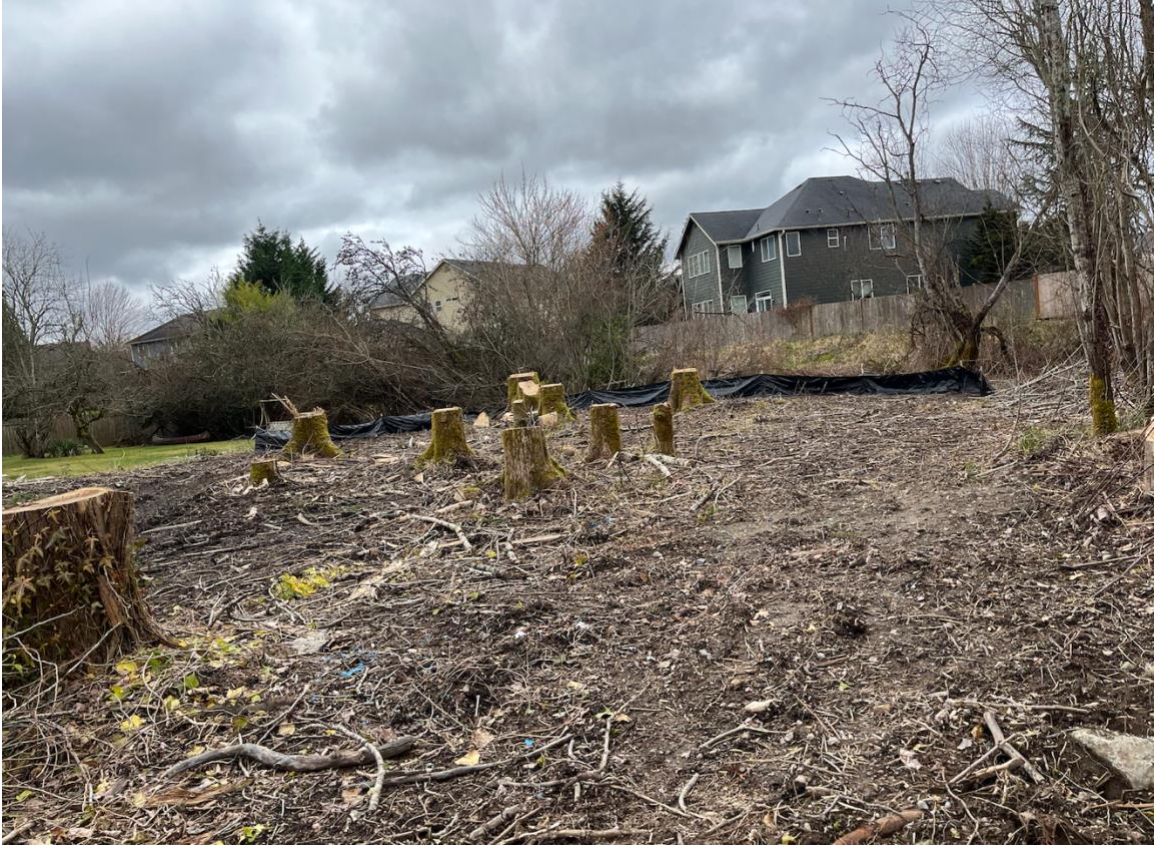
Figure 1. Site.

Some standing water and saturated soils were observed in the wetland.

The wetland rating form was completed as if the wetland were still forested, and determined to be Category III with 3 habitat points, which, in R4 zoning, results in an 80-foot buffer, plus a 15 foot building setback.

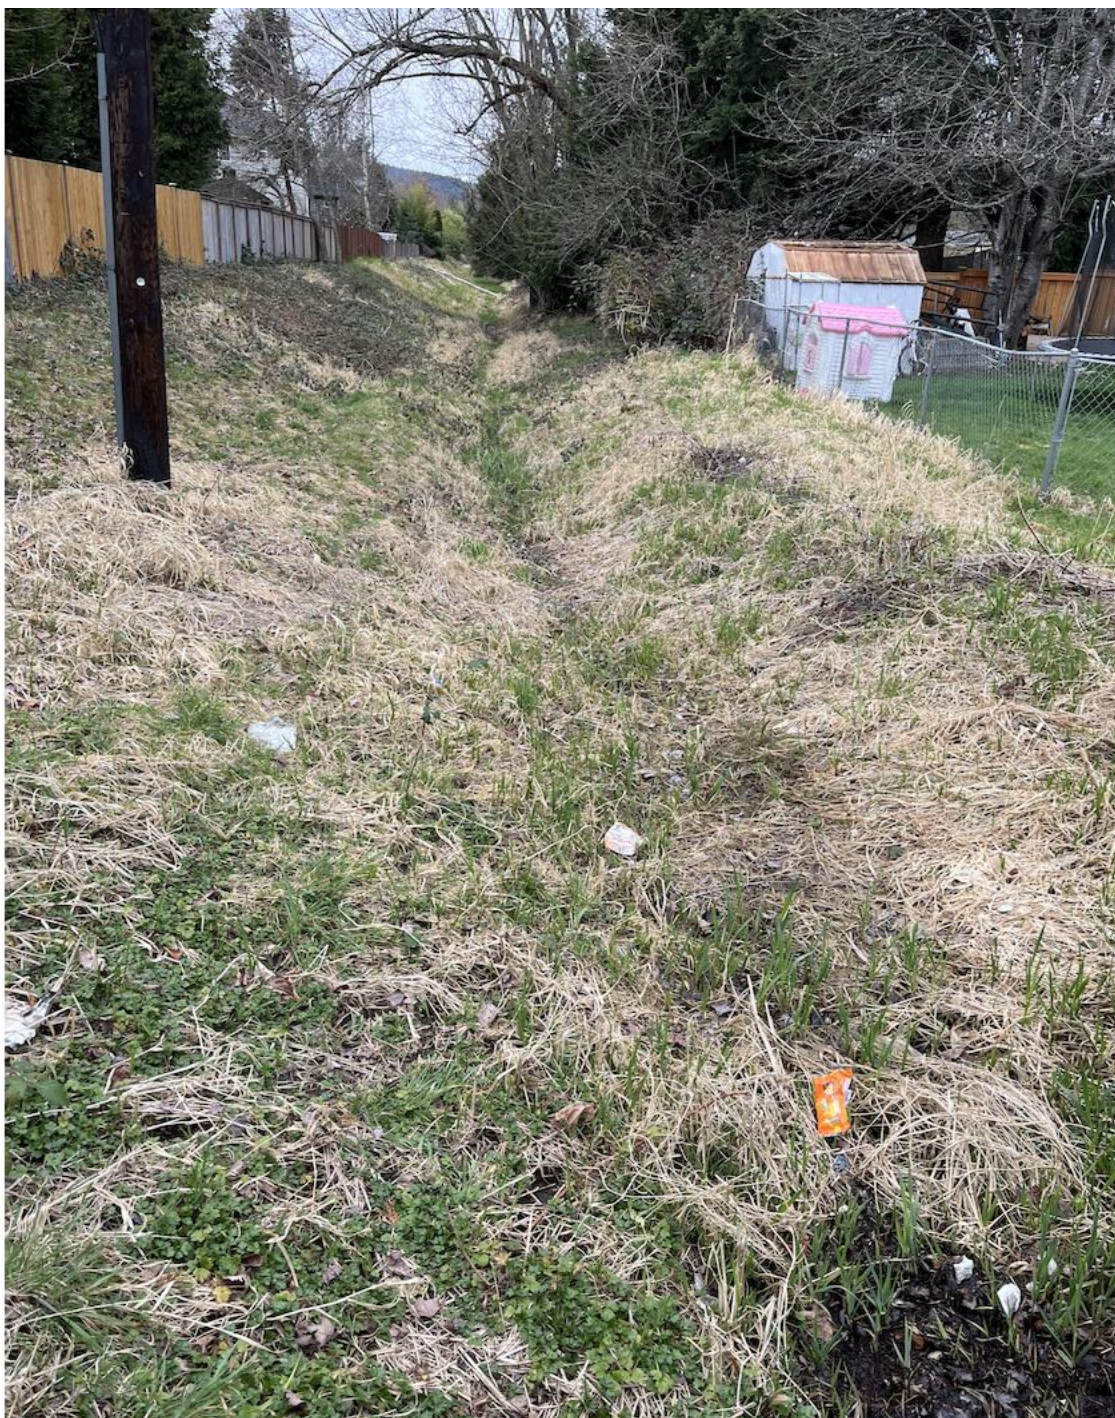
Figure 2. Open drain feature.

An offsite feature is present at the west side of the property. This is identified on City of Renton maps as “open drain”, and not included on the City’s critical area (stream) maps. This feature is shown in Figure 2. It appears to be an excavated ditch located between existing residential lots. The feature is dominated by reed canarygrass (*Phalaris arundinacea*). Pockets of standing water were observed in some spots along this ditch. It is unclear whether this would be regulated by King County.
