**CRITICAL AREAS REPORT
&
MITIGATION PLAN**

**King County Tax Parcel 085550-0260
Vashon, Washington**

Prepared By:
Eastside Environmental Pros, Inc.
Woodinville, Washington

Report Title: Critical Areas Report & Mitigation Plan
King County, Washington

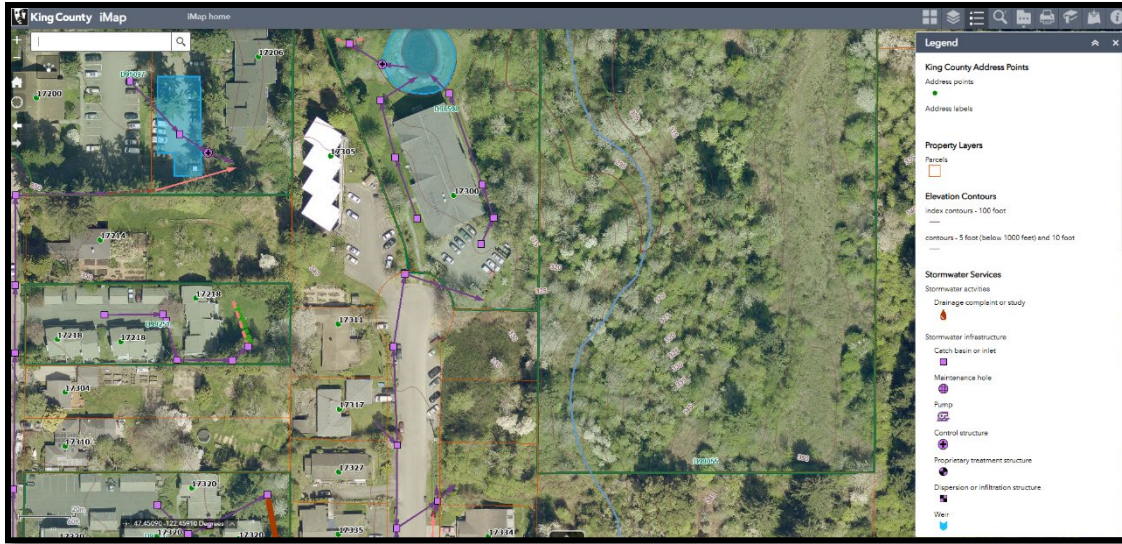
Photo 1. Photo of the unregulated stormwater feature just to the north of the property. Aerial imagery sourced from the King County iMap.

Based on the available evidence, the feature north of the Site does not meet the criteria of a regulated wetland or stream area under King County Code. The **hydrologic origin is artificial**, and the observed indicators are a function of drainage conditions rather than an existing natural resource. Therefore, no regulated wetland or aquatic area is present directly adjacent to the Site.

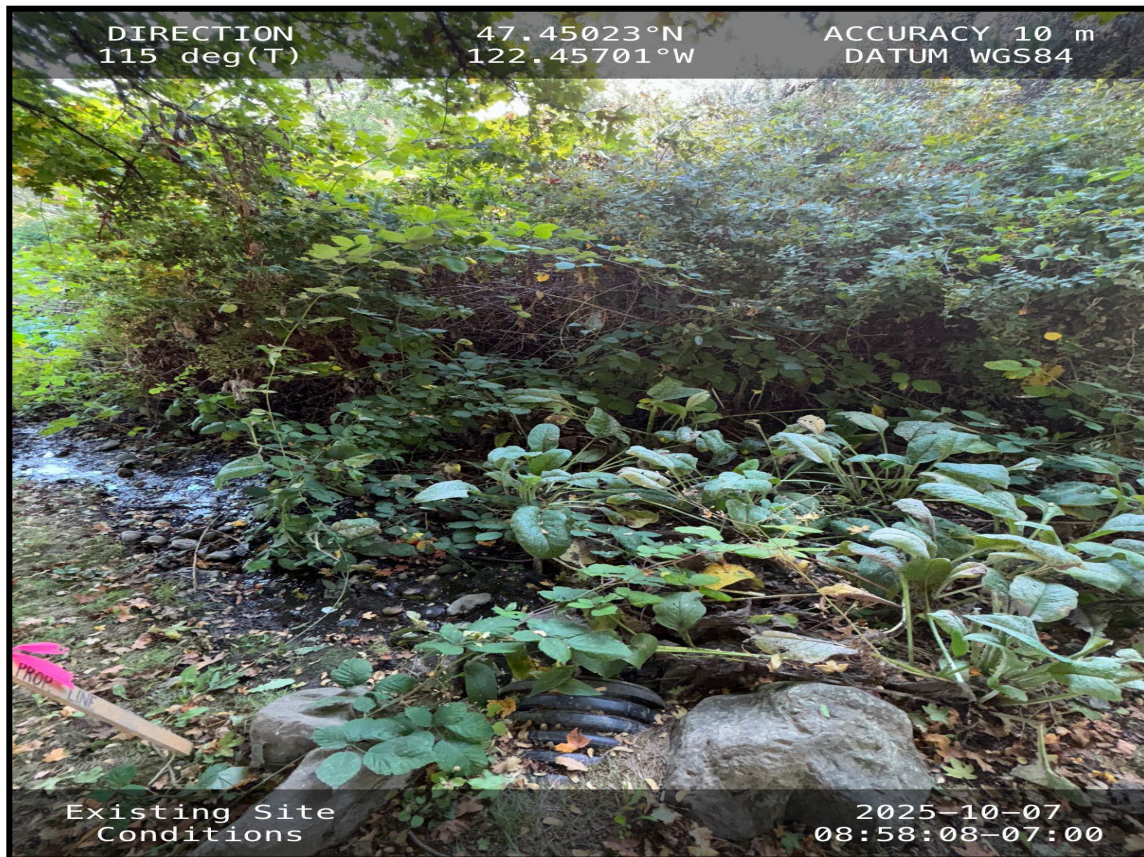
Photo 2. Photo of the unregulated stormwater feature.

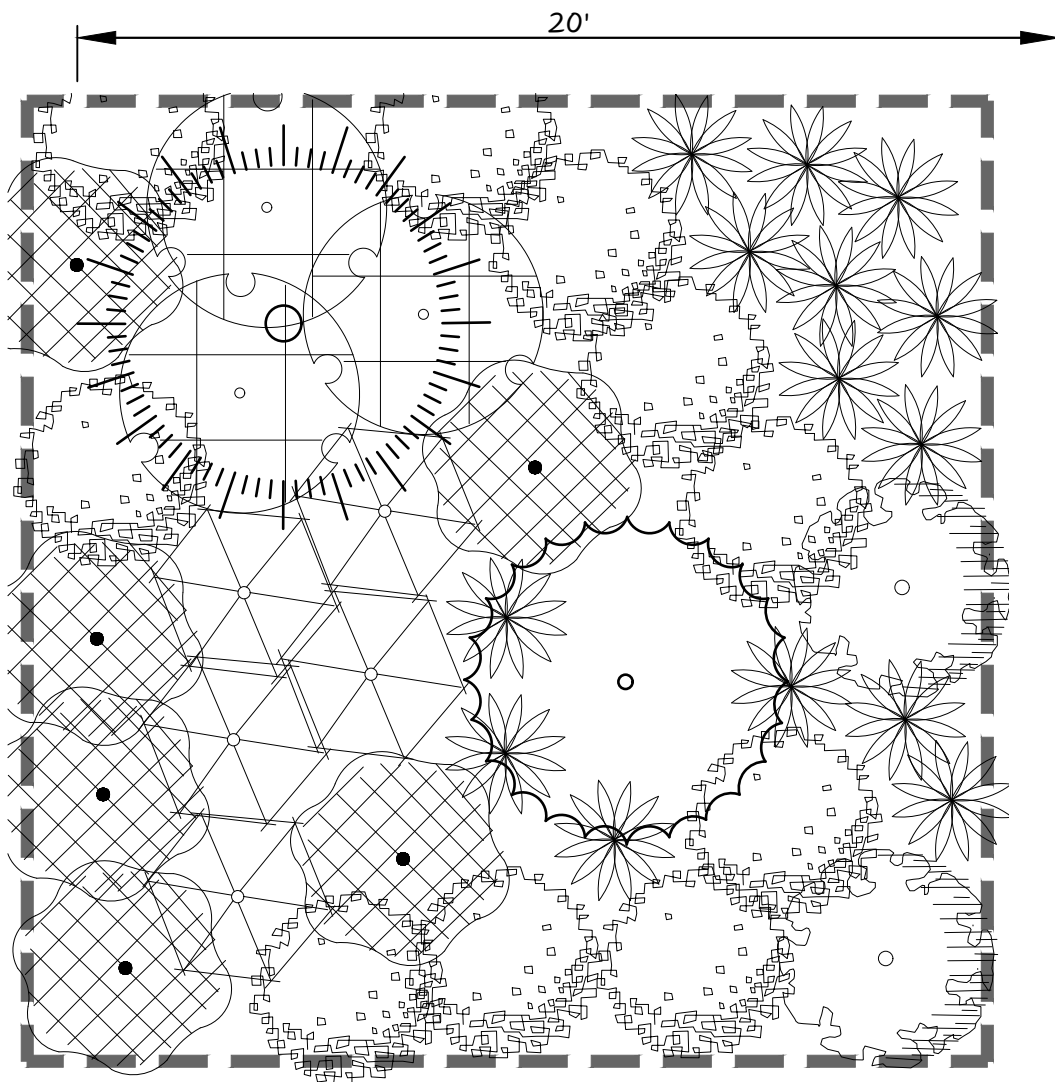
PLANTING TYPICAL 1

KING COUNTY PLANTING DENSITY CALCULATION

PLANTING STRATUM	DENSITY (# PER SF)	TOTAL PLANTING AREA (SF)	# PLANTS REQUIRED
TREES	0.012	3,016 SF	36
SHRUBS	0.028		84
HERBS/GROUNDCOVERS	0.25		754

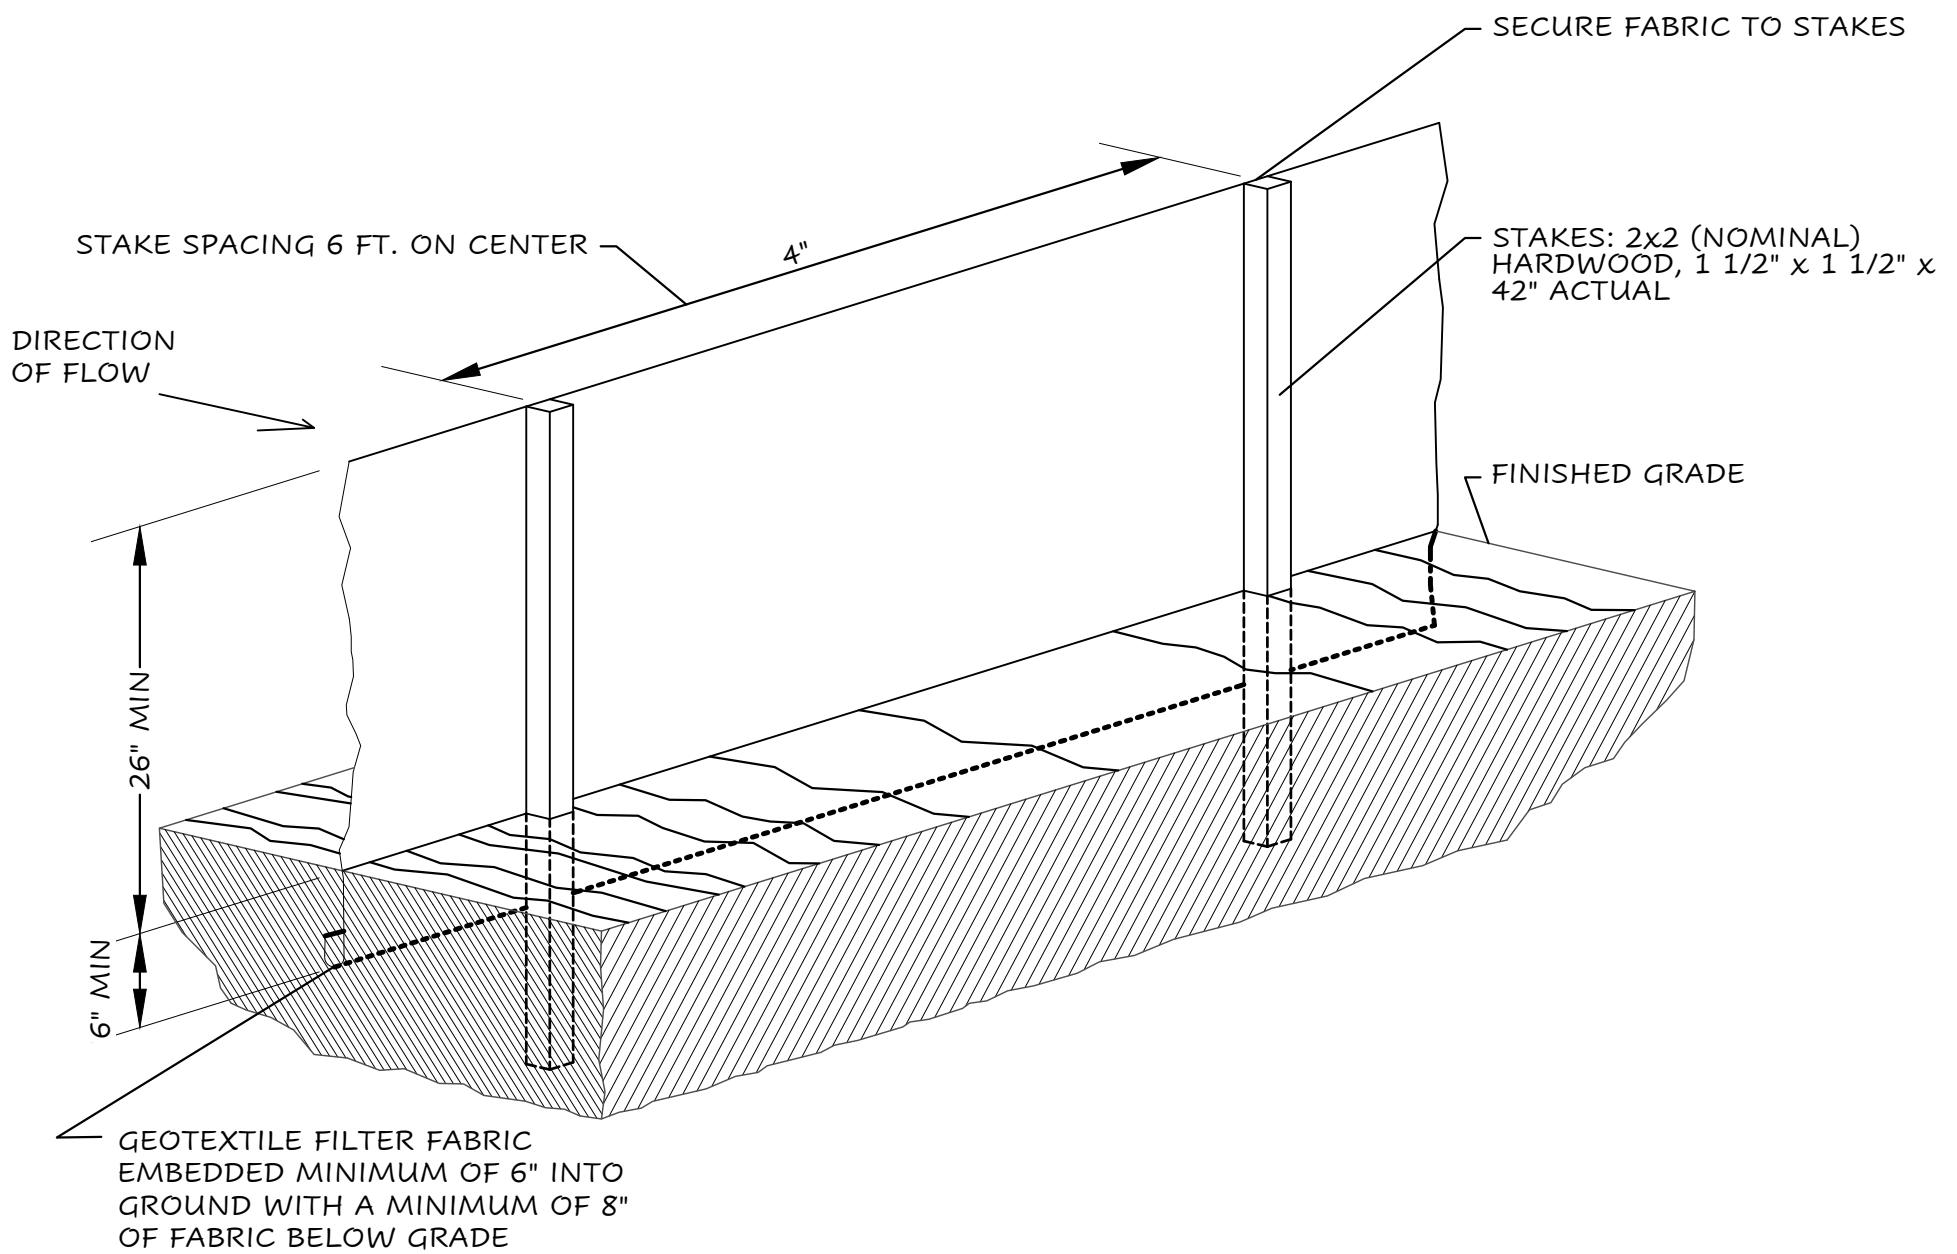
1. SILT FENCE DETAIL

1. SILT FENCE SHALL BE CONSTRUCTED BEFORE ANY GRADING WORK IS STARTED.
2. WHERE POSSIBLE, SILT FENCE SHALL BE PLACED ON THE FLATTEST AREA AVAILABLE.
3. A RUN OF SILT FENCE SHOULD FOLLOW THE CONTOUR AS CLOSE AS POSSIBLE WITH THE ENDS TURNED UPSLOPE TO POND WATER BEHIND THE FENCE.

5. THE STAKES SHALL BE PLACED ON THE DOWN SLOPE SIDE OF THE GEOTEXTILE. THE STAKES SHALL BE A MINIMUM OF 2X2 NOMINAL (1-1/2" X 1-1/2" ACTUAL) HARDWOOD STAKE OF SOUND QUALITY. T-POSTS MAY BE SUBSTITUTED IF GROUND CONDITIONS REQUIRE.

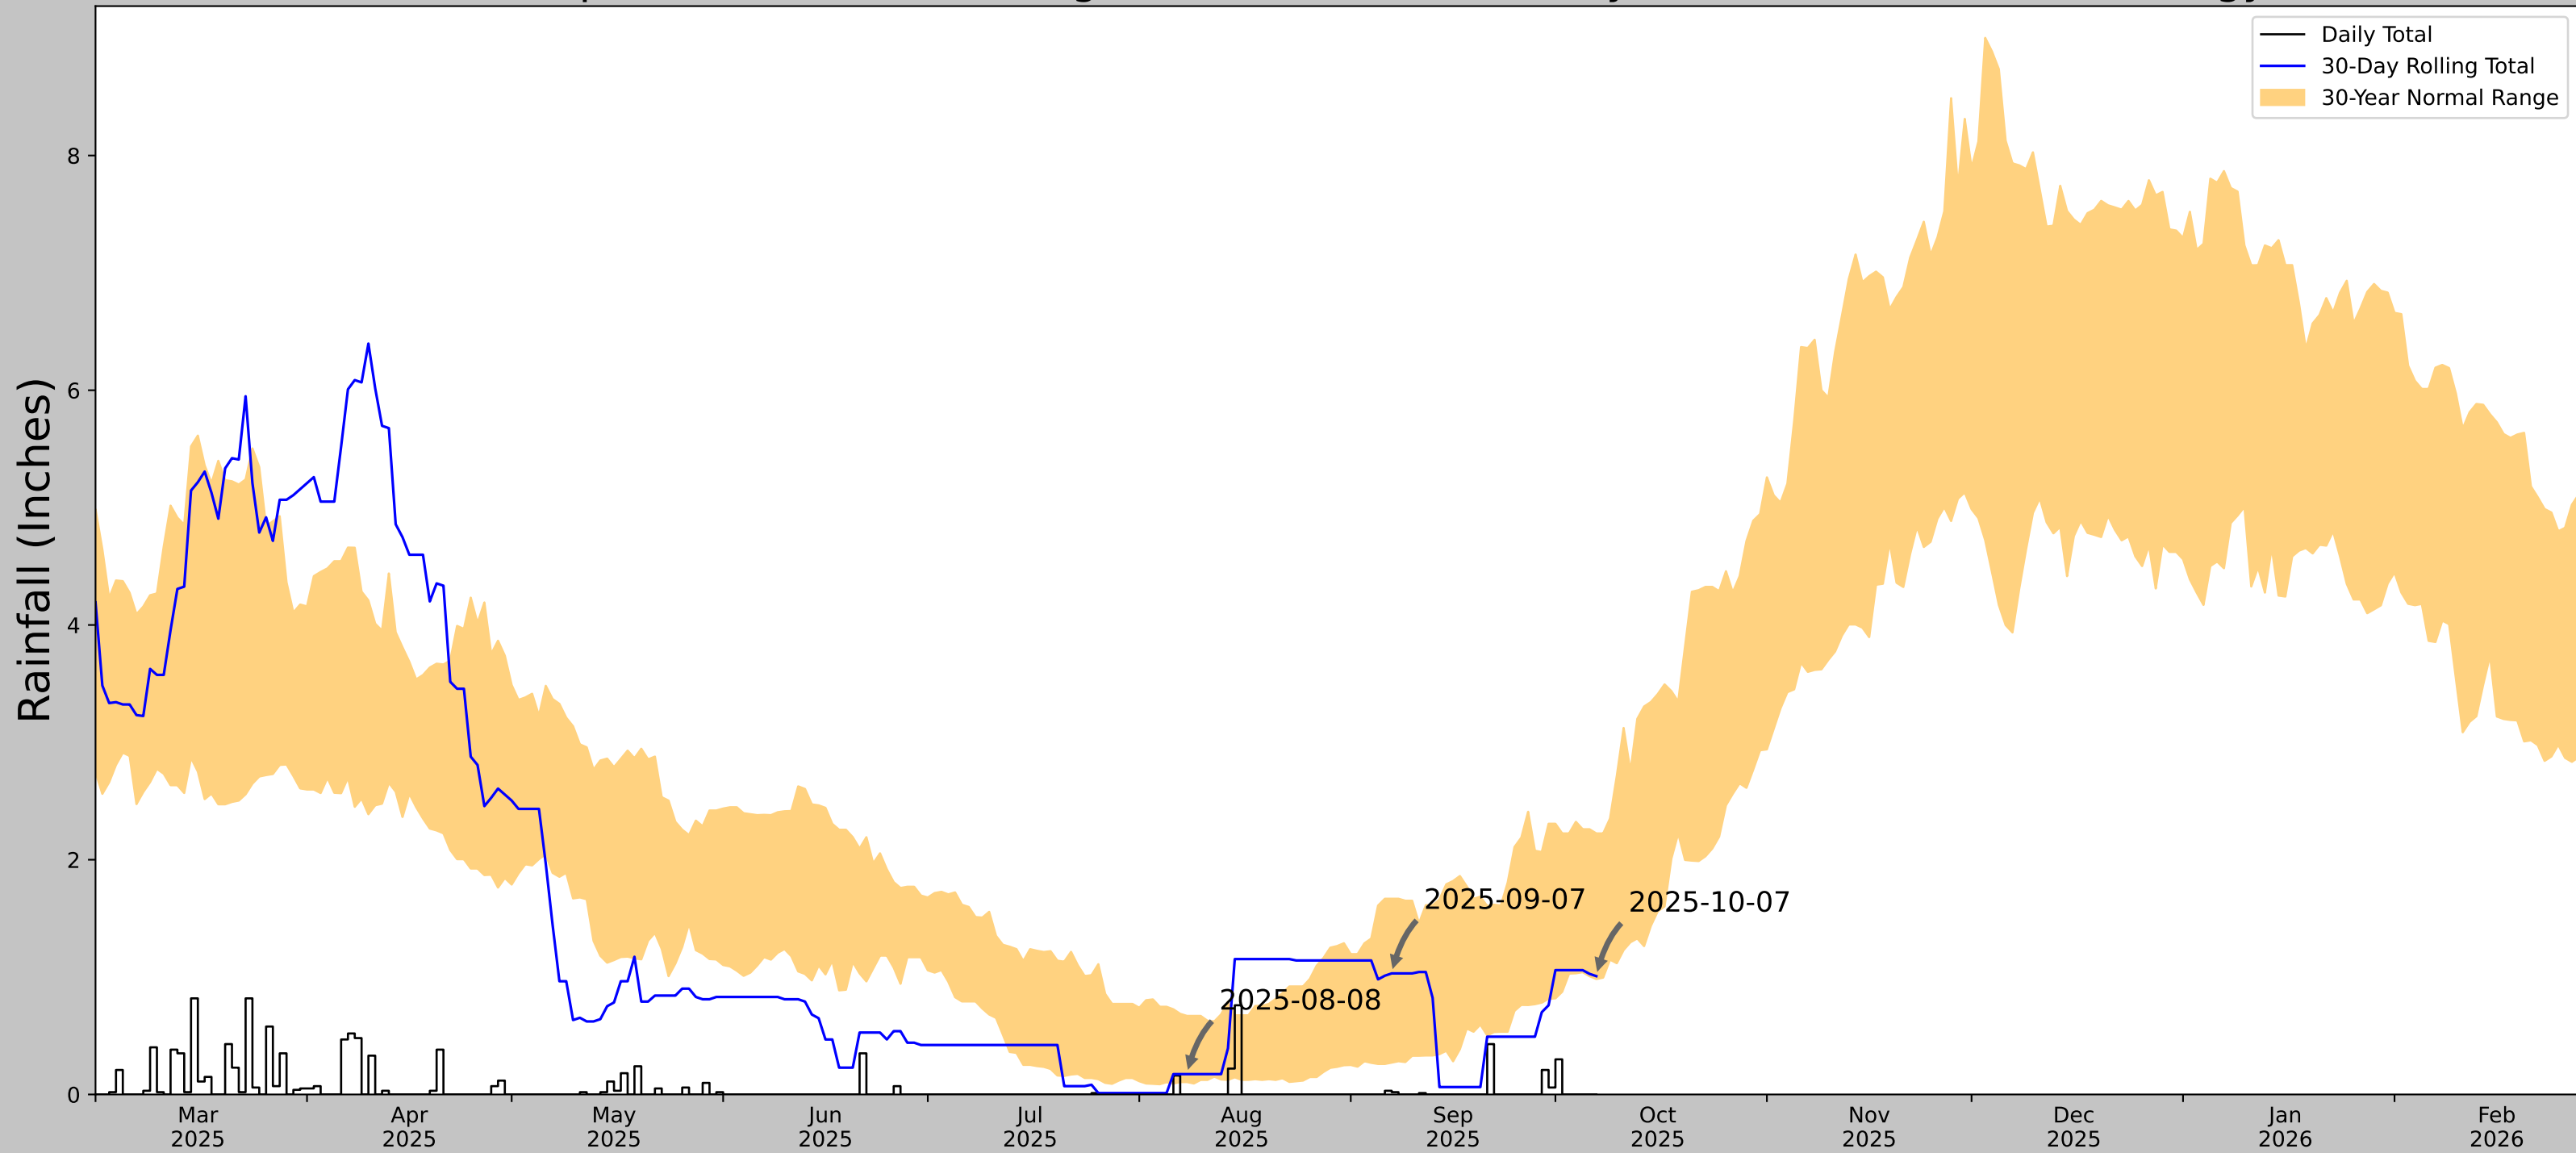
Antecedent Precipitation vs Normal Range based on NOAA's Daily Global Historical Climatology Network

Coordinates	47.45021, -122.45692
Observation Date	2025-10-07
Elevation (ft)	331.104
Drought Index (PDSI)	Not available (2025-09)
WebWIMP H ₂ O Balance	Wet Season

30 Days Ending	30 th %ile (in)	70 th %ile (in)	Observed (in)	Wetness Condition	Condition Value	Month Weight	Product
2025-10-07	0.983465	2.224016	1.007874	Normal	2	3	6
2025-09-07	0.27126	1.667717	1.031496	Normal	2	2	4
2025-08-08	0.105512	0.669291	0.173228	Normal	2	1	2
Result							Normal Conditions - 12

This normal precipitation analysis follows the methodology described by Sprecher and Warne (2000). The Corps Antecedent Precipitation application tool was used to determine that **normal** conditions were present during the 7 October 2025 Site Evaluation.

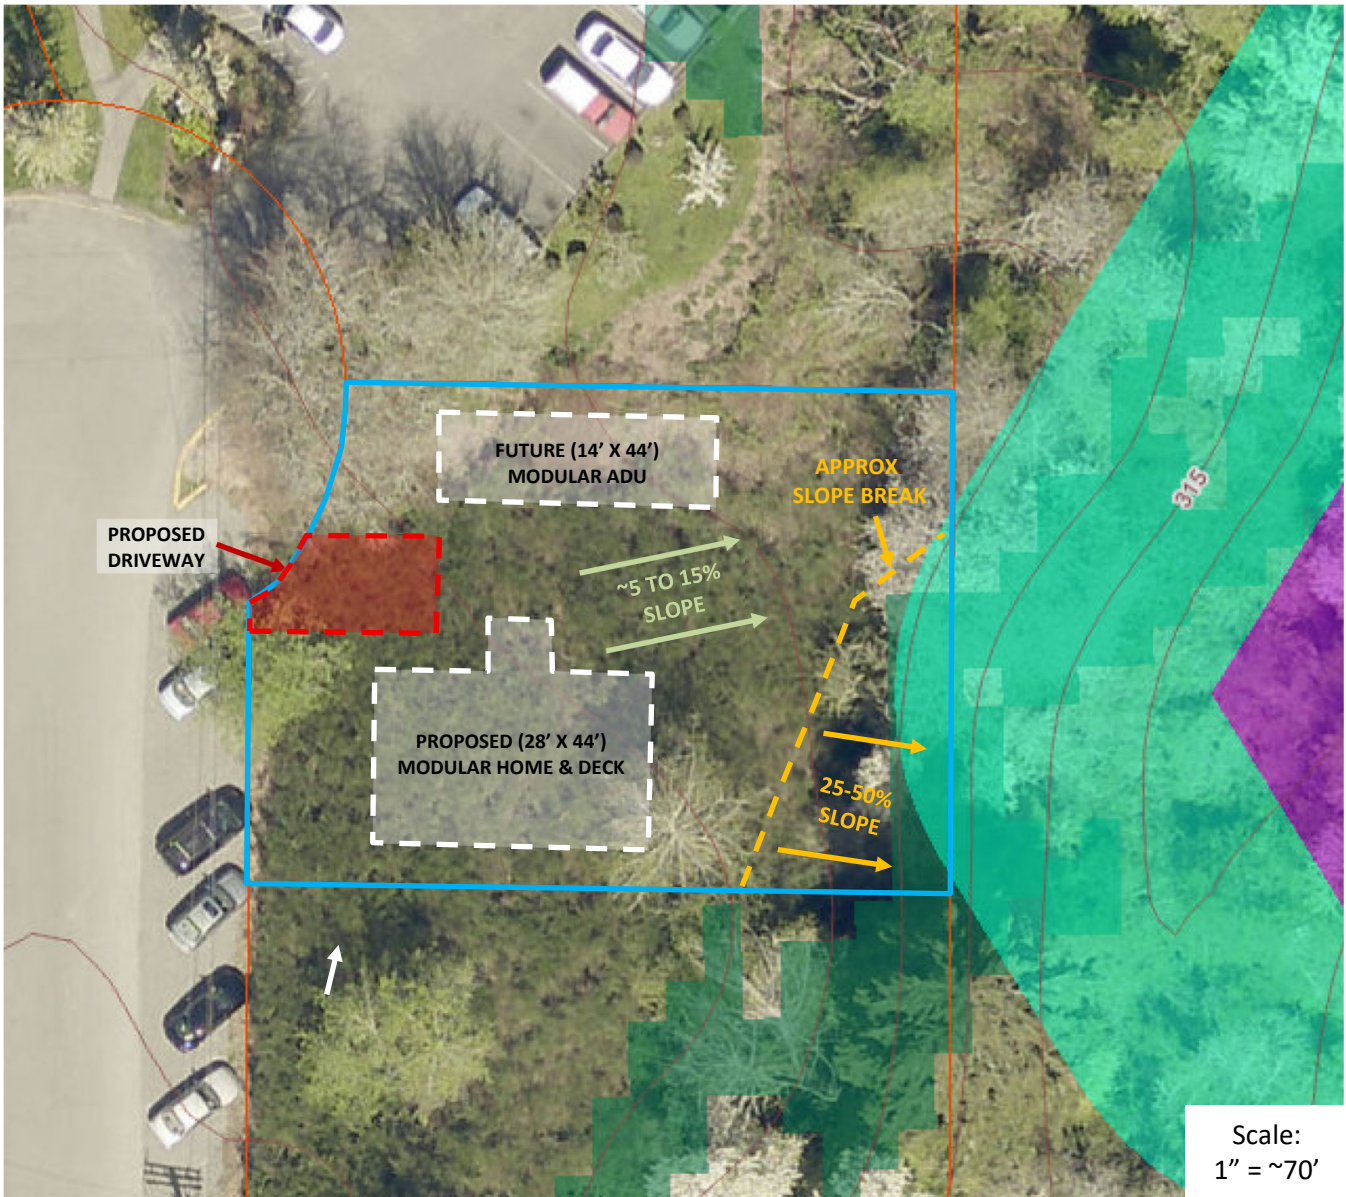
Note: Green shading indicates mapped “potential steep slope hazard areas”.
 Purple shading indicates mapped “potential landslide hazard areas”.
 Teal shading indicates mapped 50-foot buffer to landslide hazard areas.

Based on the publicly available King County KCGIS Center, iMap and Parcel Viewer, the project site is located within proximity to mapped “Potential steep slope hazard areas” and “Potential landslide hazard areas”, and as such is subject to additional scrutiny prior to development. On August 21, 2025, we visited the site and observed existing surficial slope conditions.

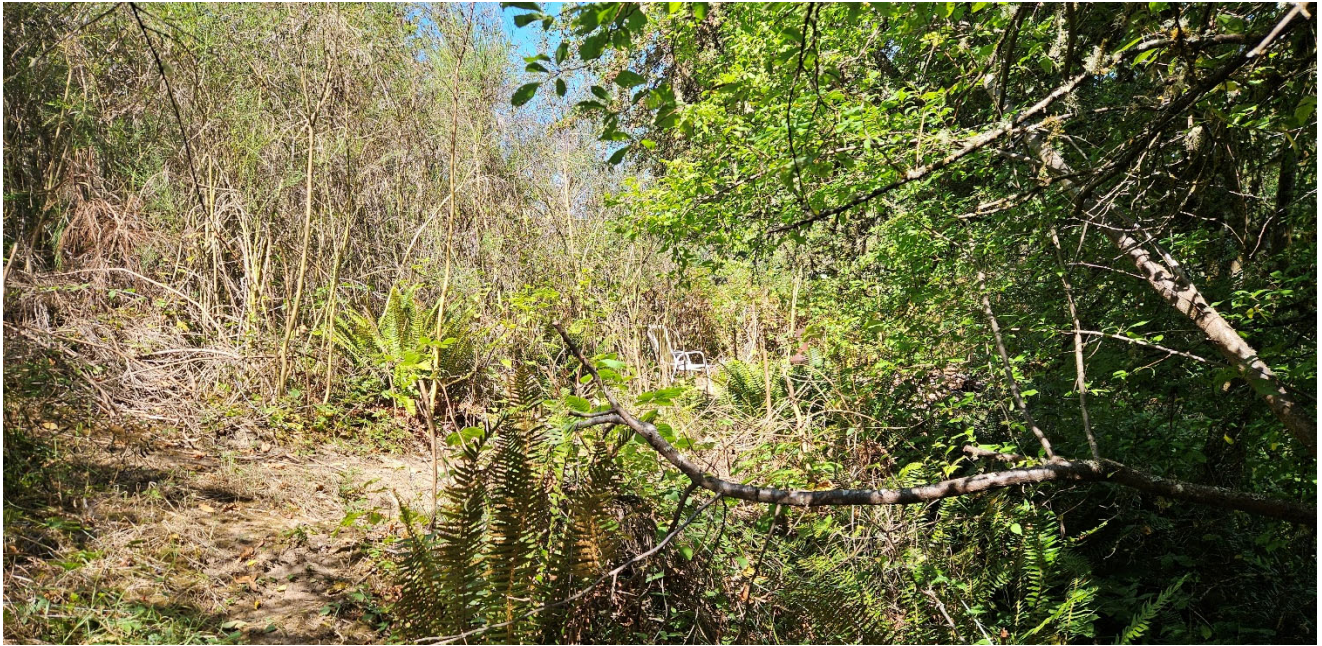
Photo 3. Project site – typical surface conditions at upper flatter area.

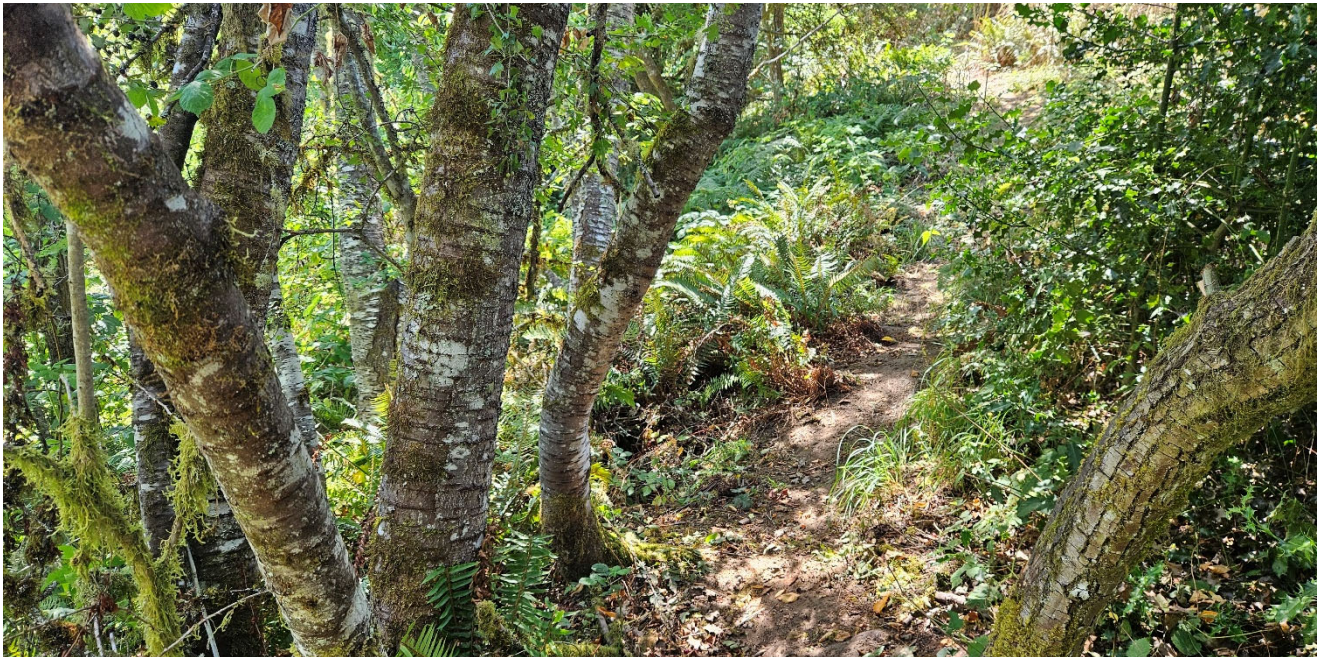
Photo 4. Project site – looking south along top of slope, slopes at left and more level area at right.
