Sewall Wetland Consulting, Inc.

RE: Critical Area Report – Parcel #7383400120
City of Renton, Washington
SWC Job #24-135

This report describes our observations of jurisdictional wetlands, streams and buffers on or within 200' of Parcel #7383400120, located at 19509 138th Avenue Se in the City of Renton, Washington (the "site").

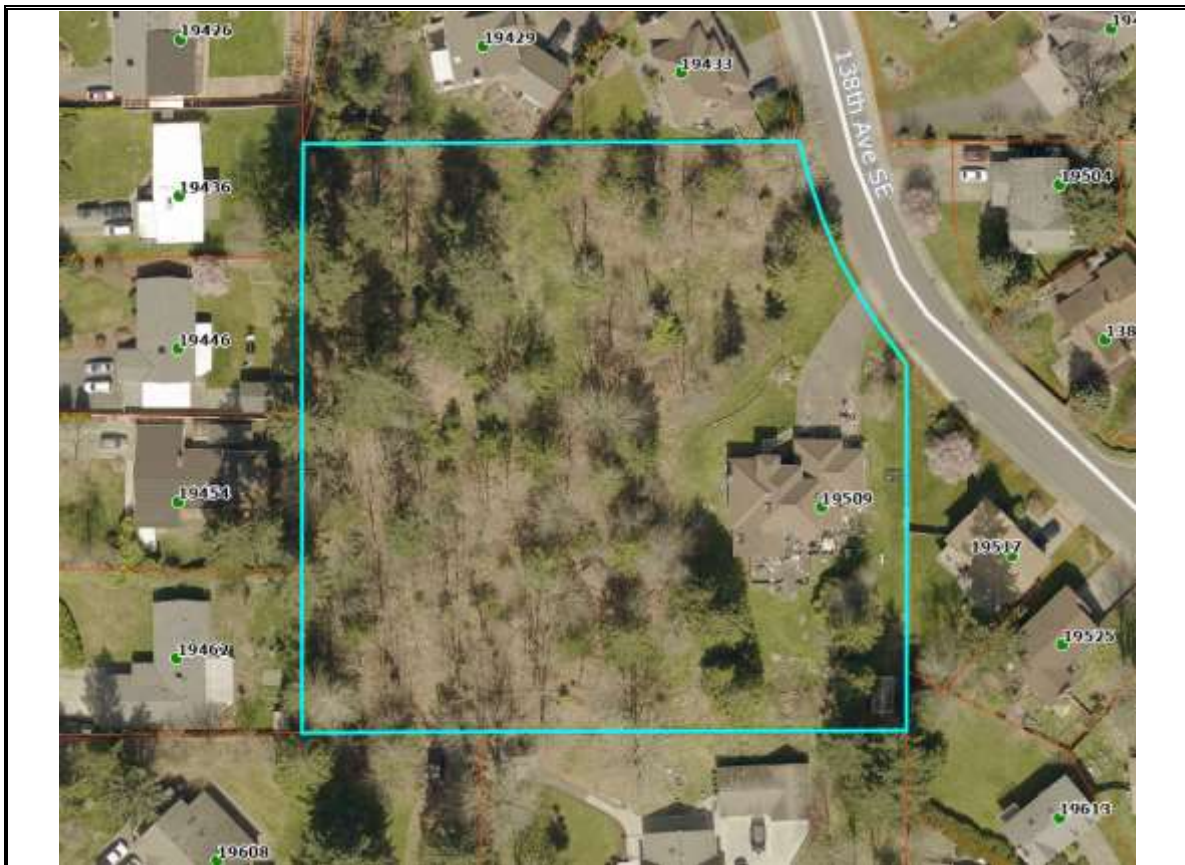
Above: iMap Vicinity Map of the site

The King County iMap website with wetland and stream layers activated depicts no wetlands or streams on or near the site (see image page 2 of this report).

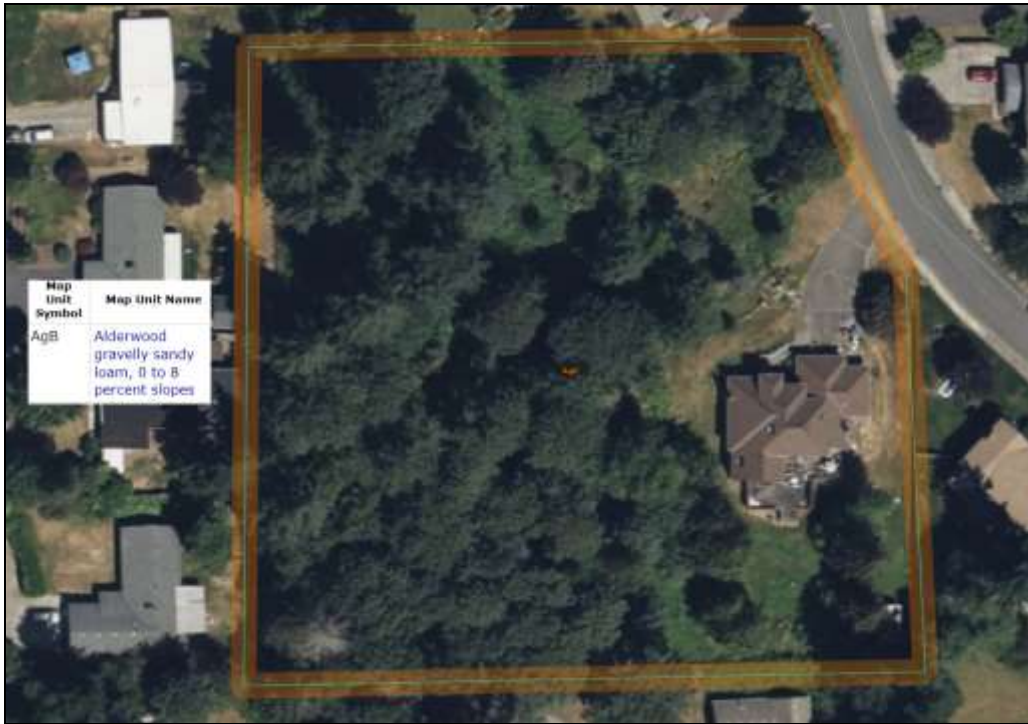
Above: USDA Soil Survey Map of the site

According to the NRCS Soil Mapper, the site is mapped as moderately well drained Alderwood gravelly sandy loam. Alderwood soils are not considered to be a hydric (or wetland) soil.

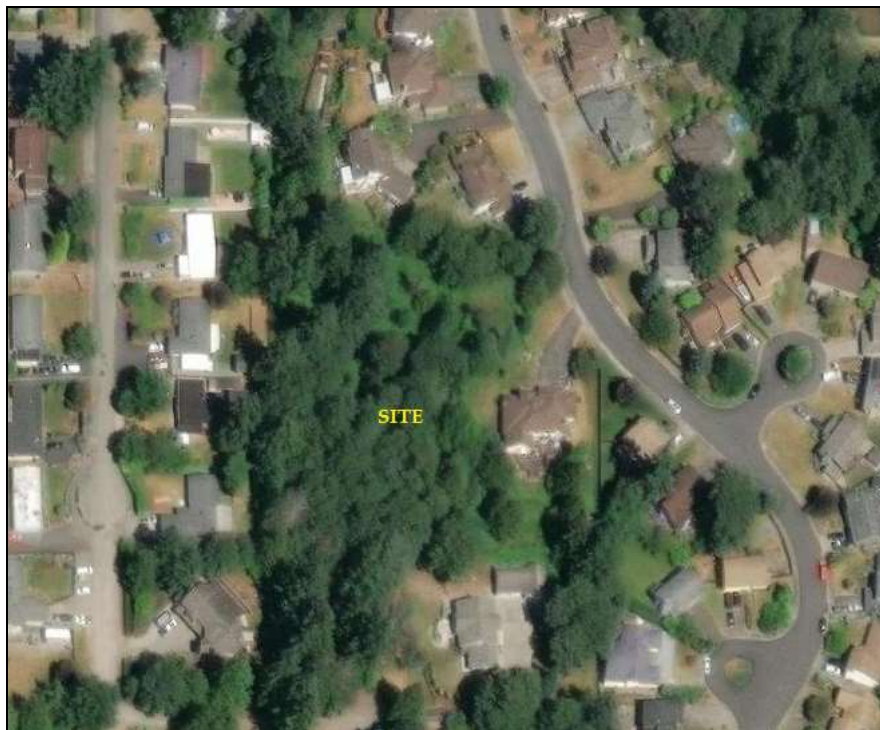
Above: National Wetlands Inventory Map of the site.

According to the NWI map for the site, there are no wetlands on or near the site.

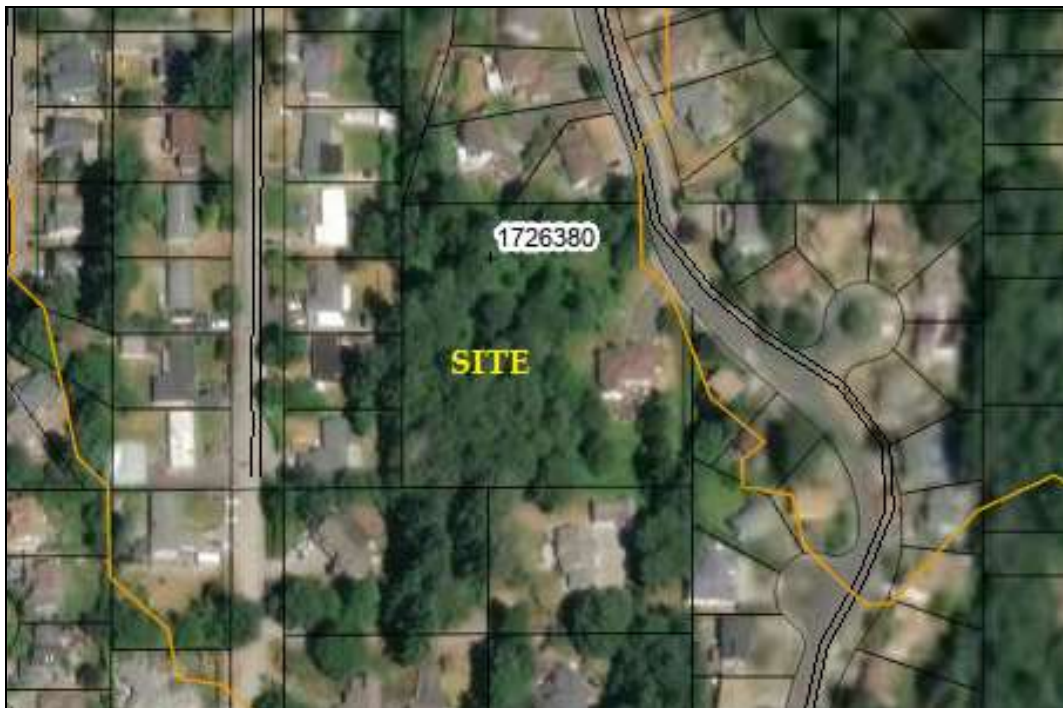
Above: WDFW Fpars stream mapping

According to the WADNR Fpars stream map, there are no streams on or near the site.
