# **WETLAND DELINEATION REPORT**

**Bristol Glen  
King County, Washington**

Title: Wetland Delineation Report for the  
Bristol Glen Project, King County Washington

Project Number: 2024-050-004

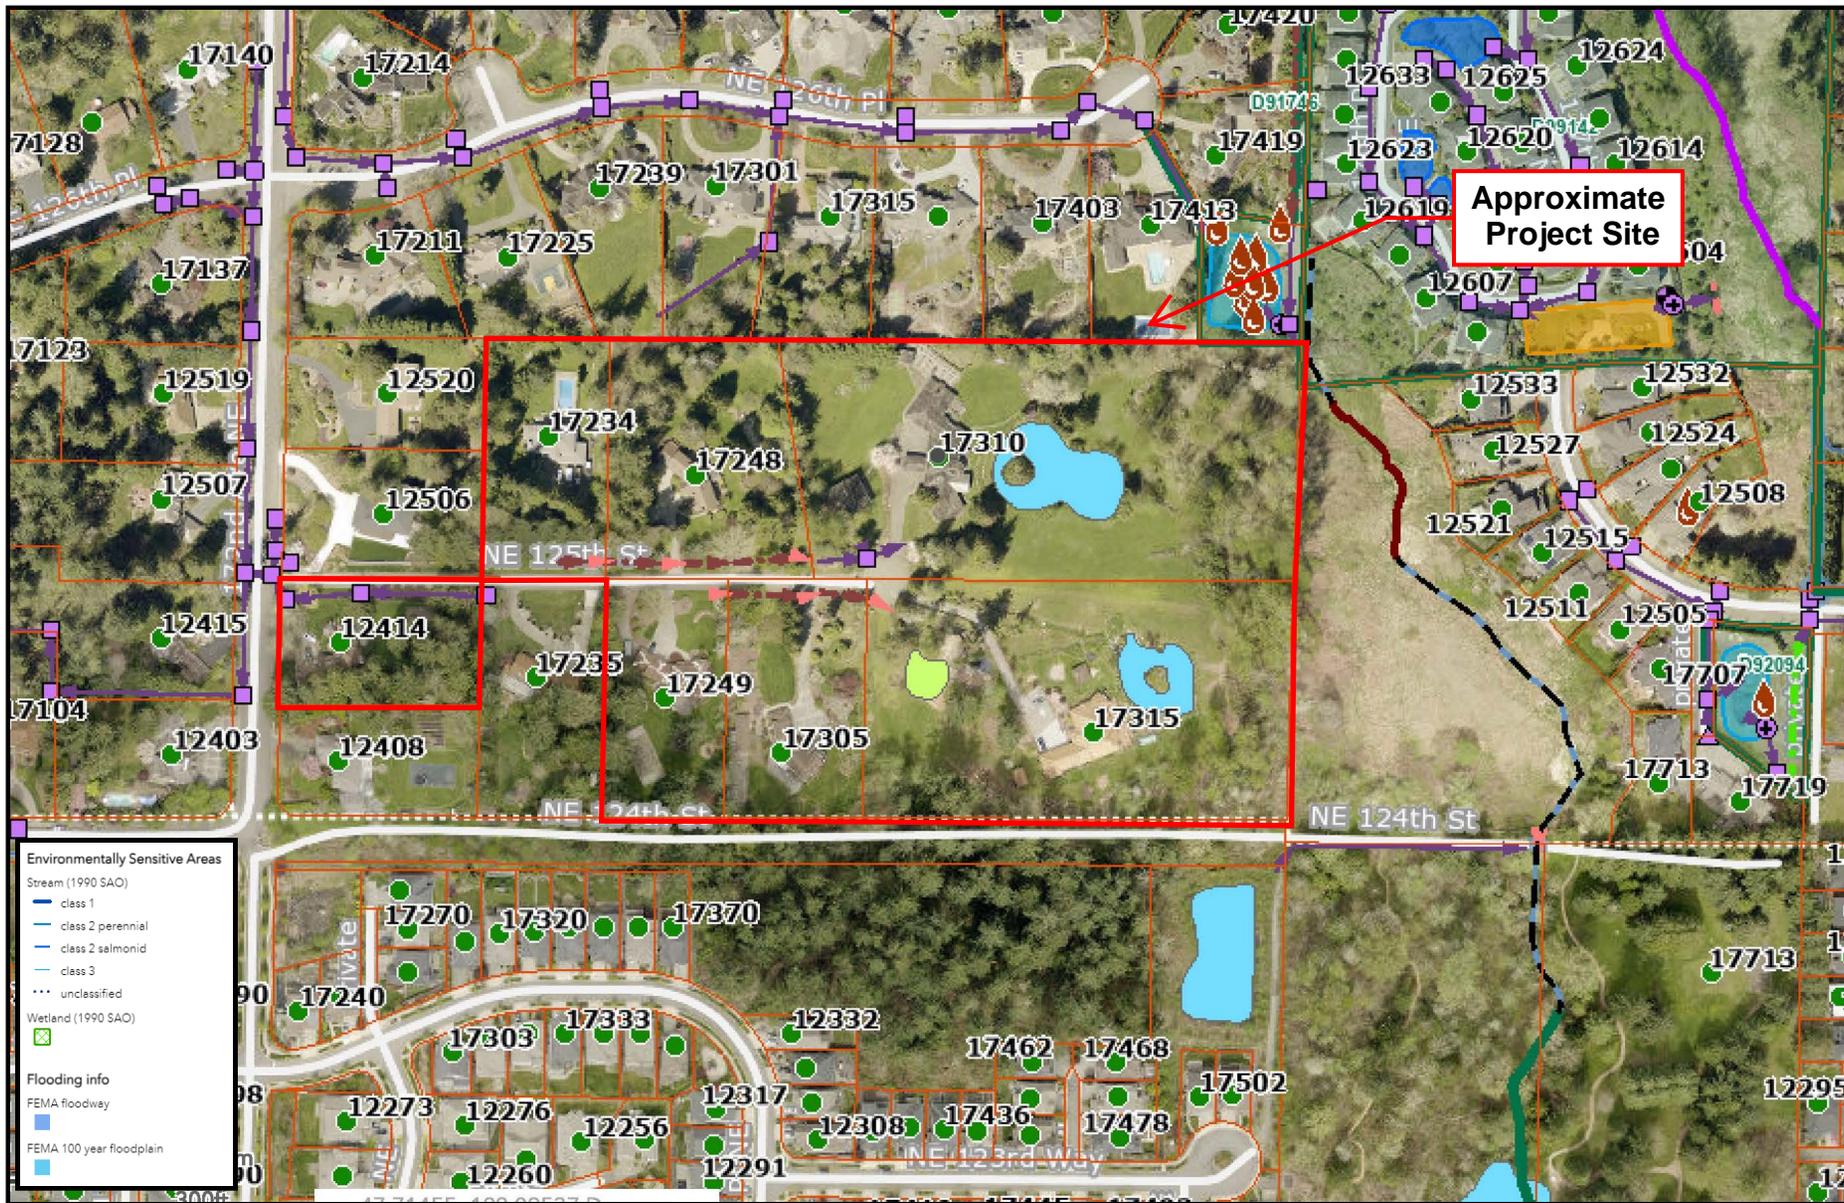
## FIGURE 4 - King County iMap English Hill, King County

that flows into a 12-inch piped conveyance along the north side of NE 125<sup>th</sup> Street along King County Parcel Nos. 2526059115, 2526059161, and 2526059003 (Figure 4). The stormwater is shown to flow to the east to the end of the cul-de-sac. During our site visits, we observed a catch basin located east of the cul-de-sac on King County Parcel No. 2526059003. The catch basin is part of a tight-lined stormwater conveyance that receives water from along the north side of NE 125<sup>th</sup> Street and carries it to an open ditch in the southeast corner of the project site. The open ditch continues approximately 30 to 40 feet to the east before discharging into Wetland 1. The ditch appears to be regularly maintained and cleared of vegetation to allow for stormwater conveyance. Based on the definition provided in King County (2025a) code section 21A.06.1391, the ditch should not be regulated as a critical area because it was excavated from the surrounding upland for the conveyance of stormwater.

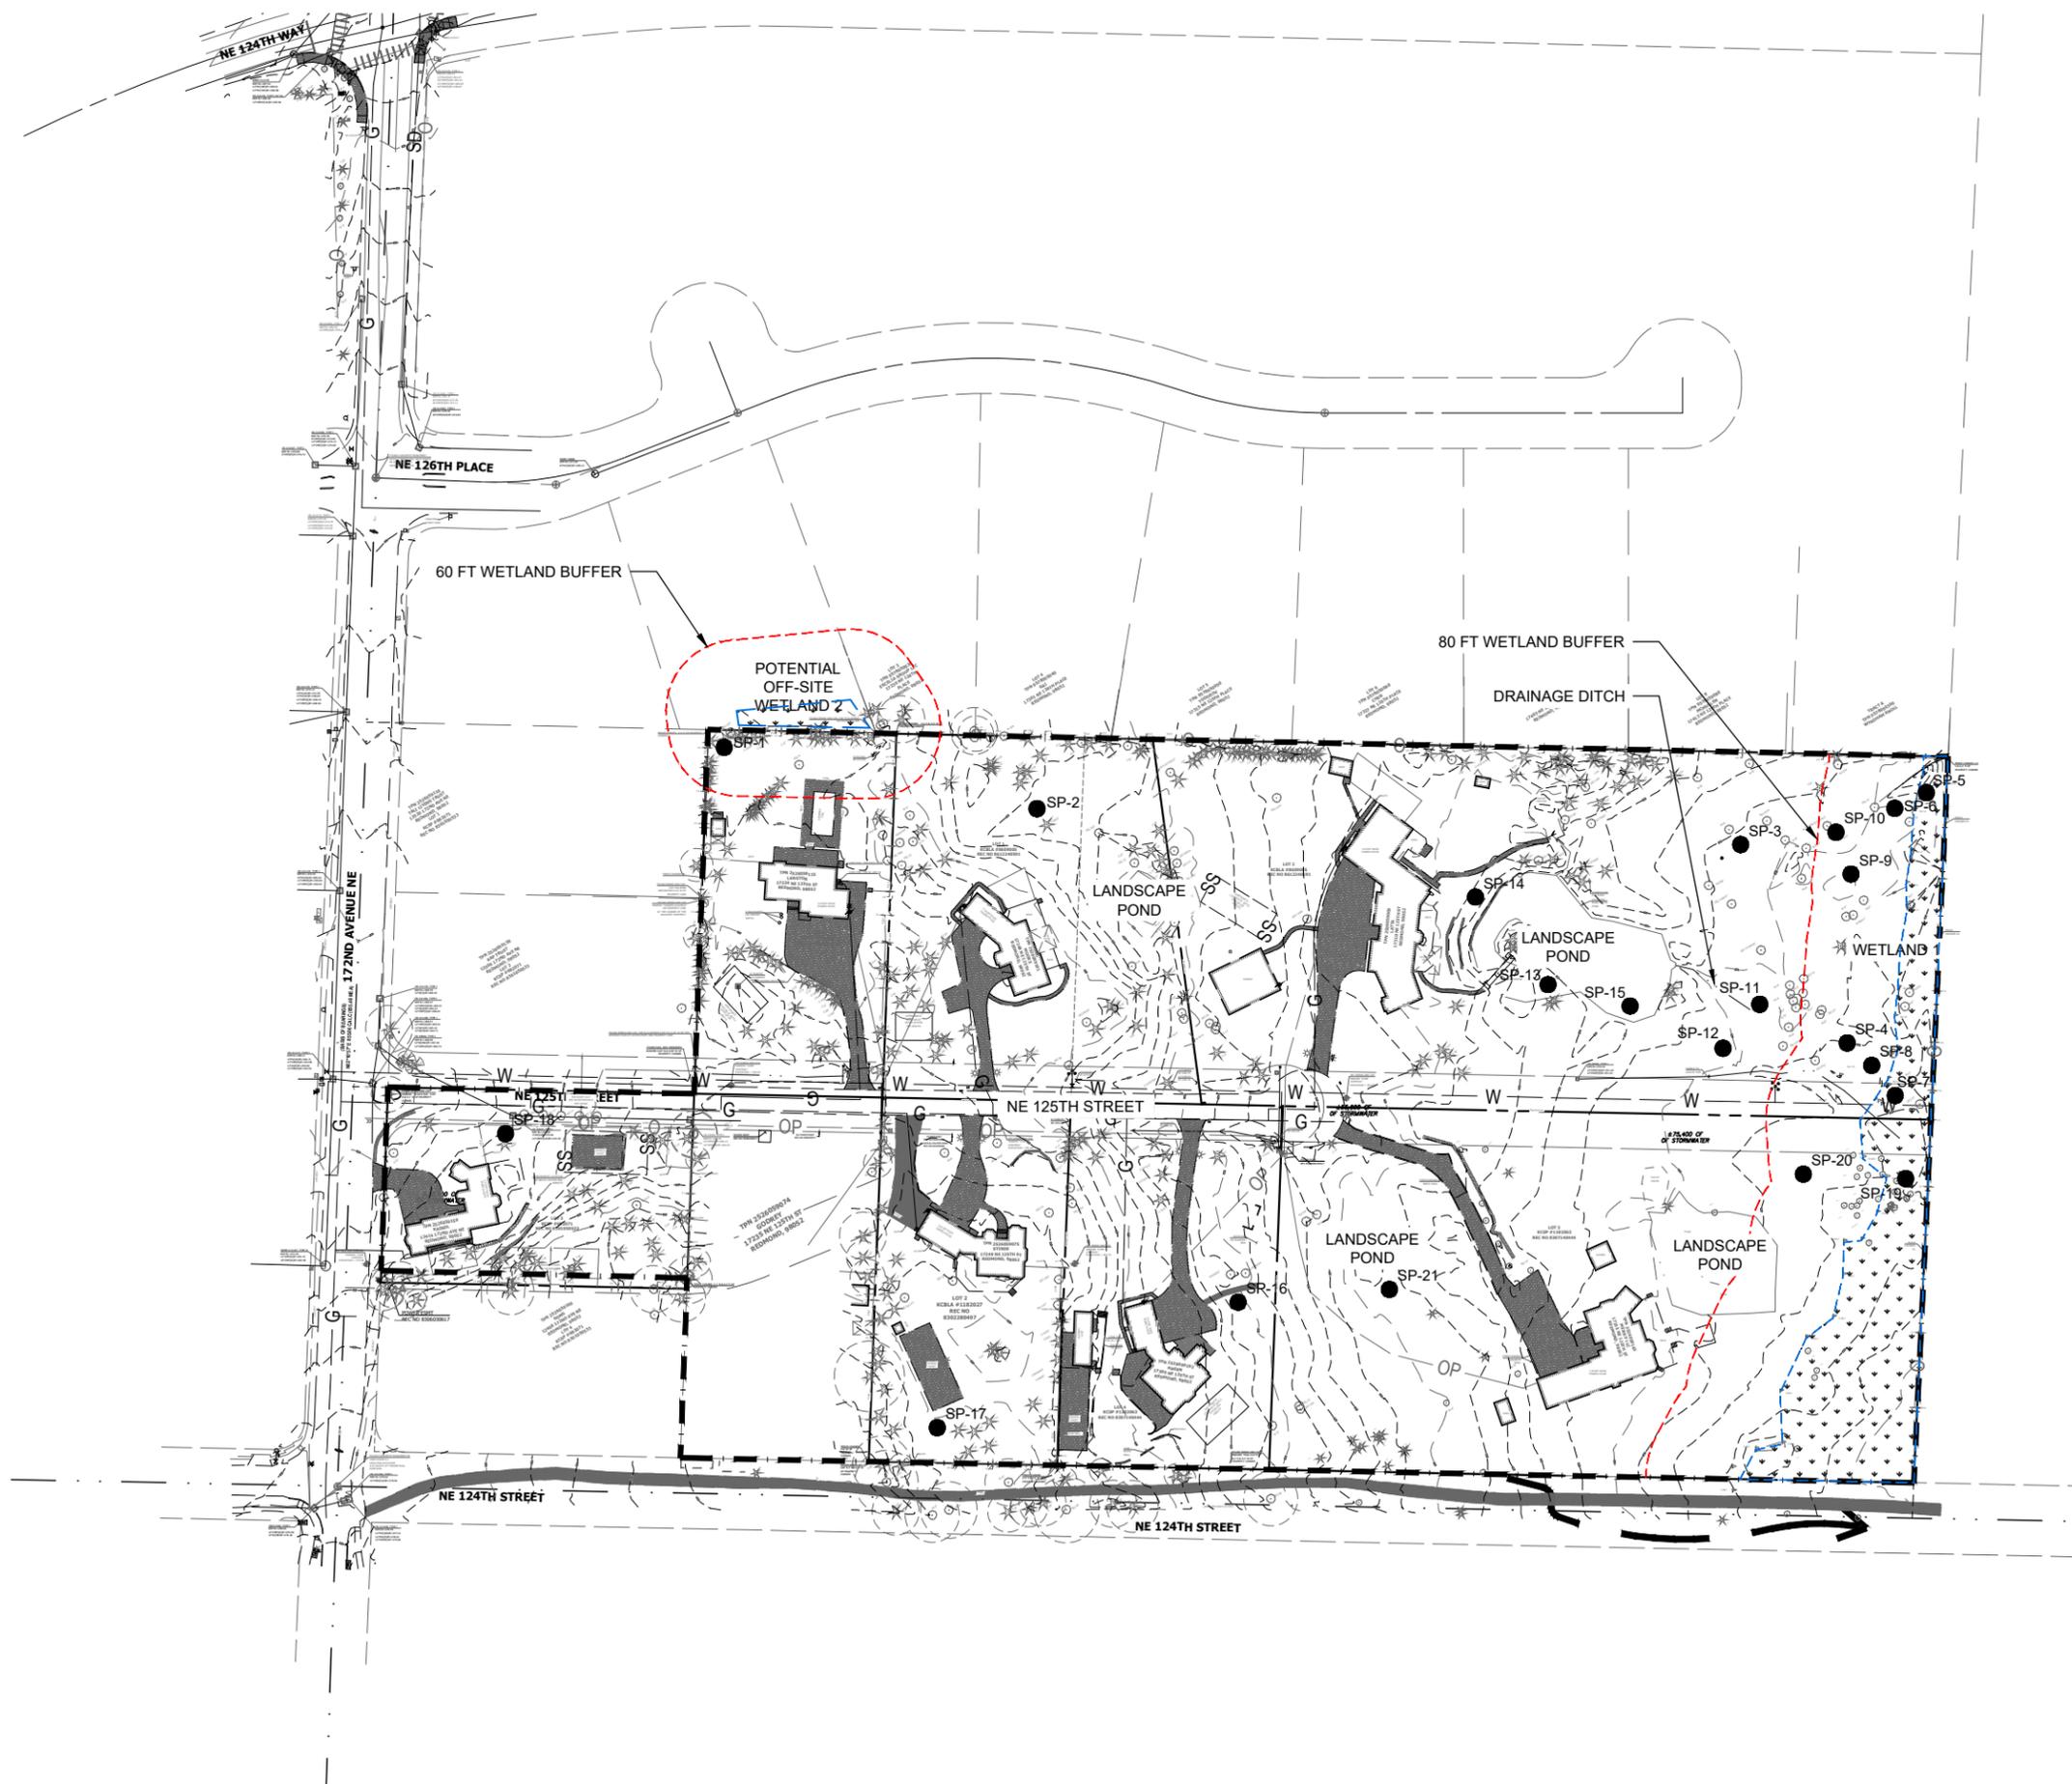
**FIGURE 6**  
**ENGLISH HILL**  
**KING COUNTY, WA**  
**EXISTING CONDITIONS**

We visited the project site on May 30, 2024, February 13, 2025, March 6, 2025, March 14, 2025, and June 5, 2025 to document the existing site conditions and identify any wetlands, streams, or fish and wildlife habitat that are in the vicinity of the project site. The project consists of seven parcels located along NE 125<sup>th</sup> Street (Figure 6). Each of

During our site investigations, we observed one off-site wetland (Wetlands 2) (Figure 6). We did not have permission to access the parcel where the off-site wetland is located; therefore, we based our assessment on our observations from the project site or publicly accessible areas.

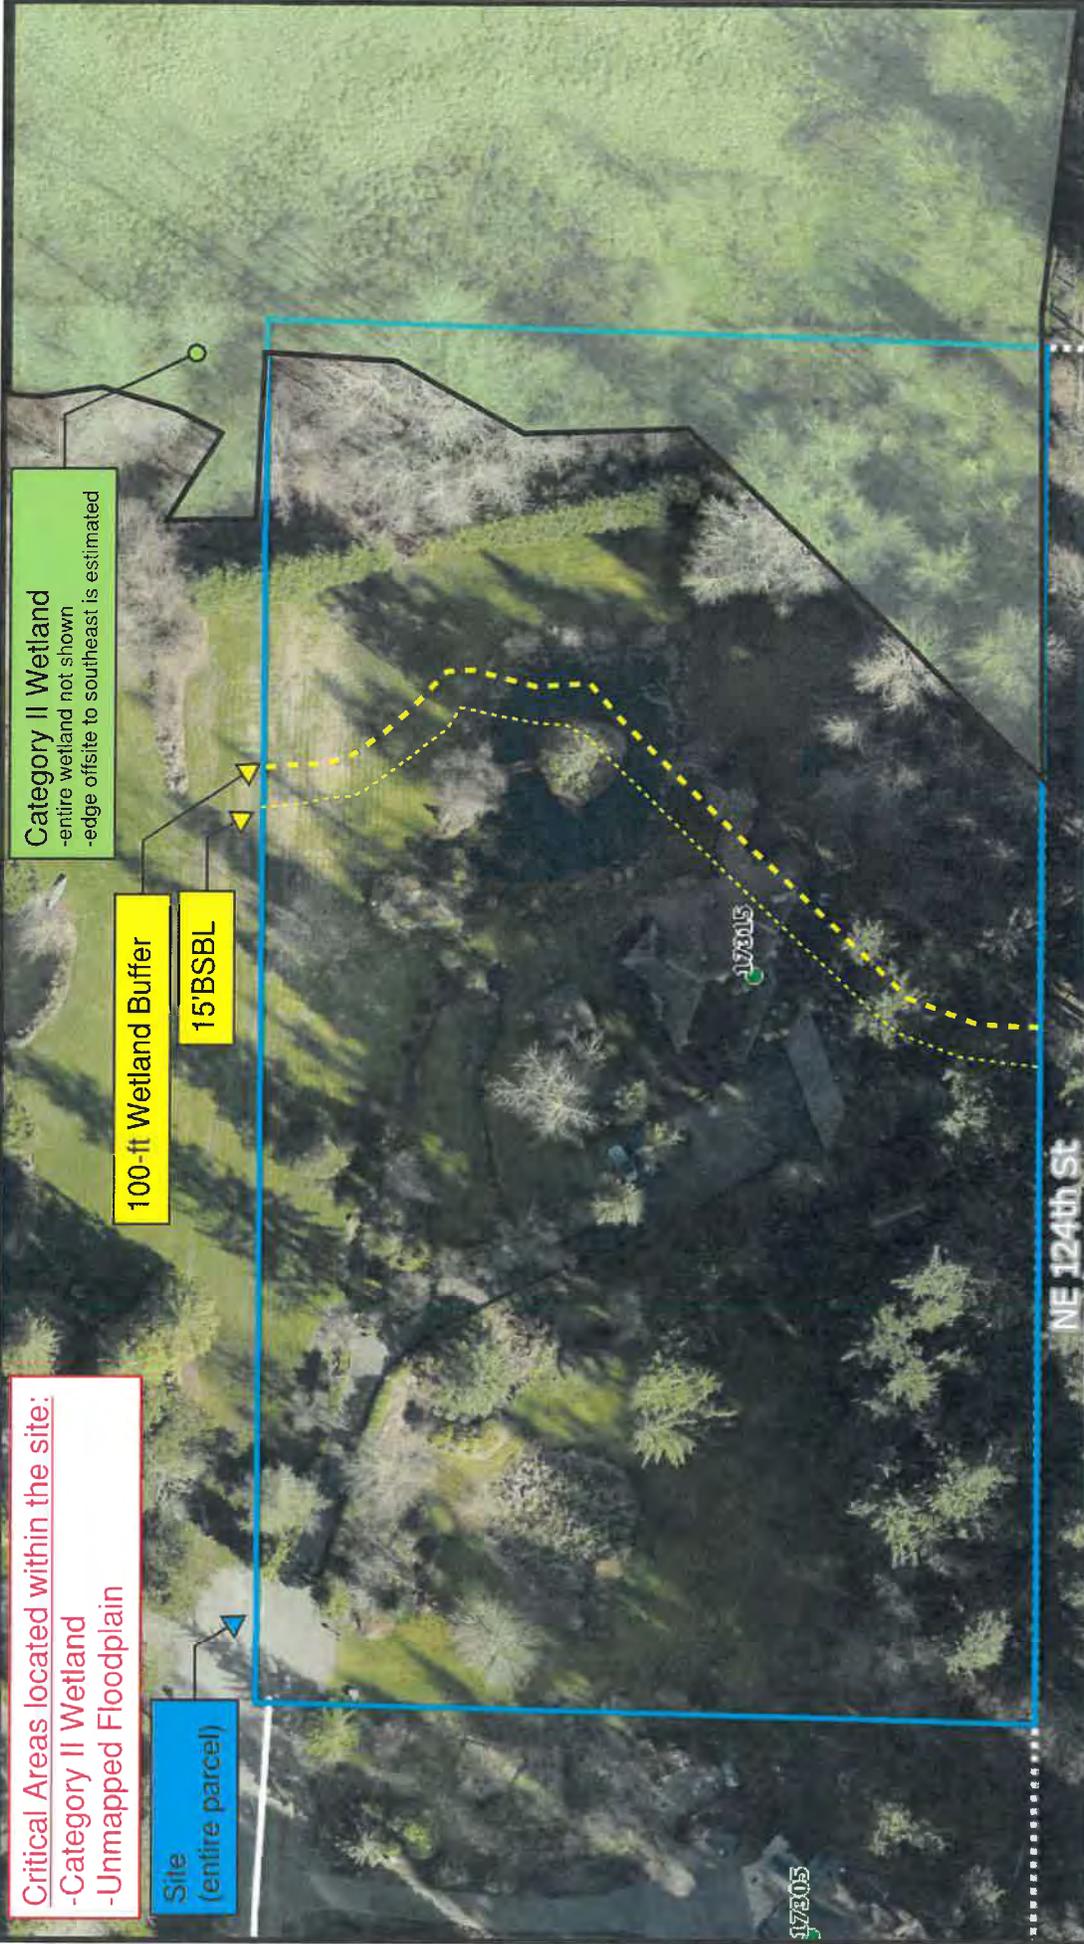
**Category II Wetland**  
 -entire wetland not shown  
 -edge offsite to southeast is estimated

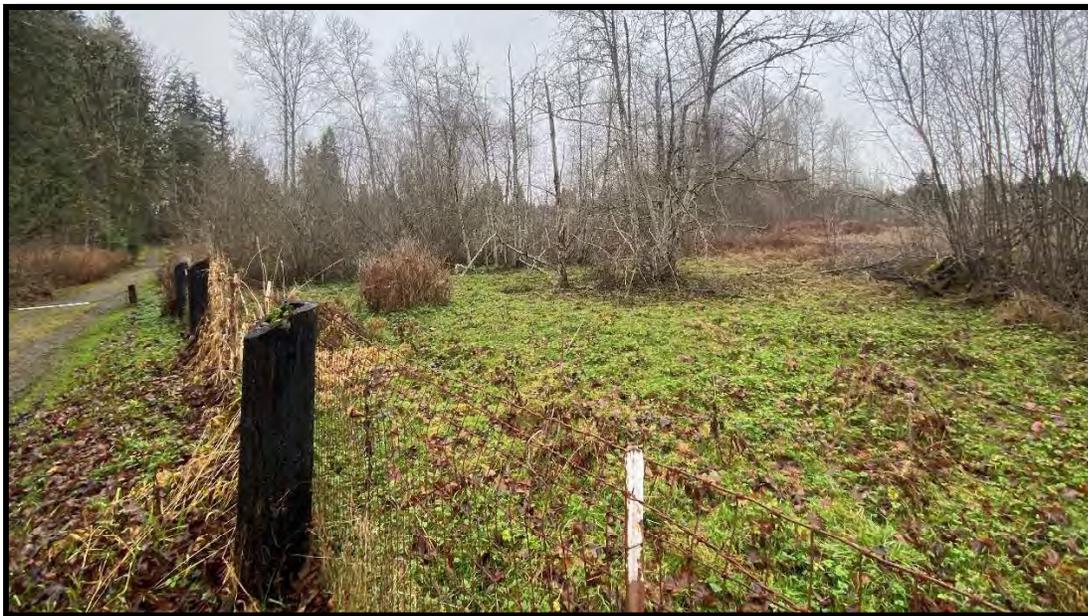
| <u>Tree Stratum</u> (Plot size: <u>5m</u> ) | Absolute % Cover | Dominant Species? | Indicator Status | |
|--|---|---|---|---|
| <u>Woody Vine Stratum</u> (Plot size: _____) | | | | |

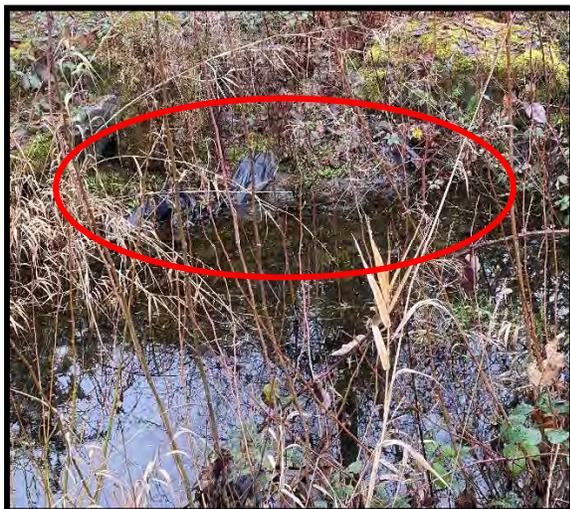
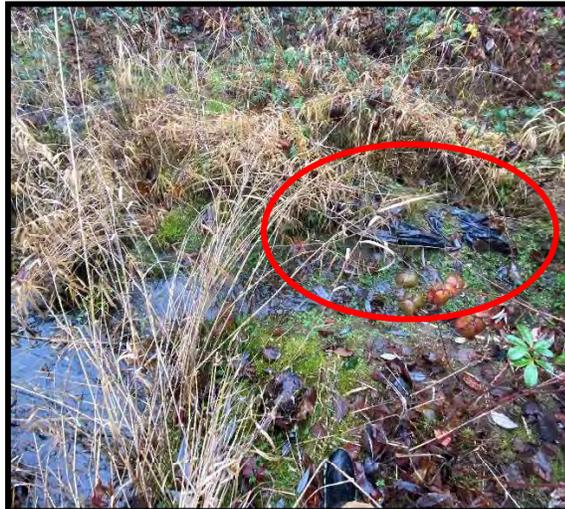
| <b>Profile Description: (Describe to the depth needed to document the indicator or confirm the absence of indicators.)</b> | | | | | | | | |
|--|---|---|---|---|---|---|---|---|
| Type: _____<br>Depth (inches): _____ | | | | | | | | |

| <b>Wetland Hydrology Indicators:</b> | | | |

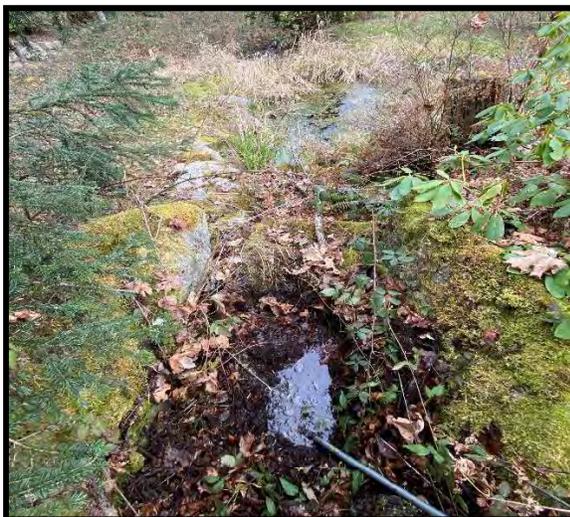
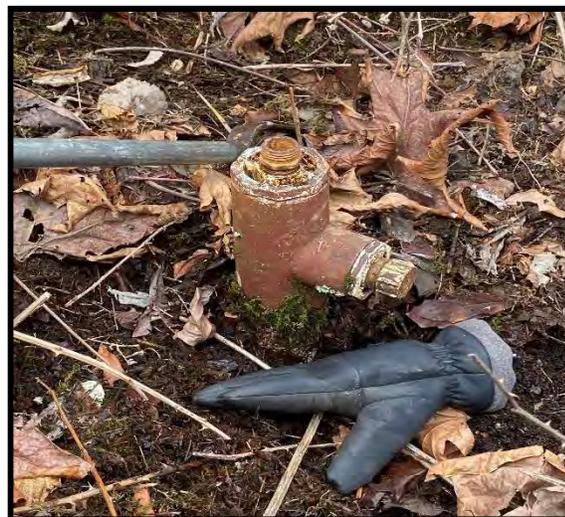
| <b>Profile Description: (Describe to the depth needed to document the indicator or confirm the absence of indicators.)</b> | | | | | | | | |
|--|---|---|---|---|---|---|---|---|
| Remarks: No hydric soil indicators observed | | | | | | | | |

| <b>Wetland Hydrology Indicators:</b> | | | |
|--|---|---|--|
| <input type="checkbox"/> Surface Water (A1) | <input type="checkbox"/> Water-Stained Leaves (B9) (except MLRA 1, 2, 4A, and 4B) | <input type="checkbox"/> Water-Stained Leaves (B9) (MLRA 1, 2, 4A, and 4B) | |

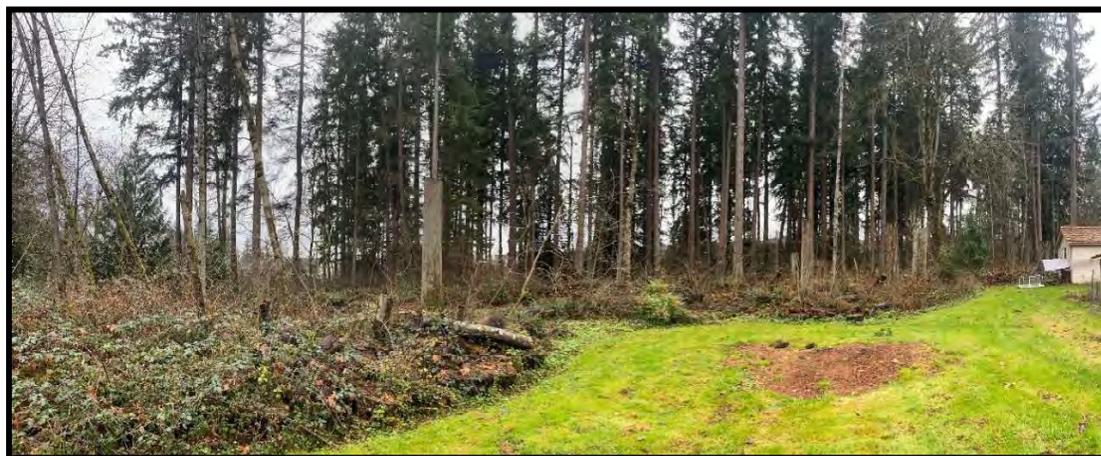
| | Absolute % Cover | Dominant Species? | Indicator Status | | |
|--|---|---|---|---|--|
| <b>Herb Stratum</b> (Plot size: 1m) | | | | | |

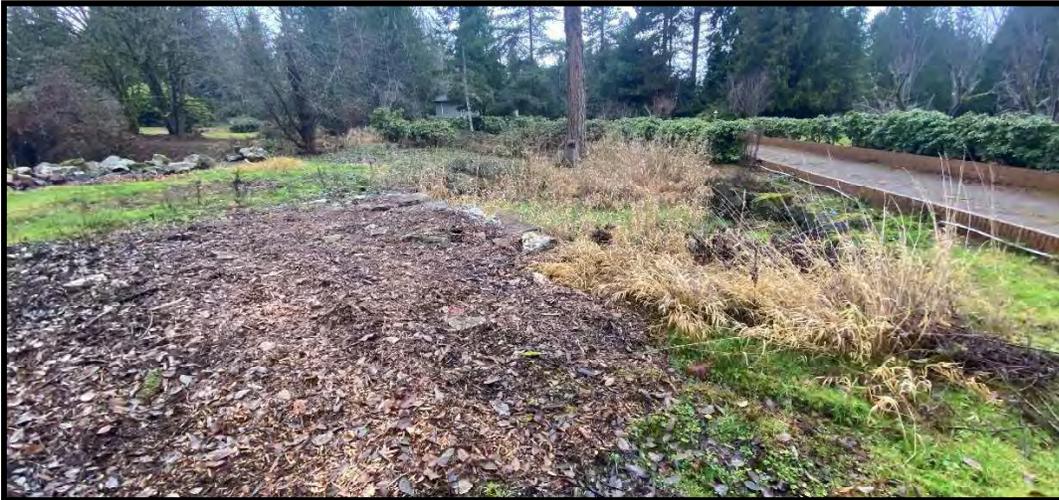
| | Absolute % Cover | Dominant Species? | Indicator Status | | |
|--|---|---|---|---|--|
| 2. _____ | _____ | _____ | _____ | | |
| 4. _____ | _____ | _____ | _____ | | |

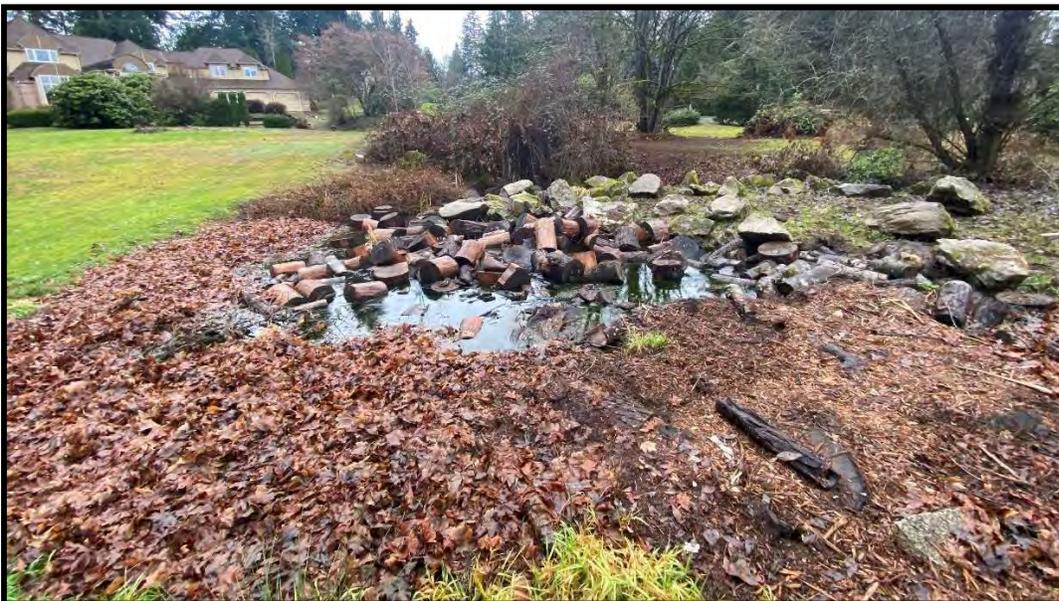
| | Absolute % Cover | Dominant Species? | Indicator Status | | |
|--|---|---|---|---|--|
| 6. _____ | _____ | _____ | _____ | | |

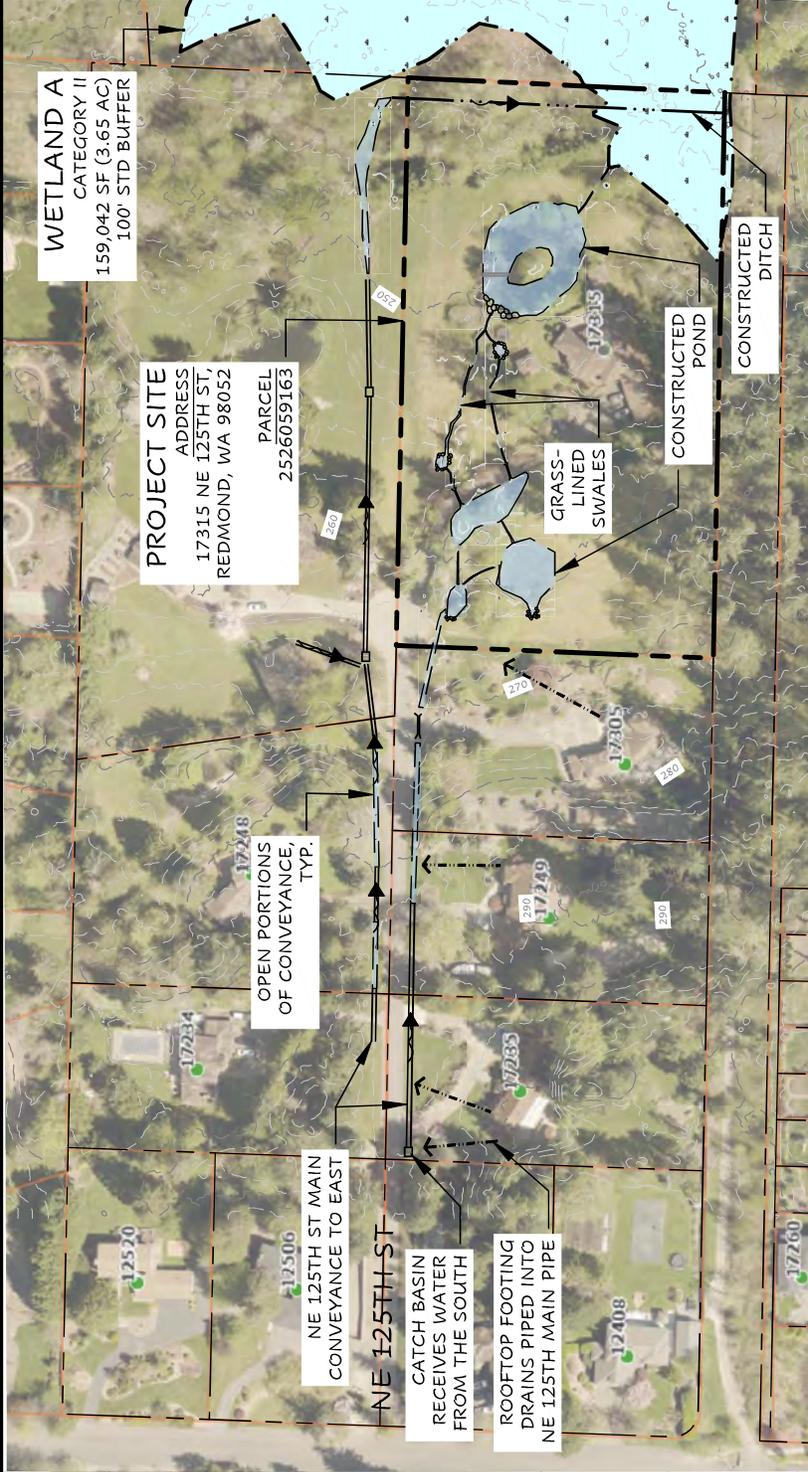
# STORMWATER CONVEYANCE MAP

- PROPERTY LINE
- EXISTING WETLAND
- UNREGULATED WATER FEATURES/ OPEN PORTIONS OF WATER CONVEYANCE
- CONSTRUCTED DITCH
- EXISTING CONTOUR (2-FT)
- STORM DRAINS CONNECTED TO PIPED CULVERTS
- ROOFTOP FOOTING DRAINS
