12047 156TH AVE SE

KING COUNTY PARCEL No. 9353300560

MITIGATION PLAN

REVISED FEBRUARY 4TH, 2026

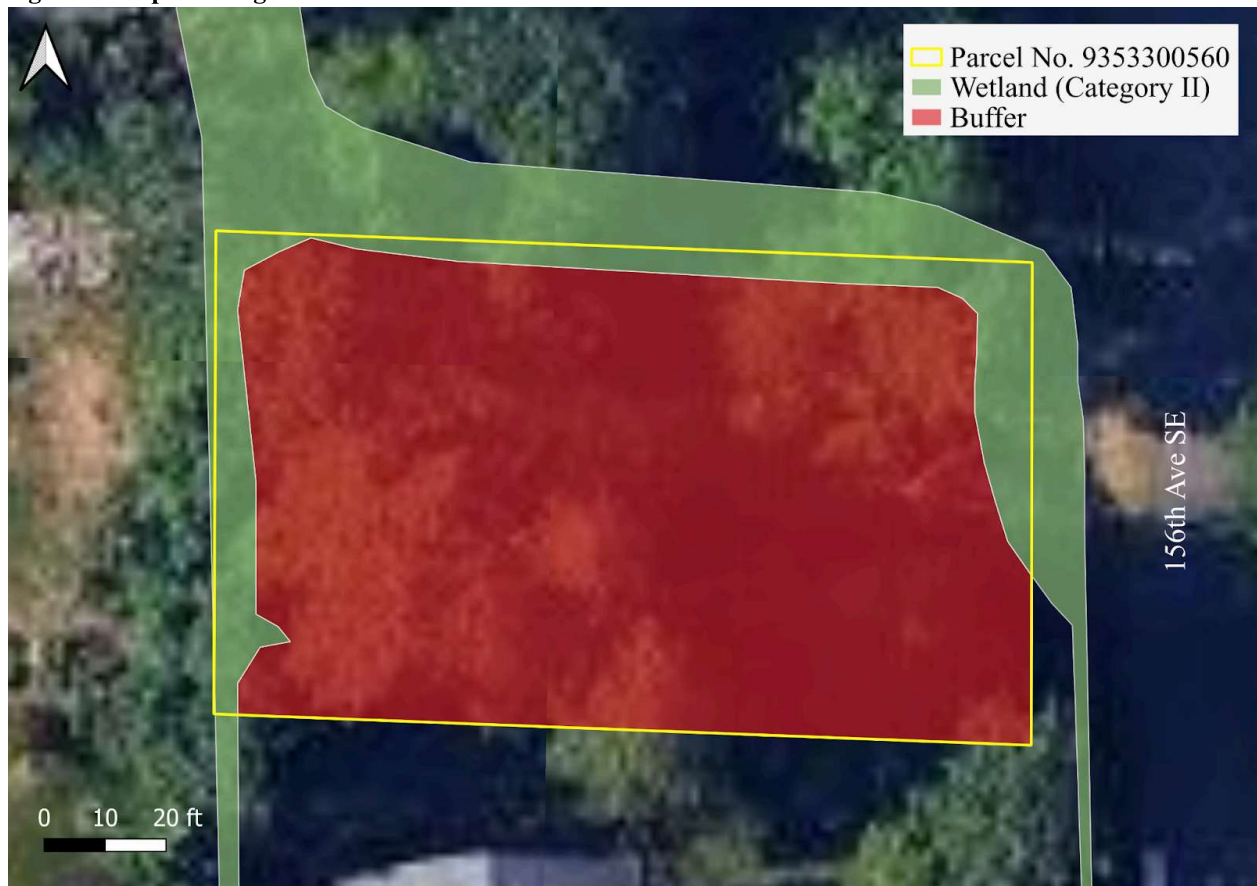
Figure 1. Map showing the wetland and buffer.

The wetland's buffer is defined according to King County Code (KCC) 21A.24.325. The wetland is rated as a Category II feature (Table 1). According to KCC 21A.24.325, the wetland buffer is 150-feet for Category II wetlands with moderate habitat scores within the Urban Growth Area. The entire subject property is situated within the wetland's buffer.

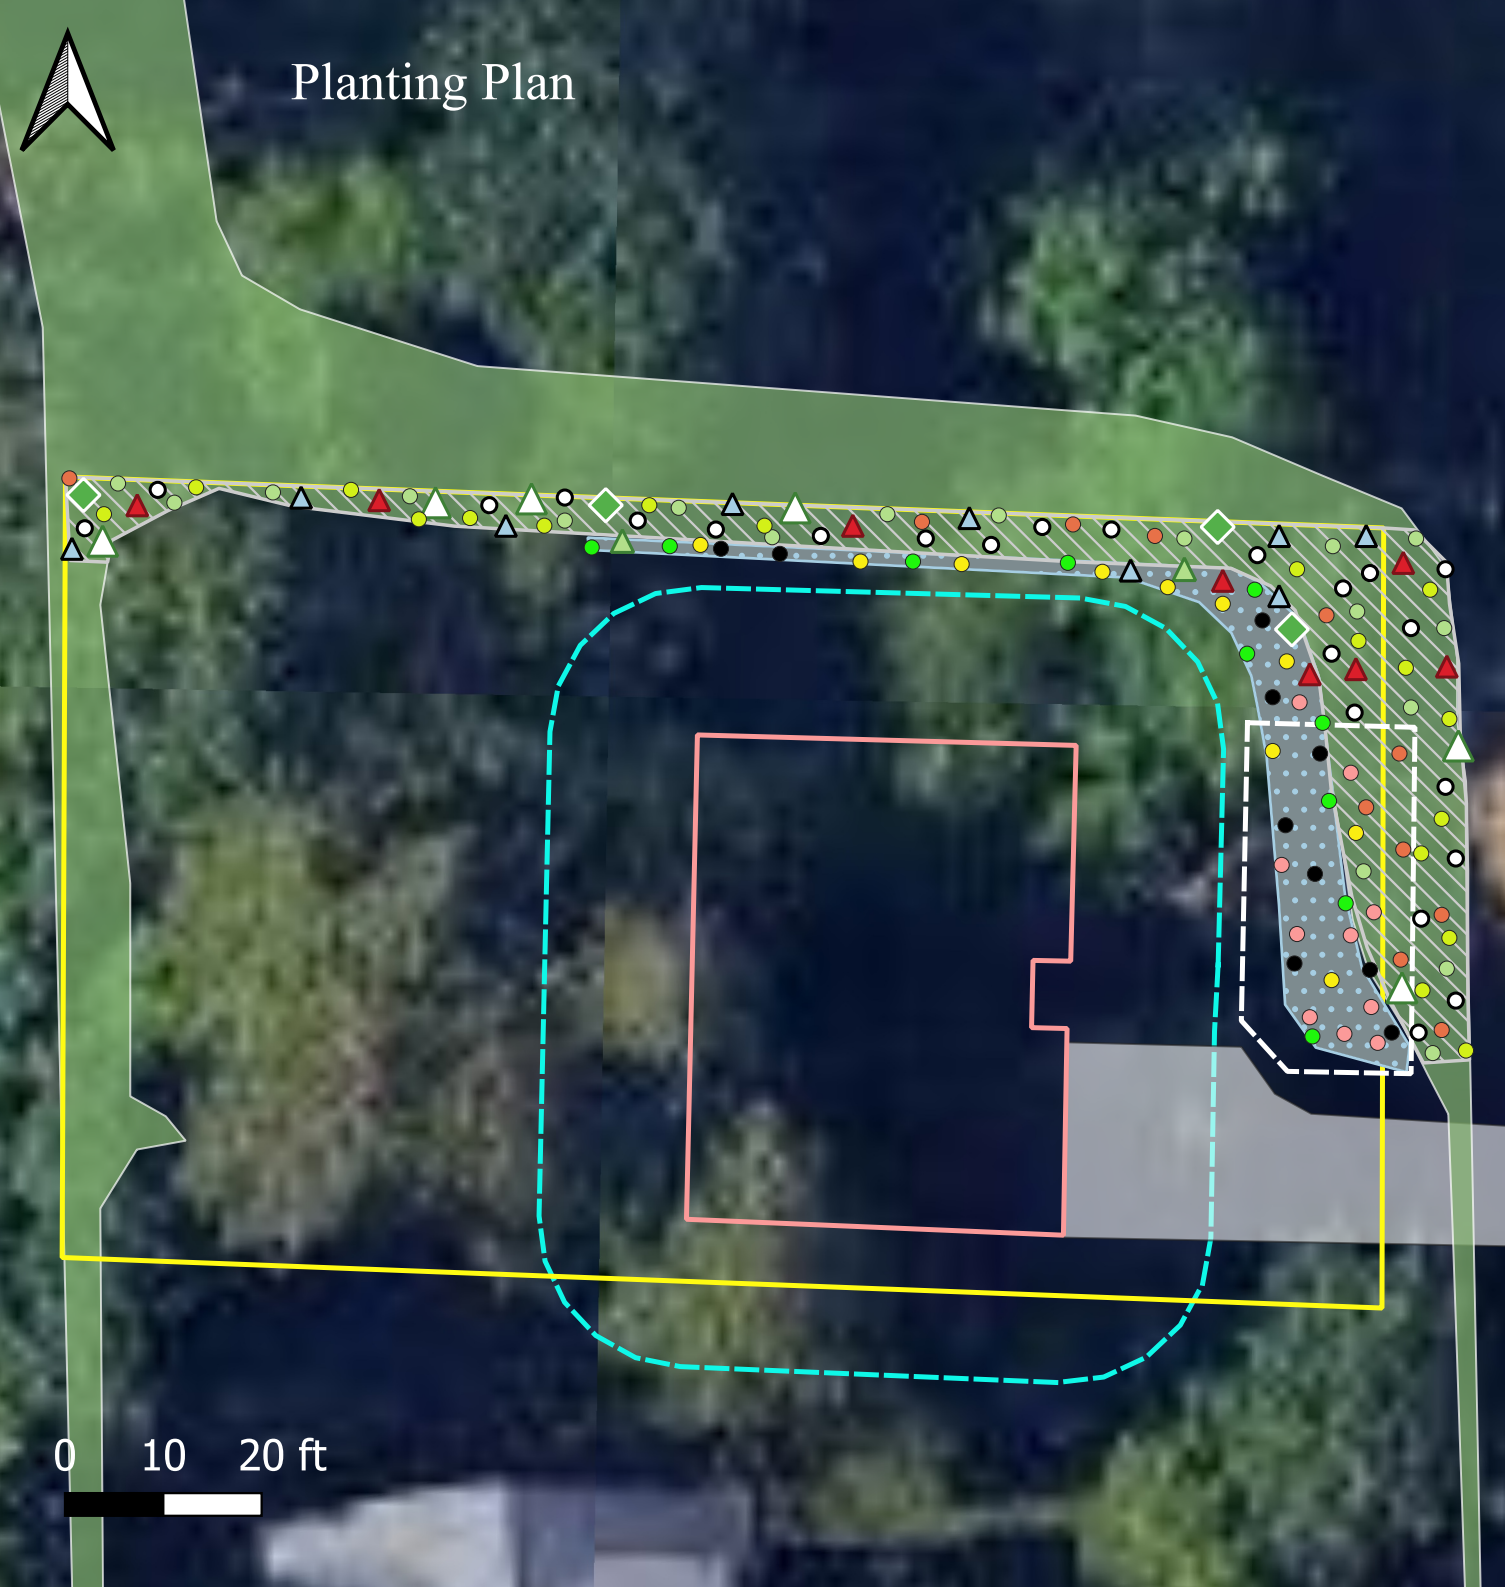
APPENDIX B. MAP OF WETLAND AND BUFFER IMPACT AREA

Planting Plan

- Parcel No. 9353300560
- Wetland (Category II)
- Residence Footprint
- Driveway
- 15-Foot BSBL
- Impact Area
- Wetland Enhancement Area
- Buffer Enhancement Area
- Acer circinatum*
- Arctostaphylos uva-ursa*
- Athyrium felix-femina*
- Cornus canadensis*
- Cornus sericea*
- Gaultheria shallon*
- Geum macrophyllum*
- Mahonia nervosa*
- Physocarpus capitatus*
- Polystichum munitum*
- Rubus spectabilis*
- Thuja plicata*
- Tolmiea menziesii*

The goal of the wetland and buffer enhancement described herein is to offset impacts from the line installations to the residence. Mitigation for the unavoidable impacts will be offset with the enhancement of onsite wetland and buffer. Native vegetation will be installed onsite in 1,350 ft² of wetland and 460 ft² of buffer that has been degraded by previous land use activities. The enhanced buffer area will provide increased quality of function over the existing buffer conditions including increased native species diversity, increased habitat complexity, and increased buffer screening and water quality enhancement.

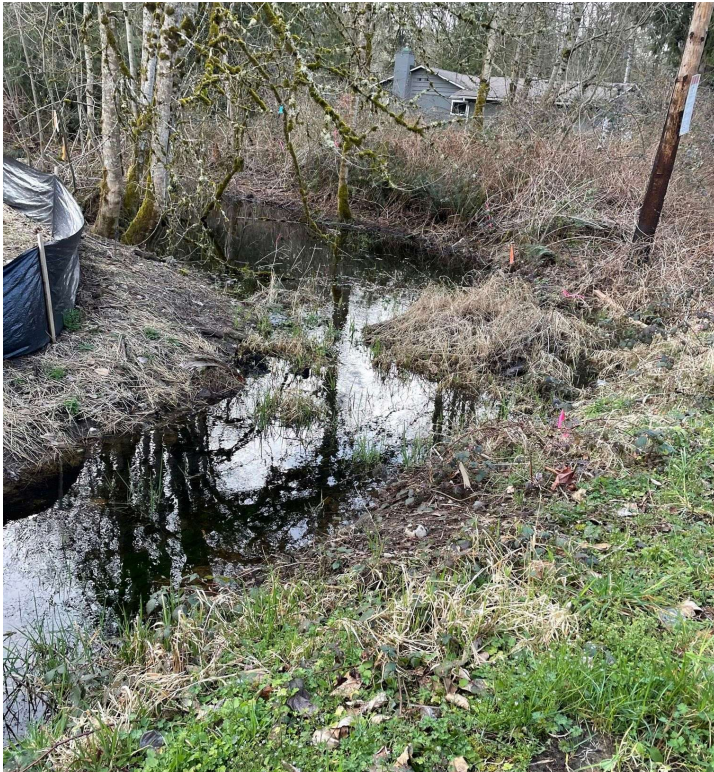
Photo 1. Looking northwest toward the onsite wetland.

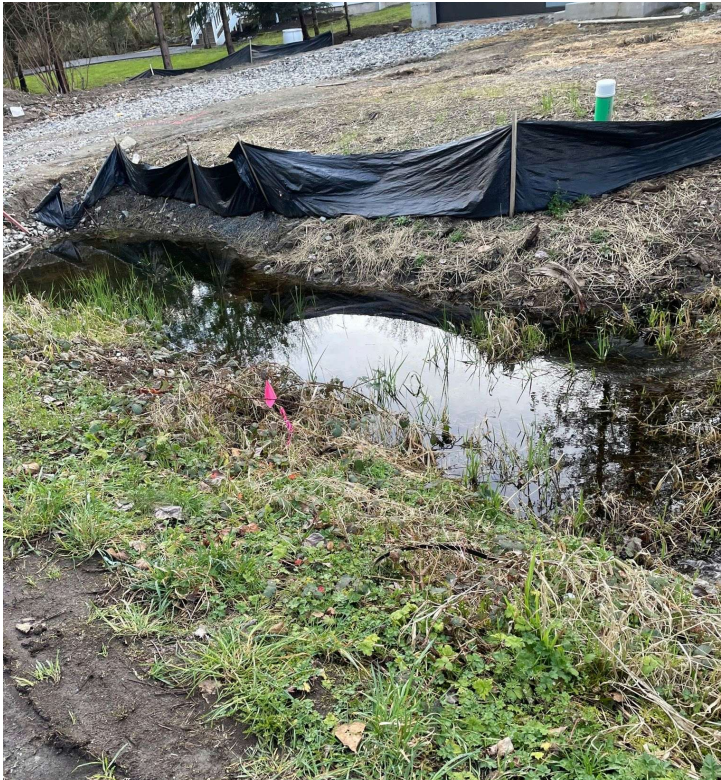
Photo 3. Looking southwest towards water and sewer lines installed in the wetland.

The purpose of the project is to connect water and sewer lines to the existing single-family residence (Appendix A). The lines were installed within portions of the onsite category II wetland and buffer. Fill was deposited in the wetland in order to install both the water and sewer lines. To provide reasonable use of the home with water and sewer utilities, the fill will remain in place and mitigation will be used to compensate for impacts.

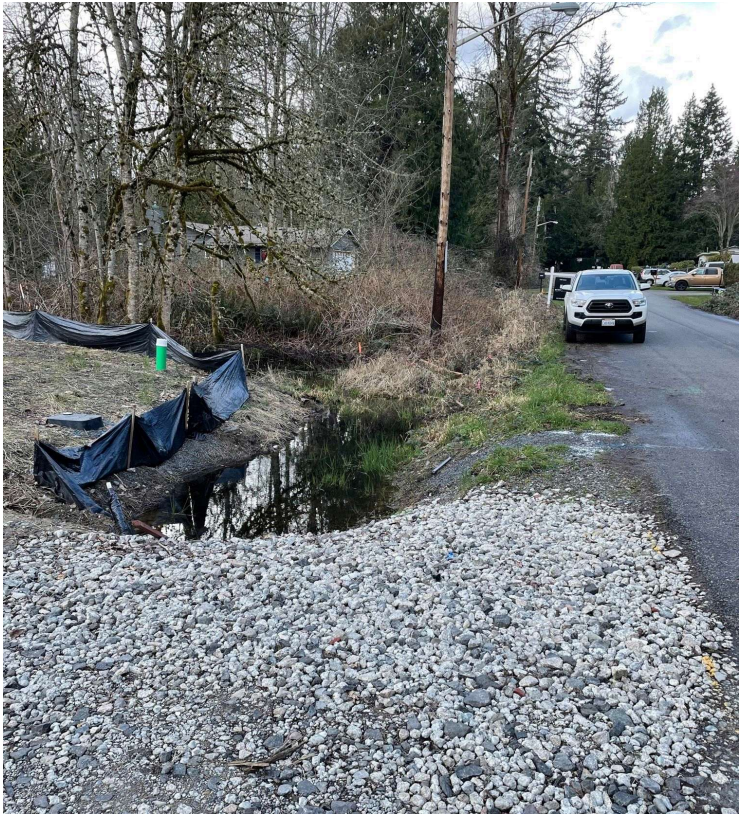
Photo 4. Looking north towards water and sewer lines installed in the wetland.
