# **CRITICAL AREA DETERMINATION**

**Guadagno Property King County, Washington**

June 13, 2022

RAEDEKE ASSOCIATES, INC.

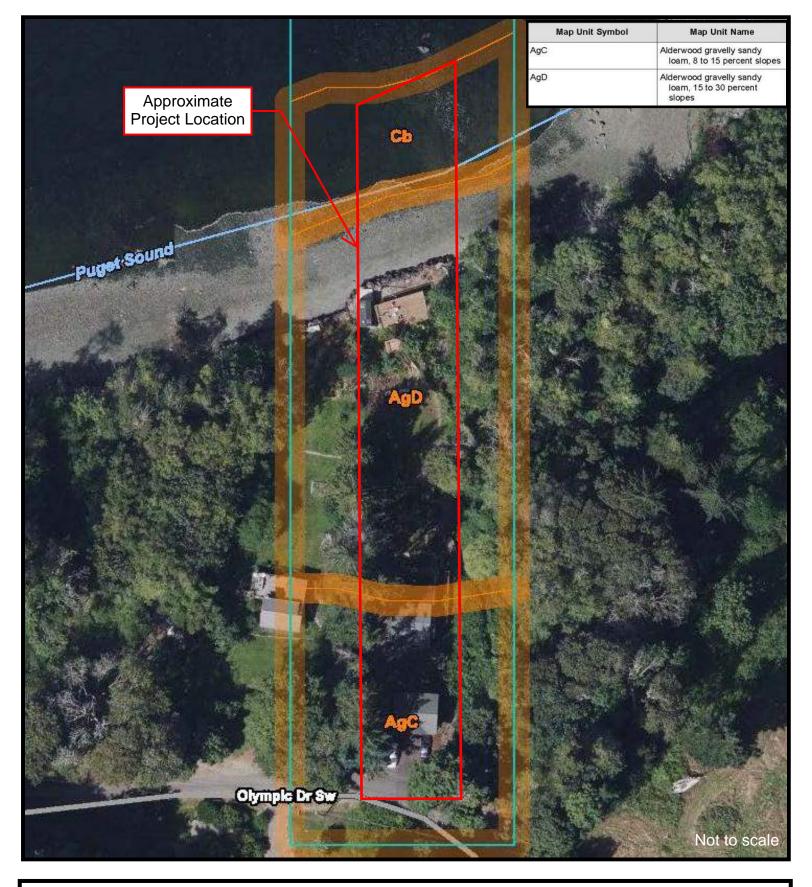
# FIGURE 2 - NRCS Web Soil Survey Map **Guadagno, King County WA**

The U.S.D.A. NRCS (2022) Web Soil Survey shows the project site mapped as Alderwood gravelly sandy loam soils series (Figure 2). Alderwood gravelly sandy loam does not meet the criteria of a hydric soil but may contain hydric inclusions including Shalcar and Norma soils. Soil series boundaries are mapped using aerial photo interpretation with limited field verification. Thus, the mapping of soils within an area may vary from one location to another.

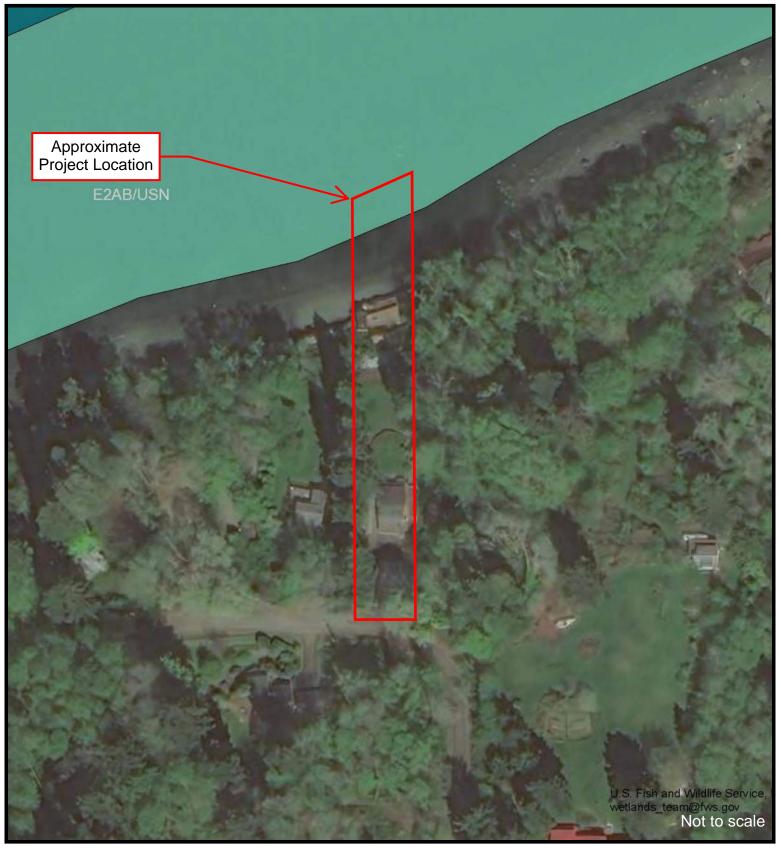
The USFWS (2022) NWI shows that the portion the project site in the intertidal area along the Puget Sound shoreline contains an estuarine, and marine wetland E2AB/USN (Figure 3). Wetlands shown on the NWI are general in terms of location and extent, as they are determined primarily from aerial photograph interpretation. Thus, the number and extent of existing wetlands located within the project area may differ from those marked on an NWI map.

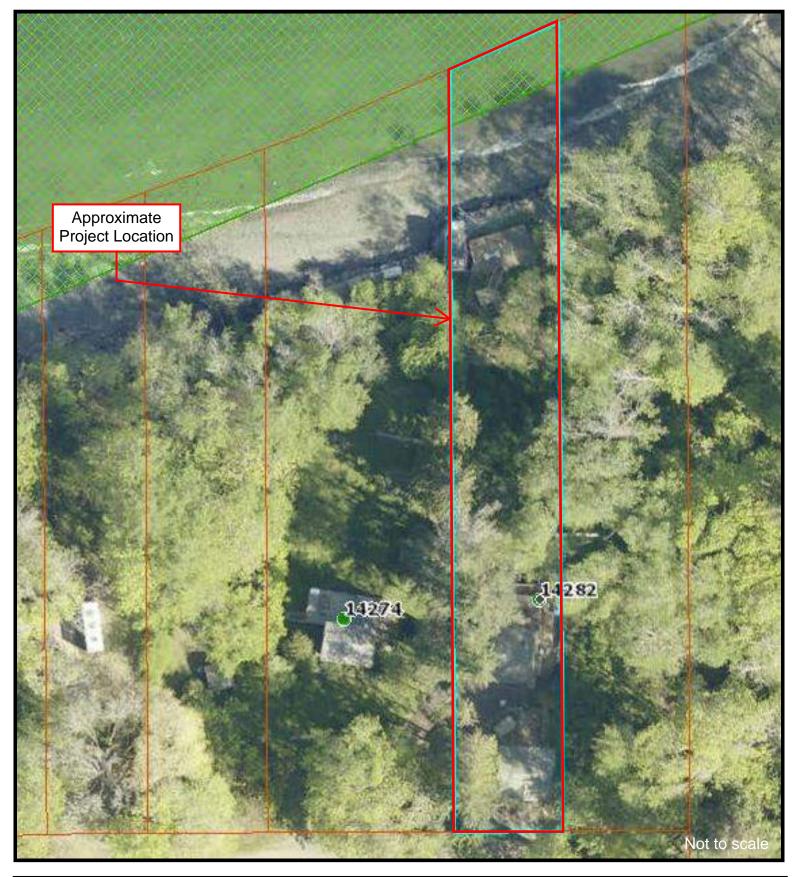
King County (2022b) iMap depicts the intertidal area on the north end of the subject parcel as a wetland (Figure 4).

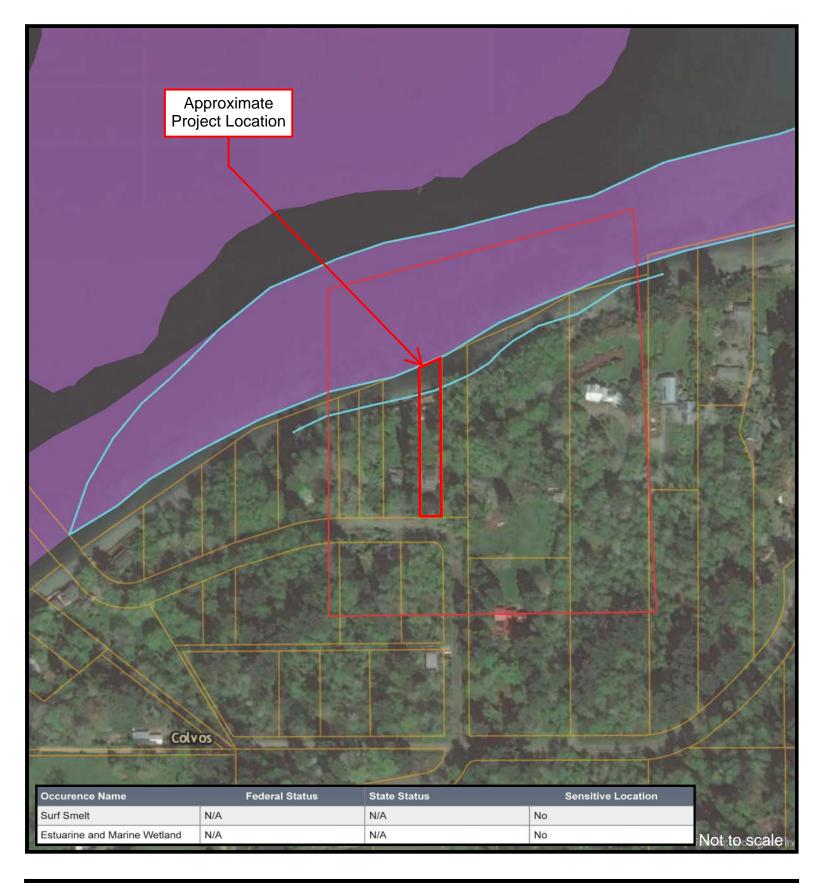
The WDFW (2022) PHS database map shows the beach at the project site as a breeding area for surf smelt (Figure 5). The PHS map also identifies the intertidal area at the north end of the subject parcel as an estuarine and marine wetland. The Washington Natural Heritage Program (2021) database does not identify a natural heritage feature within the section where the project is located.

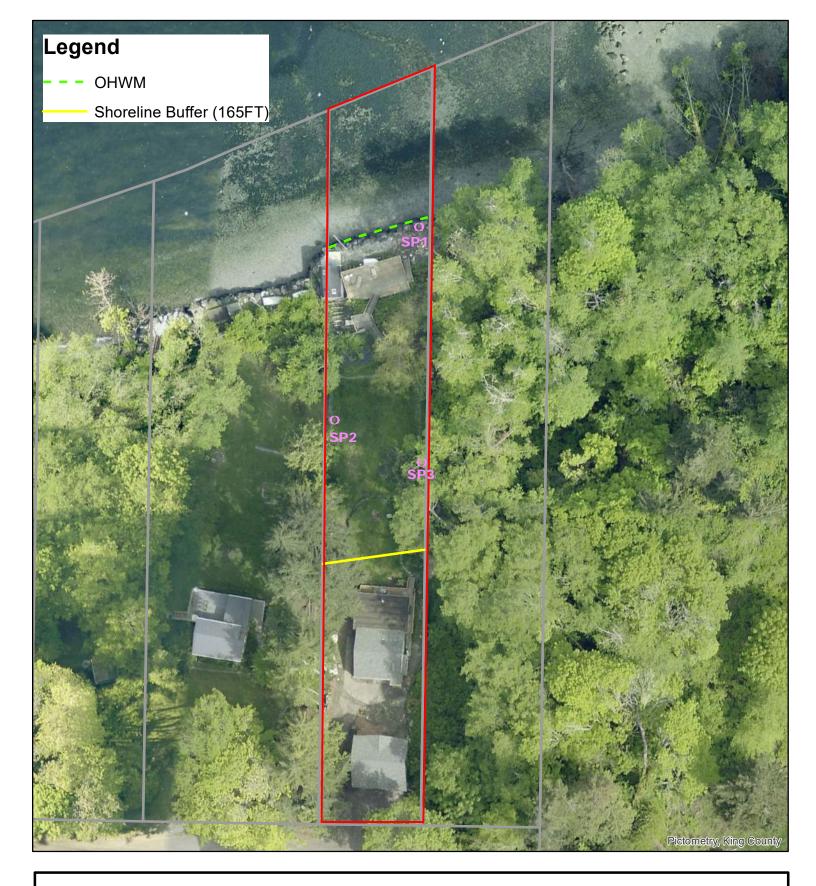
# FIGURE 6 - Guadagno King County - Existing Conditions

As noted above, the property is bordered to the north by the Puget Sound (Figure 6). We marked the OHWM with pink and black flagging. A rock bulkhead is located along the Puget Sound OHWM. The bulkhead appears to correspond to the location of the marine OHWM with a more natural marine, cobble and substrate beach environment extending to the north. The Puget Sound shoreline is designated as a Type S water or "shoreline of the state."
