TECHNICAL INFORMATION REPORT

Guadagno Landslide Repair

14282 Olympic Drive SW
Vashon, WA 98070

CG Project No. 21076.20

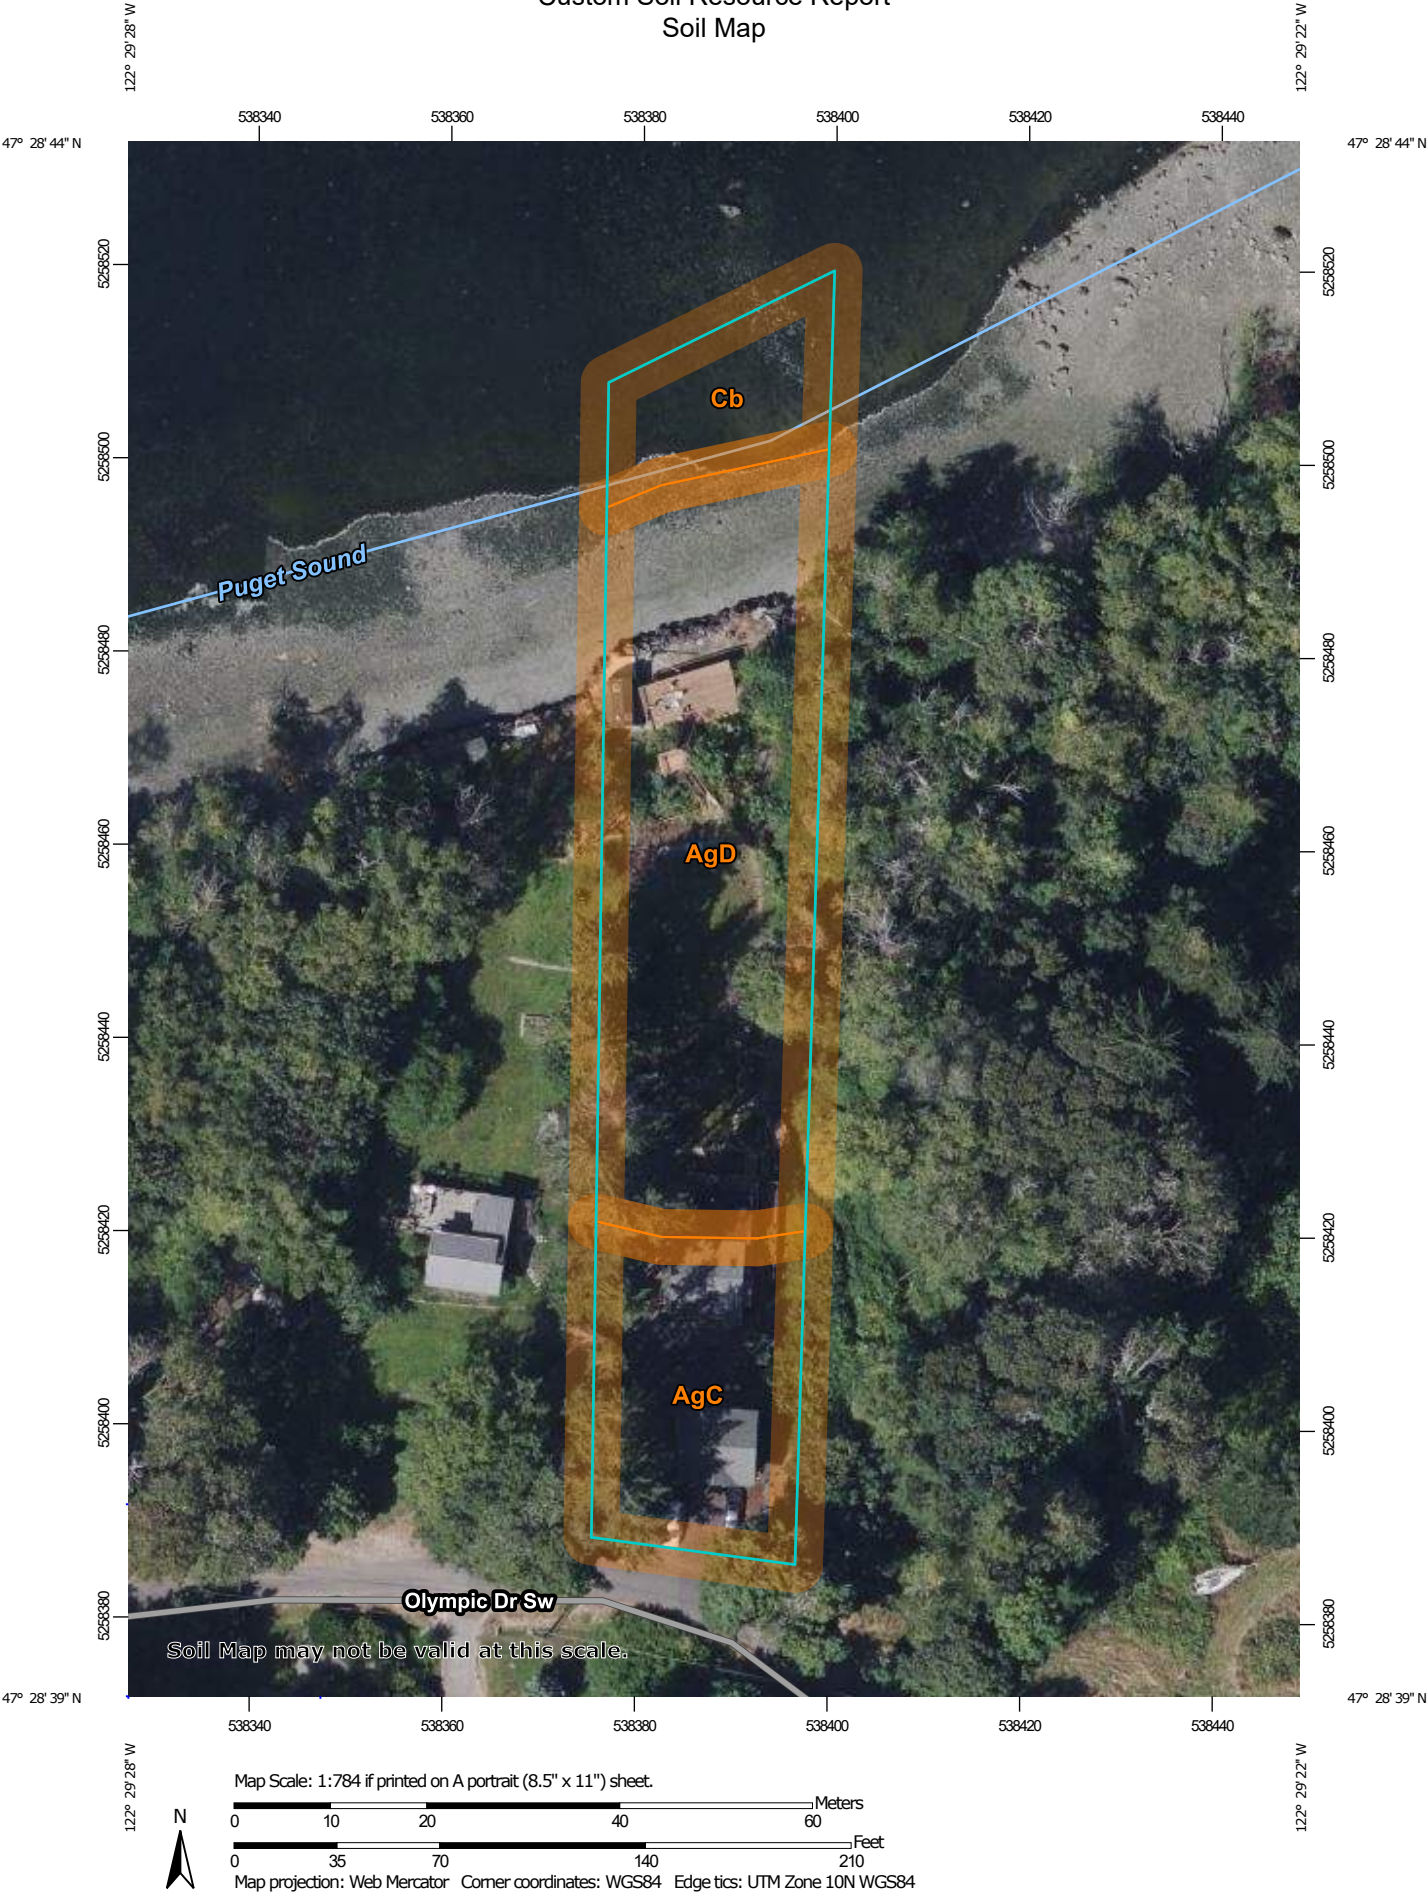
Custom Soil Resource Report
Soil Map

The soil map section includes the soil map for the defined area of interest, a list of soil map units on the map and extent of each map unit, and cartographic symbols displayed on the map. Also presented are various metadata about data used to produce the map, and a description of each soil map unit.

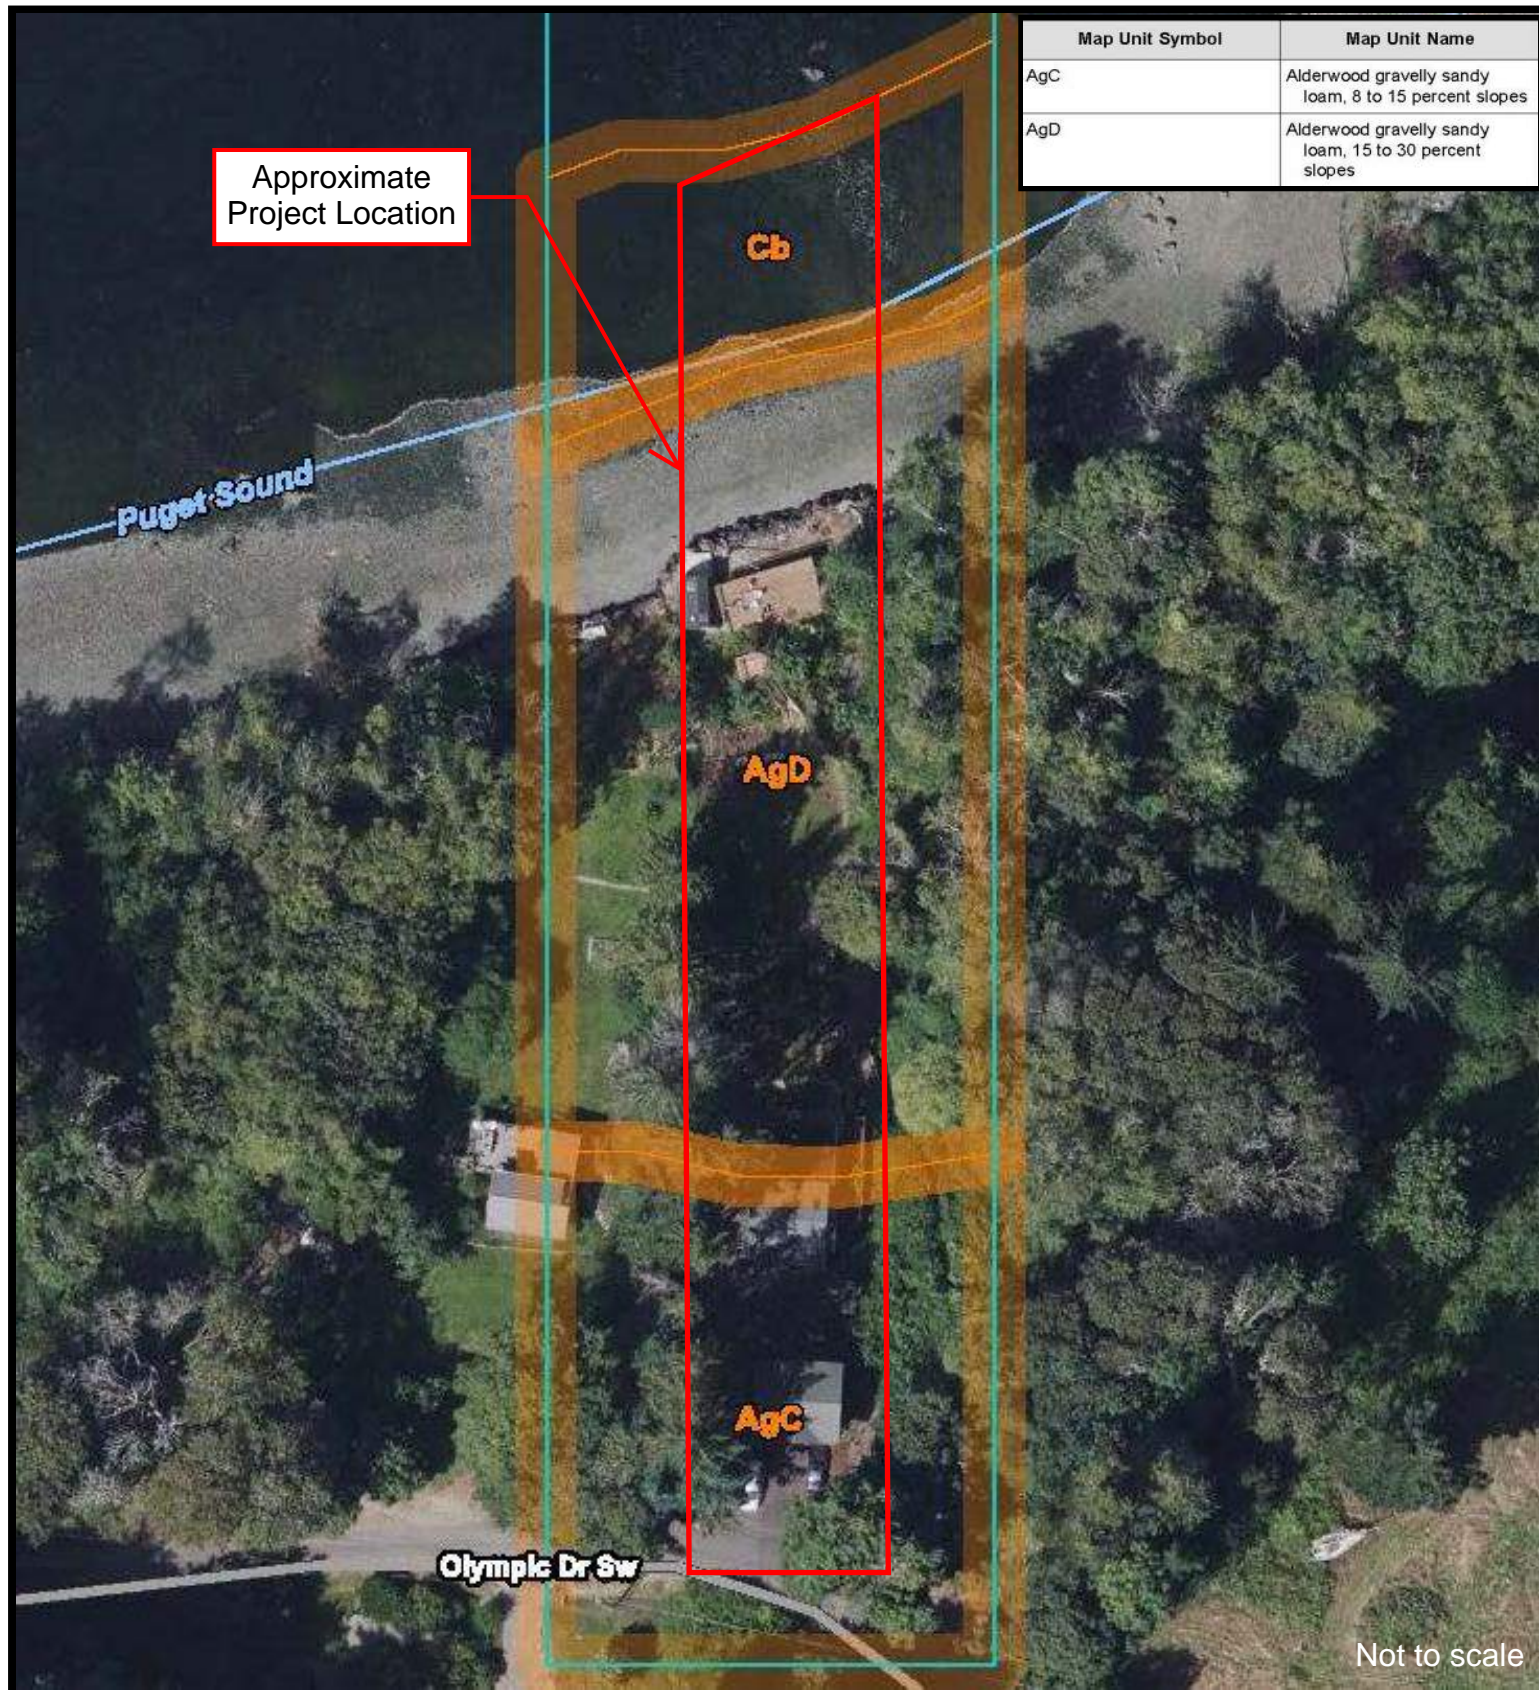
FIGURE 2 - NRCS Web Soil Survey Map Guadagno, King County WA

The U.S.D.A. NRCS (2022) Web Soil Survey shows the project site mapped as Alderwood gravelly sandy loam soils series (Figure 2). Alderwood gravelly sandy loam does not meet the criteria of a hydric soil but may contain hydric inclusions including Shalcar and Norma soils. Soil series boundaries are mapped using aerial photo interpretation with limited field verification. Thus, the mapping of soils within an area may vary from one location to another.
