Date: January 8, 2026
To: Leah Davis, Environmental Planner II
 Department of Local Services
From: Bill Rehe, Senior Associate Biologist
Subject: DeGarmo: SHOR22-0032 Response to Comments

Shoreline Protection Repair Project

Shoreline Protection Repair Project 9928 SW Bunker Trail, Vashon, WA 98070 Project Application SHOR22-0032

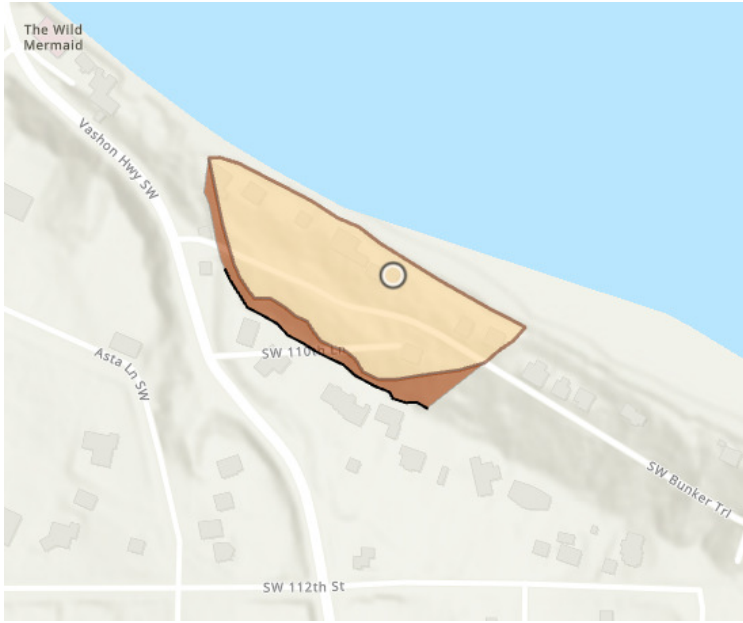
Geological Map Department of Natural Resources Washington State

The shoreline experienced a large scale landslide encompassing the entire property and adjacent properties that is mapped to be less than 150 years old. See the landslide depiction below:

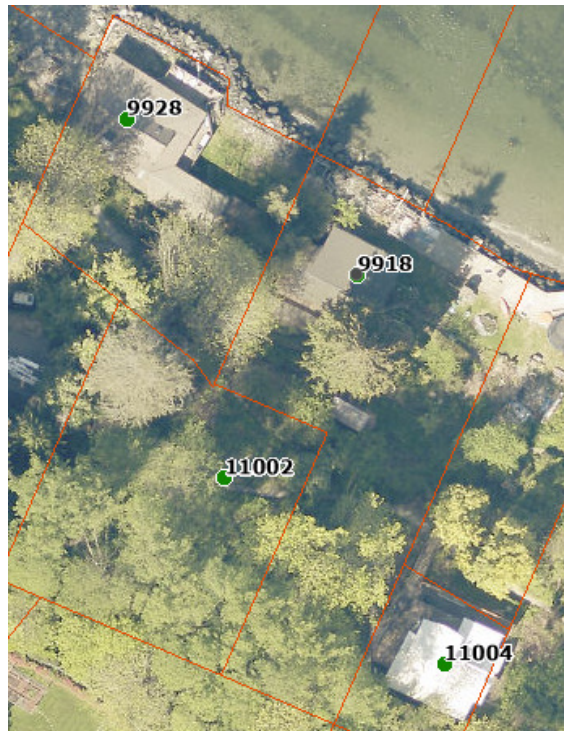
Aerial Photo from King County Website

An aerial photo of the project and immediate vicinity is provided below. See the photographs in Appendix B for illustrations of site conditions.

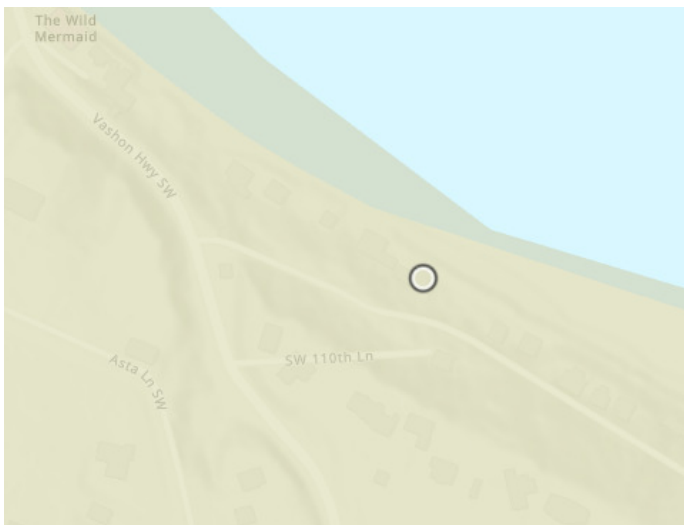
Geological Map Department of Natural Resources Washington State

The “Interactive Geologic Map” from the Department of Natural Resources provides the following caption(s) for the project area:

Map Unit: Qgt
Age: Quaternary
Name: Till
Description: Unsorted, unstratified, highly compacted mixture of clay, silt, sand, gravel, and boulders deposited by glacial ice; may contain interbedded stratified sand, silt, and gravel.

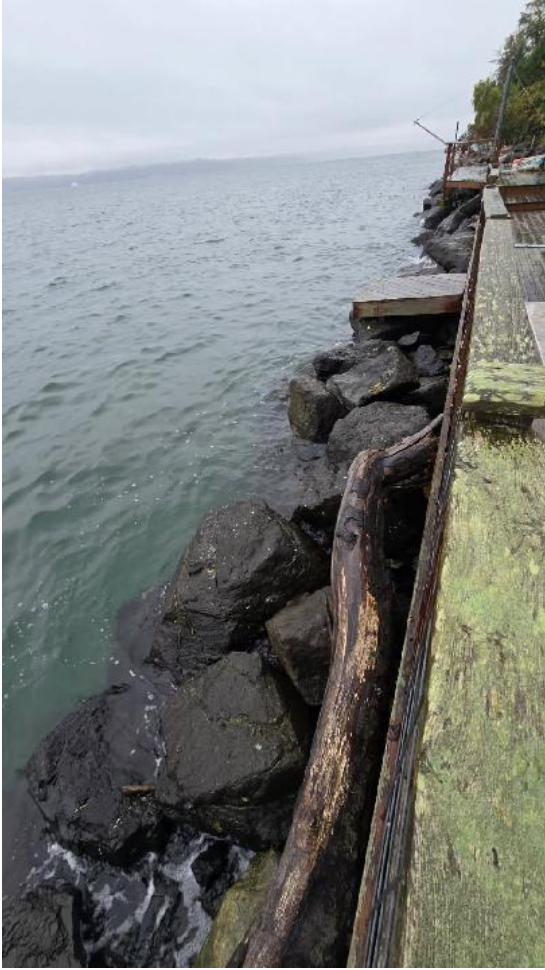
Photo 1: Timber and Rock Bulkhead

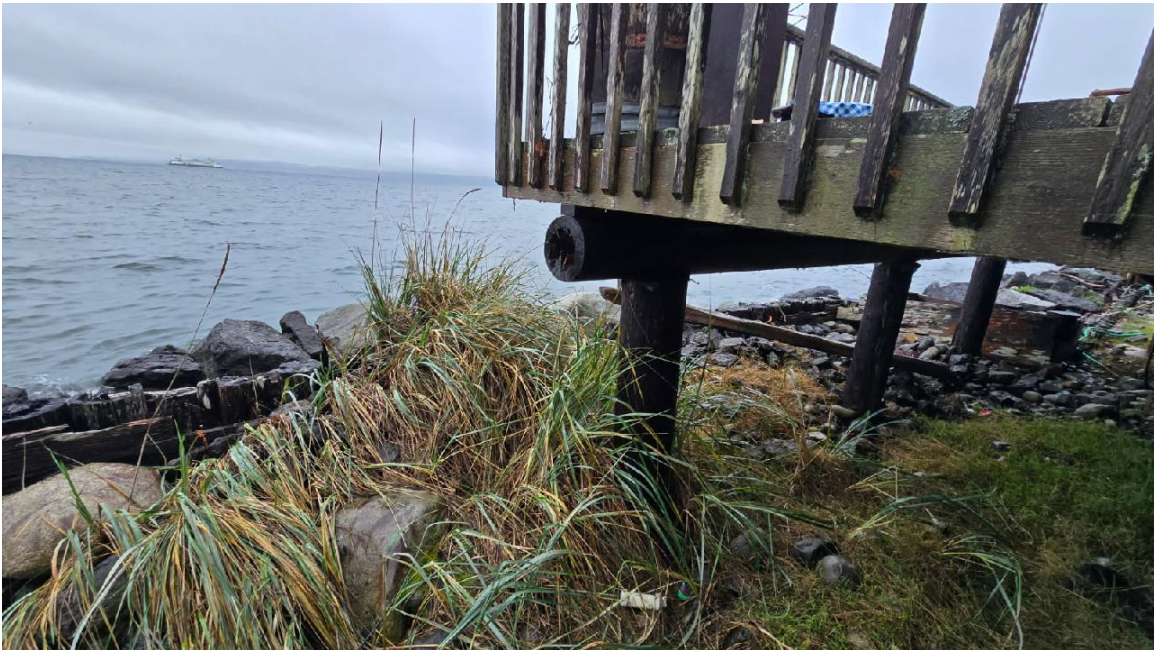
Photo 2: Backfill Area

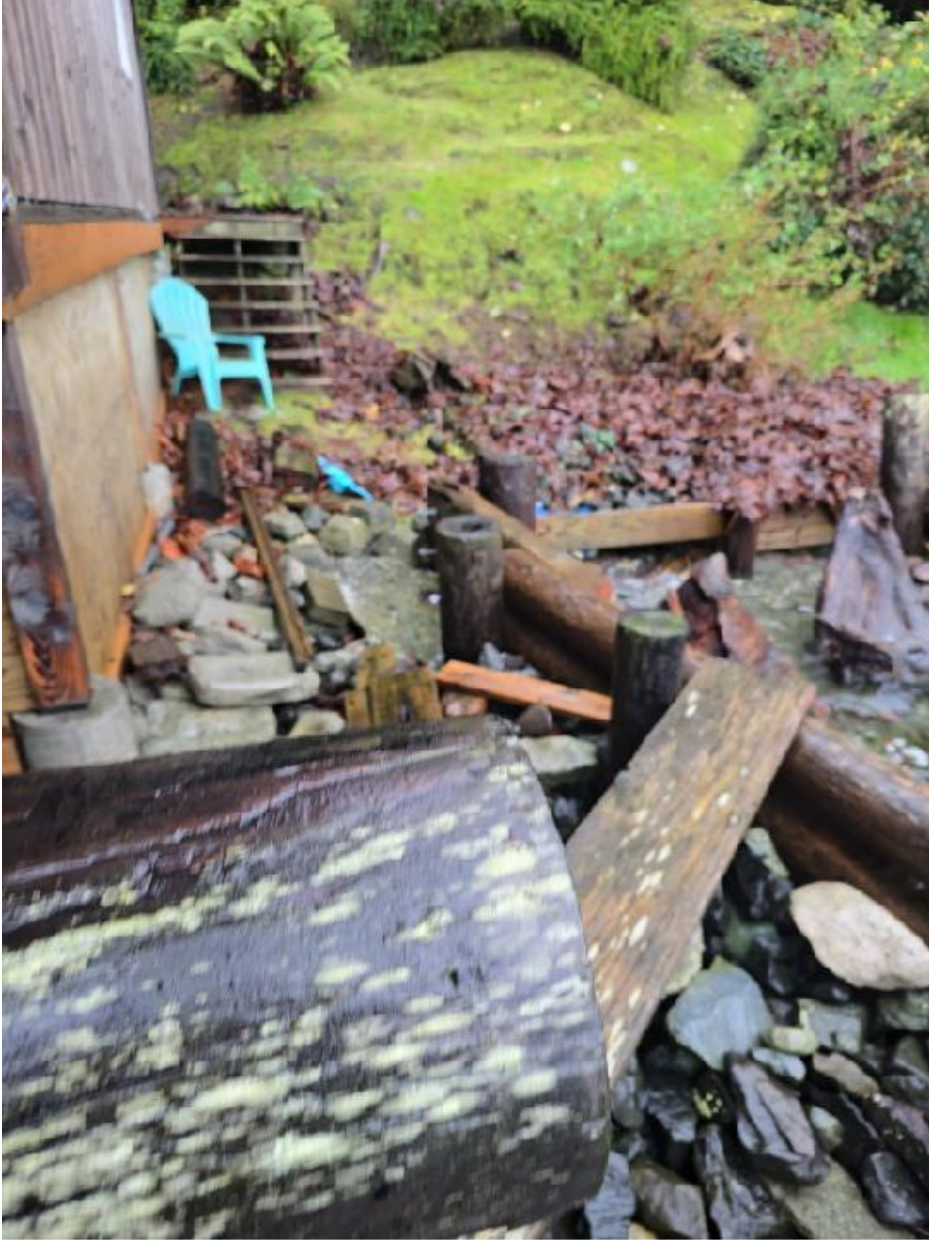
Photo 3: House Located 3 ft From Bulkhead

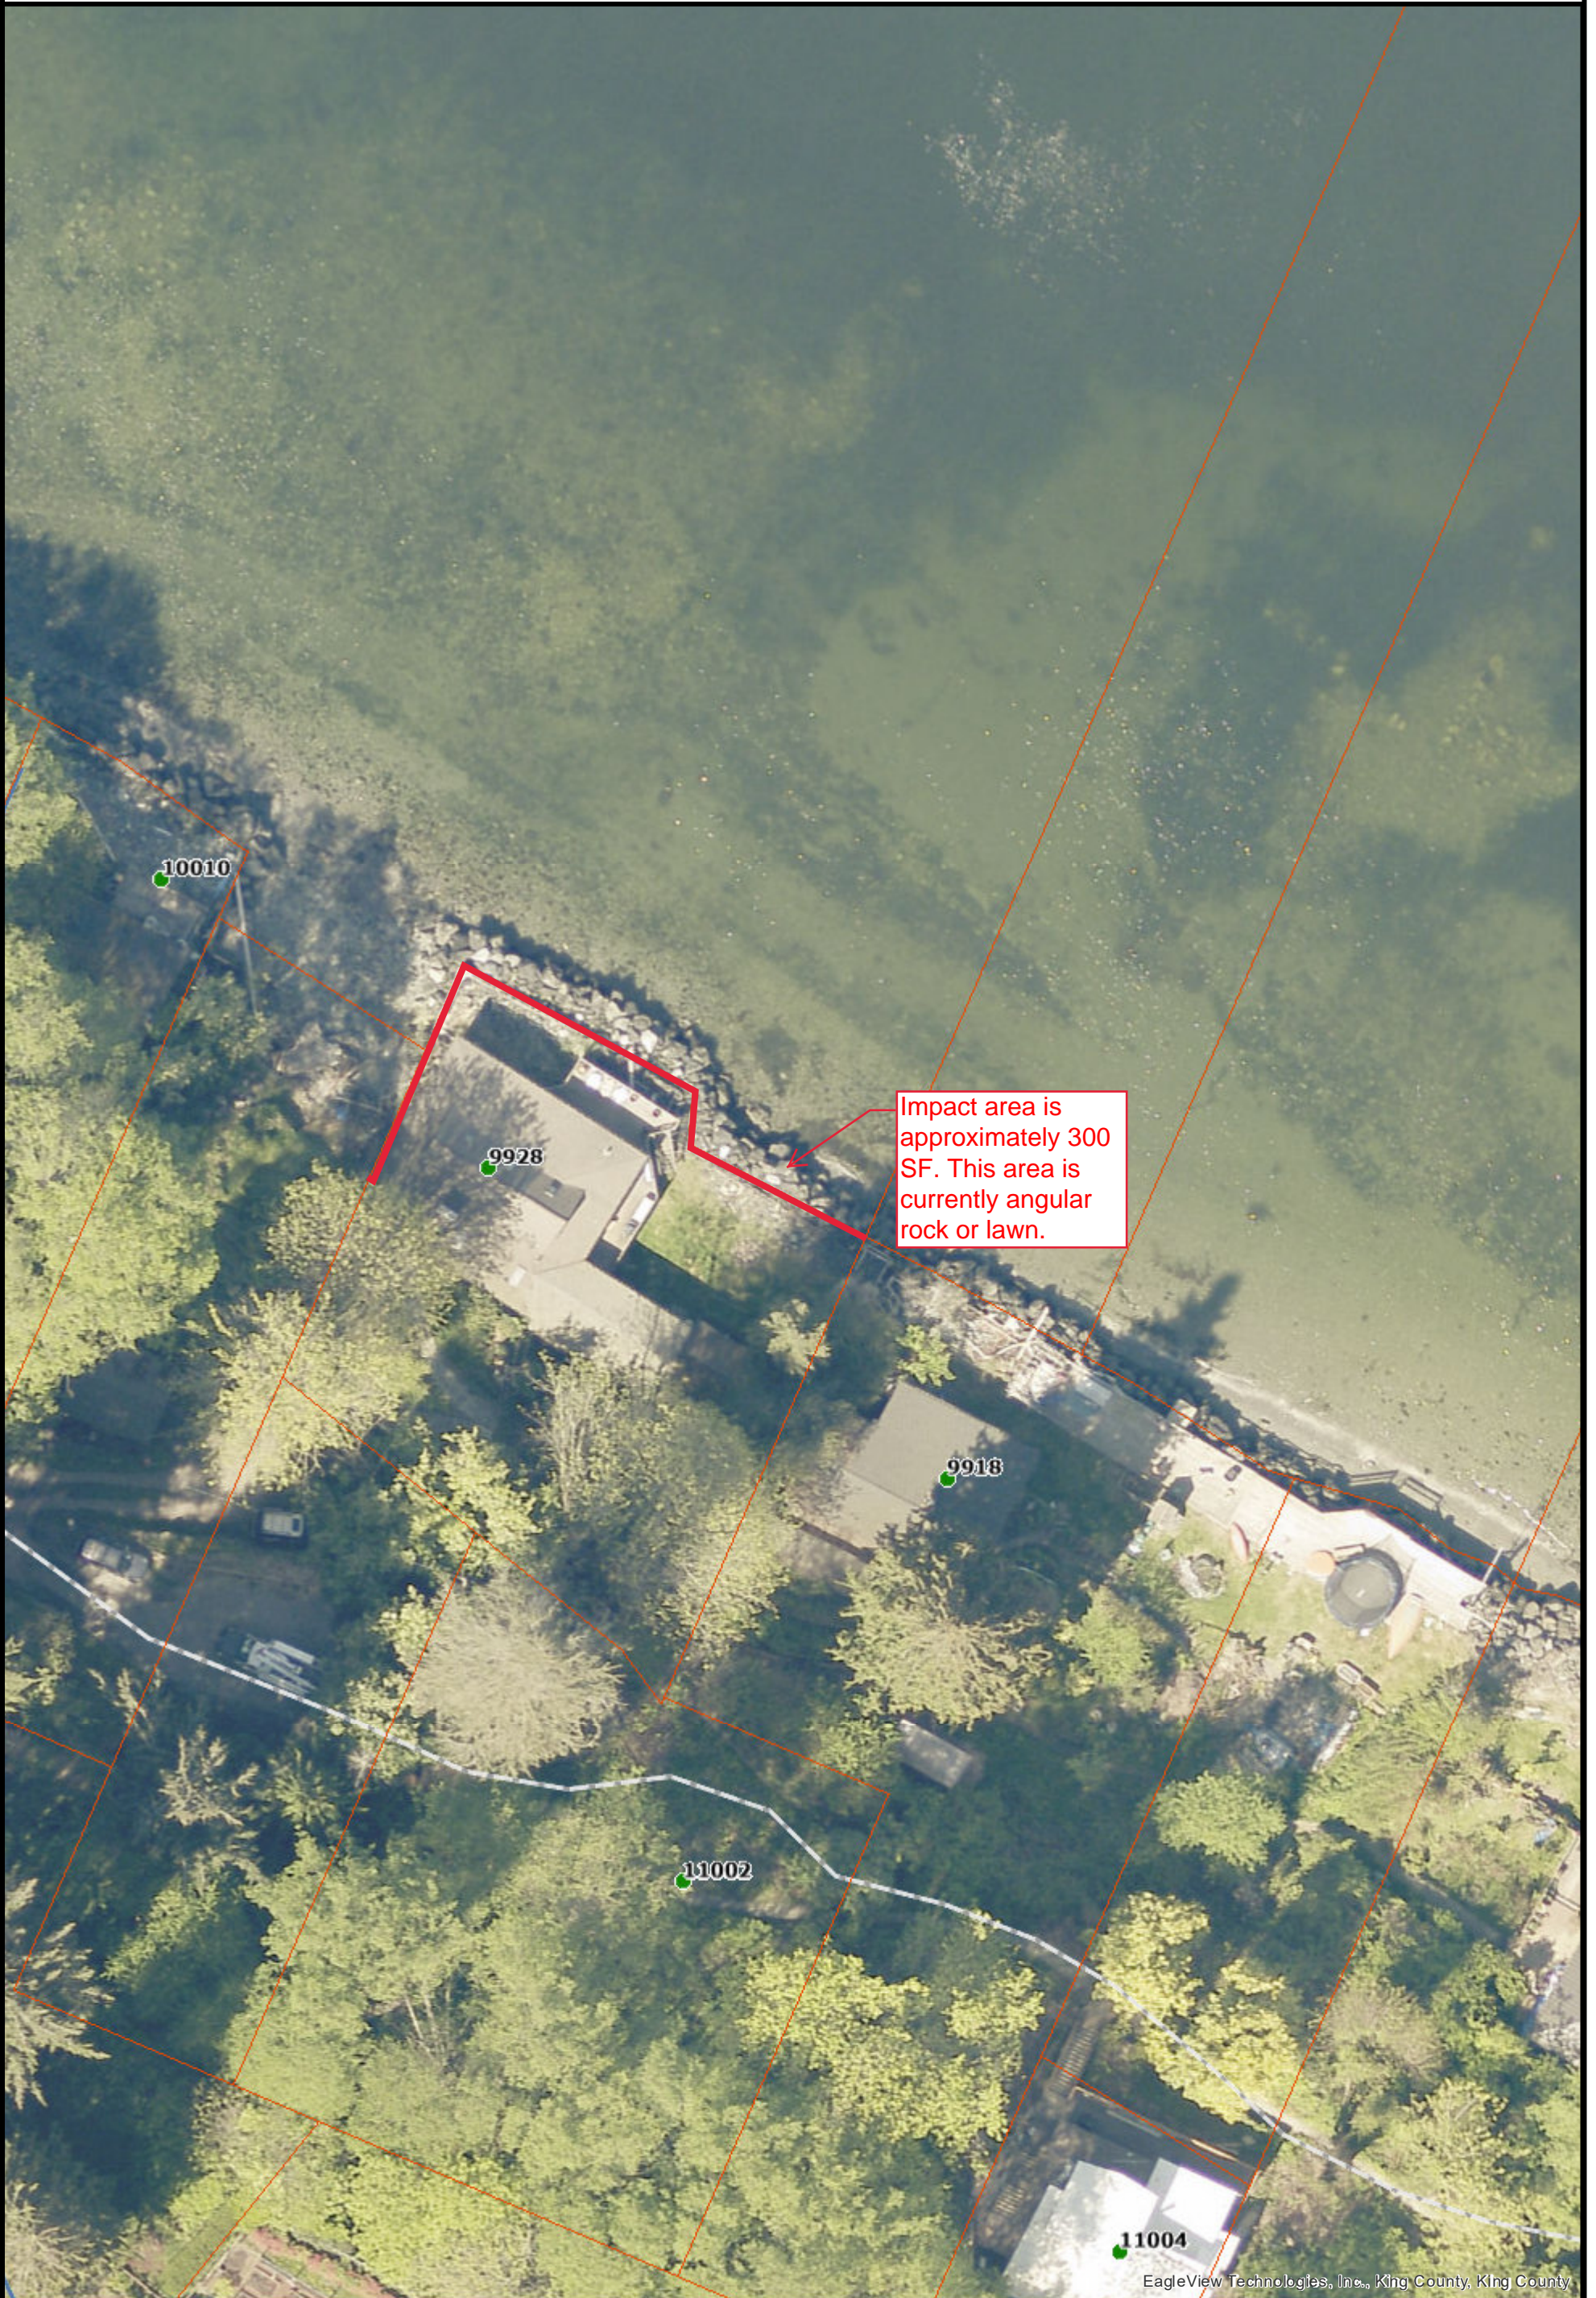
King County iMap

Impact area is approximately 300 SF. This area is currently angular rock or lawn.

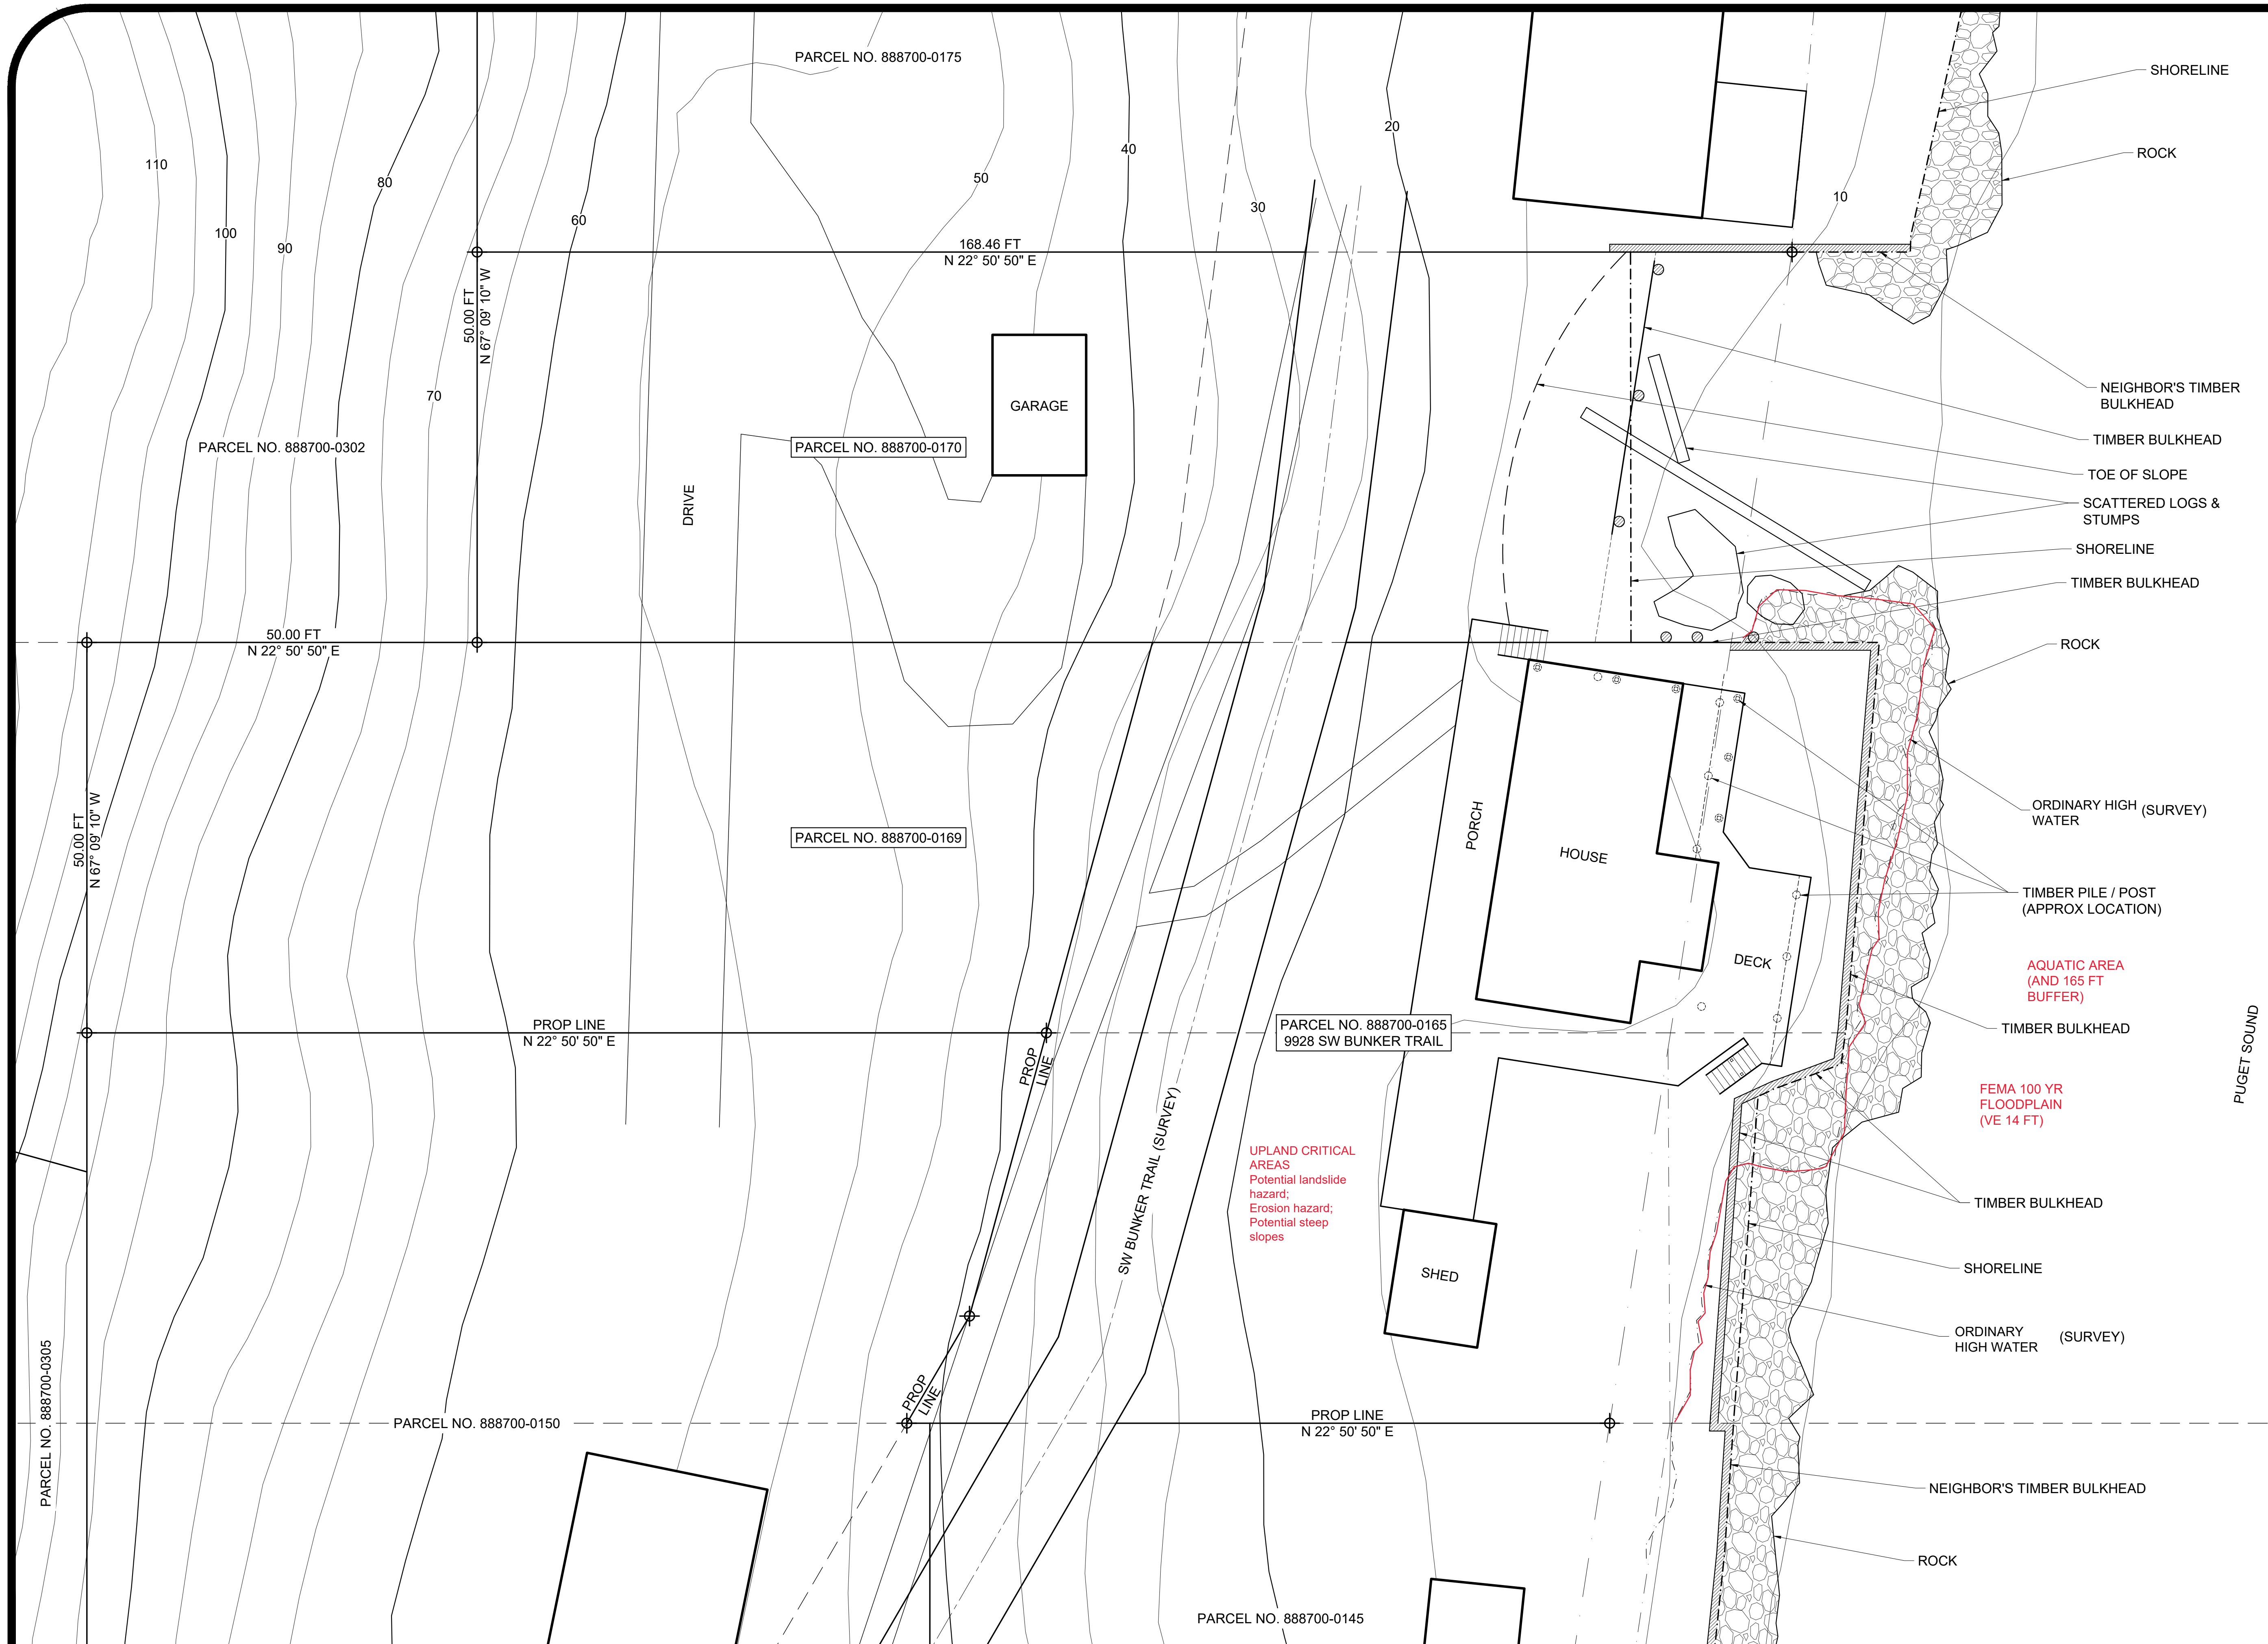
SITE PLAN - EXISTING
1" = 10'-0"

NOTE:
SITE PLAN HAS BEEN ESTABLISHED THROUGH KING COUNTY GIS INFORMATION, QUARTER SECTION MAP qs. SE062303, AND A 2000 SURVEY BY JEROLD D O'HARE (RECORDING NO. 20001005900004), BUT DOES NOT CONSTITUTE A LEGAL SURVEY AND SHOULD BE CONSIDERED APPROXIMATE ONLY.
