CRITICAL AREAS ASSESSMENT REPORT

Kennedy-Goetz Bulkhead Replacement Project
King County Parcels: 0823039061 and 0823039070
Vashon, Washington

May 2024

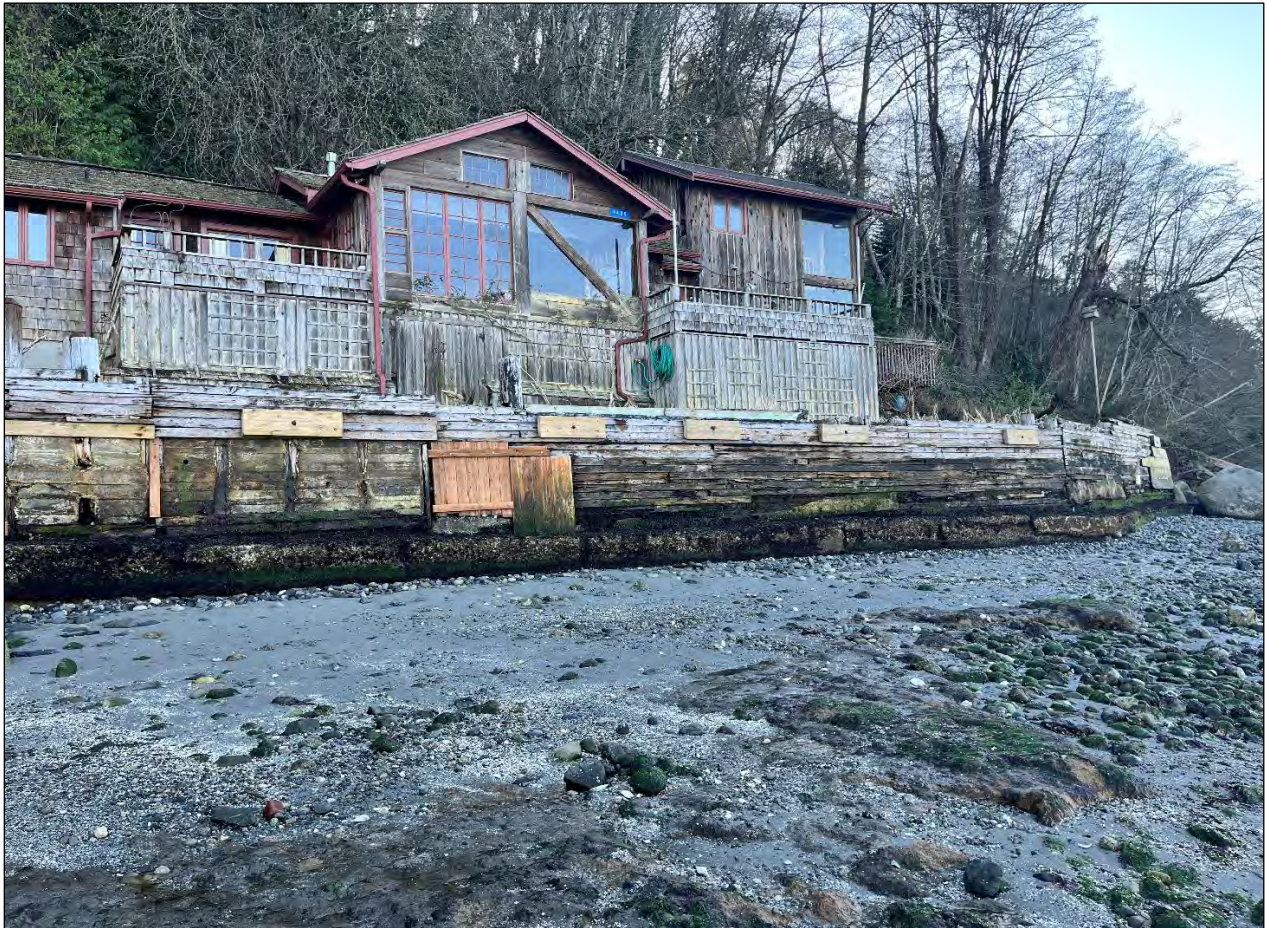
Figure 4. Project Site Shoreline Substrate

L-E biologists observed the beach substrate as a mix of sand, gravel and shell hash within the first 10-20 feet waterward of the existing shoreline protection, and a dense layer of rockweed (*Fucus gardneri*) covered the concrete toe of the existing bulkhead. From approximately 20 to 105 feet waterward of the existing shoreline protection, the sand, gravels and cobbles gradually shifted to a large area of a predominantly basalt rock outcrop intermixed with random sections of exposed hardpan (Figure 4). During the site visit, attached filamentous green algae (*Ulva spp.*) was observed on and throughout the basalt rock outcrop and cobbles, along with a few patches of unattached Turkish towels (*Mastocarpus papillatus*) and witches' hair (*Desmarestia aculeata*). Just beyond the rock outcrop, a patch of wireweed (*Sargassum muticum*) was also observed.

According to Ecology's Coastal Atlas, patchy (fringe) areas of kelp are present within the vicinity of the Kennedy-Goetz beach area (Ecology 2024), however, no kelp was observed during the site visit. Additionally, the Coastal Atlas identifies an area of patchy (fringe) eelgrass (Ecology 2024) southeast of the project site. Eelgrass was not observed on or adjacent to the project area at the time of the site visit.

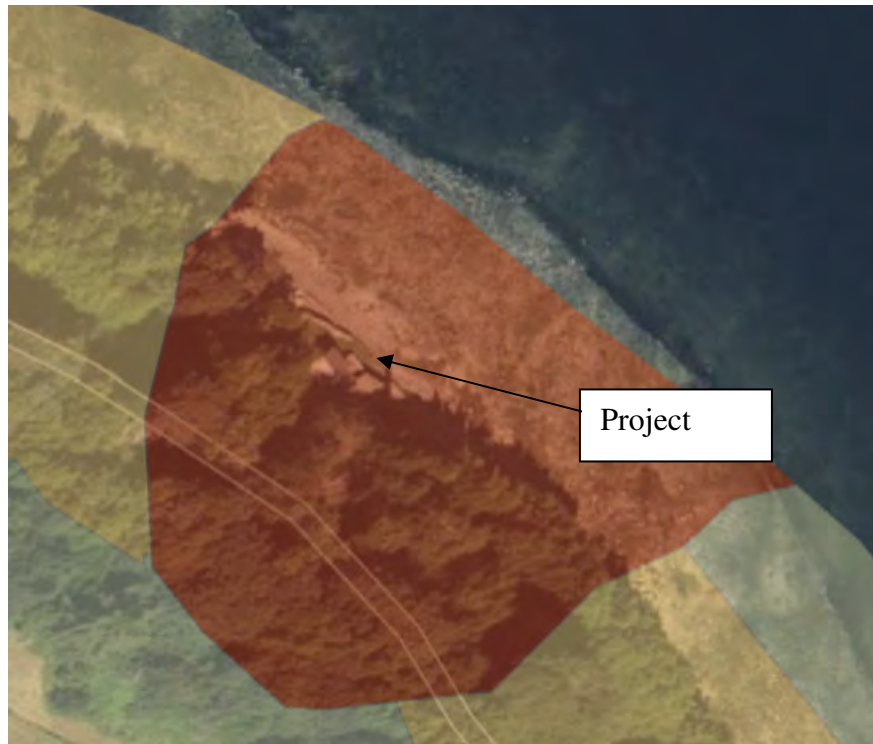
Map from Washington State Department of Ecology Website

According to the Coastal Zone Atlas of King County, Washington, the project is within and near terrain labeled 'Unstable Recent Slide' regarding potential landslide activity. See the map below from the Coastal Zone Atlas. Full descriptions may be found in the aforesaid Atlas.

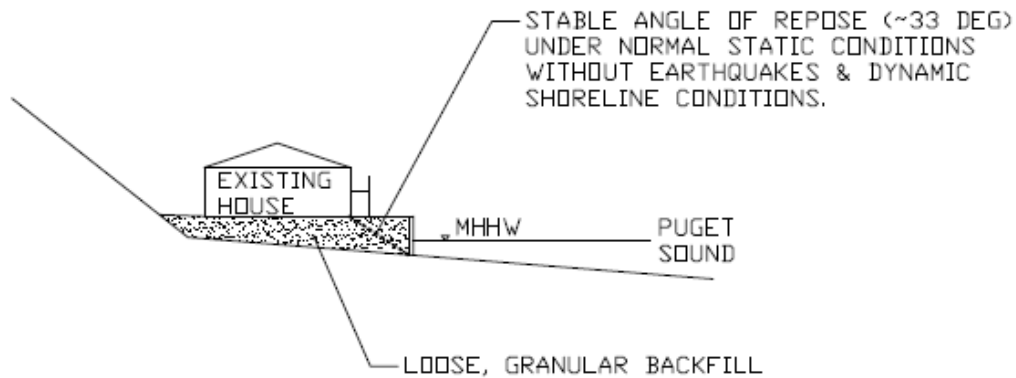
Figure 1. Cross Section

The bulkhead replacement is required because in our opinion, if the bulkhead fails, the primary residence will be in imminent danger within 3 years. The existing residence is located as close as 12 feet from the bulkhead, with the deck as close as 8 feet. Since the soil profile between the home and bulkhead is substantially loose, granular fill – these soils will erode rapidly upon bulkhead collapse and could put the house in danger within hours or days of bulkhead collapse. See the cross section below that illustrates existing site conditions.

Per the illustration above, the existing home will be in a compromised, unstable position upon bulkhead failure assuming an earthquake never occurs and the shoreline processes are non-existent. With the 3-foot MHHW height, and standard tidal influence, we expect that the loose backfill soils will erode immediately creating conditions for imminent large settlements and structural damage to the existing home.

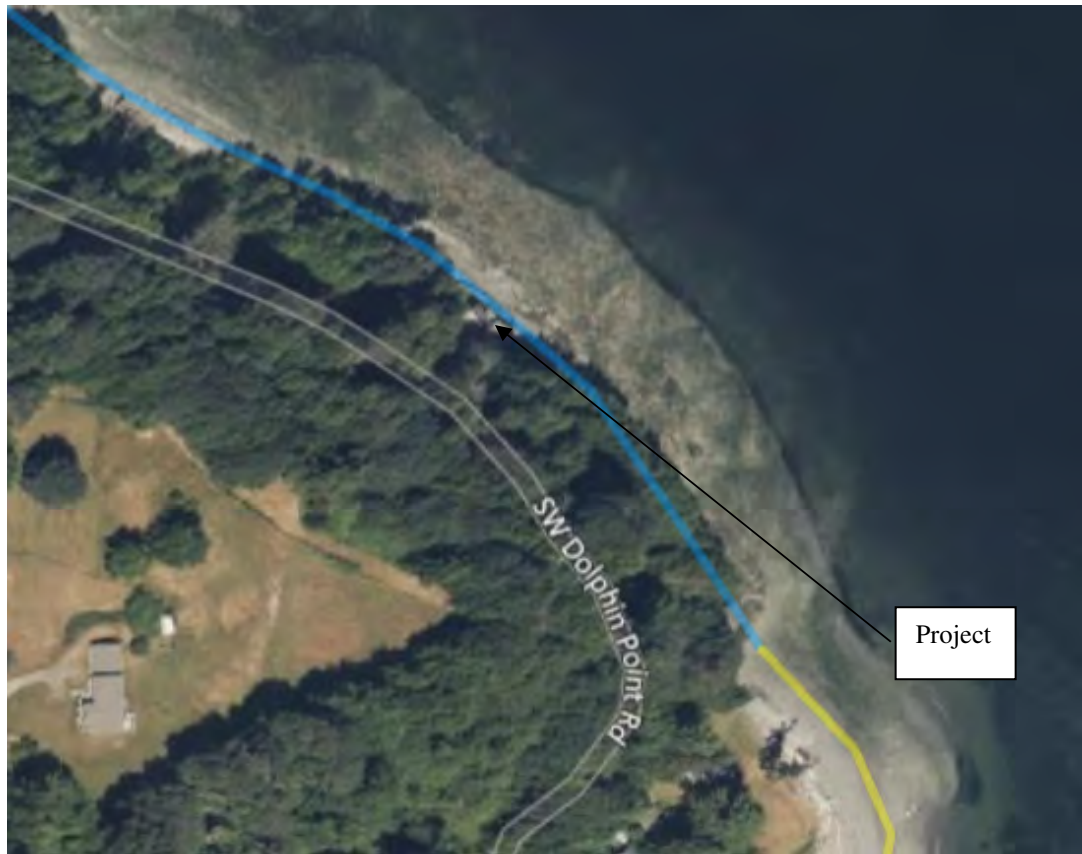
Coastal Landform Map from Washington State Department of Ecology Website

During our site visit, Envirotech observed that waves and other tidal processes have eroded the backfill/ shoreline bank and transports sediments away from the project area. This is evident from the exposed shoreline as described in the Surface Conditions of this report, and the presence of a shallow beach sediment layer over cemented glacial till as described in the Subsurface Investigation Section of this report. The property is mapped as having a feeder bluff per the Washington State Department of Ecology. See the following illustration.

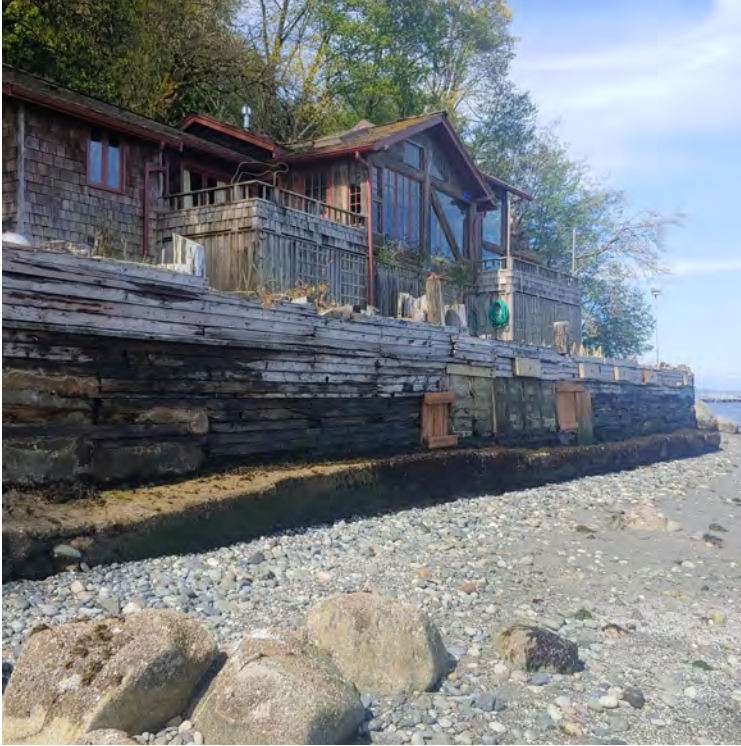
Bulkhead in poor condition with close proximity of primary structure

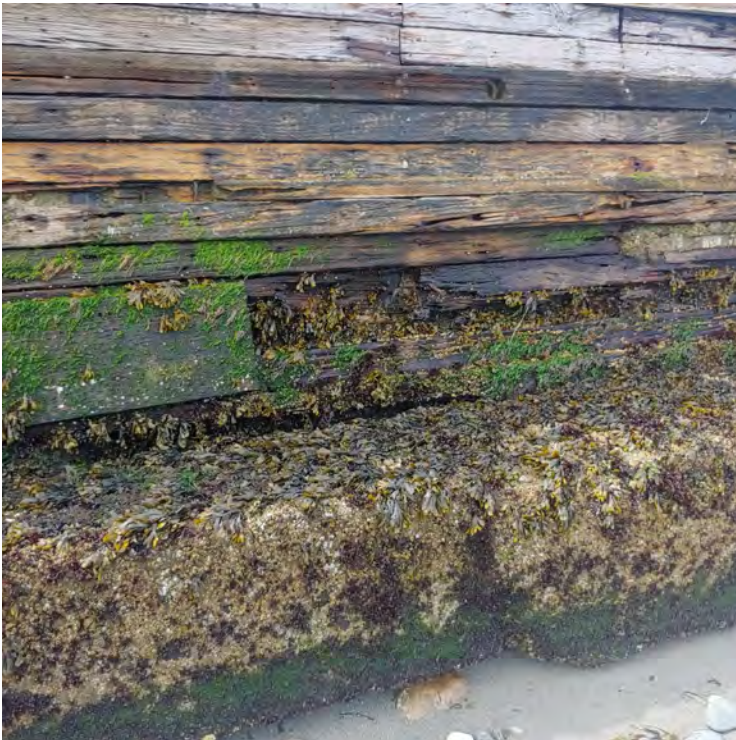
Bulkhead wood degradation and undermining

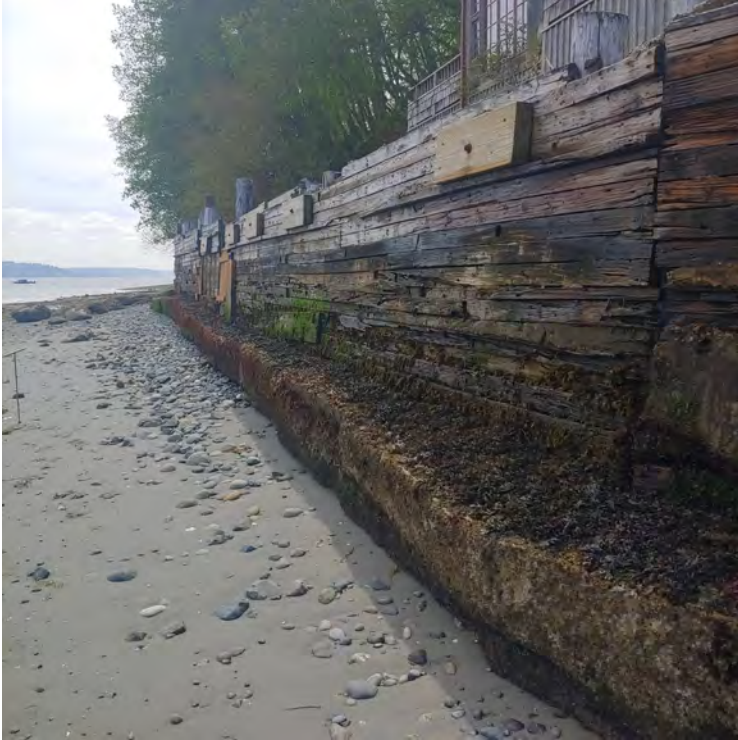
Wood patching and repairs

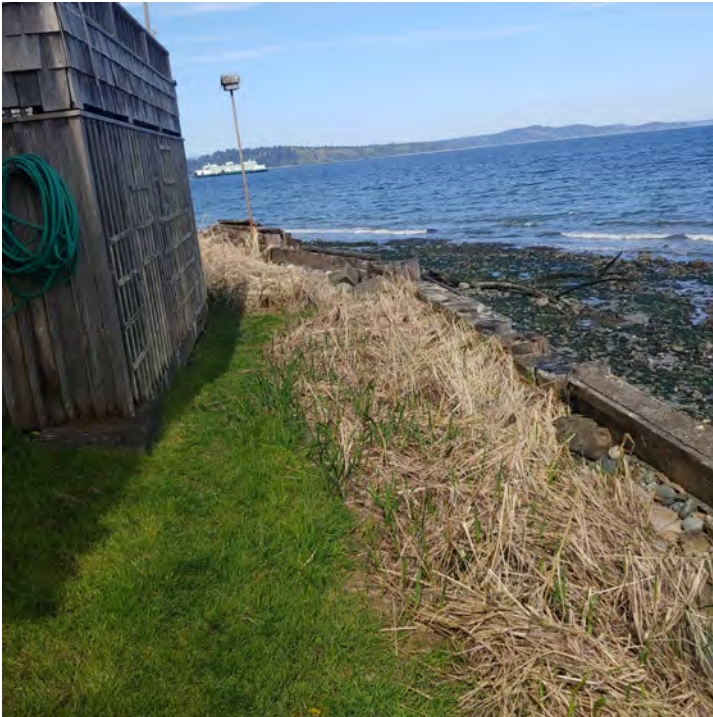
Backfill scour that has been repaired with cobble stone fill and plantings

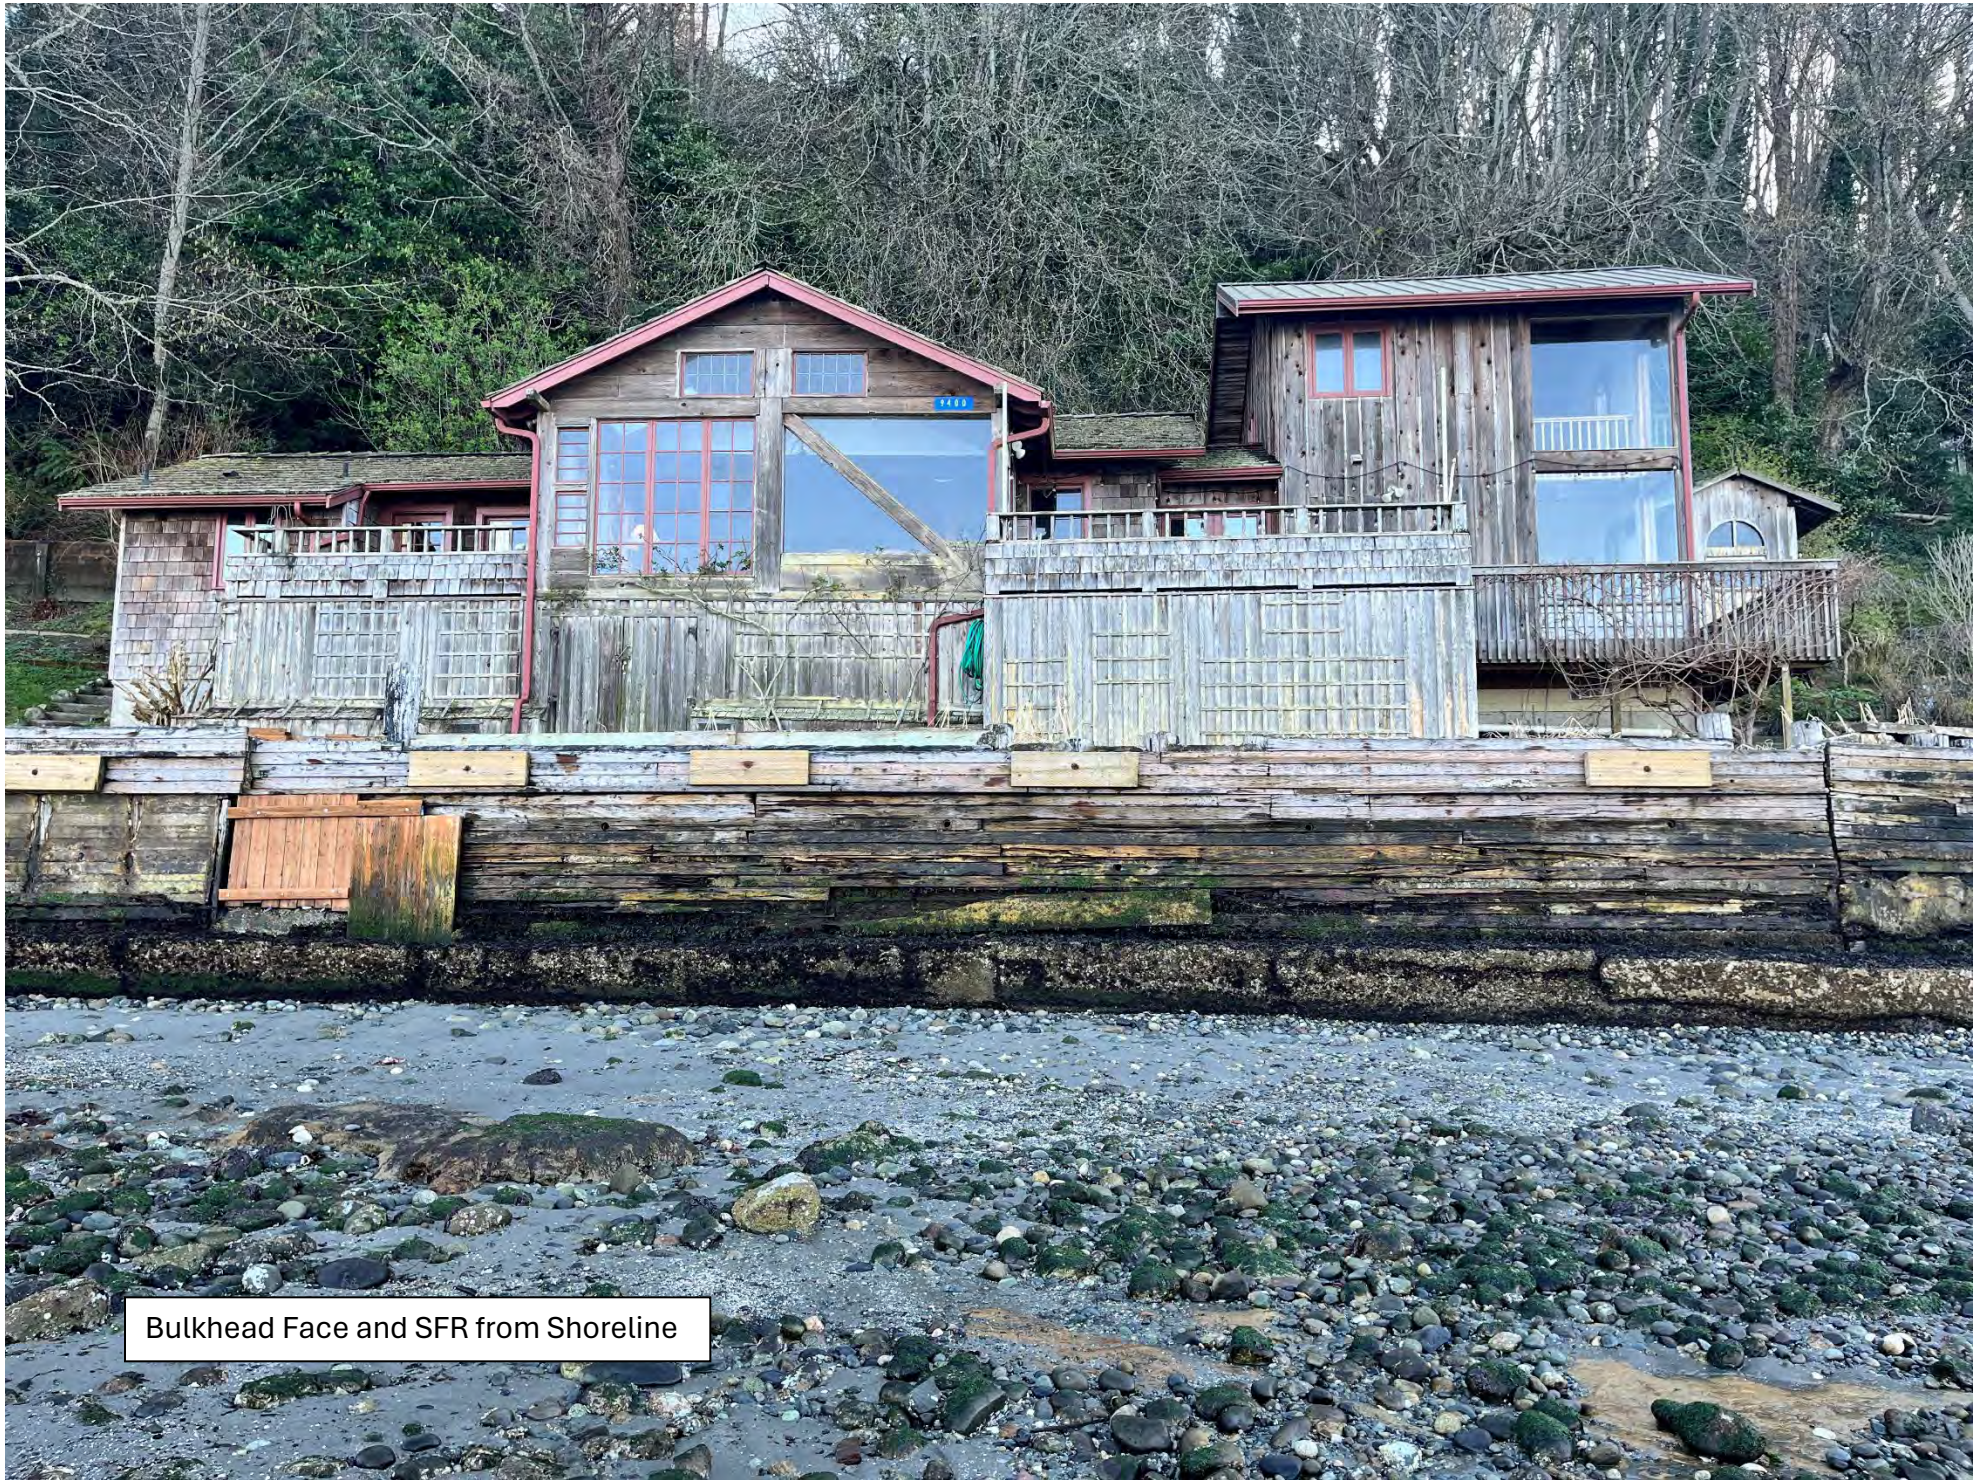
Bulkhead Face and SFR from Shoreline

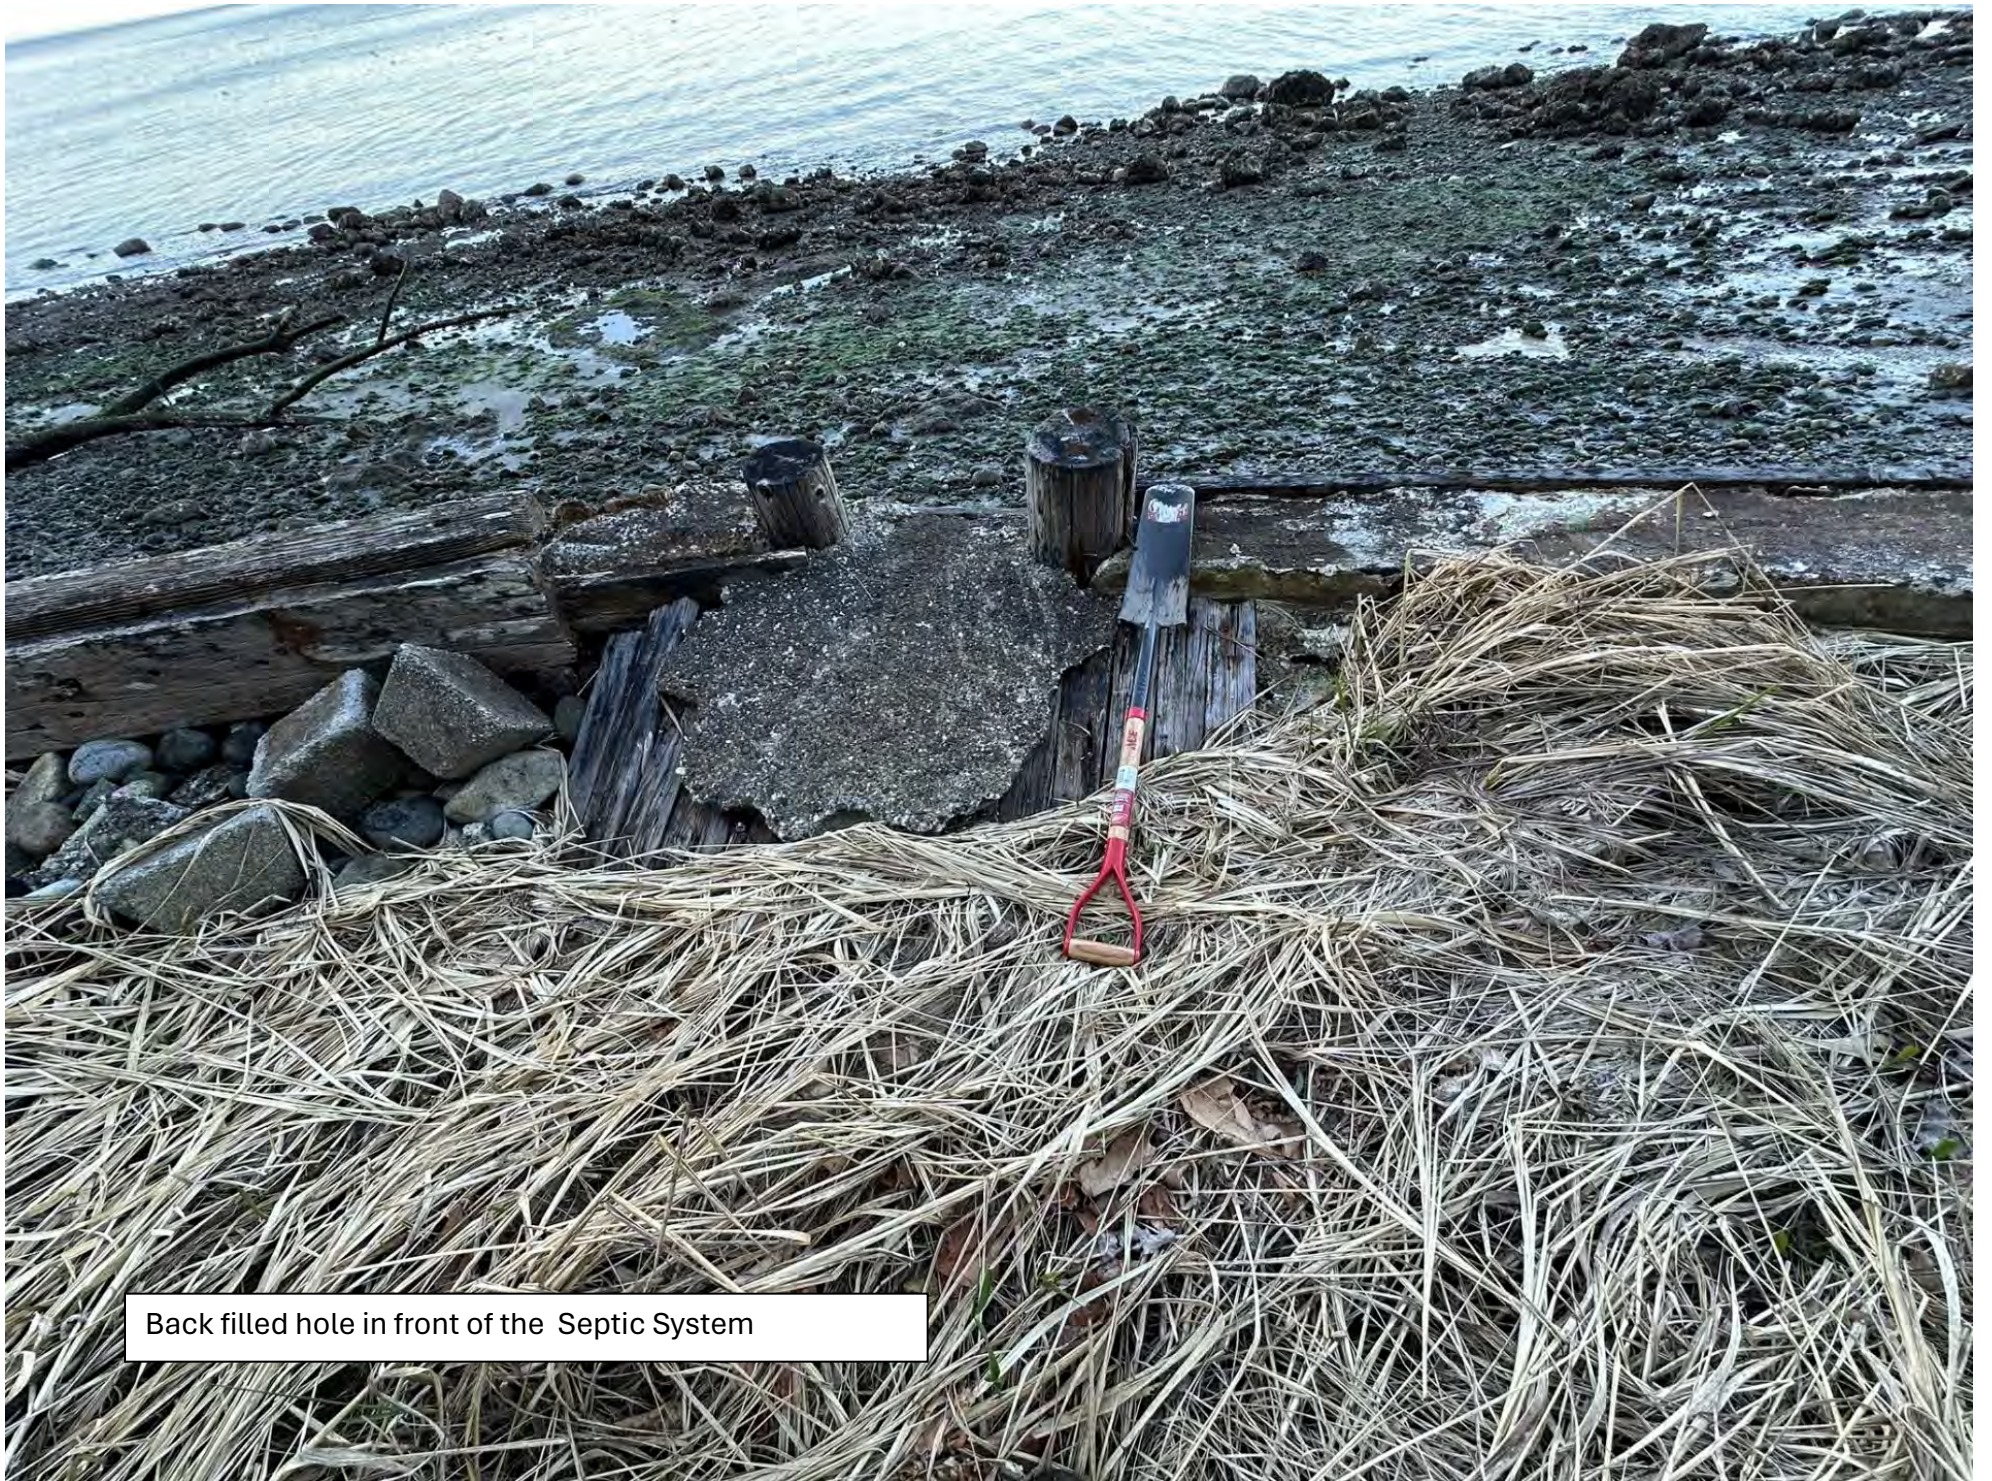
Back filled hole in front of the Septic System

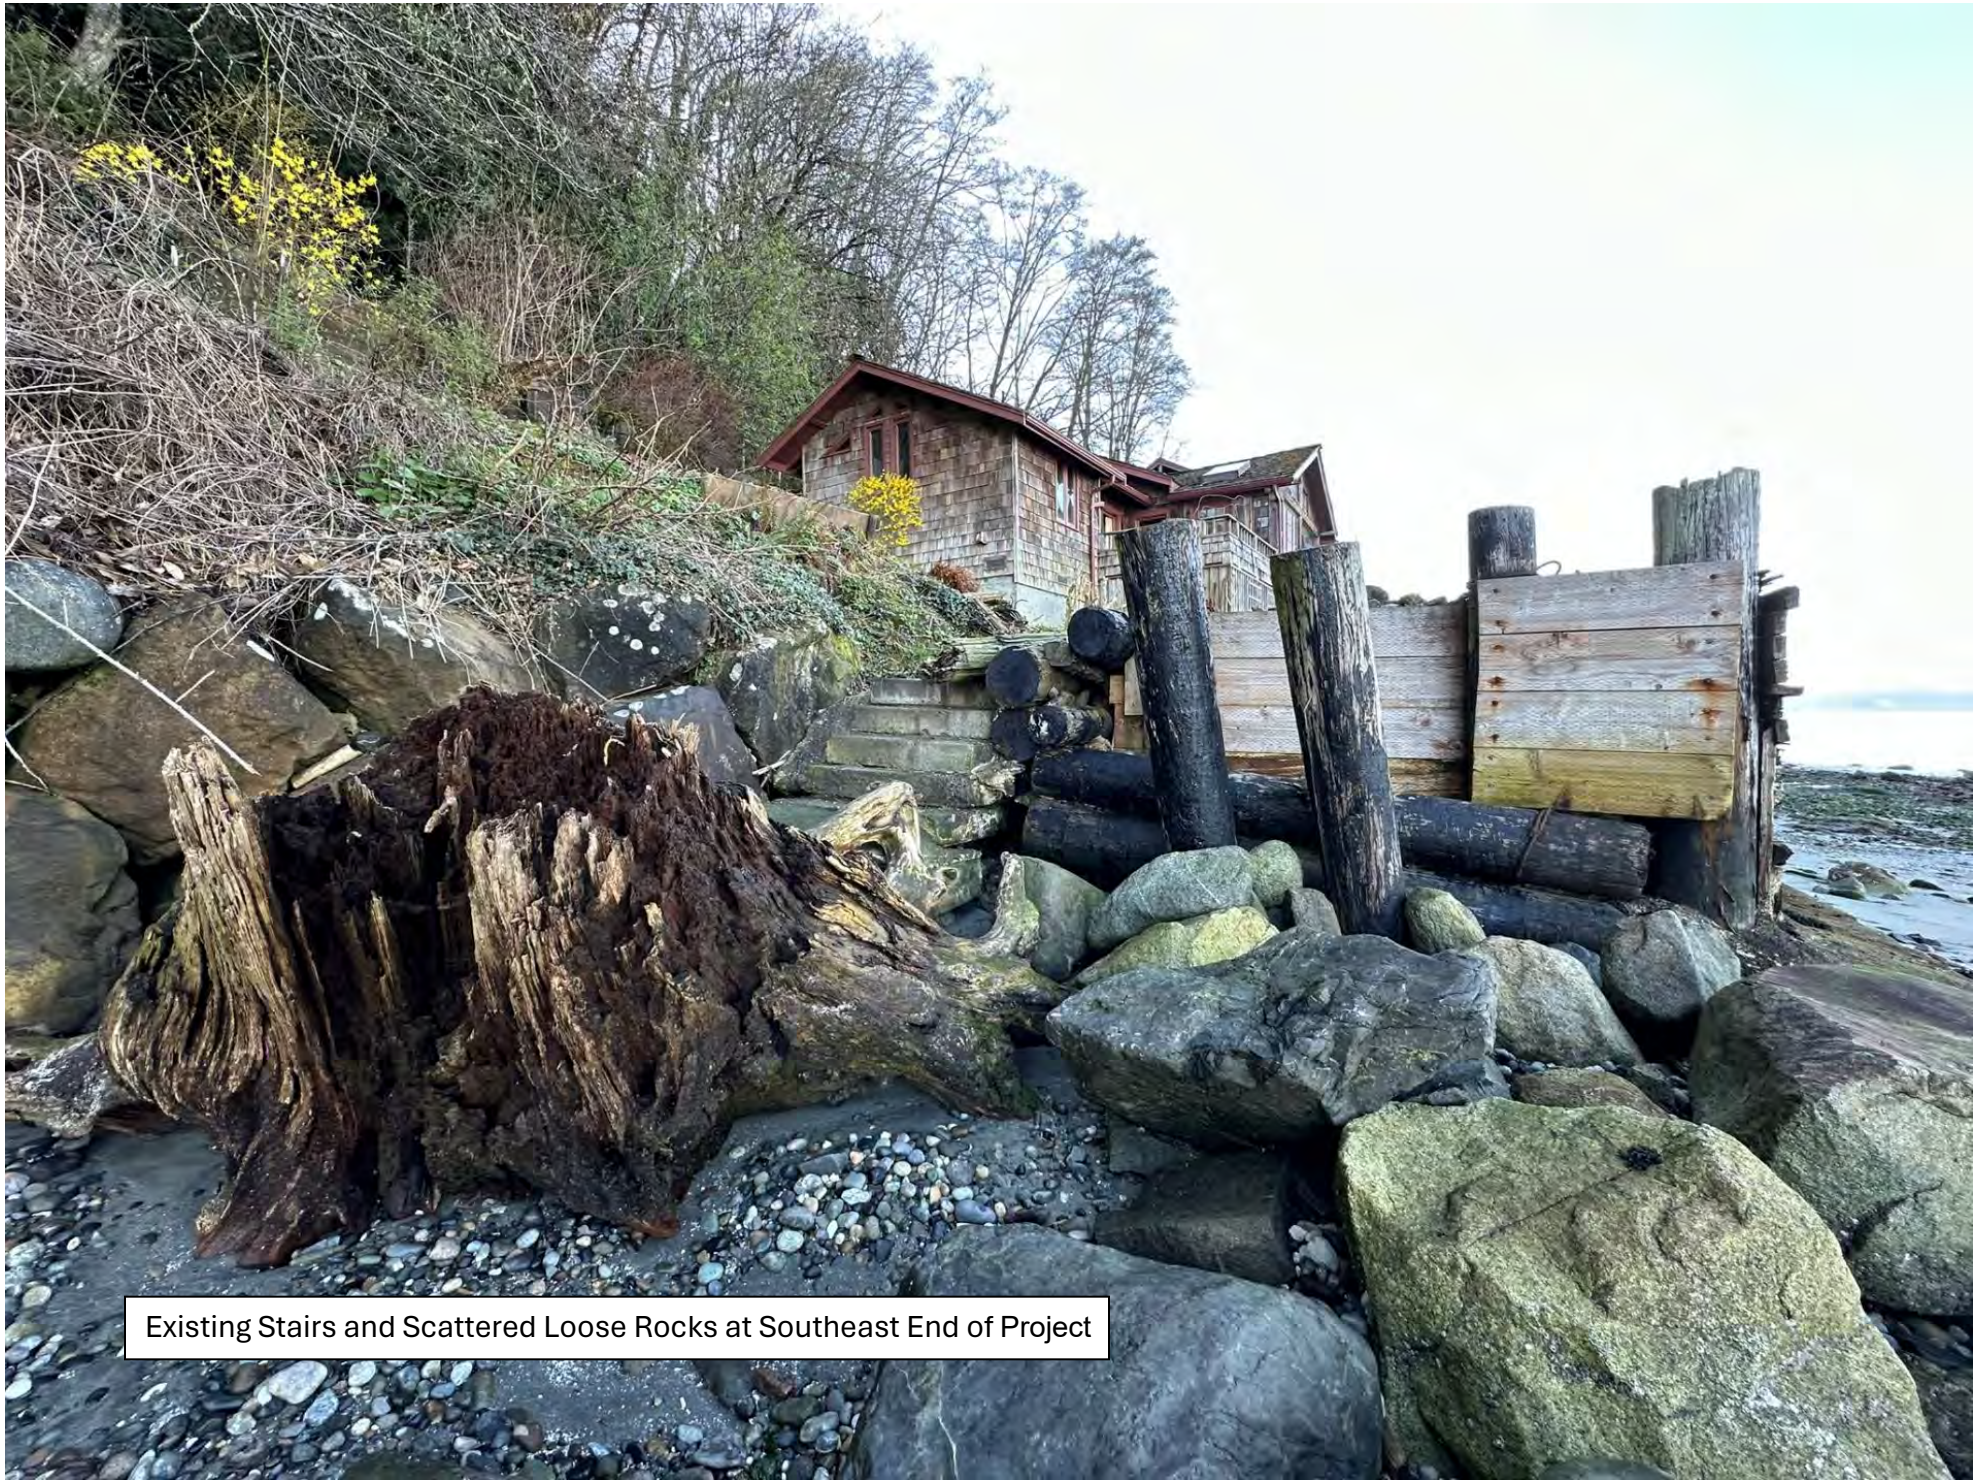
Existing Stairs and Scattered Loose Rocks at Southeast End of Project

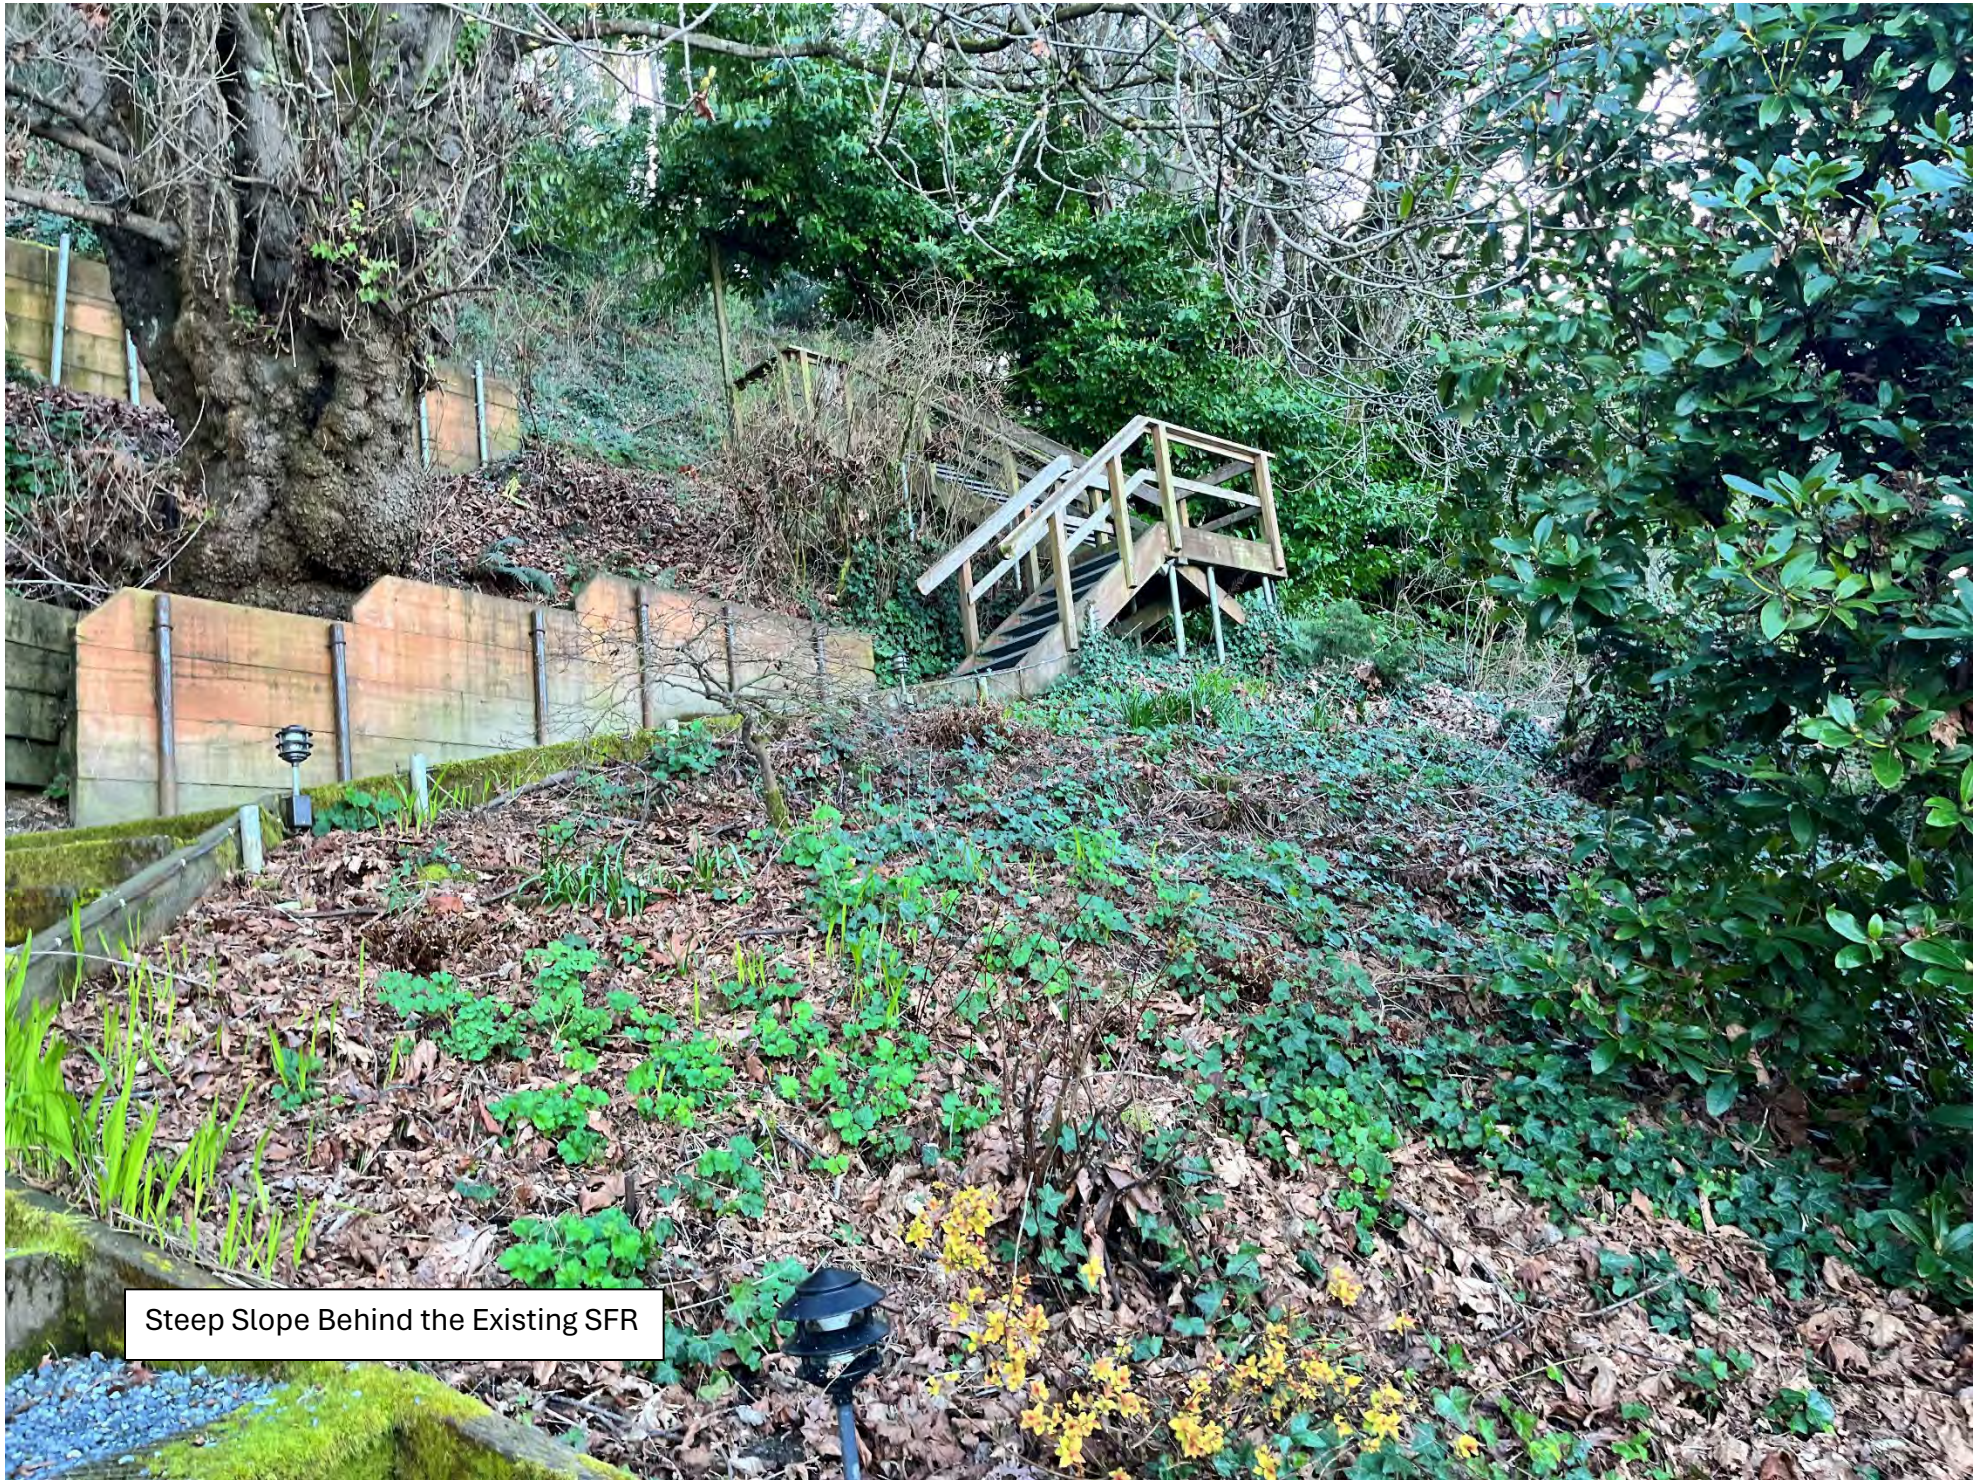
Steep Slope Behind the Existing SFR
