# MITIGATION PLAN

185<sup>th</sup> Ave NE & NE Woodinville Duvall Road, Cottage Lake WA Parcel 1630700185

June 26, 2024 Revision: 1st

Critical Areas CADS22-0074 |Closed November 20, 2022 Pre Application PREA22-0065 | Open November 22, 2022 Shoreline Development Variance SHOR24-0027 | Open June 13, 2024 + Active

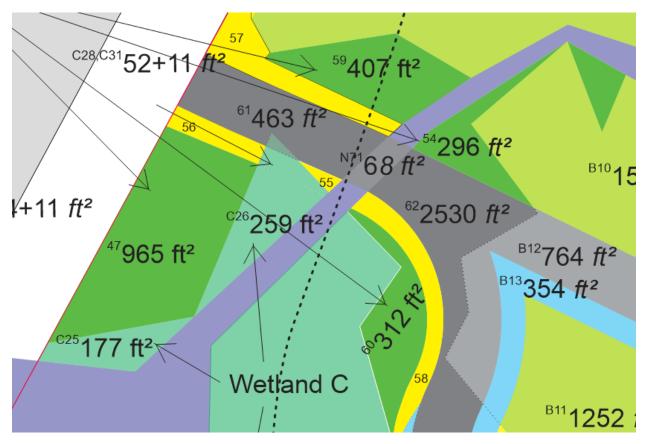
FIGURE 3: WETLAND CREATION 47,54,59,60

In the applicant's case, there are many local improvements on-site which have a high potential of success. For instance, sitemap areas (47,54,59,60) are currently classified as buffer. For on-site mitigation, these areas would be re-created into category II wetlands adding 1980 ft<sup>2</sup> of category II wetlands.

To create 1980 ft<sup>2</sup>, an Enhancement area of 4x or 7920 ft<sup>2</sup> must at the same time be created. Enhancement might include replacement of trees or management of invasive English ivy. However, the enhancement is not counted, only the creation. But the wetland creation occurs within the buffer, and the buffer offset is (1:1). By creating 1980 ft<sup>2</sup> of category II wetlands and Enhancement of another 7920 ft<sup>2</sup> of wetlands, the net benefit is 0 ft<sup>2</sup> due to the 1:1 conversion of the buffer. There is no benefit to the applicant to create or enhance when those efforts are directed towards a buffer.

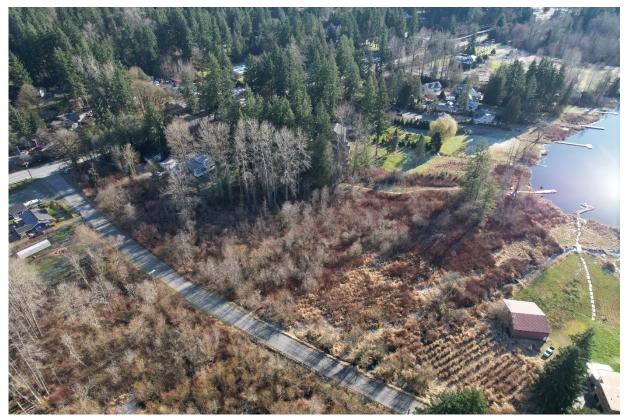
Photo 1: Site Aerial (Oriented Northeast).

The Site is bordered to the North by Northeast Woodinville Duvall Road, to the East by a developed parcel including a single-family residence, to the South by Cottage Lake and a partially developed parcel containing a single-family residence, and to the West by 185<sup>th</sup> Avenue Northeast (**Photo 1**).

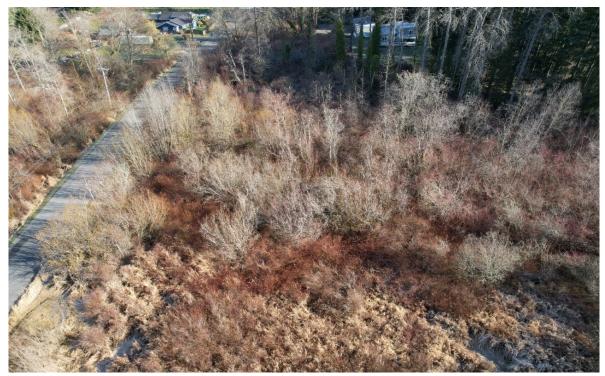
Photo 2: Wetland A Aerial (Oriented North).

Wetland A is a Category II slope wetland that covers the majority of the Site (**Photo 2, Figure 5**). The Southern half of Wetland A is mapped by the USFWS NWI as a Palustrine, Scrub-Shrub, Seasonally Flooded wetland (**Figure 2**). Wetland A scored 7 points for Improving Water Quality, 6 points for Hydrologic Functions, and 8 points for Habitat Functions. According to King County Code (KCC) §21A.24.324, Category II wetlands with high habitat scores (8-9) require 225-foot standard buffers in areas of moderate impact land uses.

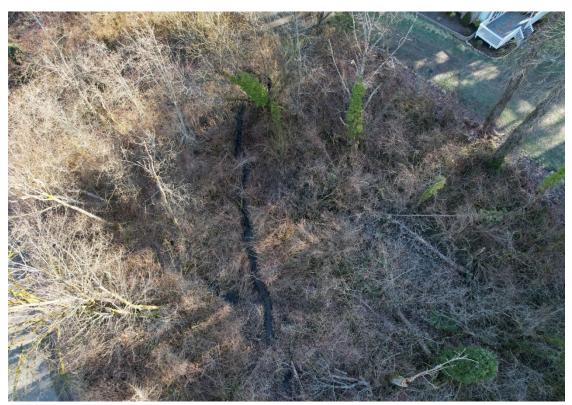
Photo 3: Stream 1 Aerial.

Stream 1 is a small, intermittent drainage that flows into Wetland A from the adjacent parcel to the east approximately 200 ft from Woodinville-Duvall Road (**Photo 3, Figure 5**). This feature is not identified by any online agency database including King County iMap (**Figure 4**). Stream 1 originates offsite to the northeast. The Stream initially flows onto the adjacent parcel to the east of the Site and passes under an existing single-family residence. Stream 1 flows in a channel for approximately 300 linear feet before fanning out within Wetland A near 185<sup>th</sup> Avenue Northeast. Stream 1 is a Type N stream requiring a 65-ft standard buffer per KCC §21A.24.355.
