# Shoreline Geotechnical Assessment

## Findlay Shoreline Protection

**10227 SW Tillicum Lane  
Parcel No. 0594000060  
Vashon, Washington**

**December 9, 2025  
Project #25320**

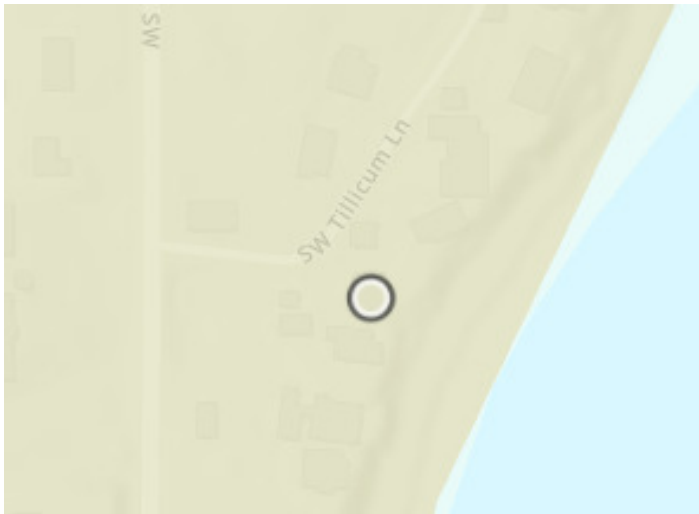
**Map Unit:** Qga  
**Age:** Quaternary  
**Name:** Advance Outwash  
**Description:** Glaciofluvial sand and gravel and lacustrine clay, silt, and sand deposited during the advance of glaciers; sandy units commonly thick, well sorted, and fine grained, with interlayered coarser sand, gravel, and cobbles; locally contains nonglacial sediments and deposits mapped as transitional between glacial and nonglacial.

*Geological Map Department of Natural Resources Washington State*

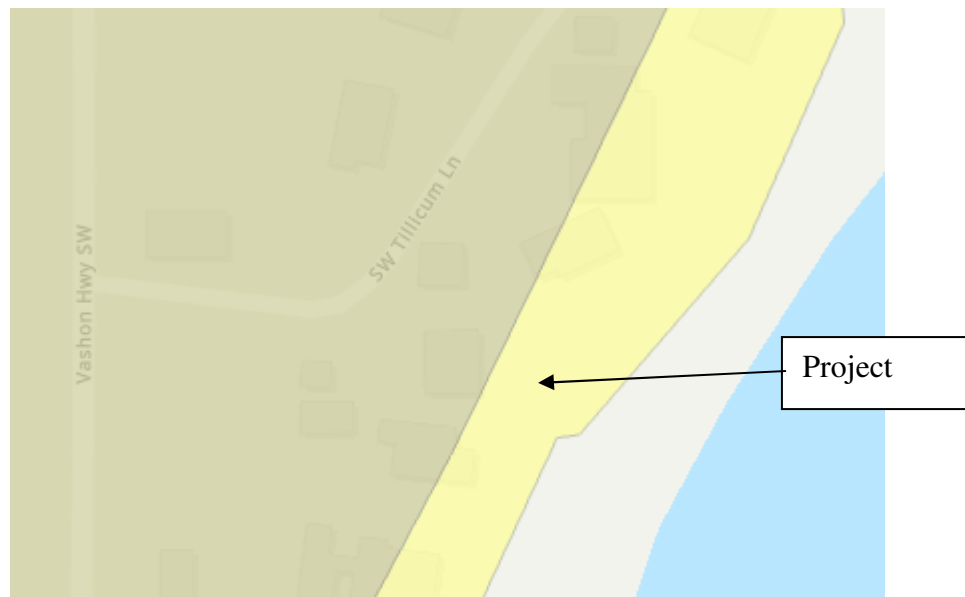
According to the Coastal Zone Atlas of King County, Washington, the project is within and near terrain labeled 'Intermediate' regarding potential landslide activity. A Stability Map from the Coastal Zone Atlas for the general area of this project may be found below.

*Map from Washington State Department of Ecology Website*

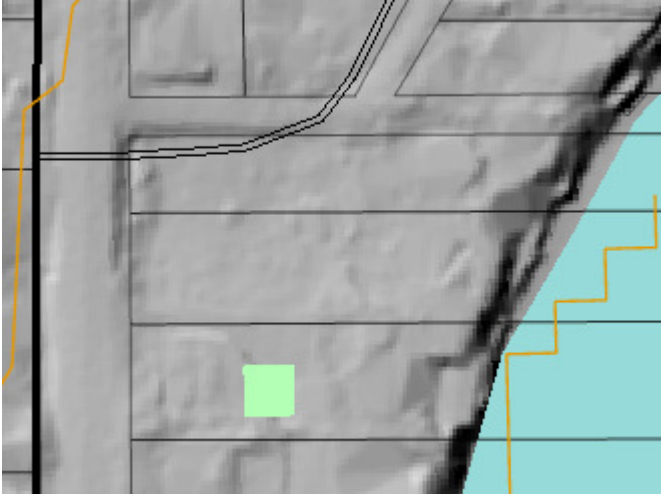
Mapping from the Department of Natural Resources, as shown below, does not indicate historic landsliding or high potentials for future landslides. It is our opinion that landslides are not a significant problem for this project.

*Map from Washington State Department of Natural Resources Website*

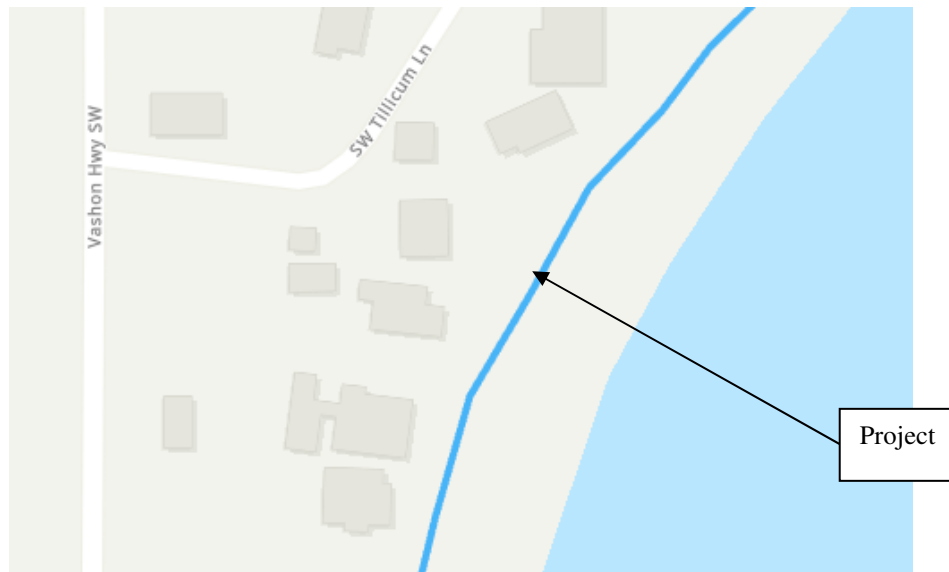
- The unprotected shoreline is a high erosion hazard, and is active. Shoreline erosion is the primary culprit that, if left unrestrained, will endanger the existing residence and undermine the onsite septic tanks. Per the Surface Conditions Section of this report, Envirotech observed active shoreline erosion. The property is mapped as having a feeder bluff per the Washington State Department of Ecology. See the illustration below. By definition, a feeder bluff is actively contributing or “feeding” sediments to beaches.

Coastal Landform Map from Washington State Department of Ecology Website

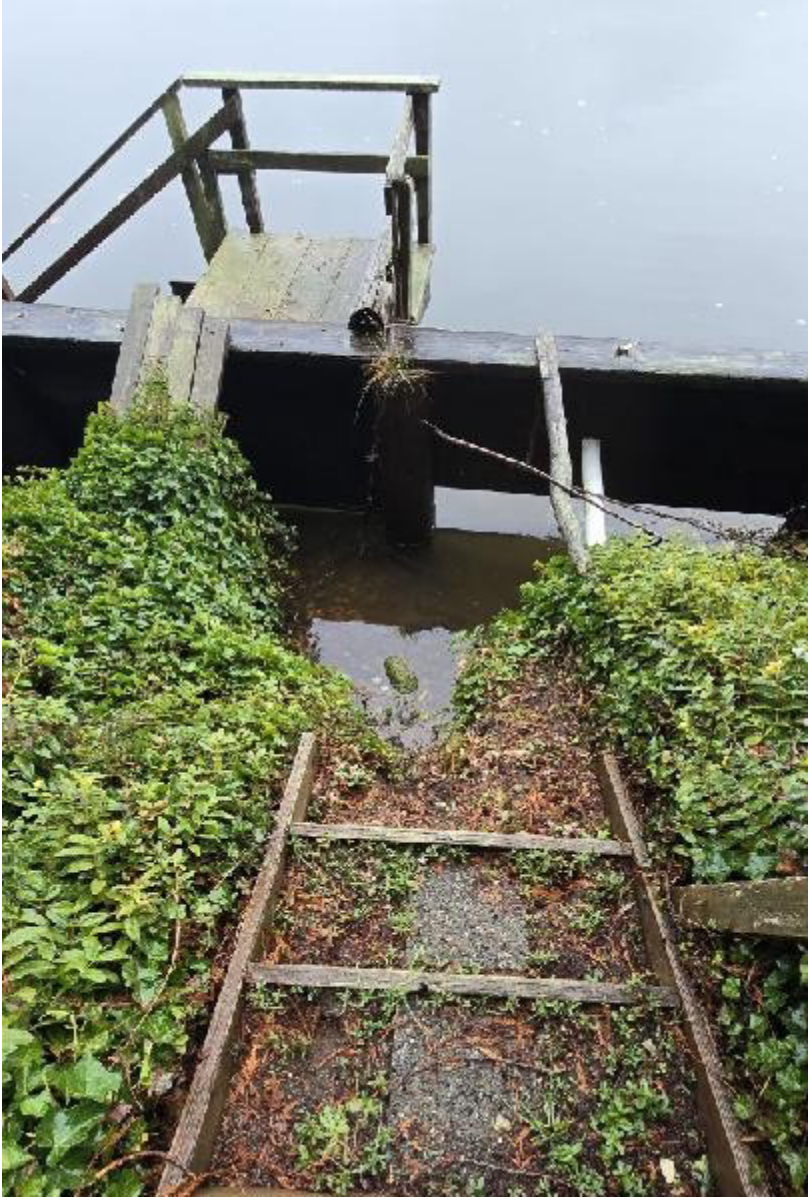
The closest point from the existing infrastructure to the bulkhead is approximately 50 feet. The existing timber bulkhead is approximately 4.5 feet high, and is in failure mode with a large gap that has allowed shoreline erosion to occur. The scour is over 3.5 feet high, and about 10 feet horizontally behind the bulkhead. Per property owner accounts, the land has been receding for about 6 years.

Photo 1: Failed Timber Bulkhead w/ Backfill Erosion

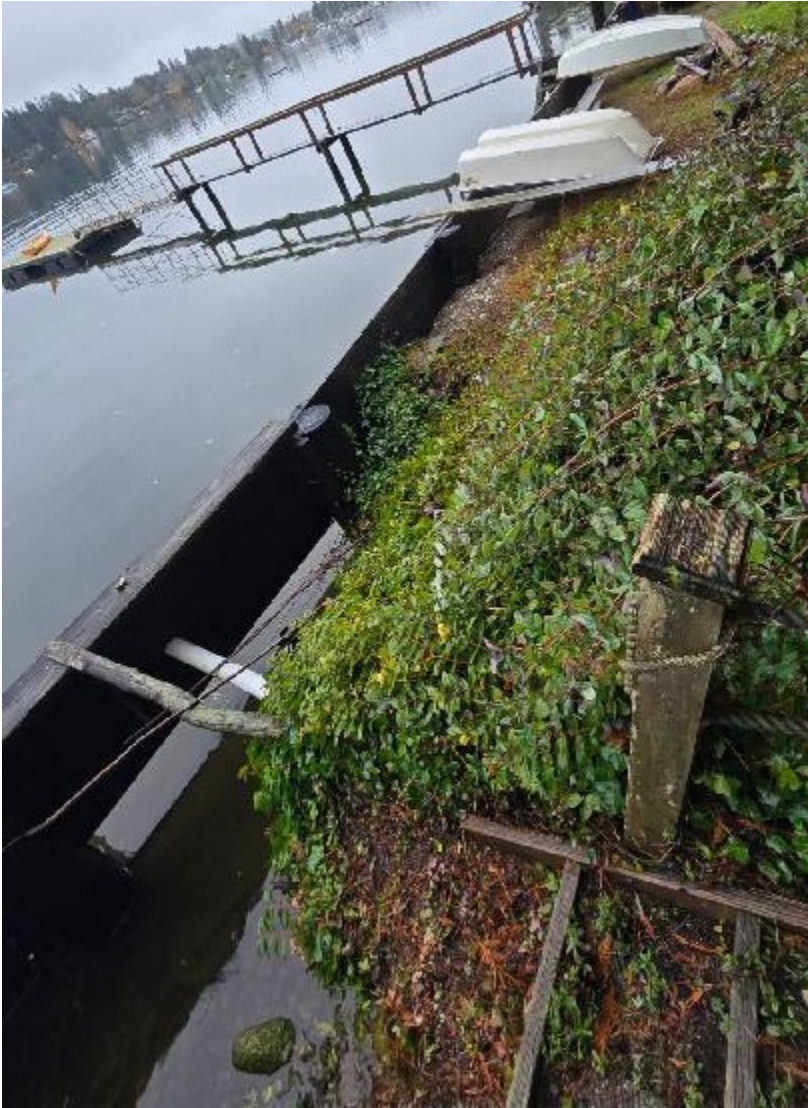
As previously mentioned, severe erosion has occurred behind the existing timber bulkhead. The 4.5 feet high by approximately 10 feet deep scour is largely denuded of vegetation at the base indicating active erosion. Additional landslide and shoreline erosion information is provided in the Engineering Conclusions and Recommendations Section of this report.

Photo 2: Active Shoreline Erosion Behind Bulkhead to South Beyond Bulkhead Failure

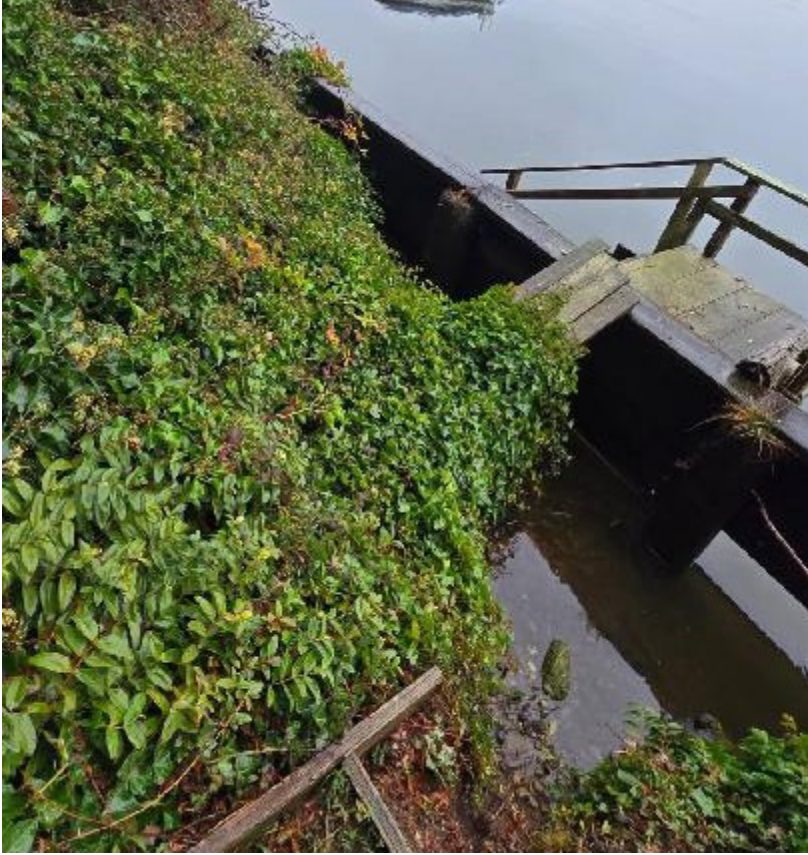
Photo 3: Shoreline Erosion Behind Bulkhead to North Beyond Bulkhead Failure
