FINDLAY IMPACT ANALYSIS AND MITIGATION PLAN

Shoreline Permit –Shoreline Protection Repair Project

10227 SW Tillicum Lane, Vashon, WA 98070

Project Application SHOR24-0045

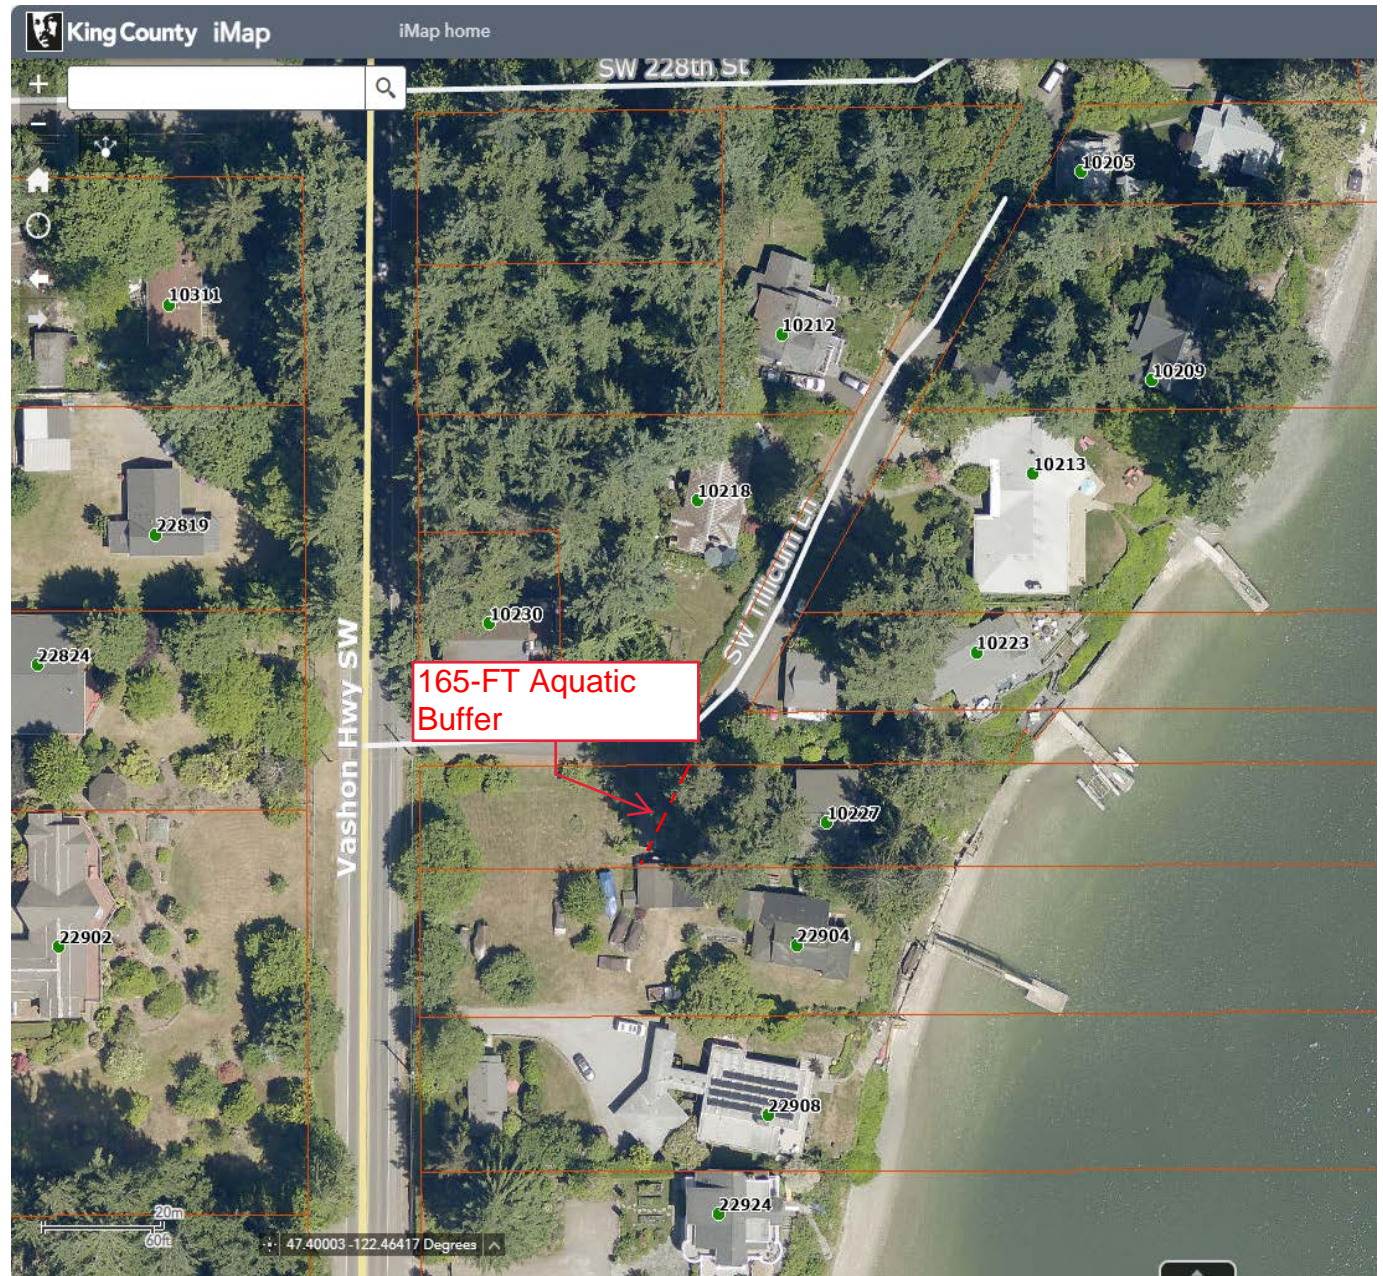
Figure 2.

Aquatic Buffer

King County identifies a 165-foot aquatic buffer on the project property. The aquatic buffer begins at OHW of the Puget Sound and extends towards Vashon Highway (Figure 2). The aquatic buffer has been modified due to previous development, leaving primarily landscaping species, lawn and invasive species. According to Ecology aerial photos, most of these impacts appear to have occurred on or before the 1970s.

The proposed project site is adjacent to Puget Sound; an aquatic area with a 165-foot marine riparian buffer. The buffer starts at the line of OHW and extends towards Vashon Highway (Figure 2). Impacts in the aquatic buffer will be minimized to the greatest extent possible but cannot be fully avoided because of the location of the shoreline work. The area directly behind the existing bulkhead appears to be upland fill.
