# **RED BARNACLE, LLC IMPACT ANALYSIS AND MITIGATION PLAN**

## **Shoreline Permit – Bulkhead Repair and Maintenance**

**25820 & 25832 120th Lane SW, Vashon, WA 98070**

**November 2025**

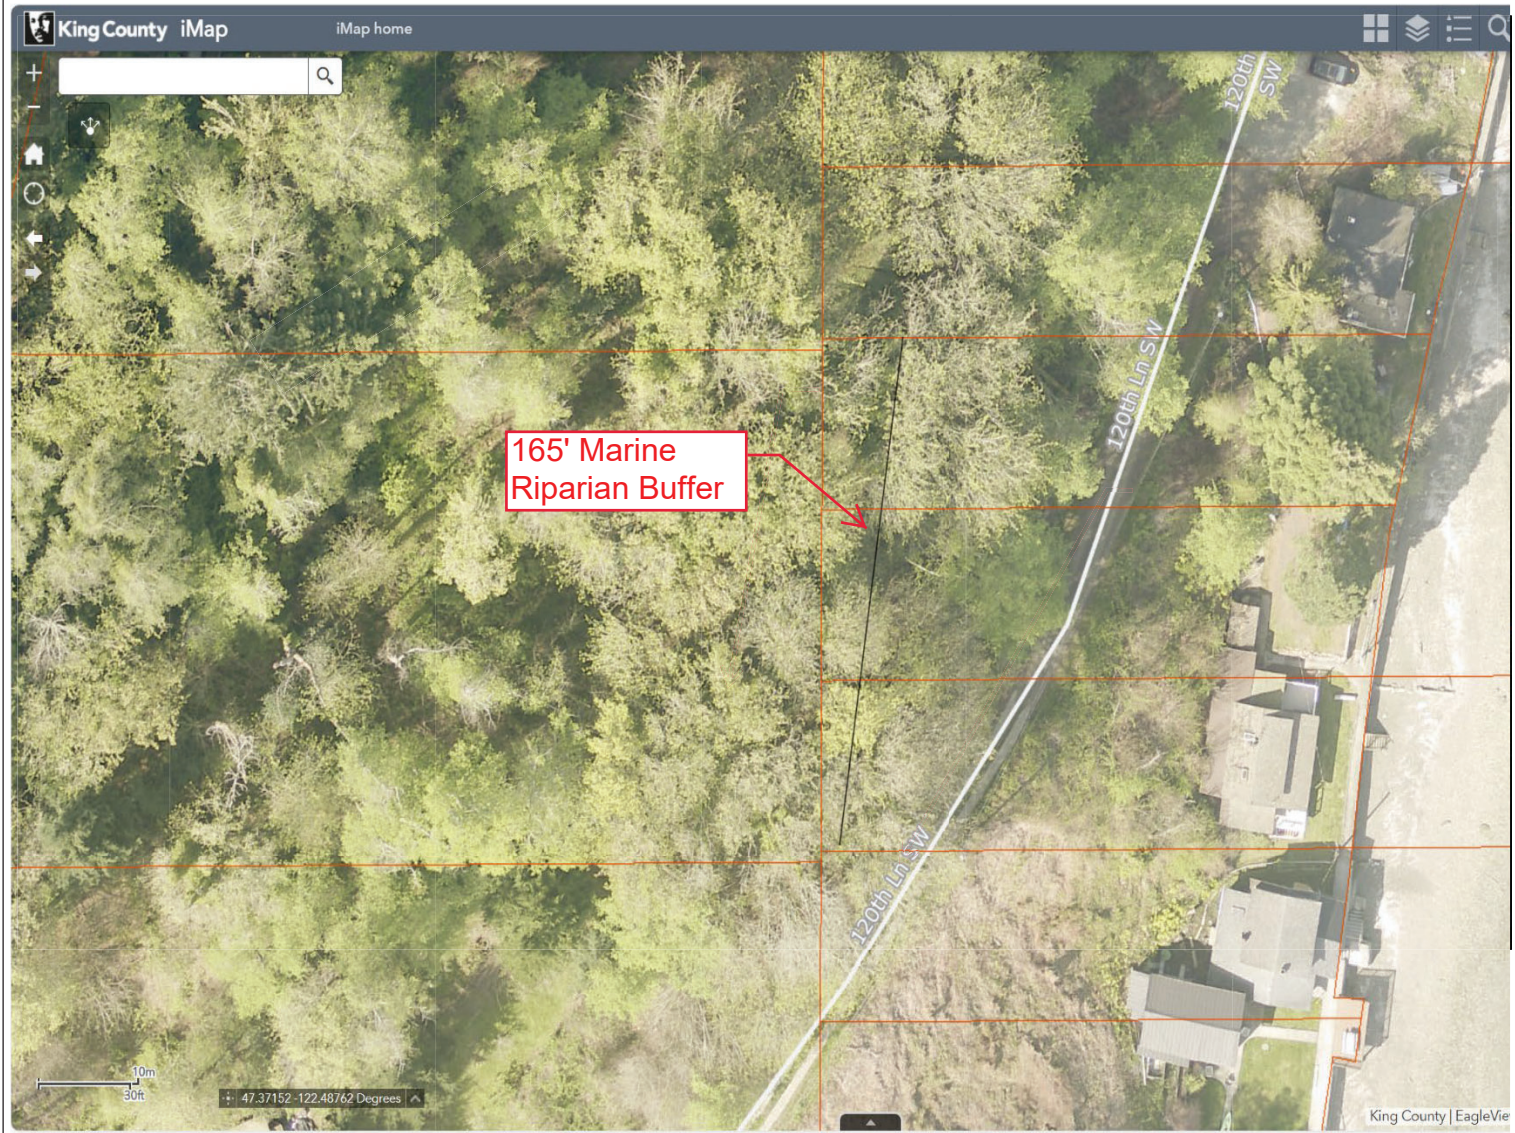
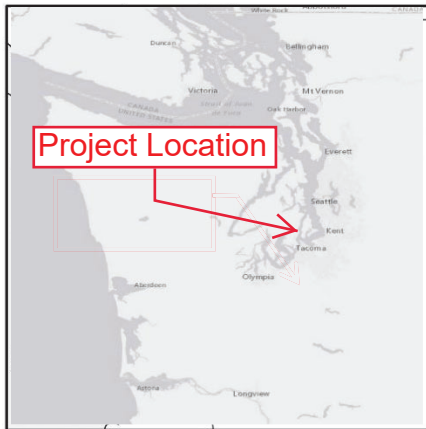
Bulkhead Repair  
Figure 2. Marine  
Riparian Buffer  
November 2025

King County identifies a 165-foot aquatic buffer on the project property. The aquatic buffer begins at OHW of the Puget Sound and extends towards 120th Lane SW (Figure 2). The majority of the aquatic buffer is modified due to previous development, leaving primarily landscaping species and lawn. According to Ecology aerial photos, most of these impacts appear to have occurred on or before the 1970s.

The proposed project site is adjacent to Puget Sound; an aquatic area with a 165-foot marine riparian buffer. The buffer starts at the line of OHW and extends towards 120th Lane SW (Figure 2). Impacts in the aquatic buffer will be minimized to the greatest extent possible but cannot be fully avoided because of the location of the repairs to the existing bulkhead. The area directly behind the existing bulkhead was originally filled with upland soils to create buildable land and planted with grass.

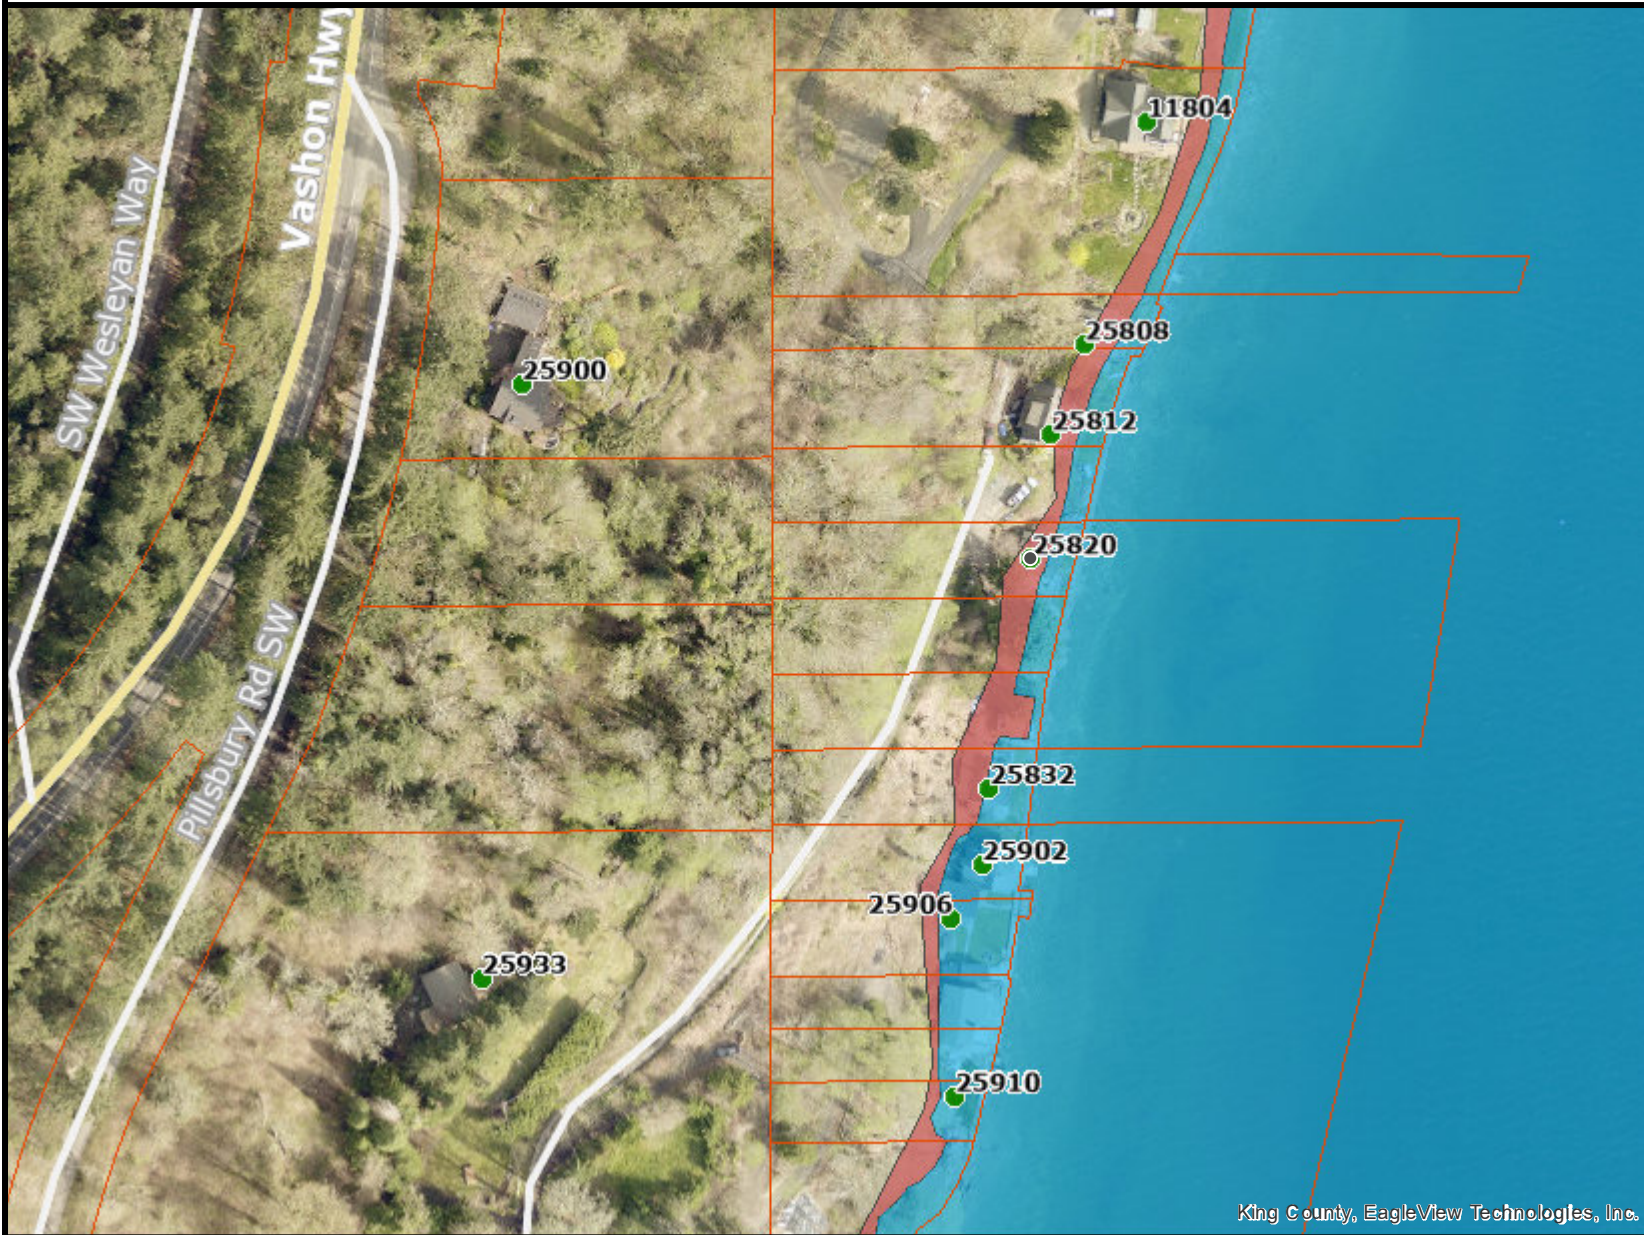
# Red Barnacle\_County Mapped 100-yr and sea-level rise

- Address points
- Address labels
- Parcels
- FEMA 100 year floodplain
- King County sea level rise risk area
