# Shoreline Geotechnical Assessment

## Red Barnacle Shoreline – 4 Parcels

**25820 & 25832 120<sup>th</sup> Lane SW  
Parcels 2522029058, et. al.  
Vashon, Washington**

**February 17, 2026  
Project #25019**

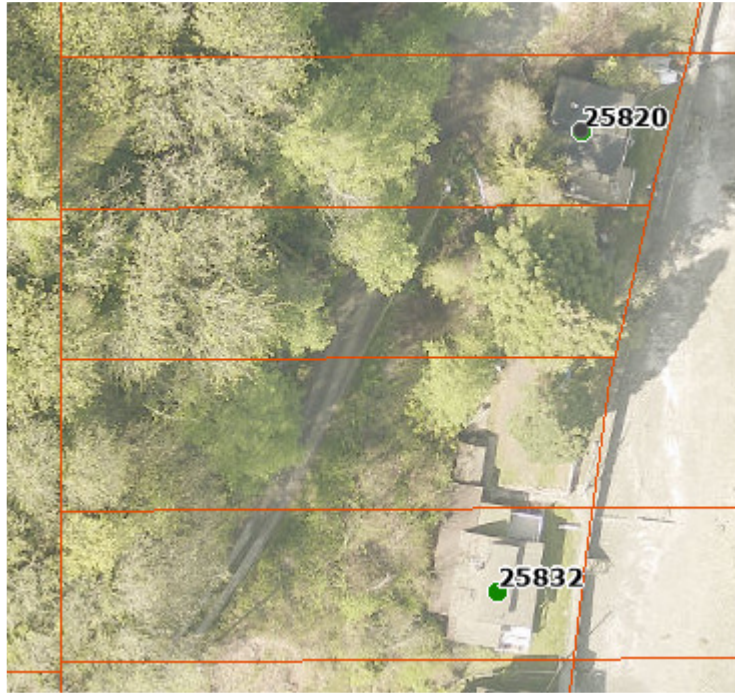
*Aerial Photo from King County Website*

An aerial photo of the project and immediate vicinity is provided below. See the photographs in Appendix B for illustrations of site conditions.

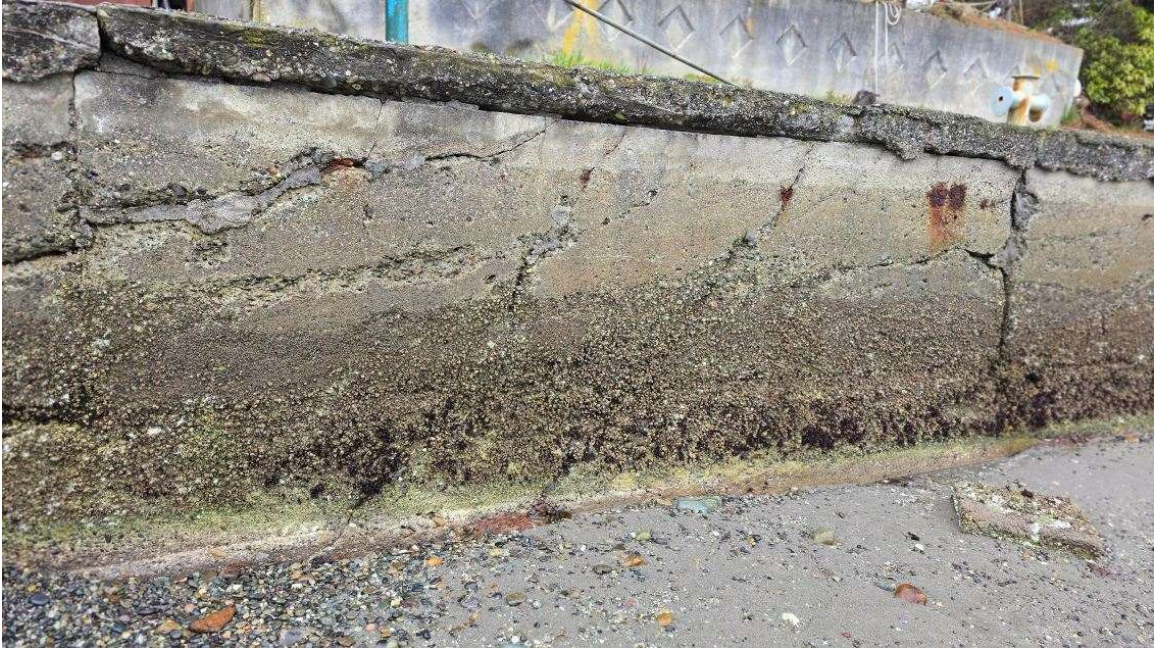
The concrete bulkhead was observed to have severe cracks, minor bleeding of the reinforcement corrosion, and have substantial degradation of the concrete.

Photo 1: Bulkhead Cracking and Reinforcement Bleeding.

It is our opinion that the repair plan of soldier piles behind the existing bulkhead for added support will mitigate adverse impacts on the properties of others to the maximum extent practical.

The following recommendations are offered for the proposed project. This includes general wall design recommendations, foundations, earthwork and drainage considerations. It is our opinion that the bulkhead may be replaced with another concrete bulkhead, or repaired in order to extend the life of the bulkhead. A repair plan would be a soldier pile wall directly behind the existing bulkhead.

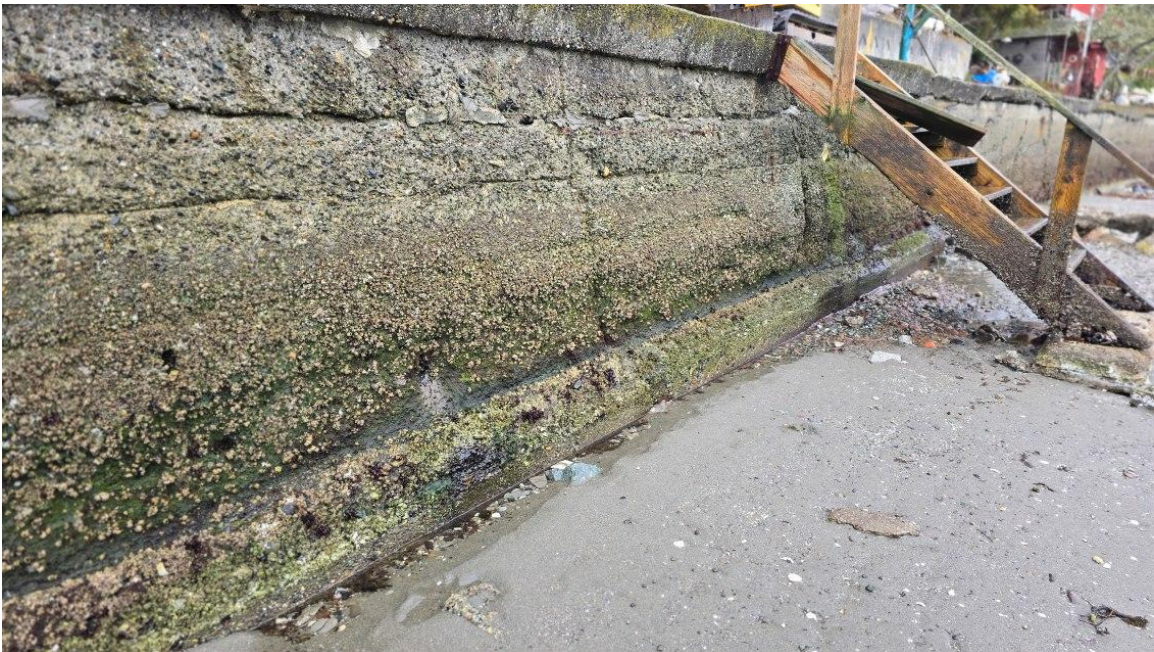
Photo 2: Bulkhead Concrete Degradation.

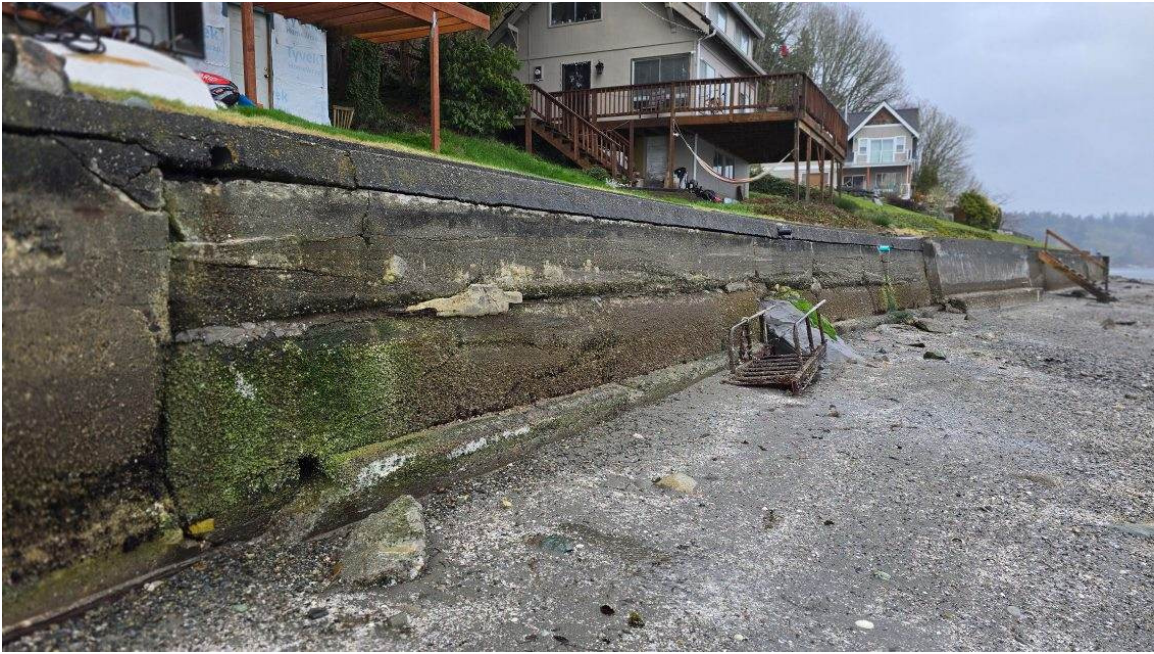
Shoreline erosion that we observed included very minor erosion directly behind the bulkhead in isolated places, and some toe erosion at the base of the bulkhead. A pre-historic landslide on and within the vicinity of the properties is evident from an upland scarp and hummocky/ stepped terrain.

Photo 3: Bulkhead & Beach Erosion

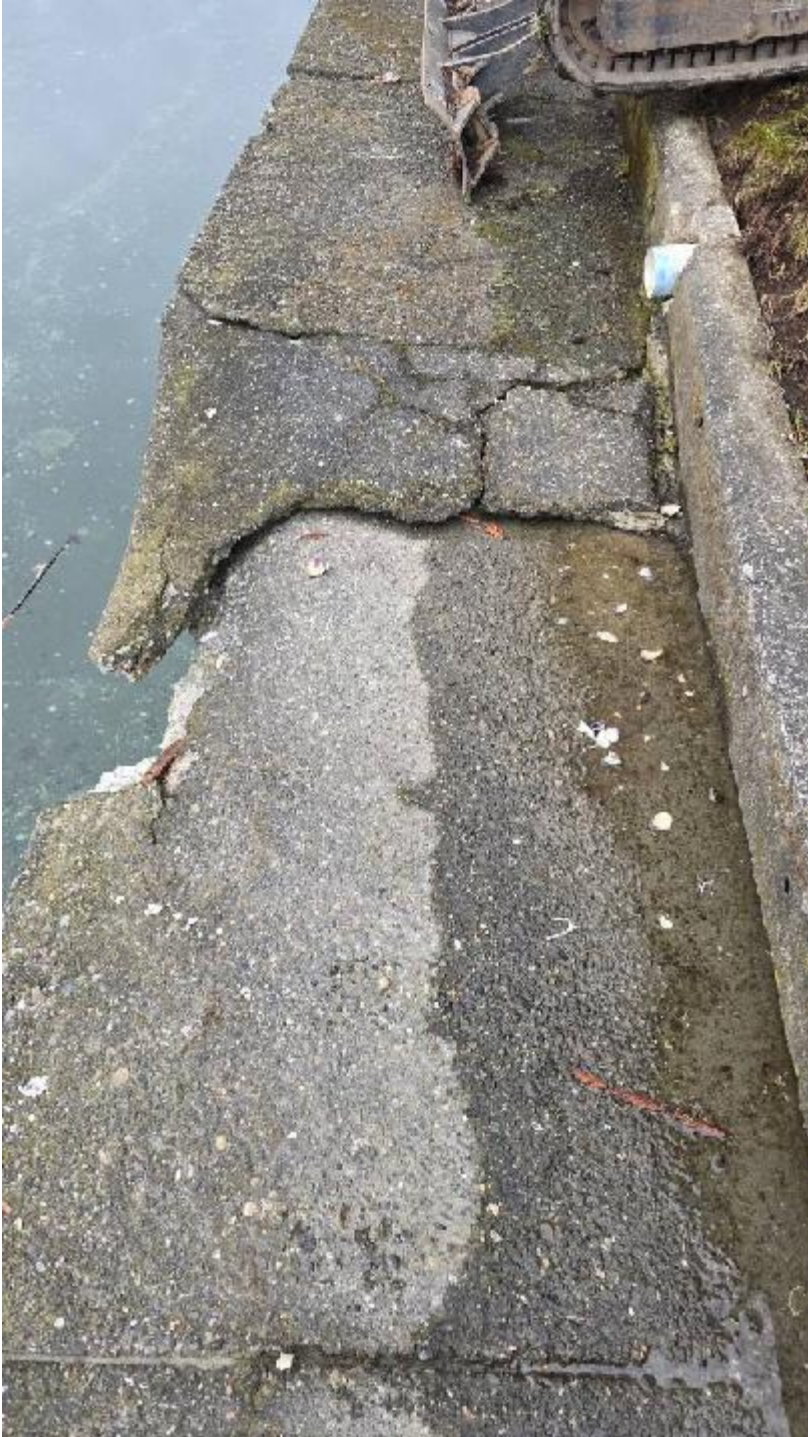
Photo 4: Failing Bulkhead Cap & Slight Backfill Erosion
