PRELIMINARY TECHNICAL INFORMATION REPORT

Wildlife Meadows 275## SE Kent-Kangley Road Ravensdale, WA 98051

January 27, 2023

Encompass Engineering Job No. 22539

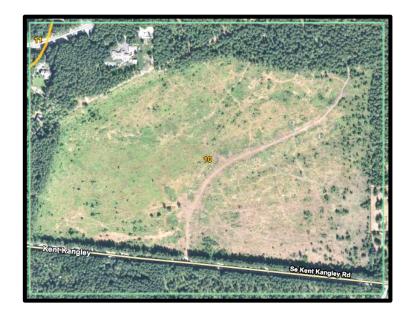
Figure 3: Soils Map and Legend

The topography of the site is mostly flat, with grades of 1-10% sloping to the south and to the west. The soils on site have been classified by the United States Department of Agriculture (USDA) National Resource Conservation Service (NRCS) Web Soils Survey as (10) Barneston gravelly ashy coarse sandy loam, 0-8% slopes – (see Figure 3 below). According to the Septic Feasibility Letter (Appendix A), the soils have a shallow topsoil layer underlaid by a mixture of sandy loams, sand, and cobbles. The geotechnical report included in Appendix D, also confirms the soils as being well-draining outwash medium sand soils with gravel and cobbles. The report notes groundwater as relatively shallow at 4-8 feet below grade in a few of the test pits. Other test pits were found to be dry when samples were collected. The geotechnical report indicates the soils to have moderate infiltration potential and that small, localized, shallow infiltration systems are most appropriate given the shallow groundwater condition.

Map Unit Symbol	Map Unit Name	Acres in AOI	Percent of AOI					
10	Barneston gravelly ashy coarse sandy loam, 0 to 8 percent slopes	124.2	99.3%					
11	Barneston gravelly ashy coarse sandy loam, 8 to 15 percent slopes	0.8	0.7%					
Totals for Area of Interest		125.0	100.0%

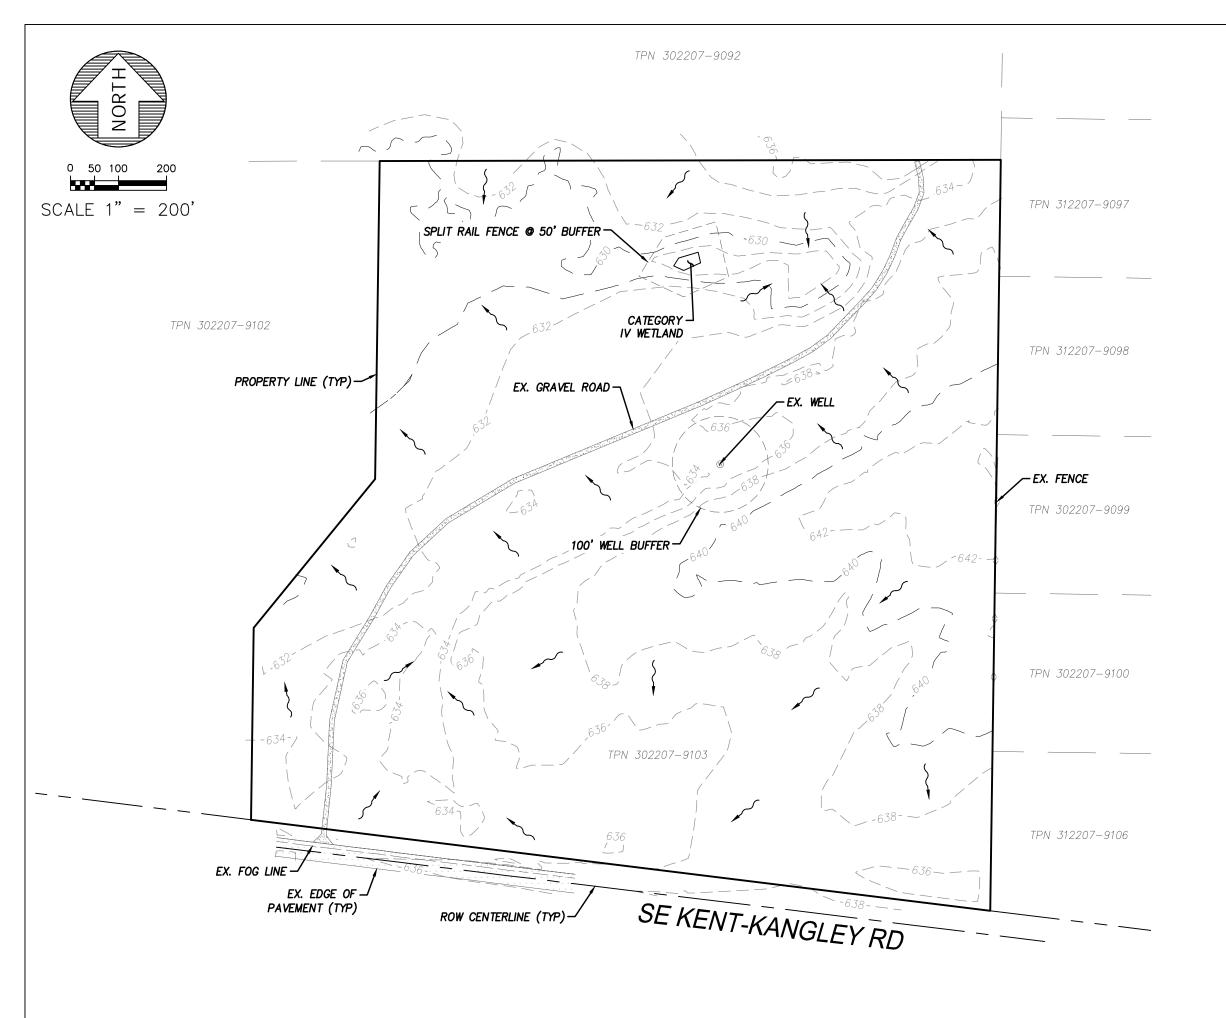
1 01 1	SHEET			
22539	DATE 01/27/2023	SCALE 1"=200' SHEET			
JOB NO.	DATE 01/	SCALE			
REVISIONS					
Encompass	Encine Step Set				
PREPARED FOR	WILDLIFE MEADOWS	275## SE KENT-KANGLEY ROAD			
	EXISTING CONDITIONS

Stormwater from the site generally infiltrates into the native soils on-site. However, stormwater that does not infiltrate sheet flows to the south and west across gentle slopes ranging from 1-10%. The site is located within a single Threshold Discharge Area (TDA). A full description of the drainage patterns is included in Section III. An Existing Conditions Map is provided as Figure 4 at the end of this section.

The project is located on tax parcel number 302207-9103 in unincorporated King County near the community of Ravensdale, WA. The site is contained within one drainage basin, Lower Cedar River Drainage Basin, in the Cedar River / Lake Washington Watershed. The site is located within a single Threshold Discharge Area (TDA). According to the Septic Feasibility Letter (Appendix A), stormwater from the site infiltrates into native soils on-site. However, stormwater that does not infiltrate generally sheet flows to the southwest towards SE Kent-Kangley RD across moderate slopes ranging from 1-10%. An Existing Conditions Map is included as Figure 4 in this TIR.

The 2,060,943 SF (47.3 AC) lot currently contains a primitive 20,323 SF gravel driveway that connects to SE Kent-Kangley Road on the south side of the site. The gravel driveway is to be removed/replaced with construction of the new campground facilities. Apart from the existing driveway, the site is primarily vegetated with native vegetation, including grass, shrubs, and trees. The property is located within a single drainage basin, Lower Cedar Basin, and runoff from the site generally sheet flows off-site to the south and west. Refer to Figure 4 for an Existing Conditions Map.

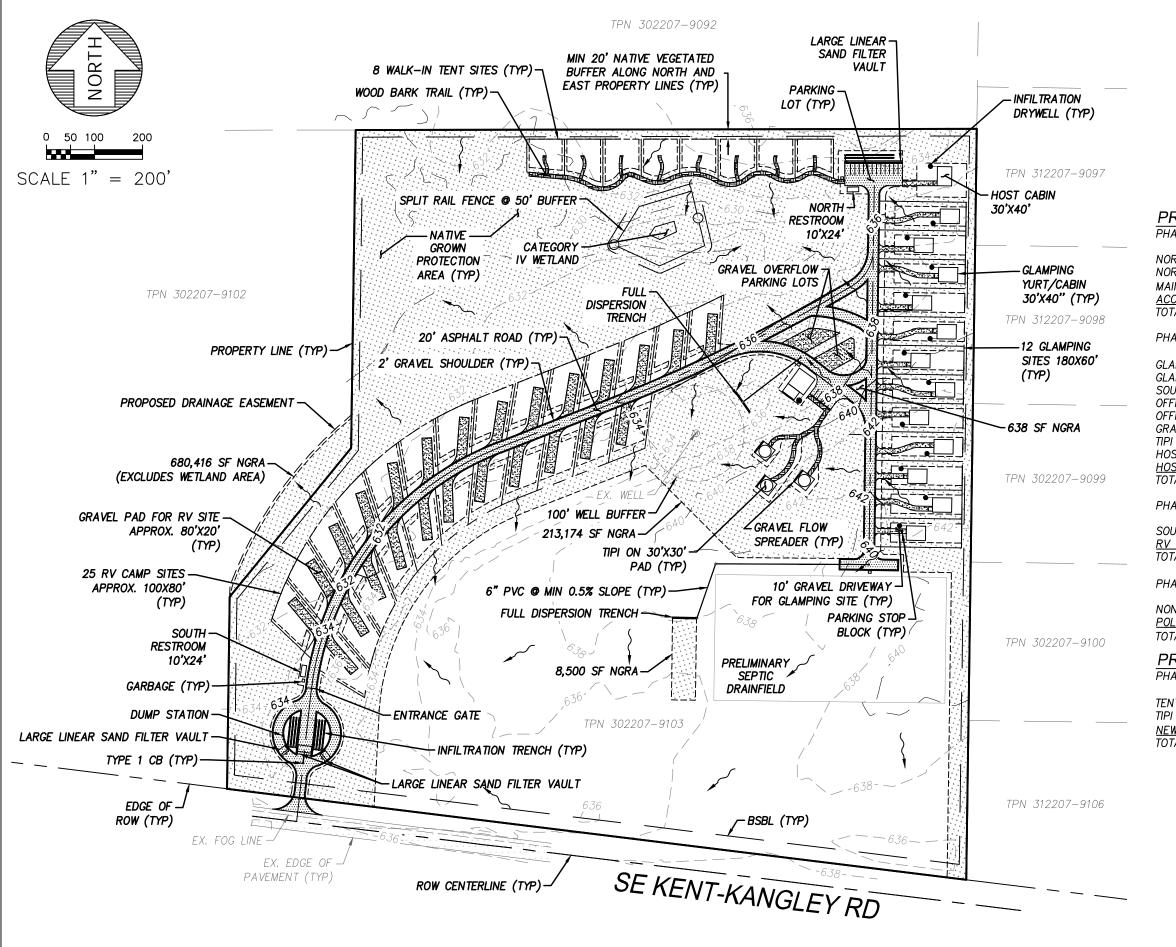
All proposed impervious and pervious surfaces will be fully dispersed except for the main entrance access road/circular turnaround (16,288 SF), the north parking lot (6,405 SF), rooftop runoff from the 12 glamping site cabins/yurts (14,000 SF), rooftop runoff from the office building (1,600 SF), and rooftop runoff from the host cabin (1,200 SF). These remaining surfaces will be mitigated using full infiltration. Pollution-generating impervious surfaces will be treated for enhanced basic water quality using large linear sand filters prior to being fully infiltrated on site. In addition, a 914,287 SF (21 AC) Native Growth Retention Area (NGRA) is proposed. Please refer to Core Requirements 3, 8, and 9 in Section II as well as Section IV of this TIR for additional discussion on the storm design.

1 01 1	SHEET
	22539	27/2023	1*=200'
	JOB NO.	DATE 01/	SCALE
<u>RFACE:</u>	/ISIONS		
240 SF 6,405 SF 16,288 SF <u>67,380 SF</u> 90,313 SF			
	N S S		e: (+2>) <i>592-</i> 0231 9) 674-7433
14,400 SF 12,105 SF 2,498 SF 1,600 SF 600 SF 6,094 SF 2,700 SF 1,200 SF <u>723 SF</u> 41,920 SF	Fncompa		 Ne. Juniper Street. Suite 2019. Instantian WAX 2022. Phone: (425) 322. 407 Swithvater Blvd Cle Elum, WA 38922. Phone: (509) 674-7433.
240 SF			AD
44,563 SF 44,803 SF		NS	
20,980 SF <u>156,056 SF</u> 177,036 SF (8,59%)	RED FOR	MEADOI	-KANGLE
<u>ACE:</u>	REPA	DLIFE	KENT
7,704 SF 3,311 SF <u>220,533 SF</u> 231,548 SF	Д	MIL	275## SE KENT-KANGLEY
		SNO	
		DSED CONDITI	
	240 SF 6,405 SF 16,288 SF <u>67,380 SF</u> 90,313 SF 14,400 SF 12,105 SF 2,498 SF 1,600 SF 6,094 SF 2,700 SF 1,200 SF 1,200 SF <u>723 SF</u> 41,920 SF <u>240 SF</u> <u>44,563 SF</u> 44,803 SF <u>20,980 SF</u> <u>156,056 SF</u> 177,036 SF (8.59%) <u>ACE:</u> 7,704 SF <u>3,311 SF</u> <u>220,533 SF</u>	240 SF 6,405 SF 16,288 SF 7 5 240 SF 6,405 SF 16,288 SF 7 5 16,288 SF 90,313 SF 90,313 SF 14,400 SF 12,105 SF 2,498 SF 1,600 SF 6,094 SF 2,700 SF 1,200 SF </td <td>ZFACE: 240 SF SF SSEQUE 240 SF 6,405 SF 16,288 SF SF 67,380 SF 90,313 SF SSEQUE SUBJECT 14,400 SF 12,105 SF 2,498 SF 1,600 SF 1,200 SF 2,700 SF 1,200 SF SEQUE 240 SF 44,563 SF 41,920 SF SEQUE 20,980 SF 156,056 SF 177,036 SF (8.59%) ACE: 7,704 SF 3,311 SF 220,533 SF SF</td>	ZFACE: 240 SF SF SSEQUE 240 SF 6,405 SF 16,288 SF SF 67,380 SF 90,313 SF SSEQUE SUBJECT 14,400 SF 12,105 SF 2,498 SF 1,600 SF 1,200 SF 2,700 SF 1,200 SF SEQUE 240 SF 44,563 SF 41,920 SF SEQUE 20,980 SF 156,056 SF 177,036 SF (8.59%) ACE: 7,704 SF 3,311 SF 220,533 SF SF

A Developed Conditions Map is provided as Figure 5 at this end of this Section.

All proposed impervious and pervious surfaces will be fully dispersed except for the main entrance access road/circular turnaround (16,288 SF), the north parking lot (6,405 SF), rooftop runoff from the 12 glamping site cabins/yurts (14,000 SF), rooftop runoff from the office building (1,600 SF), and rooftop runoff from the host cabin (1,200 SF). These remaining surfaces will be mitigated using full infiltration. Pollution-generating impervious surfaces will be treated for enhanced basic water quality using large linear sand filters prior to being fully infiltrated on site. Please refer to Core Requirements 3, 8, and 9 in Section II of this TIR for additional discussion on the storm design. A Developed Conditions Map is provided in Figure 5.

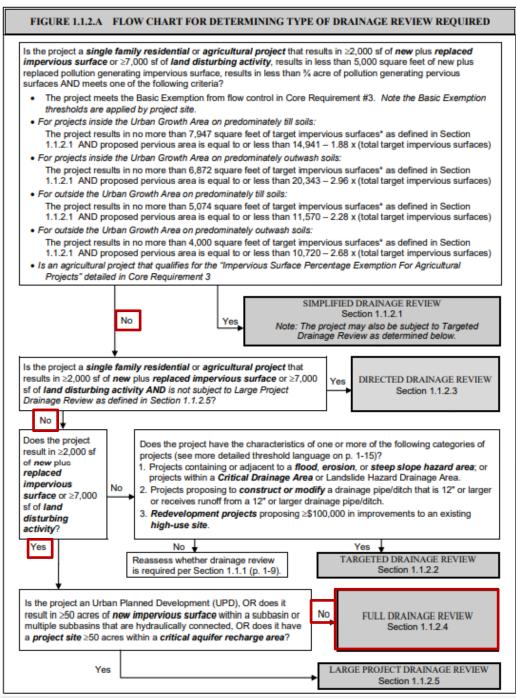
Figure 6: Drainage Review Flow Chart

The 2021 King County Surface Water Design Manual (KCSWDM) was used to determine and address all core and special requirements. Based on the criteria specified in KCSWDM 1.1.2, the project falls under Full Drainage Review in accordance with KCSWDM Section 1.1.2.4. This means the property must meet all core and special requirements. See Figure 6 below for more information on how the type of drainage review required was determined.

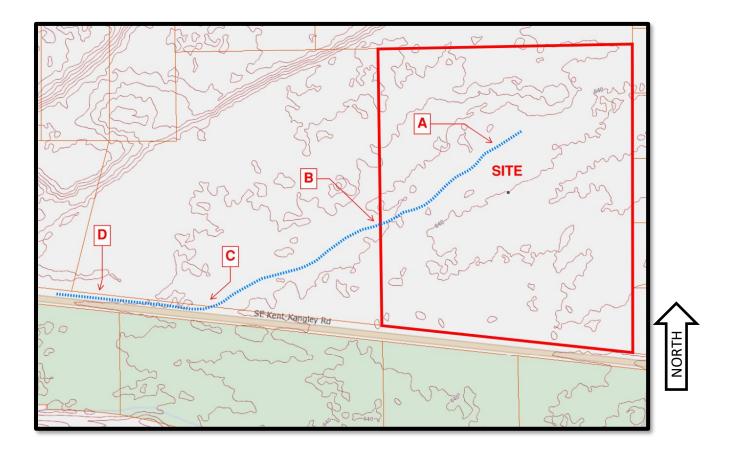
Figure 7: Downstream Map

The site has only one natural discharge location (NDA) on the western side of the property, which results in one total TDA for the site. Stormwater runoff from the site generally sheet flows in the southwestern direction towards the western property line (A). After flowing off the property, the runoff continues sheet flowing to the southwest (B), following the natural topography throughout the adjacent lot. After roughly 1,000 FT, the runoff intercepts SE Kent-Kangley Rd and enters the roadside ditch on the northern side of the road (C). From here, the runoff continues being conveyed to the west within the roadside ditch until the ¼ mile downstream limit was reached (D). The runoff ultimately gets discharged into the Lower Cedar River. No drainage related issues were observed downstream of the site, and no relevant drainage complaints were identified on the King County iMap system within a quarter mile of the site discharge location. Please refer to the Downstream Map (Figure 7), Drainage System Table (Table 1), and photographs on the following pages for additional details.

Symbol (see map)	Drainage Component	Drainage Component Description	Slope %	Distance from site discharge (¼ ml = 1,320 ft.)	Existing Problems	Potential Problems	Observations of field inspector, resource reviewer, or resident
А	SHEET FLOW	VEGETATION	1-10%	0'	NO	NO	NO IMMINENT PROBLEMS
В	SHEET FLOW	VEGETATION	1-10%	0'	NO	NO	NO IMMINENT PROBLEMS
C	ROADSIDE DITCH	GRASS	1-5%	0-1,000'	NO	NO	NO IMMINENT PROBLEMS
D	ROADSIDE DITCH	GRASS	1-5%	1,000'- 1,320'	NO	NO	NO IMMINENT PROBLEMS

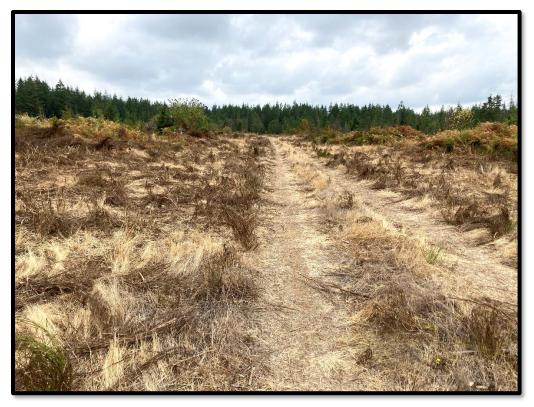
Element A: Runoff from site sheet flows in the southwesterly direction

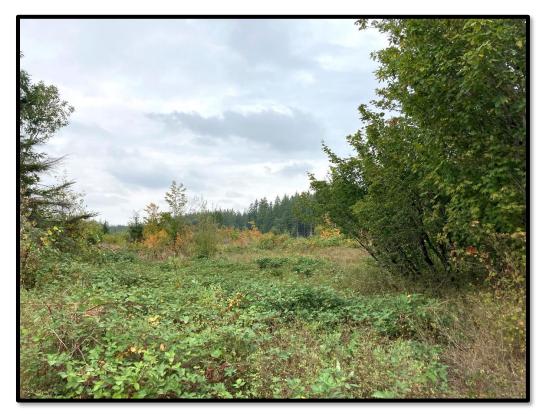
Element B: Runoff generally leaves the site from the western property line and continues sheet flowing through a separate lot

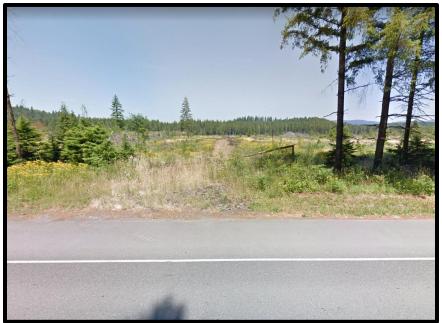
Element C: Runoff intercepts SE Kent-Kangley Rd and begins flowing west within the roadside ditch

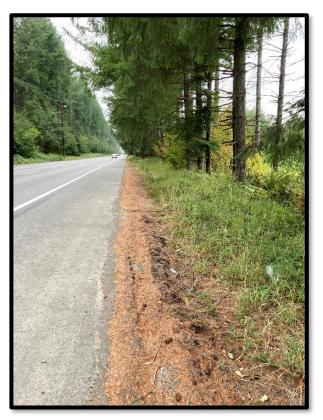
Element D: Runoff continues flowing west within roadside ditch until ¼ downstream limit is reached

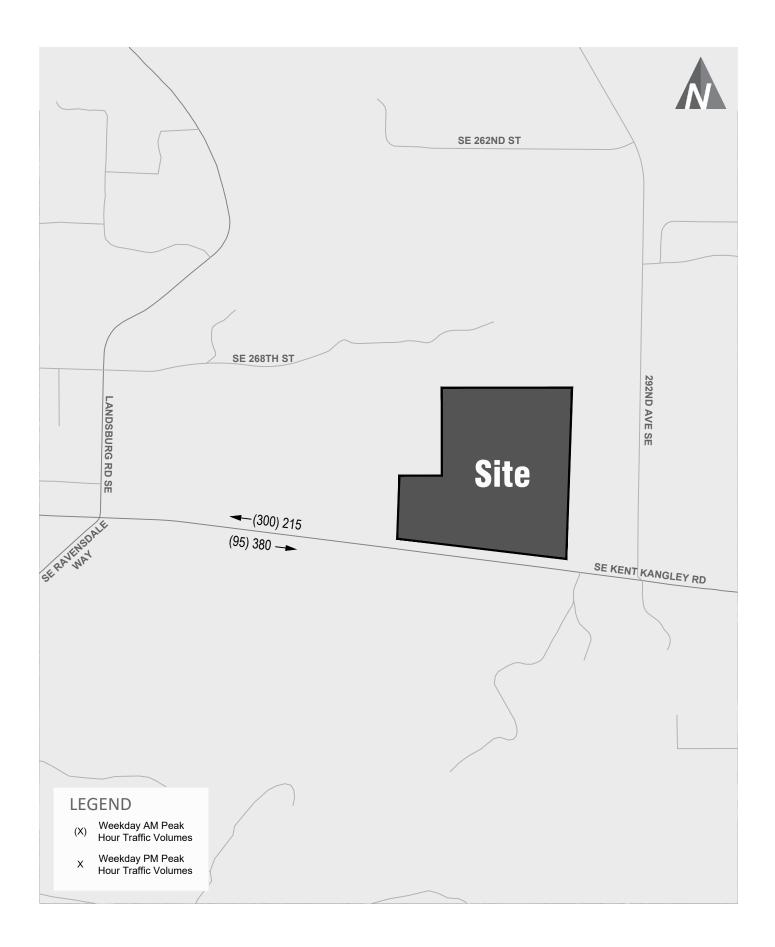
Existing Peak Hour Traffic Volumes

The estimated existing (2022) weekday AM and PM peak hour traffic volumes along SE Kent Kangley Road in the vicinity of the project are shown on Figure 3. The traffic volumes were rounded to the nearest five vehicles to account for daily fluctuations. The detailed weekday peak period traffic counts are included in Appendix A.

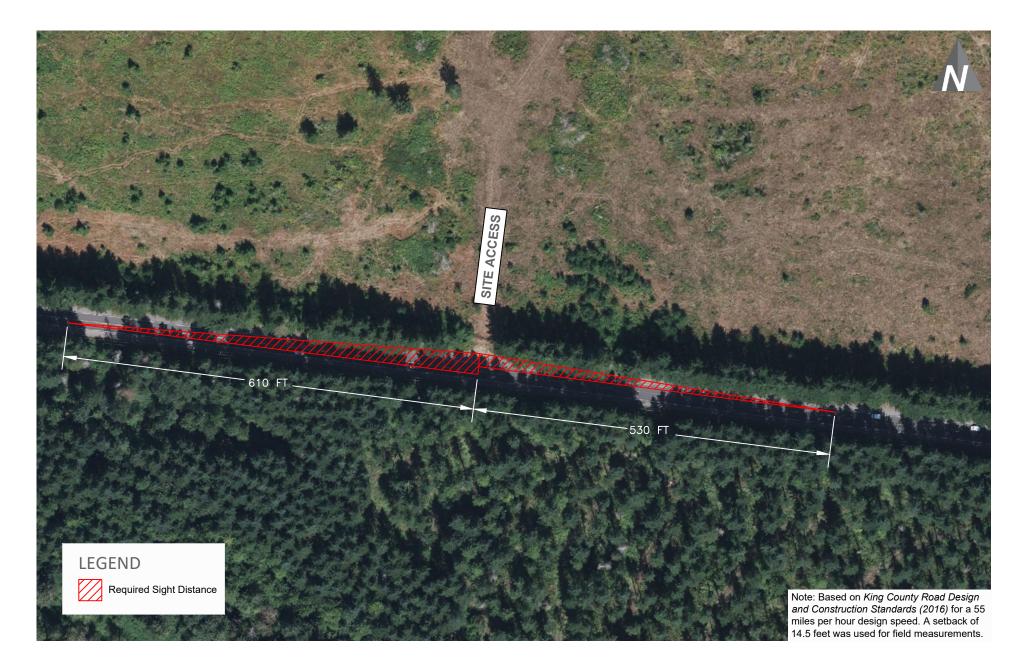
Entering Sight Distance

Stopping and entering sight distance were evaluated at the proposed site driveway. Stopping sight distance is the distance necessary to enable a motorist to stop before reaching a stationary object in its path. In contrast, entering sight distance is the distance necessary for a motorist to enter the traffic stream without causing traffic on the major street to reduce its travel speed. The methods and standards used to measure the available sight distance are defined in the *King County Road Design and Construction Standards (2016)*. With an estimated 55 mph design speed along SE Kent Kangley Road (equal to 10 mph above the posted speed limit as defined on page 1-13 of these *Standards*), the recommended minimum stopping sight distance is 495 feet and the recommended minimum entering sight distance is 610 feet and 530 feet for the left- and right- turning vehicles, respectively.

The sight distance triangles for the driveway were evaluated by in-field measurements and are shown in Appendix D. As shown in the appendix, sight distance at the site driveway in the east and west directions are anticipated to meet the recommended entering and stopping sight distances.

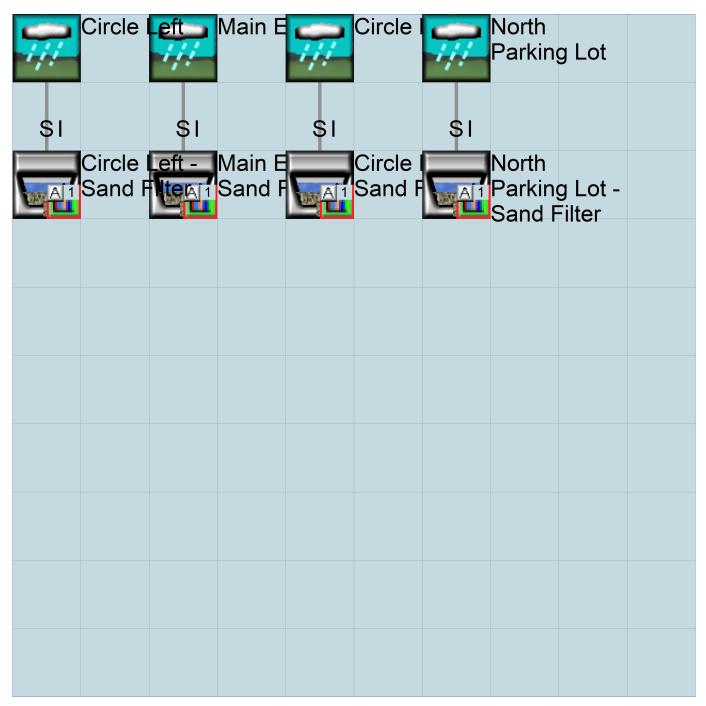
Mitigated Schematic

Basin 1 0.37ac
