## Annual Bridge Report

Department of Local Services

Road Services Division

2024

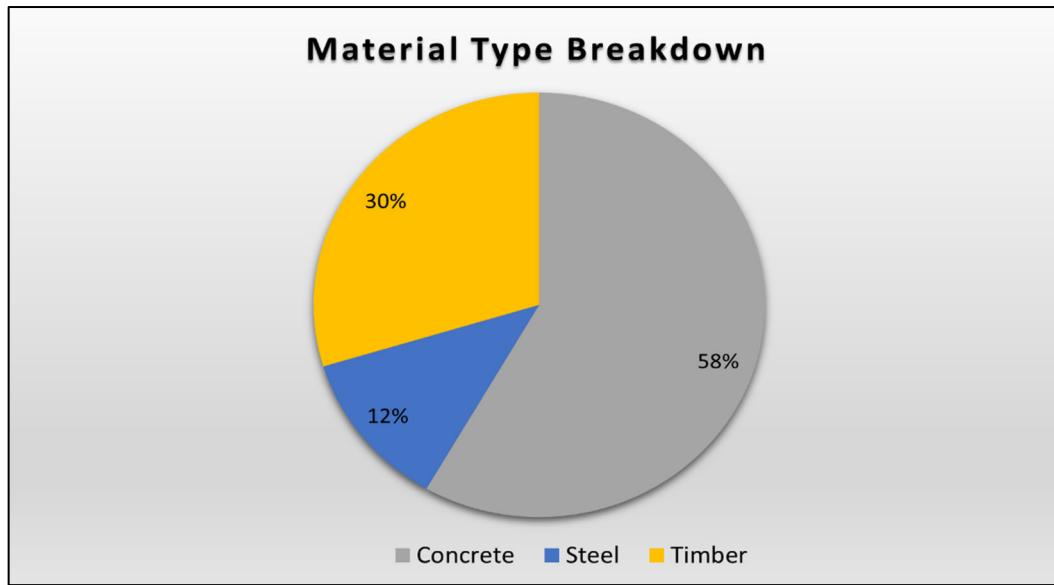
Figure 1: Bridges by Material Types

Figure 1 shows the breakdown by material type of the King County Roads bridge inventory.

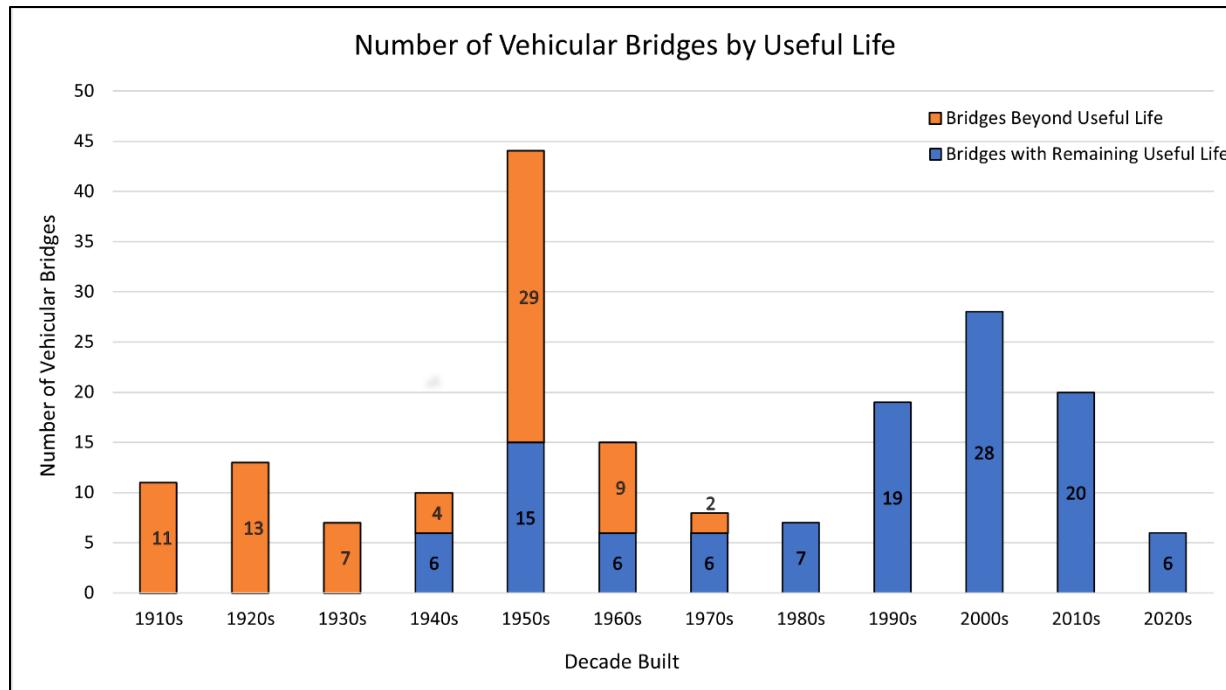
Figure 2: Vehicular Bridges by Useful Life

Figure 2 shows the number of vehicular bridges built by decade. It also shows the number of bridges (40% of vehicular bridge inventory) that are beyond their useful life. The anticipated useful life of bridges varies by material type with timber bridges at 50 years, and steel bridges and concrete bridges at 80 years. Most of the county bridges are comprised of multiple material types for the substructure, superstructure, and decking. Of the 188 vehicular bridges in the inventory, 75 are beyond their expected useful life. In addition, the average age of the vehicular bridge inventory is 52 years, and the average age of the entire inventory is 52 years old.

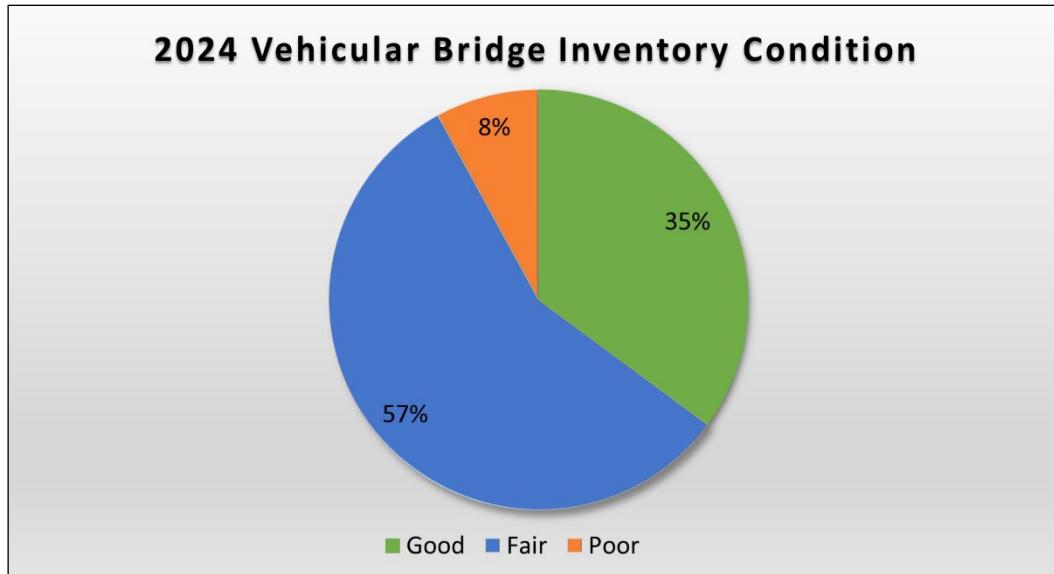
Figure 3: Vehicular Bridge Condition Classification

Figure 3 shows the number of vehicular bridges in each classification. In 2024, there are 15 bridges (8%) categorized in the state of “Poor”, 107 bridges (56%) in Fair and 66 bridges (35%) are in “Good.” A bridge in poor condition has advanced deficiencies such as: section loss, deterioration, scour, or a structural component(s) with a serious defect. Due to these deficiencies, these structures may have weight restrictions. Because damage and deterioration tend to compound when left unchecked, it is likely that the bridges in the “fair” category may fall into the poor category if the assets are not managed with proper maintenance.

Starting in 2023, bridge inventory condition has been assessed based on condition. For each bridge, the deck, substructure, and superstructure condition states are rated on a scale from one to eight. If any of these elements are rated less than or equal to four, the bridge is classified as “Poor”, elements rated five or six are classified as “Fair” and elements greater than or equal to seven are classified as “Good”.

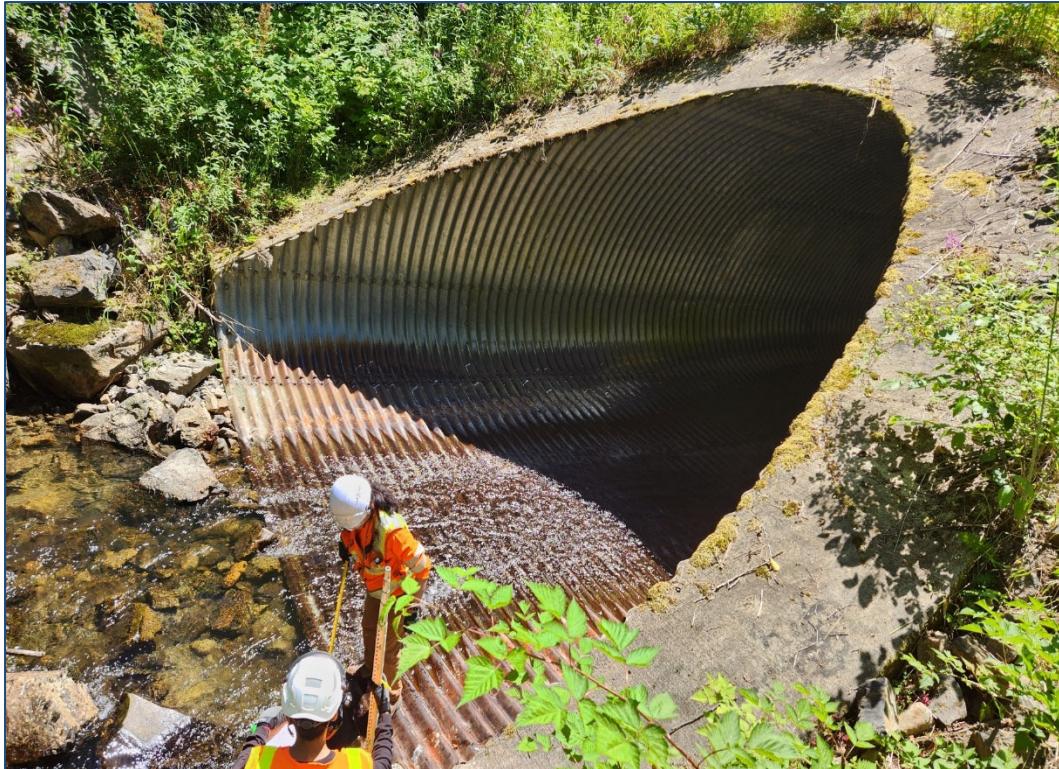
Photo 1: Lake Dorothy Super Span No. 359V

Lake Dorothy Super Span No 359V is a buried corrugated metal pipe culvert carrying SE Middle Fork Road and a National Forest Road NF-5600, located northeast of North Bend. It was turned over to King County from the National Forest Service.

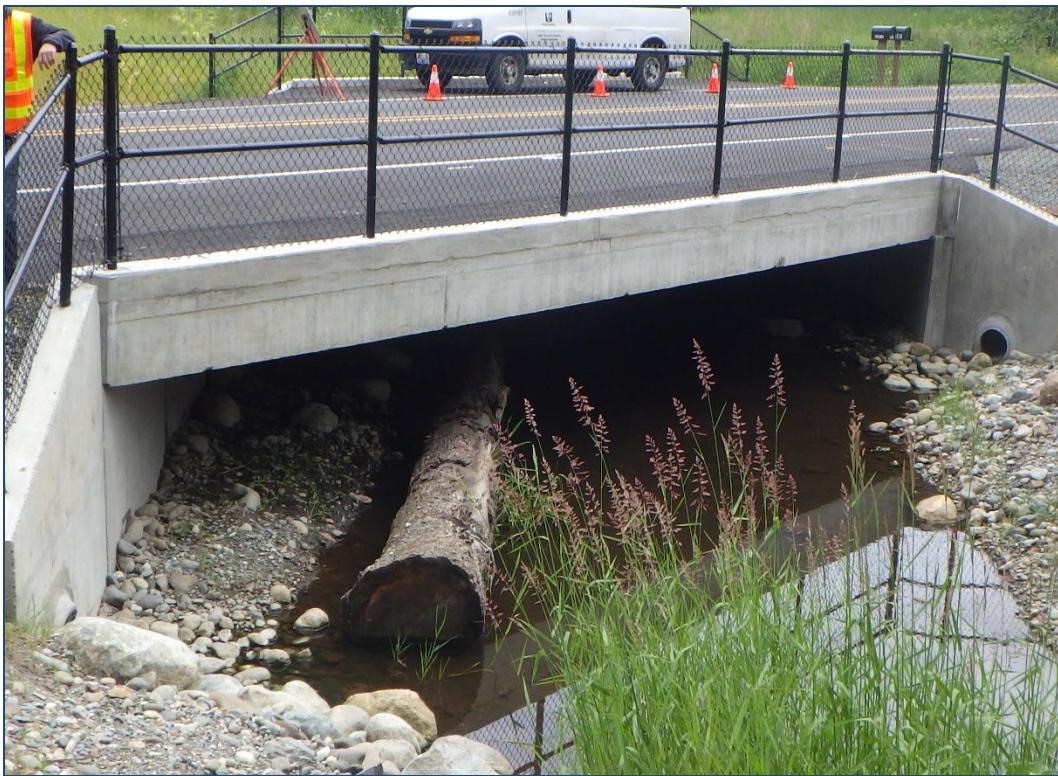
Photo 2: 284<sup>th</sup> Ave SE Culvert No. 3049A

284<sup>th</sup> Ave SE Culvert No 3049A is a pre-cast concrete culvert carrying 284<sup>th</sup> Ave SE, located south of Enumclaw. It was constructed under the Fish Passage Program to replace a failing narrow diameter pipe culvert.

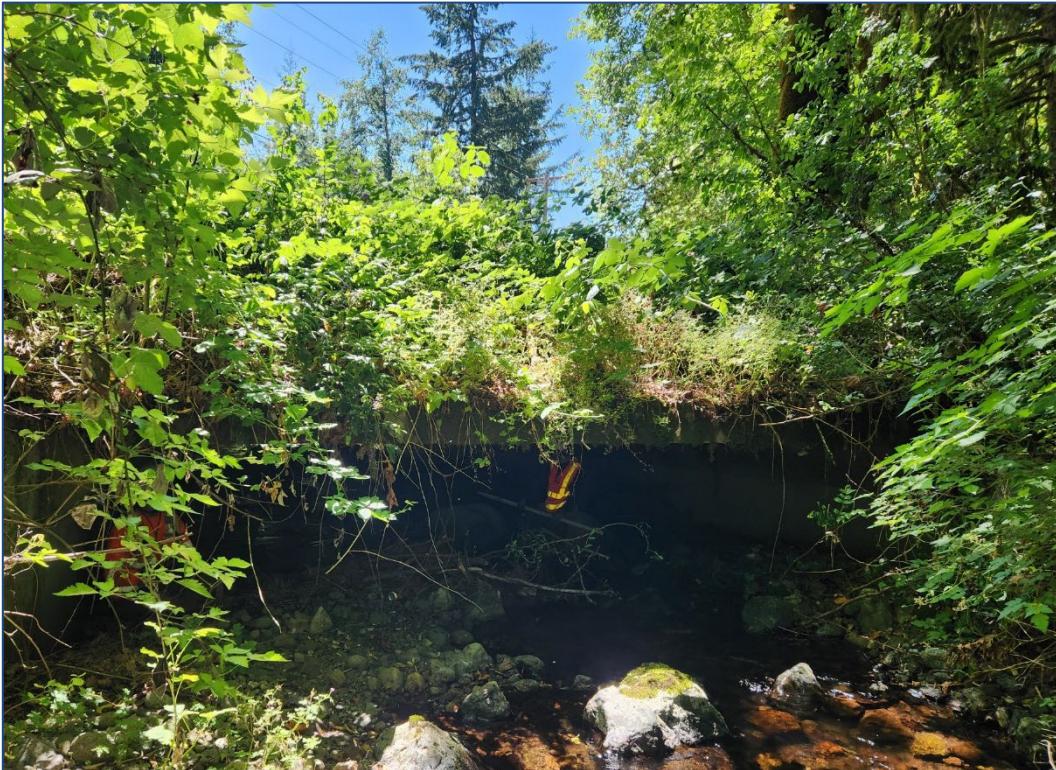
Photo 3: Roaring Creek Culvert No. 2550B

Roaring Creek Culvert No 2550B is a pre-cast concrete culvert carrying SE Mt Si Rd, located east of North Bend. It was constructed under the Drainage Program to improve water conveyance in the area in 2002. It was inventoried in 2024.

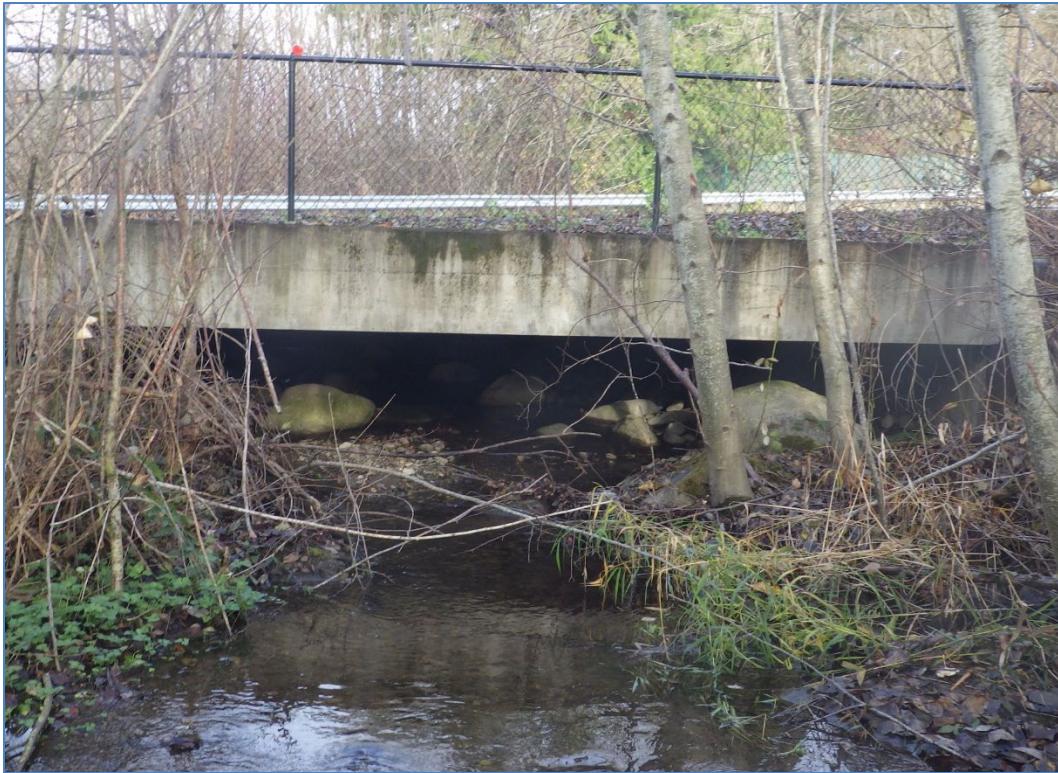
Photo 4: NE 95<sup>th</sup> St Culvert No. 952E

NE 95<sup>th</sup> St Culvert No 952E is a pre-cast concrete culvert carrying NE 95<sup>th</sup> St, located east of Redmond. It was constructed as part of a larger capital improvement project in the area in 2010. It was inventoried in 2024.

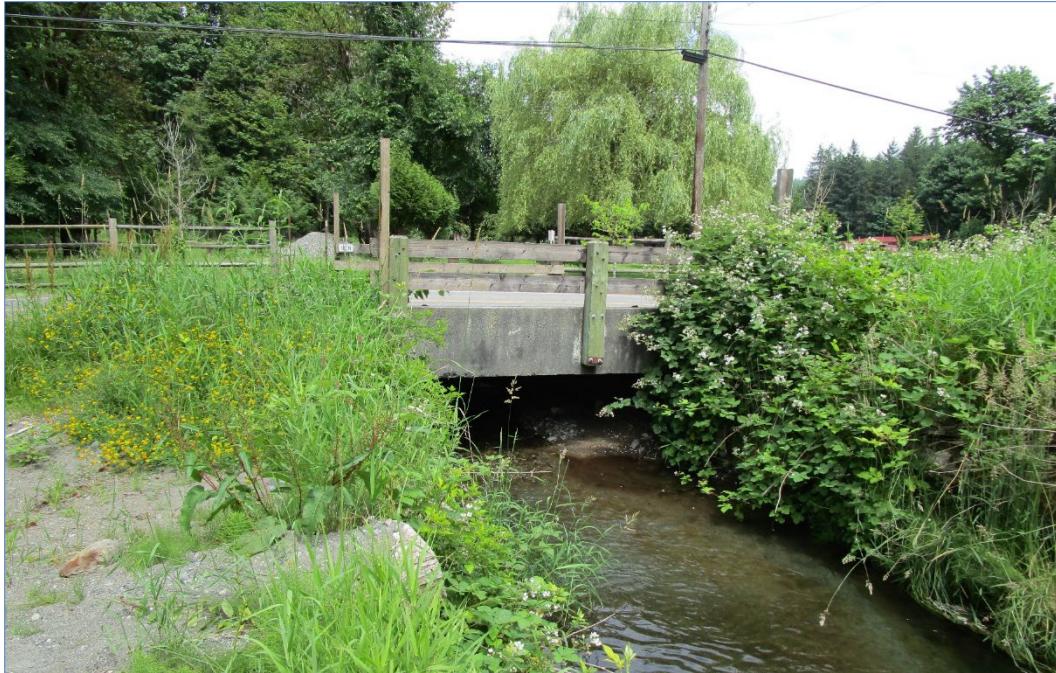
Photo 5: Tate Creek Bridge No. 122N

Located north of the city of North Bend, this short span sole-access bridge carries North Fork Road SE over Tate Creek. The hydraulic opening under the bridge is very limited due to sediment accumulation and causes overtopping of the approach roadway and results in the isolation of 200-plus residents in this neighborhood during flood events.

The bridge is located on a substandard horizontal alignment with additional sight distance and private property owner impact challenges. Funding for the Concept Development Report (CDR) phase has been authorized with Flood Control District funds. As short span bridges are not eligible for federal funding, other funding sources need to be considered for design, right-of-way, and construction.

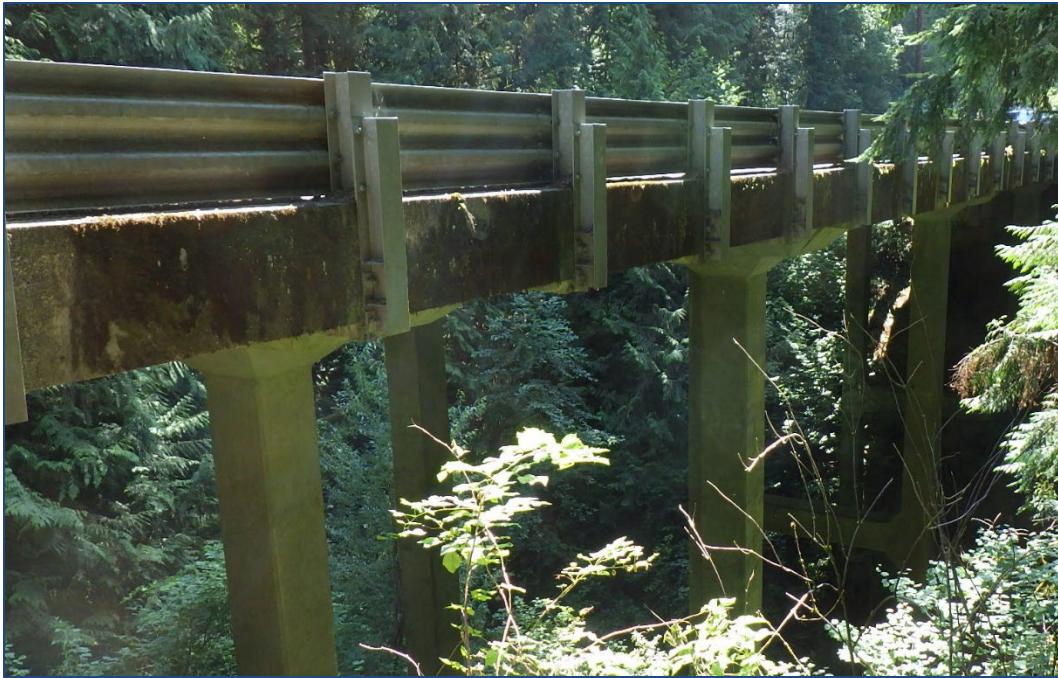
Photo 6: Cherry Valley Trestle Bridge No 267X

### **Cherry Valley Trestle Bridge No. 267X**

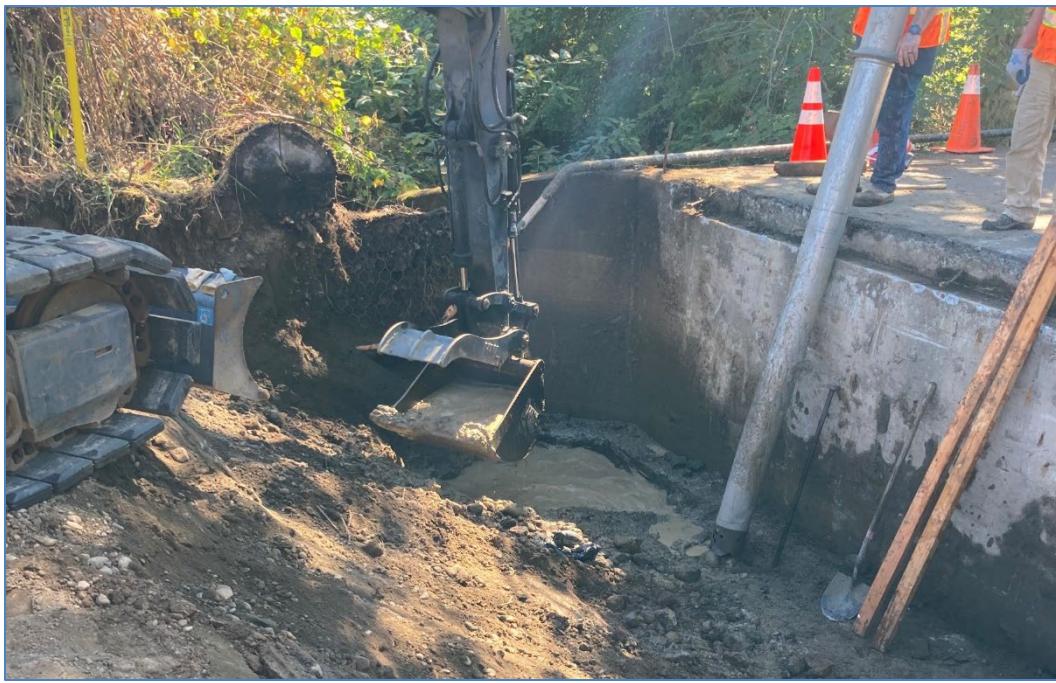
Photo 7: Boise Creek Bridge No. 3051 – exposing scour void

This project required a 14-day bridge closure and was completed in September 2024.

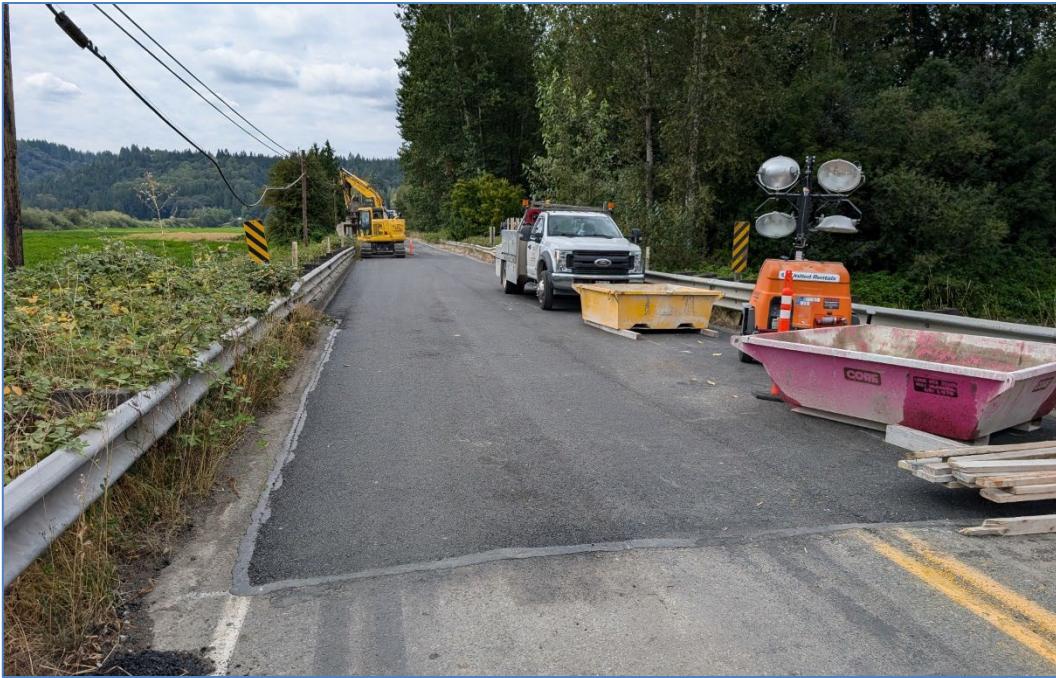
Photo 8: Woodinville – Duvall Bridge No. 1136C – completed overlay

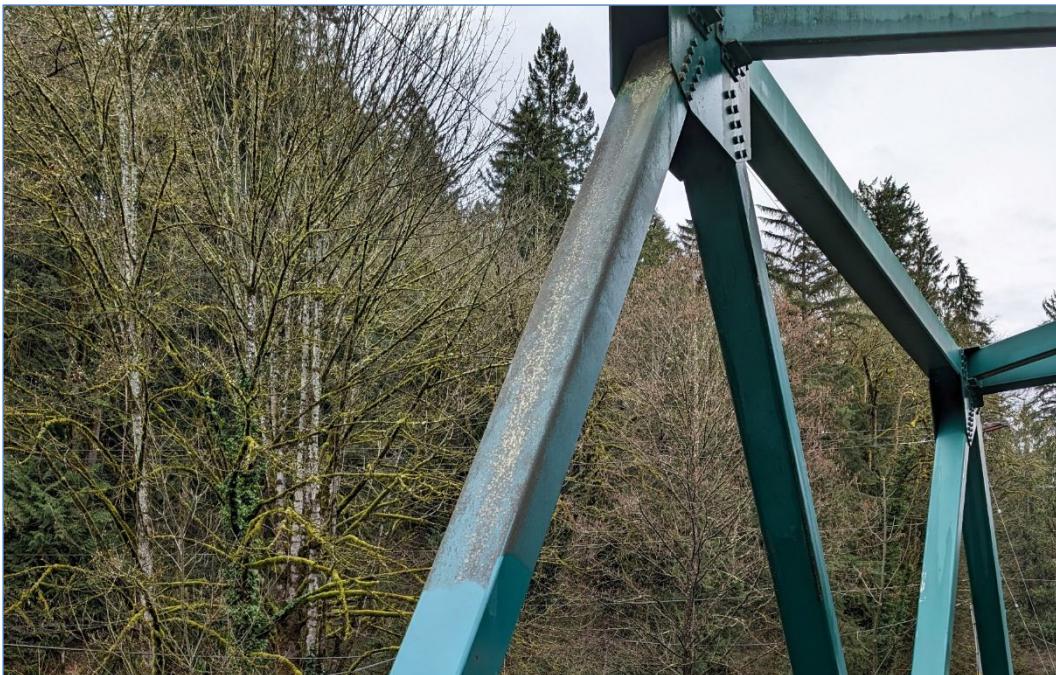
Photo 9: Smith – Parker Bridge No. 615A washing in progress

Novelty Bridge No. 404B and Smith-Parker Bridge No. 615A are both steel truss bridges with failing paint and are listed as high priority candidates for repainting. Keeping these bridges clean and clear of sediment build-up helps prevent further loss of paint and deterioration of the underlying steel until they can be repainted.

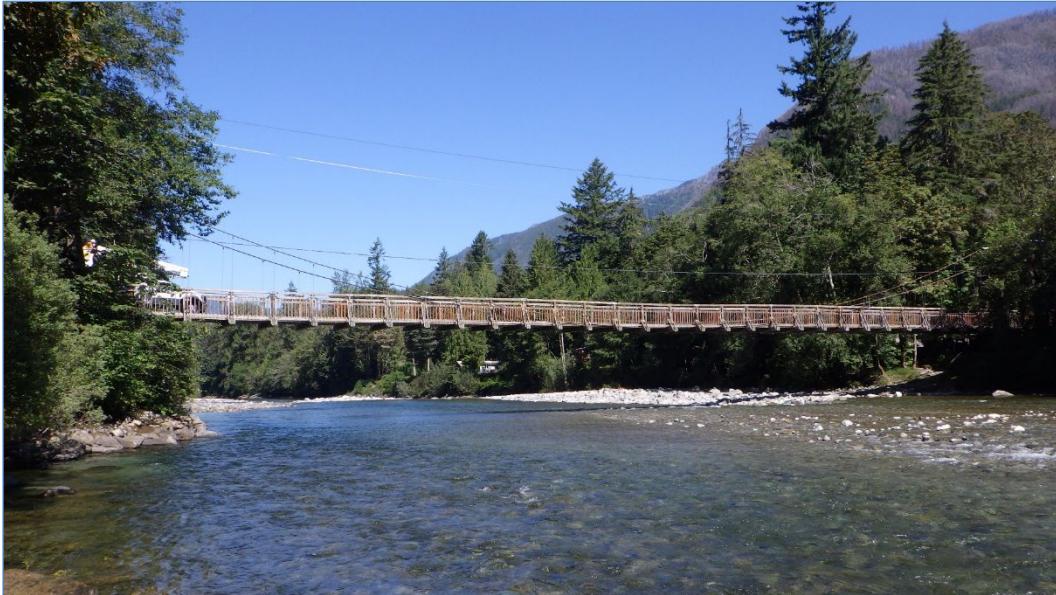
Photo 10: Baring Bridge No. 509A – Upstream elevation

**Baring Bridge No. 509A**

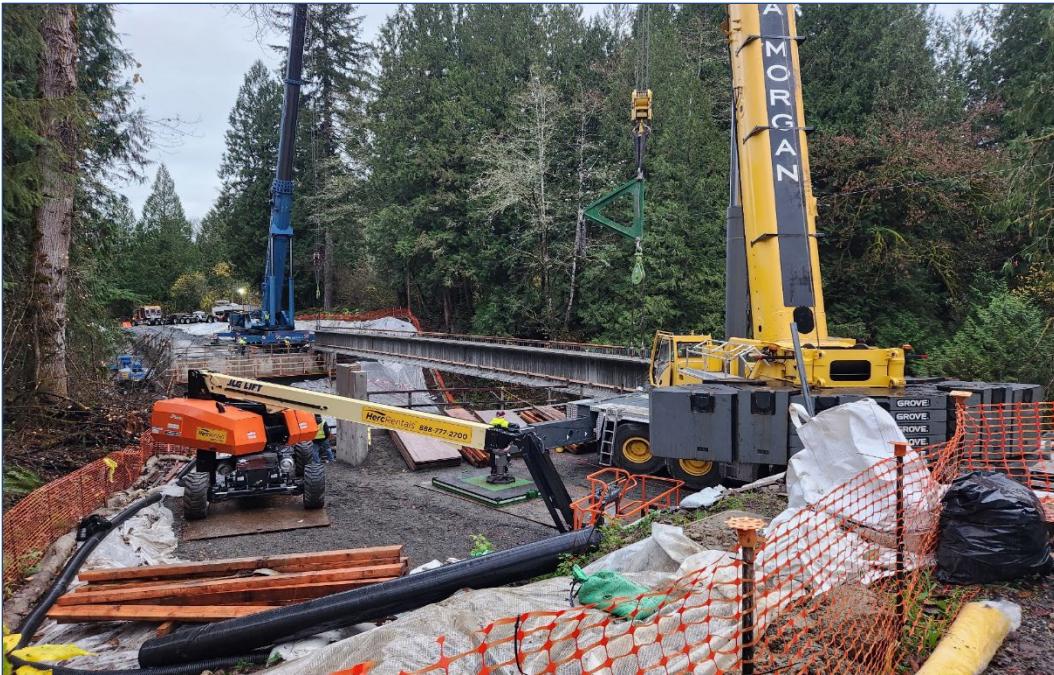
Photo 11: Ames Lake Trestle No. 1320A – Concrete girder launch for new bridge, Nov 2024

All permits approvals and ROW acquisitions were complete by the end of 2023. The project was advertised in January 2024 and the road was closed to traffic in June 2024. Coordination with utilities was needed to relocate gas and electric services during construction. The removal of timber piling within the Ordinary High Water (OHW) and stream grading/restoration was completed within the in-water work window. The new bridge girders were launched in November 2024 and the concrete bridge deck was poured in December 2024. The new bridge is expected to open to traffic in spring 2025.

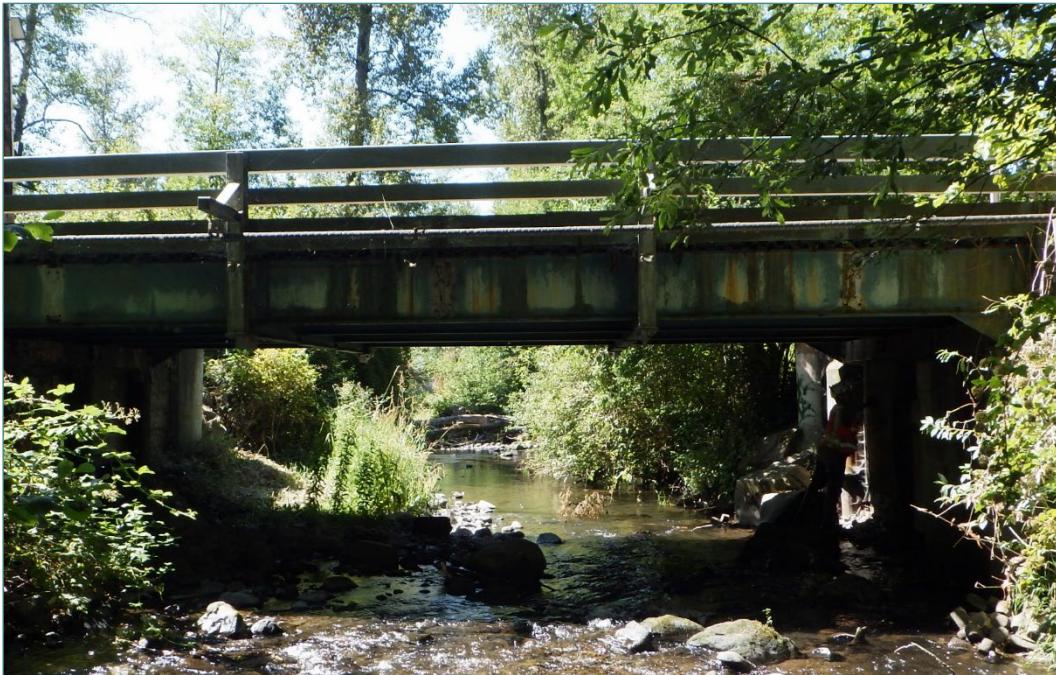
Photo 12: Boise X Connection Bridge No. 3055A - Deteriorating steel girders and timber piles

In December 2019, the bridge was awarded federal funding for design and construction of a bridge replacement. Federal funding for the design phase was obligated and authorized to proceed in May of 2020. Due to challenges encountered with staffing resources, the short fish window, and fabrication lead time, the project is scheduled for bid advertisement in 2025 to meet the fish window for in water construction work in 2026. A five to six months general closure is expected in the summer months of 2026.

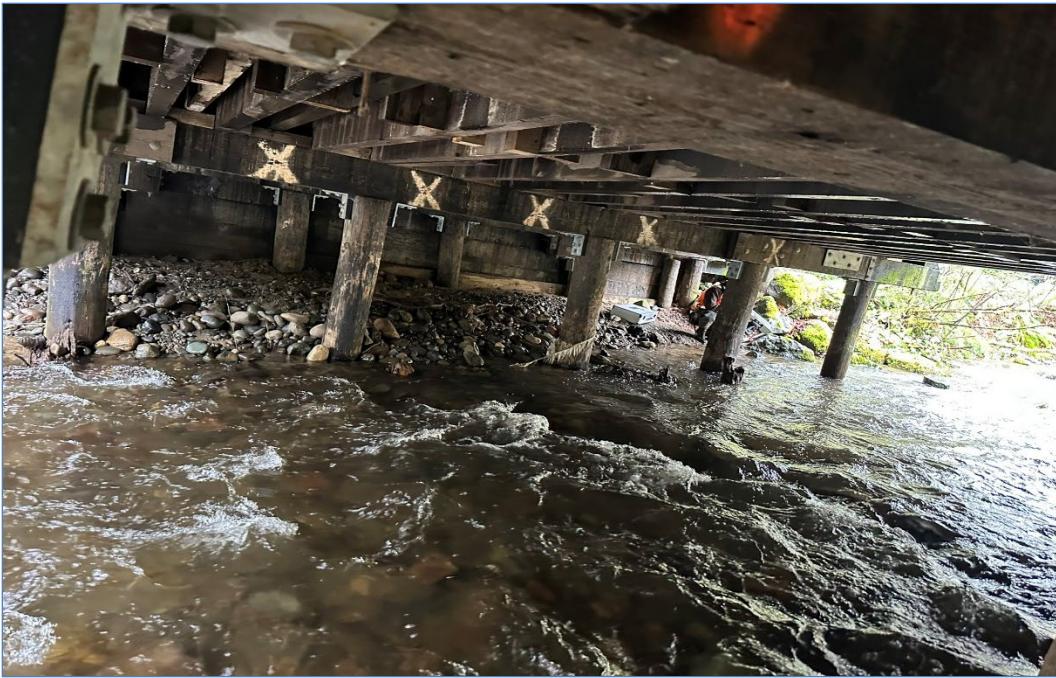
Photo 13: Fifteen Mile Creek Bridge No. 493C - Deteriorating timber superstructure and substructure

A federal grant for design and construction was awarded in December 2019. Federal funding for the design phase was obligated and authorized to proceed in May of 2020. Design and permitting is 100% complete and right-of-way agreements have been certified. Contract advertisement is planned for fall 2025 with replacement construction planned for summer 2026 and involves a full road closure for the duration.

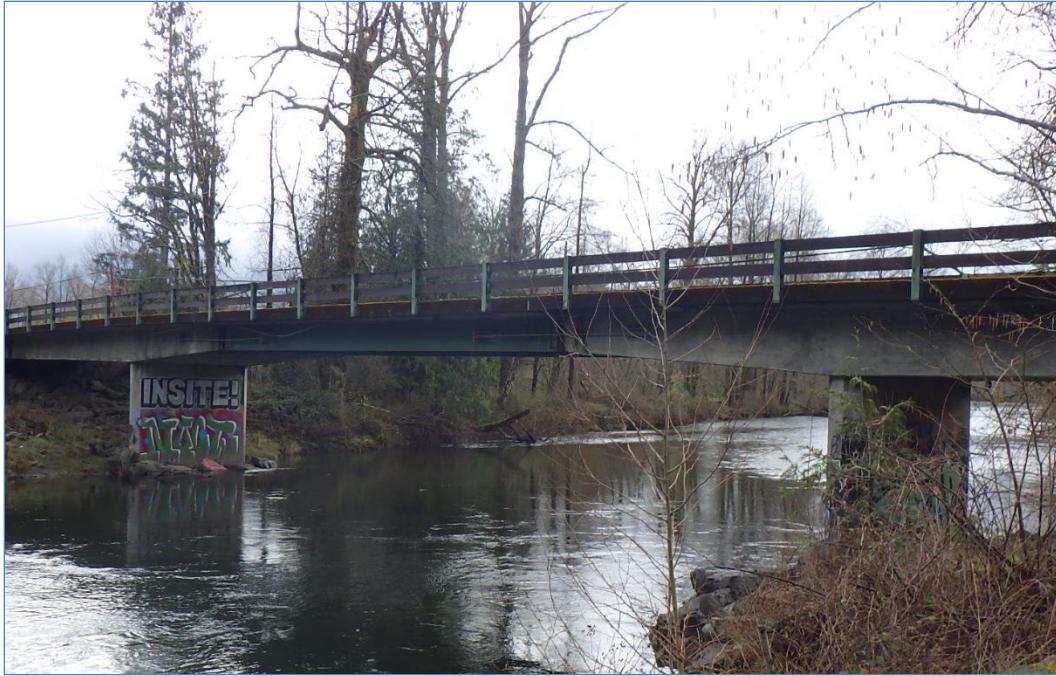
Photo 14: North Fork Bridge No. 122I - Looking west

### **North Fork Bridge No. 122I**

In October 2023, the Federal Local Bridge Program awarded \$25M for all phases of the North Fork Bridge No. 122I Replacement project.

Currently the project is at the preliminary design phase, which is expected to be completed in December 2025. The project is expected to go to construction in 2030.

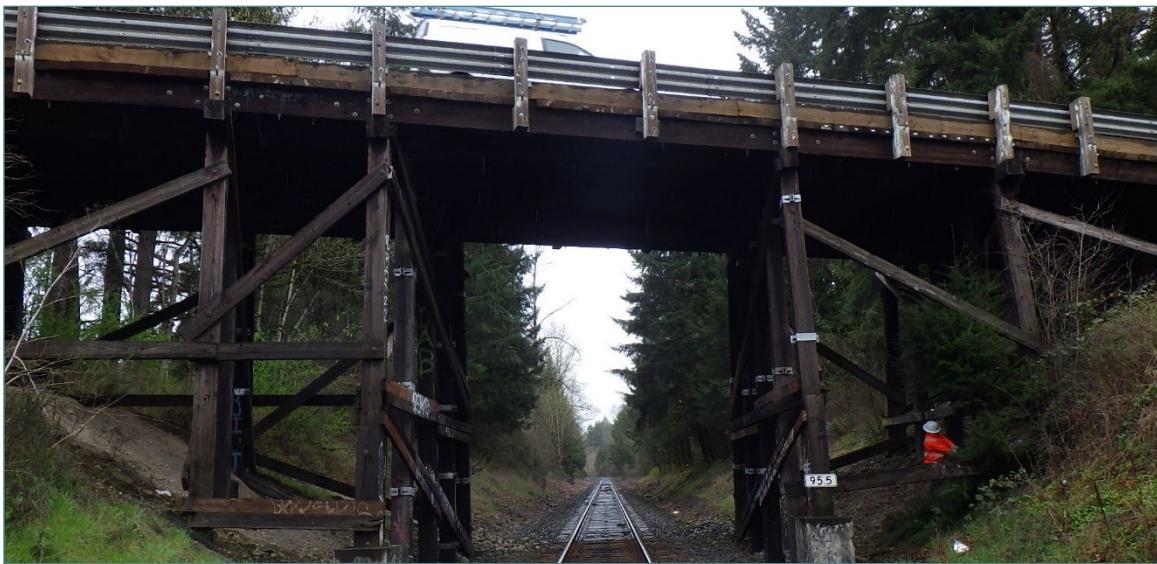
Photo 15: Berrydale Overcrossing Bridge No. 3086OX – Looking south over the BNSF rail line

### Berrydale Overcrossing Bridge No. 3086OX

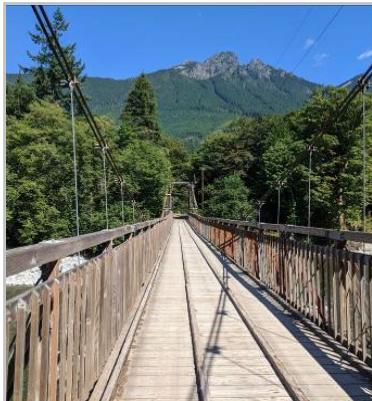
### Baring Bridge No. 509A

Built in 1930, this timber suspension bridge spans the South Fork Skykomish River at Northeast Index Creek Road, near the community of Baring.

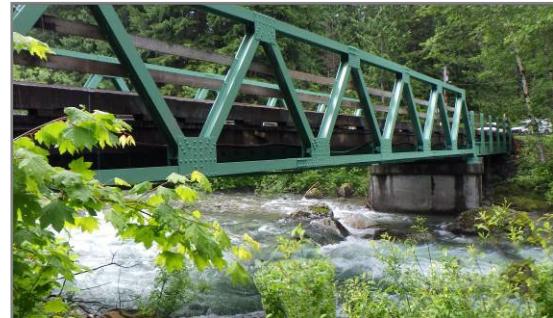
### Foss River Bridge No. 2605A

Built in 1951, spanning a tributary to the Skykomish River in northeast King County. This warren pony truss was added to the National Historic Registry in 2002.

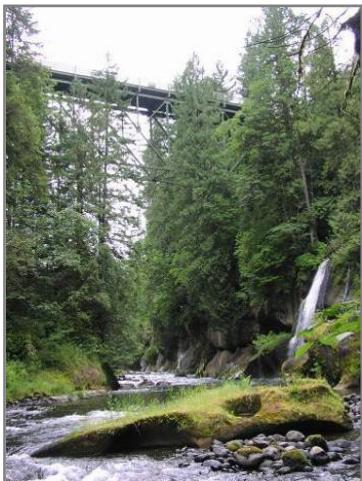
### Green River Gorge Bridge No. 3032

Built in 1914, spanning the Green River Gorge in southeast King County. This is a rare and intact example of the Baltimore Petit deck truss structural design. The Green River Gorge Bridge is the only Baltimore Petit deck truss bridge owned and maintained by King County. Designated in 2004.

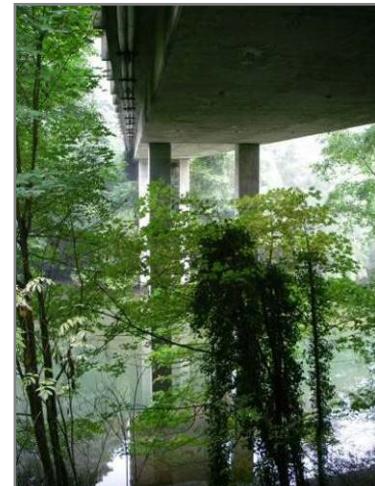
### Judd Creek Bridge No. 3184

Built in 1953 on Vashon Island, it carries SW Vashon Hwy over Judd Creek. It is a concrete hollow-box (box girder) bridge designed by Homer M. Hadley. Designated in 2004.

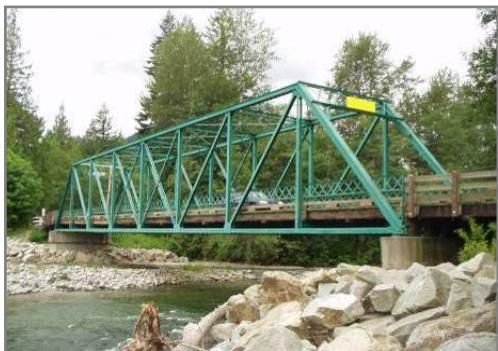
### Miller River Bridge No. 999W

Built in 1922, it carries the Old Cascade Scenic Highway over Miller River. This riveted Pratt truss is located near the community of Skykomish. Designated in 1999.

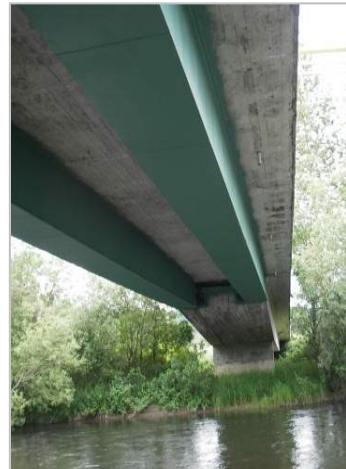
### Patton Bridge No. 3015

Built in 1950, spanning the Green River in the vicinity of Auburn. A rare and early example of innovative structural design associated with Homer M. Hadley. In 1995, the Patton Bridge was listed in the National Register of Historic Places and the Washington Heritage Registry.

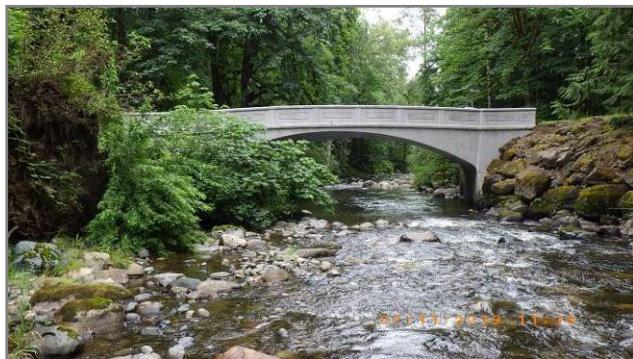
### Raging River Bridge No. 1008E

Built in 1915, this bridge spans the Raging River between the communities of Fall City and Preston. It is a concrete earthen-filled arch structure, originally built to carry the Sunset Highway across the Raging River. Designated in 1997.

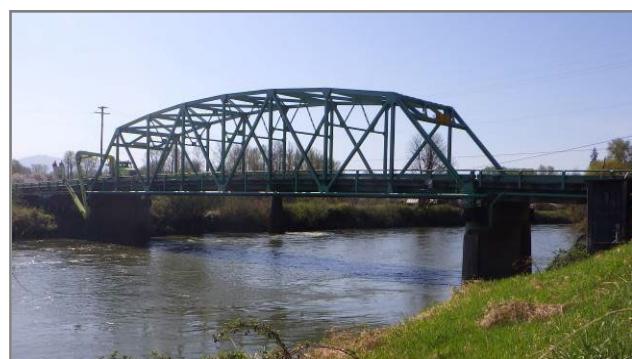
### Stossel Bridge No. 1023A

Built in 1951, spanning the Snoqualmie River, this riveted Warren truss is located north of the community of Carnation. Listed on the Washington Historic Registry in 2002. Designated in 1997.
