LEESA MANION (she/her)  
PROSECUTING ATTORNEY

Memorandum regarding Seattle Police Department case # 2023-22231

The **ACES**  
The Accredited Collision Examination Specialists Inc

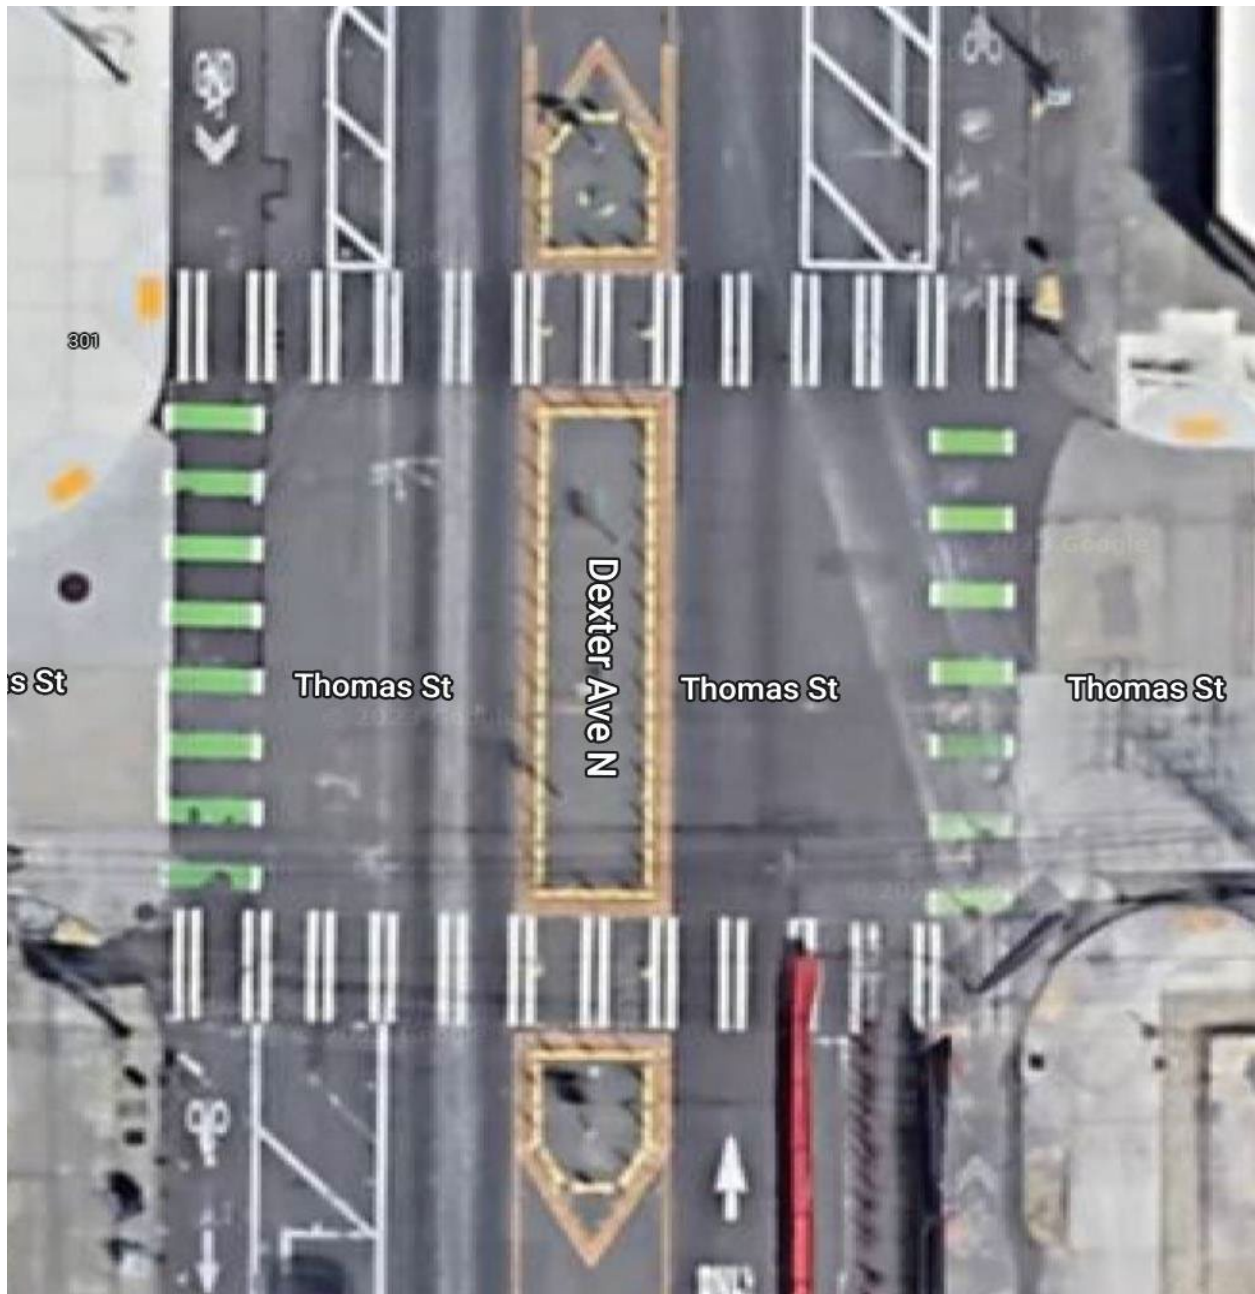
(both sidewalk, bike, and parking lane), as the road approached Thomas Street was closed due to construction. The construction zone on Dexter Avenue North was marked off with concrete jersey barriers that were placed along the fog line. The image below depicts an overhead Google map. On the map, north is located at the top, and the concrete jersey barriers are identified in red.

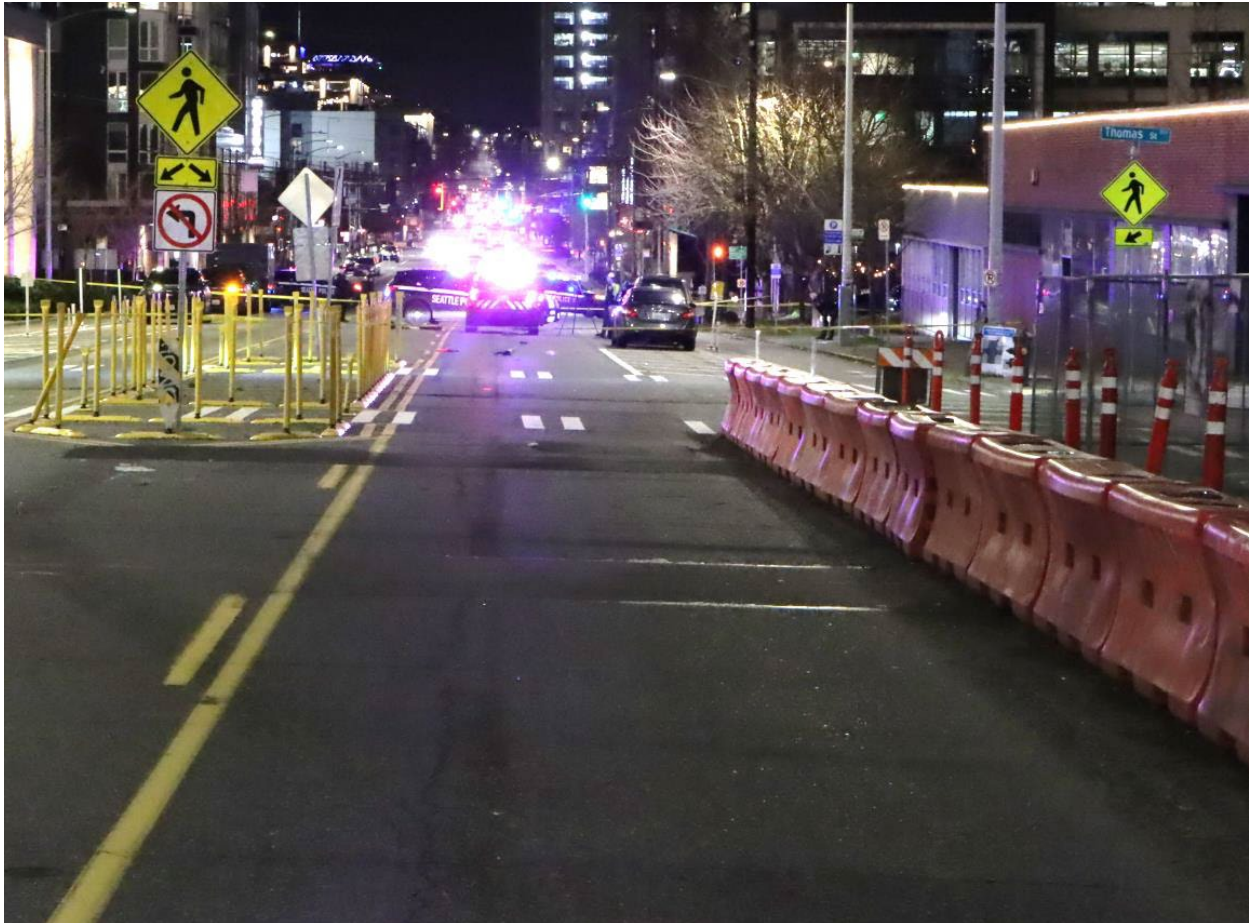
The following image depicts Dexter Avenue North looking northbound to the intersection with Thomas Street. The lighting conditions depicted in the image below are brighter than the actual lighting conditions at the time of the collision events.

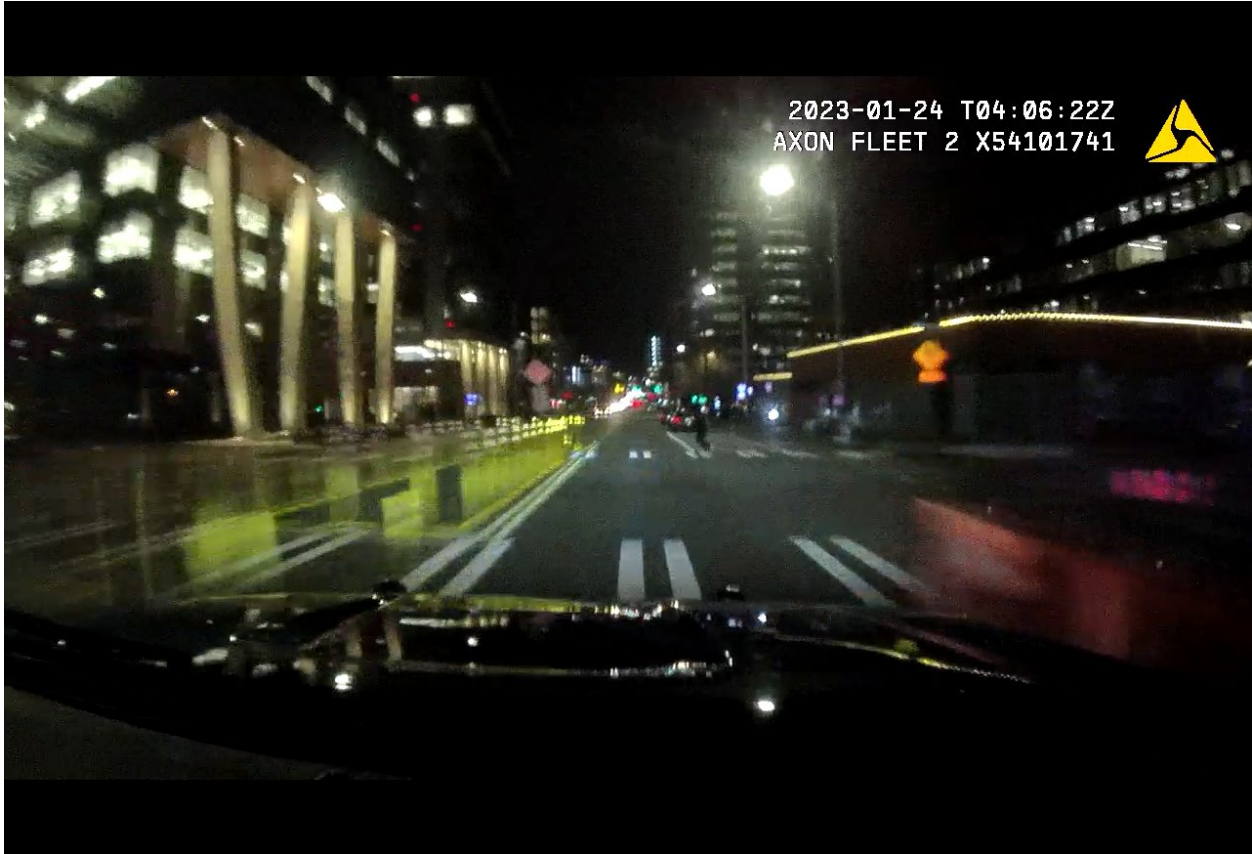
The ICV also shows that Ms. Kandula appears to realize that the patrol vehicle was rapidly approaching just as she was a few steps from the inside lane. Ofc. Dave’s ICV shows that Ms. Kandula changed her walk into a run, and she appeared to start to run across Dexter Avenue North while she was still within the outside lane.

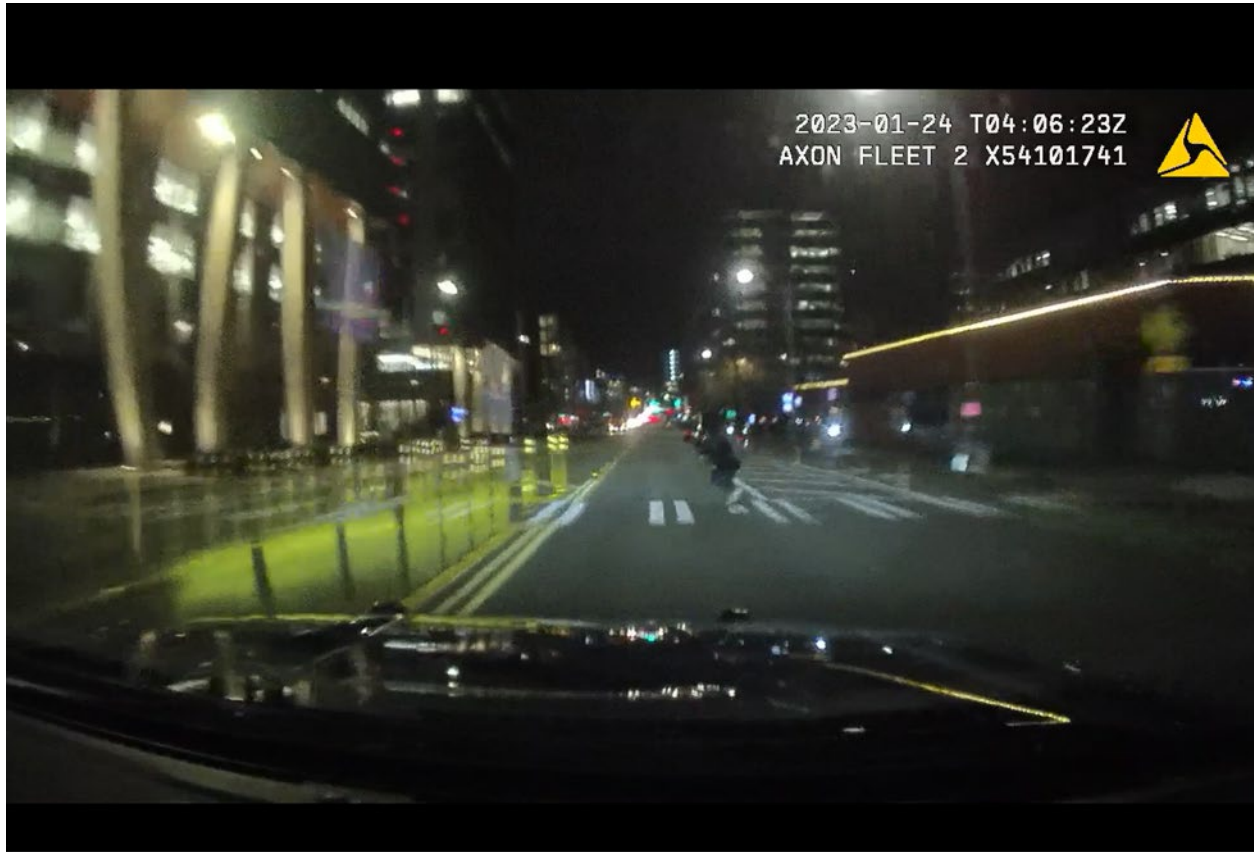
Ms. Kandula was attempting to run across the inside lane of Dexter Avenue North before the patrol vehicle crossed Thomas Street, but she was struck by the patrol vehicle before reaching the other side.

Ofc. Dave was unable to stop the patrol vehicle in time to avoid a collision with Ms. Kandula. Ms. Kandula was struck by the patrol vehicle. The front passenger side of Ofc. Dave's patrol vehicle collided with Ms. Kandula. At the time of the collision, the patrol vehicle's speed was reduced to 63 mph. The damage to the patrol vehicle (which appears as a diagonal dent along the hood of the vehicle) is consistent with the type of damage that would occur if the patrol vehicle collided with Ms. Kandula while she was running.

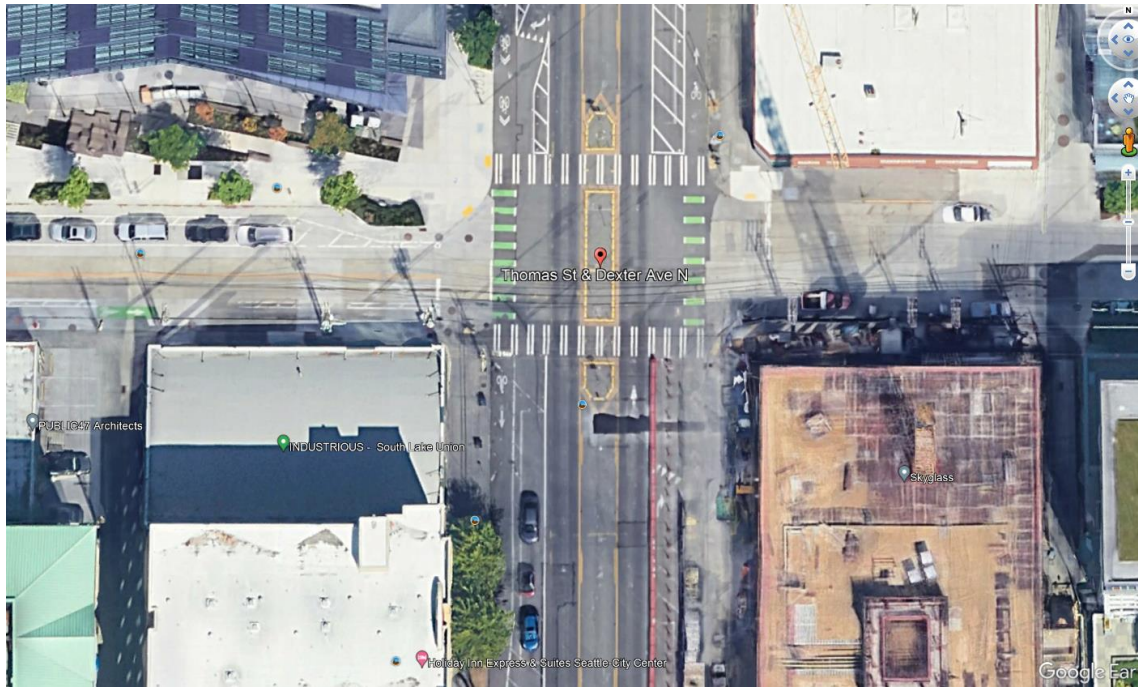
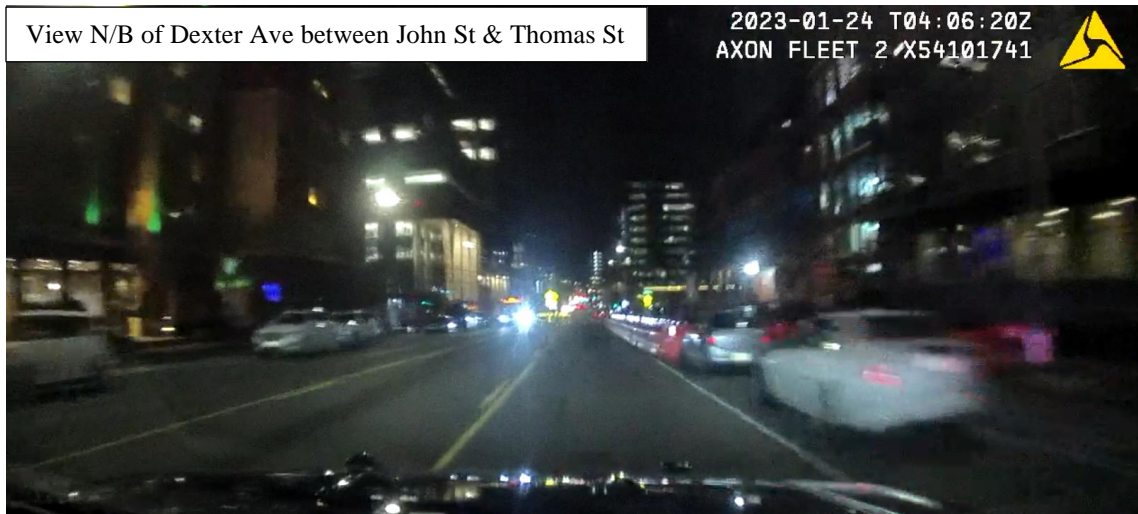
View N/B of Dexter Ave at Thomas St

There were two marked crosswalks at the intersection of Thomas St. One was on the south side and the other was on the north side of Thomas St. These were identified by solid white lines painted on the roadway in the standard configuration. There were also signs in the middle of the roadway noting the presence of a crosswalk. There were streetlights on the northeast and northwest corners of the intersection. There were no traffic control devices for northbound or southbound vehicles. Pedestrians crossing Dexter Ave N had no traffic control devices at this intersection.

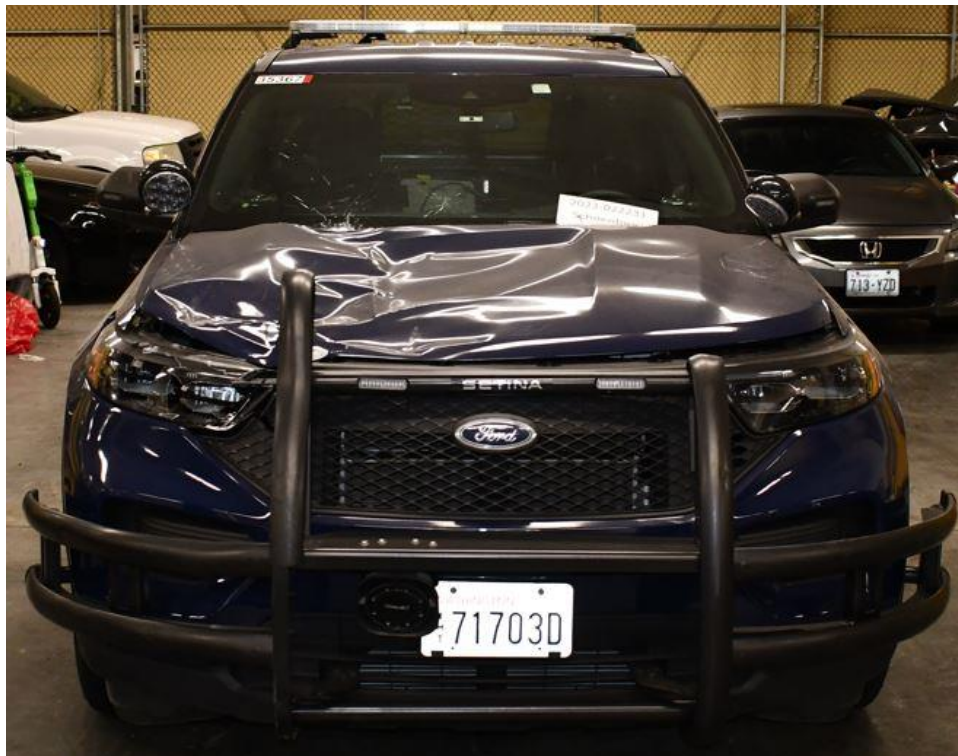
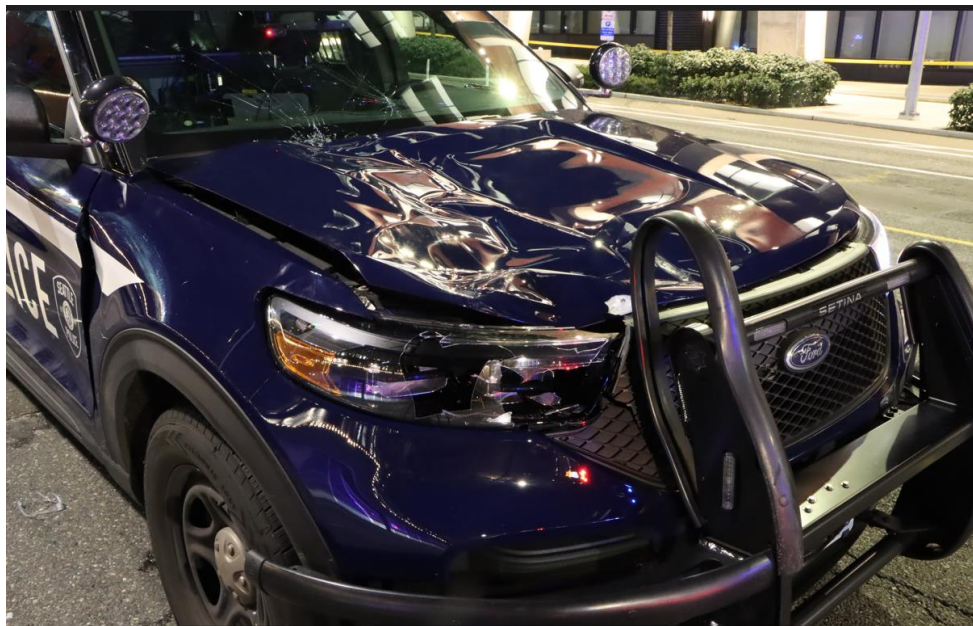
Detective Schoenberg reported that the Ford was in the northbound lane of Dexter Ave N where it had come to a controlled stop. The engine was still running, and its overhead lights were still activated. The In-Car Video (ICV) system's forward-facing camera had a red intermittent flashing LED light indicating that it was still recording. The driver's side headlight was still illuminating and appeared to be operating normally. The passenger side headlight was not illuminating and appeared to have collision related damage.

The push bar and fender guard created the leading edge of the vehicle. There was contact damage to the right front push bar. The right push bar was bent rearward and upward. There was contact damage on the right front corner of the hood. The damage pattern continued rearward to the base of the windshield. The windshield was broken in two spots. There was a break at the base of the windshield at the end of the hood damage, somewhat in line with the right front occupant area. The second break was a few inches up from the base of the windshield and just to the right of center. There was induced damage to the front passenger side door and the passenger side front fender had damage to it. No airbags deployed inside the patrol car.

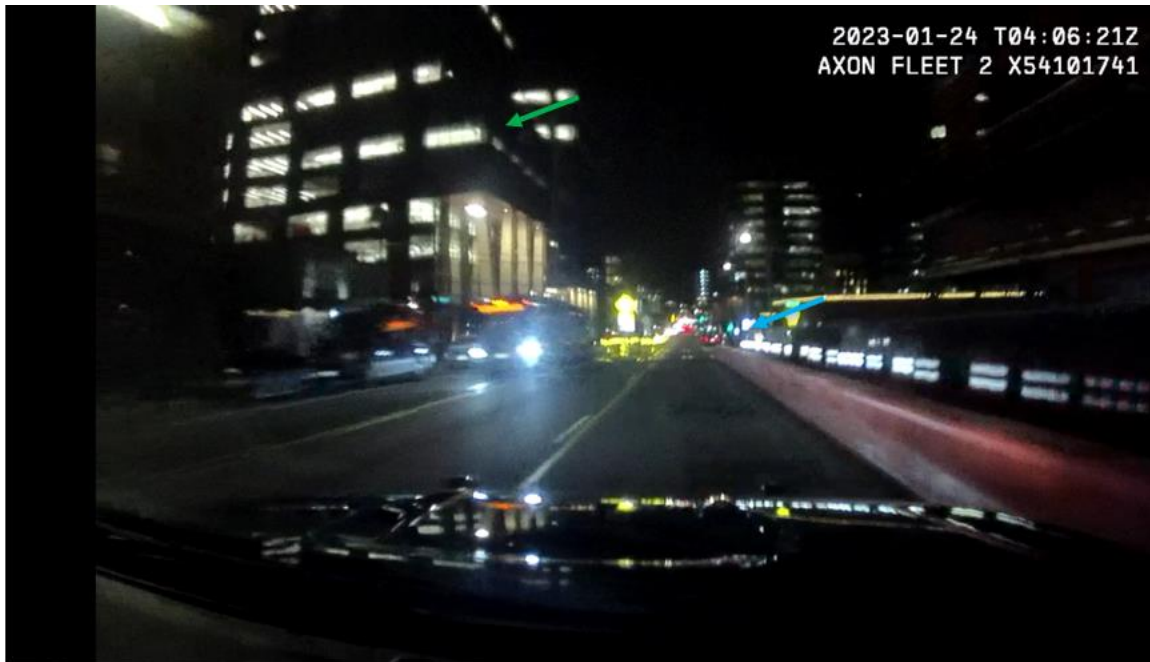
As the patrol car is approaching Thomas St, Officer Dave has accelerated up to what appears to be 69 MPH according to his speedometer (yellow circle) at about 2:04 minutes into the dash cam video and 2:03 minutes into the body camera video. You can see the dark silhouette of the pedestrian (blue arrow) on the right side up at the intersection. The pedestrian is moving westbound. The building (green arrow) on the left is used as a fixed point to help place the two videos at about the same location. There is a construction zone consisting of a row of orange cones and fencing to the right of the patrol car. The patrol car has emergency lights activated with no siren and is still accelerating.

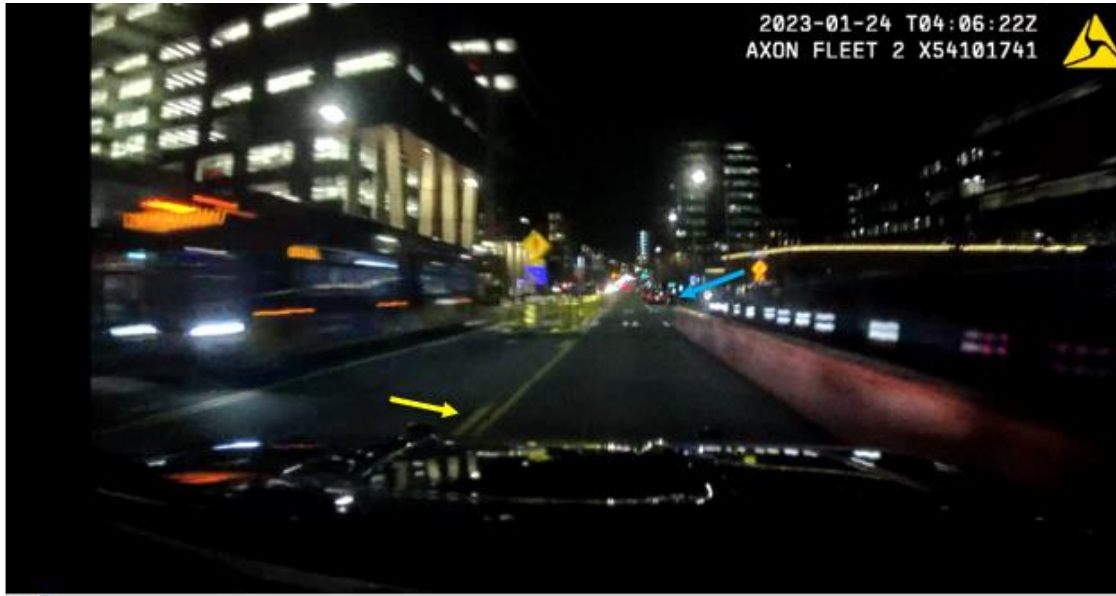
In the snapshot below, the patrol car is approaching the yellow center divider. The patrol car is near the second yellow dash centerline (yellow arrow). You can see the silhouette of the pedestrian (blue arrow).

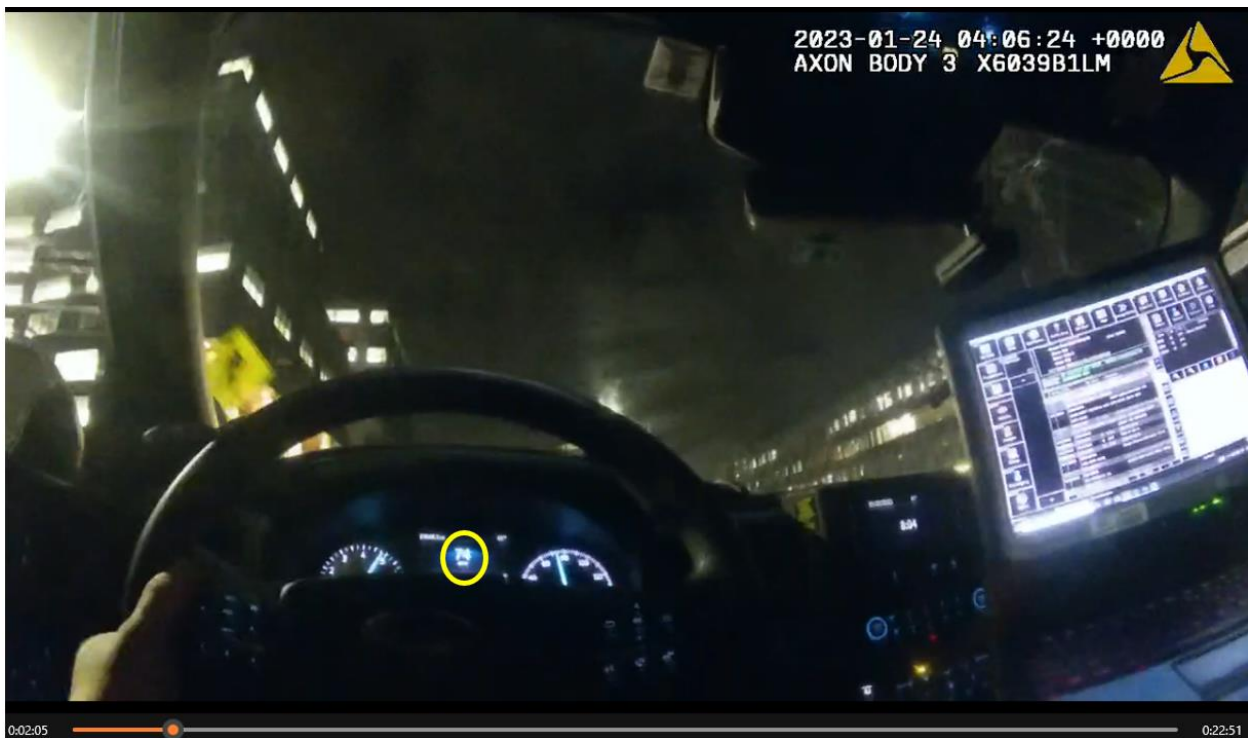
As the patrol vehicle is approaching Thomas St, Officer Dave has accelerated up to 74 MPH according to his speedometer (yellow circle) at about 2:05 minutes into the body camera video.

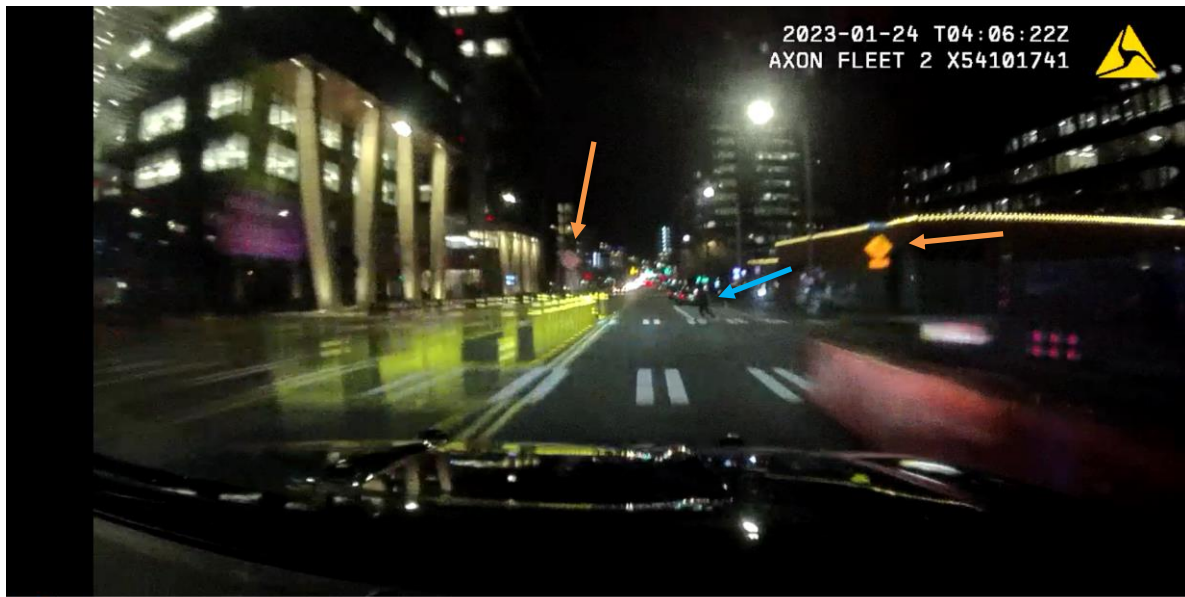
In the snapshot below, the patrol car is approaching the yellow center divider. You can see the yellow pedestrian signs (orange arrows) at the center divider and to the right side. You can see the dark silhouette of the pedestrian (blue arrow), in the crosswalk and about to enter the northbound lane walking westbound at about time stamp 04:06:22Z. The patrol car has

emergency lights activated and as the patrol car reaches the area of the south crosswalk, you can hear the siren come on and stay on until impact.

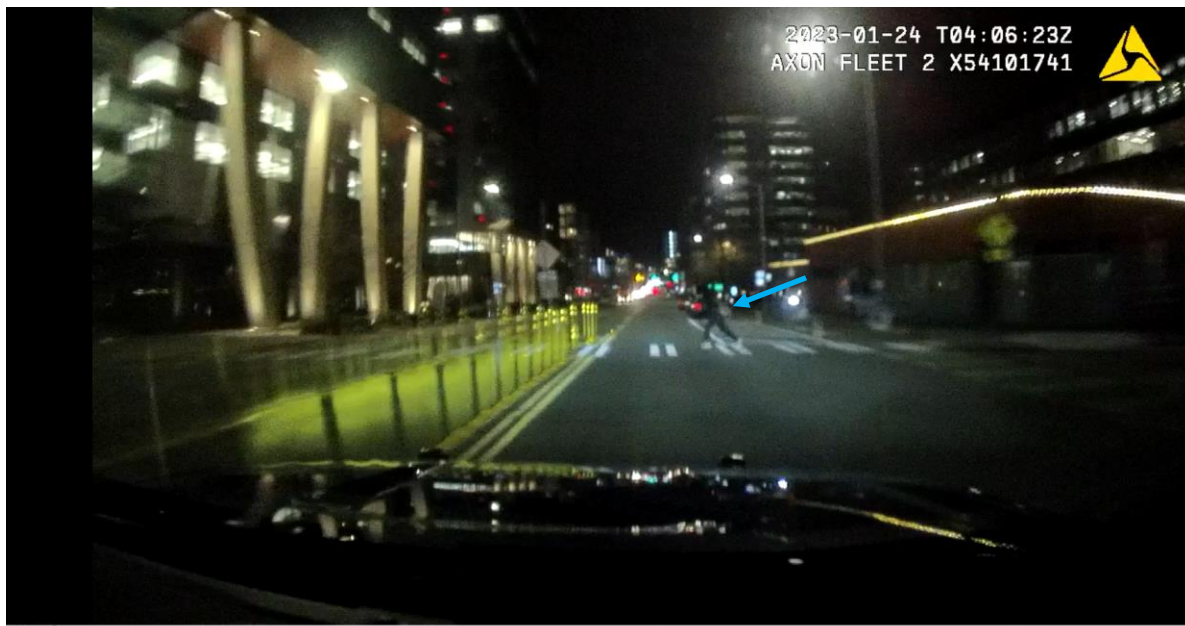
It is also at about time stamp 04:06:22Z, as Ms. Kandula reaches the area of the solid white fog line for the northbound lane, she starts running westbound into the northbound lane directly in front of the patrol car and she is subsequently impacted.

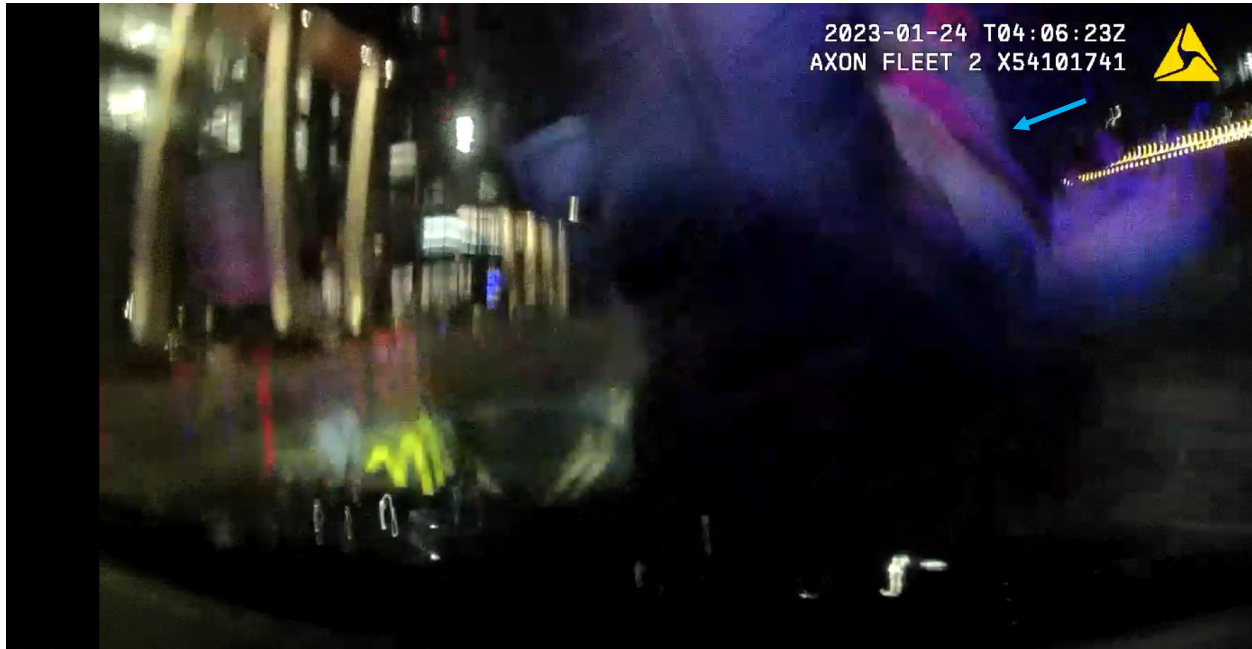
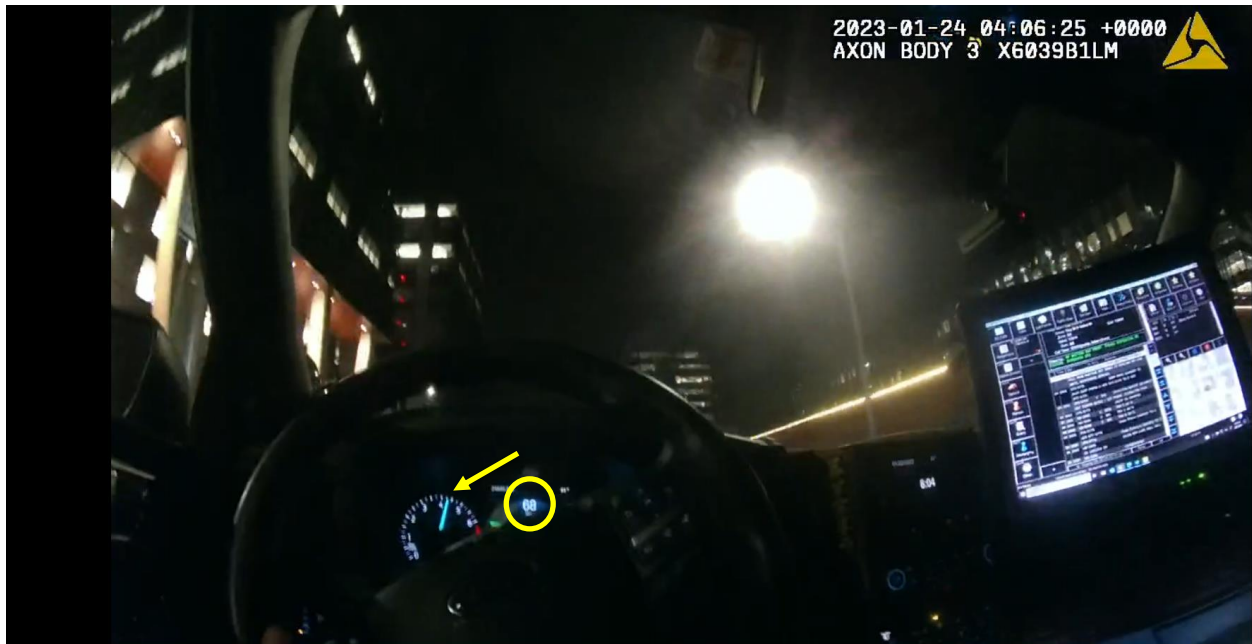
The patrol continues to slow rapidly to a stop. Ms. Kandula is at final rest in the center two-way turn lane adjacent to the patrol car in the northbound lane.

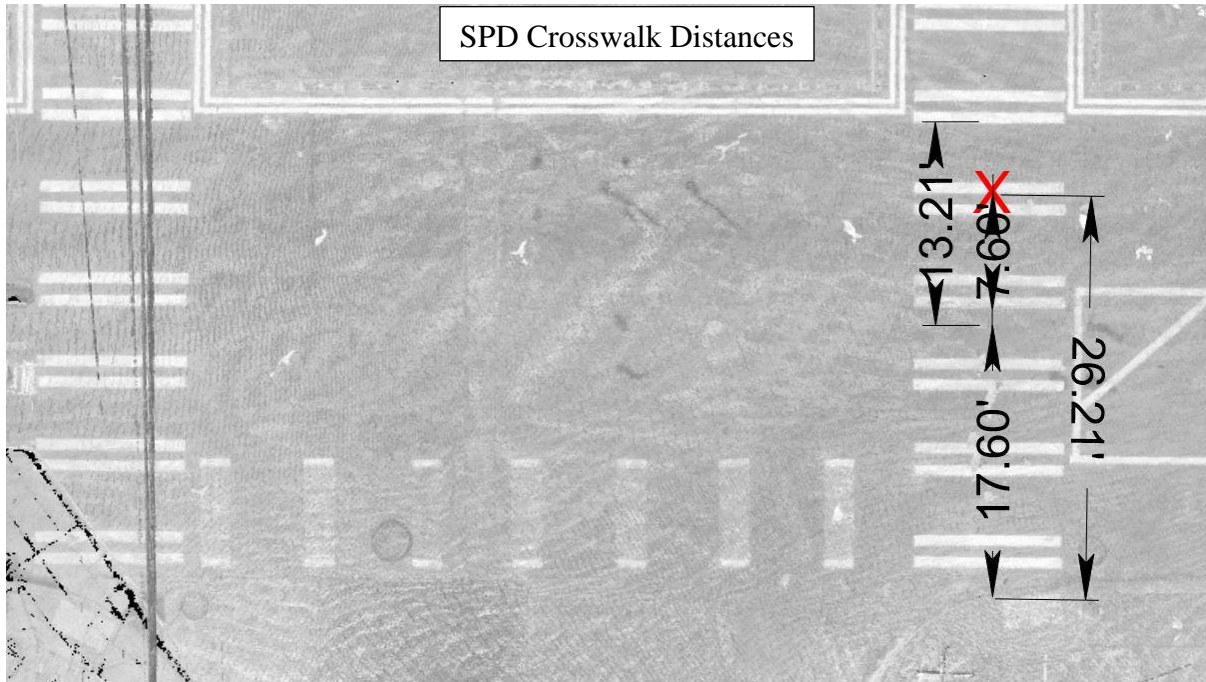
Detective Schoenberg calculated Ms. Kandula's running pace over a distance of 7.6 feet. In the paragraph (pg.34) he typed 18.7 feet from the east curb as the start of Ms. Kandula's running. In his math and in the screenshot of the diagram the distance was 18.5 feet. I believe the 18.7 feet is a typo, not 18.5 feet. Detective Schoenberg calculated a running pace of 8.44 fps (5.75 MPH). The 8.44 fps run pace is below the 15<sup>th</sup> percentile (9.2 fps) for someone in Ms. Kandula's age group. Ms. Kandula was likely still accelerating when she was struck. The sample distance of 7.6 feet is short, but it is the only evidence. Detective Schoenberg's use of 8.44 fps is reasonable and appropriate.

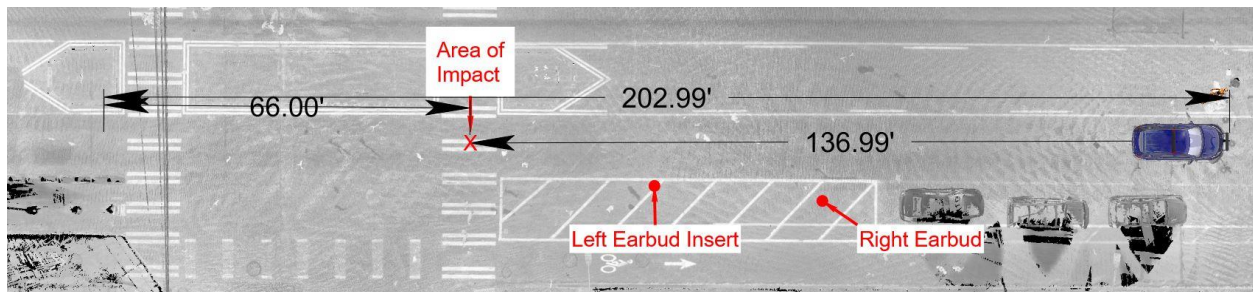
I measured the stopping distance at 203 feet.

If the patrol car was travelling at 72 MPH at the start of braking, then the drag factor would have been .851g or 27.41 fps<sup>2</sup>. Using the drag factor of .851g, then the speed of the patrol at the start of braking was 73.77 MPH. The analysis based on our distances, supports Detective Schoenberg's patrol car speeds.

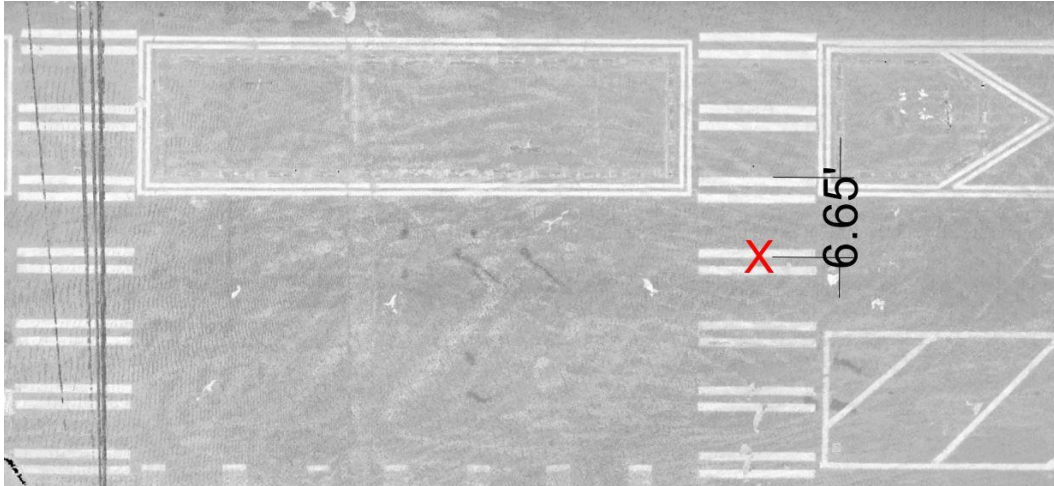
There would have been an additional .665 seconds (1.34 sec -.675 sec) for Ms. Kandula to travel towards the traffic island if the patrol car had been travelling at 50 MPH at the start of the collision sequence. Ms. Kandula was likely travelling between 8.44 fps and 11.6 fps during her run portion. Ms. Kandula would have covered between 5.61 to 7.71 feet, approximately 6.6 feet with the additional .665 seconds. Ms. Kandula would have likely reached the center traffic island.

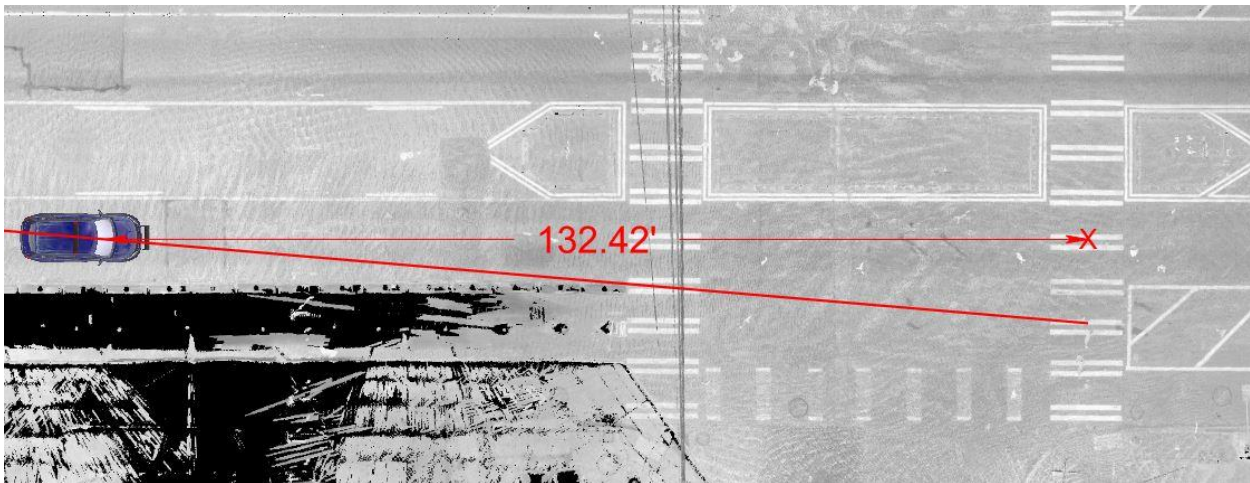
Using the patrol car's ICV Ms. Kandula became recognizable as a pedestrian about the time she was standing on the third crosswalk painted line. The patrol car was between 130 to 135 feet away from the point of impact.

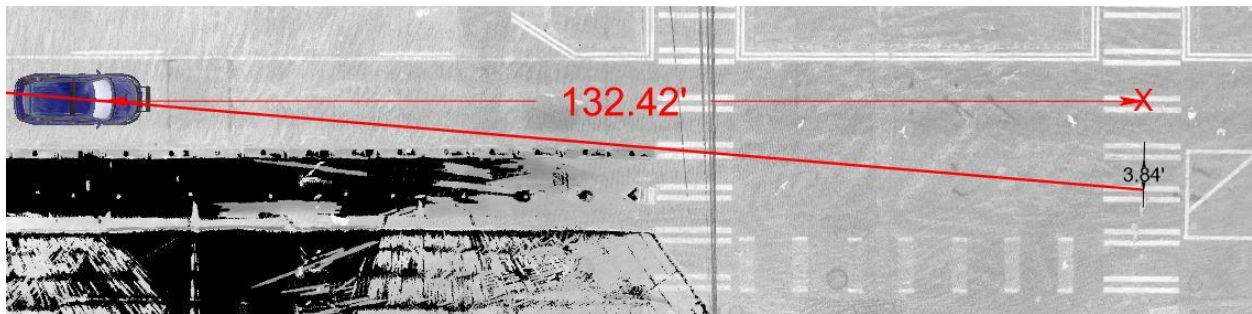
The reverse argument is also true. When the patrol car was 130 to 135 feet away from impact, Ms. Kandula had not yet entered the northbound lane. Ms. Kandula could have also seen the approaching patrol car. Ms. Kandula was still walking when she was crossing the third painted crosswalk line. Assuming she also needed 1.3 seconds to perceive and react to the patrol car and

her walking pace was between 4.3 to 5.0 fps, then she would have covered approximately 3.3 to 3.8 feet during the 1.3 seconds.
