Subject: North Beach Force Main Evaluation

**TETRA TECH, INC.
KING COUNTY WTD
NORTH BEACH FORCE MAIN
CONDITION ASSESSMENT PROJECT
FINAL REPORT**

Norton Corrosion Limited (NCL) was retained by Tetra Tech, Inc. to assist with a condition assessment of King County WTD North Beach Force Main located in Seattle, Washington. NCL developed an inspection/sampling program to be conducted at select excavation sites with field activities to collect necessary data and laboratory analysis to support formation of a professional opinion on present conditions. Authorization was by Consulting Services Agreement dated September 5, 2012. The field portion of the inspection/sampling occurred during the week of August 17, 2012.

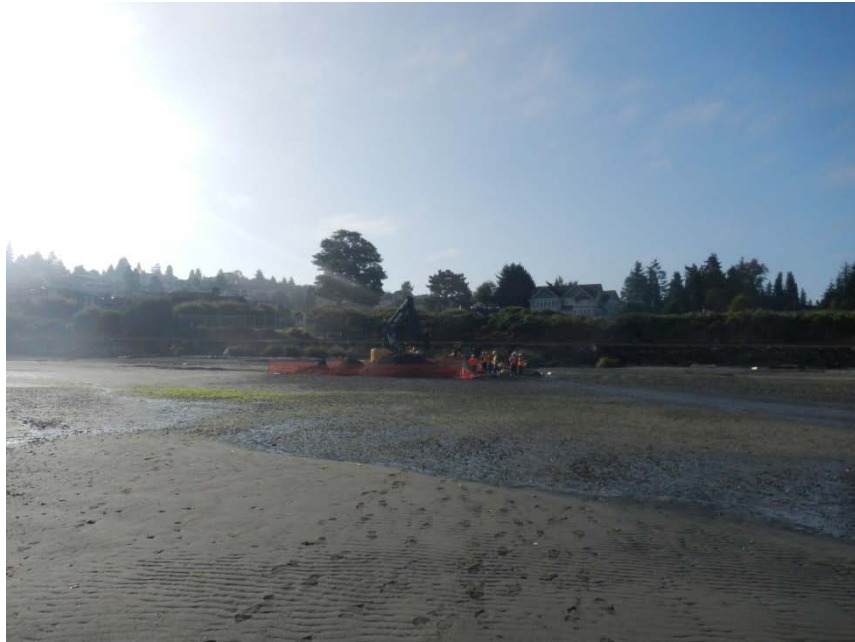
Picture 1-1: General Overview of Excavation

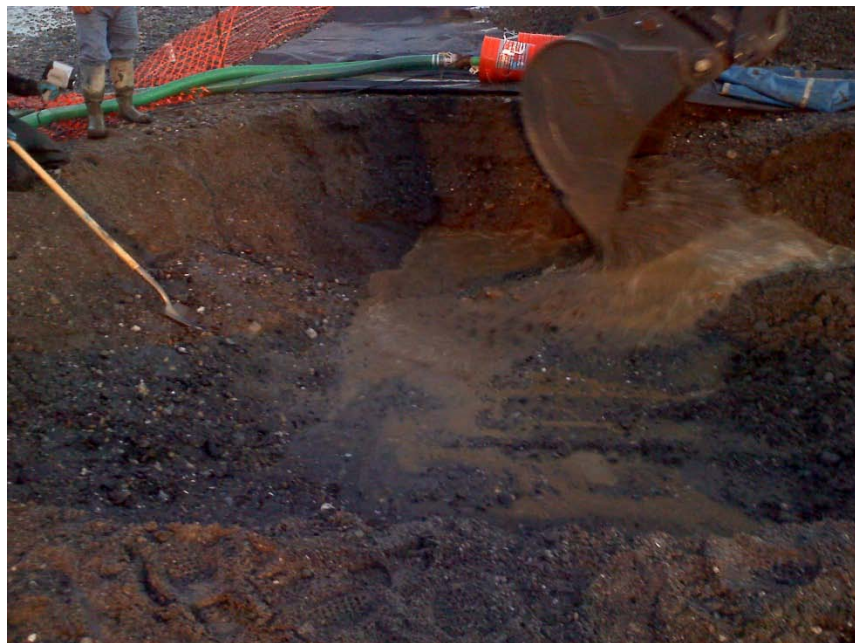
Picture 1-2: Excavation at Beginning Stages Depicting Water Level

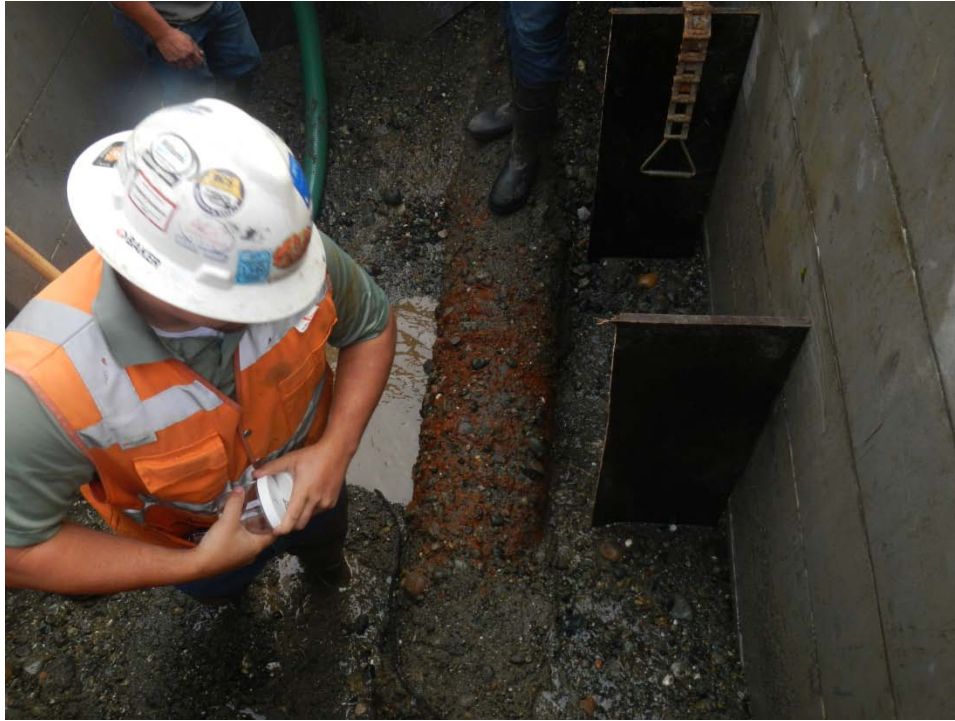
Picture 1-3: Pipe with Carbonation Layer Intact

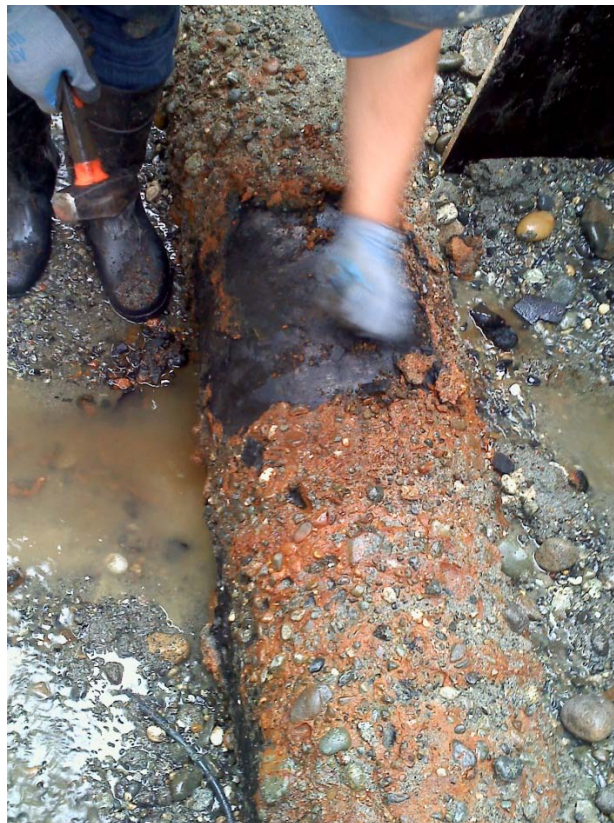
Picture 1-4: Carbonation Layer Removed to Bare Pipe Surface

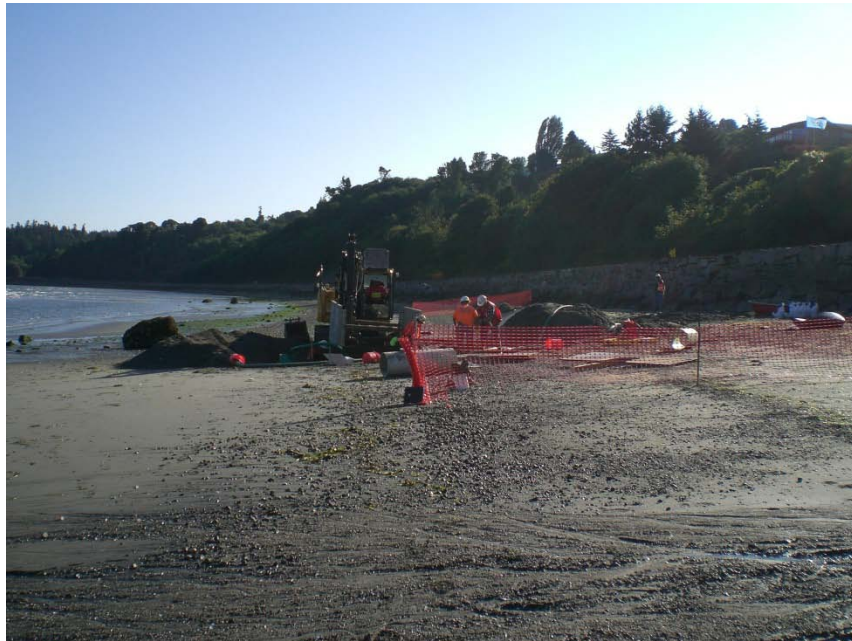
Picture 2-1: General Overview of Excavation

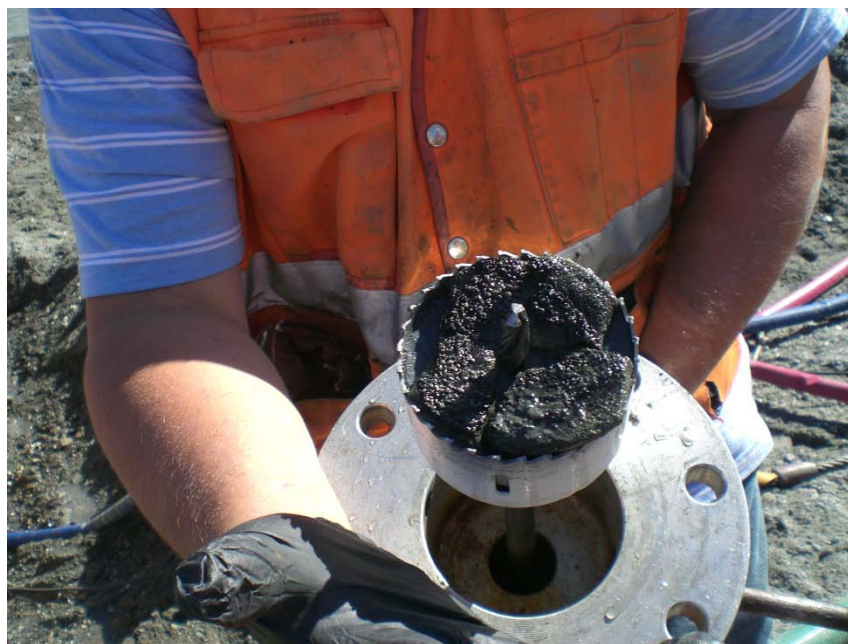
Picture 2-6: Tapping Machine with Coupon Inside
& Concrete Lining
(This is the only sample that retained the concrete lining.)

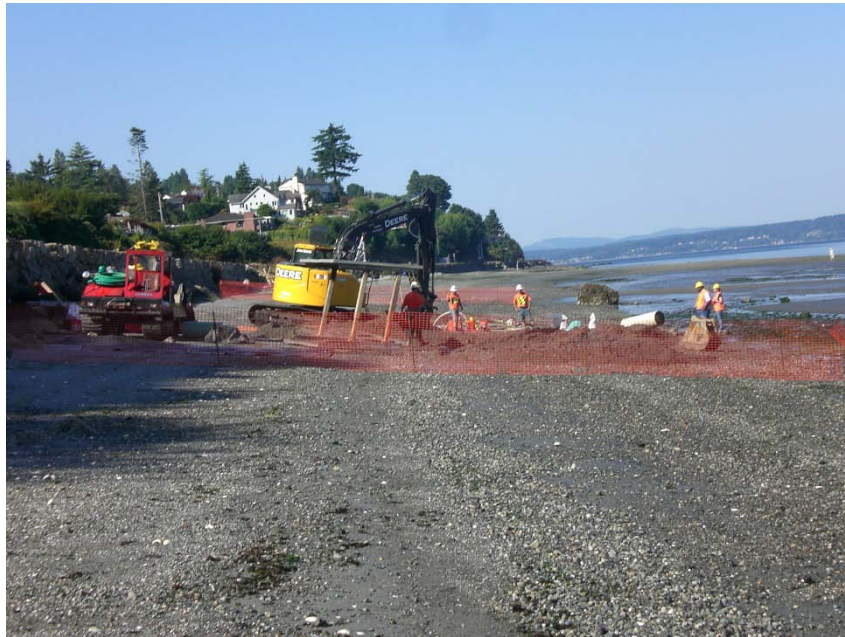
Picture 3-1: General Overview of Excavation

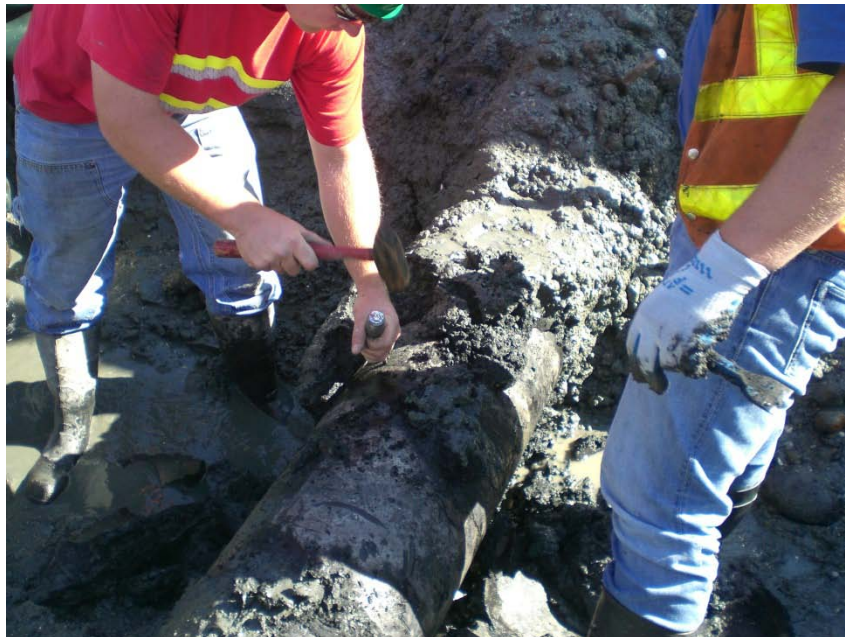
Picture 3-2: Pipe Surface Visible while Tapping Crew Removes Carbonation Layer

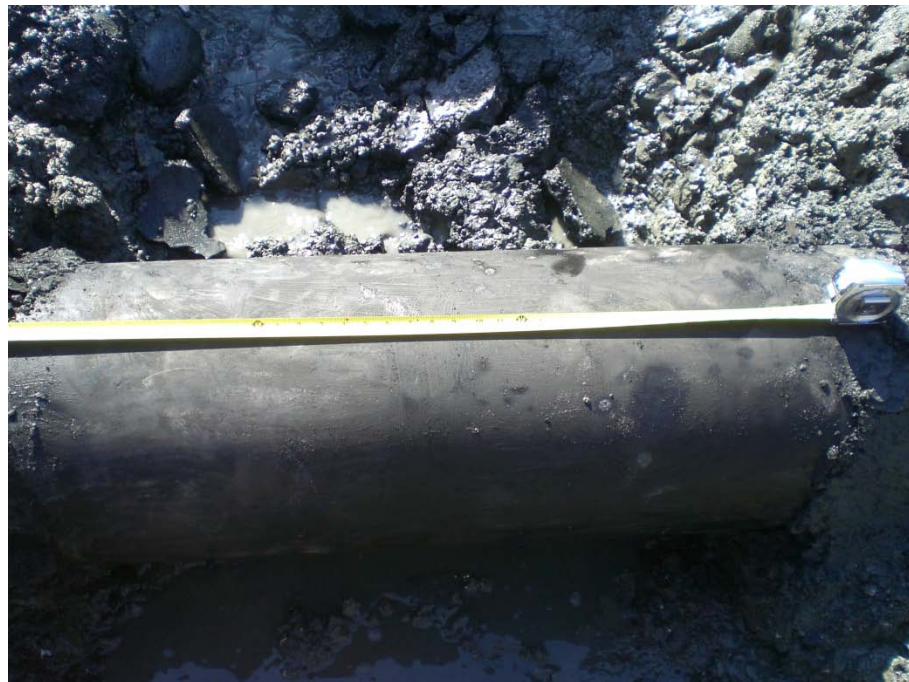
Picture 3-4: General Profile of Cleaned Pipe

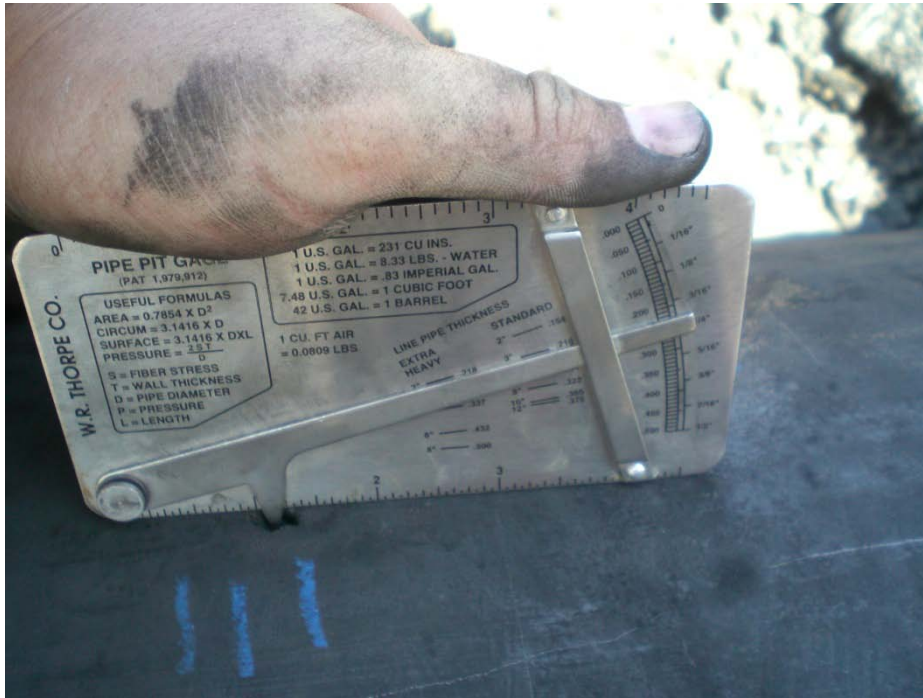
Picture 3-5: Depth of Pit 3

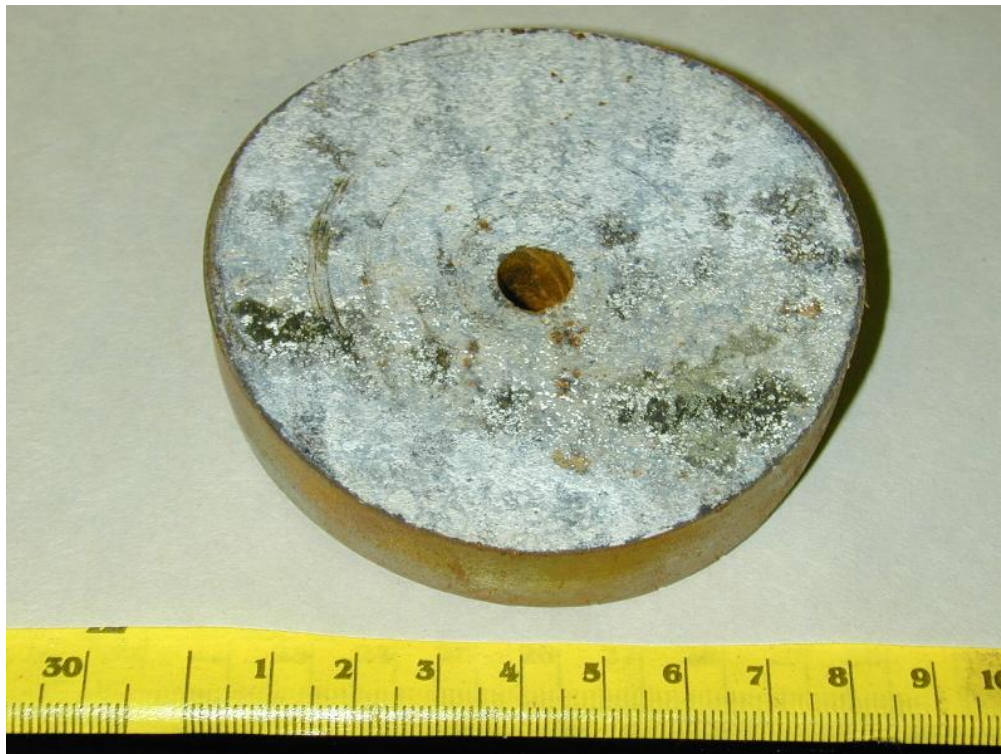
Fig. 2: Overall view of the ID of sample #1. Note, the white material is residue from the concrete liner.

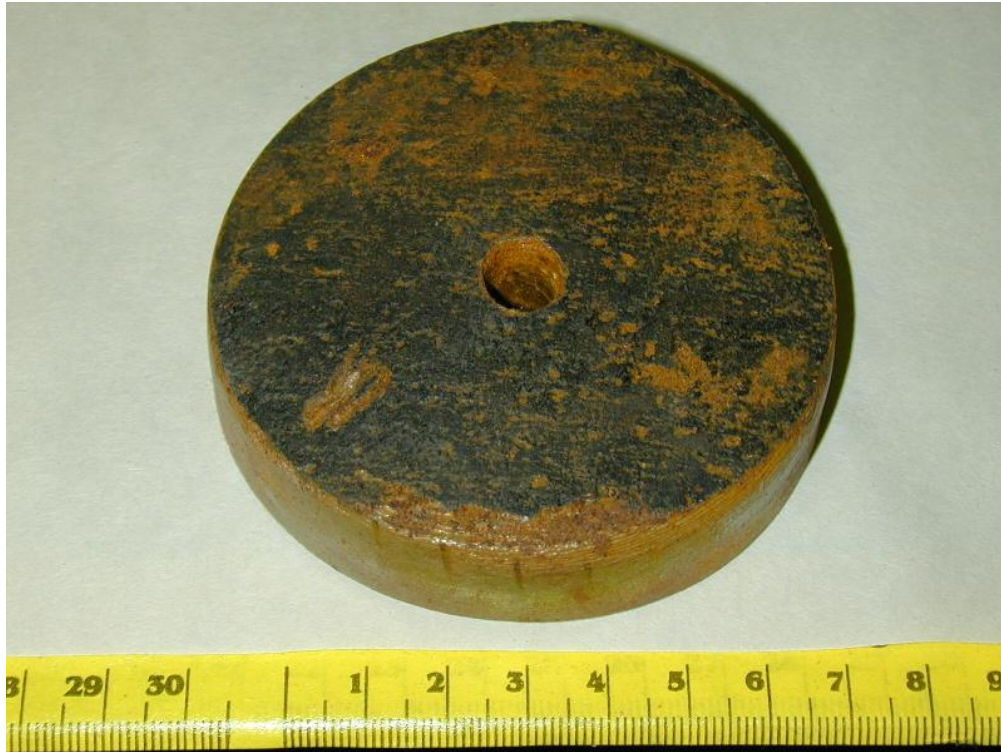
Fig. 3: Overall view of the OD of sample #1.

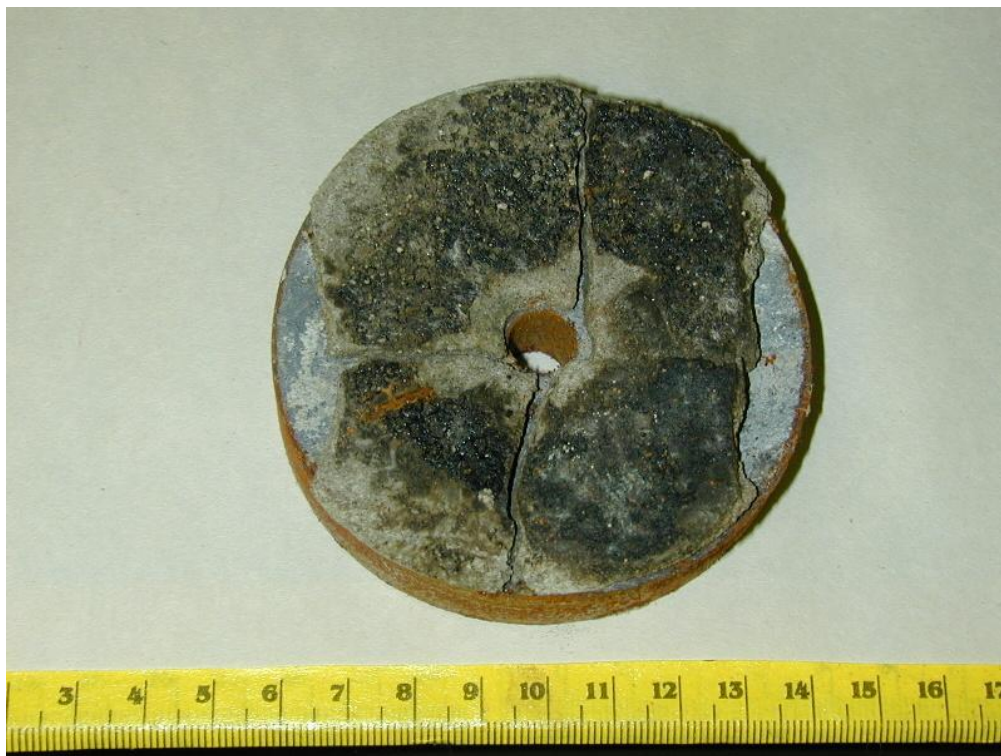
Fig. 4: Overall view of the ID of sample #2. Note, the tar (asphalt) coated concrete was retained with this sample.

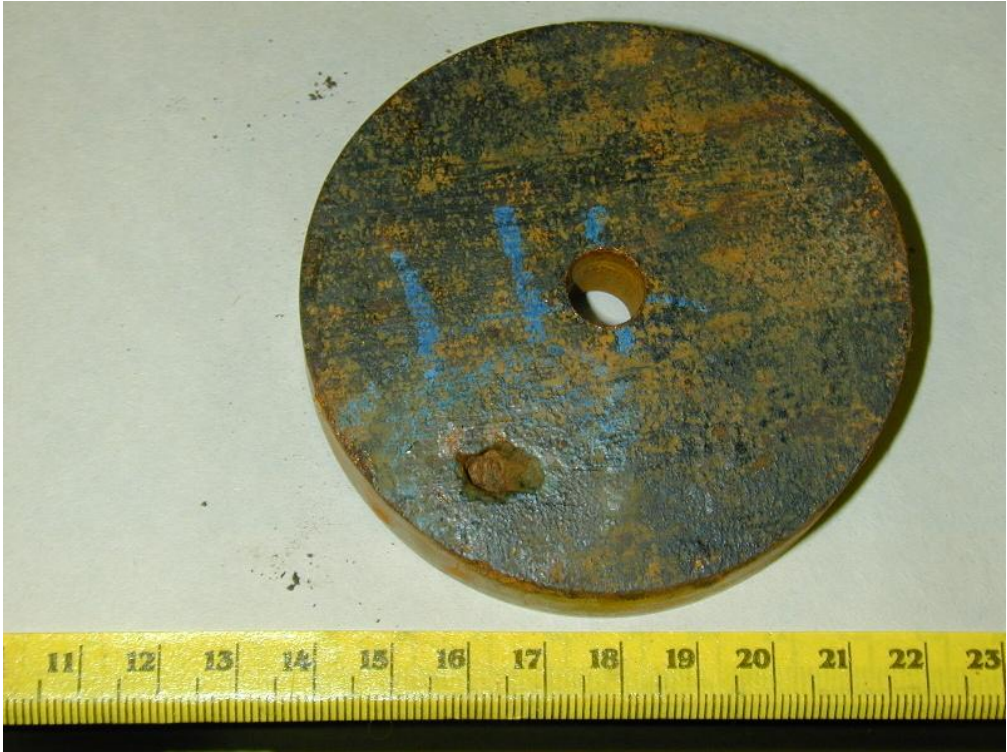
Fig. 8: Overall view of the OD of sample #3.

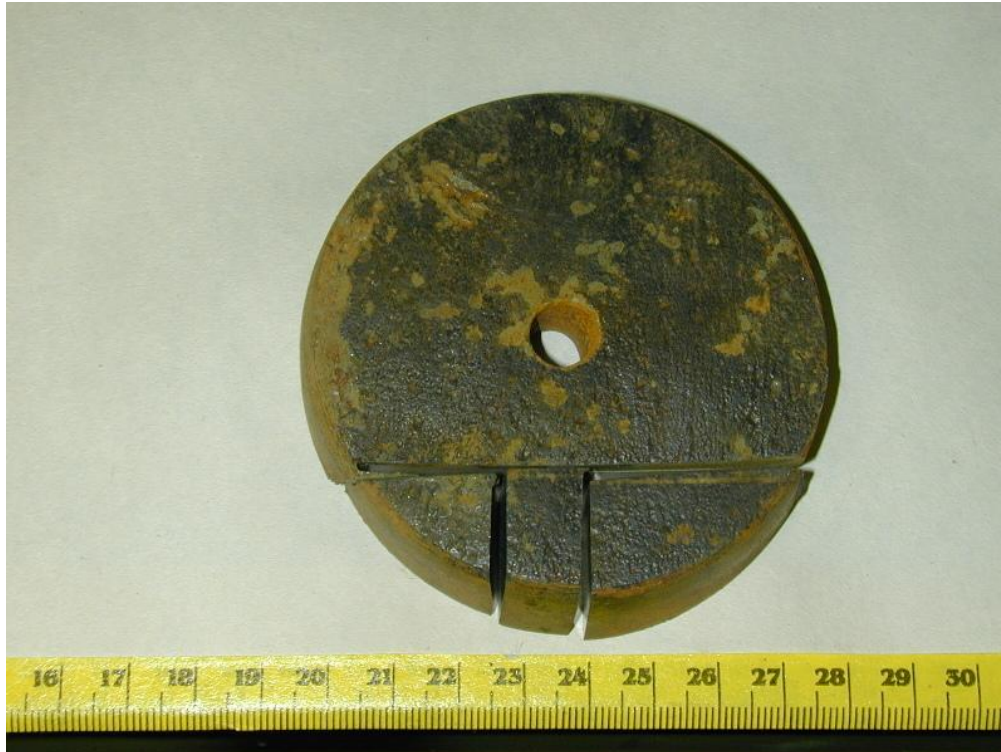
The coupons were then sectioned and mounted to better examine the extent and depth of corrosion (Figures 17 to 26).

Fig. 17: Overall view of sample #1 after sectioning for metallurgical examination.

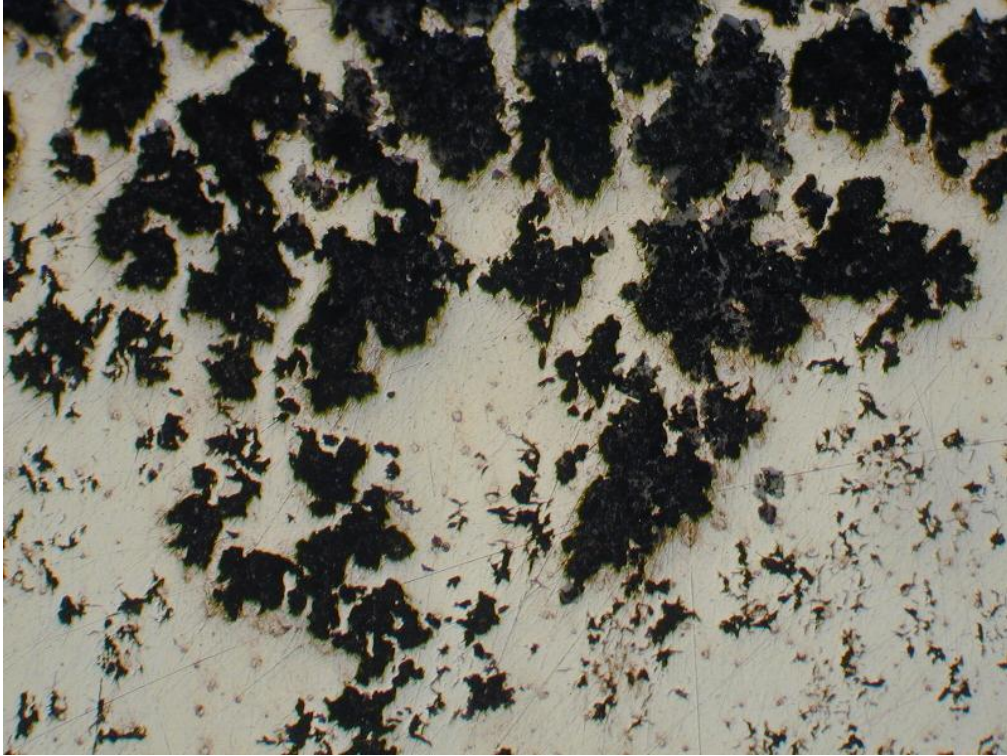
Fig. 35: 100x view of Fig. 33 at the deepest area of corrosion.
