Technical Information Report

Reserve Inert Waste Landfill Expansion Project

DRAFT
February 28, 2025

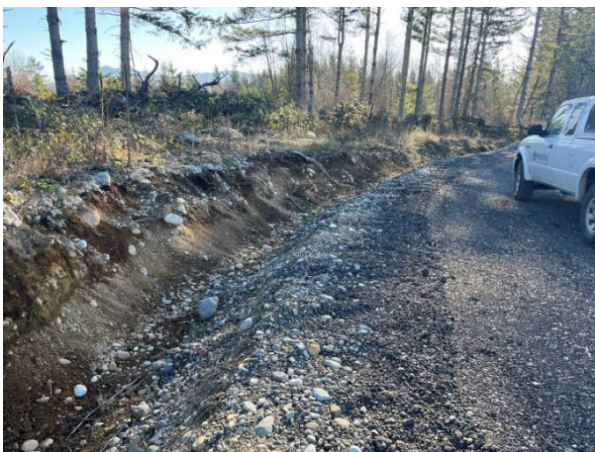
Figure 1. Eastern Boundary of TDA 1.

View: Looking south along eastern side of eastern haul road (upper arm)

Other notes: Ditches look recently maintained. Ditch typically has a 6' top width, 2' bottom width, and 1.5' depth. Rock edge treatment along ditch appears to prevent road runoff into ditch.

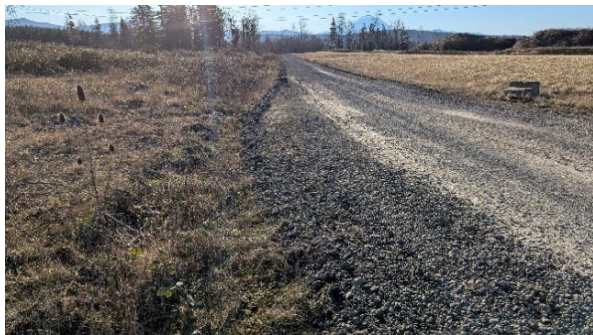
The team's observations confirmed the presence of intermittent roadside ditch networks along the eastern main haul roads draining south (Figure 15). The team located a culvert draining east under main haul road appears to collect runoff from Dale Strip Pit area (Figure 16). Ditches were observed downstream of the culvert (Figure 17) which appear to drain to a low point located on a small access road (Figure 18). The team followed the ditch flowline until the existing discharge point for TDA 2 was located (Figures 19 through 22).

View: Looking south along eastern side of main haul road.

Notes: Gravel thickened edge keeps runoff from TDA 1 separate from haul road runoff. A ditch drainage line slightly visible; may be natural forming as runoff from Area 5 drains south along the edge of the haul road.

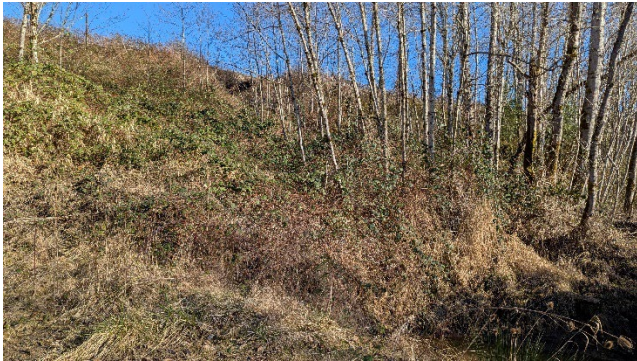
The team evaluated the downstream flow path of runoff from TDA 3 which currently drains west towards a culvert under the lower haul road which discharges to an existing interceptor swale on the downhill side of Area 1 (Figure 23). The swale discharges towards the existing Southwest Pond (Figure 24). From this pond, runoff that does not infiltrate, is dispersed into the forest to the west through rock dispersion device (Figure 25). The team also photo documented the newly constructed wetpond (West Central Pond) designed to receive runoff from the central portion of the existing inert waste landfill (Figure 26).

View: Looking northwest along the lower haul road.

Notes: A 12-inch smooth wall polyethene pipe under the haul road discharges to an existing swale.

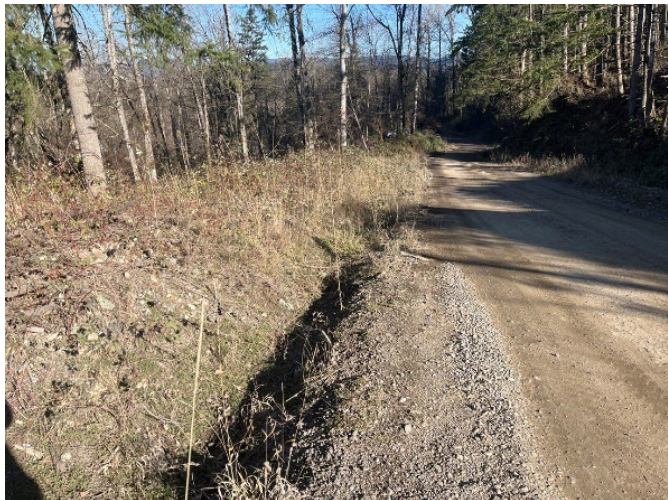
Figure 27. Roadside Ditch Network Along West Side of Main Haul Road

While following the downstream flow path of Areas 3/4, the team observed that some runoff appears to collect in ditches along the west side of the main haul road (Figure 27). However, majority of runoff from Area 3/4, along with Area 4, drains west towards an access road above the LDA where runoff is collected in ditches that convey it to the northeast. Roadside ditches continue along the east side of the upper haul road downstream of the haul road switchback, draining towards a low point east of the intersection of the lower haul road and the upper haul road in the northwest (i.e., the Y). At the low point at the Y, a culvert conveys runoff from the ditches towards forested cover to the west (Figures 28 and 29).

View: Looking north on main haul road.

Notes: Ditch geometry is similar to that on the east side of the road (as describe in Figure 27). Two ditch turnouts were observed which direct runoff west onto Area 4.

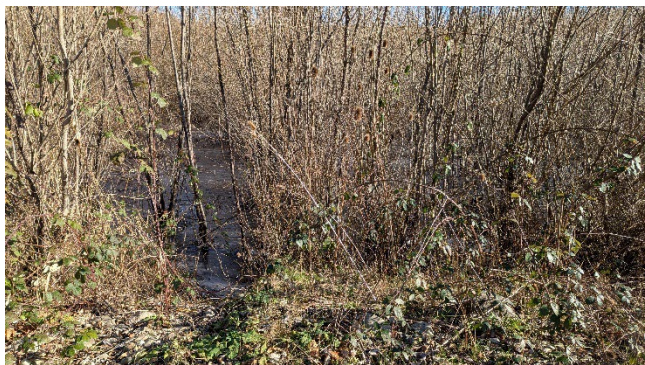
View: Looking east towards first stormwater pond cell along perimeter road.

Notes: An 18-inch smooth wall polyethylene pipe located under the perimeter road hydraulically connects the two stormwater ponds.
