# GEOTECHNICAL REPORT PHASE I—WATER DISTRIBUTION SYSTEM DESIGN

CAMP RIVER RANCH CARNATION, WASHINGTON

Project Number: PNR0776

August 15, 2024

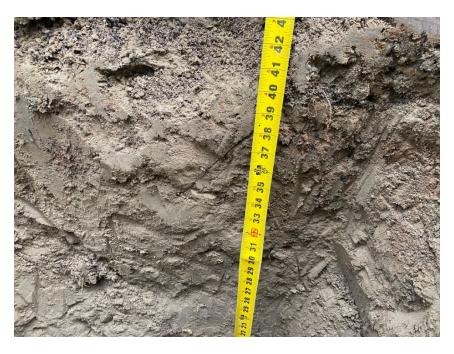
Figure 2: Wall of the Test Pit Showing Silty Sands

We performed a site visit on December 15, 2022. The site visit included a surface area reconnaissance of the proposed tank location and other geologic features of interest in the vicinity, as well as the excavation of four hand-dug, 2-to-4-foot-deep test pits. Three test pits were in the vicinity of the proposed tank location, and one was about 10 feet down the slope along the expected pipeline alignment. In each test pit, the encountered subsurface material comprised mostly homogeneous, moist, silty sands, which appeared to have increasing fines content with depth. Gravel was observed in the upper 6 inches of excavation, and a cobble was observed at the bottom of one of the test pits. In the test pit performed on the slope, the encountered subsurface materials included some fine gravels. The walls of the excavations remained generally stable during the digging (Figure 2). The holes were backfilled with the excavated materials.
