Regional Stormwater Facility

TECHNICAL INFORMATION REPORT King County, Washington

Issued: November 14, 2024

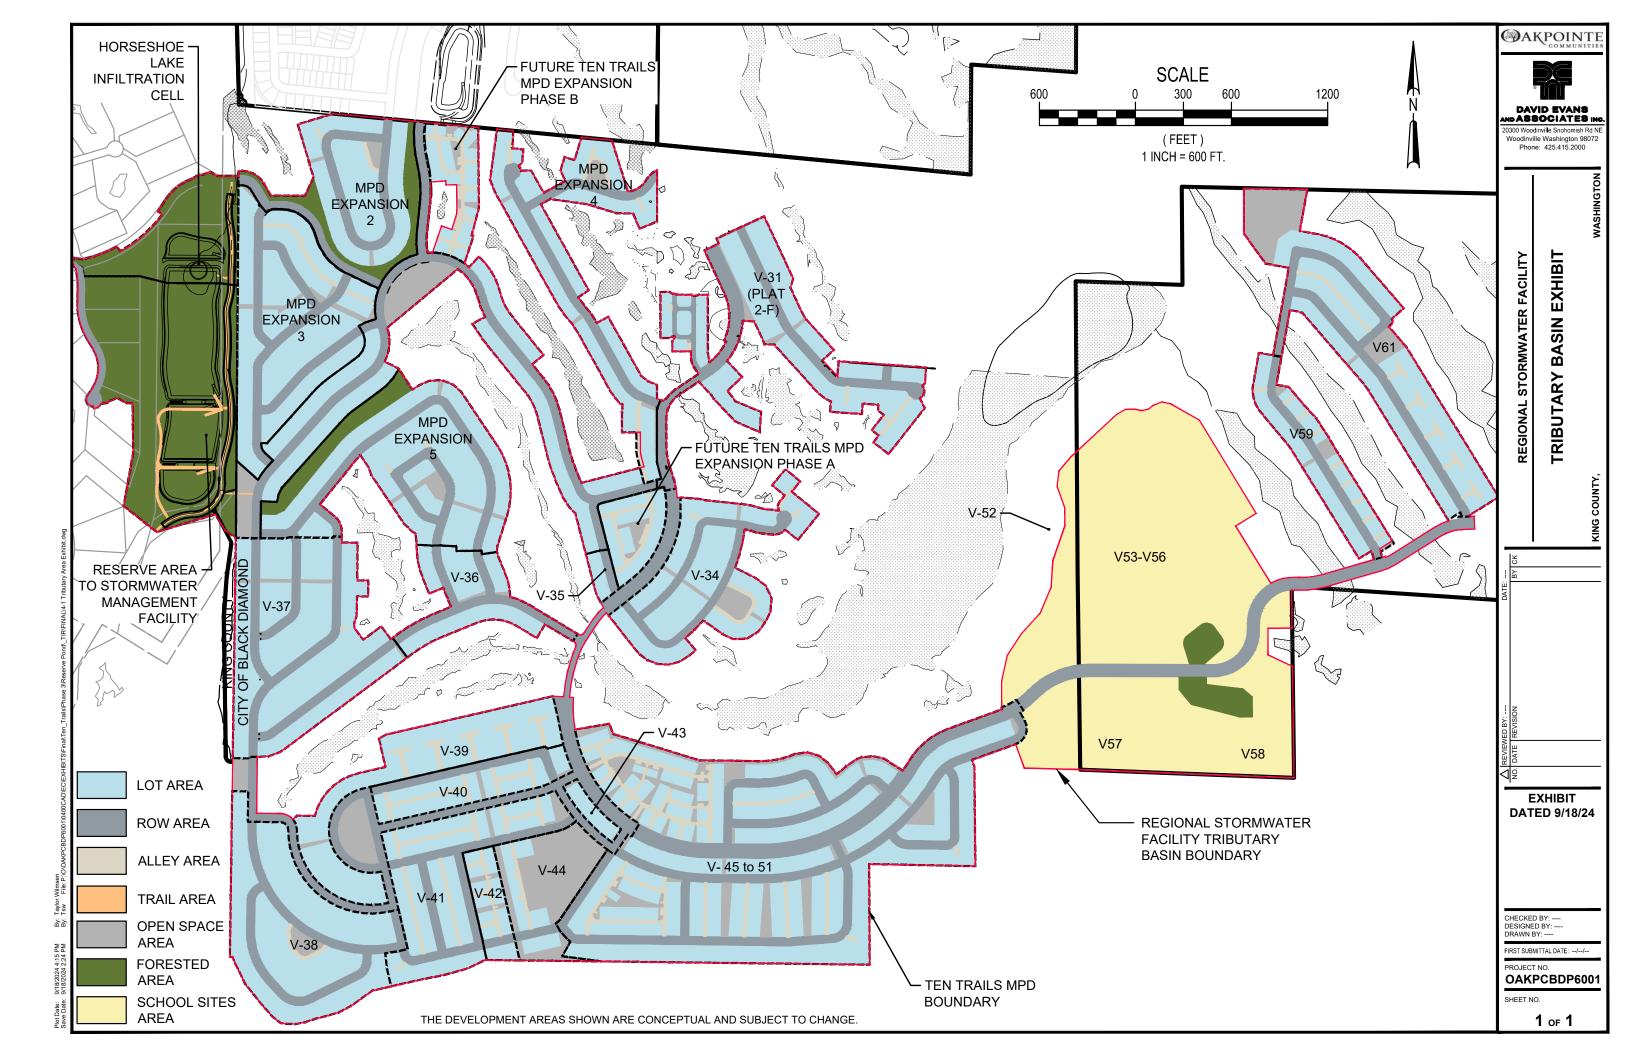
TRIBUTARY AREA TABLE

Stormwater Management Zones	Total Area (SF)	Total Area (AC)	Lot Area (SF)	Lot Area (AC)	Percent Impervious	Impervious Area (AC)	Pervious Area (AC)	Open Space (SF)	Open Space (AC)	Percent Impervious	Impervious Area (AC)	Pervious Area (AC)	ROW Area (SF)	ROW Area (AC)	Percent Impervious	Impervious Area (AC)	Pervious Area (AC)	Alley Area (SF)	Alley Area (AC)	Percent Impervious	Impervious Area (AC)	Pervious Area (AC)	Trib. Undeveloped (SF)	Trib. Undeveloped (AC)	Percent Impervious	Impervious Area (AC)	Pervious Area (AC)
Palmer Property/Offsite							·	•				-		Palm	er Property												
Palmer Property	6,112,182	140.32	2,790,826	64.07	70%	44.85	19.22	271,316	6.23	30%	1.87	4.36	1,093,410	25.10	80%	20.08	5.02	210,700	4.84	100%	4.84	0.00	1,745,930	40.08	0%	0.00	40.08
Outwash	3,543,450	81.35	1,471,449	33.78	70%	23.65	10.13	200,446	4.60	30%	1.38	3.22	599,196	13.76	80%	11.00	2.75	176,644	4.06	100%	4.06	0.00	1,095,715	25.15	0%	0.00	25.15

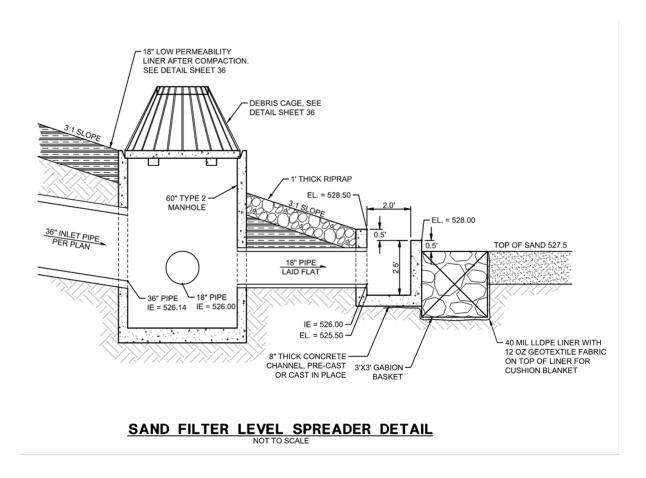
Flow will leave the pre-settling cell and enter the large sand filter through three 36-inch pipes located at the west end of the pre-settling cell. These pipes will have a reverse slope, with an inlet invert elevation of 528.5 (top of sediment storage elevation) and an outlet invert elevation of 529.04. The outlet pipes will connect to three concrete vaults (one pipe connecting to each vault) located within the berm between the pre-settling cell and the large sand filter. The vaults will contain an 18-foot-long weir with a top elevation of 534.5. The weirs set the design water surface elevation of the pre-settling cell. Stormwater that overflows the weirs will exit each vault via a 36-inch pipe that connects to a 48-inch Type II catch basin (one catch basin per each vault outlet). Flows will connect laterally via 18" pipes between these three catch basins and four additional catch basins located on the south end of the berm. These seven catch basins will distribute flow to the concrete level spreader at seven different locations. The level spreader is located 6" above the bottom of the large sand filter and runs the entire width of the filter. Flows from the level spreader fall onto a

row of gabion baskets located below the low edge of the level spreader for additional energy dissipation. As the water in the sand filter rises to the level of the catch basins, flows will bubble up out of the seven catch basins into the sand filter. This system is depicted in the figure, below.

To analyze the conveyance pipe on the sand filter side of the berm, it was assumed that the sand filter is filled to an elevation of 533.5 when the 100-year peak flow is entering the pond. The 533.5 elevation was used as the tailwater at the catch basin beehive outlet. Any of the three pipes can be chosen to be analyzed as they are identical. StormCAD was used to calculate the required headwater on the 36-inch pipe at the vault. A third of the total basin conveyance flow of 116.16 cfs was applied to this pipe. A head water elevation of 540.15 was found to be required to pass the conveyance flow through this pipe. The headwater elevation is below the weir elevation and will therefore not affect the upstream conveyance systems.
