**King County**  
**ADA Self-Evaluation and Transition Plan Update**  
**Facility Cost Projection Summary**  
**August 2023**

# Site Accessibility Evaluation

**Burien PnR Garage (KC)**  
**14900 4th Ave SW**  
**Burien, WA 98166**  
**Accessibility Evaluation**  
**Inspection Date: 07/11/2023**  
**Evaluators: Kalia Klein**

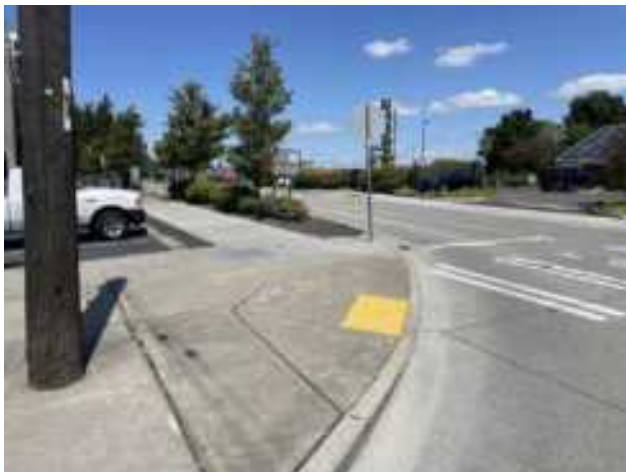
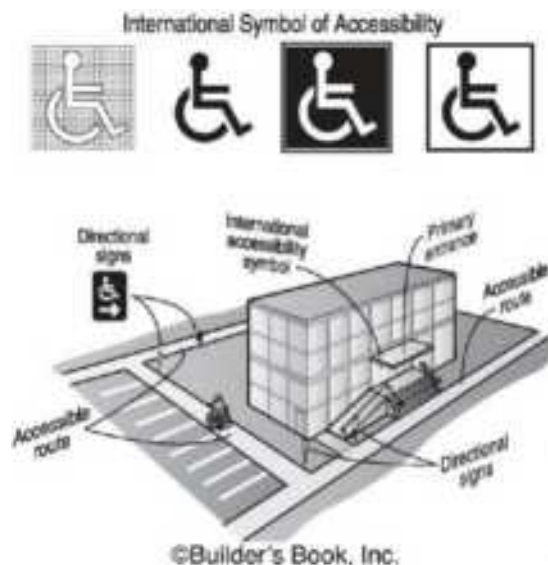
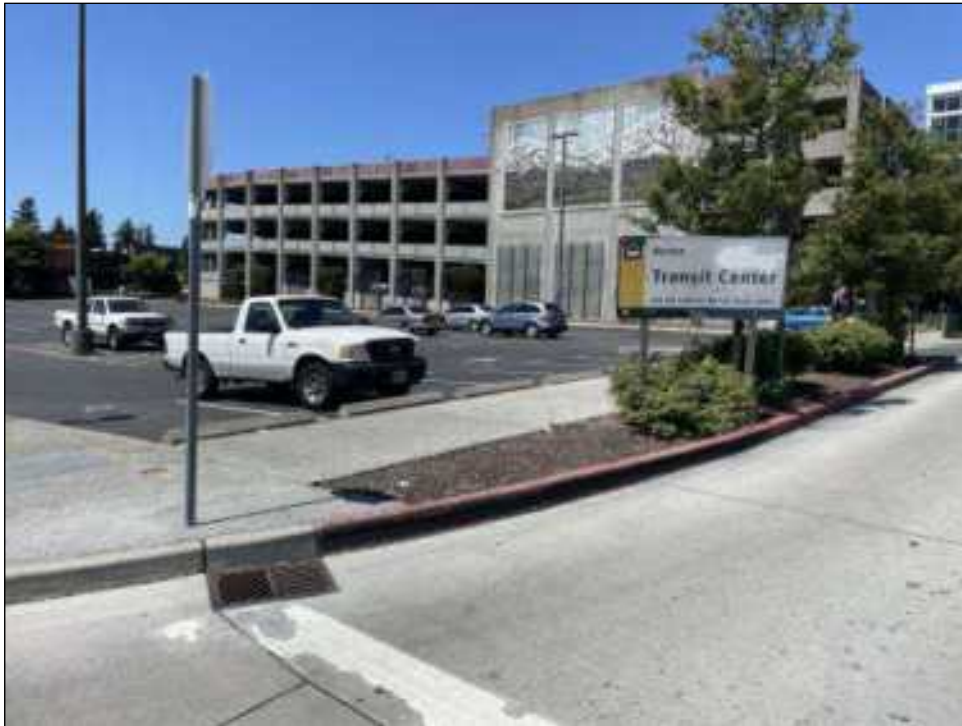
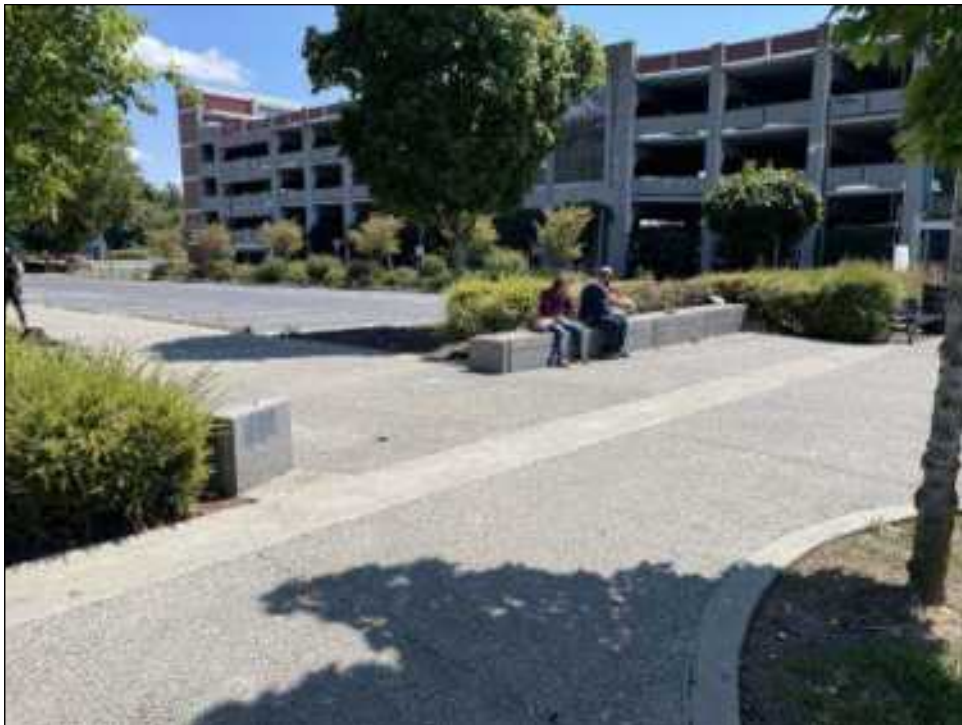
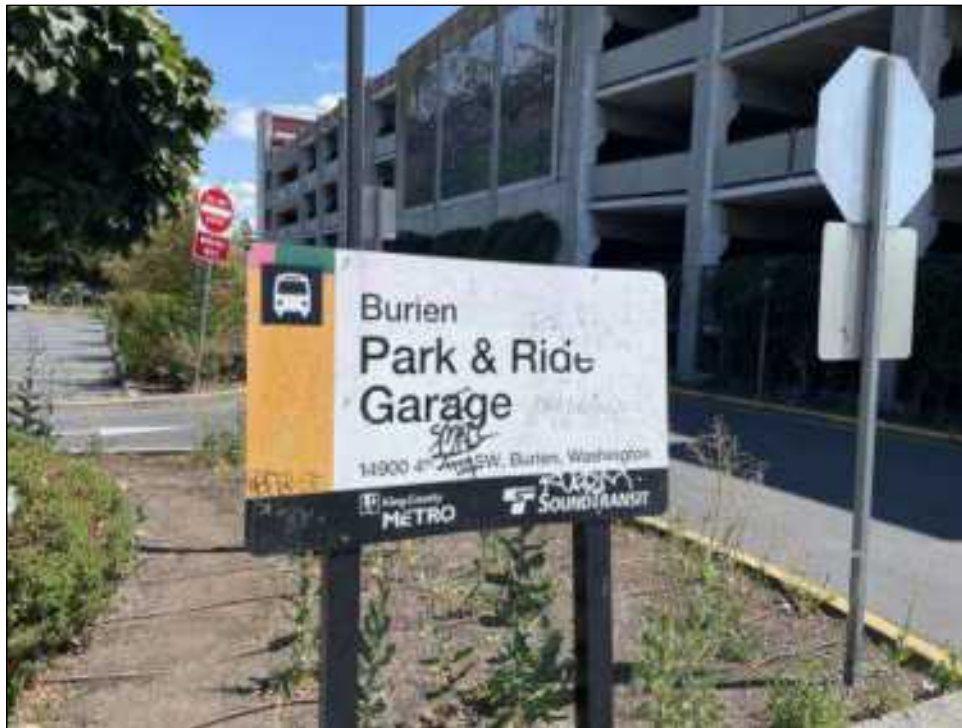
**Barrier #1 Additional Barrier Photos**

The walk is missing directional signage that identifies the location/direction of the accessible route of travel to the accessible building entrance.

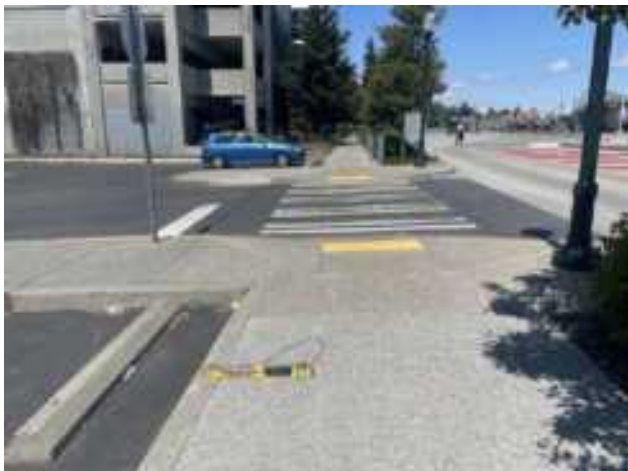
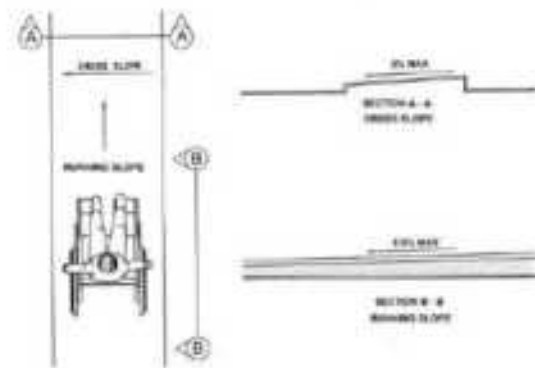
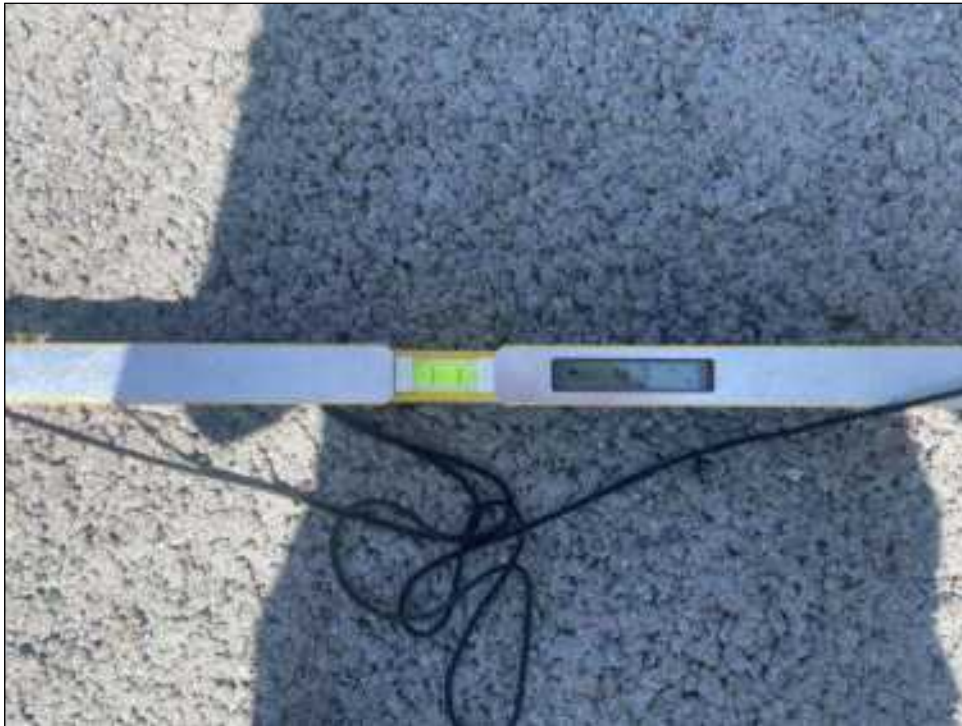
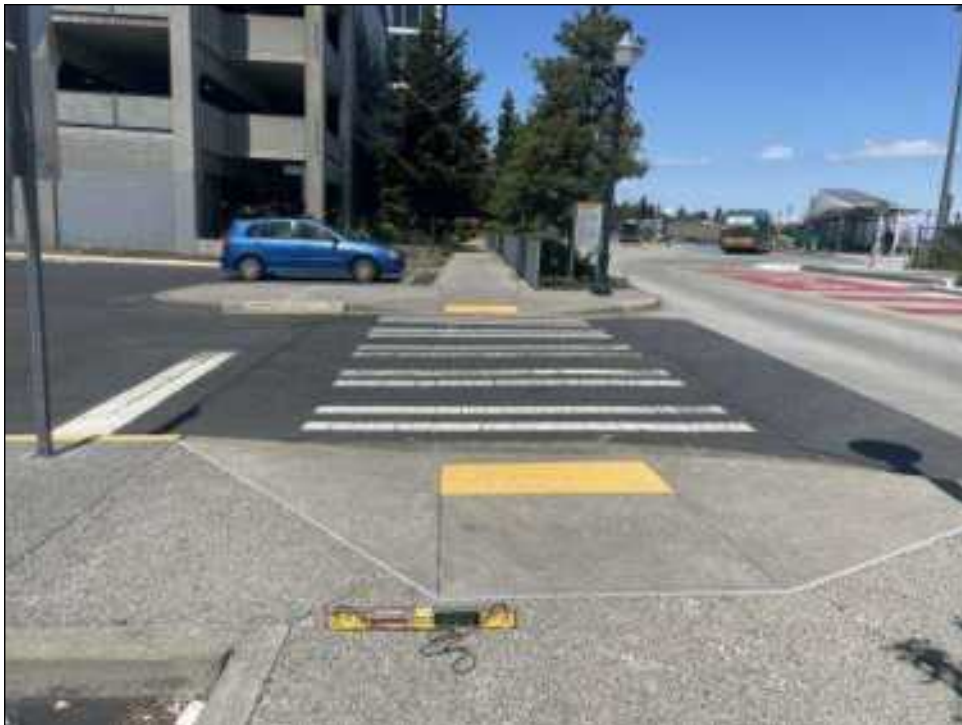
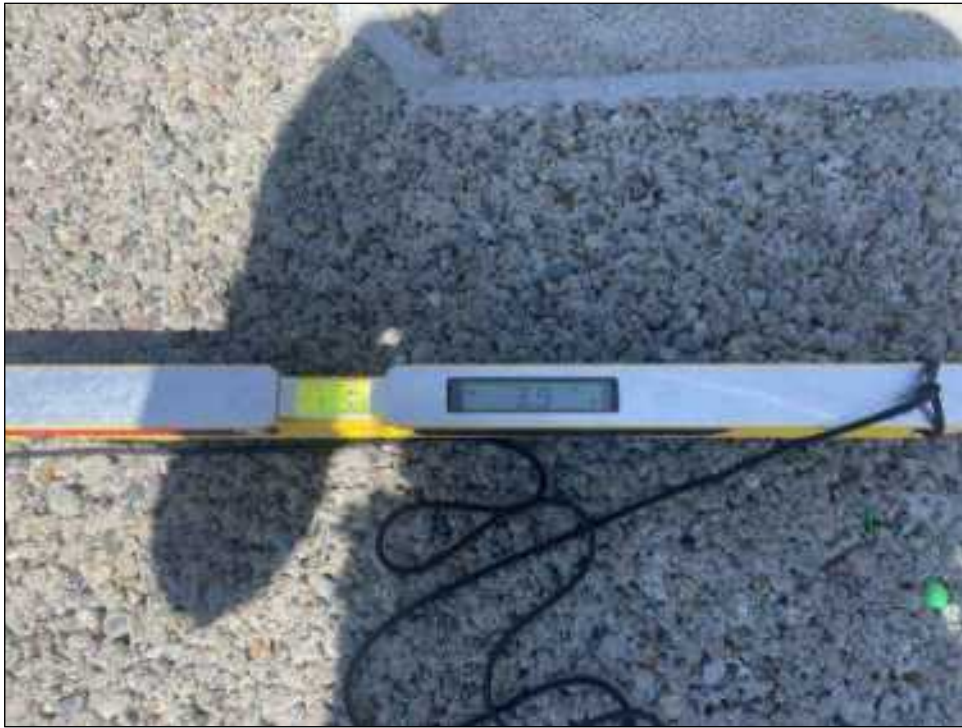
**Barrier #2 Additional Barrier Photos**

Alter or replace the sidewalk to ensure the cross slope is no more than 2 percent for the entire distance in front of the parking spaces.

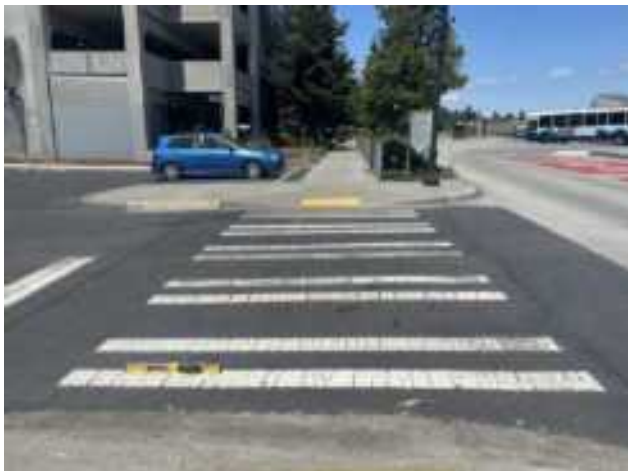
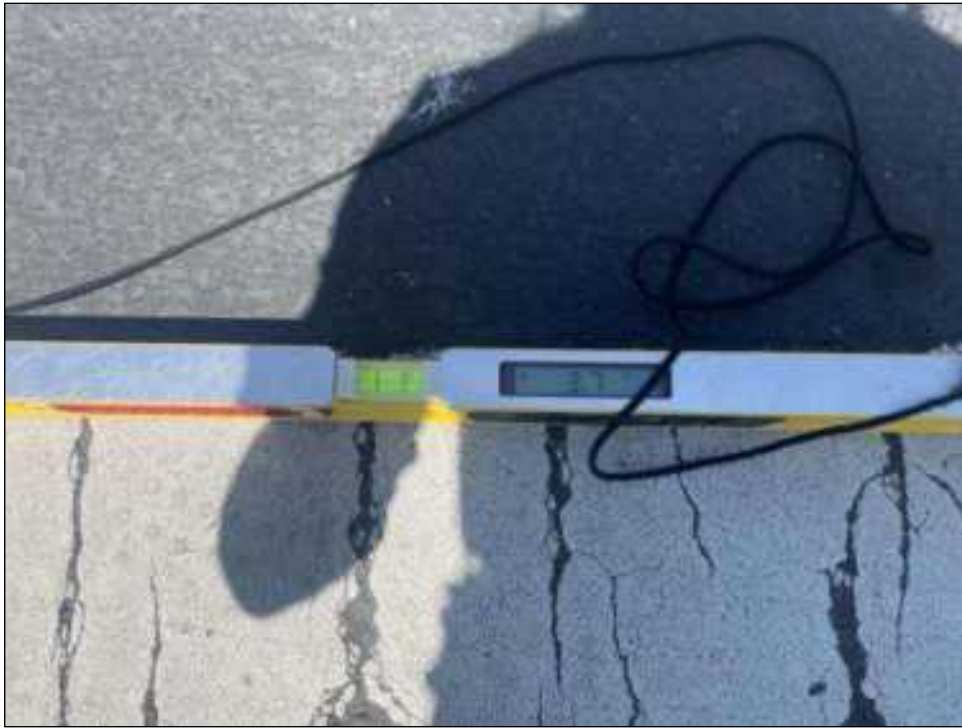
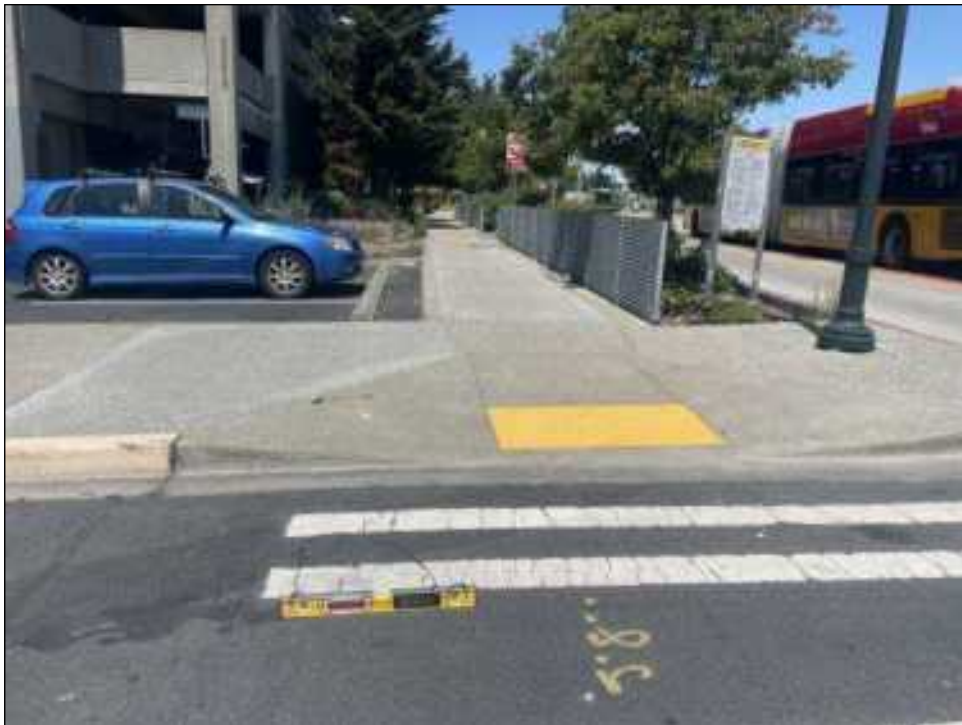
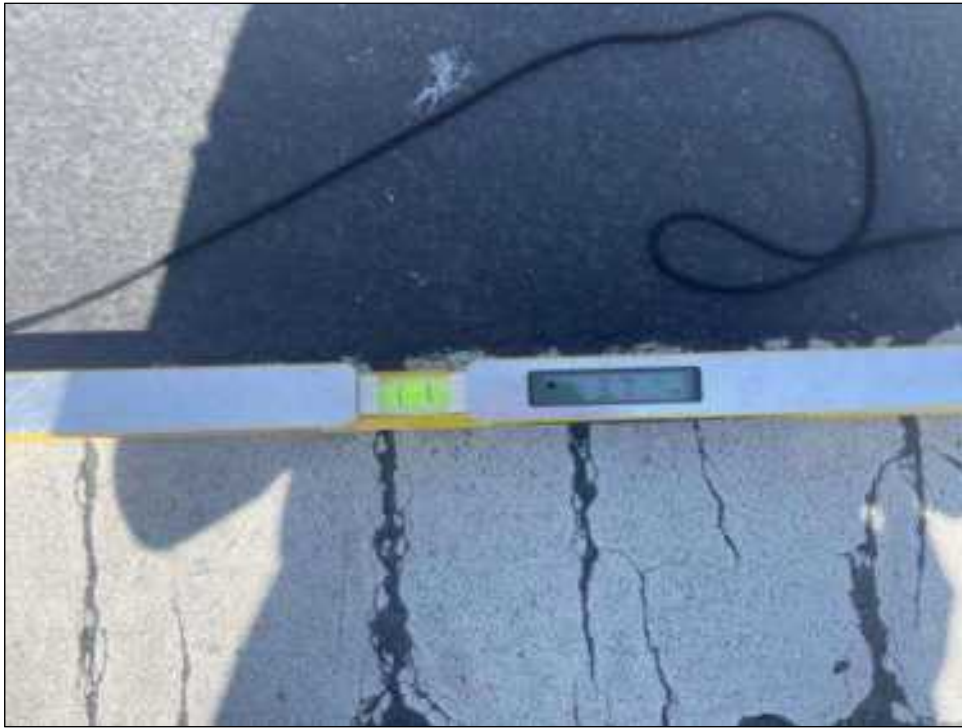
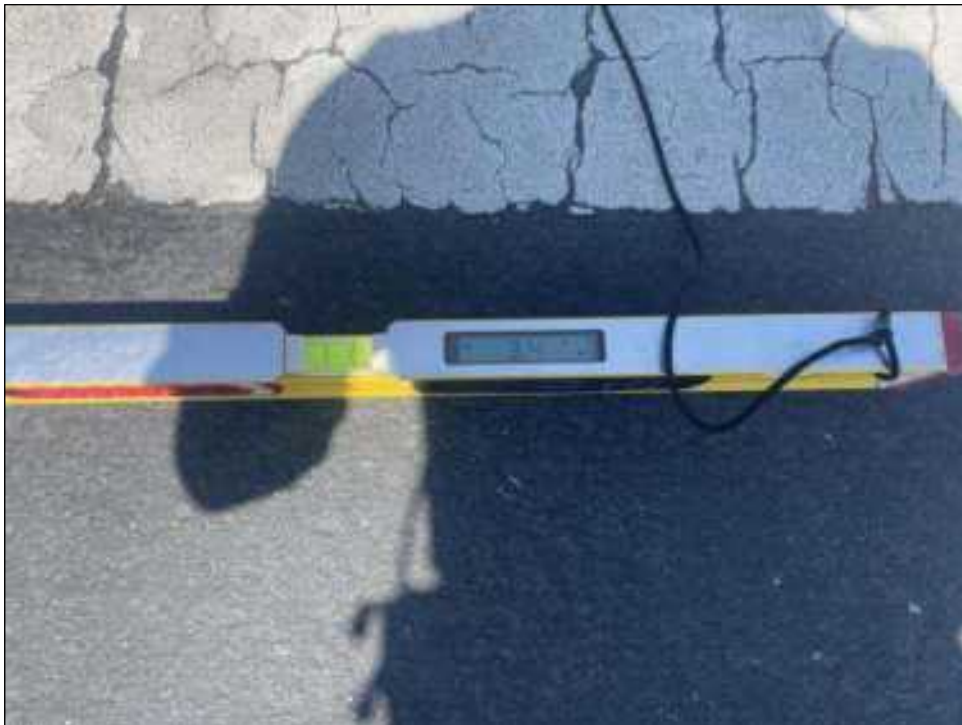
**Barrier #3 Additional Barrier Photos**

Alter or replace the sidewalk to ensure the cross slope is no more than 2 percent for the entire distance of the path of travel.

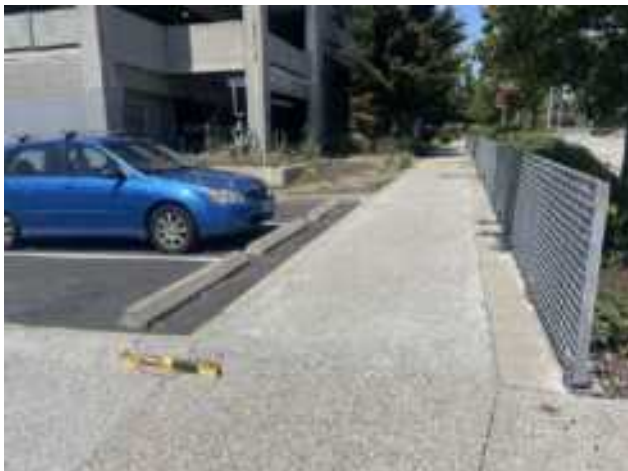
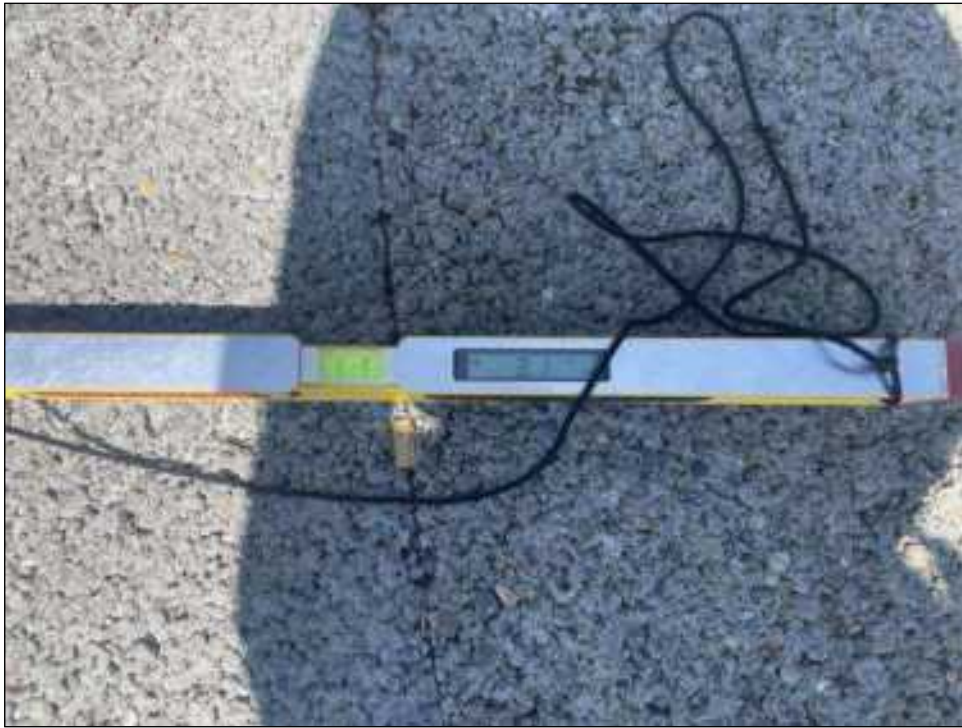
**Barrier #5 Additional Barrier Photos**

Alter or replace the sidewalk to ensure the cross slope is no more than 2 percent for the entire path of travel.

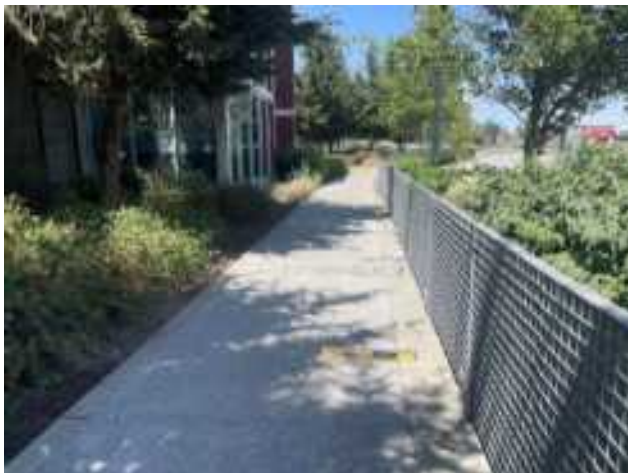
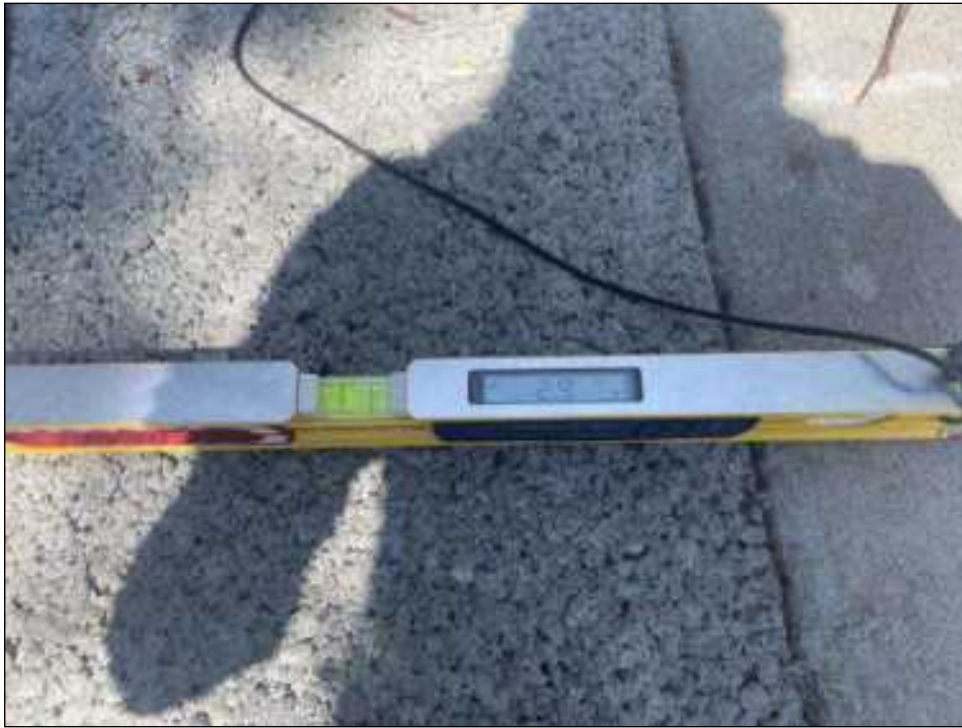
**Barrier #6 Additional Barrier Photos**

Alter or replace the sidewalk to ensure the cross slope is no more than 2 percent for the entire path of travel

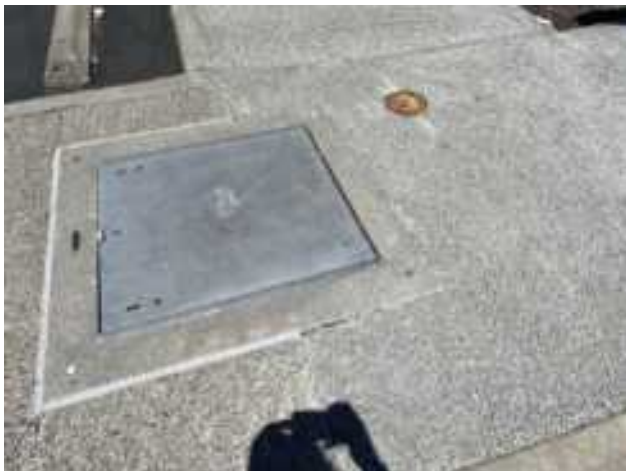
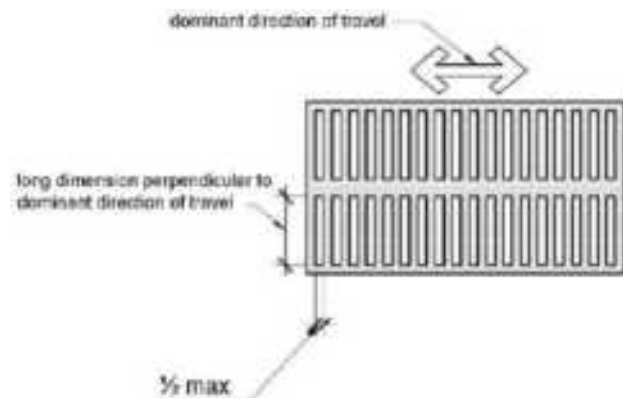
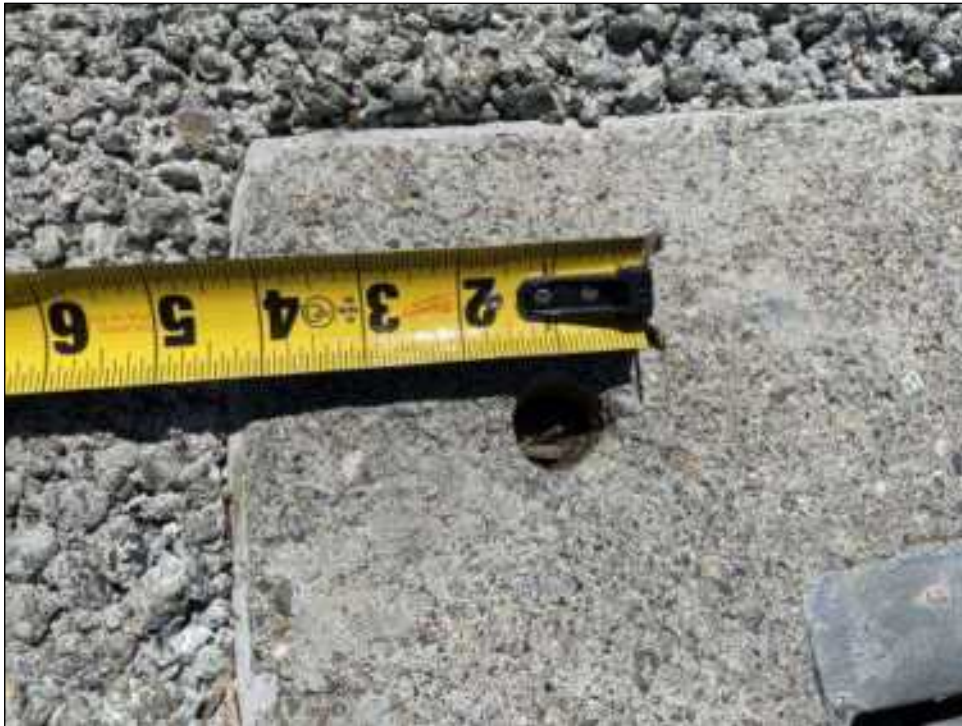
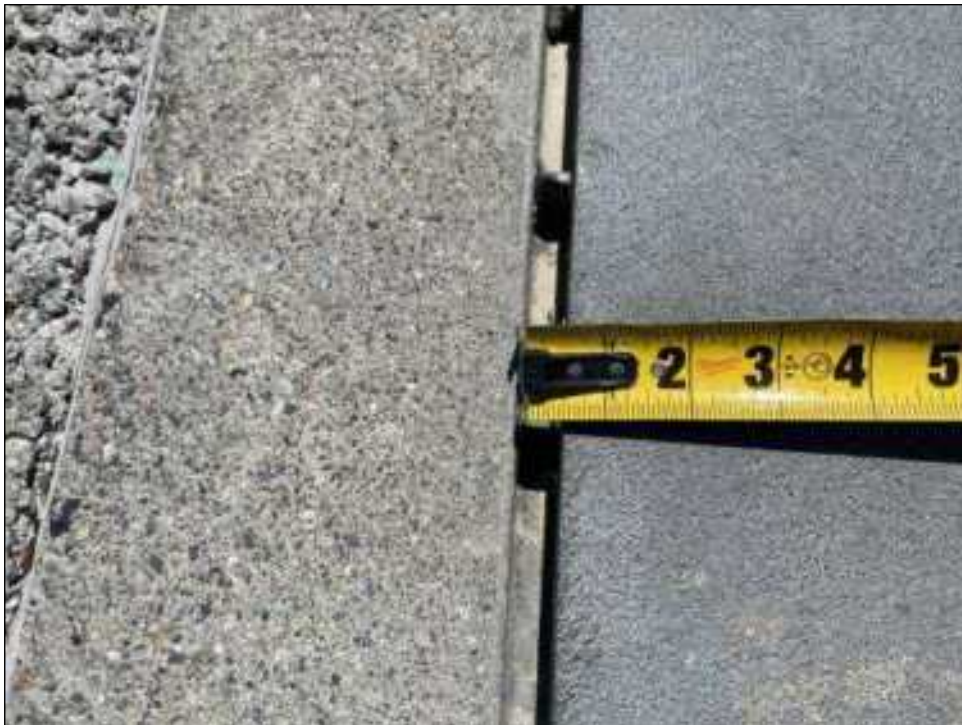
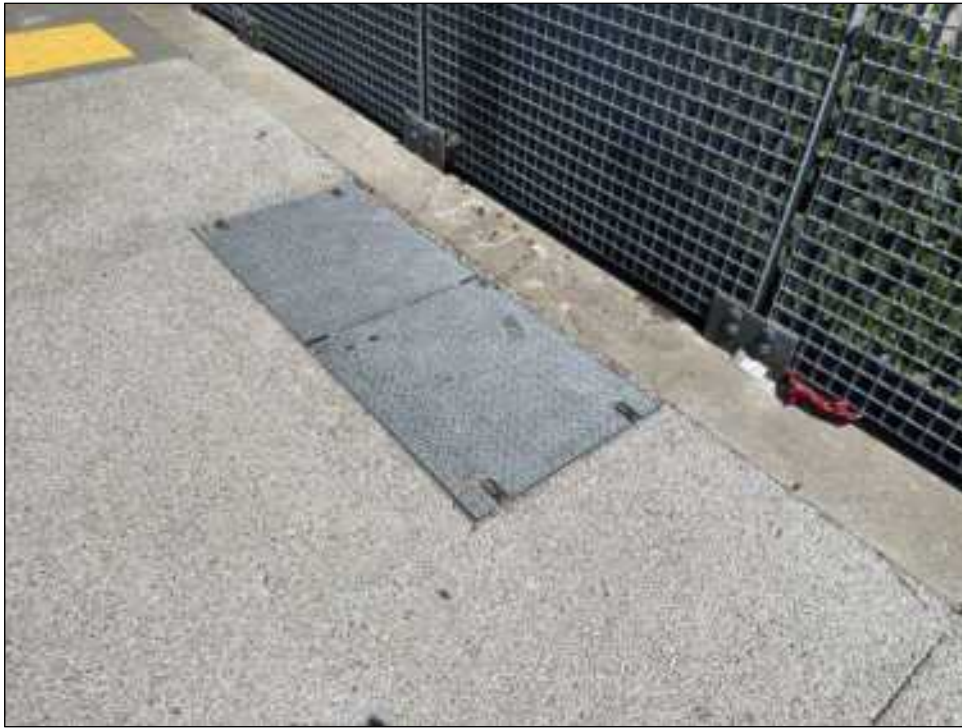
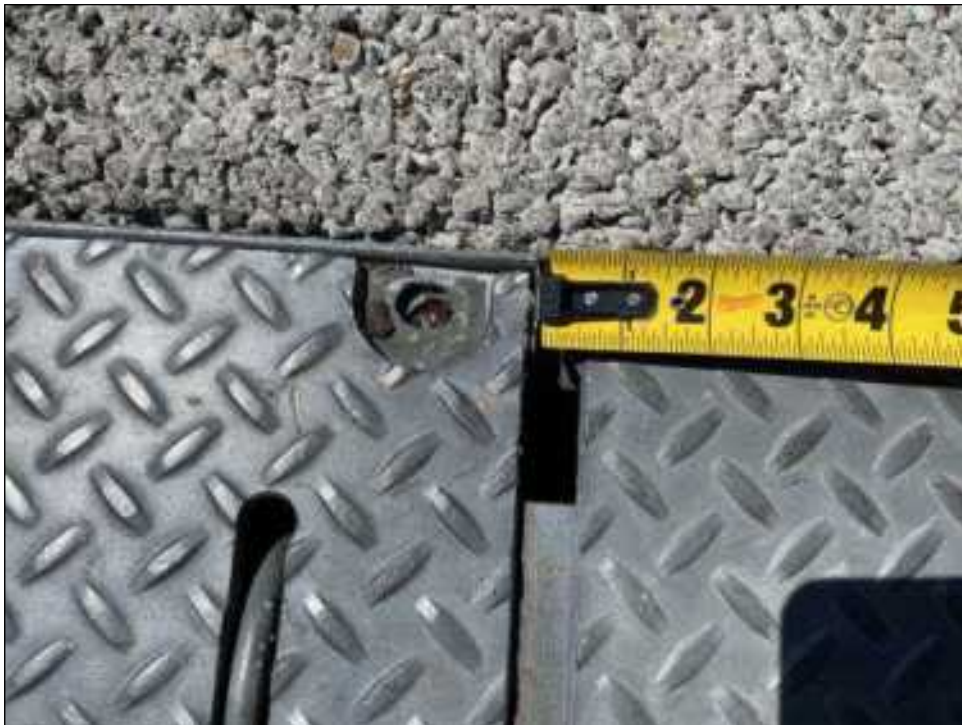
## Barrier #7 Additional Barrier Photos

Replace or alter grating to achieve smooth transitions over the entire path of travel.

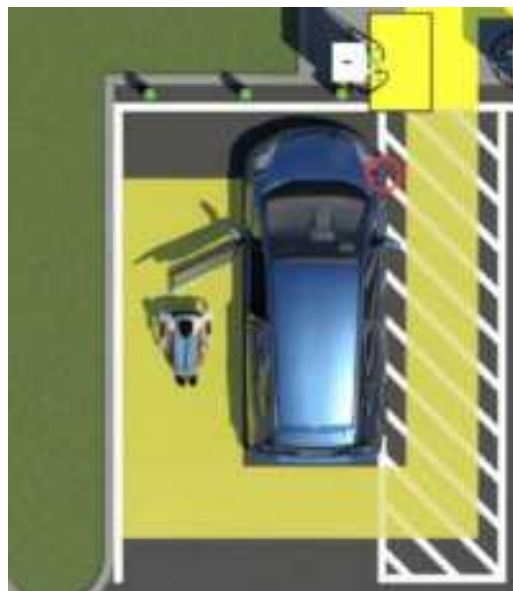
- a vehicle charging space at least 11 feet wide and 20 feet long
- adjoining access aisle at least 5 feet wide
- clear floor or ground space at the same level as the vehicle charging space and positioned for an unobstructed side reach
- accessible operable parts, including on the charger and connector

These mobility features allow sufficient space for a person who uses a mobility device to exit and maneuver around the vehicle, retrieve the EV connector, and plug the connector into the electric vehicle charging inlet. Since EVs do not have a uniform vehicle charging inlet location, a larger vehicle charging space is needed to maneuver around all sides of the electric vehicle.

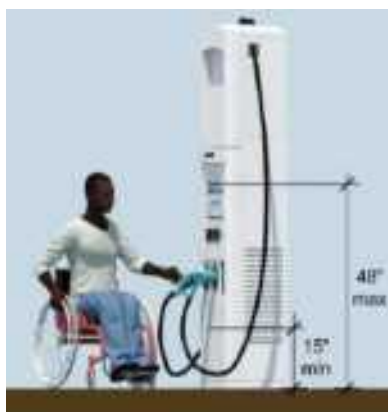
### **Unobstructed side reach**

All operable parts should meet the requirements for an unobstructed side reach ([§308.3.1](#)) and be no higher than 48 inches above the clear floor or ground space and no farther than 10 inches away. The exception for fuel dispensers should not be used (See: fuel dispensers). Placing operable parts higher than the 15 inch minimum is recommended.

All operable parts should meet the requirements for an unobstructed side reach ([§308.3.1](#)) and be no higher than 48 inches above the clear floor or ground space and no farther than 10 inches away. The exception for fuel dispensers should not be used (See: fuel dispensers). Placing operable parts higher than the 15 inch minimum is recommended.

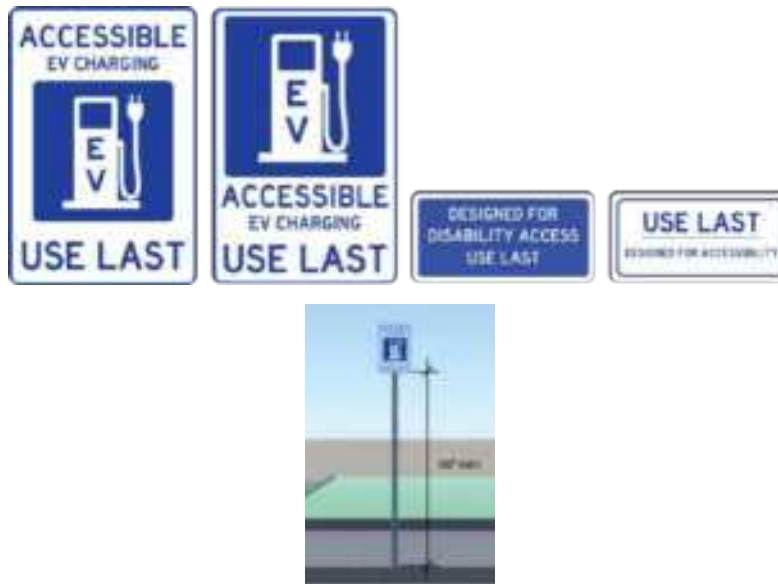
A “use last” sign would indicate an EV charging space is accessible, but also direct people to use this space only when other charging spaces are occupied or accessibility features are needed.

At the time of this guidance, neither Manual on Uniform Traffic Control Devices (MUTCD) nor any other code-setting organization has a standard for “use last” signs, but the Access Board has designed several examples.

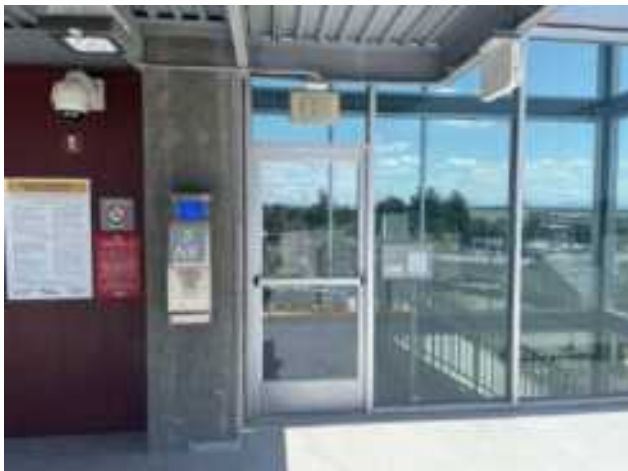
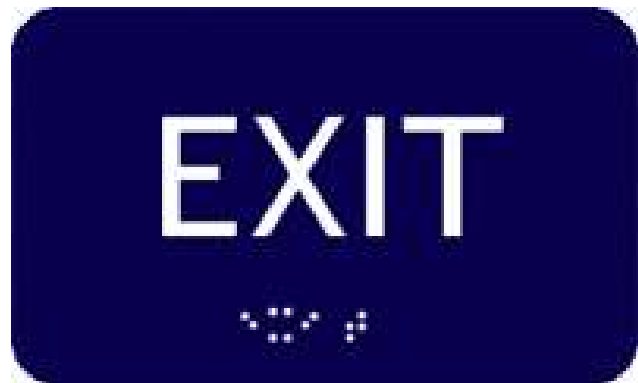
### **Barrier: 19**

The tactile EXIT sign is missing at the door.

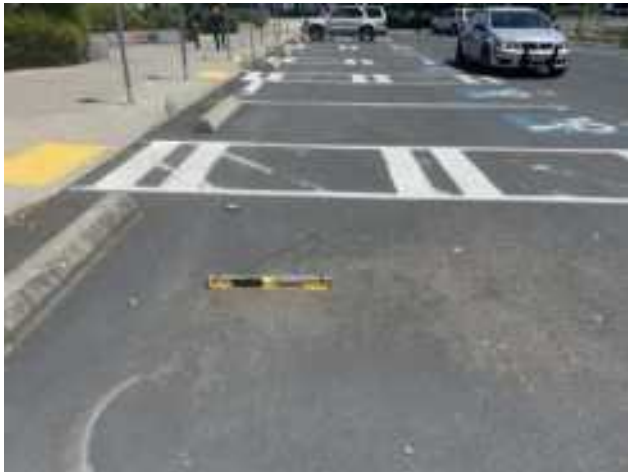
### **Barrier: 25**

High (Level 4): Parking and exterior accessible routes (DOJ Level 1) – moderately out of compliance

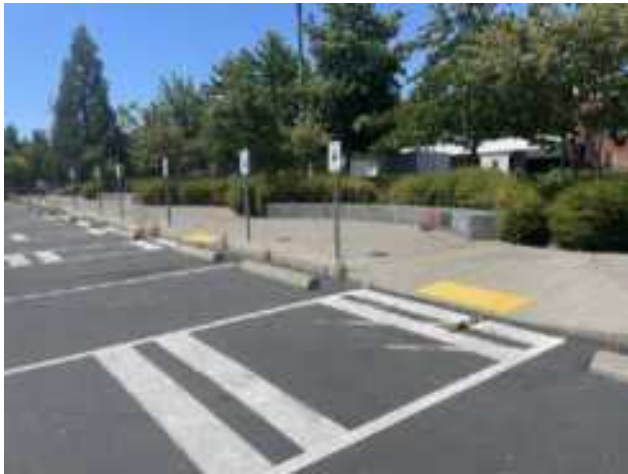
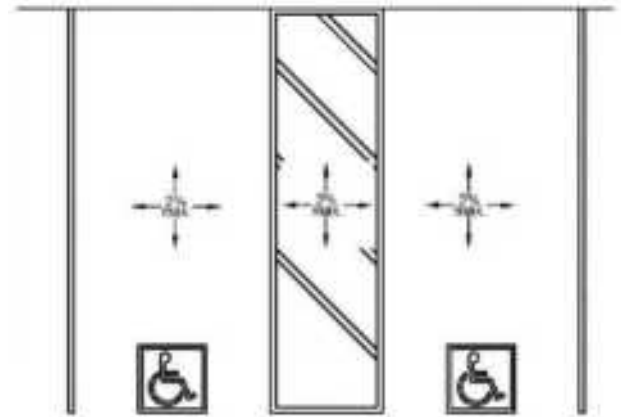
### **Barrier: 26**

High (Level 4): Parking and exterior accessible routes (DOJ Level 1) – moderately out of compliance

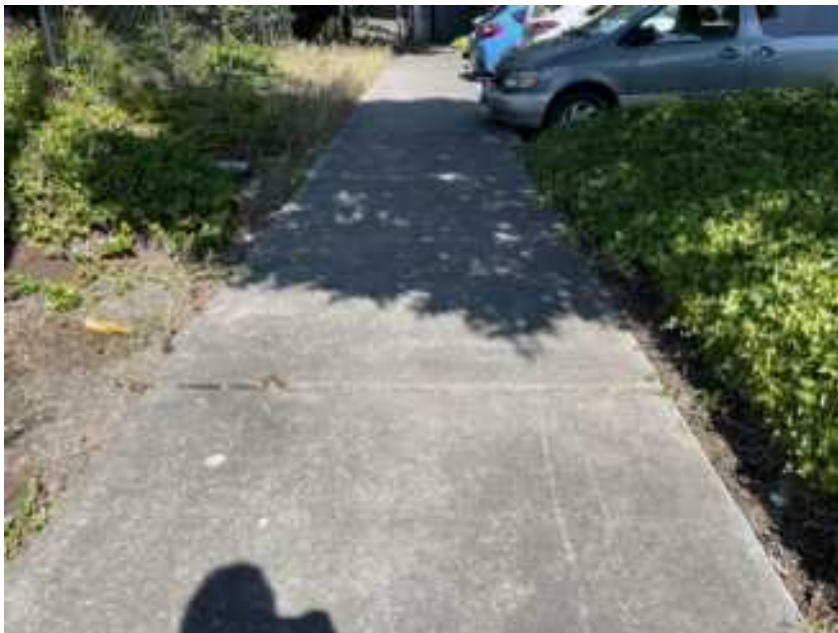
### **Barrier: 2**

Replace caulk or other material in the expansion joint to achieve smooth transactions over the entire path of travel.

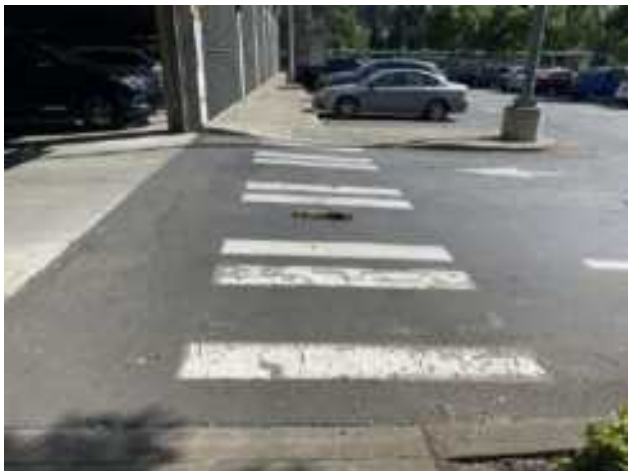
### **Barrier: 3**

Alter or replace the sidewalk to ensure the cross slope is no more than 2 percent for the entire path of travel.

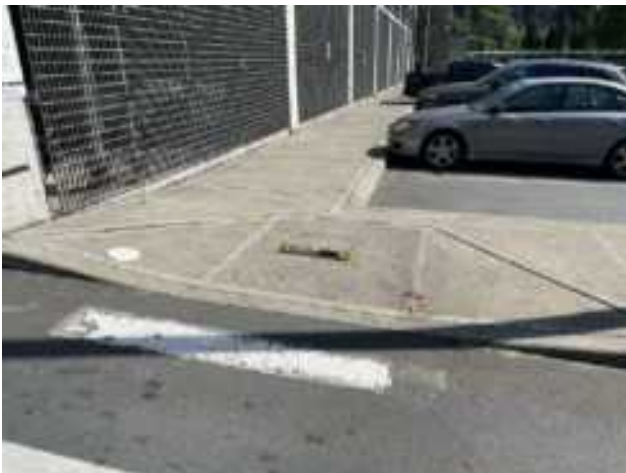
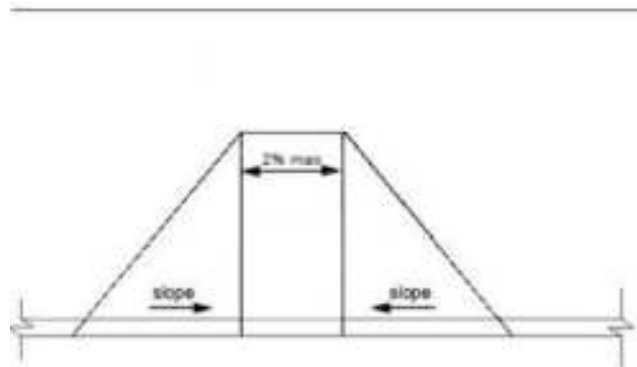
### **Barrier: 4**

Modify or replace the curb ramp to provide a cross slope of no more than 2 percent and a run slope no more than 8.33 percent.

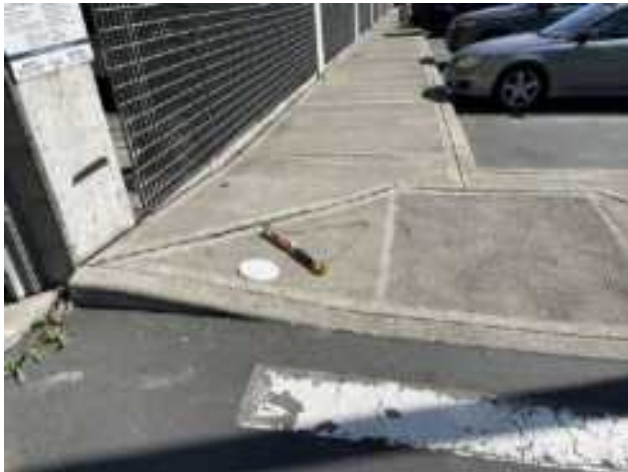
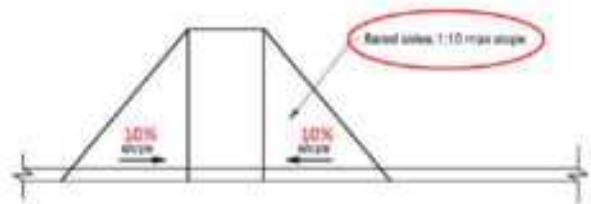
### **Barrier: 5**

High (Level 4): Parking and exterior accessible routes (DOJ Level 1) – moderately out of compliance

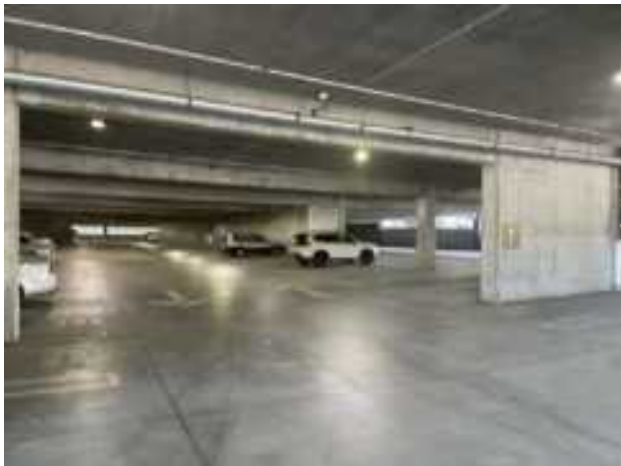
### Barrier: 6

High (Level 4): Parking and exterior accessible routes (DOJ Level 1) – moderately out of compliance

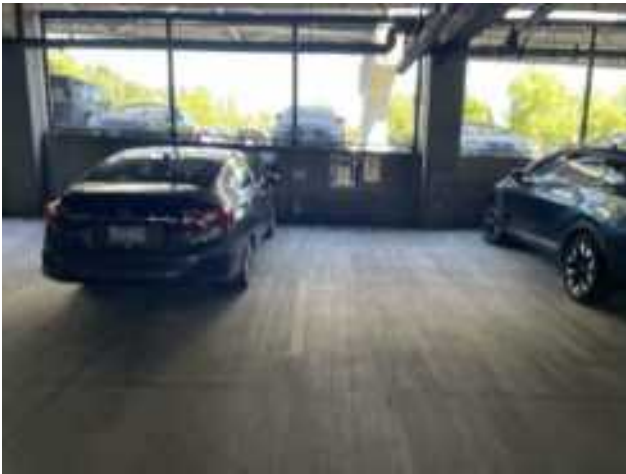
**Barrier #7 Continued**

Although these may be eligible for safe harbor and there are specific standards adopted at this time, it is recommended that the agency follow The U.S. Access Board's Design Recommendations for Accessible Electric Vehicle Charging Stations.

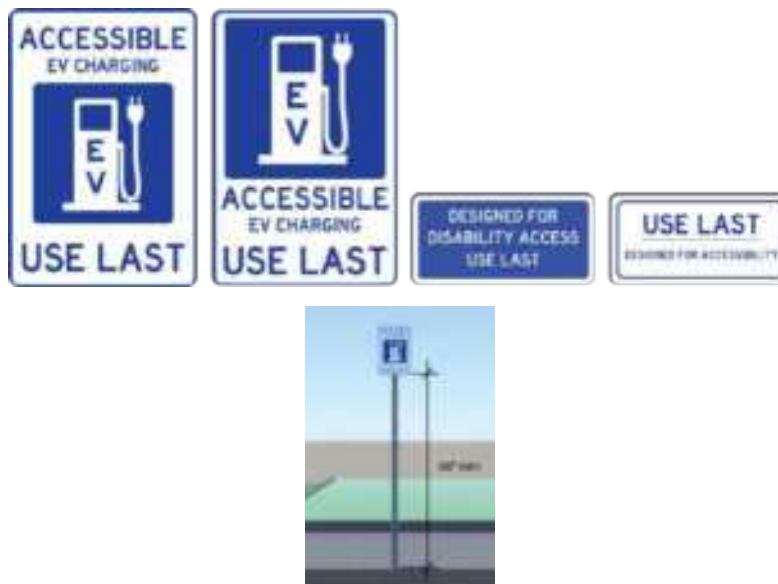
A “use last” sign would indicate an EV charging space is accessible, but also direct people to use this space only when other charging spaces are occupied or accessibility features are needed.

At the time of this guidance, neither Manual on Uniform Traffic Control Devices (MUTCD) nor any other code-setting organization has a standard for “use last” signs, but the Access Board has designed several examples.

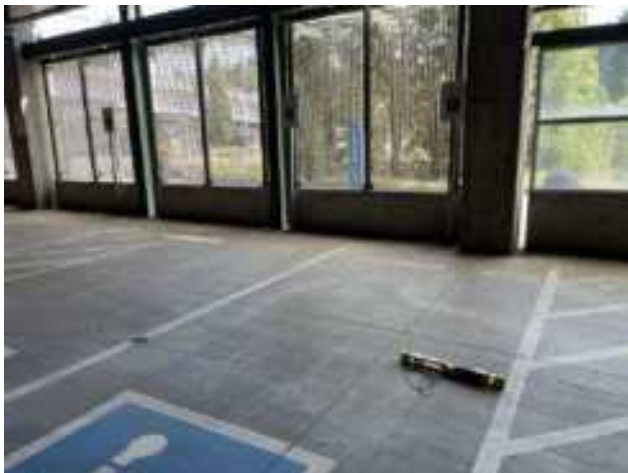
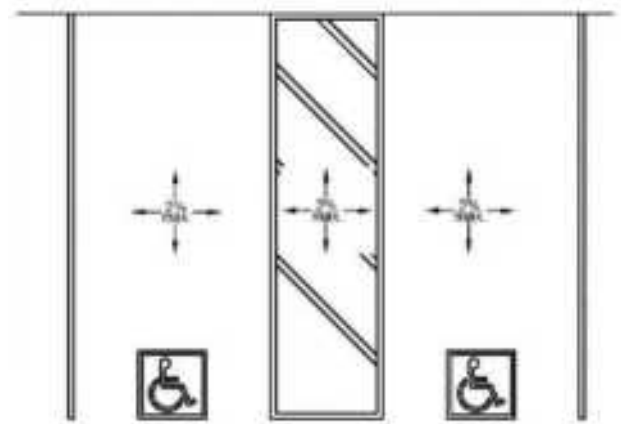
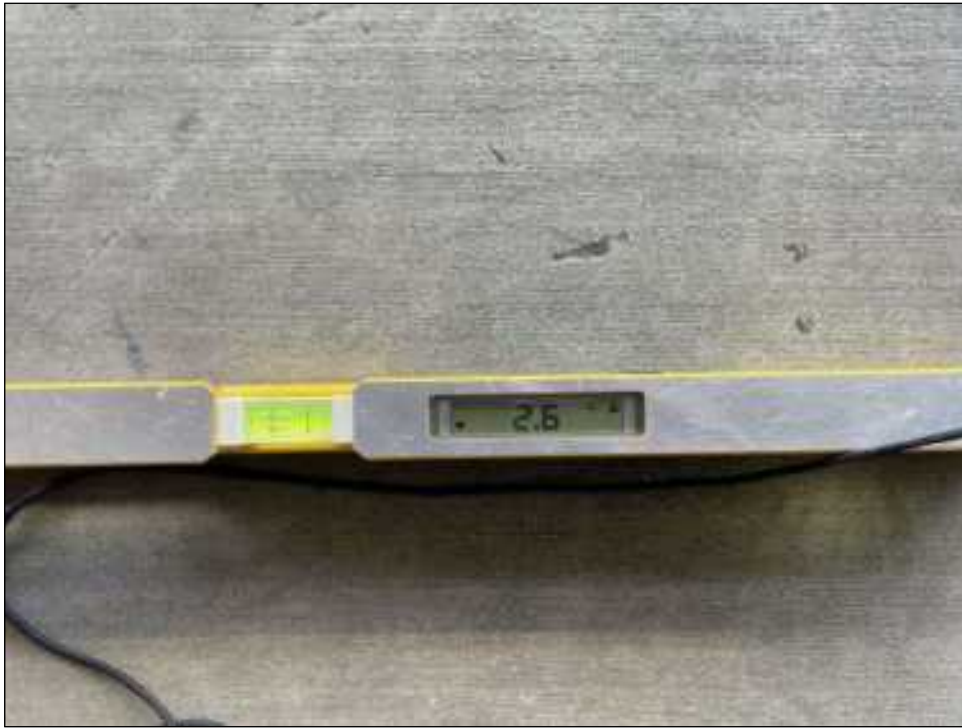
**Barrier #9 Additional Barrier Photos**

Alter or replace the existing accessible parking space to ensure the slope is no more than 2.08 percent as required.
