**King County**  
**ADA Self-Evaluation and Transition Plan Update**  
**Facility Cost Projection Summary**  
**August 2023**

# Site Accessibility Evaluation

**Burien PnR Garage (KC)**  
**14900 4th Ave SW**  
**Burien, WA 98166**  
**Accessibility Evaluation**  
**Inspection Date: 07/11/2023**  
**Evaluators: Kalia Klein**

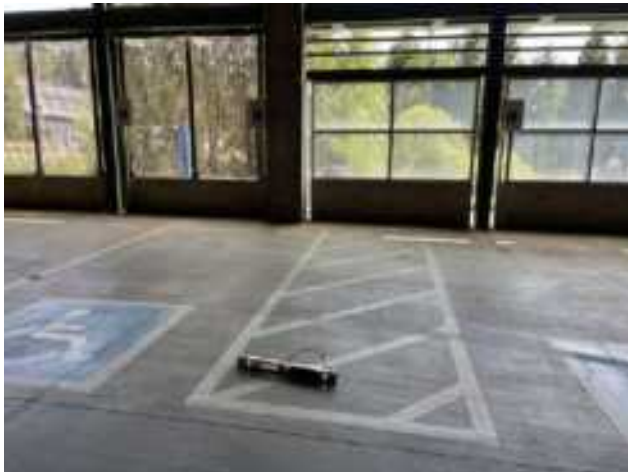
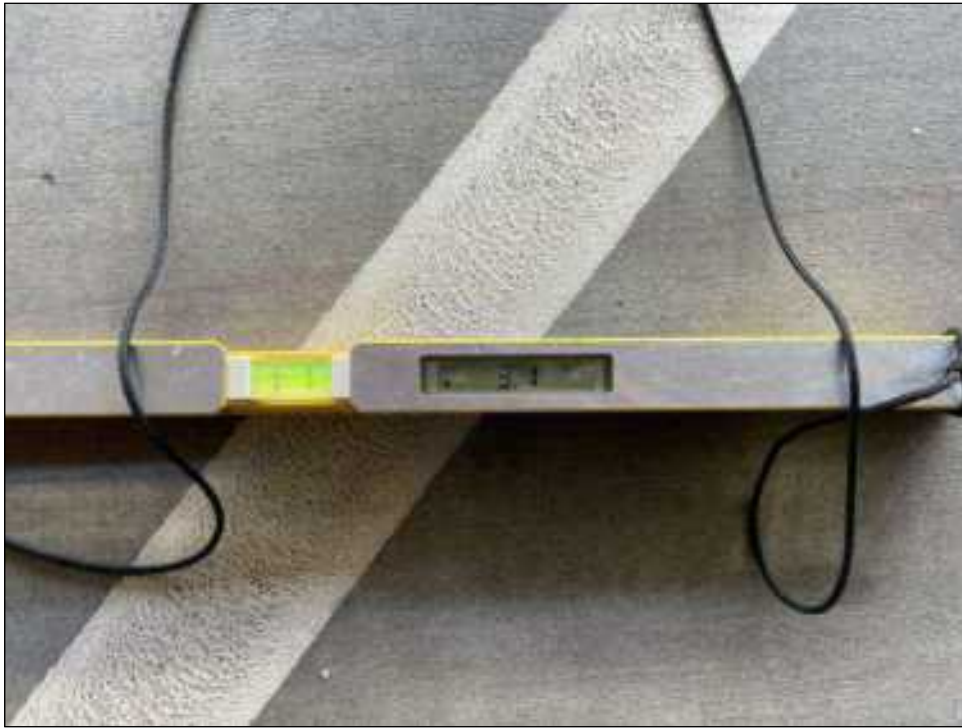
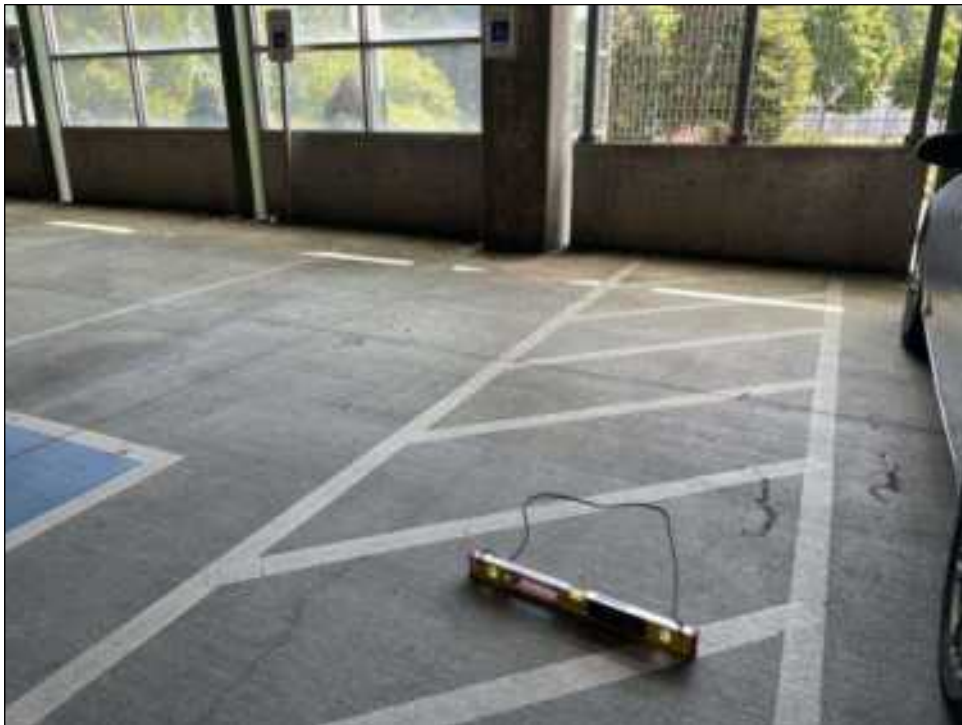
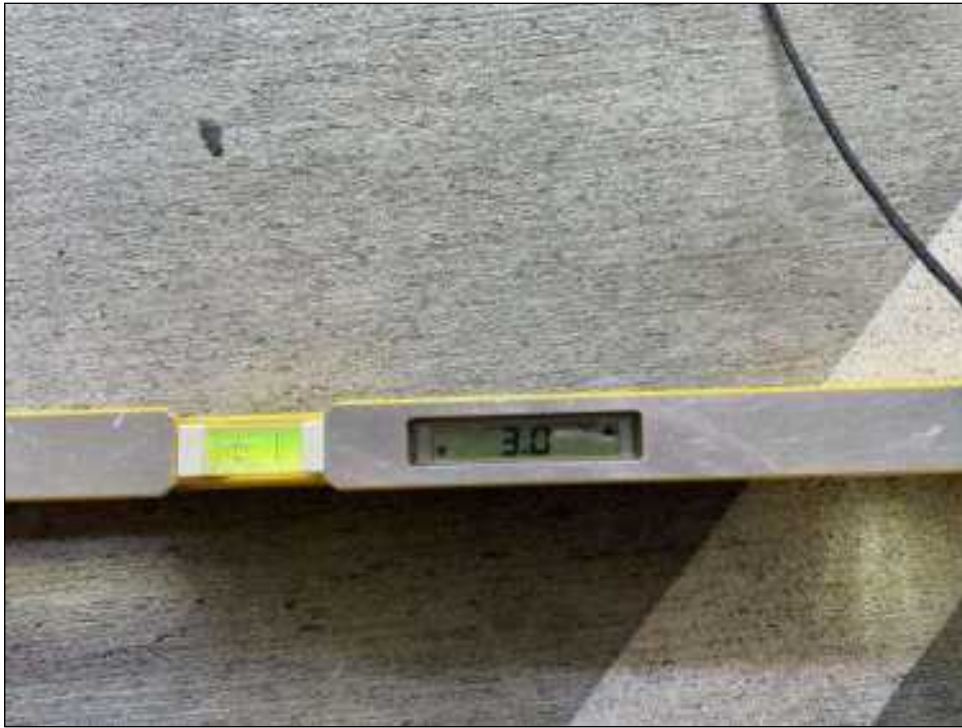
**Barrier #10 Additional Barrier Photos**

Alter or replace the existing access aisle to ensure the slope is no more than 2.08 percent as required.

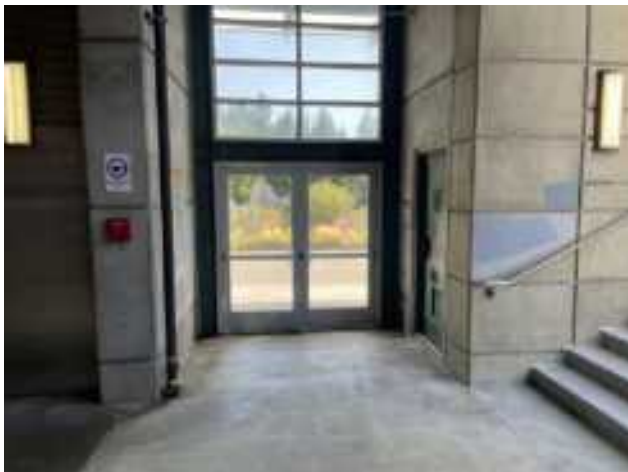
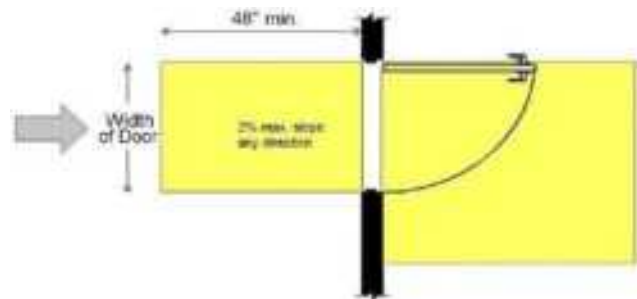
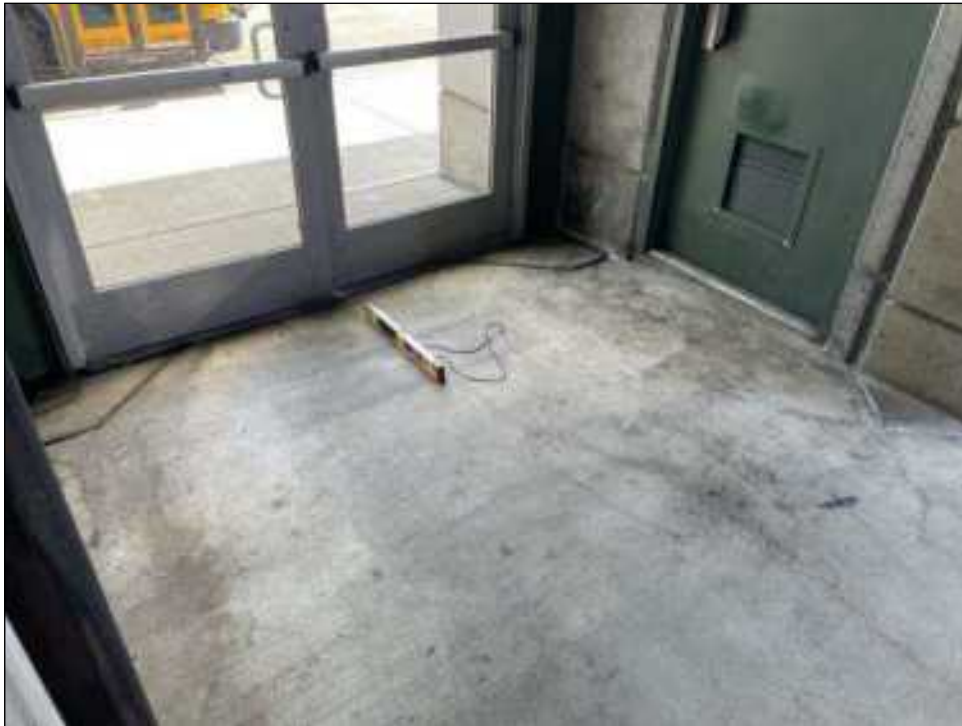
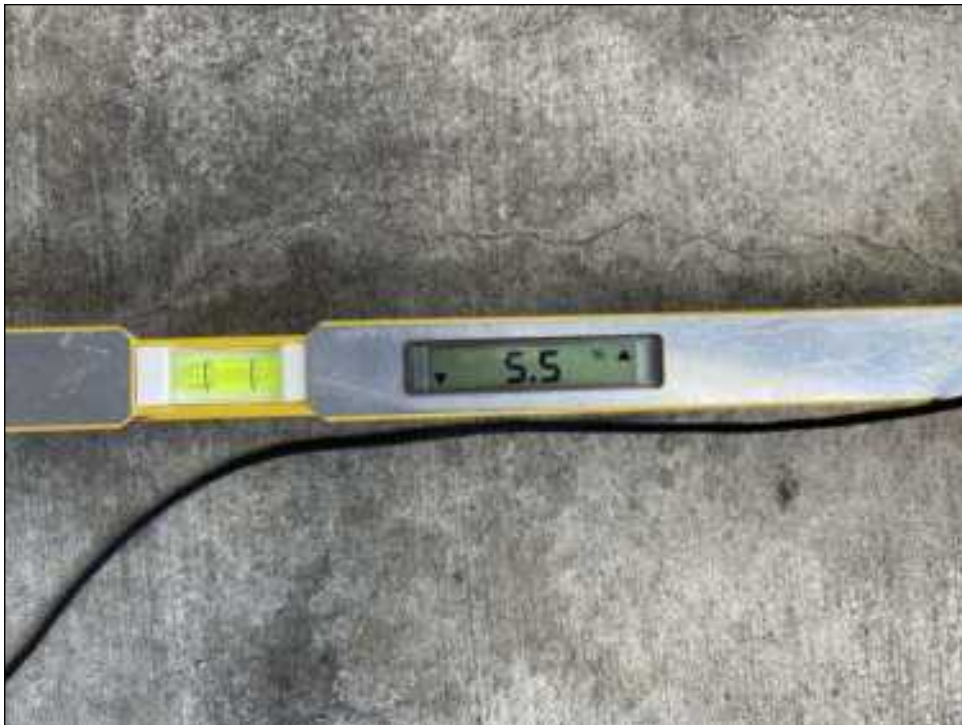
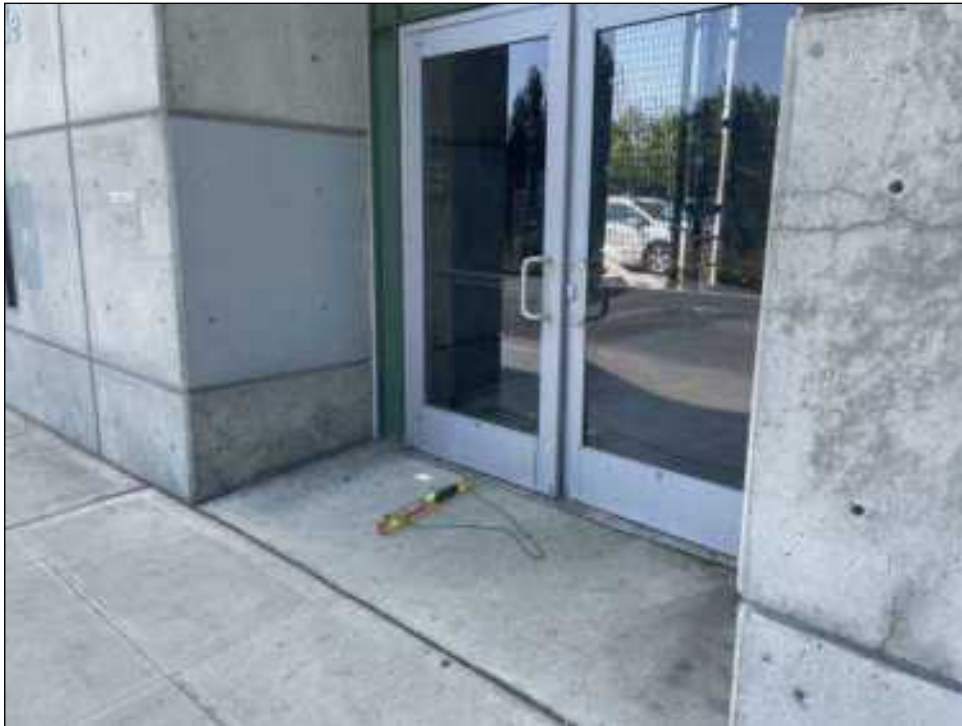
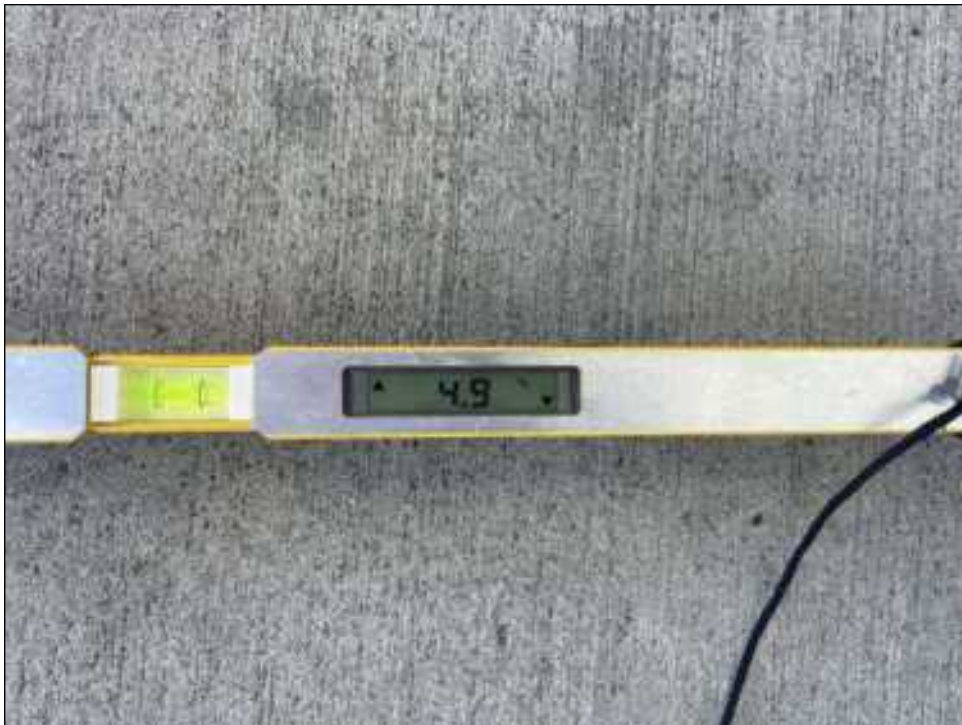
**Barrier #11 Additional Barrier Photos**

Alter or replace the door landing to ensure the clear floor space slope does exceed 2.08 percent.

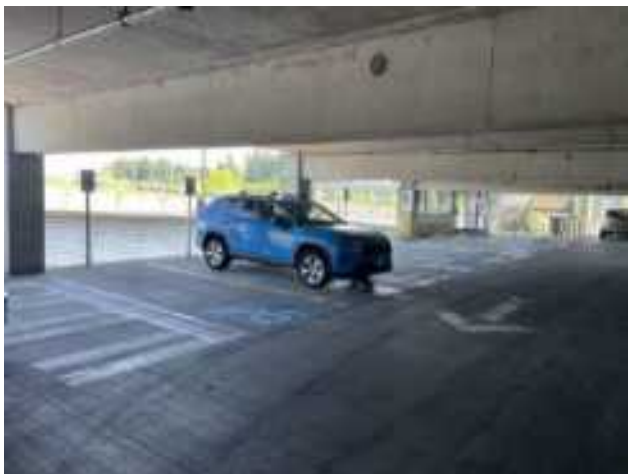
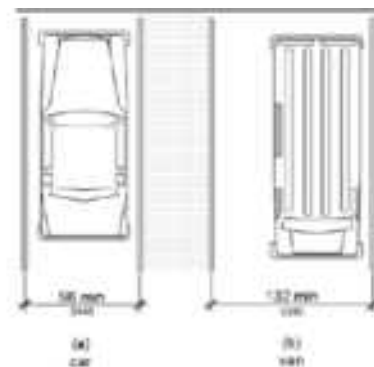
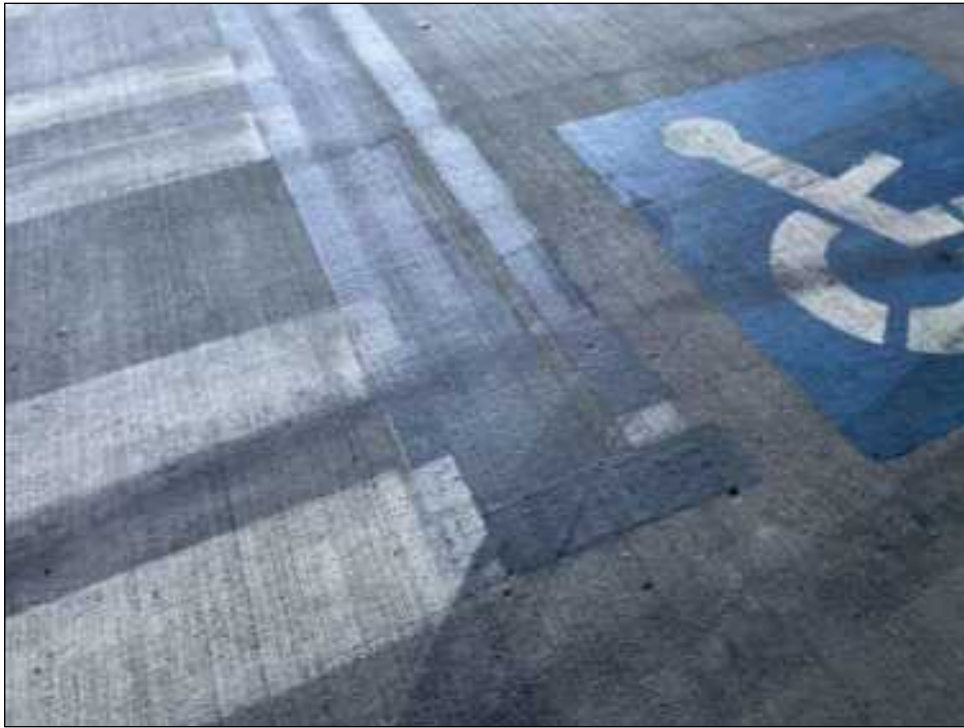
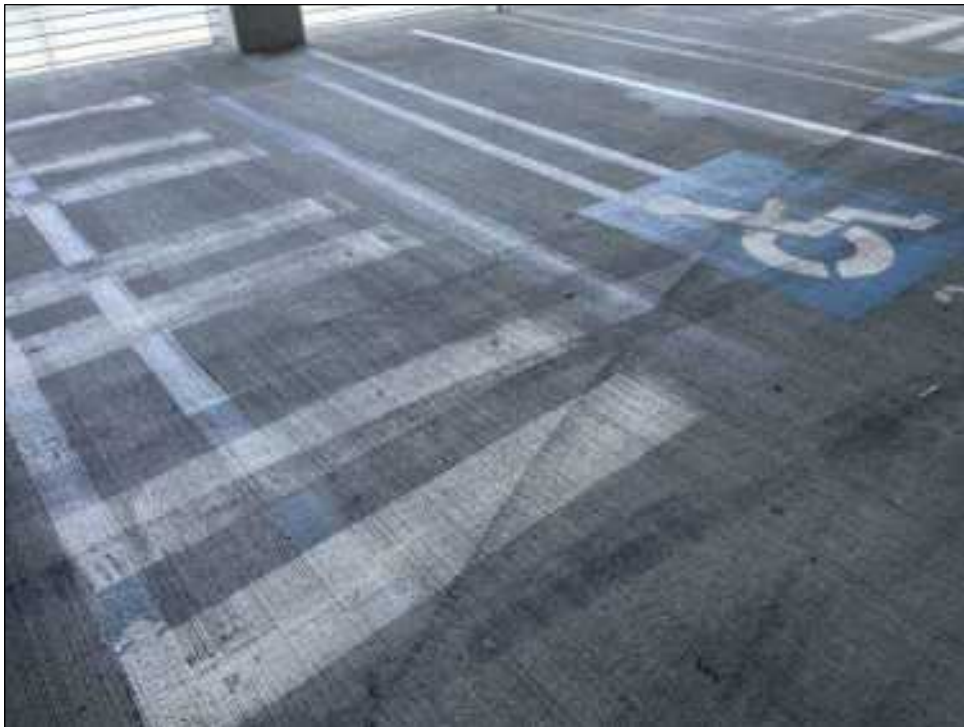
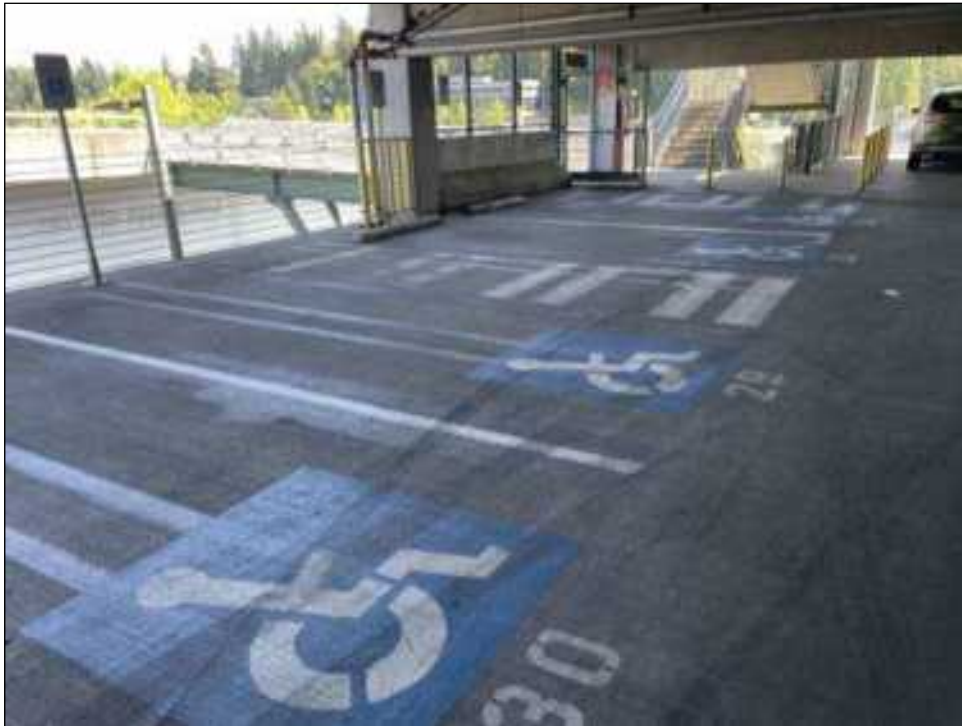
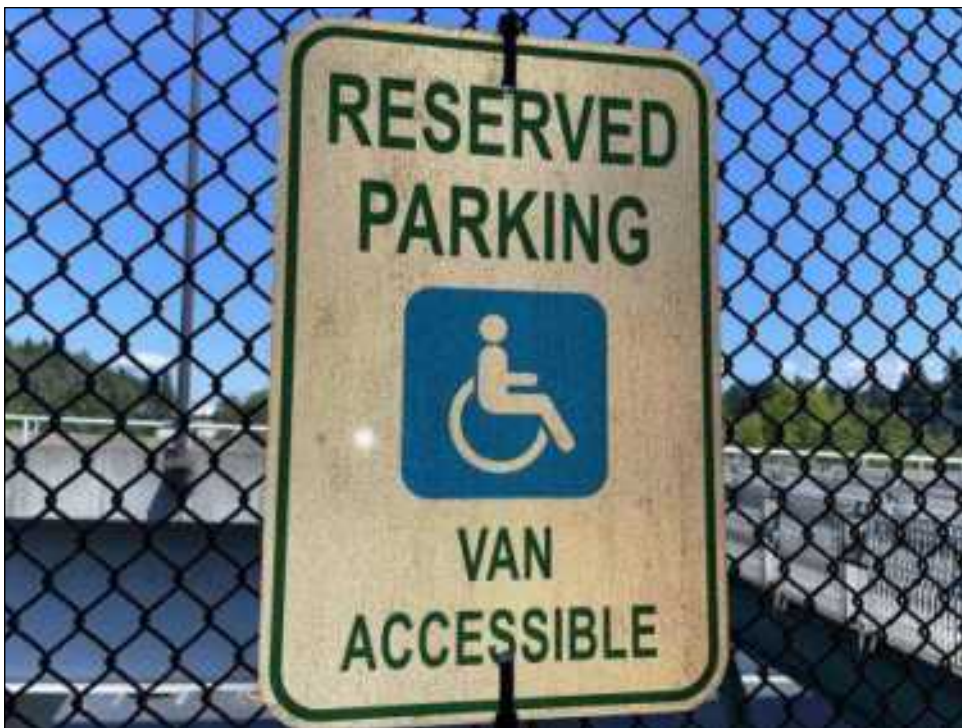
**Barrier #12 Additional Barrier Photos**

The parking spaces and access aisles are incorrect widths; the striping is dilapidated and in need of repair and/or maintenance. The access aisles are not on an accessible route/obstructed required clear widths, signage is incorrect, and/or installed at incorrect heights. There are no Van stalls, even though marked van.

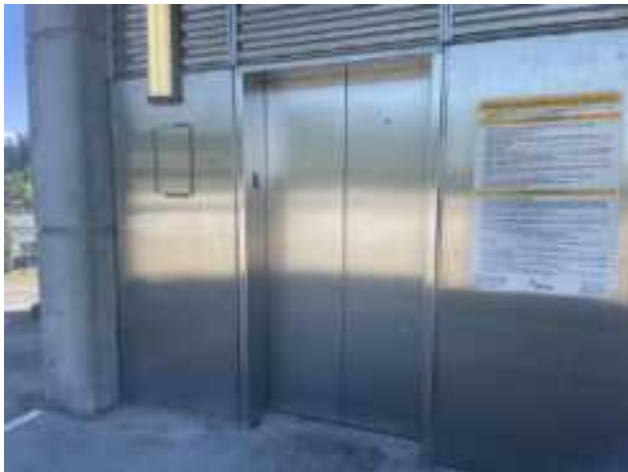
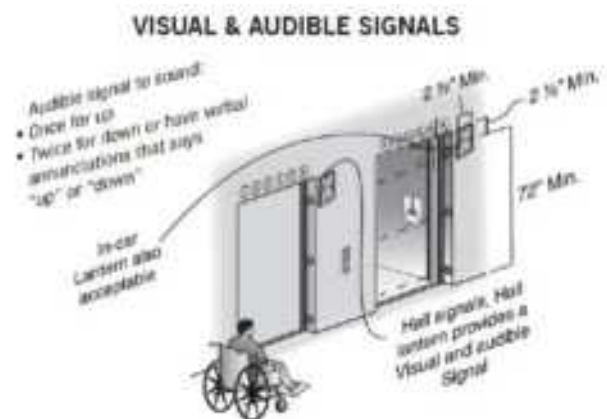
Alter or replace the audible call system to meet the compliant requirements.

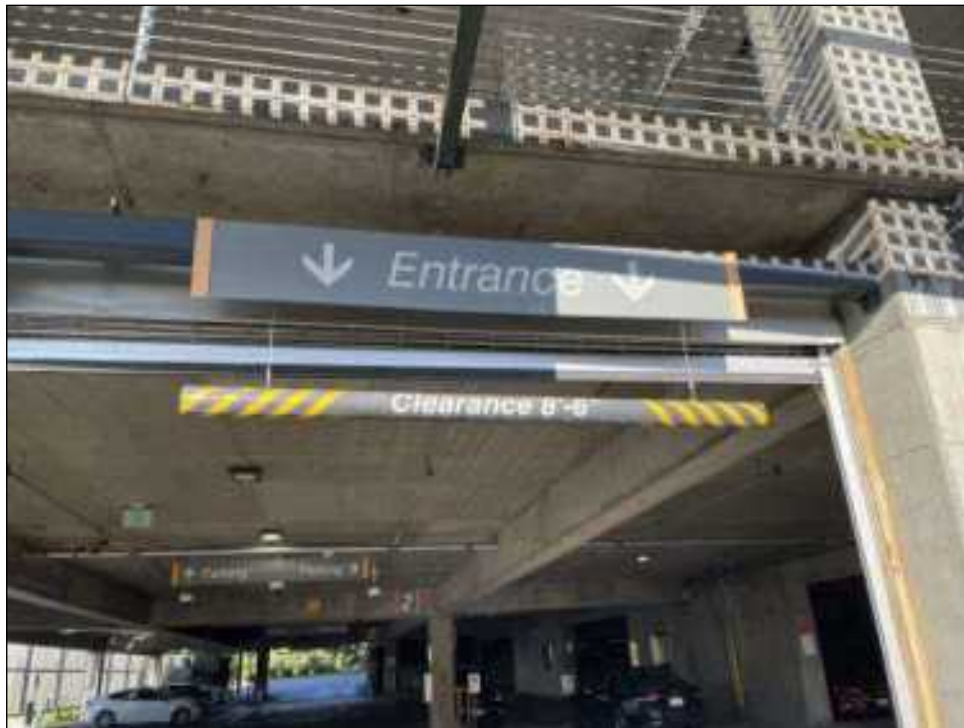
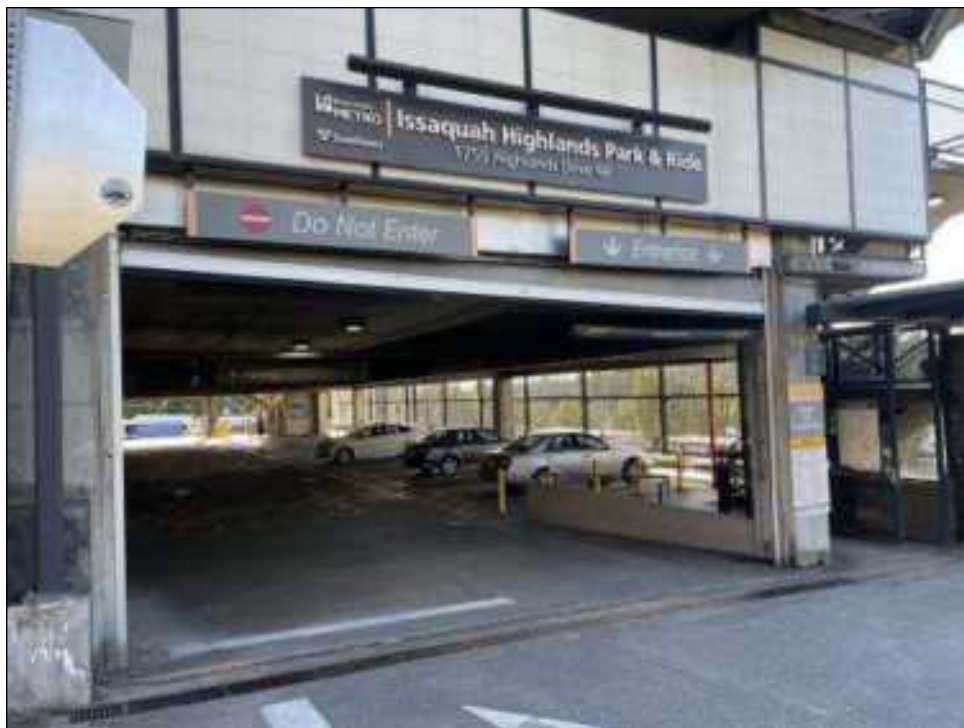
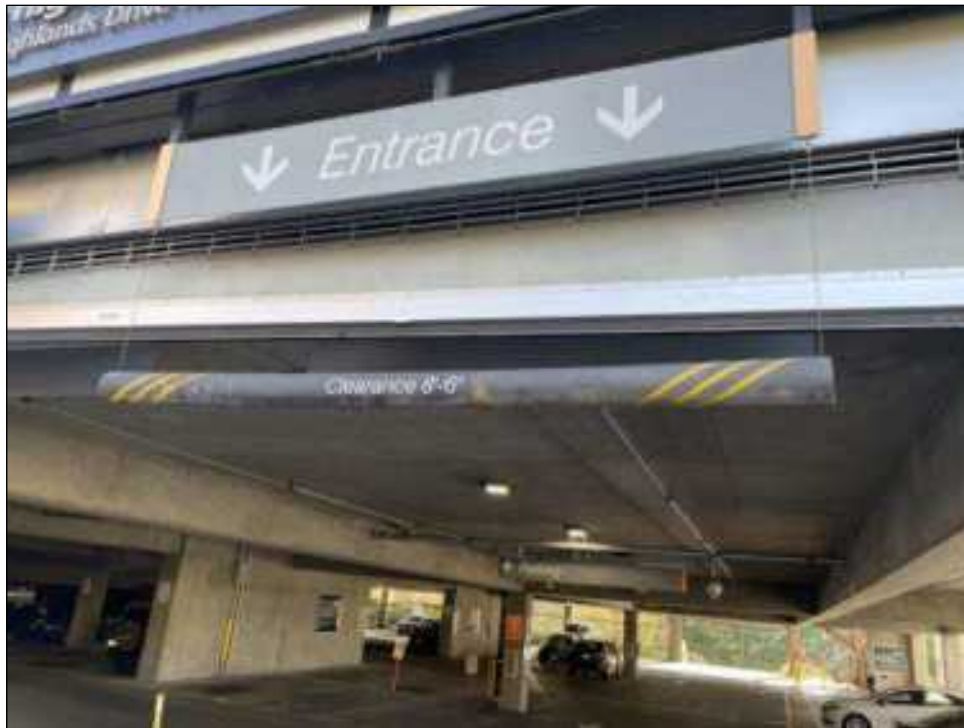
## **Barrier #2 Additional Barrier Photos**

Low (Level 9): Restrooms (DOJ Level 3) – minimally out of compliance

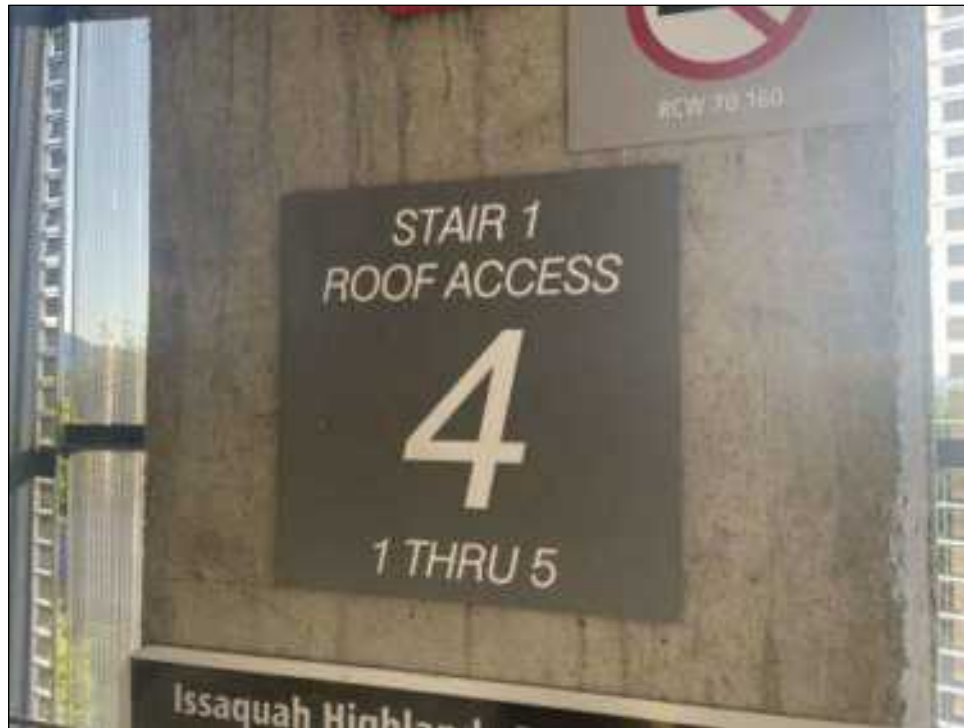
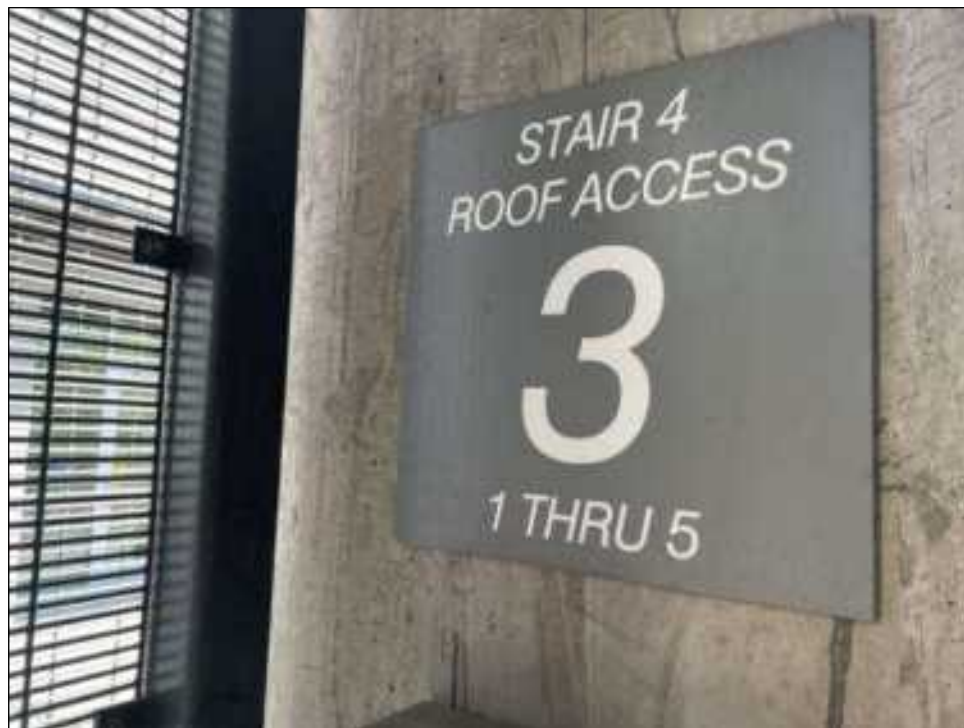
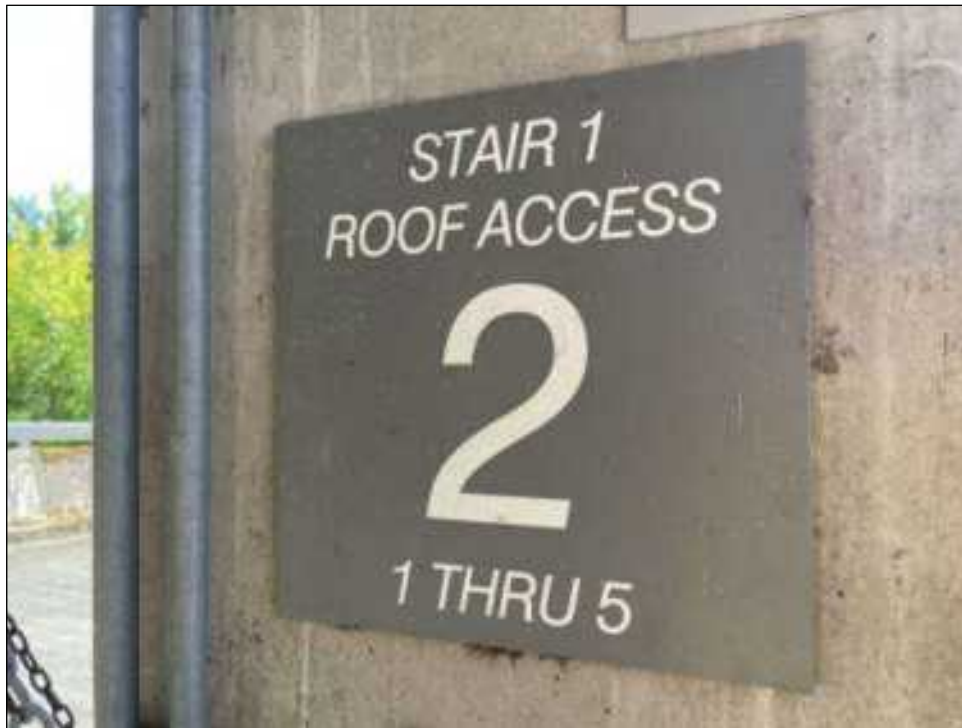
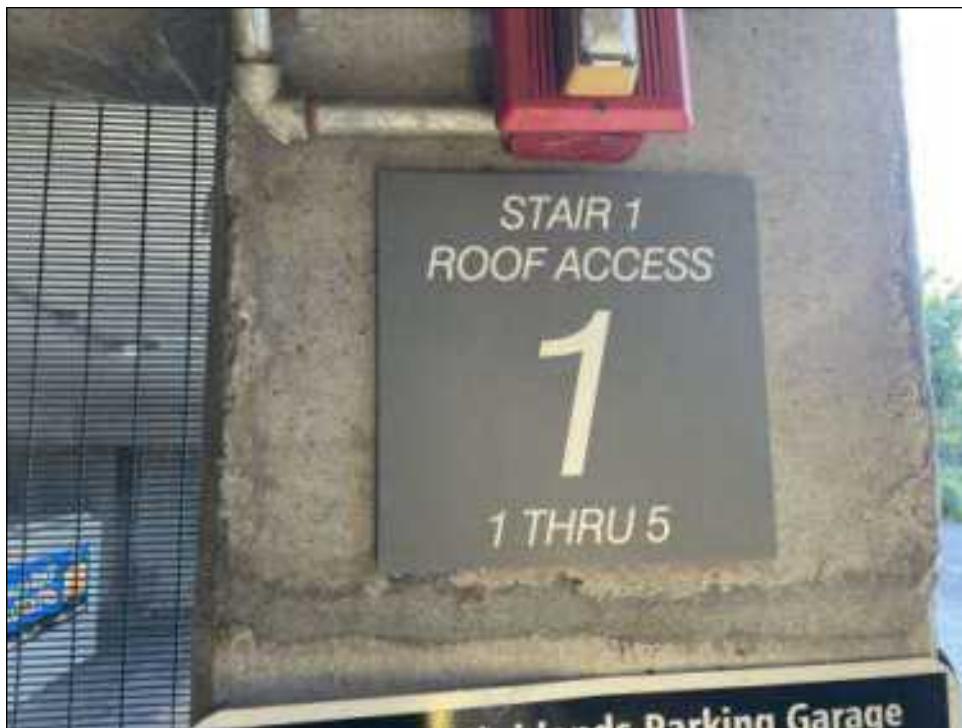
**Barrier #3 Additional Barrier Photos**

Low (Level 9): Restrooms (DOJ Level 3) – minimally out of compliance

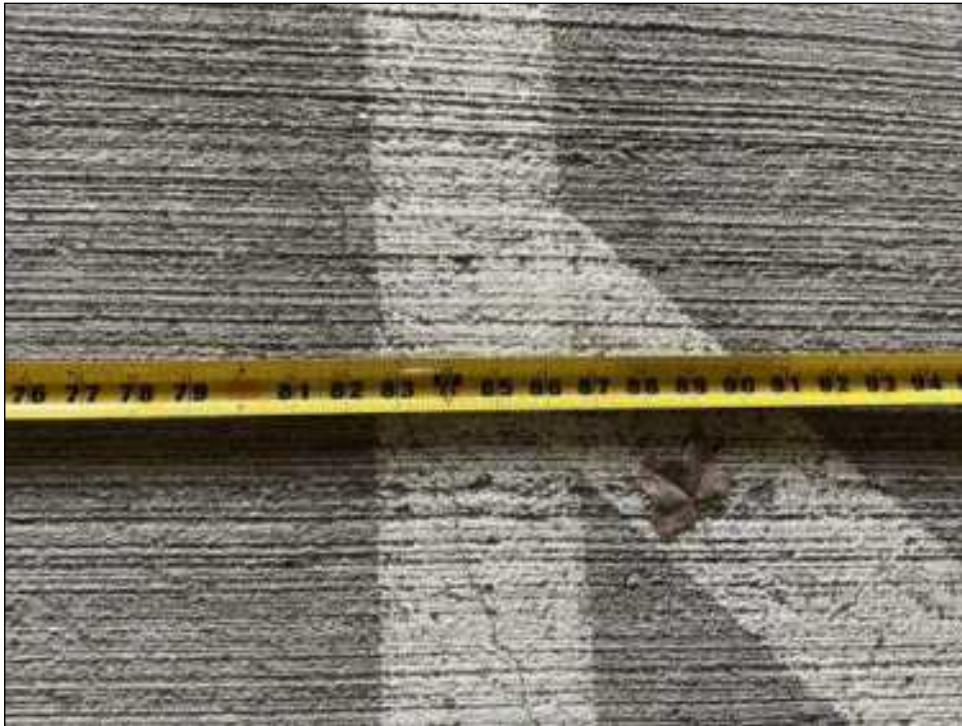
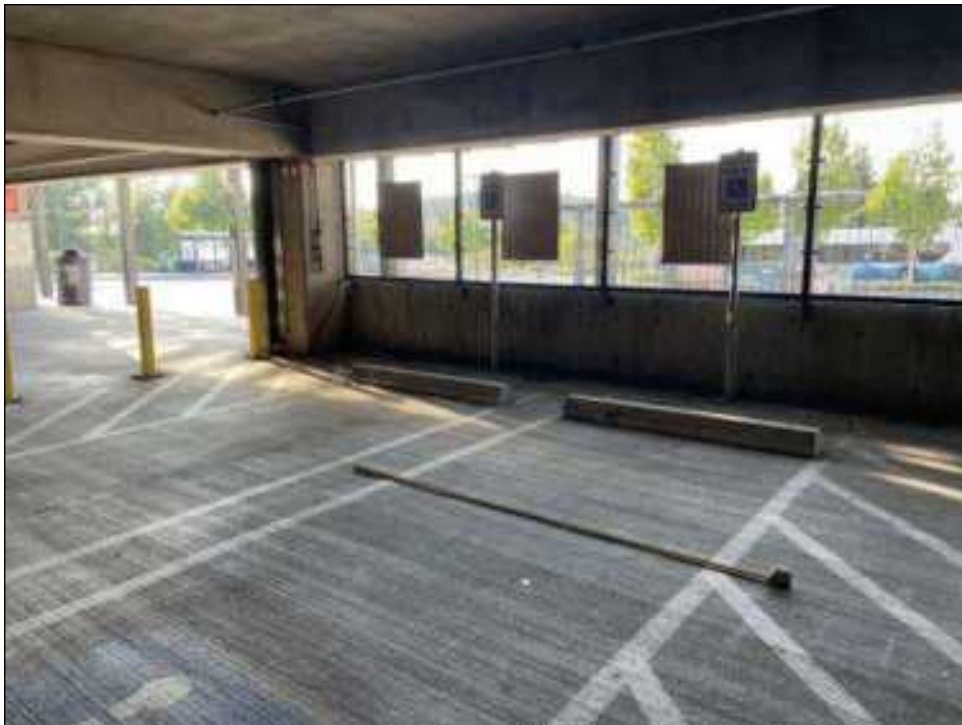
**Barrier #4 Additional Barrier Photos**

Access to goods and services (DOJ Level 2) – moderately out of compliance

Restrooms (DOJ Level 3) – severely out of compliance

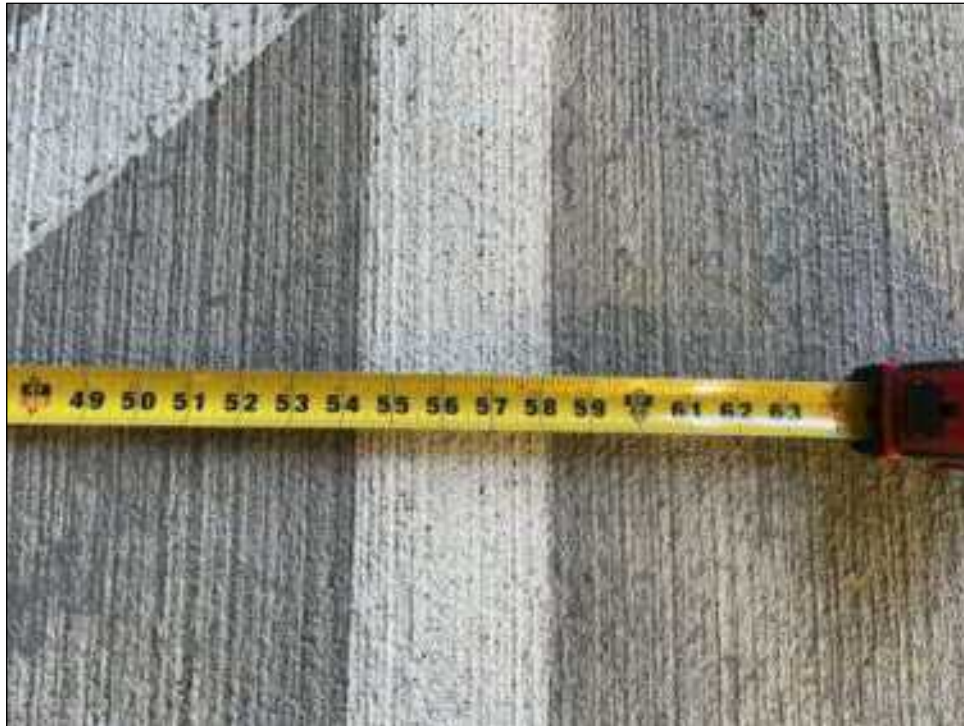
**Barrier #5 Additional Barrier Photos**

Access to goods and services (DOJ Level 2) – moderately out of compliance

Restrooms (DOJ Level 3) – severely out of compliance

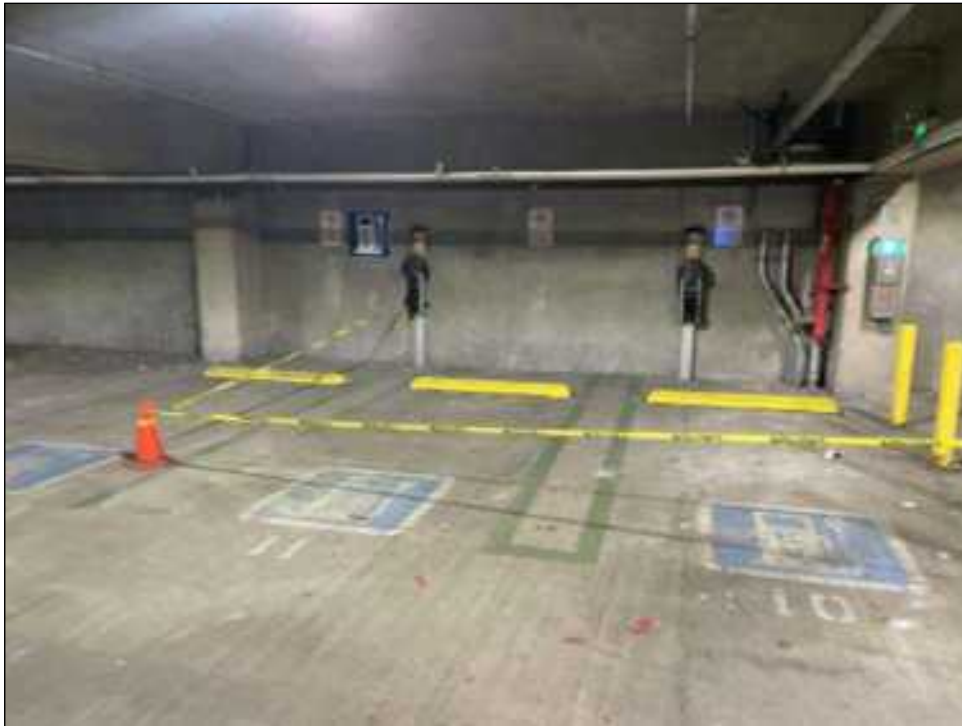
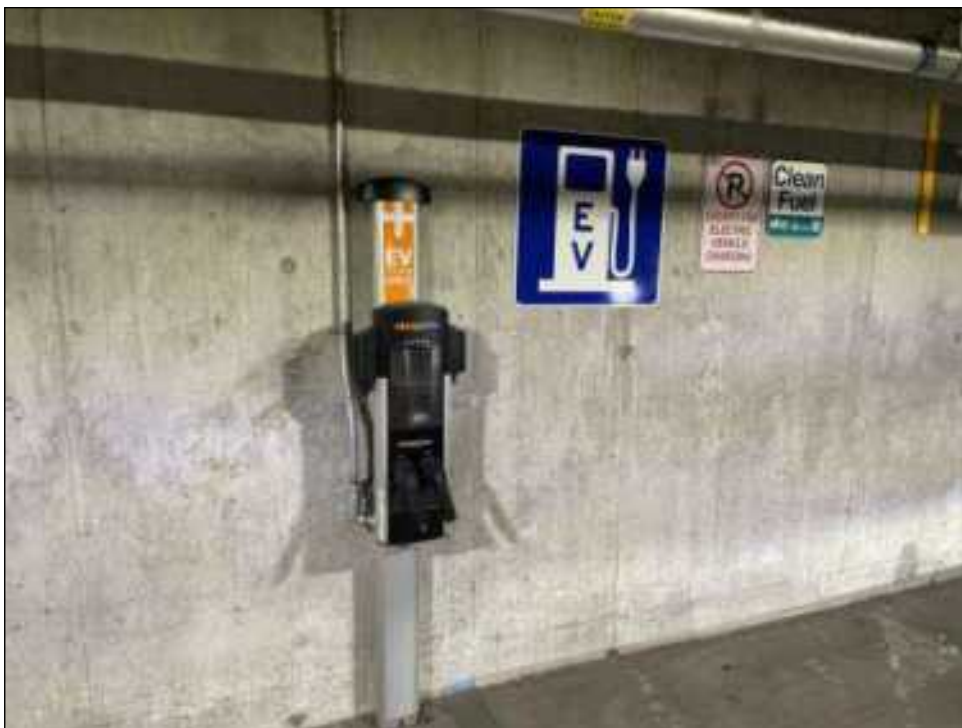
**Barrier #6 Additional Barrier Photos**

Although these may be eligible for safe harbor and there are specific standards adopted at this time, it is recommended that the agency follow The U.S. Access Board's Design Recommendations for Accessible Electric Vehicle Charging Stations.

Low (Level 12): Element is in compliance with previous standards (safe-harbor) but must comply with current standards if altered

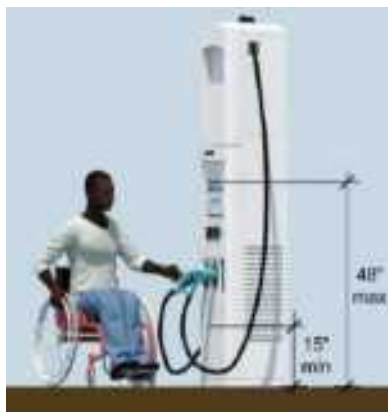
### **Unobstructed side reach**

All operable parts should meet the requirements for an unobstructed side reach ([§308.3.1](#)) and be no higher than 48 inches above the clear floor or ground space and no farther than 10 inches away. The exception for fuel dispensers should not be used (See: fuel dispensers). Placing operable parts higher than the 15 inch minimum is recommended.

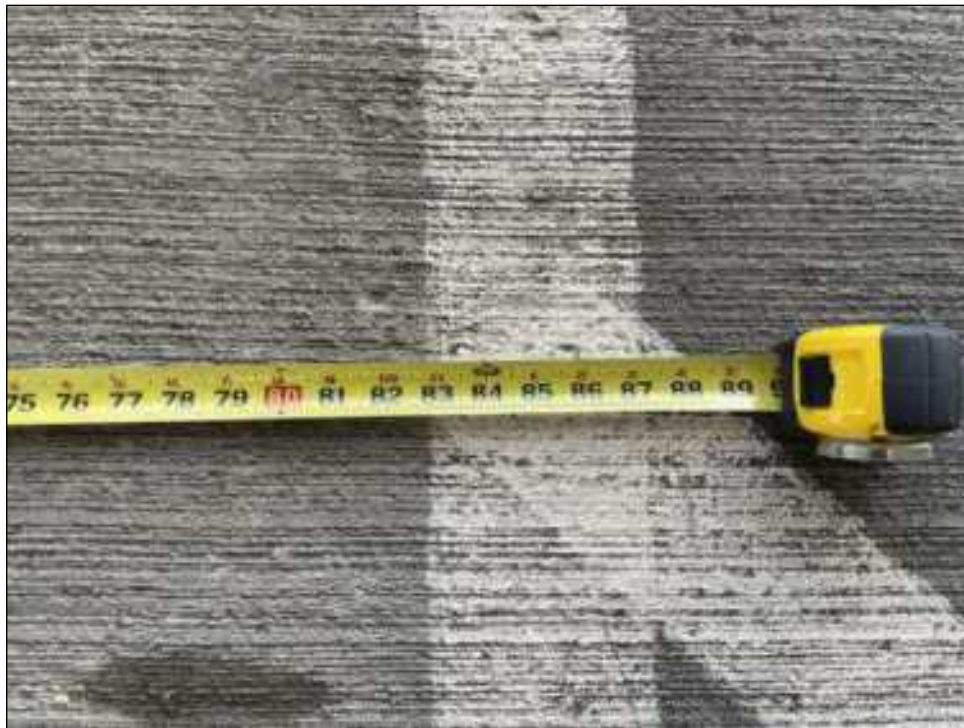
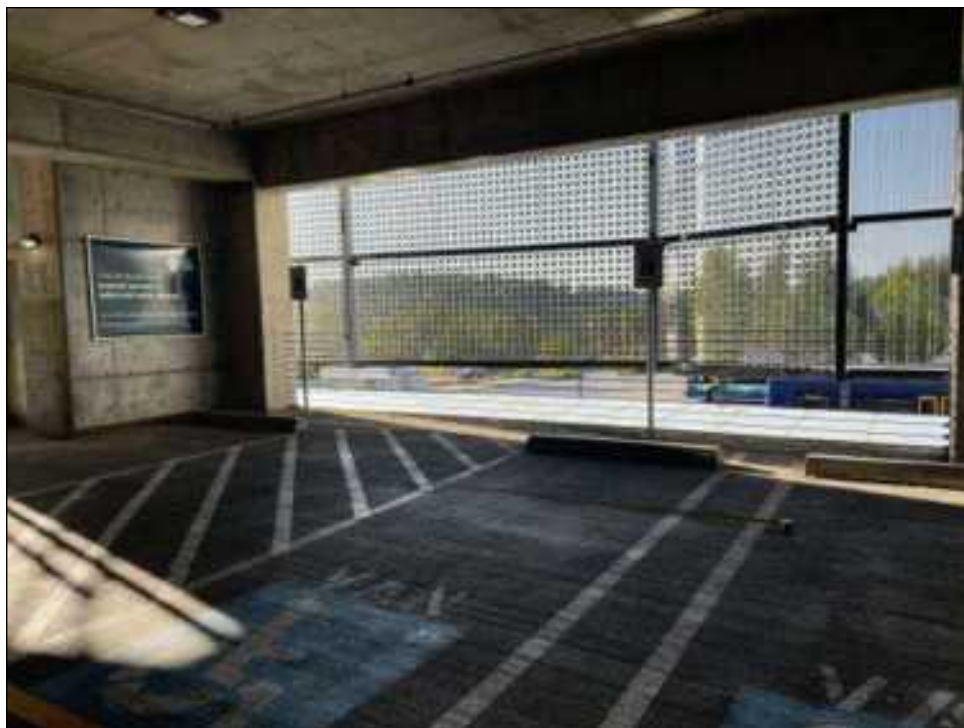
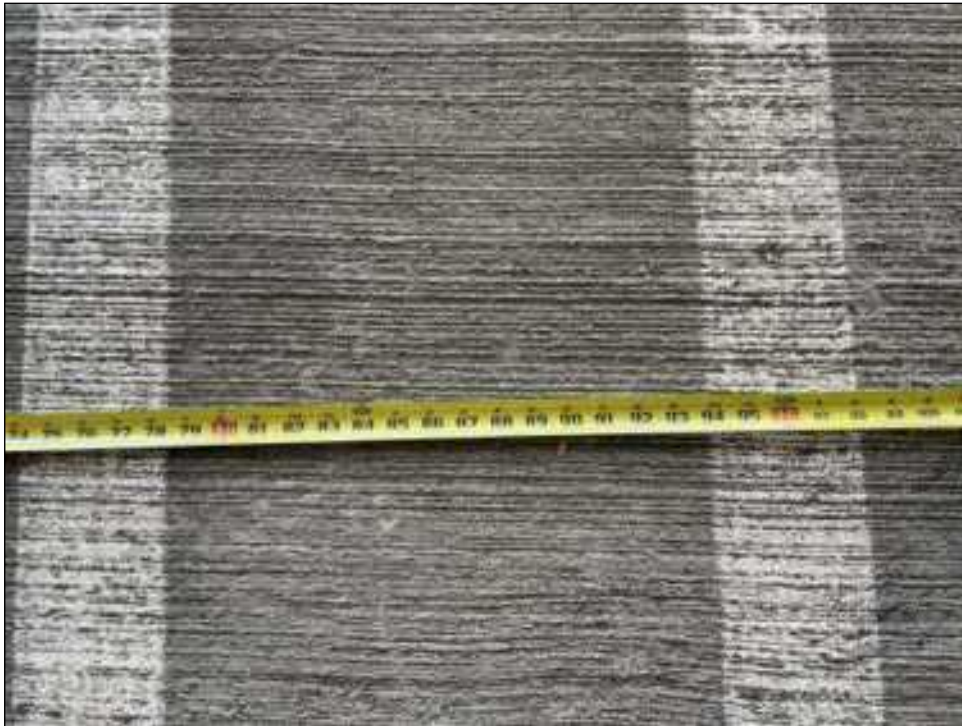
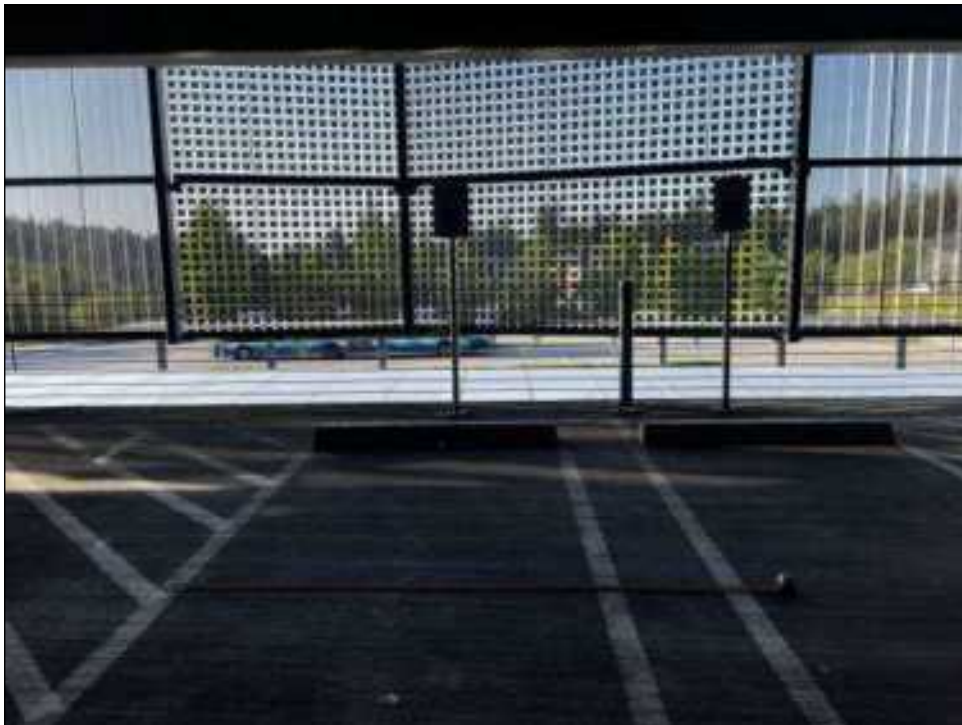
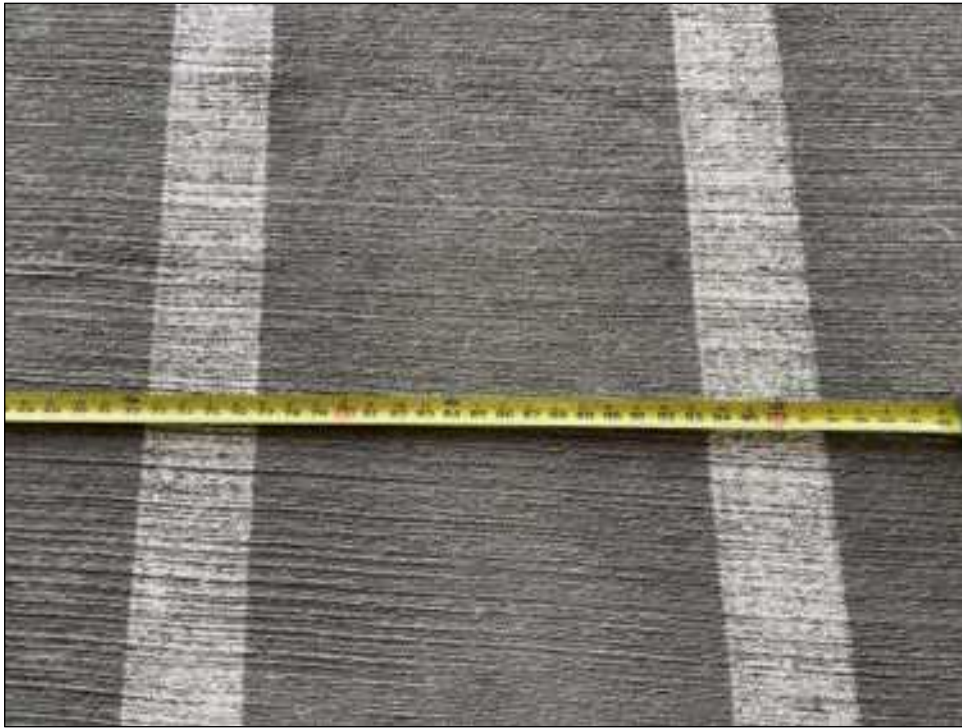
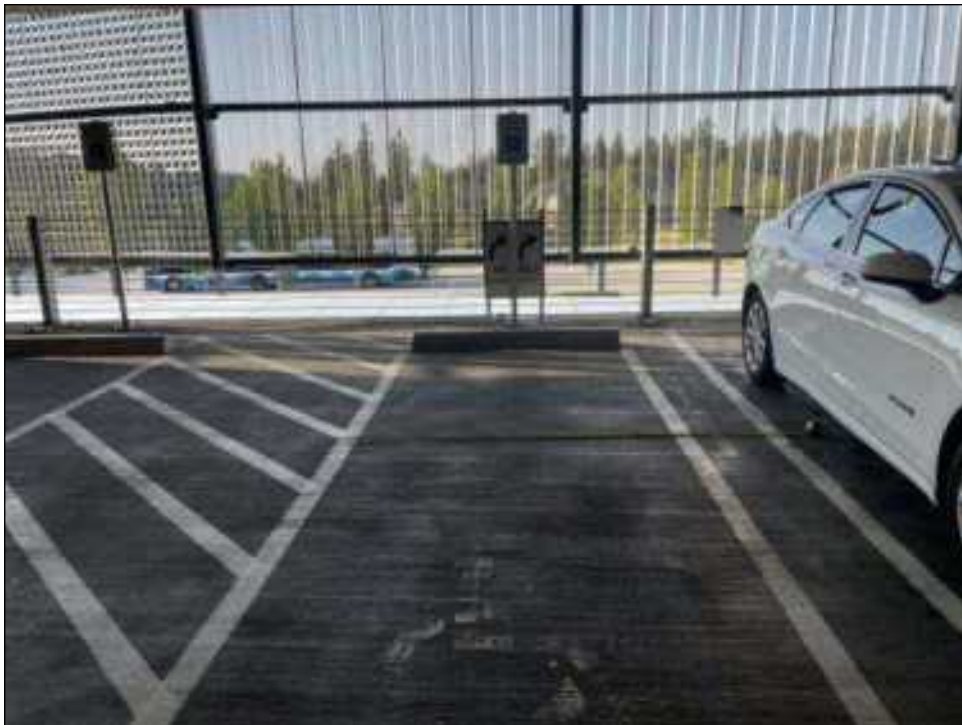
**Barrier #7 Additional Barrier Photos**

Medium (Level 5): Access to goods and services issues (DOJ Level 2) – severely out of compliance
