**King County**  
**ADA Self-Evaluation and Transition Plan Update**  
**Facility Cost Projection Summary**  
**August 2023**

# Site Accessibility Evaluation

**Burien PnR Garage (KC)**  
**14900 4th Ave SW**  
**Burien, WA 98166**  
**Accessibility Evaluation**  
**Inspection Date: 07/11/2023**  
**Evaluators: Kalia Klein**

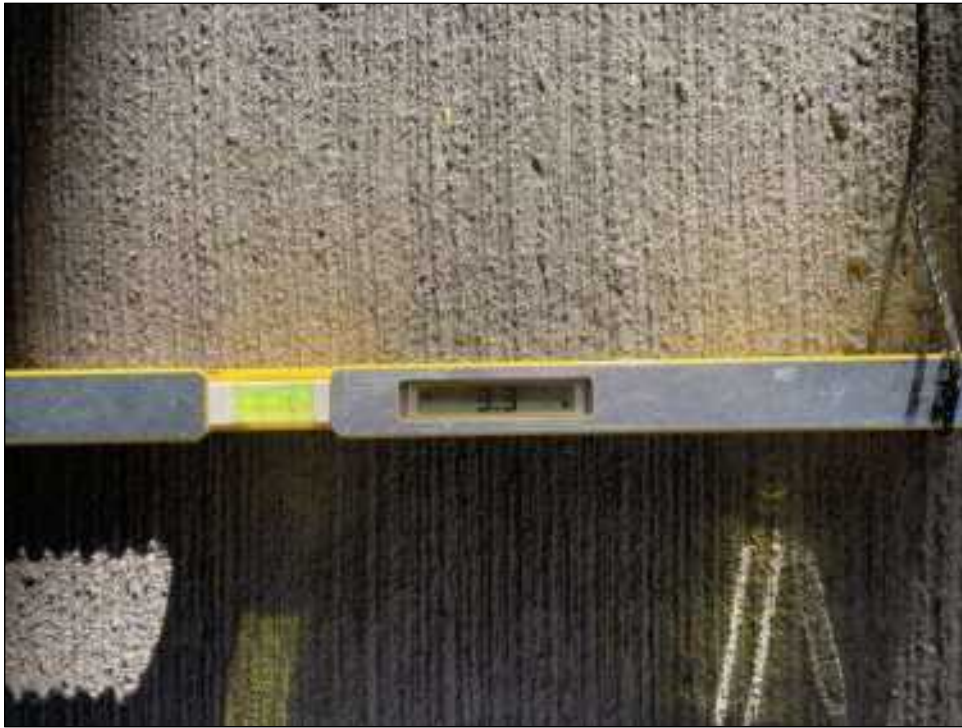
**Barrier #8 Additional Barrier Photos**

High (Level 4): Parking and exterior accessible routes (DOJ Level 1) – moderately out of compliance

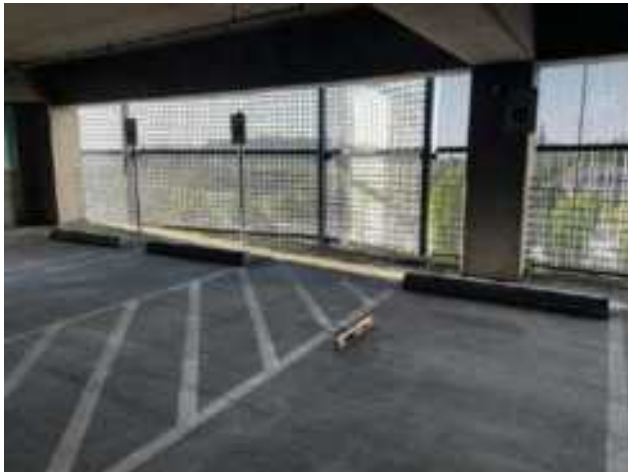
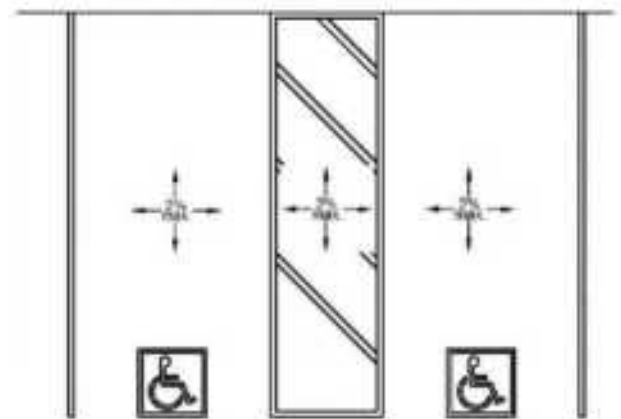
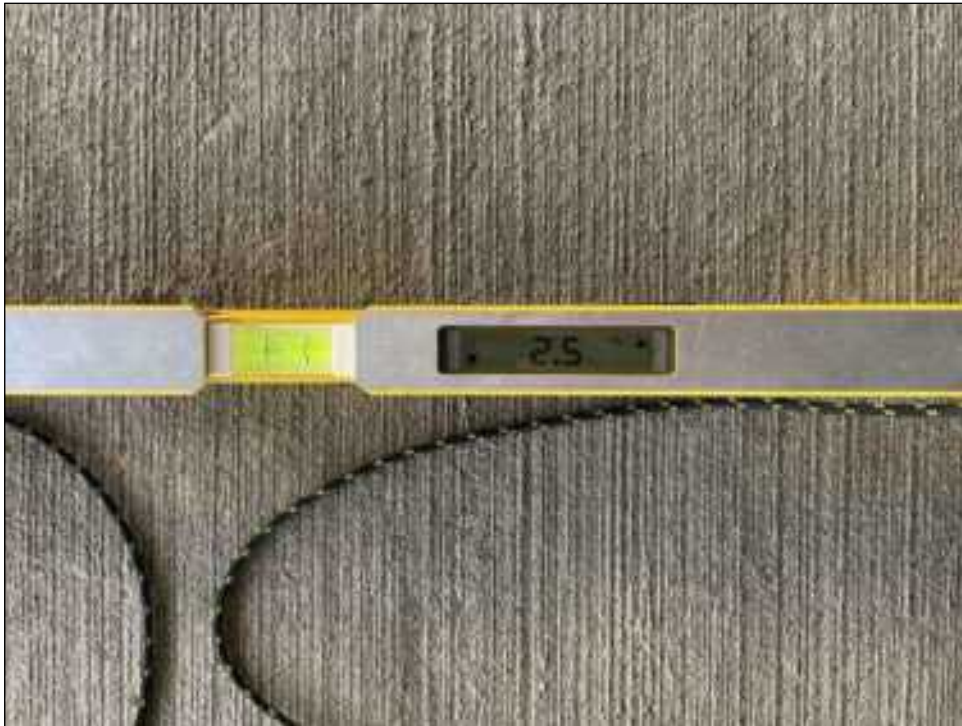
**Barrier #9 Additional Barrier Photos**

High (Level 4): Parking and exterior accessible routes (DOJ Level 1) – moderately out of compliance

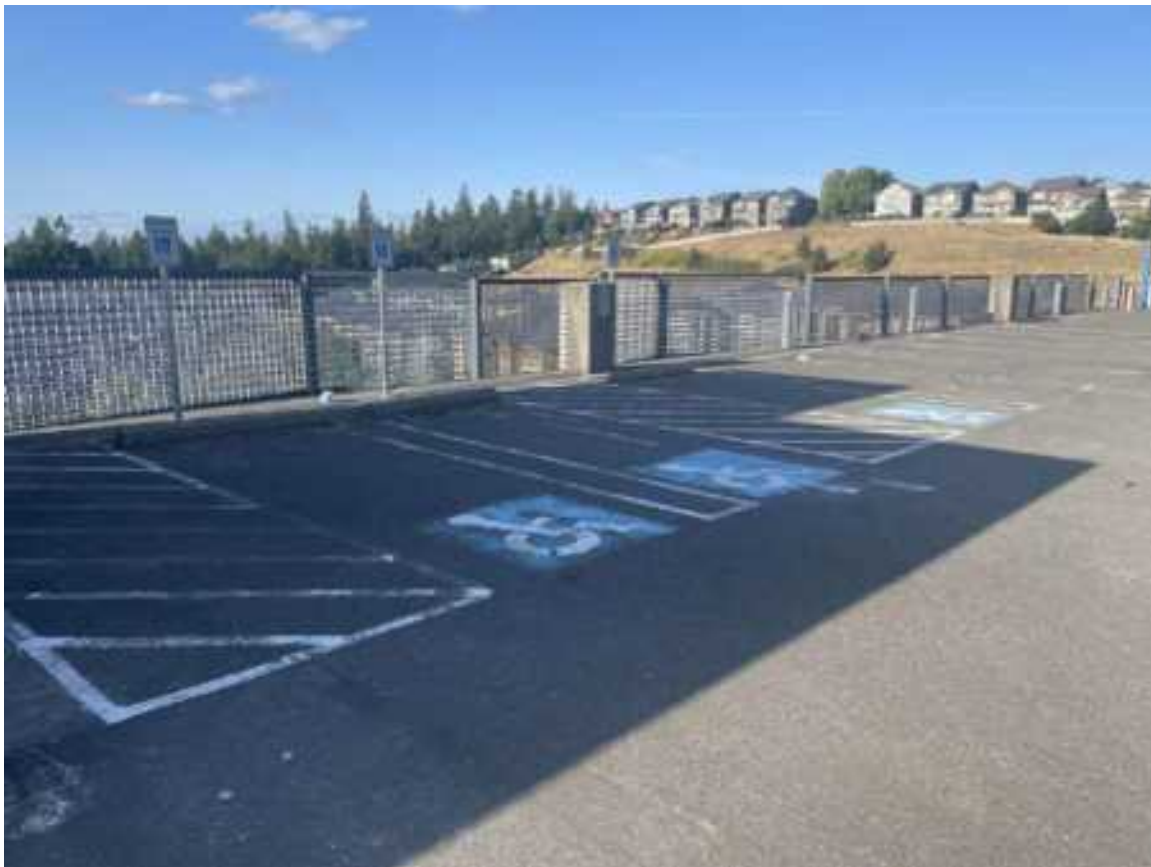
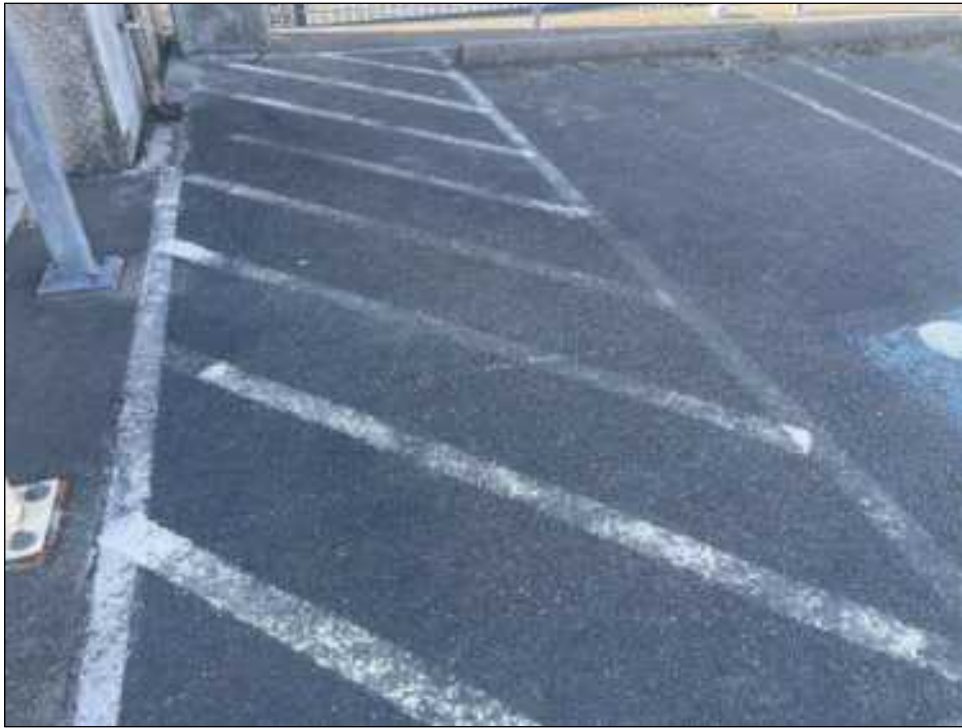
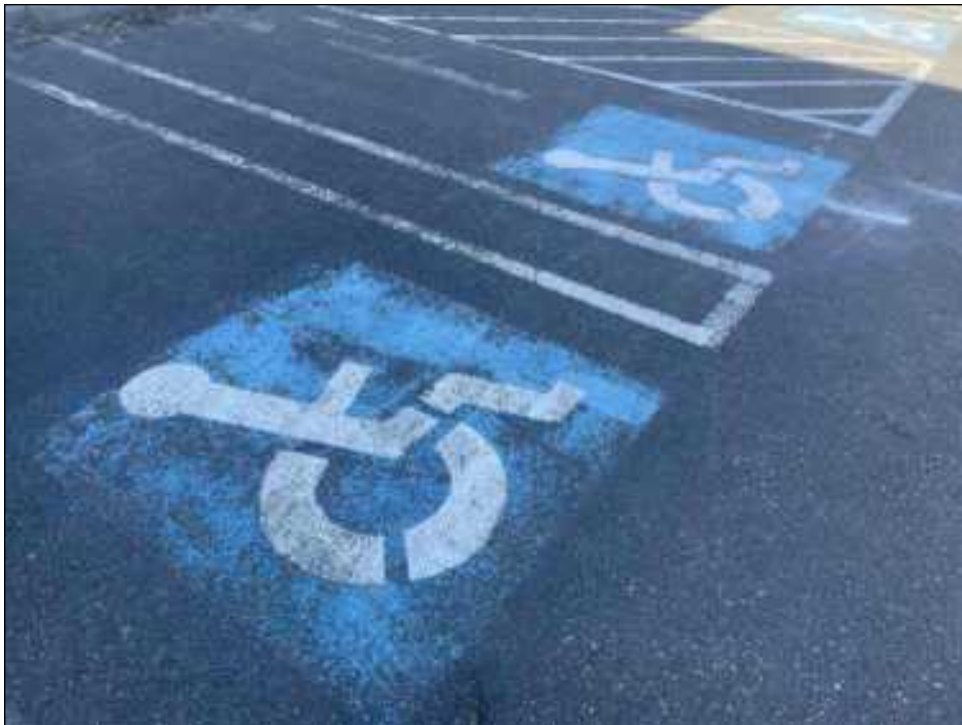
**Barrier #13 Additional Barrier Photos**

The striping and markings for the accessible parking stalls and loading/unloading access aisle are dilapidated and in need of repair and/or maintenance.

Alter and/or repair the markings for the accessible parking stalls and loading/unloading access aisle.

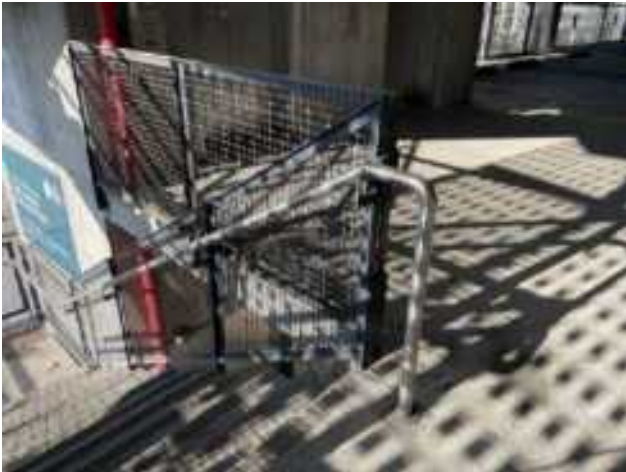
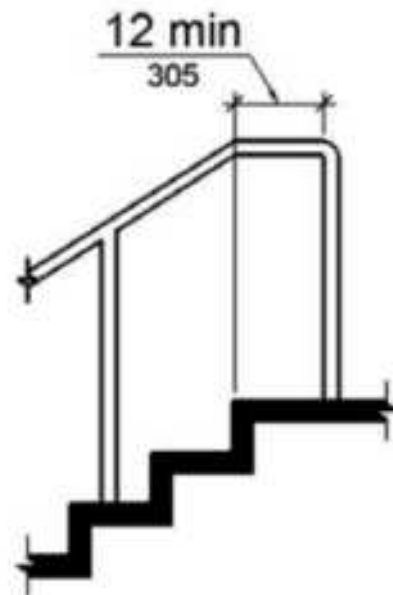
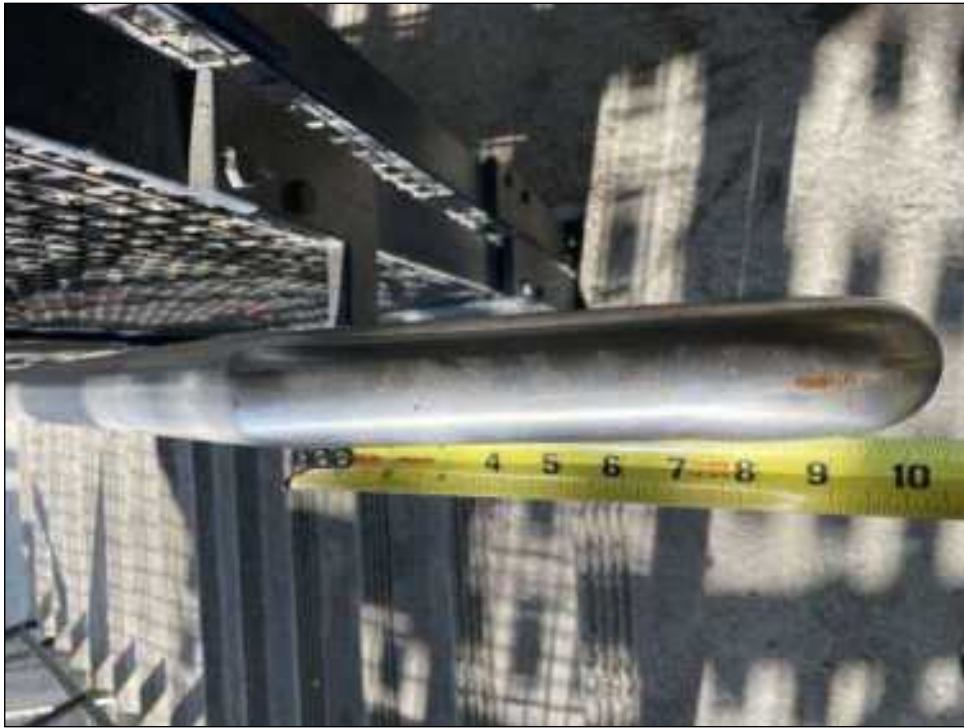
**Barrier #16 Additional Barrier Photos**

Alter or replace the handrails to ensure they have the required extensions as detailed in the figure on this page.

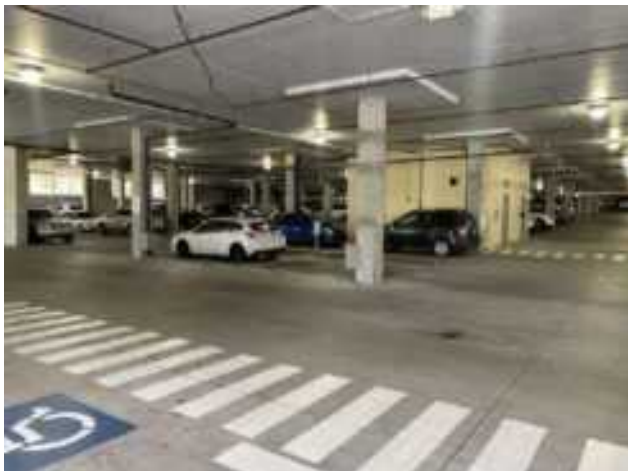
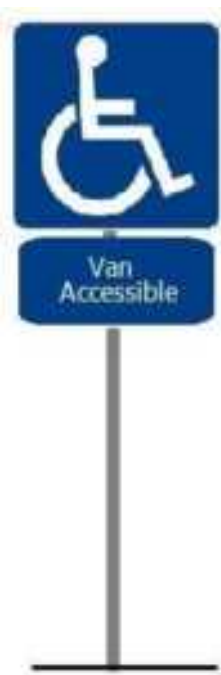
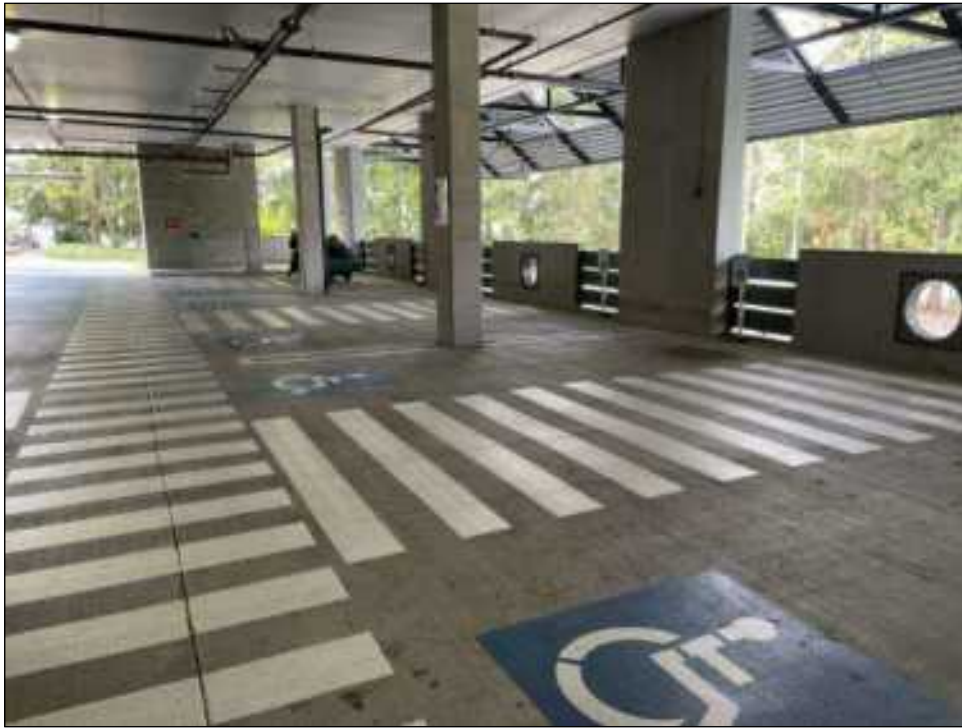
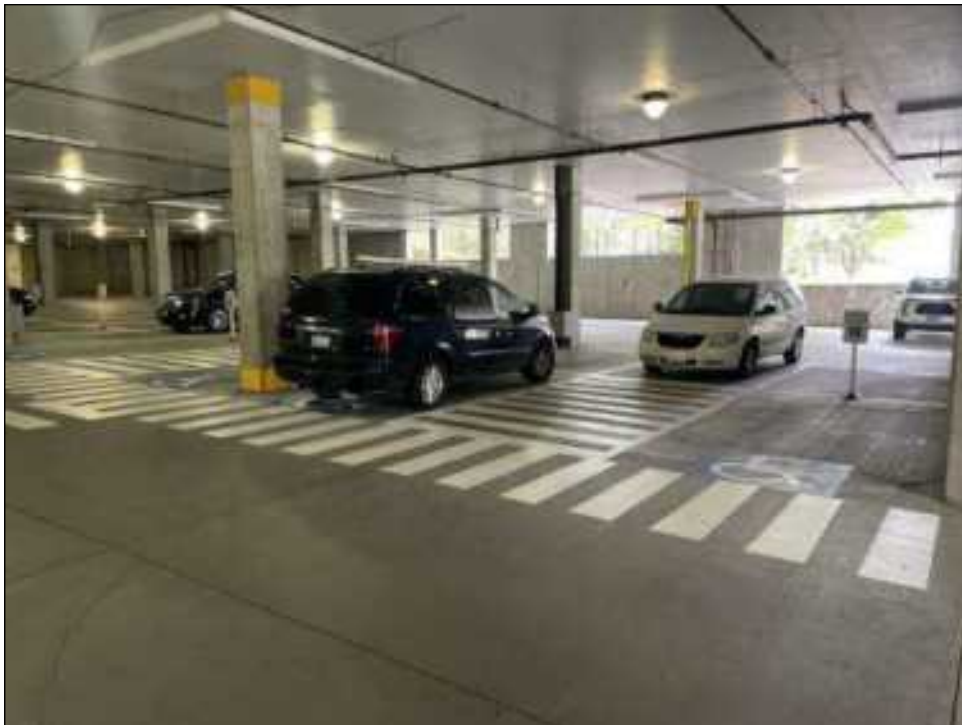
## Barrier #1 Additional Barrier Photos

The van stalls are missing a sign identifying it as a van-accessible stall.

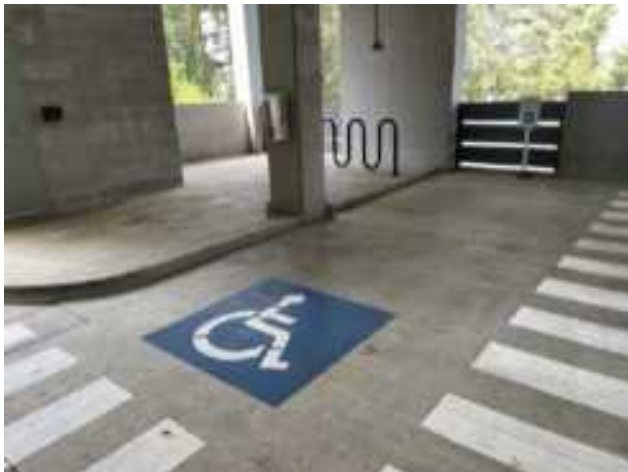
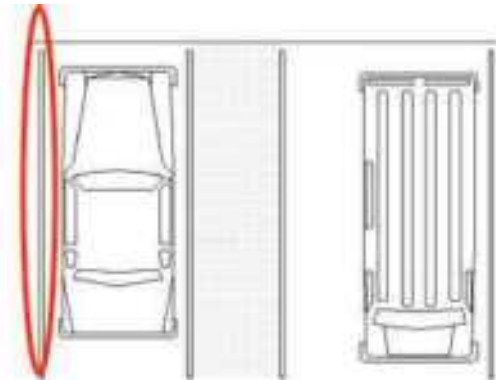
### Barrier: 3

The stripe is missing on the left parking stall which identifies its border.

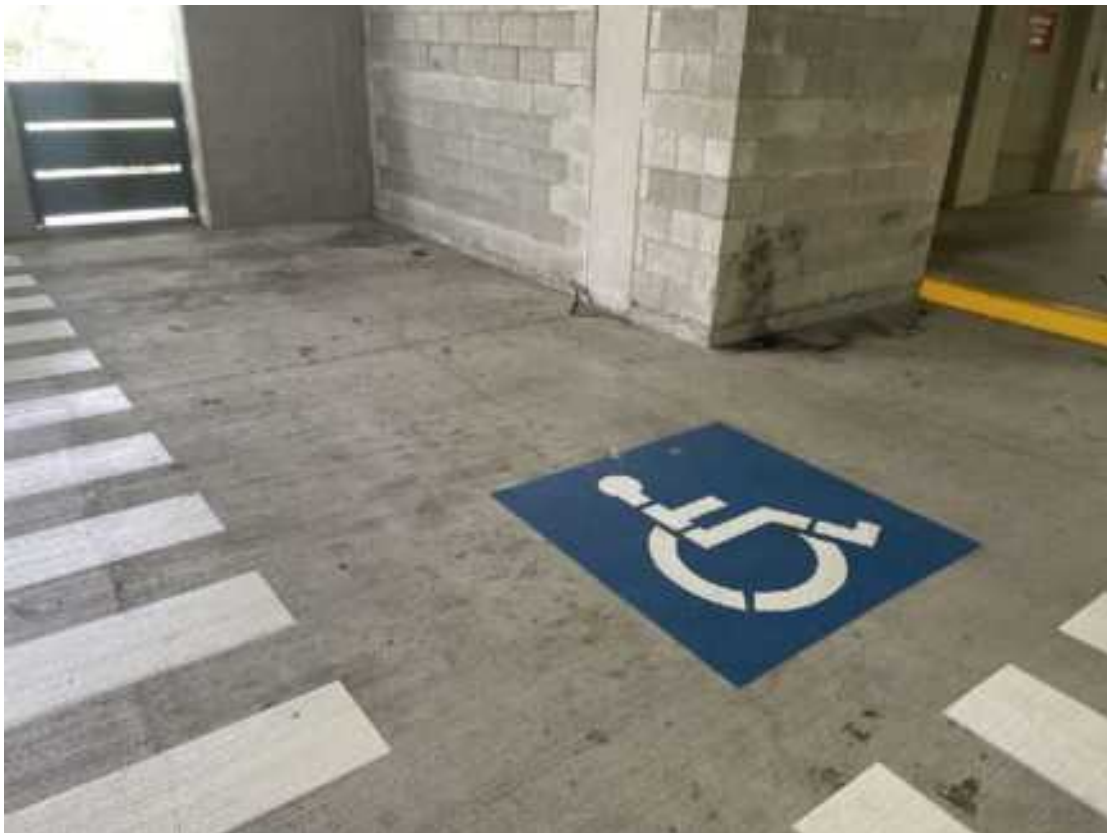
### Barrier: 4

The accessible parking space is missing the required markings.

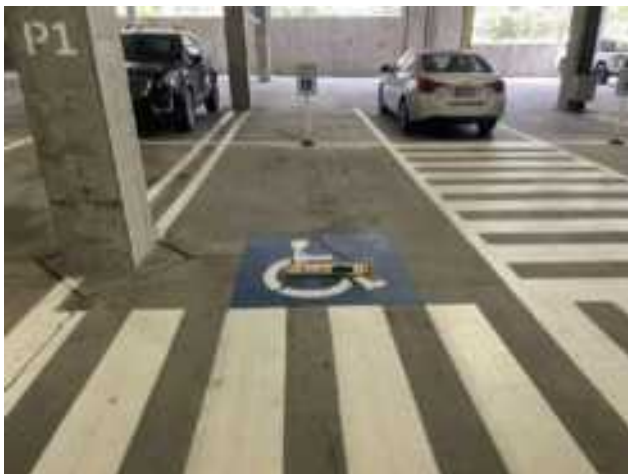
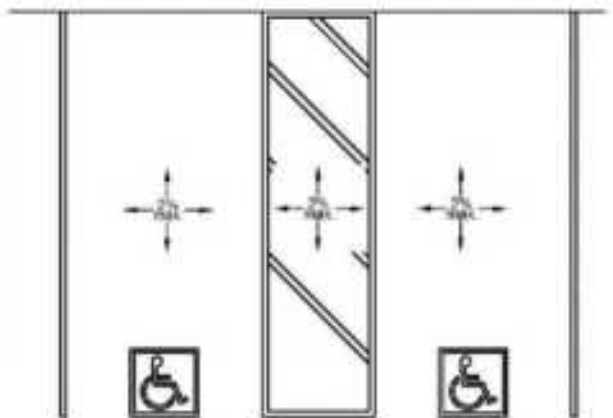
### Barrier: 5

Alter or replace the existing accessible parking space to ensure the slope is no more than 2.08 percent as required.

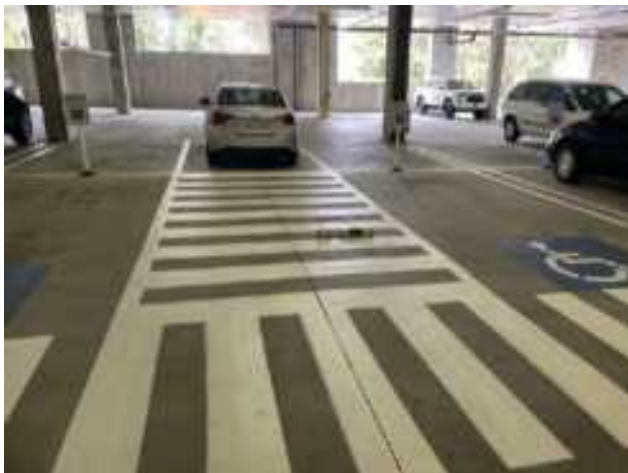
### Barrier: 6

Alter or replace the existing accessible aisle to ensure the slope is no more than 2.08 percent as required.

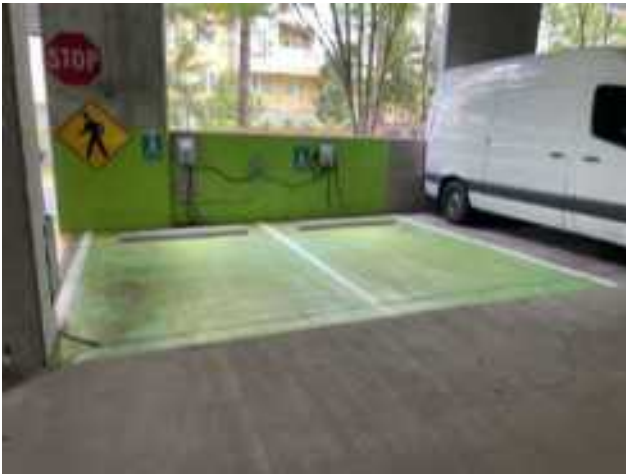
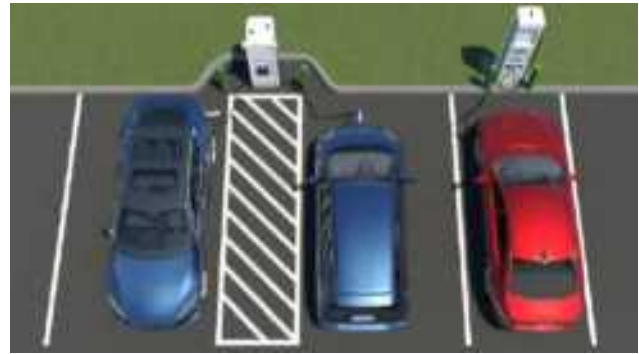
## Barrier #7 Continued

Although these may be eligible for safe harbor and there are specific standards adopted at this time, it is recommended that the agency follow The U.S. Access Board's Design Recommendations for Accessible Electric Vehicle Charging Stations.

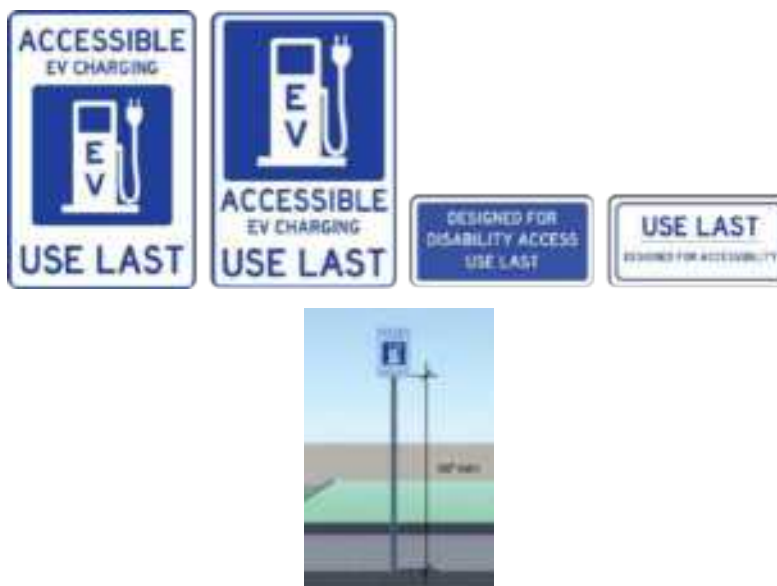
A “use last” sign would indicate an EV charging space is accessible, but also direct people to use this space only when other charging spaces are occupied or accessibility features are needed.

At the time of this guidance, neither Manual on Uniform Traffic Control Devices (MUTCD) nor any other code-setting organization has a standard for “use last” signs, but the Access Board has designed several examples.

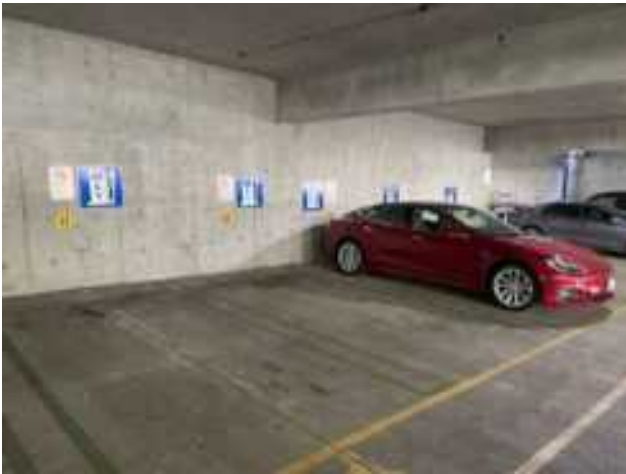
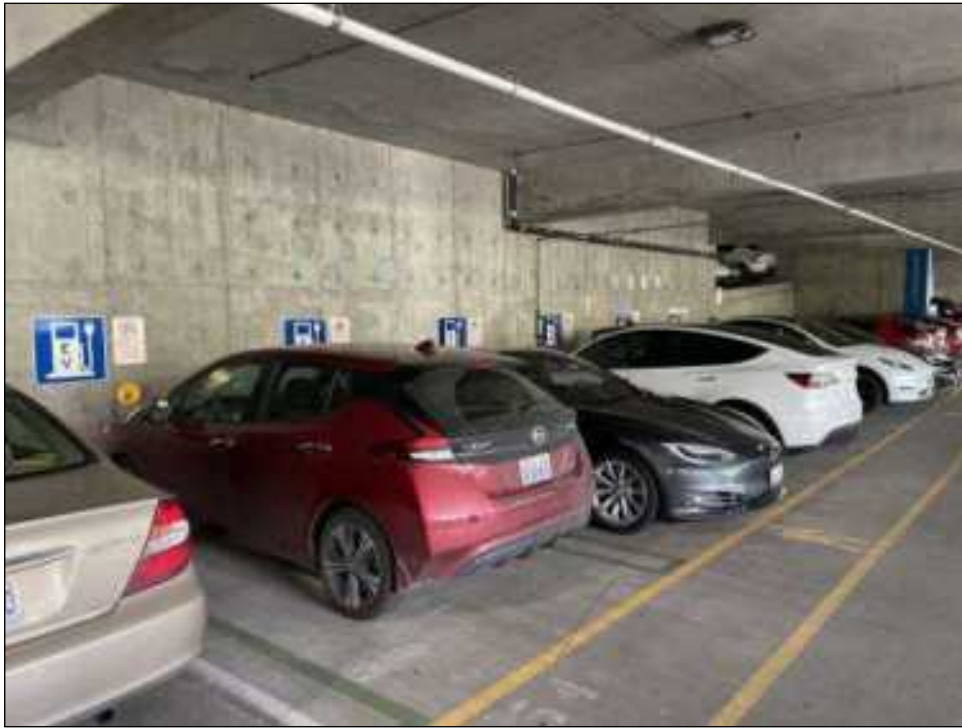
**Barrier #3 Additional Barrier Photos**

Although these may be eligible for safe harbor and there are specific standards adopted at this time, it is recommended that the agency follow The U.S. Access Board's Design Recommendations for Accessible Electric Vehicle Charging Stations.

The U.S. Access Board has released Design Recommendations for Accessible Electric Vehicle Charging Stations, a technical assistance document that reviews existing requirements and new recommendations for making electric vehicle (EV) charging stations accessible.

Low (Level 12): Element is in compliance with previous standards (safe-harbor) but must comply with current standards if altered

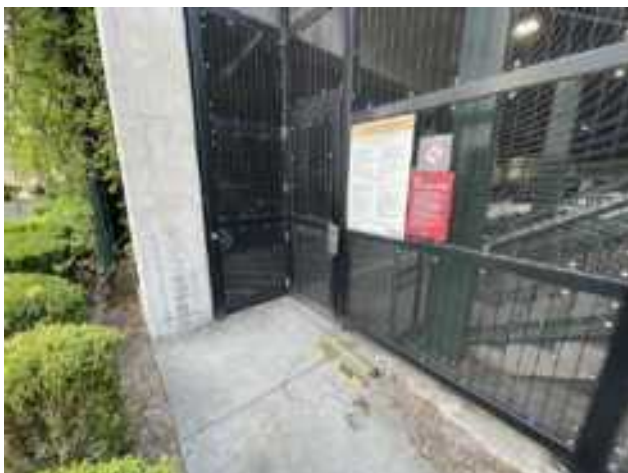
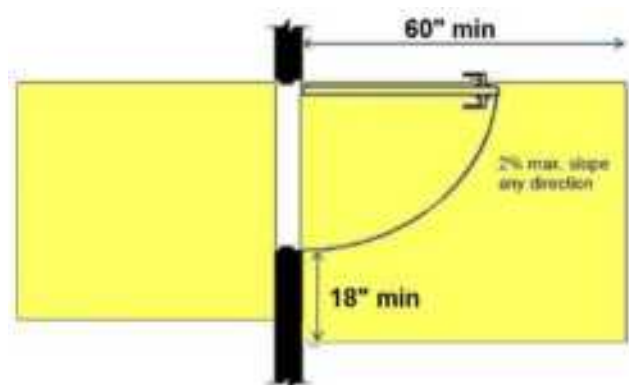
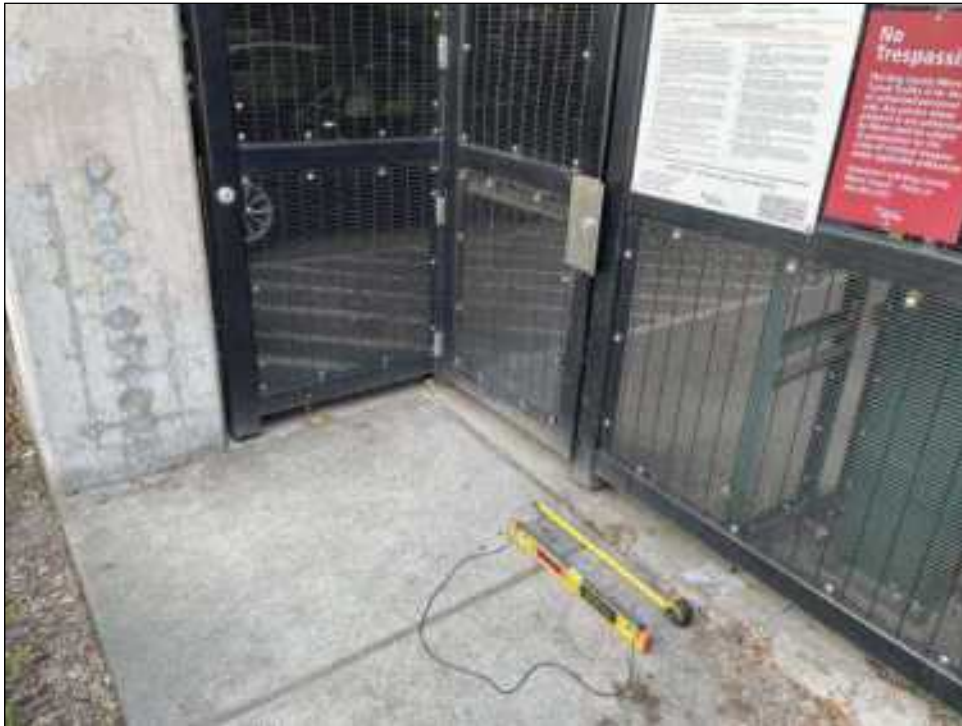
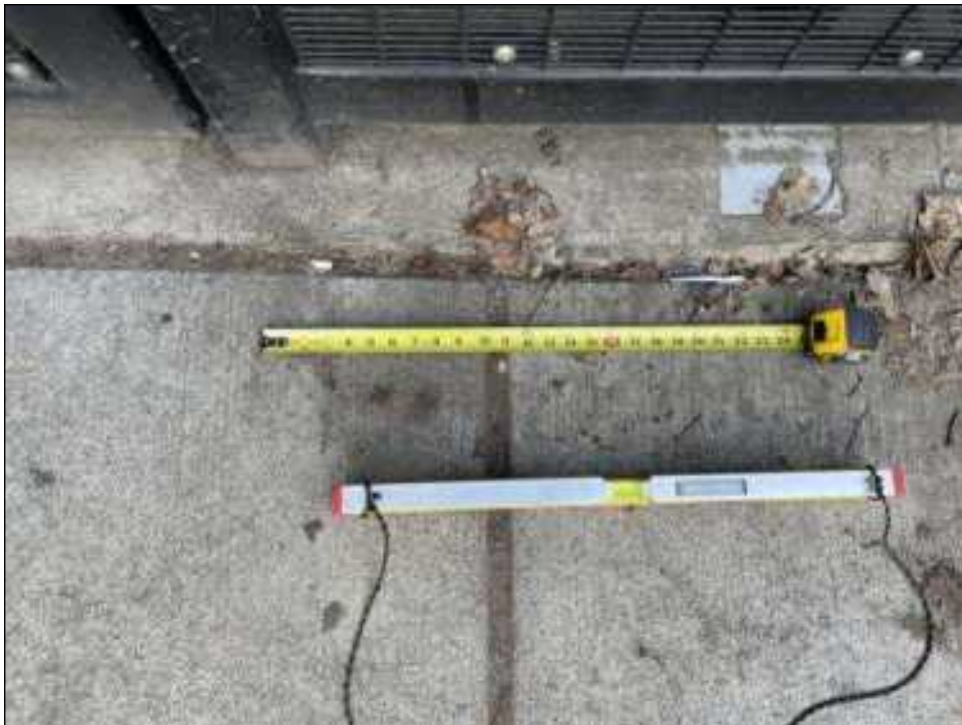
## Barrier #4 Additional Barrier Photos

Medium (Level 5): Access to goods and services issues (DOJ Level 2) – severely out of compliance

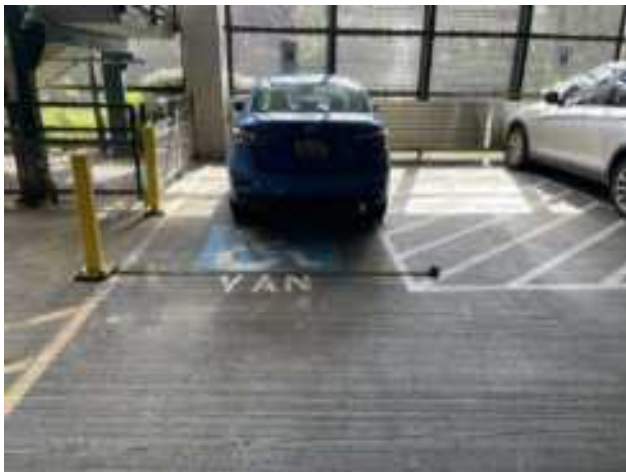
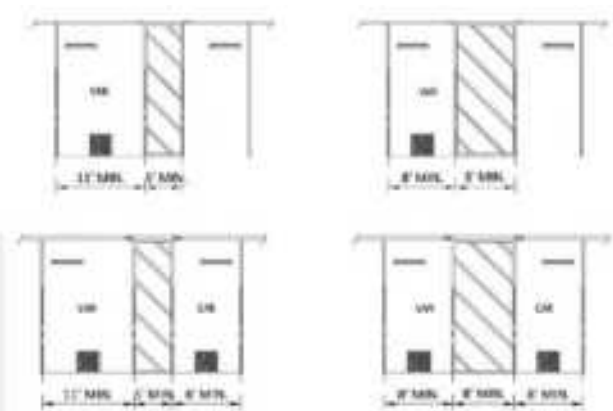
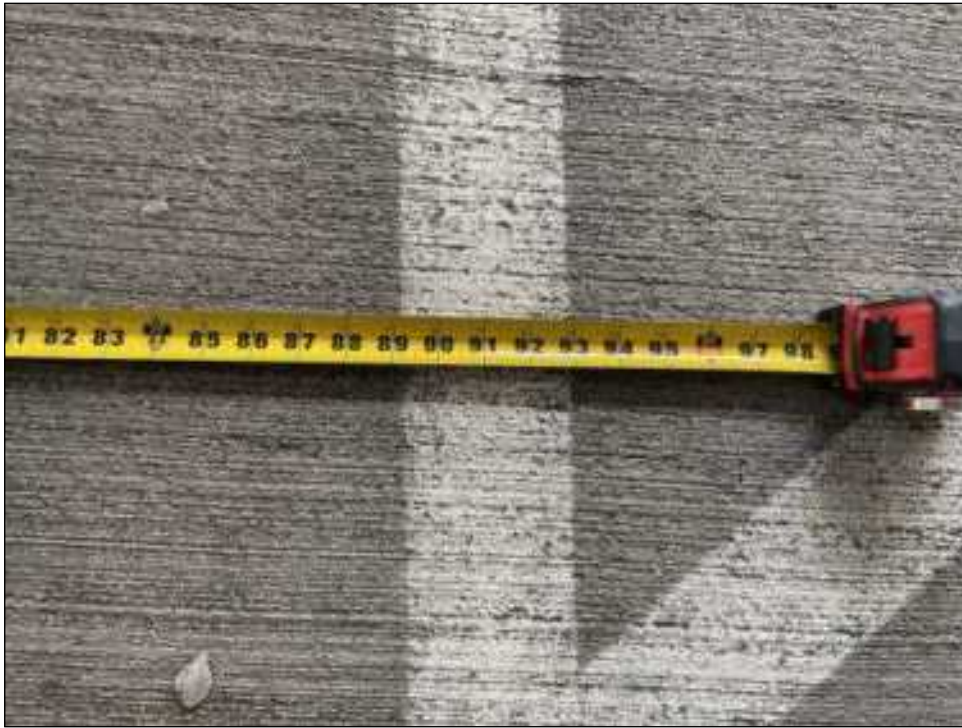
## Barrier #8 Additional Barrier Photos

Medium (Level 5): Access to goods and services issues (DOJ Level 2) – severely out of compliance

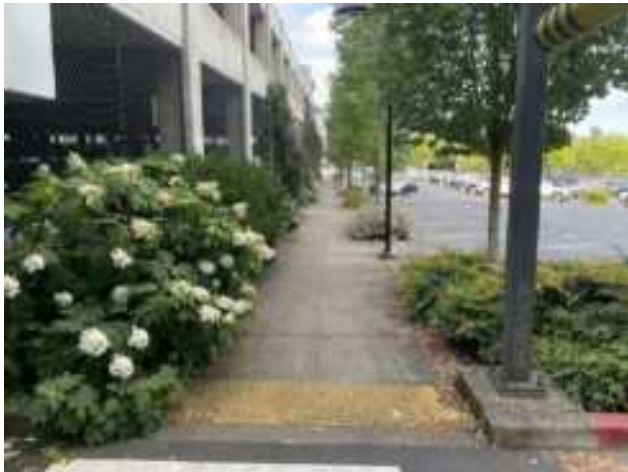
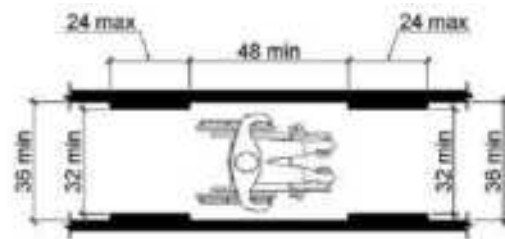
Vegetation along the accessible route from the public way obstructs headroom in maneuvering, clear floor, spaces, maintenance and trimming are recommended.

High (Level 4): Parking and exterior accessible routes (DOJ Level 1) – moderately out of compliance

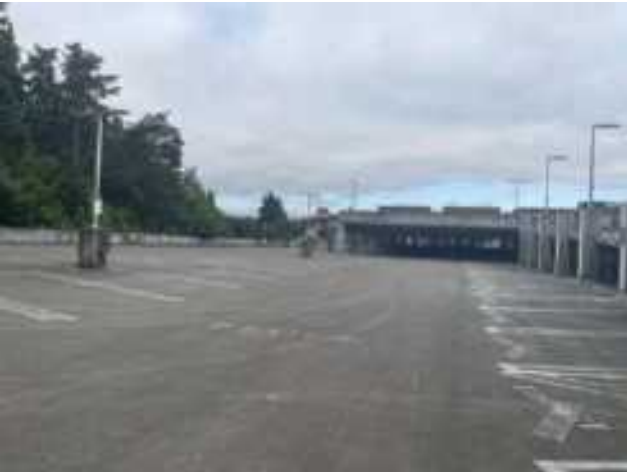
Barrier Priority:

High (Level 4): Parking and exterior accessible routes (DOJ Level 1) – moderately out of compliance

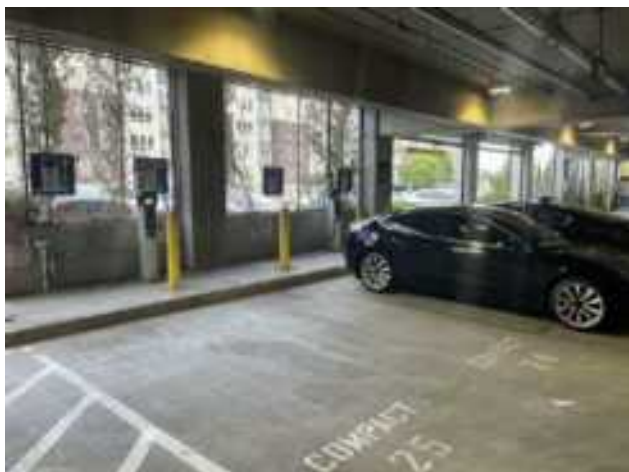
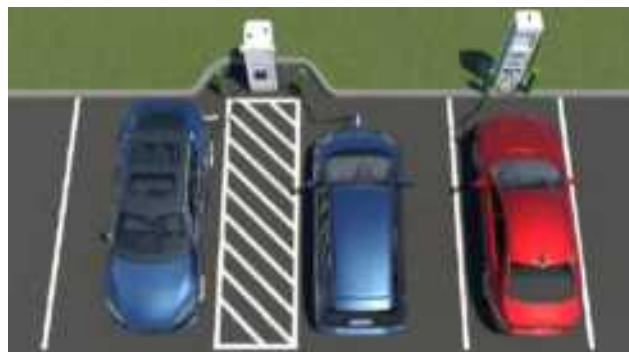
## **Barrier #5 Continued**

Although these may be eligible for safe harbor and there are specific standards adopted at this time, it is recommended that the agency follow The U.S. Access Board's Design Recommendations for Accessible Electric Vehicle Charging Stations.

Low (Level 12): Element is in compliance with previous standards (safe-harbor) but must comply with current standards if altered

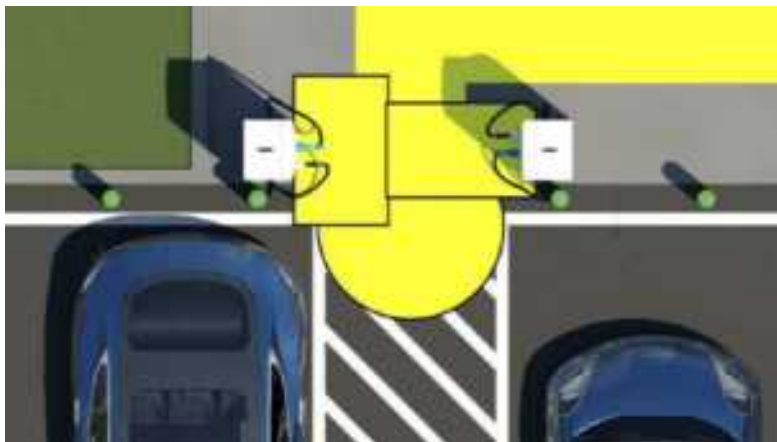
### **Operable Parts within Reach Range**

At a charging station, a reasonable number of EV chargers must comply with [§205 Operable Parts](#), including technical requirements for clear floor or ground space ([§305](#)), reach ranges & ([§308](#)), and operation ([§309](#)). We recommend EV chargers be designed with parts that are operable by the widest range of users with disabilities, including people with limited or no hand dexterity, limb differences, or upper extremity amputations.

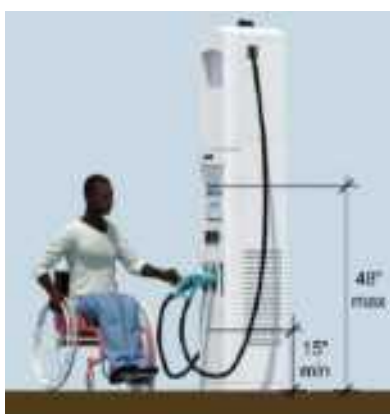
### **Unobstructed side reach**

All operable parts should meet the requirements for an unobstructed side reach ([§308.3.1](#)) and be no higher than 48 inches above the clear floor or ground space and no farther than 10 inches away. The exception for fuel dispensers should not be used (See: fuel dispensers). Placing operable parts higher than the 15 inch minimum is recommended.

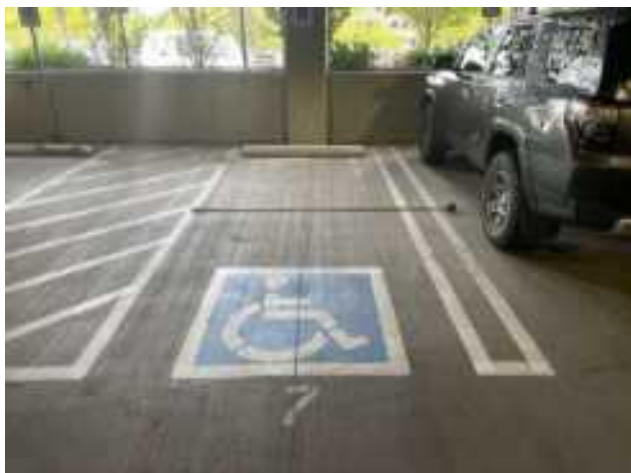
### Barrier Priority:

Medium (Level 5): Access to goods and services issues (DOJ Level 2) – severely out of compliance

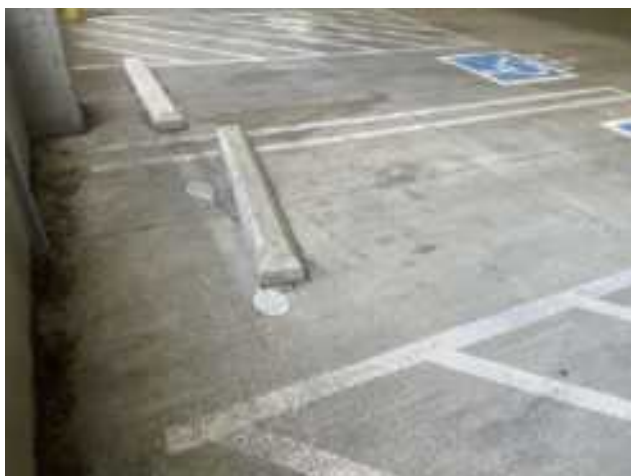
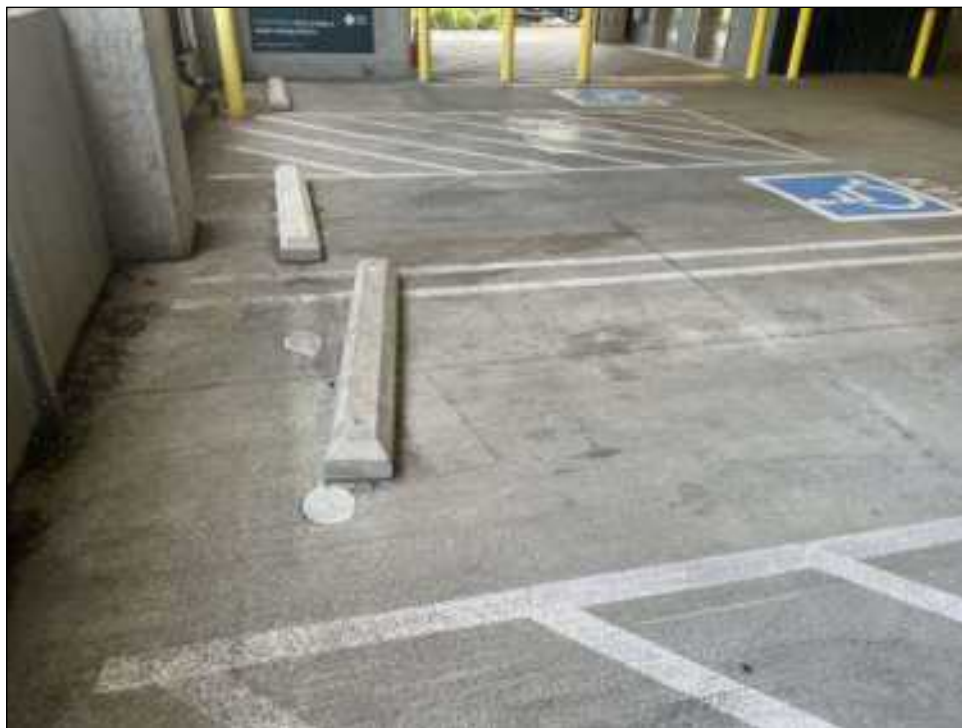
**Barrier #8 Additional Barrier Photos**

The wheel stop is unsecured from the parking stall, maintenance and repair are needed.

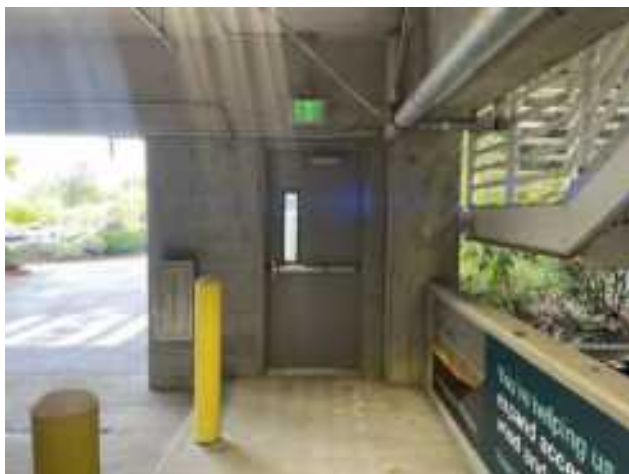
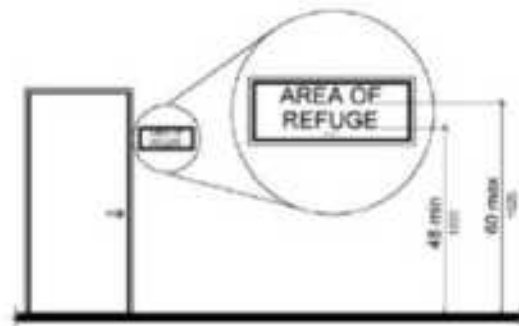
## Barrier #9 Continued

Compliant room identification signs are missing.

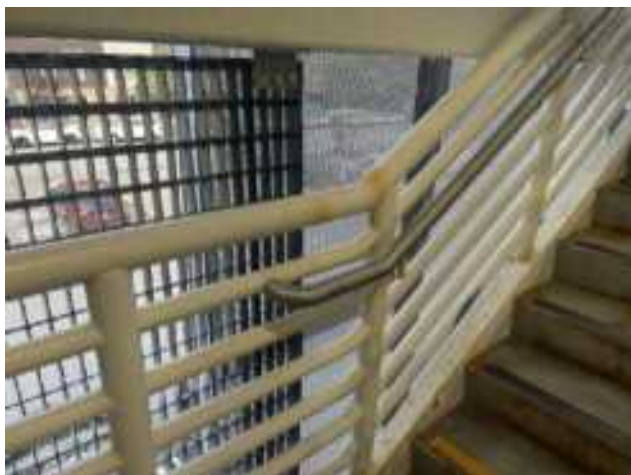
Figure 505.10.3 Bottom Handrail Extension at Stairs

Note: X = tread depth

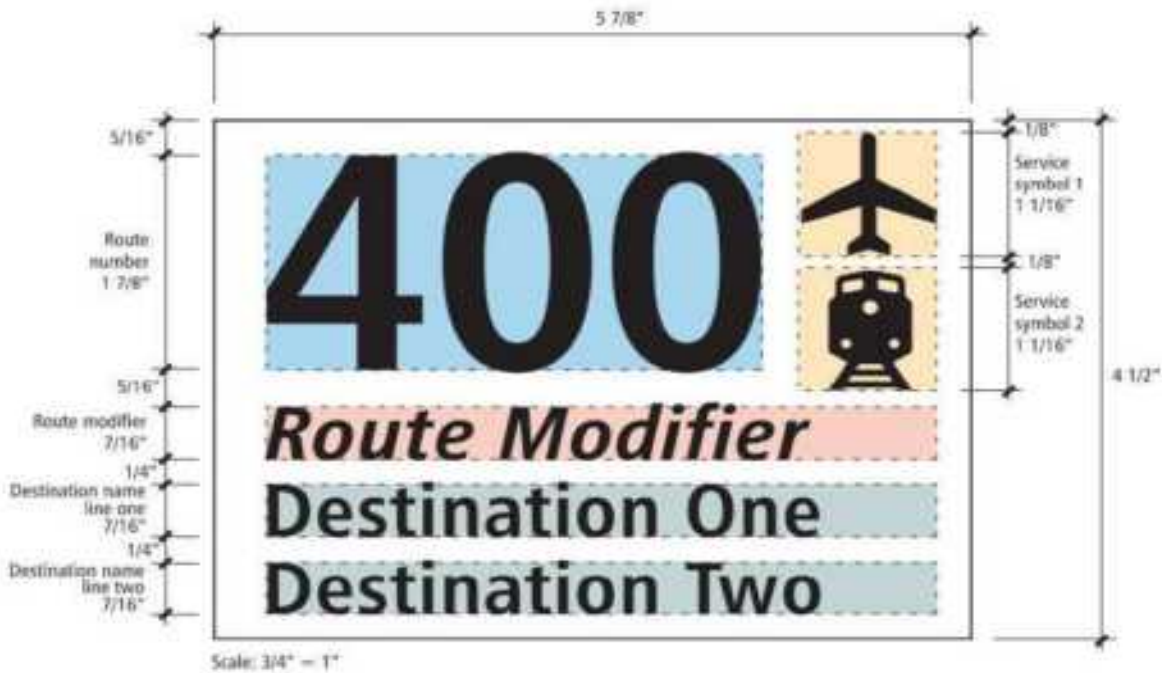
King County Metro Transit Stop Signage Review: Requirement and Compliance Summary

PROWAG Requirement Section	Requirement			ADA Transition Plan "Sign 1" Compliance Status	ADA Transition Plan "Sign 1" Compliance Notes
<a href="#">R410.2 Finish and Contrast</a>	Characters and their background shall have a non-glare finish. Characters shall contrast with their background with either light characters on a dark background or dark characters on a light background.			Compliant	
<a href="#">R410.3 Case</a>	Characters shall be uppercase or lowercase or a combination of both.			Compliant	
<a href="#">R410.4 Style</a>	Characters shall be conventional in form. Characters shall not be italic, oblique, script, highly decorative, or of other unusual forms.			Compliant	
<a href="#">R410.5 Character Proportions</a>	Characters shall be selected from fonts where the width of the uppercase letter "O" is 55 percent minimum and 110 percent maximum of the height of the uppercase letter "I".			Compliant

<a href="#">R410.6 Character Height</a>	Minimum character height shall comply with Table R410.6. Viewing distance shall be measured as the horizontal distance between the character and an obstruction preventing further approach towards the sign. Character height shall be based on the uppercase letter "I".			Non-compliant	Observed signs were typically 6'-8' from ground to bottom of sign
<a href="#">R410.6 Visual Character Height</a>	Height to Finish Surface from Baseline of Character	Horizontal Viewing Distance	Minimum Character Height		
	40 inches (1015 mm) to less than or equal to 70 inches (1780 mm)	Less than 72 inches (1830 mm)	5/8 inch (16 mm)		
	40 inches (1015 mm) to less than or equal to 70 inches (1780 mm)	72 inches (1830 mm) and greater	5/8 inch (16 mm), plus 1/8 inch (3.2 mm) per foot (305 mm) of viewing distance above 72 inches (1830 mm)		
	Greater than 70 inches (1780 mm) to less than or equal to 120 inches (3050 mm)	Less than 180 inches (4570 mm)	2 inches (51 mm)

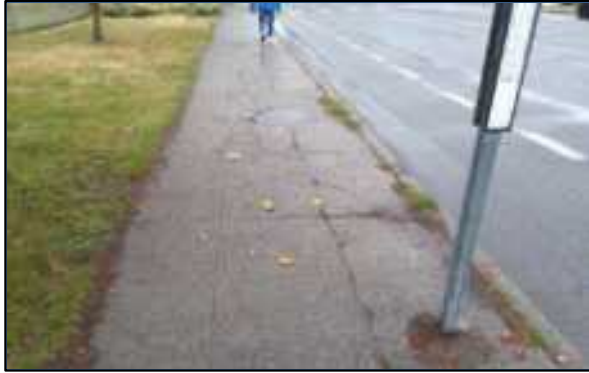
Boarding/Alighting Area

Boarding Area Issues	Issue Exists	Possible Solutions
Boarding area does not exist		
Boarding area length is less than 96"	X	
Boarding area width is less than 60"		
Boarding area running slope is greater than 2%	X	Remove and replace boarding area
Boarding area cross slope is greater than adjacent street grade		
Heaving/Sinking/Cracking present in the boarding area	X	
Ponding present in the boarding area	X	
Permanent obstruction (>0.25") in boarding area		
Temporary obstruction (>0.25") in boarding area		
Transition at connection to the curb is greater than 0.25"	X	Fix connection transition
Boarding area is missing a connection to the street or sidewalk network		
Adjacent Sidewalk Network Issues	Issue Exists	Possible Solutions
Sidewalk network width is less than 48"		
Sidewalk network cross slope is greater than 2%		
Heaving/Sinking/Cracking present in the sidewalk network		
Ponding present in the sidewalk network

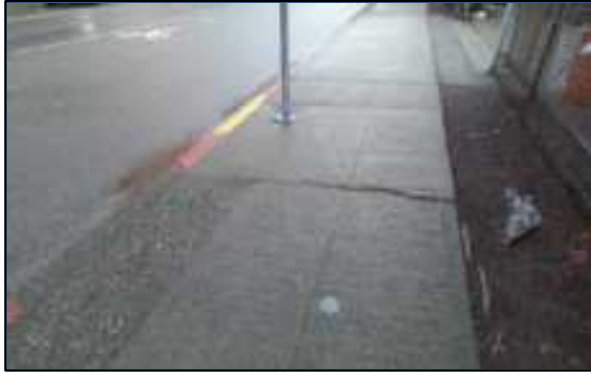
Boarding/Alighting Area

Boarding Area Issues	Issue Exists	Possible Solutions
Boarding area does not exist		
Boarding area length is less than 96"	X	
Boarding area width is less than 60"		
Boarding area running slope is greater than 2%		Remove and replace boarding area
Boarding area cross slope is greater than adjacent street grade		
Heaving/Sinking/Cracking present in the boarding area	X	
Ponding present in the boarding area		
Permanent obstruction (>0.25") in boarding area		
Temporary obstruction (>0.25") in boarding area		
Transition at connection to the curb is greater than 0.25"		
Boarding area is missing a connection to the street or sidewalk network		
Adjacent Sidewalk Network Issues	Issue Exists	Possible Solutions
Sidewalk network width is less than 48"		
Sidewalk network cross slope is greater than 2%		
Heaving/Sinking/Cracking present in the sidewalk network		
Ponding present in the sidewalk network		
Permanent obstruction (>0.25") in sidewalk network

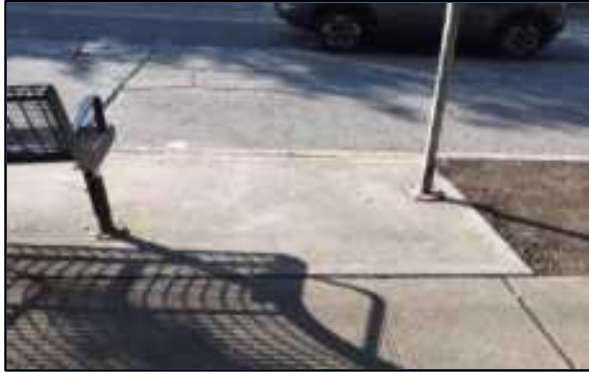
Boarding/Alighting Area

Boarding Area Issues	Issue Exists	Possible Solutions
Boarding area does not exist		
Boarding area length is less than 96"		
Boarding area width is less than 60"		
Boarding area running slope is greater than 2%	X	Remove and replace boarding area
Boarding area cross slope is greater than adjacent street grade		
Heaving/Sinking/Cracking present in the boarding area		
Ponding present in the boarding area		
Permanent obstruction (>0.25") in boarding area	X	Remove obstruction
Temporary obstruction (>0.25") in boarding area		
Transition at connection to the curb is greater than 0.25"	X	Fix connection transition
Boarding area is missing a connection to the street or sidewalk network		
Adjacent Sidewalk Network Issues	Issue Exists	Possible Solutions
Sidewalk network width is less than 48"		
Sidewalk network cross slope is greater than 2%		
Heaving/Sinking/Cracking present in the sidewalk network		
Ponding present in the sidewalk network
