**King County**  
**ADA Self-Evaluation and Transition Plan Update**  
**Facility Cost Projection Summary**  
**August 2023**

# Site Accessibility Evaluation

**Burien PnR Garage (KC)**  
**14900 4th Ave SW**  
**Burien, WA 98166**  
**Accessibility Evaluation**  
**Inspection Date: 07/11/2023**  
**Evaluators: Kalia Klein**

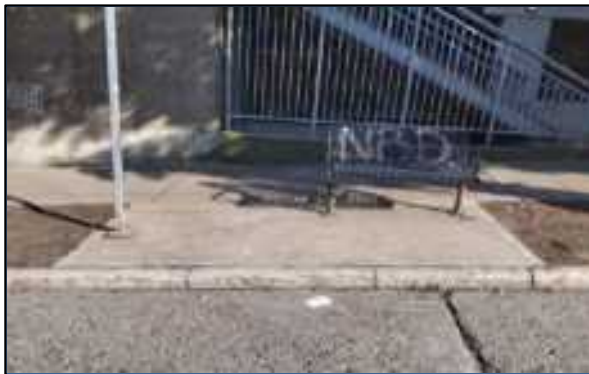
Stand-Alone Bench/Clear Space

Permanent obstruction (>0.25") in sidewalk network		
Temporary obstruction (>0.25") in sidewalk network		
Transition at connection to boarding area is greater than 0.25"		
Transit Stop Sidewalk Issues	Issue Exists	Possible Solutions
Transit stop sidewalk cross slope is greater than 2%		
Heaving/Sinking/Cracking present in the transit stop sidewalk		
Ponding present in the transit stop sidewalk		
Permanent obstruction (>0.25") in transit stop sidewalk		
Temporary obstruction (>0.25") in transit stop sidewalk		
Transition at connection to sidewalk network is greater than 0.25"		
Transit Stop Amenity Issues	Issue Exists	Possible Solutions
No transit stop signage		
Transit stop signage is non-compliant	X	Remove and replace transit stop signage
No clear space adjacent to stand-alone bench		
Stand-alone bench clear space length is less than 48"		
Stand-alone bench clear space width is less than 30"		
Stand-alone bench clear space running slope is greater than 2%	X	Remove and replace clear space

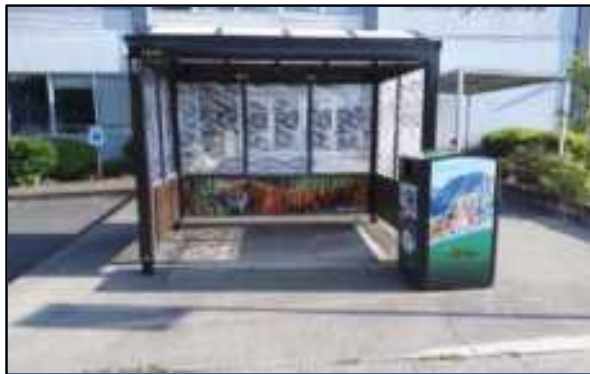
Shelter/Clear Space

No clear space under shelter		
Shelter clear space length is less than 48"		
Shelter clear space width is less than 30"		
Shelter clear space running slope is greater than 2%	X	Remove and replace clear space
Shelter opening clear width is less than 32"

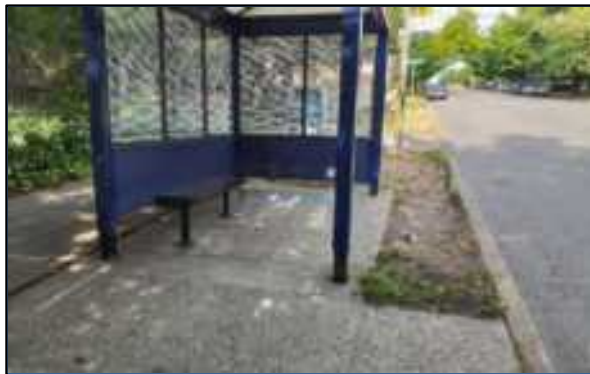
Shelter/Clear Space

No clear space under shelter		
Shelter clear space length is less than 48"		
Shelter clear space width is less than 30"		
Shelter clear space running slope is greater than 2%	X	Remove and replace clear space
Shelter opening clear width is less than 32"

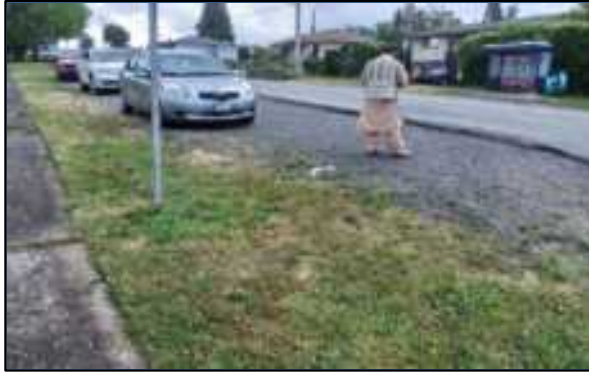
Boarding/Alighting Area

Boarding Area Issues	Issue Exists	Possible Solutions
Boarding area does not exist	X	Install boarding area
Boarding area length is less than 96"		
Boarding area width is less than 60"		
Boarding area running slope is greater than 2%		
Boarding area cross slope is greater than adjacent street grade		
Heaving/Sinking/Cracking present in the boarding area		
Ponding present in the boarding area		
Permanent obstruction (>0.25") in boarding area		
Temporary obstruction (>0.25") in boarding area		
Transition at connection to the curb is greater than 0.25"		
Boarding area is missing a connection to the street or sidewalk network	X	Install connection
Adjacent Sidewalk Network Issues	Issue Exists	Possible Solutions
Sidewalk network width is less than 48"		
Sidewalk network cross slope is greater than 2%		
Heaving/Sinking/Cracking present in the sidewalk network		
Ponding present in the sidewalk network		
Permanent obstruction (>0.25") in sidewalk network

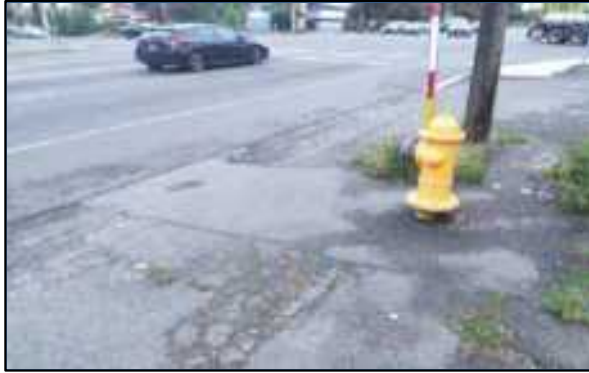
Boarding/Alighting Area

Boarding Area Issues	Issue Exists	Possible Solutions
Boarding area does not exist		
Boarding area length is less than 96"		
Boarding area width is less than 60"		
Boarding area running slope is greater than 2%	X	
Boarding area cross slope is greater than adjacent street grade		Remove and replace boarding area
Heaving/Sinking/Cracking present in the boarding area	X	
Ponding present in the boarding area	X	Remove obstruction
Permanent obstruction (>0.25") in boarding area	X	
Temporary obstruction (>0.25") in boarding area	X	Fix connection transition
Transition at connection to the curb is greater than 0.25"		
Boarding area is missing a connection to the street or sidewalk network		
Adjacent Sidewalk Network Issues	Issue Exists	Possible Solutions
Sidewalk network width is less than 48"		
Sidewalk network cross slope is greater than 2%		
Heaving/Sinking/Cracking present in the sidewalk network		
Ponding present in the sidewalk network

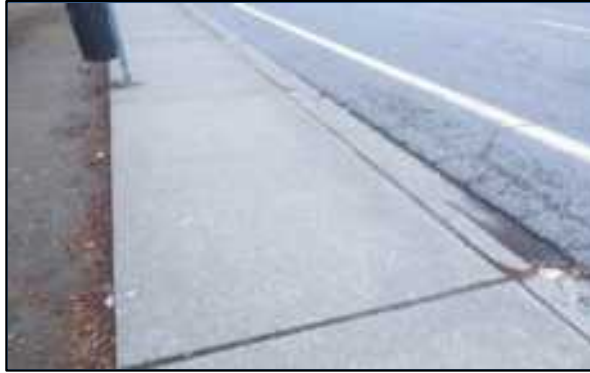
Boarding/Alighting Area

Boarding Area Issues	Issue Exists	Possible Solutions
Boarding area does not exist		
Boarding area length is less than 96"	X	
Boarding area width is less than 60"		
Boarding area running slope is greater than 2%	X	Remove and replace boarding area
Boarding area cross slope is greater than adjacent street grade		
Heaving/Sinking/Cracking present in the boarding area		
Ponding present in the boarding area		
Permanent obstruction (>0.25") in boarding area		
Temporary obstruction (>0.25") in boarding area		
Transition at connection to the curb is greater than 0.25"	X	Fix connection transition
Boarding area is missing a connection to the street or sidewalk network		
Adjacent Sidewalk Network Issues	Issue Exists	Possible Solutions
Sidewalk network width is less than 48"		
Sidewalk network cross slope is greater than 2%		
Heaving/Sinking/Cracking present in the sidewalk network		
Ponding present in the sidewalk network

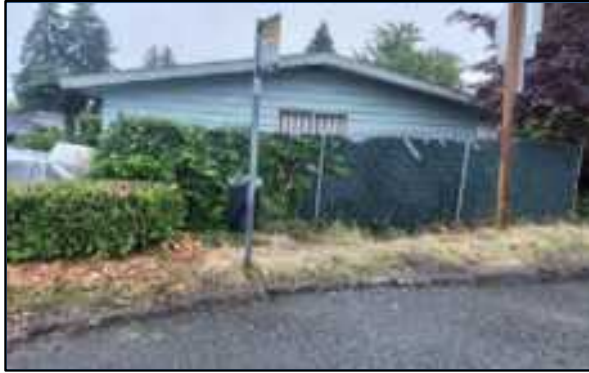
Boarding/Alighting Area

Boarding Area Issues	Issue Exists	Possible Solutions
Boarding area does not exist	X	Install boarding area
Boarding area length is less than 96"		
Boarding area width is less than 60"		
Boarding area running slope is greater than 2%		
Boarding area cross slope is greater than adjacent street grade		
Heaving/Sinking/Cracking present in the boarding area		
Ponding present in the boarding area		
Permanent obstruction (>0.25") in boarding area		
Temporary obstruction (>0.25") in boarding area		
Transition at connection to the curb is greater than 0.25"		
Boarding area is missing a connection to the street or sidewalk network	X	Install connection
Adjacent Sidewalk Network Issues	Issue Exists	Possible Solutions
Sidewalk network width is less than 48"		
Sidewalk network cross slope is greater than 2%		
Heaving/Sinking/Cracking present in the sidewalk network		
Ponding present in the sidewalk network		
Permanent obstruction (>0.25") in sidewalk network

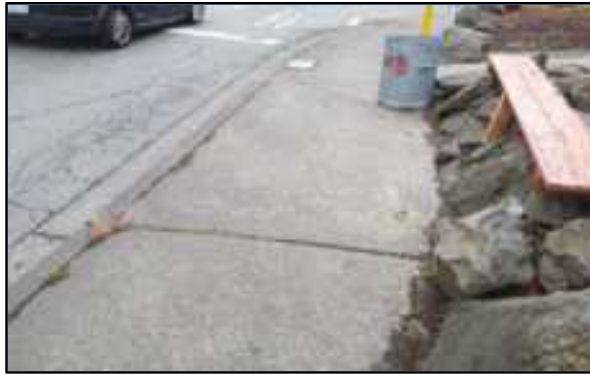
Boarding/Alighting Area

Boarding Area Issues	Issue Exists	Possible Solutions
Boarding area does not exist		
Boarding area length is less than 96"	X	
Boarding area width is less than 60"		
Boarding area running slope is greater than 2%	X	Remove and replace boarding area
Boarding area cross slope is greater than adjacent street grade		
Heaving/Sinking/Cracking present in the boarding area	X	
Ponding present in the boarding area	X	
Permanent obstruction (>0.25") in boarding area		
Temporary obstruction (>0.25") in boarding area		
Transition at connection to the curb is greater than 0.25"	X	Fix connection transition
Boarding area is missing a connection to the street or sidewalk network		
Adjacent Sidewalk Network Issues	Issue Exists	Possible Solutions
Sidewalk network width is less than 48"		
Sidewalk network cross slope is greater than 2%		
Heaving/Sinking/Cracking present in the sidewalk network		
Ponding present in the sidewalk network

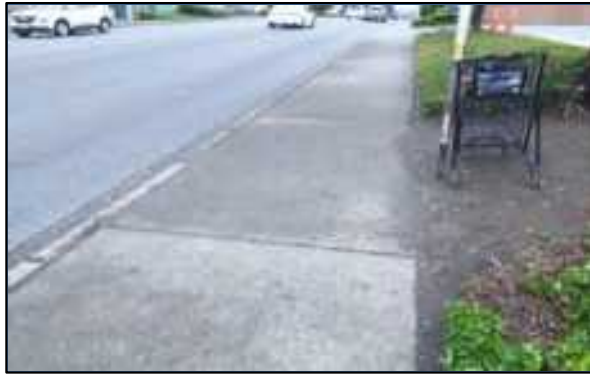
Boarding/Alighting Area

Boarding Area Issues	Issue Exists	Possible Solutions
Boarding area does not exist		
Boarding area length is less than 96"	X	
Boarding area width is less than 60"		
Boarding area running slope is greater than 2%	X	Remove and replace boarding area
Boarding area cross slope is greater than adjacent street grade		
Heaving/Sinking/Cracking present in the boarding area		
Ponding present in the boarding area	X	
Permanent obstruction (>0.25") in boarding area		
Temporary obstruction (>0.25") in boarding area		
Transition at connection to the curb is greater than 0.25"	X	Fix connection transition
Boarding area is missing a connection to the street or sidewalk network		
Adjacent Sidewalk Network Issues	Issue Exists	Possible Solutions
Sidewalk network width is less than 48"		
Sidewalk network cross slope is greater than 2%		
Heaving/Sinking/Cracking present in the sidewalk network		
Ponding present in the sidewalk network

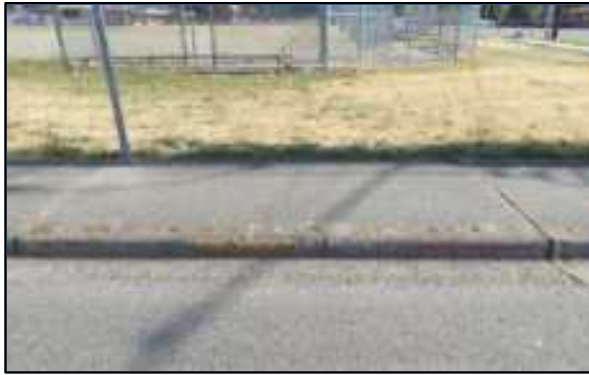
Boarding/Alighting Area

Boarding Area Issues	Issue Exists	Possible Solutions
Boarding area does not exist		
Boarding area length is less than 96"	X	
Boarding area width is less than 60"		
Boarding area running slope is greater than 2%	X	Remove and replace boarding area
Boarding area cross slope is greater than adjacent street grade		
Heaving/Sinking/Cracking present in the boarding area		
Ponding present in the boarding area		
Permanent obstruction (>0.25") in boarding area		
Temporary obstruction (>0.25") in boarding area		
Transition at connection to the curb is greater than 0.25"		
Boarding area is missing a connection to the street or sidewalk network		
Adjacent Sidewalk Network Issues	Issue Exists	Possible Solutions
Sidewalk network width is less than 48"		
Sidewalk network cross slope is greater than 2%		
Heaving/Sinking/Cracking present in the sidewalk network		
Ponding present in the sidewalk network		
Permanent obstruction (>0.25") in sidewalk network

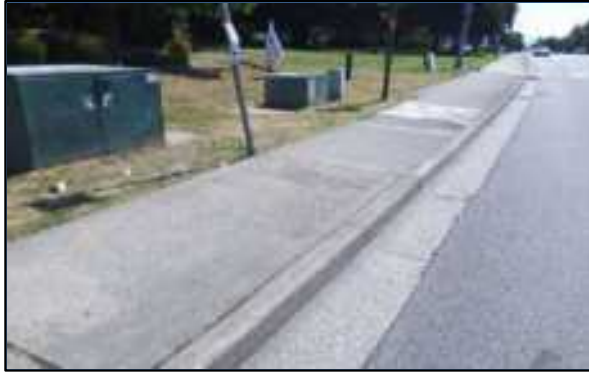
Boarding/Alighting Area

Boarding Area Issues	Issue Exists	Possible Solutions
Boarding area does not exist		
Boarding area length is less than 96"	X	Increase boarding area size
Boarding area width is less than 60"		
Boarding area running slope is greater than 2%		
Boarding area cross slope is greater than adjacent street grade		
Heaving/Sinking/Cracking present in the boarding area		
Ponding present in the boarding area		
Permanent obstruction (>0.25") in boarding area		
Temporary obstruction (>0.25") in boarding area		
Transition at connection to the curb is greater than 0.25"		
Boarding area is missing a connection to the street or sidewalk network		
Adjacent Sidewalk Network Issues	Issue Exists	Possible Solutions
Sidewalk network width is less than 48"		
Sidewalk network cross slope is greater than 2%		
Heaving/Sinking/Cracking present in the sidewalk network		
Ponding present in the sidewalk network		
Permanent obstruction (>0.25") in sidewalk network

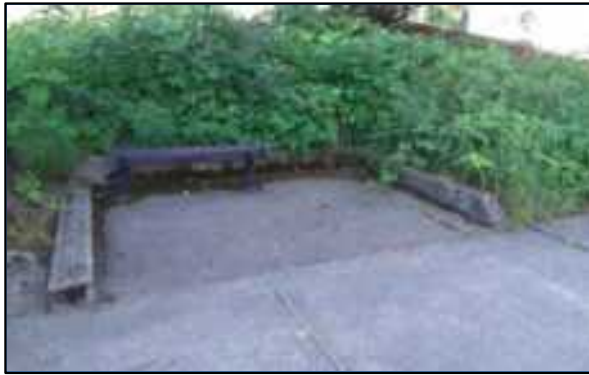
Stand-Alone Bench/Clear Space

Temporary obstruction (>0.25") in sidewalk network		
Transition at connection to boarding area is greater than 0.25"		
Transit Stop Sidewalk Issues	Issue Exists	Possible Solutions
Transit stop sidewalk cross slope is greater than 2%		
Heaving/Sinking/Cracking present in the transit stop sidewalk		
Ponding present in the transit stop sidewalk		
Permanent obstruction (>0.25") in transit stop sidewalk		
Temporary obstruction (>0.25") in transit stop sidewalk		
Transition at connection to sidewalk network is greater than 0.25"		
Transit Stop Amenity Issues	Issue Exists	Possible Solutions
No transit stop signage		
Transit stop signage is non-compliant	X	Remove and replace transit stop signage
No clear space adjacent to stand-alone bench		
Stand-alone bench clear space length is less than 48"		
Stand-alone bench clear space width is less than 30"		
Stand-alone bench clear space running slope is greater than 2%	X	Remove and replace clear space

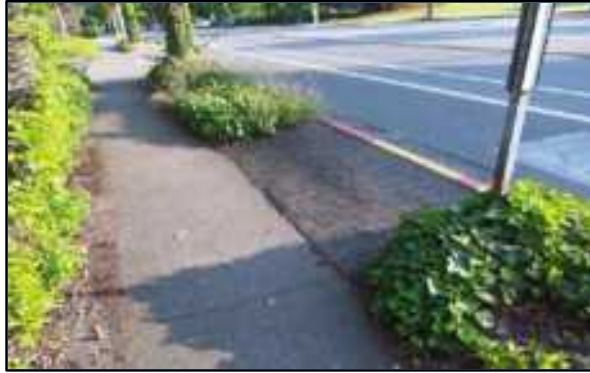
Boarding/Alighting Area

Boarding Area Issues	Issue Exists	Possible Solutions
Boarding area does not exist		
Boarding area length is less than 96"		
Boarding area width is less than 60"		
Boarding area running slope is greater than 2%	X	Remove and replace boarding area
Boarding area cross slope is greater than adjacent street grade		
Heaving/Sinking/Cracking present in the boarding area	X	
Ponding present in the boarding area		
Permanent obstruction (>0.25") in boarding area		
Temporary obstruction (>0.25") in boarding area		
Transition at connection to the curb is greater than 0.25"		
Boarding area is missing a connection to the street or sidewalk network		
Adjacent Sidewalk Network Issues	Issue Exists	Possible Solutions
Sidewalk network width is less than 48"		
Sidewalk network cross slope is greater than 2%		
Heaving/Sinking/Cracking present in the sidewalk network		
Ponding present in the sidewalk network		
Permanent obstruction (>0.25") in sidewalk network

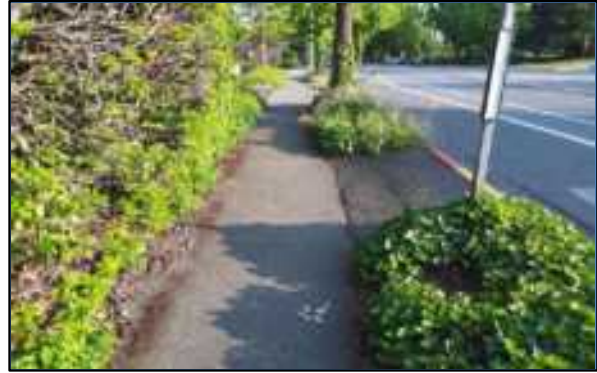
Adjacent Sidewalk Network

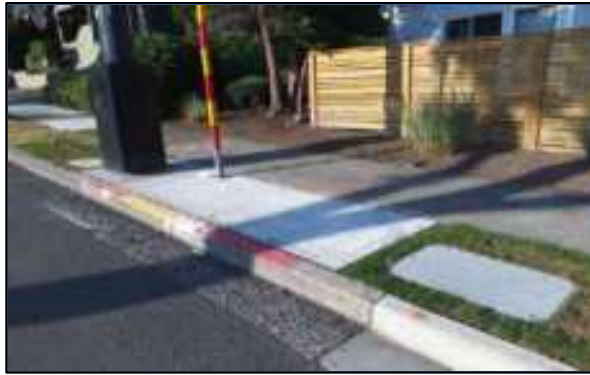
Boarding/Alighting Area

Boarding Area Issues	Issue Exists	Possible Solutions
Boarding area does not exist		
Boarding area length is less than 96"		
Boarding area width is less than 60"		
Boarding area running slope is greater than 2%		
Boarding area cross slope is greater than adjacent street grade		
Heaving/Sinking/Cracking present in the boarding area		
Ponding present in the boarding area		
Permanent obstruction (>0.25") in boarding area		
Temporary obstruction (>0.25") in boarding area		
Transition at connection to the curb is greater than 0.25"		
Boarding area is missing a connection to the street or sidewalk network		
Adjacent Sidewalk Network Issues	Issue Exists	Possible Solutions
Sidewalk network width is less than 48"		
Sidewalk network cross slope is greater than 2%		
Heaving/Sinking/Cracking present in the sidewalk network		
Ponding present in the sidewalk network		
Permanent obstruction (>0.25") in sidewalk network

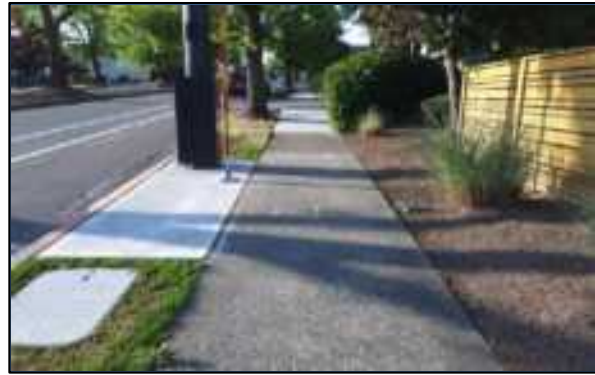
Adjacent Sidewalk Network

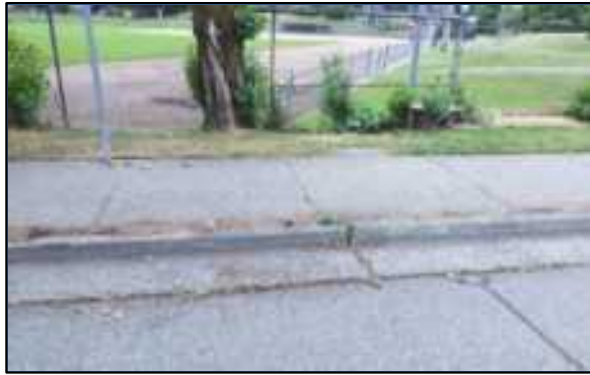
Boarding/Alighting Area

Boarding Area Issues	Issue Exists	Possible Solutions
Boarding area does not exist		
Boarding area length is less than 96"	X	Increase boarding area size
Boarding area width is less than 60"		
Boarding area running slope is greater than 2%		
Boarding area cross slope is greater than adjacent street grade		
Heaving/Sinking/Cracking present in the boarding area		
Ponding present in the boarding area		
Permanent obstruction (>0.25") in boarding area		
Temporary obstruction (>0.25") in boarding area		
Transition at connection to the curb is greater than 0.25"	X	Fix connection transition
Boarding area is missing a connection to the street or sidewalk network		
Adjacent Sidewalk Network Issues	Issue Exists	Possible Solutions
Sidewalk network width is less than 48"		
Sidewalk network cross slope is greater than 2%		
Heaving/Sinking/Cracking present in the sidewalk network		
Ponding present in the sidewalk network

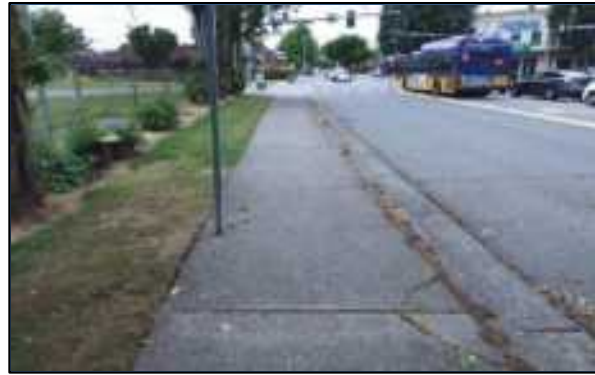
Adjacent Sidewalk Network

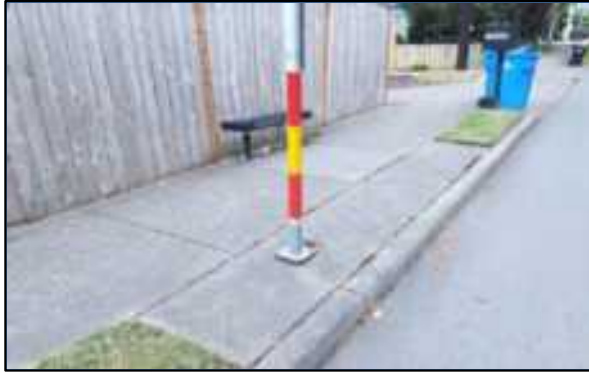
Boarding/Alighting Area

Boarding Area Issues	Issue Exists	Possible Solutions
Boarding area does not exist		
Boarding area length is less than 96"	X	
Boarding area width is less than 60"		
Boarding area running slope is greater than 2%	X	Remove and replace boarding area
Boarding area cross slope is greater than adjacent street grade		
Heaving/Sinking/Cracking present in the boarding area	X	
Ponding present in the boarding area		
Permanent obstruction (>0.25") in boarding area	X	Remove obstruction
Temporary obstruction (>0.25") in boarding area		
Transition at connection to the curb is greater than 0.25"	X	Fix connection transition
Boarding area is missing a connection to the street or sidewalk network		
Adjacent Sidewalk Network Issues	Issue Exists	Possible Solutions
Sidewalk network width is less than 48"		
Sidewalk network cross slope is greater than 2%		
Heaving/Sinking/Cracking present in the sidewalk network		
Ponding present in the sidewalk network

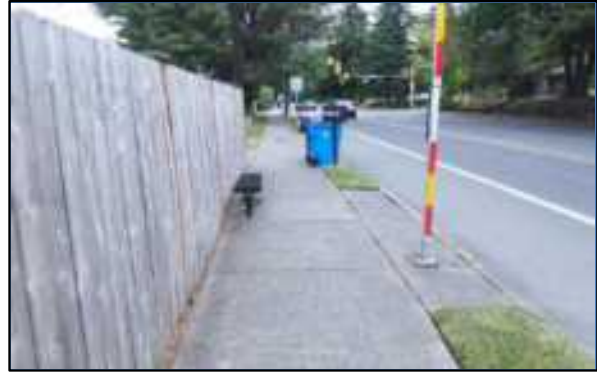
Adjacent Sidewalk Network

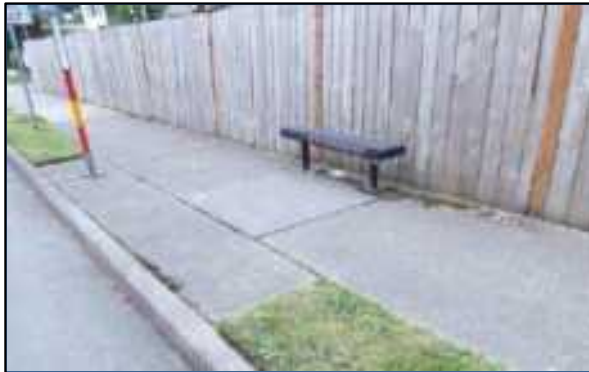
Stand-Alone Bench/Clear Space

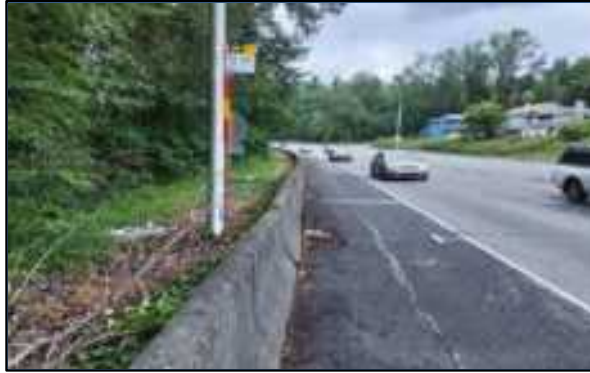
Boarding/Alighting Area

Boarding Area Issues	Issue Exists	Possible Solutions
Boarding area does not exist	X	Install boarding area
Boarding area length is less than 96"		
Boarding area width is less than 60"		
Boarding area running slope is greater than 2%		
Boarding area cross slope is greater than adjacent street grade		
Heaving/Sinking/Cracking present in the boarding area		
Ponding present in the boarding area		
Permanent obstruction (>0.25") in boarding area		
Temporary obstruction (>0.25") in boarding area		
Transition at connection to the curb is greater than 0.25"		
Boarding area is missing a connection to the street or sidewalk network	X	Install connection
Adjacent Sidewalk Network Issues	Issue Exists	Possible Solutions
Sidewalk network width is less than 48"		
Sidewalk network cross slope is greater than 2%		
Heaving/Sinking/Cracking present in the sidewalk network		
Ponding present in the sidewalk network		
Permanent obstruction (>0.25") in sidewalk network

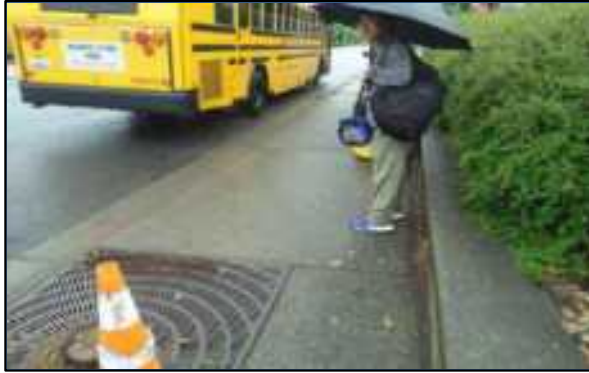
Boarding/Alighting Area

Boarding Area Issues	Issue Exists	Possible Solutions
Boarding area does not exist		
Boarding area length is less than 96"	X	Increase boarding area size
Boarding area width is less than 60"		
Boarding area running slope is greater than 2%		
Boarding area cross slope is greater than adjacent street grade		
Heaving/Sinking/Cracking present in the boarding area		
Ponding present in the boarding area		
Permanent obstruction (>0.25") in boarding area		
Temporary obstruction (>0.25") in boarding area		
Transition at connection to the curb is greater than 0.25"	X	Fix connection transition
Boarding area is missing a connection to the street or sidewalk network		
Adjacent Sidewalk Network Issues	Issue Exists	Possible Solutions
Sidewalk network width is less than 48"		
Sidewalk network cross slope is greater than 2%		
Heaving/Sinking/Cracking present in the sidewalk network		
Ponding present in the sidewalk network

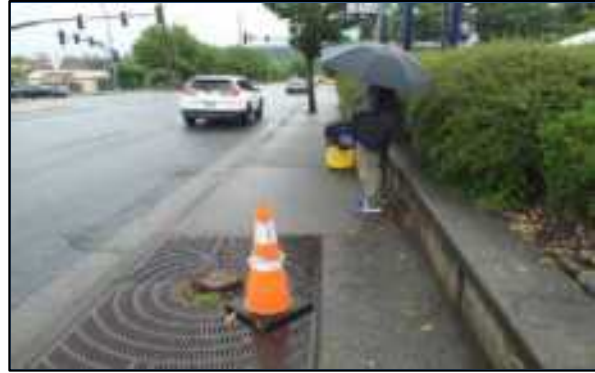
Adjacent Sidewalk Network

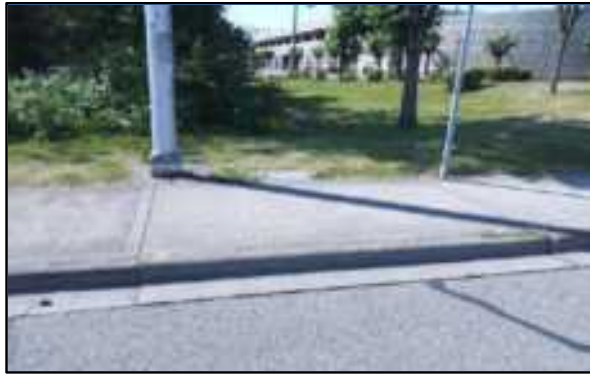
Boarding/Alighting Area

Boarding Area Issues	Issue Exists	Possible Solutions
Boarding area does not exist		
Boarding area length is less than 96"	X	Increase boarding area size
Boarding area width is less than 60"		
Boarding area running slope is greater than 2%		
Boarding area cross slope is greater than adjacent street grade		
Heaving/Sinking/Cracking present in the boarding area		
Ponding present in the boarding area		
Permanent obstruction (>0.25") in boarding area		
Temporary obstruction (>0.25") in boarding area		
Transition at connection to the curb is greater than 0.25"		
Boarding area is missing a connection to the street or sidewalk network		
Adjacent Sidewalk Network Issues	Issue Exists	Possible Solutions
Sidewalk network width is less than 48"		
Sidewalk network cross slope is greater than 2%		
Heaving/Sinking/Cracking present in the sidewalk network		
Ponding present in the sidewalk network		
Permanent obstruction (>0.25") in sidewalk network

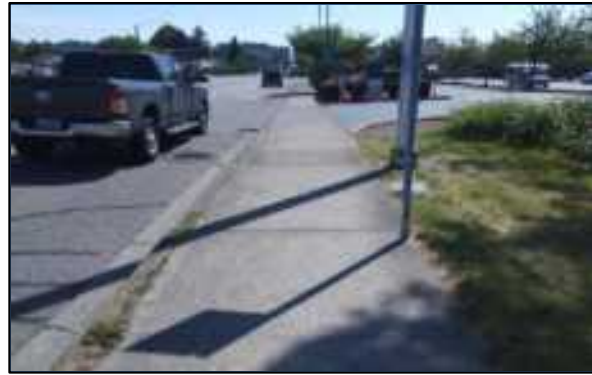
Adjacent Sidewalk Network

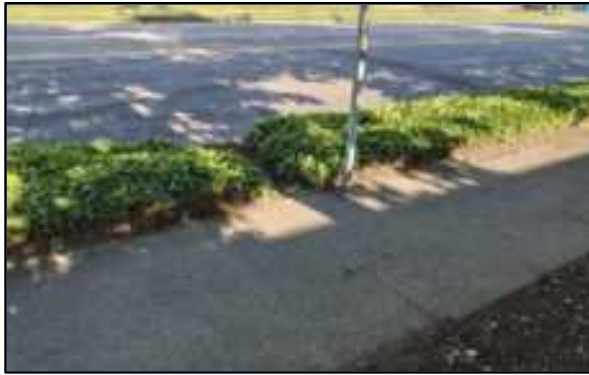
Boarding/Alighting Area

Boarding Area Issues	Issue Exists	Possible Solutions
Boarding area does not exist	X	Install boarding area
Boarding area length is less than 96"		
Boarding area width is less than 60"		
Boarding area running slope is greater than 2%		
Boarding area cross slope is greater than adjacent street grade		
Heaving/Sinking/Cracking present in the boarding area		
Ponding present in the boarding area		
Permanent obstruction (>0.25") in boarding area		
Temporary obstruction (>0.25") in boarding area		
Transition at connection to the curb is greater than 0.25"		
Boarding area is missing a connection to the street or sidewalk network	X	Install connection
Adjacent Sidewalk Network Issues	Issue Exists	Possible Solutions
Sidewalk network width is less than 48"		
Sidewalk network cross slope is greater than 2%		
Heaving/Sinking/Cracking present in the sidewalk network		
Ponding present in the sidewalk network		
Permanent obstruction (>0.25") in sidewalk network

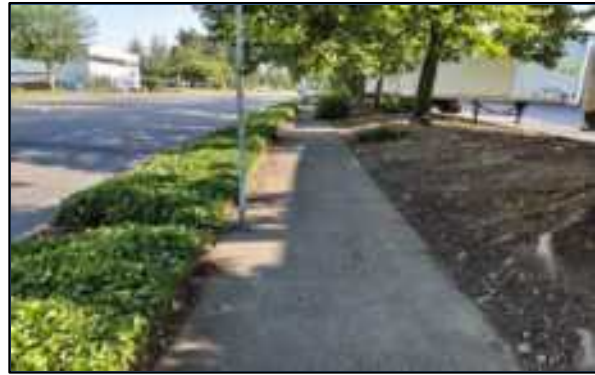
Adjacent Sidewalk Network

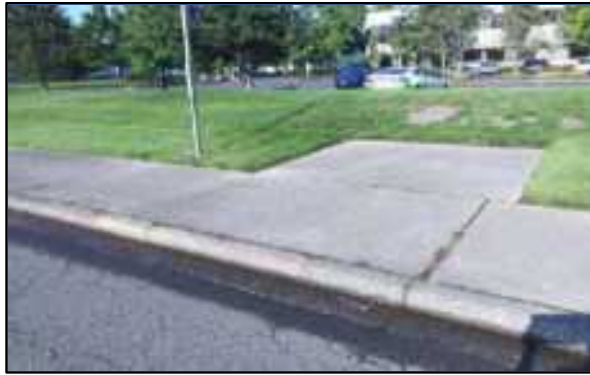
Boarding/Alighting Area

Boarding Area Issues	Issue Exists	Possible Solutions
Boarding area does not exist		
Boarding area length is less than 96"		
Boarding area width is less than 60"		
Boarding area running slope is greater than 2%	X	Remove and replace boarding area
Boarding area cross slope is greater than adjacent street grade		
Heaving/Sinking/Cracking present in the boarding area		
Ponding present in the boarding area		
Permanent obstruction (>0.25") in boarding area		
Temporary obstruction (>0.25") in boarding area		
Transition at connection to the curb is greater than 0.25"	X	Fix connection transition
Boarding area is missing a connection to the street or sidewalk network		
Adjacent Sidewalk Network Issues	Issue Exists	Possible Solutions
Sidewalk network width is less than 48"		
Sidewalk network cross slope is greater than 2%		
Heaving/Sinking/Cracking present in the sidewalk network		
Ponding present in the sidewalk network

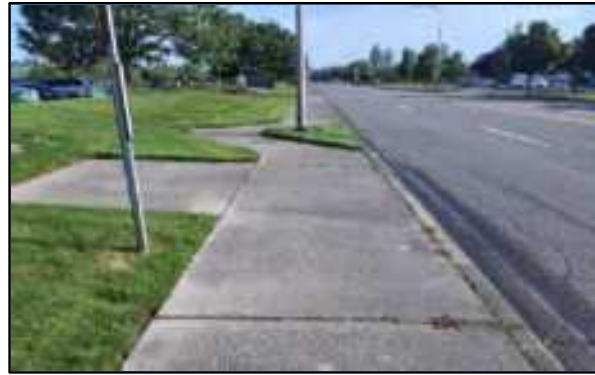
Adjacent Sidewalk Network

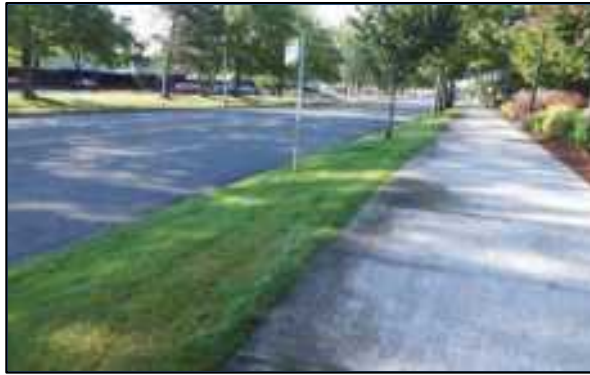
Boarding/Alighting Area

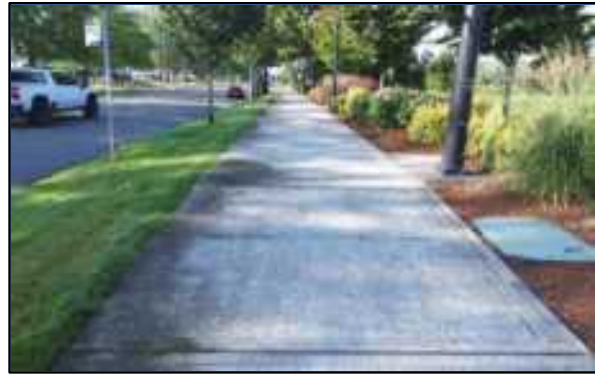
Adjacent Sidewalk Network

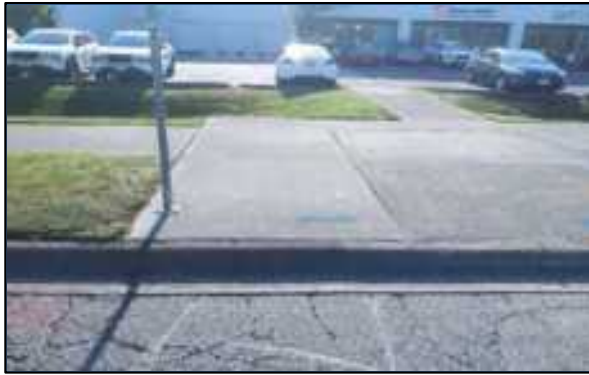
Boarding/Alighting Area

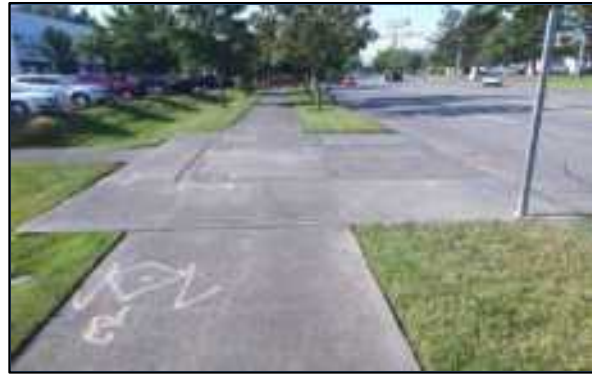
Adjacent Sidewalk Network

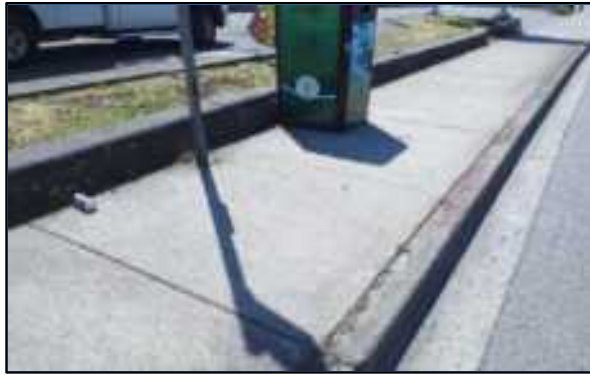
Boarding/Alighting Area

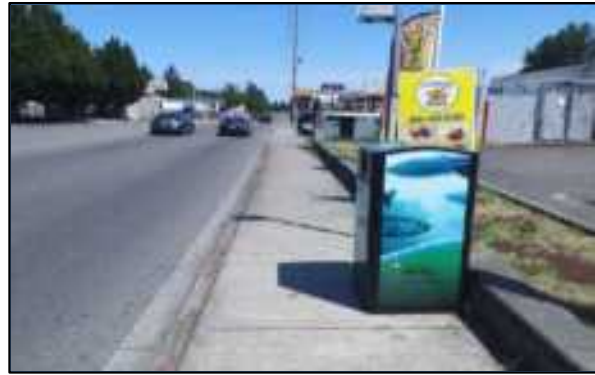
Adjacent Sidewalk Network

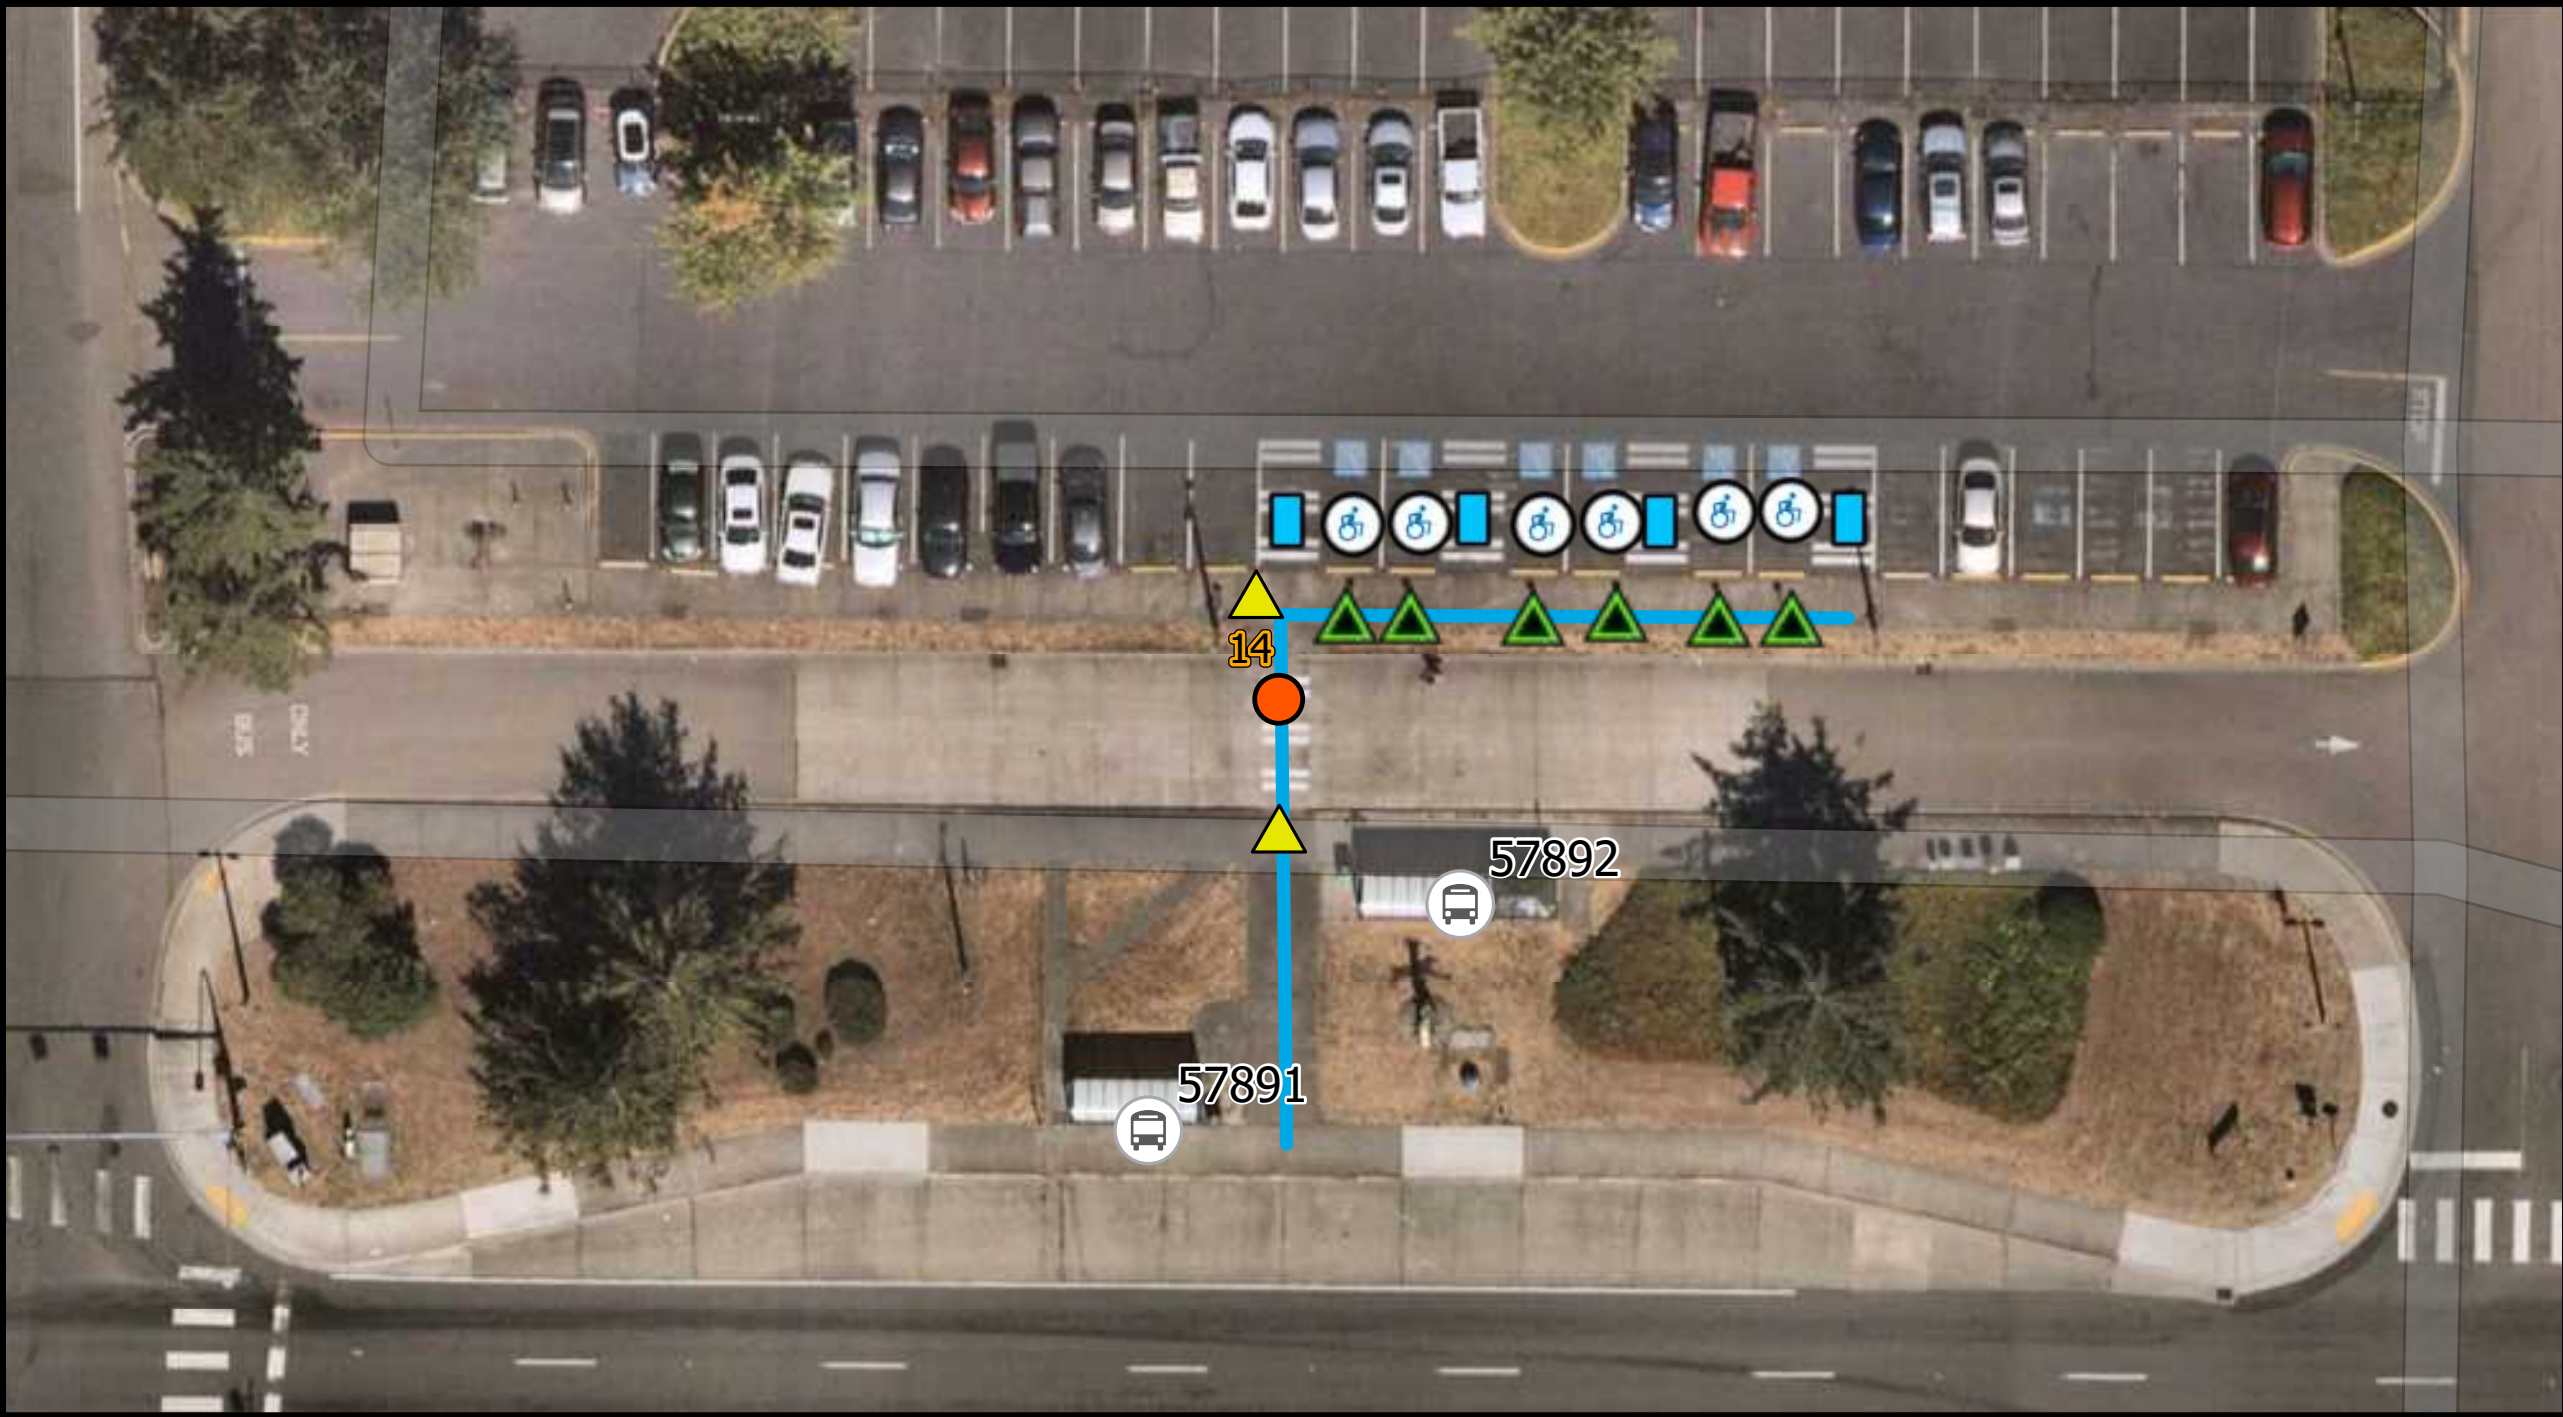
# Auburn Park and Ride

- Intersections and ID
- Curb Ramp
- Path of Travel
- Accessible Parking Sign
- Accessible Parking
- Access Aisle
- Transit Stop and ID
- Ramp
- Building

Feet
Path of Travel	<b>143</b>
	Quantity
Intersections with Curb Ramps	<b>1</b>
Ramps	<b>0</b>
Transit Stops	<b>2</b>
Accessible Parking Spaces	<b>6</b>

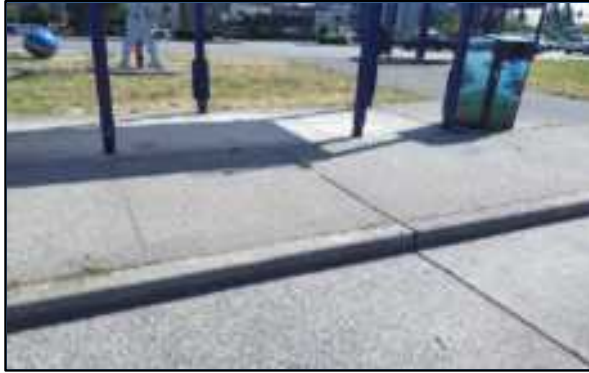
Boarding/Alighting Area

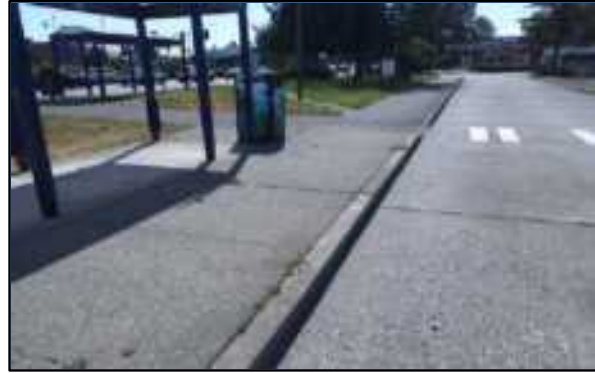
Adjacent Sidewalk Network

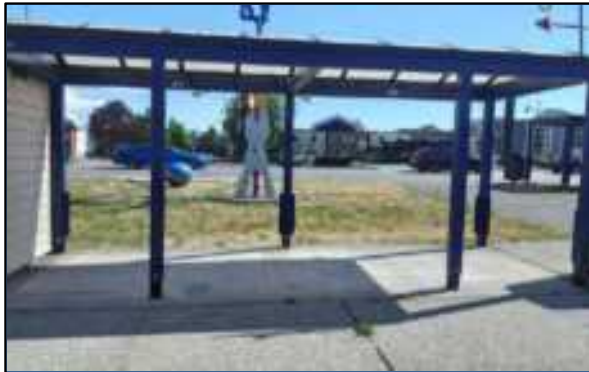
Shelter/Clear Space

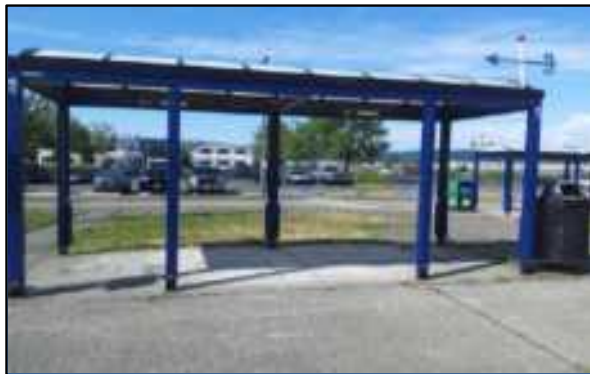
Shelter/Clear Space

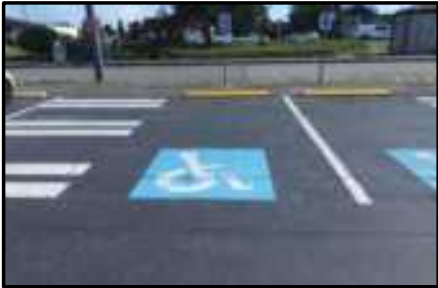
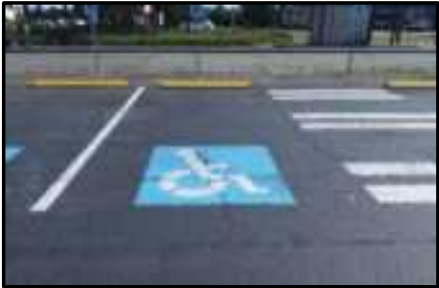
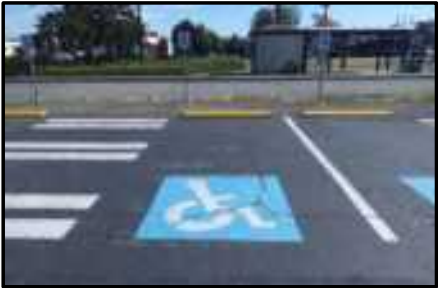
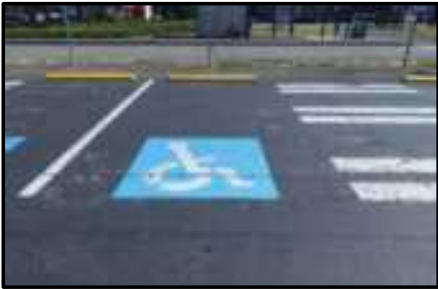
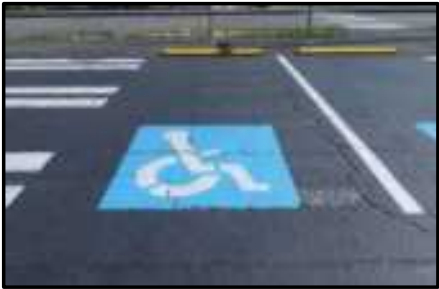
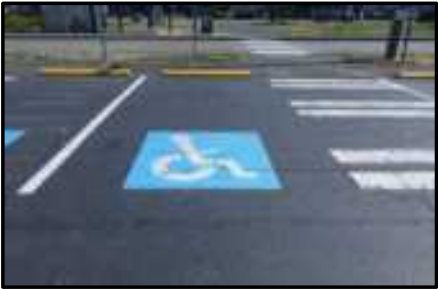
Parking Space Issue	Parking Space ID						Possible Solutions
	P1	P2	P3	P4	P5	P6	
Parking space not marked as accessible							
Parking space width is less than 96"			x		x		Remove and replace pavement markings
Parking space does not have an adjacent access aisle							
Car parking space access aisle width is less than 60"							
Van parking space access aisle width is less than 96"						x	Remove and replace pavement markings
Access aisle does not extend the full length of the parking space it serves							
Access aisle is not marked to discourage parking in the aisle						x	Install access aisle hatch pavement markings
Access aisle overlaps the vehicular way							
Access aisle does not adjoin an accessible route							
Constrained width where the access aisle adjoins the accessible route is less than 48"							
Access aisle has change in level > 0.25"		x		x		x	
Access aisle has horizontal openings > 0.5"						x

Access aisle running slope is > 2%						x	Repave and restripe access aisle or relocate access aisle
Access aisle cross slope is > 2%							
Parking space has change in level > 0.25"	x	x	x	x	x		
Parking space horizontal openings > 0.5"	x		x				
Parking space running slope is > 2%					x	x	Repave and restripe accessible parking space or relocate accessible parking space
Parking space cross slope is > 2%							
Parking space vertical clearance is < 98"							
Parking space identification sign is missing or incorrect
