**King County**  
**ADA Self-Evaluation and Transition Plan Update**  
**Facility Cost Projection Summary**  
**August 2023**

# Site Accessibility Evaluation

**Burien PnR Garage (KC)**  
**14900 4th Ave SW**  
**Burien, WA 98166**  
**Accessibility Evaluation**  
**Inspection Date: 07/11/2023**  
**Evaluators: Kalia Klein**

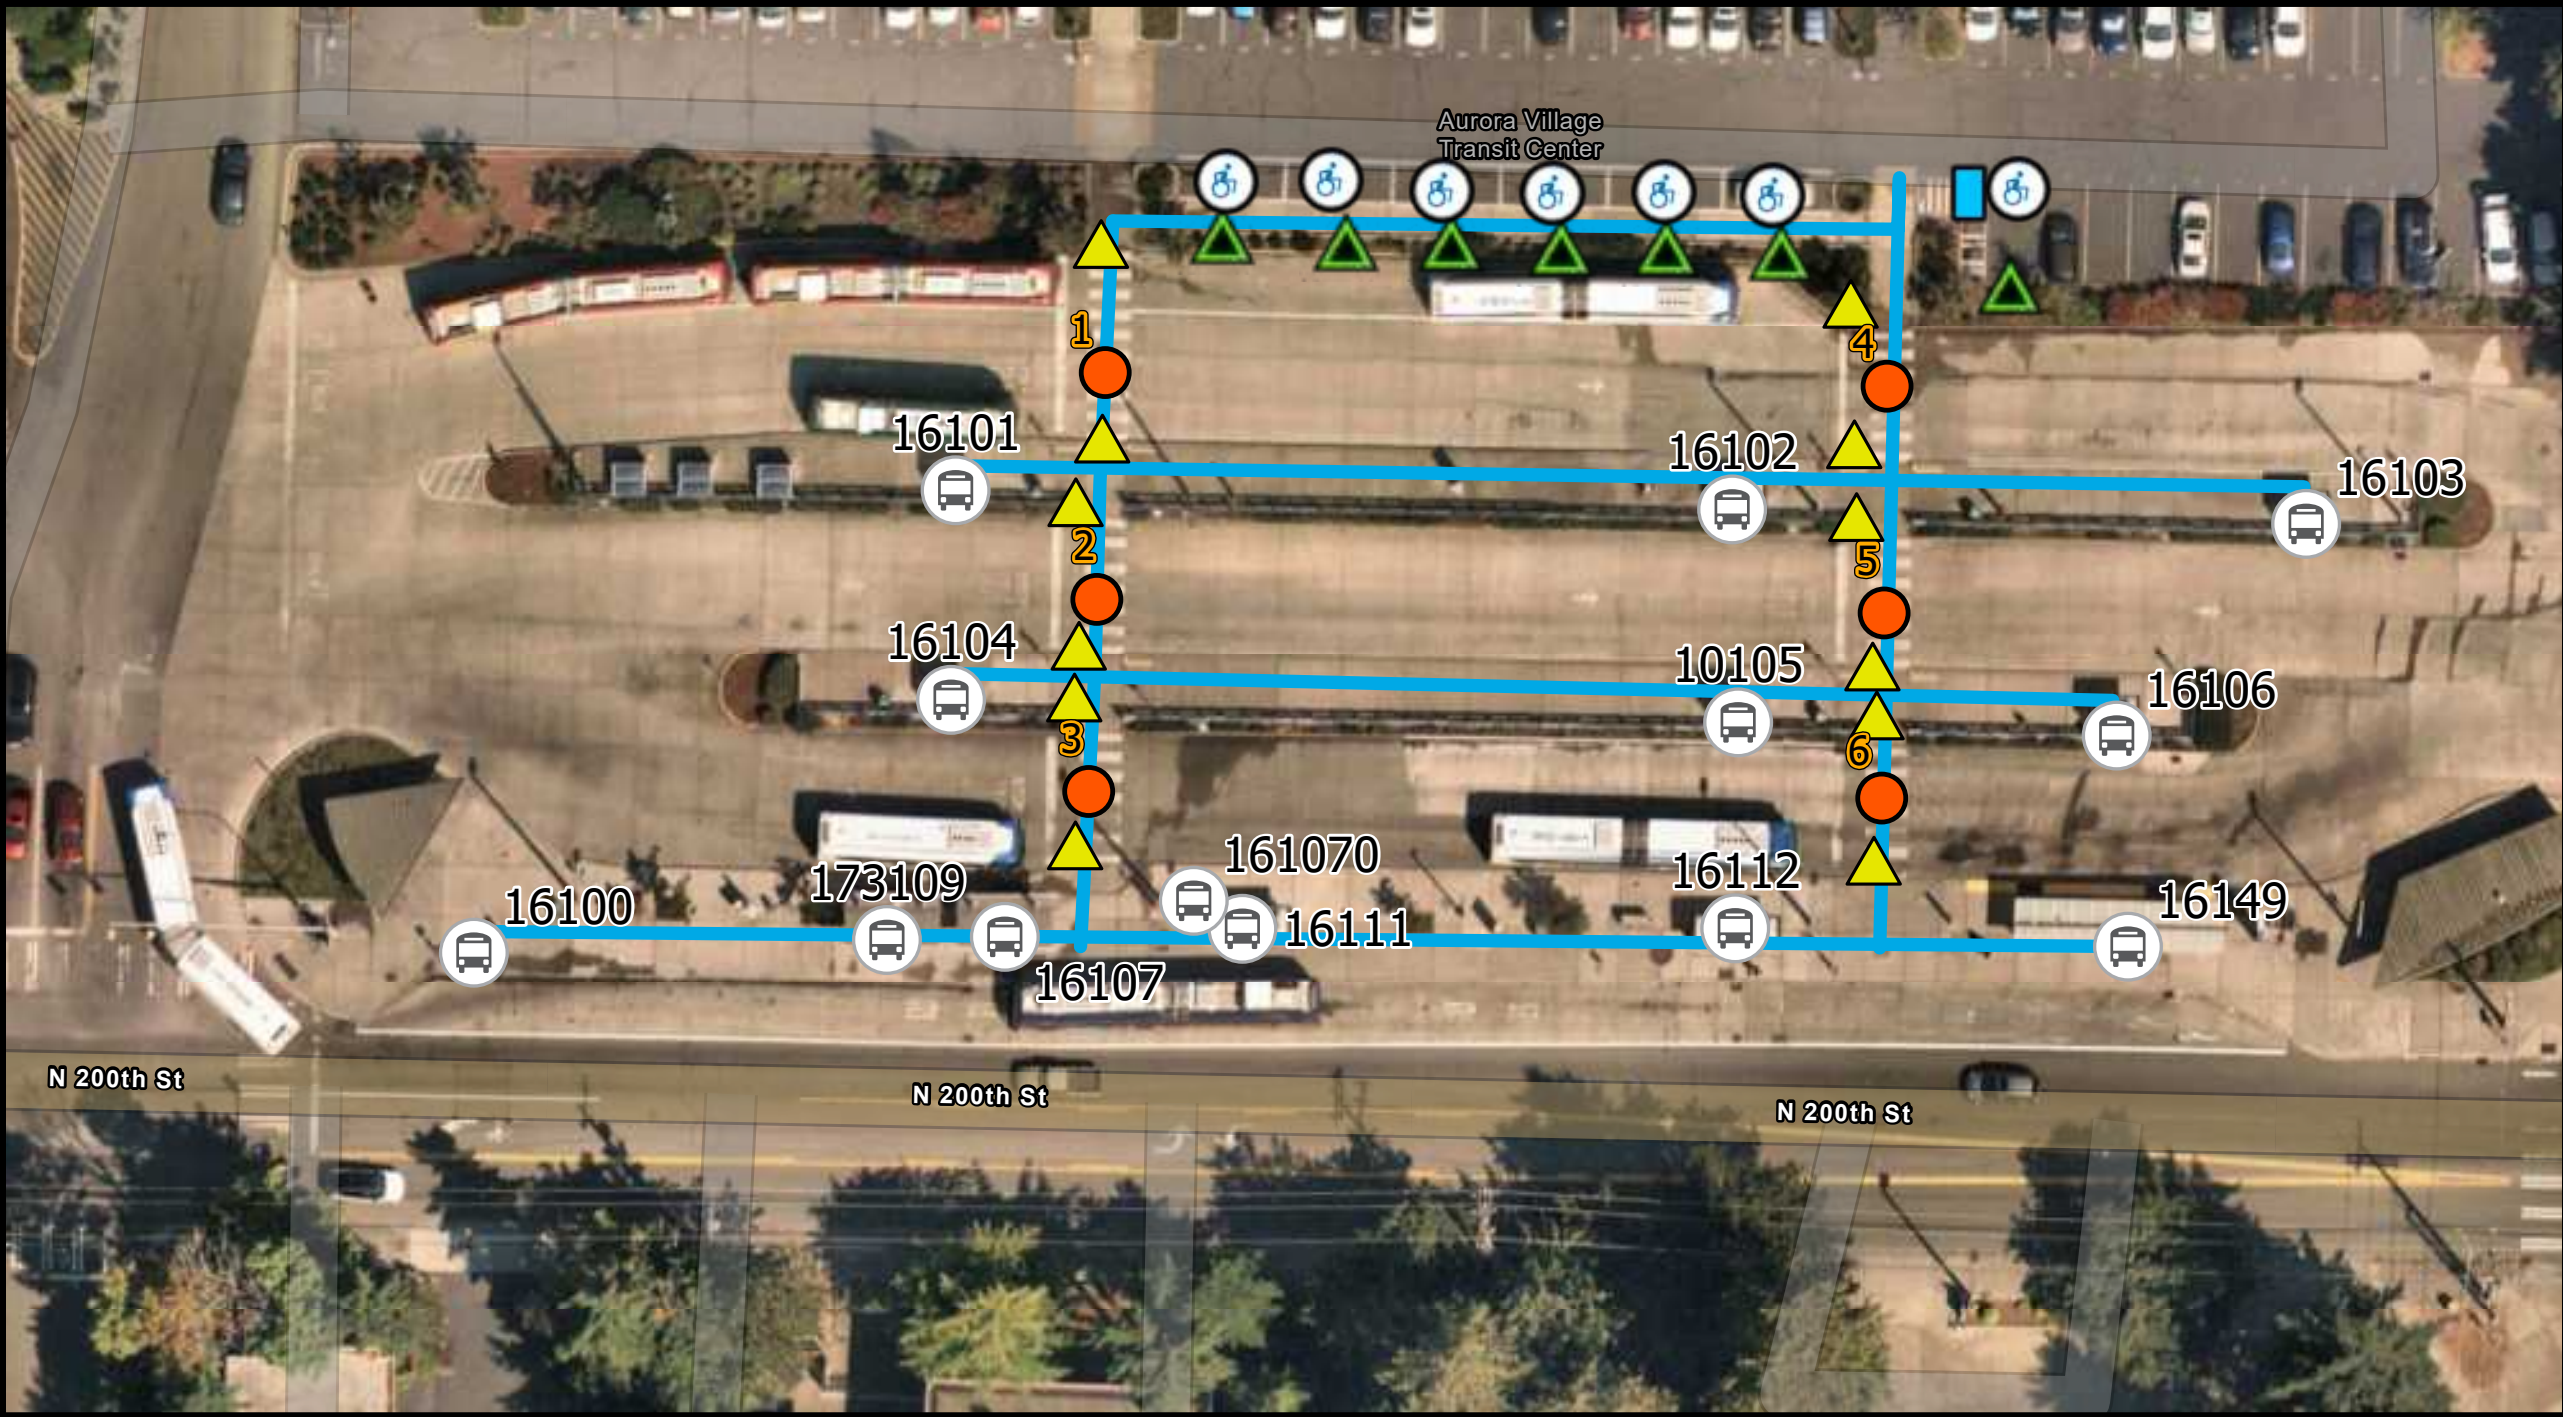
# Aurora Village TC Park and Ride Facility Overview and Cost Summary

- Intersections and ID
- Curb Ramp
- Path of Travel
- Accessible Parking Sign
- Accessible Parking
- Access Aisle
- Transit Stop and ID
- Ramp
- Building

Facility Quantity Summary of Evaluated Elements	
	Feet
Path of Travel	1265
	Quantity
Intersections with Curb Ramps	6
Ramps	0
Transit Stops	13
Accessible Parking Spaces	7

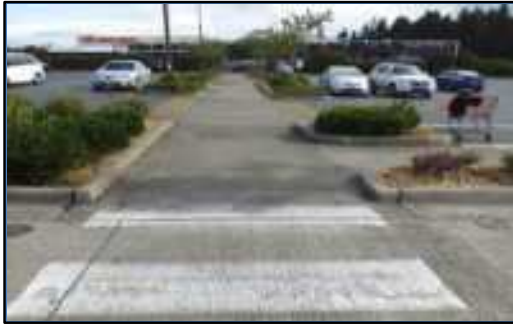
Ramp 1A

Issues	1A	4A	Point ID	Possible Solutions
Curb ramp does not exist and is needed				
Curb ramp does not land in crosswalk				
No 4' x 4' clear space at base of curb ramp				
Curbed side is not 90° or has traversable adjacent surface				
Flare cross slope is greater than 10%				
Curb ramp running slope is greater than 8.3%		X		
Blended transition running slope is greater than 5%				
Cut-thru ramp running slope is greater than 5%				
Curb ramp cross slope is greater than 2%	X			
Cut-thru ramp cross slope is greater than 2%				
Curb ramp width is less than 48"				Remove and replace curb ramp / corner sidewalk
Cut-thru ramp width is less than 60"				
Permanent obstruction (>0.25") in curb ramp/landing/flares				
Turning space does not exist and is needed				
Turning space length is less than 4' (or 5' when constrained)				
Turning space width is less than 4' (or 5' when constrained)				
Turning space running slope is greater than 2%

Turning space cross slope greater than 2%	X	X		
Temporary obstruction (>0.25") in curb ramp/landing/flares				
Non-compliant detectable warning surface (DWS)				
No detectable warning surface (DWS)				
Transition onto roadway is greater than 0.25"		X		Fix transition to roadway
Counter slope of the gutter or street at the foot of the curb ramp is greater than 5%				
Ponding occurs at base of curb ramp

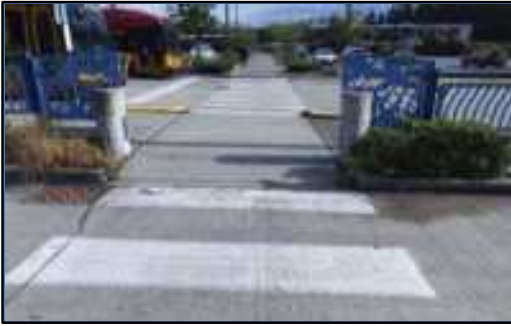
Ramp 1A

Remove and replace curb ramp / corner sidewalk

Fix transition to roadway

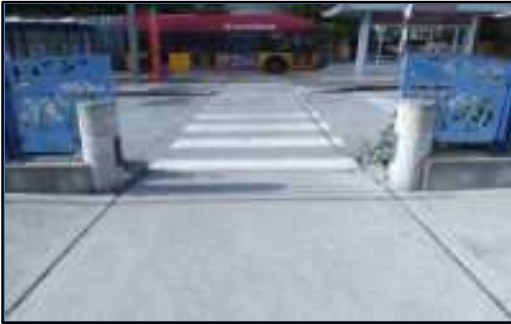
Ramp 1A

Remove and replace curb ramp / corner sidewalk

Fix transition to roadway

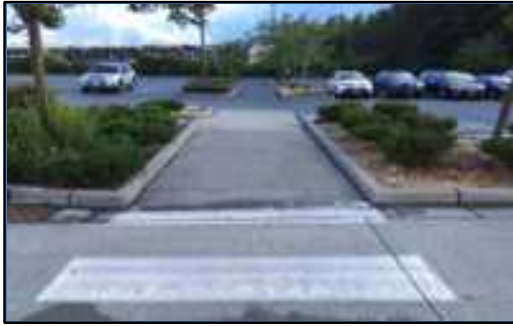
Ramp 1A

Issues	Point ID		Possible Solutions
	1A	4A	
Curb ramp does not exist and is needed			Remove and replace curb ramp / corner sidewalk
Curb ramp does not land in crosswalk			
No 4' x 4' clear space at base of curb ramp			
Curbed side is not 90° or has traversable adjacent surface		X	
Flare cross slope is greater than 10%			
Curb ramp running slope is greater than 8.3%		X	
Blended transition running slope is greater than 5%			
Cut-thru ramp running slope is greater than 5%			
Curb ramp cross slope is greater than 2%		X	
Cut-thru ramp cross slope is greater than 2%			
Curb ramp width is less than 48"			
Cut-thru ramp width is less than 60"			
Permanent obstruction (>0.25") in curb ramp/landing/flares			
Turning space does not exist and is needed			
Turning space length is less than 4' (or 5' when constrained)			
Turning space width is less than 4' (or 5' when constrained)			Fix transition to roadway
Turning space running slope is greater than 2%

Turning space cross slope greater than 2%	X	X	
Temporary obstruction (>0.25") in curb ramp/landing/flares			
Non-compliant detectable warning surface (DWS)			
No detectable warning surface (DWS)			Fix curb ramp counter slope
Transition onto roadway is greater than 0.25"		X	
Counter slope of the gutter or street at the foot of the curb ramp is greater than 5%		X	
Ponding occurs at base of curb ramp

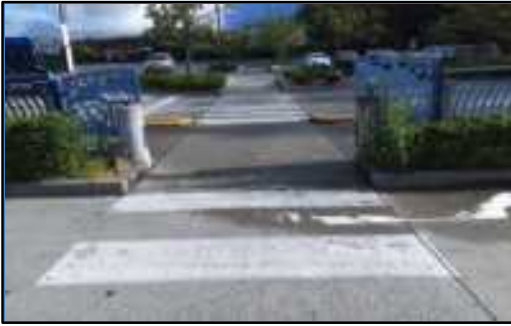
Ramp 1A

Remove and replace curb ramp / corner sidewalk

Fix transition to roadway

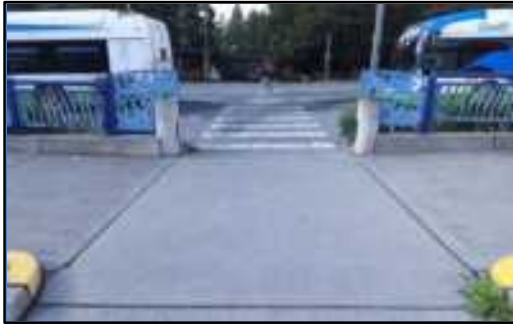
Ramp 1A

Issues	Point ID		Possible Solutions
	1A	4A	
Curb ramp does not exist and is needed			
Curb ramp does not land in crosswalk			
No 4' x 4' clear space at base of curb ramp			
Curbed side is not 90° or has traversable adjacent surface			
Flare cross slope is greater than 10%		X	
Curb ramp running slope is greater than 8.3%	X	X	
Blended transition running slope is greater than 5%			
Cut-thru ramp running slope is greater than 5%			
Curb ramp cross slope is greater than 2%	X	X	
Cut-thru ramp cross slope is greater than 2%			
Curb ramp width is less than 48"			
Cut-thru ramp width is less than 60"			
Permanent obstruction (>0.25") in curb ramp/landing/flares		X	
Turning space does not exist and is needed			
Turning space length is less than 4' (or 5' when constrained)			
Turning space width is less than 4' (or 5' when constrained)			
Turning space running slope is greater than 2%			
Turning space cross slope greater than 2%	X	X

Temporary obstruction (>0.25") in curb ramp/landing/flares			
Non-compliant detectable warning surface (DWS)			
No detectable warning surface (DWS)			
Transition onto roadway is greater than 0.25"			
Counter slope of the gutter or street at the foot of the curb ramp is greater than 5%			
Ponding occurs at base of curb ramp	X		Fix ponding

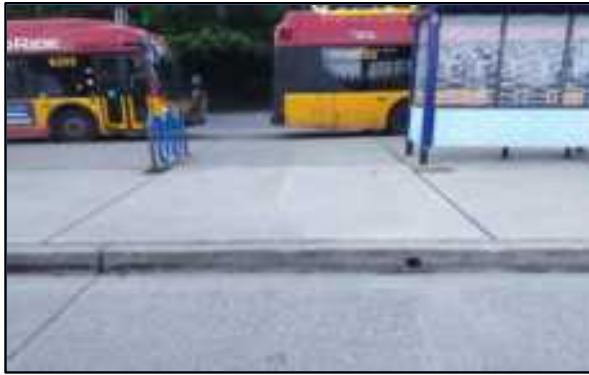
Boarding/Alighting Area

Boarding Area Issues	Issue Exists	Possible Solutions
Boarding area does not exist		
Boarding area length is less than 96"		
Boarding area width is less than 60"		
Boarding area running slope is greater than 2%	X	Remove and replace boarding area
Boarding area cross slope is greater than adjacent street grade		
Heaving/Sinking/Cracking present in the boarding area		
Ponding present in the boarding area		
Permanent obstruction (>0.25") in boarding area		
Temporary obstruction (>0.25") in boarding area		
Transition at connection to the curb is greater than 0.25"		
Boarding area is missing a connection to the street or sidewalk network		
Adjacent Sidewalk Network Issues	Issue Exists	Possible Solutions
Sidewalk network width is less than 48"		
Sidewalk network cross slope is greater than 2%		
Heaving/Sinking/Cracking present in the sidewalk network		
Ponding present in the sidewalk network		
Permanent obstruction (>0.25") in sidewalk network

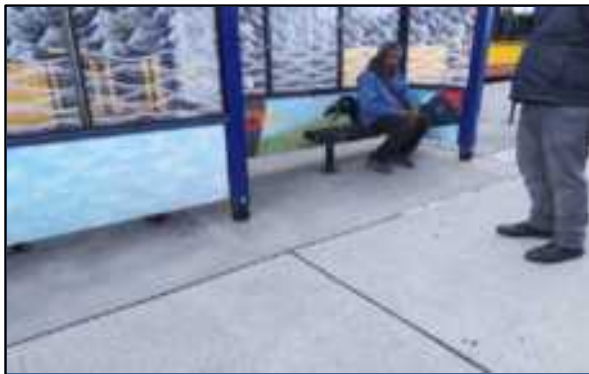
Shelter/Clear Space

Shelter clear space length is less than 48"	X	Remove and replace clear space
Shelter clear space width is less than 30"		
Shelter clear space running slope is greater than 2%	X	
Shelter opening clear width is less than 32"

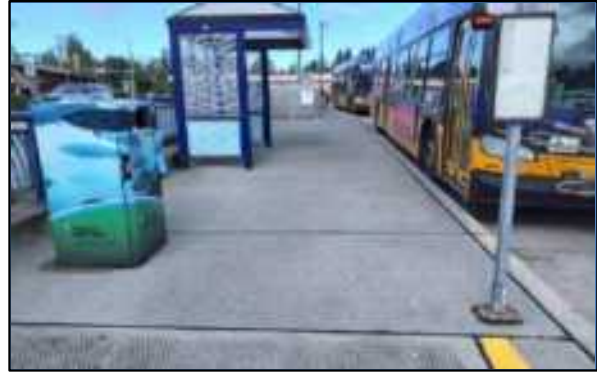
Adjacent Sidewalk Network

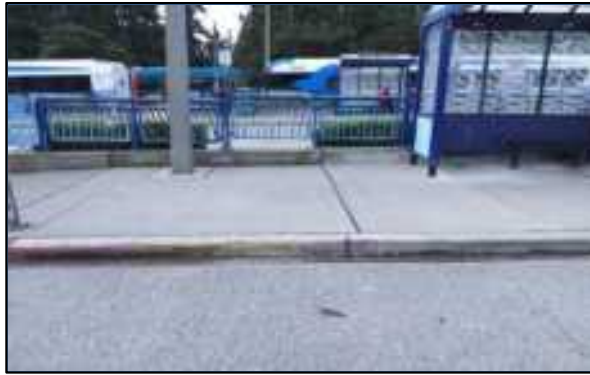
Boarding/Alighting Area

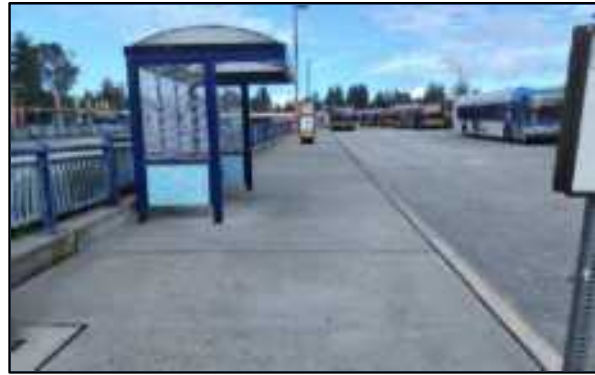
Adjacent Sidewalk Network

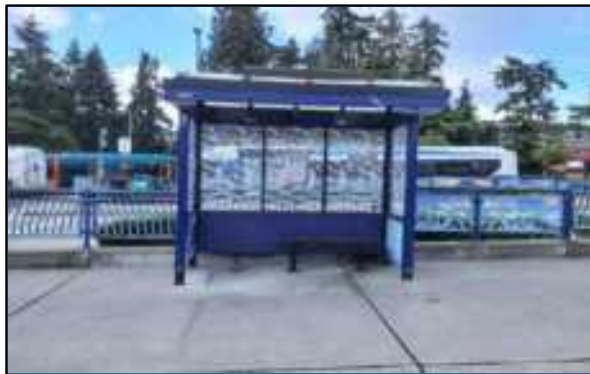
No clear space under shelter		
Shelter clear space length is less than 48"		
Shelter clear space width is less than 30"		
Shelter clear space running slope is greater than 2%	X	Remove and replace clear space
Shelter opening clear width is less than 32"

Shelter/Clear Space

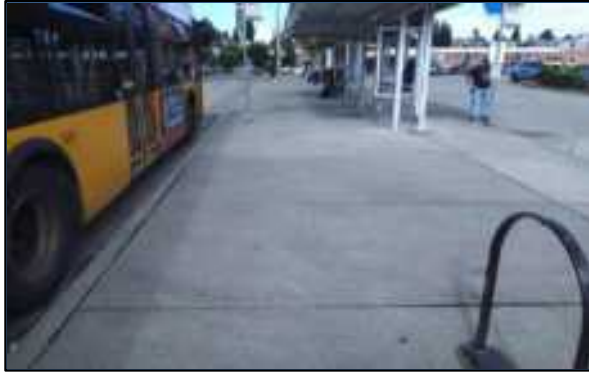
Boarding Area Issues	Issue Exists	Possible Solutions
Boarding area does not exist		
Boarding area length is less than 96"		
Boarding area width is less than 60"		
Boarding area running slope is greater than 2%	X	Remove and replace boarding area
Boarding area cross slope is greater than adjacent street grade		
Heaving/Sinking/Cracking present in the boarding area		
Ponding present in the boarding area		
Permanent obstruction (>0.25") in boarding area		
Temporary obstruction (>0.25") in boarding area		
Transition at connection to the curb is greater than 0.25"		
Boarding area is missing a connection to the street or sidewalk network		
Adjacent Sidewalk Network Issues	Issue Exists	Possible Solutions
Sidewalk network width is less than 48"		
Sidewalk network cross slope is greater than 2%		
Heaving/Sinking/Cracking present in the sidewalk network		
Ponding present in the sidewalk network		
Permanent obstruction (>0.25") in sidewalk network

Boarding/Alighting Area

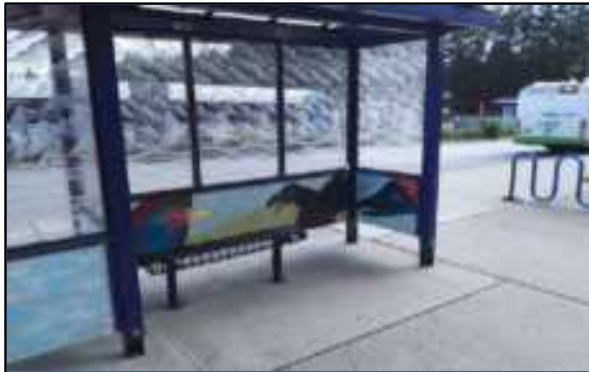
No clear space under shelter		
Shelter clear space length is less than 48"		
Shelter clear space width is less than 30"		
Shelter clear space running slope is greater than 2%	X	Remove and replace clear space
Shelter opening clear width is less than 32"

Shelter/Clear Space

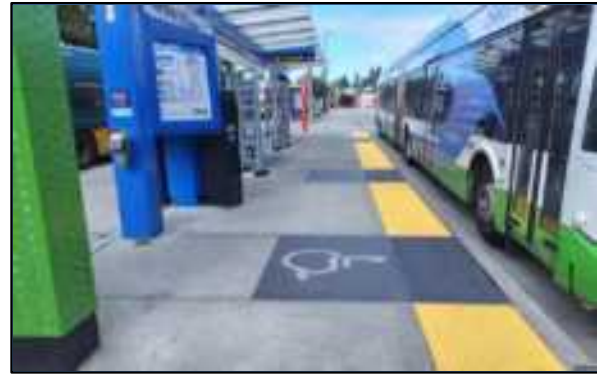
Boarding/Alighting Area

Boarding Area Issues	Issue Exists	Possible Solutions
Boarding area does not exist		
Boarding area length is less than 96"		
Boarding area width is less than 60"		
Boarding area running slope is greater than 2%		
Boarding area cross slope is greater than adjacent street grade		
Heaving/Sinking/Cracking present in the boarding area		
Ponding present in the boarding area		
Permanent obstruction (>0.25") in boarding area		
Temporary obstruction (>0.25") in boarding area		
Transition at connection to the curb is greater than 0.25"	X	Fix connection transition
Boarding area is missing a connection to the street or sidewalk network		
Adjacent Sidewalk Network Issues	Issue Exists	Possible Solutions
Sidewalk network width is less than 48"		
Sidewalk network cross slope is greater than 2%		
Heaving/Sinking/Cracking present in the sidewalk network		
Ponding present in the sidewalk network		
Permanent obstruction (>0.25") in sidewalk network

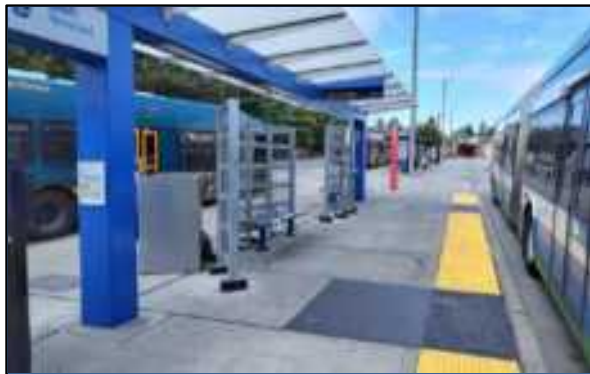
Adjacent Sidewalk Network

Temporary obstruction (>0.25") in sidewalk network		
Transition at connection to boarding area is greater than 0.25"		
Transit Stop Sidewalk Issues	Issue Exists	Possible Solutions
Transit stop sidewalk cross slope is greater than 2%		
Heaving/Sinking/Cracking present in the transit stop sidewalk		
Ponding present in the transit stop sidewalk		
Permanent obstruction (>0.25") in transit stop sidewalk		
Temporary obstruction (>0.25") in transit stop sidewalk		
Transition at connection to sidewalk network is greater than 0.25"		
Transit Stop Amenity Issues	Issue Exists	Possible Solutions
No transit stop signage		
Transit stop signage is non-compliant	X	Remove and replace transit stop signage
No clear space adjacent to stand-alone bench		
Stand-alone bench clear space length is less than 48"		
Stand-alone bench clear space width is less than 30"		
Stand-alone bench clear space running slope is greater than 2%

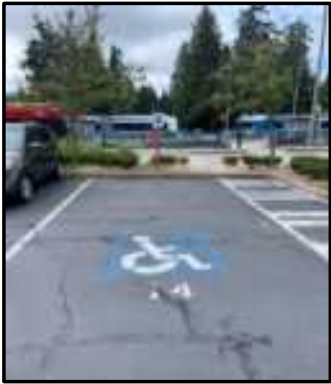
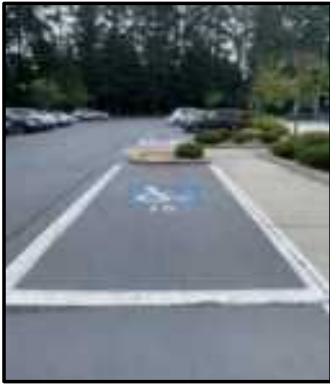
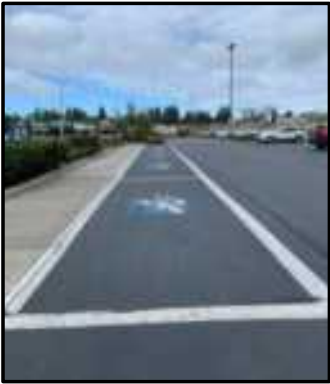
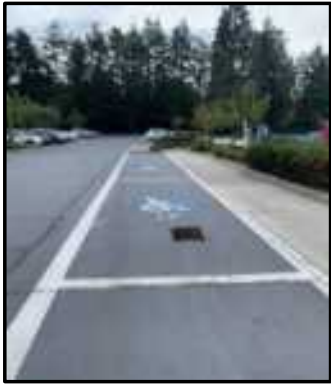
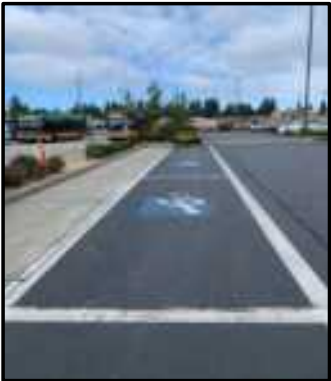
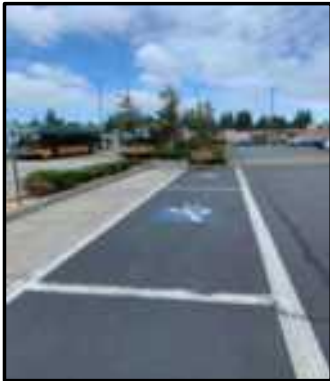
Parking Space Issue	Parking Space ID							Possible Solutions
	P1	P2	P3	P4	P5	P6	P7	
Parking space not marked as accessible		x	x					
Parking space width is less than 96"								
Parking space does not have an adjacent access aisle								
Car parking space access aisle width is less than 60"								
Van parking space access aisle width is less than 96"	x							Remove and replace pavement markings
Access aisle does not extend the full length of the parking space it serves								Install access aisle hatch pavement markings
Access aisle is not marked to discourage parking in the aisle	x							
Access aisle overlaps the vehicular way								
Access aisle does not adjoin an accessible route								
Constrained width where the access aisle adjoins the accessible route is less than 48"								
Access aisle has change in level > 0.25"	x							
Access aisle has horizontal openings > 0.5"								Repave and restripe access aisle or relocate access aisle

Access aisle running slope is > 2%								
Access aisle cross slope is > 2%	x							
Parking space has change in level > 0.25"	x			x				
Parking space horizontal openings > 0.5"				x				
Parking space running slope is > 2%		x	x	x	x	x	x	Repave and restripe accessible parking space or relocate accessible parking space
Parking space cross slope is > 2%				x				
Parking space vertical clearance is < 98"								
Parking space identification sign is missing or incorrect	x	x	x					Install accessible parking sign

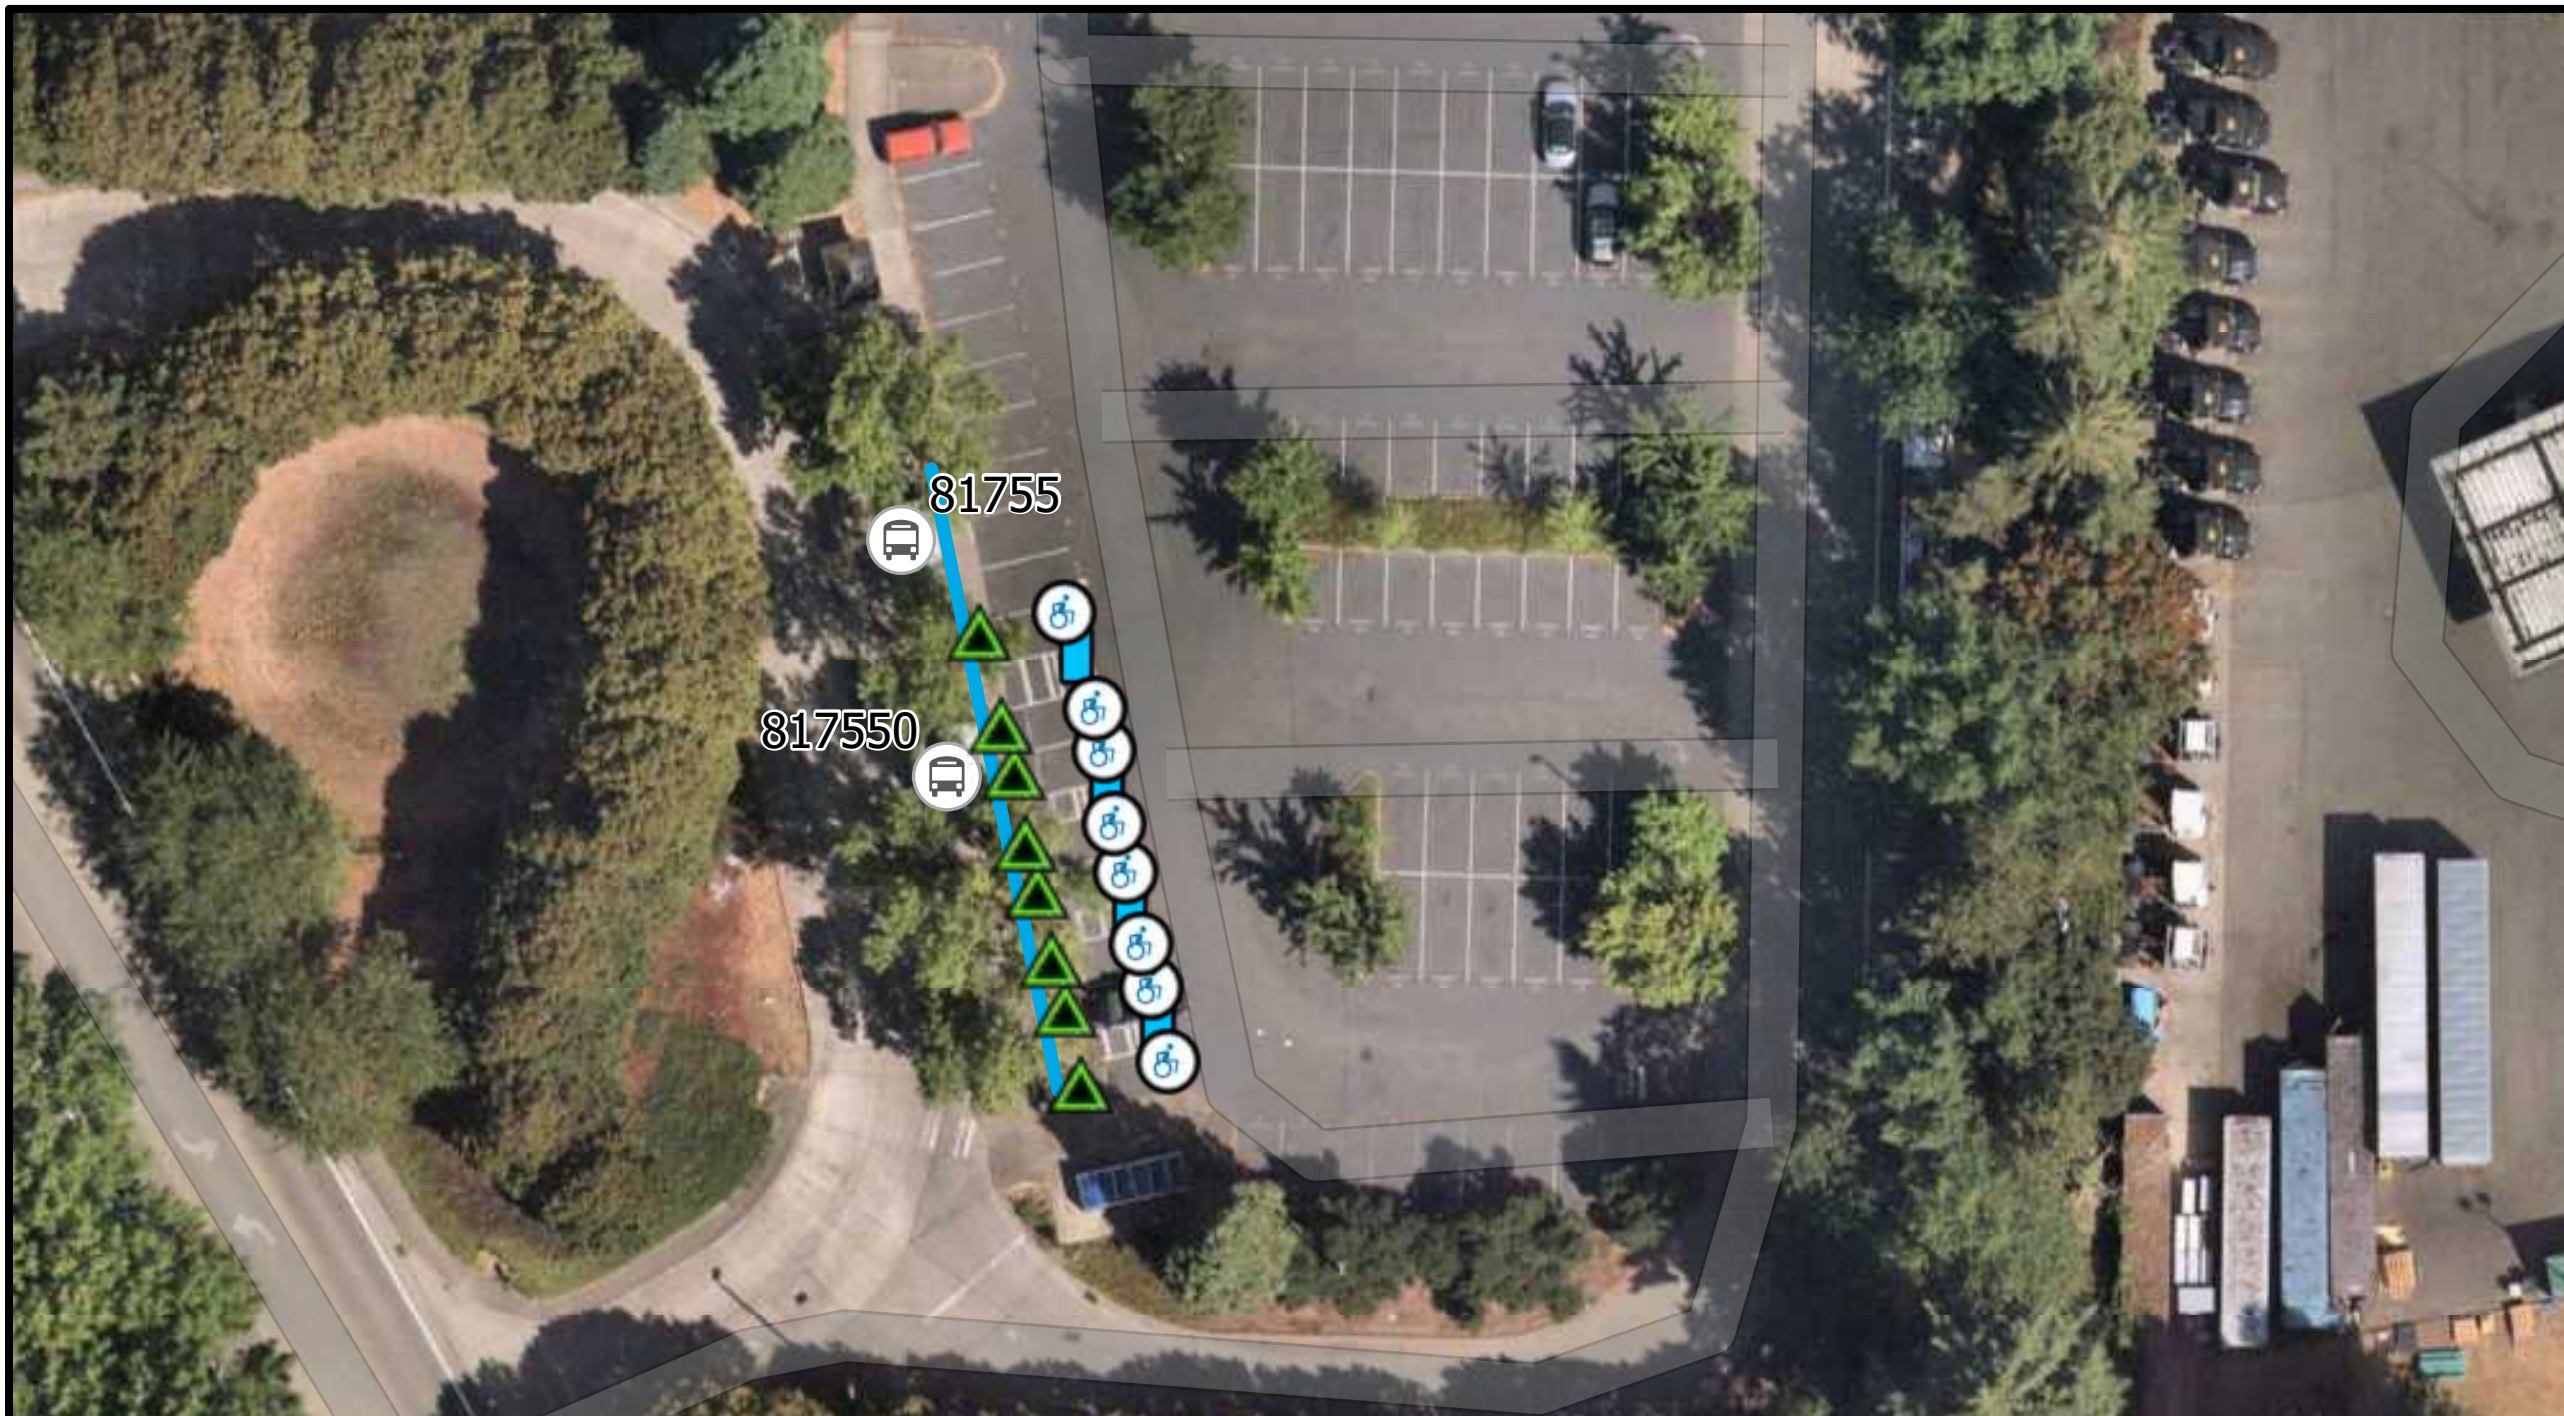
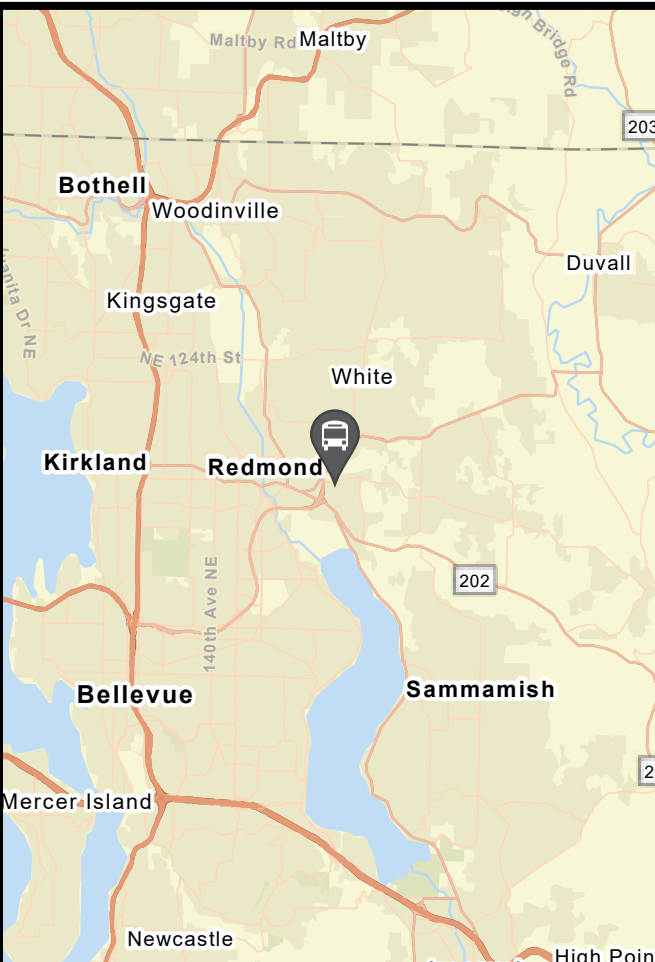
- ### Legend
- Intersections and ID
  - Curb Ramp
  - Path of Travel
  - Accessible Parking Sign
  - Accessible Parking
  - Access Aisle
  - Transit Stop and ID
  - Ramp
  - Building

Facility Quantity Summary of Evaluated Elements	
	Feet
Path of Travel	<b>111</b>
	Quantity
Intersections with Curb Ramps	<b>0</b>
Ramps	<b>0</b>
Transit Stops	<b>2</b>
Accessible Parking Spaces	<b>8</b>

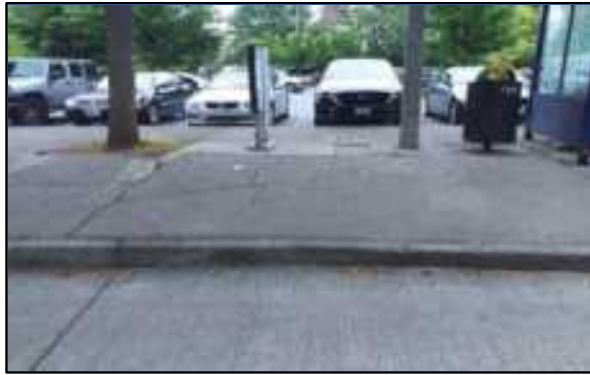
Boarding/Alighting Area

Boarding Area Issues	Issue Exists	Possible Solutions
Boarding area does not exist		
Boarding area length is less than 96"		
Boarding area width is less than 60"		
Boarding area running slope is greater than 2%	X	Remove and replace boarding area
Boarding area cross slope is greater than adjacent street grade		
Heaving/Sinking/Cracking present in the boarding area	X	
Ponding present in the boarding area		
Permanent obstruction (>0.25") in boarding area		
Temporary obstruction (>0.25") in boarding area		
Transition at connection to the curb is greater than 0.25"	X	Fix connection transition
Boarding area is missing a connection to the street or sidewalk network		
Adjacent Sidewalk Network Issues	Issue Exists	Possible Solutions
Sidewalk network width is less than 48"		
Sidewalk network cross slope is greater than 2%		
Heaving/Sinking/Cracking present in the sidewalk network		
Ponding present in the sidewalk network

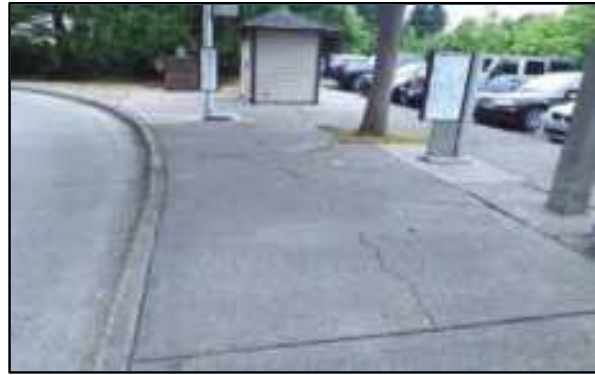
Adjacent Sidewalk Network

Permanent obstruction (>0.25") in sidewalk network		
Temporary obstruction (>0.25") in sidewalk network		
Transition at connection to boarding area is greater than 0.25"		
Transit Stop Sidewalk Issues	Issue Exists	Possible Solutions
Transit stop sidewalk cross slope is greater than 2%		
Heaving/Sinking/Cracking present in the transit stop sidewalk		
Ponding present in the transit stop sidewalk		
Permanent obstruction (>0.25") in transit stop sidewalk		
Temporary obstruction (>0.25") in transit stop sidewalk		
Transition at connection to sidewalk network is greater than 0.25"		
Transit Stop Amenity Issues	Issue Exists	Possible Solutions
No transit stop signage		
Transit stop signage is non-compliant	X	Remove and replace transit stop signage
No clear space adjacent to stand-alone bench		
Stand-alone bench clear space length is less than 48"		
Stand-alone bench clear space width is less than 30"		
Stand-alone bench clear space running slope is greater than 2%

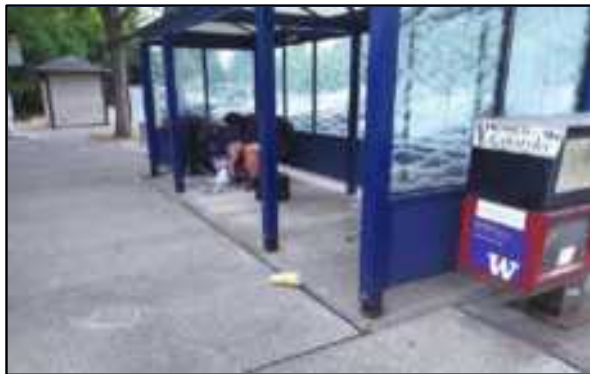
Shelter/Clear Space

No clear space under shelter		
Shelter clear space length is less than 48"		
Shelter clear space width is less than 30"		
Shelter clear space running slope is greater than 2%	X	Remove and replace clear space
Shelter opening clear width is less than 32"

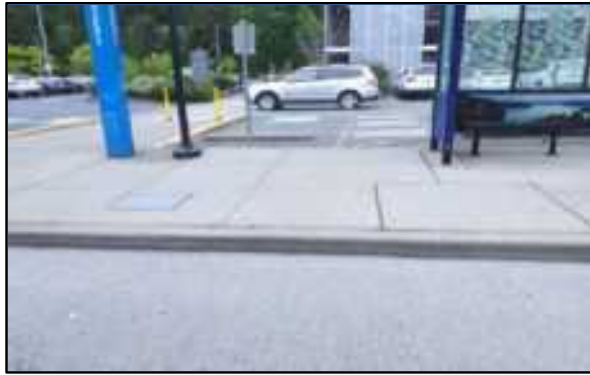
Boarding/Alighting Area

Boarding Area Issues	Issue Exists	Possible Solutions
Boarding area does not exist		
Boarding area length is less than 96"		
Boarding area width is less than 60"		
Boarding area running slope is greater than 2%	X	Remove and replace boarding area
Boarding area cross slope is greater than adjacent street grade		
Heaving/Sinking/Cracking present in the boarding area		
Ponding present in the boarding area		
Permanent obstruction (>0.25") in boarding area		
Temporary obstruction (>0.25") in boarding area		
Transition at connection to the curb is greater than 0.25"		
Boarding area is missing a connection to the street or sidewalk network		
Adjacent Sidewalk Network Issues	Issue Exists	Possible Solutions
Sidewalk network width is less than 48"		
Sidewalk network cross slope is greater than 2%		
Heaving/Sinking/Cracking present in the sidewalk network		
Ponding present in the sidewalk network		
Permanent obstruction (>0.25") in sidewalk network

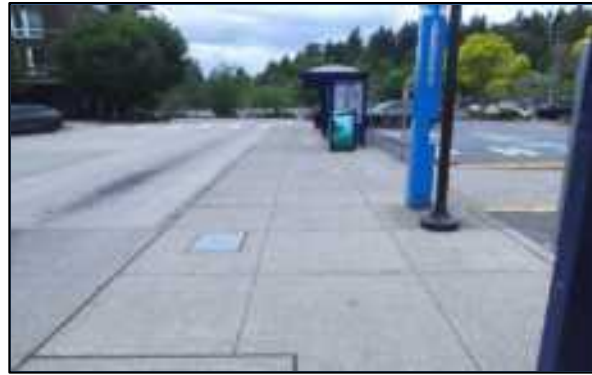
Adjacent Sidewalk Network

Temporary obstruction (>0.25") in sidewalk network		
Transition at connection to boarding area is greater than 0.25"		
Transit Stop Sidewalk Issues	Issue Exists	Possible Solutions
Transit stop sidewalk cross slope is greater than 2%		
Heaving/Sinking/Cracking present in the transit stop sidewalk		
Ponding present in the transit stop sidewalk		
Permanent obstruction (>0.25") in transit stop sidewalk		
Temporary obstruction (>0.25") in transit stop sidewalk		
Transition at connection to sidewalk network is greater than 0.25"		
Transit Stop Amenity Issues	Issue Exists	Possible Solutions
No transit stop signage		
Transit stop signage is non-compliant	X	Remove and replace transit stop signage
No clear space adjacent to stand-alone bench		
Stand-alone bench clear space length is less than 48"		
Stand-alone bench clear space width is less than 30"		
Stand-alone bench clear space running slope is greater than 2%

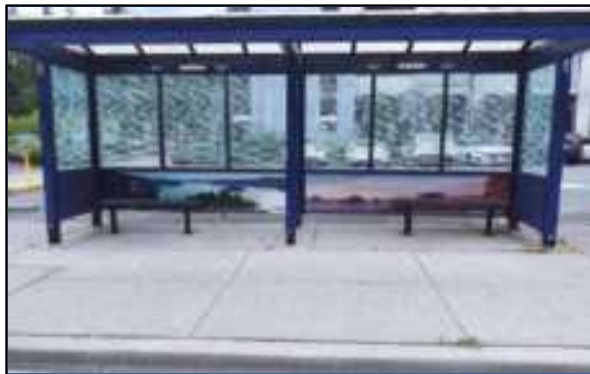
Shelter/Clear Space

No clear space under shelter		
Shelter clear space length is less than 48"		
Shelter clear space width is less than 30"		
Shelter clear space running slope is greater than 2%		
Shelter opening clear width is less than 32"

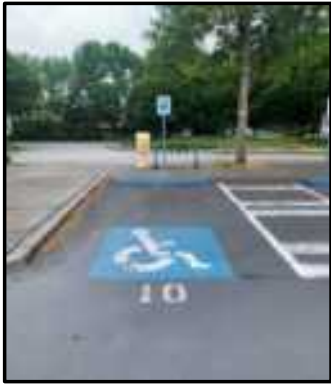
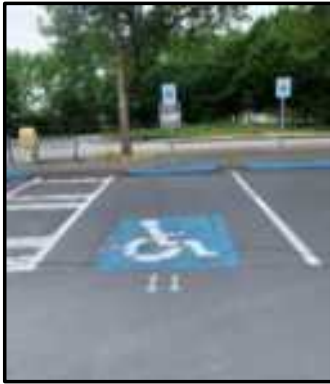
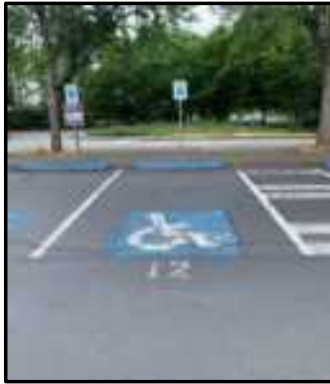
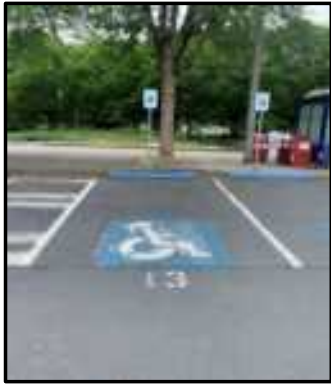
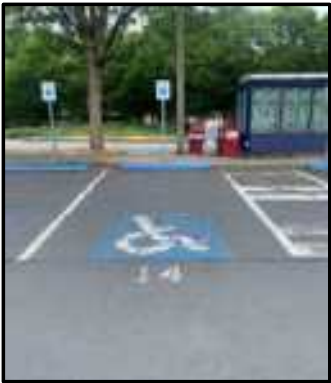
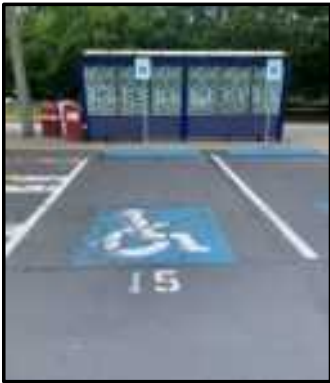
Parking Space Issue	Parking Space ID								Possible Solutions
	P1	P2	P3	P4	P5	P6	P7	P8	
Parking space not marked as accessible		X	X	X	X	X			
Parking space width is less than 96"									
Parking space does not have an adjacent access aisle									
Car parking space access aisle width is less than 60"									
Van parking space access aisle width is less than 96"									
Access aisle does not extend the full length of the parking space it serves									
Access aisle is not marked to discourage parking in the aisle	X		X		X				Install access aisle hatch pavement markings
Access aisle overlaps the vehicular way									
Access aisle does not adjoin an accessible route									
Constrained width where the access aisle adjoins the accessible route is less than 48"									
Access aisle has change in level > 0.25"	X				X				
Access aisle has horizontal openings > 0.5"	X		X		X				Repave and restripe access aisle or relocate access aisle

Access aisle running slope is > 2%	X		X		X		X		
Access aisle cross slope is > 2%					X				
Parking space has change in level > 0.25"									
Parking space horizontal openings > 0.5"			X			X			
Parking space running slope is > 2%	X	X	X	X	X	X	X		Repave and restripe accessible parking space or relocate accessible parking space
Parking space cross slope is > 2%	X								
Parking space vertical clearance is < 98"									
Parking space identification sign is missing or incorrect

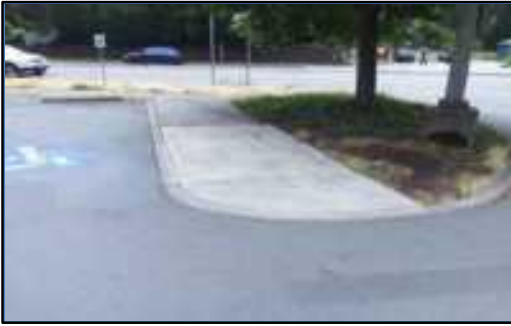
Corner 4 No Ramp (4z)

Issues	Point ID	Possible Solutions
	4z	
Curb ramp does not exist and is needed		
Curb ramp does not land in crosswalk		
No 4' x 4' clear space at base of curb ramp		
Curbed side is not 90° or has traversable adjacent surface		
Flare cross slope is greater than 10%		
Curb ramp running slope is greater than 8.3%		
Blended transition running slope is greater than 5%		
Cut-thru ramp running slope is greater than 5%		
Curb ramp cross slope is greater than 2%		
Cut-thru ramp cross slope is greater than 2%		
Curb ramp width is less than 48"		
Cut-thru ramp width is less than 60"		
Permanent obstruction (>0.25') in curb ramp/landing/flares		
Turning space does not exist and is needed		
Turning space length is less than 4' (or 5' when constrained)		
Turning space width is less than 4' (or 5' when constrained)		
Turning space running slope is greater than 2%		
Turning space cross slope greater than 2%		
Temporary obstruction (>0.25') in curb ramp/landing/flares

Non-compliant detectable warning surface (DWS)		
No detectable warning surface (DWS)	X	Install DWS
Transition onto roadway is greater than 0.25'		
Counter slope of the gutter or street at the foot of the curb ramp is greater than 5%		
Ponding occurs at base of curb ramp

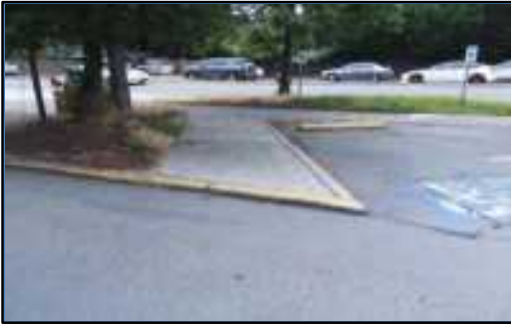
Corner 4 No Ramp (4z)

Issues	Point ID	Possible Solutions
	4z	
Curb ramp does not exist and is needed	X	Install curb ramp / corner sidewalk; if median improvement, see shapefile
Curb ramp does not land in crosswalk		
No 4' x 4' clear space at base of curb ramp		
Curbed side is not 90° or has traversable adjacent surface		
Flare cross slope is greater than 10%		
Curb ramp running slope is greater than 8.3%		
Blended transition running slope is greater than 5%		
Cut-thru ramp running slope is greater than 5%		
Curb ramp cross slope is greater than 2%		
Cut-thru ramp cross slope is greater than 2%		
Curb ramp width is less than 48"		
Cut-thru ramp width is less than 60"		
Permanent obstruction (>0.25') in curb ramp/landing/flares		
Turning space does not exist and is needed		
Turning space length is less than 4' (or 5' when constrained)		
Turning space width is less than 4' (or 5' when constrained)		
Turning space running slope is greater than 2%

Turning space cross slope greater than 2%		
Temporary obstruction (>0.25') in curb ramp/landing/flares		
Non-compliant detectable warning surface (DWS)		
No detectable warning surface (DWS)		
Transition onto roadway is greater than 0.25'		
Counter slope of the gutter or street at the foot of the curb ramp is greater than 5%		
Ponding occurs at base of curb ramp

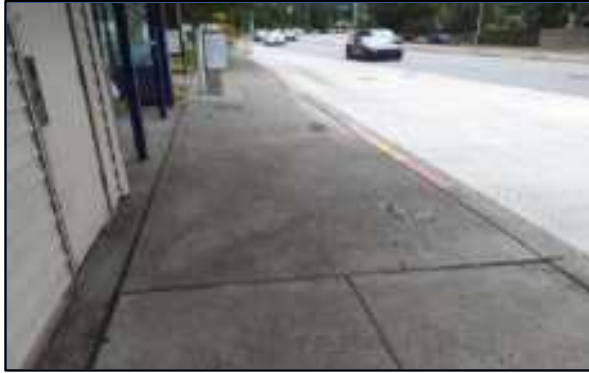
Boarding/Alighting Area

Boarding Area Issues	Issue Exists	Possible Solutions
Boarding area does not exist		
Boarding area length is less than 96"		
Boarding area width is less than 60"		
Boarding area running slope is greater than 2%	X	Remove and replace boarding area
Boarding area cross slope is greater than adjacent street grade		
Heaving/Sinking/Cracking present in the boarding area		
Ponding present in the boarding area		
Permanent obstruction (>0.25") in boarding area		
Temporary obstruction (>0.25") in boarding area		
Transition at connection to the curb is greater than 0.25"		
Boarding area is missing a connection to the street or sidewalk network		
Adjacent Sidewalk Network Issues	Issue Exists	Possible Solutions
Sidewalk network width is less than 48"		
Sidewalk network cross slope is greater than 2%		
Heaving/Sinking/Cracking present in the sidewalk network		
Ponding present in the sidewalk network		
Permanent obstruction (>0.25") in sidewalk network

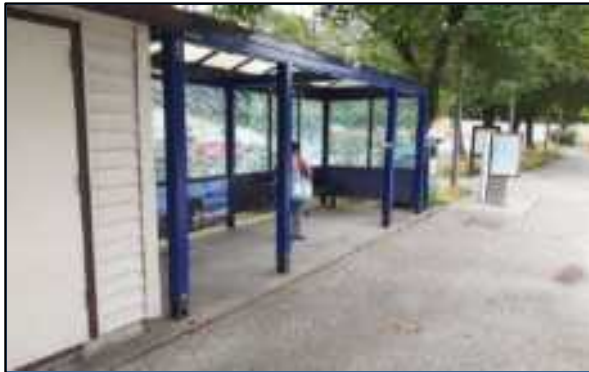
Shelter/Clear Space

No clear space under shelter		
Shelter clear space length is less than 48"		
Shelter clear space width is less than 30"		
Shelter clear space running slope is greater than 2%		
Shelter opening clear width is less than 32"

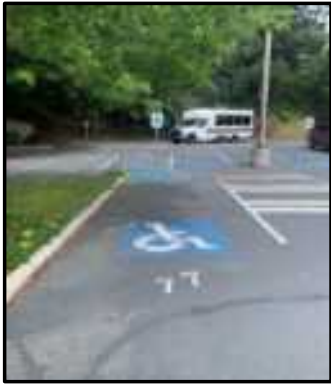
Parking Space ID 1

Parking Space Issue	Parking Space ID							Possible Solutions
	P1	P2	P3	P4	P5	P6	P7	
Parking space not marked as accessible		X		X	X	X	X	
Parking space width is less than 96"				X		X	X	Remove and replace pavement markings
Parking space does not have an adjacent access aisle								
Car parking space access aisle width is less than 60"				X	X			
Van parking space access aisle width is less than 96"			X					Remove and replace pavement markings
Access aisle does not extend the full length of the parking space it serves								
Access aisle is not marked to discourage parking in the aisle	X			X	X	X		Install access aisle hatch pavement markings
Access aisle overlaps the vehicular way								
Access aisle does not adjoin an accessible route								
Constrained width where the access aisle adjoins the accessible route is less than 48"								
Access aisle has change in level > 0.25"								
Access aisle has horizontal openings > 0.5"						X

Access aisle running slope is > 2%				X	X	X		Repave and restripe access aisle or relocate access aisle
Access aisle cross slope is > 2%								
Parking space has change in level > 0.25"								
Parking space horizontal openings > 0.5"		X						
Parking space running slope is > 2%				X	X	X	X	Repave and restripe accessible parking space or relocate accessible parking space
Parking space cross slope is > 2%				X				
Parking space vertical clearance is < 98"								
Parking space identification sign is missing or incorrect
