**King County**  
**ADA Self-Evaluation and Transition Plan Update**  
**Facility Cost Projection Summary**  
**August 2023**

# Site Accessibility Evaluation

**Burien PnR Garage (KC)**  
**14900 4th Ave SW**  
**Burien, WA 98166**  
**Accessibility Evaluation**  
**Inspection Date: 07/11/2023**  
**Evaluators: Kalia Klein**

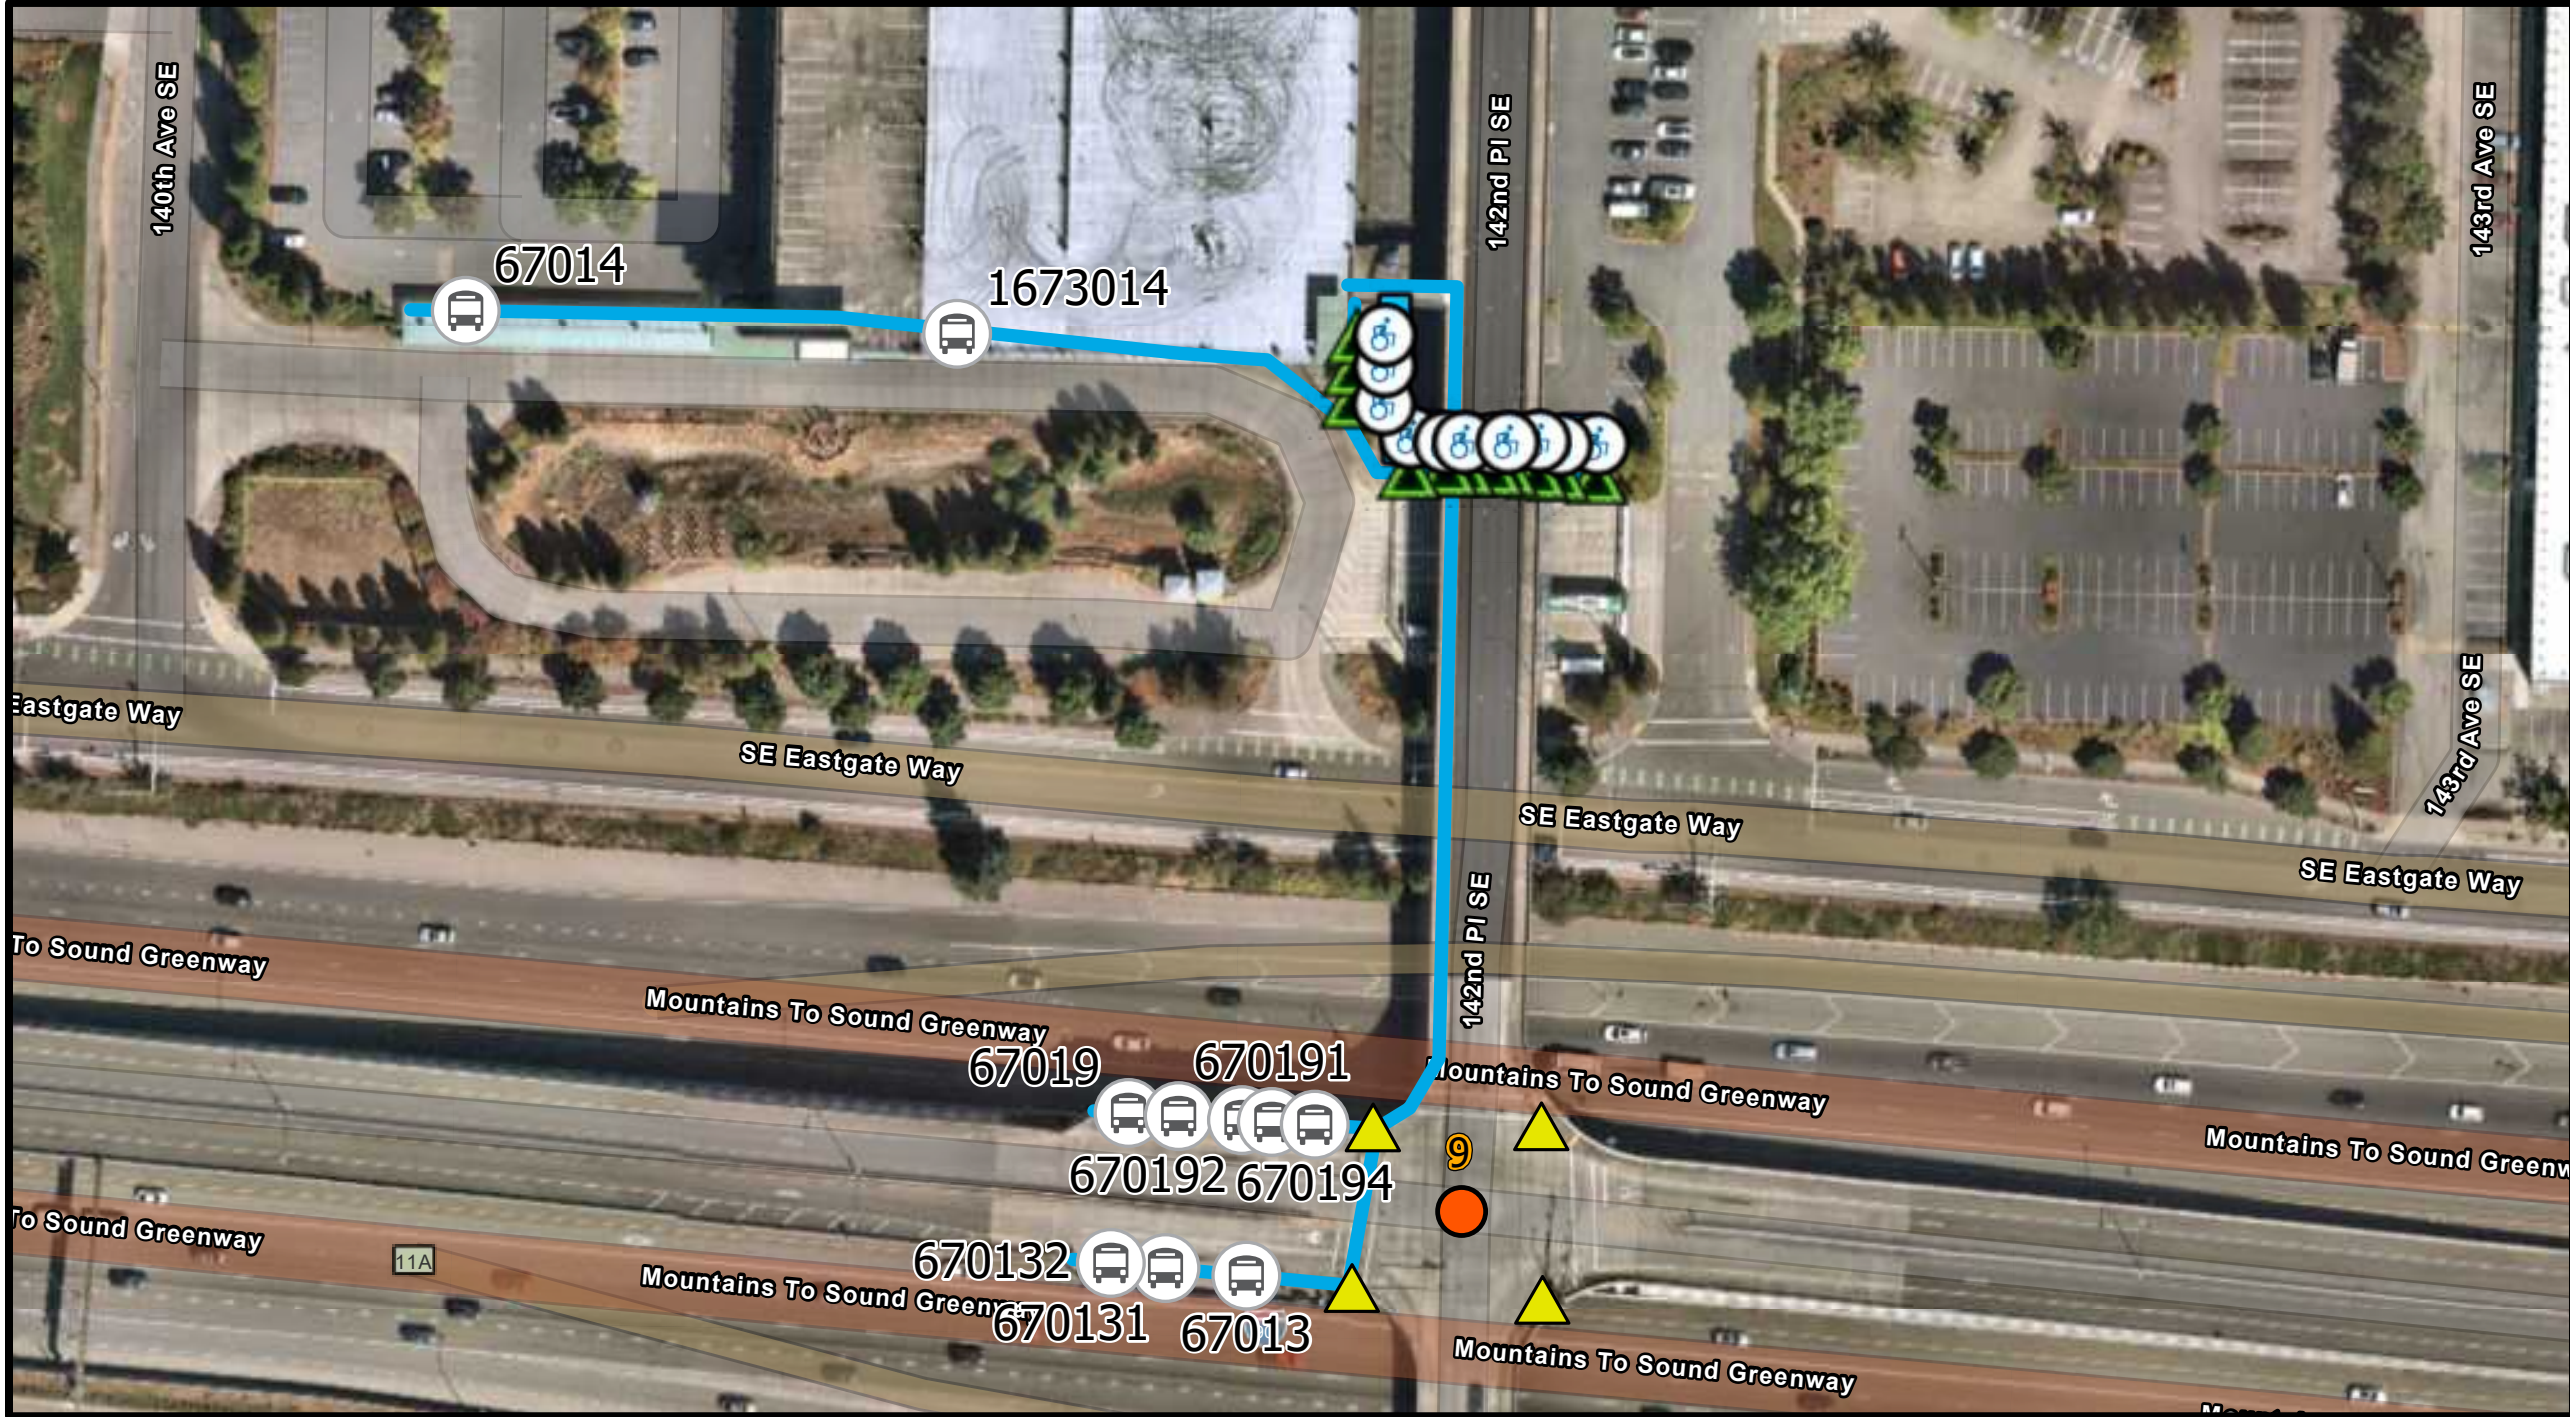
Facility Quantity Summary of  
Evaluated Elements

Feet
Path of Travel	1322
	Quantity
Intersections with Curb Ramps	1
Ramps	0
Transit Stops	10
Accessible Parking Spaces	11

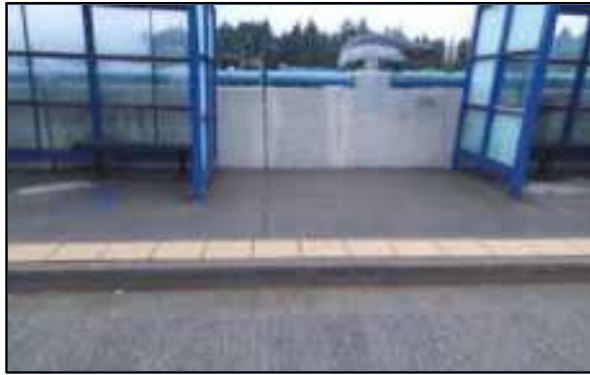
Boarding/Alighting Area

Boarding Area Issues	Issue Exists	Possible Solutions
Boarding area does not exist		
Boarding area length is less than 96"		
Boarding area width is less than 60"		
Boarding area running slope is greater than 2%	X	Remove and replace boarding area
Boarding area cross slope is greater than adjacent street grade		
Heaving/Sinking/Cracking present in the boarding area		
Ponding present in the boarding area		
Permanent obstruction (>0.25") in boarding area		
Temporary obstruction (>0.25") in boarding area		
Transition at connection to the curb is greater than 0.25"		
Boarding area is missing a connection to the street or sidewalk network		
Adjacent Sidewalk Network Issues	Issue Exists	Possible Solutions
Sidewalk network width is less than 48"		
Sidewalk network cross slope is greater than 2%		
Heaving/Sinking/Cracking present in the sidewalk network		
Ponding present in the sidewalk network		
Permanent obstruction (>0.25") in sidewalk network

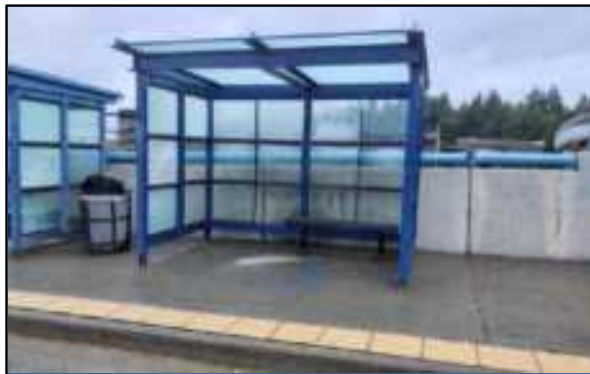
Shelter/Clear Space

No clear space under shelter		
Shelter clear space length is less than 48"		
Shelter clear space width is less than 30"		
Shelter clear space running slope is greater than 2%	X	Remove and replace clear space
Shelter opening clear width is less than 32"

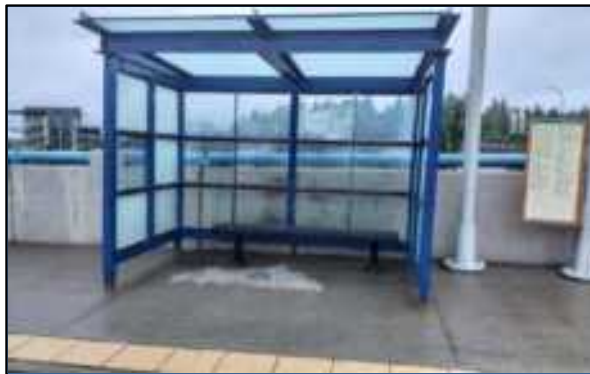
Shelter/Clear Space

No clear space under shelter		
Shelter clear space length is less than 48"	X	Install clear space under shelter and adjacent to bench, if possible
Shelter clear space width is less than 30"		
Shelter clear space running slope is greater than 2%		
Shelter opening clear width is less than 32"

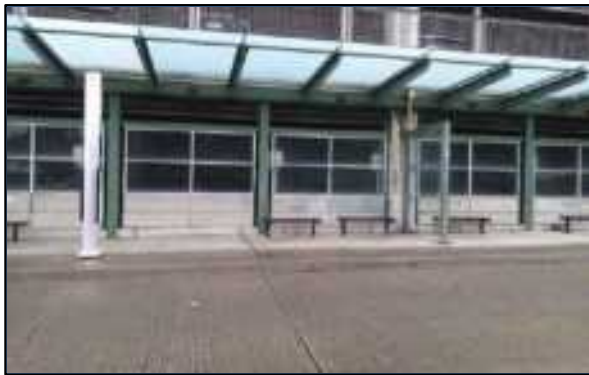
Shelter/Clear Space

No clear space under shelter		
Shelter clear space length is less than 48"	X	Remove and replace clear space
Shelter clear space width is less than 30"		
Shelter clear space running slope is greater than 2%		
Shelter opening clear width is less than 32"

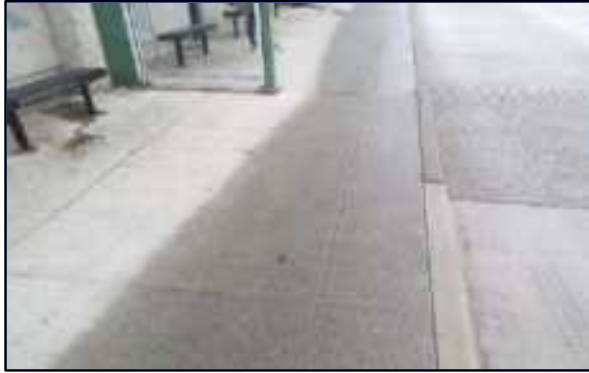
Boarding/Alighting Area

No clear space under shelter		
Shelter clear space length is less than 48"		
Shelter clear space width is less than 30"		
Shelter clear space running slope is greater than 2%		
Shelter opening clear width is less than 32"

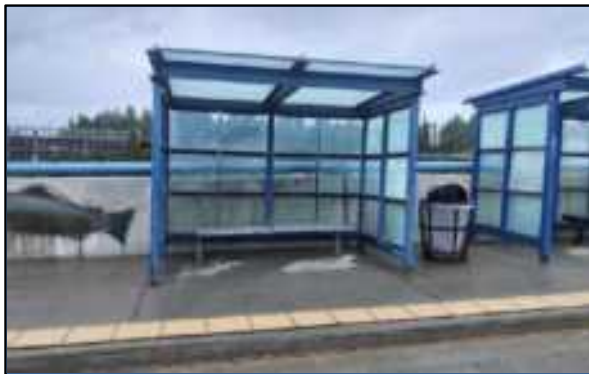
Shelter/Clear Space

No clear space under shelter	X	Install clear space under shelter and adjacent to bench, if possible
Shelter clear space length is less than 48"		
Shelter clear space width is less than 30"		
Shelter clear space running slope is greater than 2%		
Shelter opening clear width is less than 32"

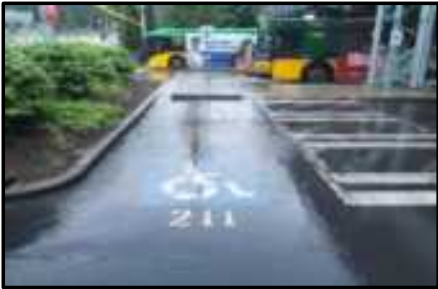
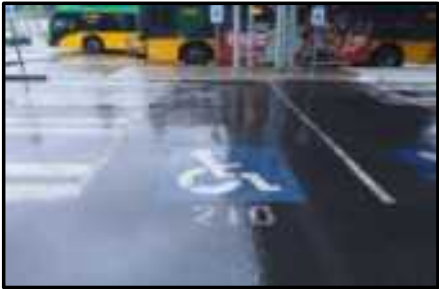
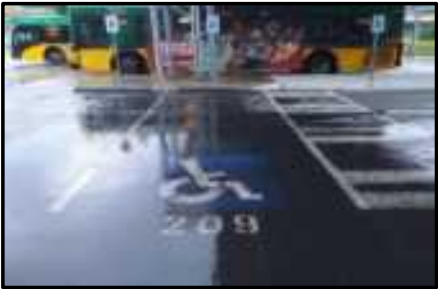
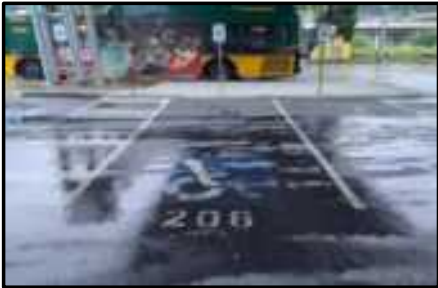
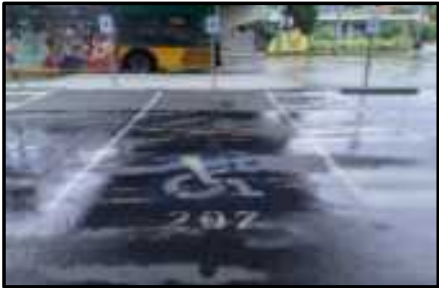
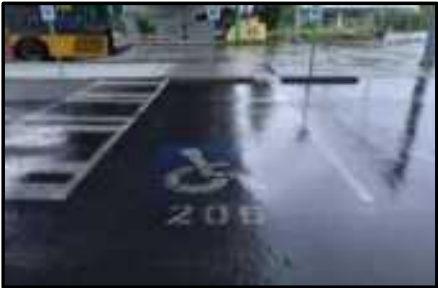
Parking Space Issue	Parking Space ID											Possible Solutions
	P1	P2	P3	P4	P5	P6	P7	P8	P9	P10	P11	
Parking space not marked as accessible	x											Remove and replace pavement markings
Parking space width is less than 96"												
Parking space does not have an adjacent access aisle												
Car parking space access aisle width is less than 60"												Remove and replace pavement markings
Van parking space access aisle width is less than 96"									x	x		
Access aisle does not extend the full length of the parking space it serves												
Access aisle is not marked to discourage parking in the aisle	x						x	x				Install access aisle hatch pavement markings
Access aisle overlaps the vehicular way												
Access aisle does not adjoin an accessible route											x	
Constrained width where the access aisle adjoins the accessible route is less than 48"							x			x		Relocate/restripe accessible parking space to ensure > 48" width where aisle adjoins

Access aisle has change in level > 0.25"	x											
Access aisle has horizontal openings > 0.5"							x					
Access aisle running slope is > 2%	x						x	x			x	Repave and restripe access aisle or relocate access aisle
Access aisle cross slope is > 2%	x		x		x		x	x	x	x	x	
Parking space has change in level > 0.25"	x											
Parking space horizontal openings > 0.5"												Repave and restripe accessible parking space or relocate accessible parking space
Parking space running slope is > 2%	x	x	x		x	x	x	x				
Parking space cross slope is > 2%	x	x	x	x	x	x	x	x		x	x	
Parking space vertical clearance is < 98"												Install accessible parking sign
Parking space identification sign is missing or incorrect											x

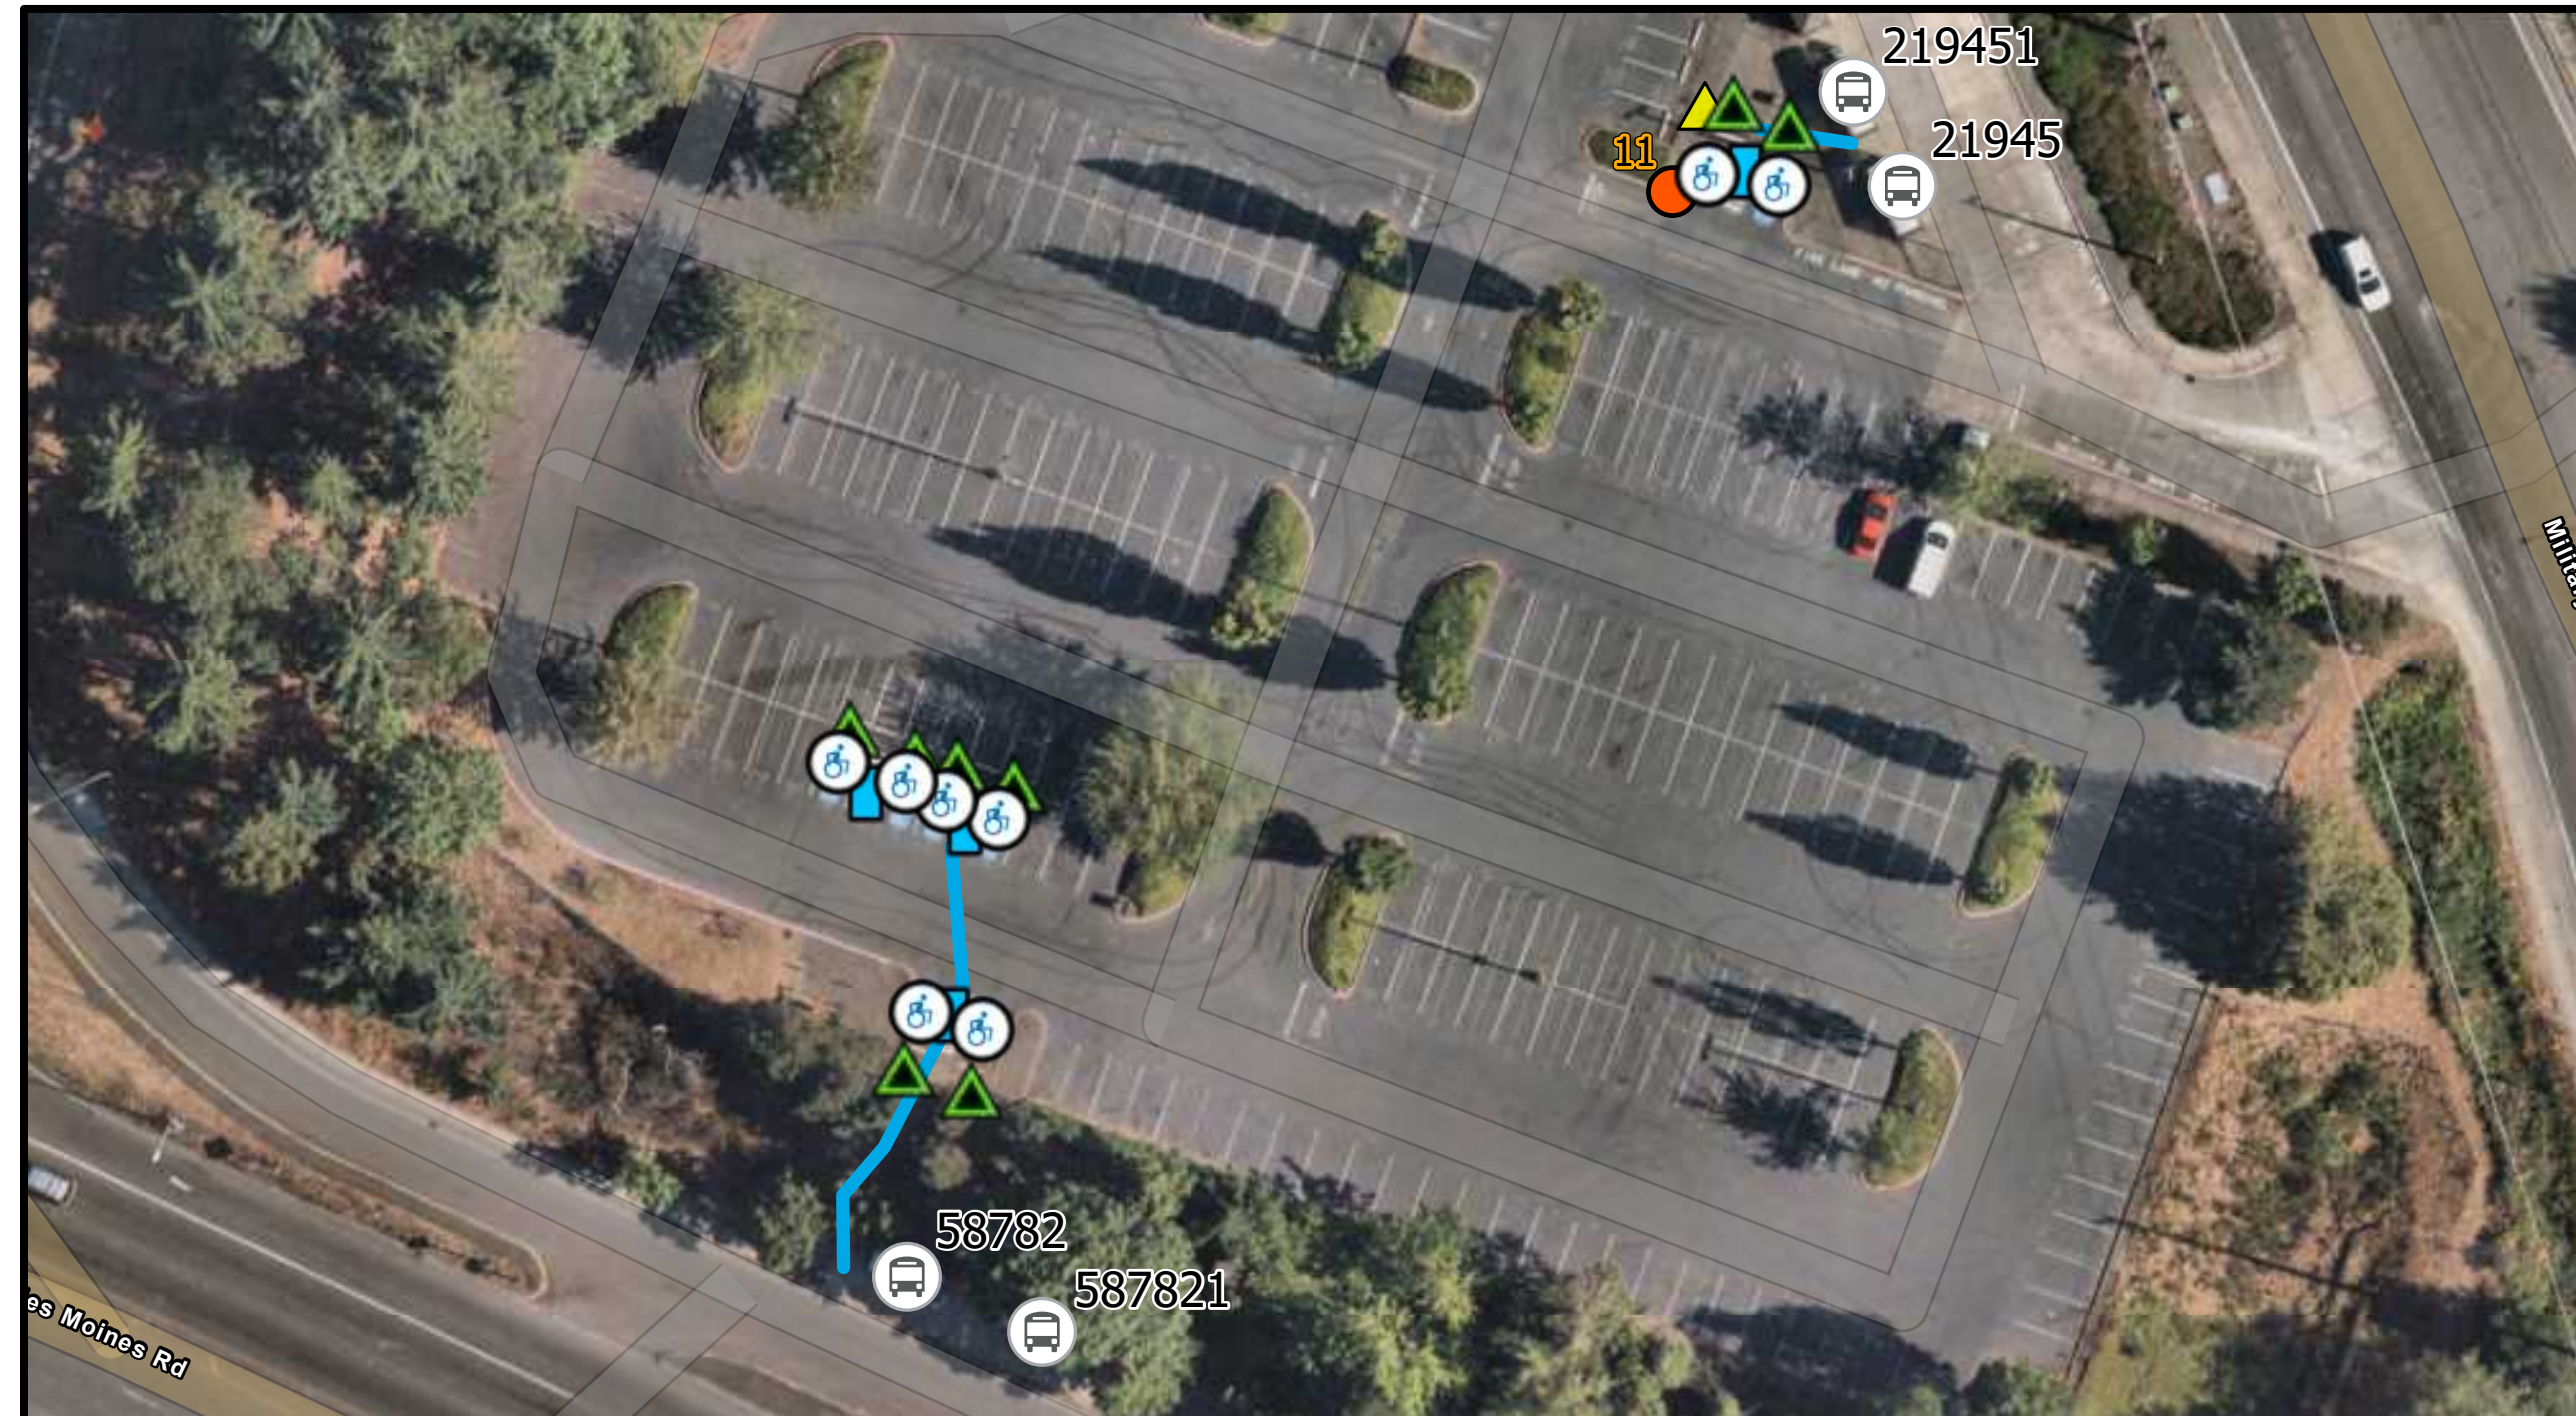
Feet
Path of Travel	<b>120</b>
	Quantity
Intersections with Curb Ramps	<b>1</b>
Ramps	<b>0</b>
Transit Stops	<b>4</b>
Accessible Parking Spaces	<b>8</b>

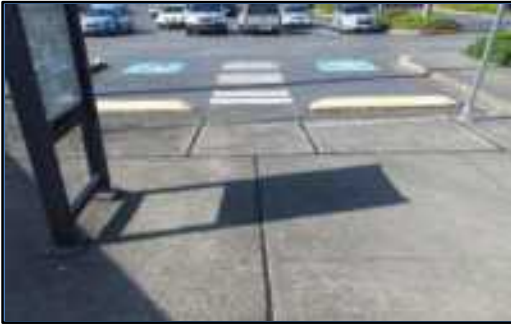
Ramp 2A

Issues	Point ID	Possible Solutions
	2A	
Curb ramp does not exist and is needed		Remove and replace curb ramp / corner sidewalk
Curb ramp does not land in crosswalk		
No 4' x 4' clear space at base of curb ramp		
Curbed side is not 90° or has traversable adjacent surface	X	
Flare cross slope is greater than 10%		
Curb ramp running slope is greater than 8.3%	X	
Blended transition running slope is greater than 5%		
Cut-thru ramp running slope is greater than 5%		
Curb ramp cross slope is greater than 2%	X	
Cut-thru ramp cross slope is greater than 2%		
Curb ramp width is less than 48"		
Cut-thru ramp width is less than 60"		
Permanent obstruction (>0.25") in curb ramp/landing/flares		
Turning space does not exist and is needed		
Turning space length is less than 4' (or 5' when constrained)		
Turning space width is less than 4' (or 5' when constrained)		
Turning space running slope is greater than 2%	X	
Turning space cross slope greater than 2%	X

Temporary obstruction (>0.25") in curb ramp/landing/flares	X	
Non-compliant detectable warning surface (DWS)		
No detectable warning surface (DWS)		
Transition onto roadway is greater than 0.25"		
Counter slope of the gutter or street at the foot of the curb ramp is greater than 5%		
Ponding occurs at base of curb ramp

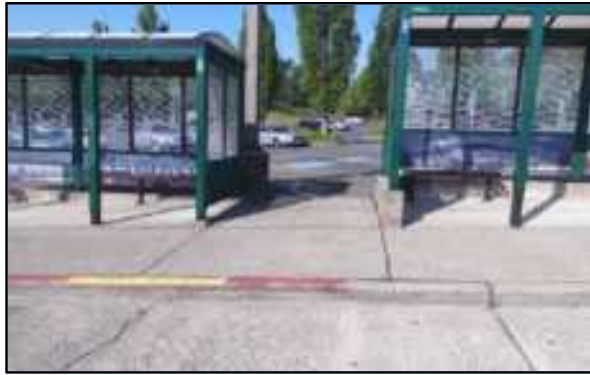
Boarding/Alighting Area

Boarding Area Issues	Issue Exists	Possible Solutions
Boarding area does not exist		
Boarding area length is less than 96"		
Boarding area width is less than 60"		
Boarding area running slope is greater than 2%	X	Remove and replace boarding area
Boarding area cross slope is greater than adjacent street grade		
Heaving/Sinking/Cracking present in the boarding area	X	
Ponding present in the boarding area		
Permanent obstruction (>0.25") in boarding area		
Temporary obstruction (>0.25") in boarding area		
Transition at connection to the curb is greater than 0.25"		
Boarding area is missing a connection to the street or sidewalk network		
Adjacent Sidewalk Network Issues	Issue Exists	Possible Solutions
Sidewalk network width is less than 48"		
Sidewalk network cross slope is greater than 2%		
Heaving/Sinking/Cracking present in the sidewalk network		
Ponding present in the sidewalk network		
Permanent obstruction (>0.25") in sidewalk network

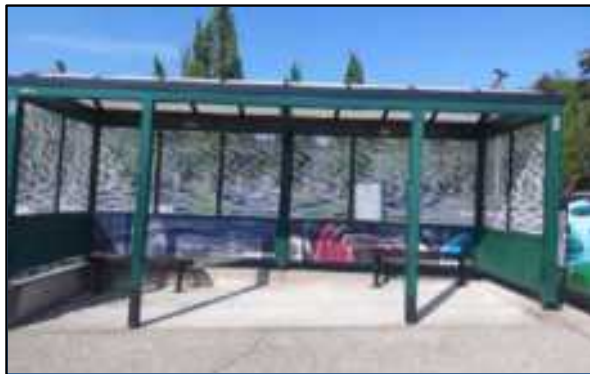
Shelter/Clear Space

No clear space under shelter		
Shelter clear space length is less than 48"		Remove and replace clear space
Shelter clear space width is less than 30"		
Shelter clear space running slope is greater than 2%	X	
Shelter opening clear width is less than 32"

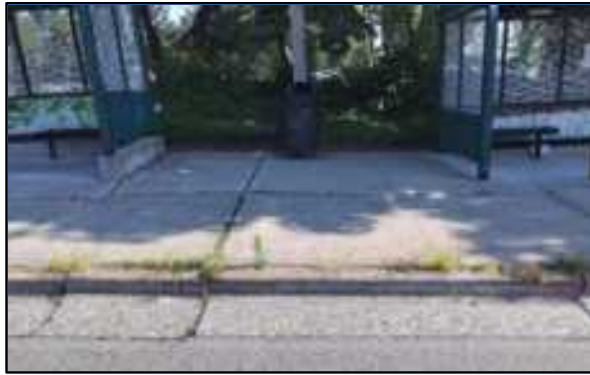
Boarding/Alighting Area

Boarding Area Issues	Issue Exists	Possible Solutions
Boarding area does not exist		
Boarding area length is less than 96"		
Boarding area width is less than 60"		
Boarding area running slope is greater than 2%	X	Remove and replace boarding area
Boarding area cross slope is greater than adjacent street grade		
Heaving/Sinking/Cracking present in the boarding area		
Ponding present in the boarding area		
Permanent obstruction (>0.25") in boarding area	X	Remove obstruction
Temporary obstruction (>0.25") in boarding area		
Transition at connection to the curb is greater than 0.25"	X	Fix connection transition
Boarding area is missing a connection to the street or sidewalk network		
Adjacent Sidewalk Network Issues	Issue Exists	Possible Solutions
Sidewalk network width is less than 48"		
Sidewalk network cross slope is greater than 2%		
Heaving/Sinking/Cracking present in the sidewalk network		
Ponding present in the sidewalk network

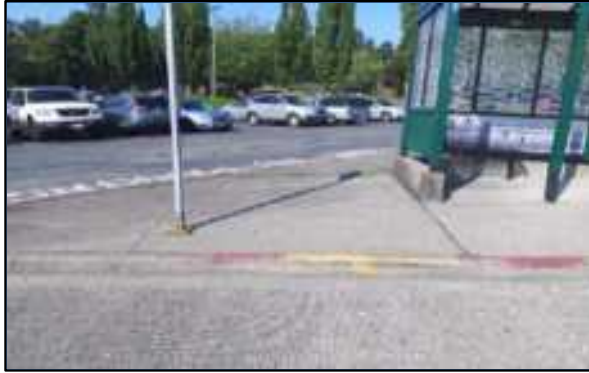
Boarding/Alighting Area

Boarding Area Issues	Issue Exists	Possible Solutions
Boarding area does not exist		
Boarding area length is less than 96"		
Boarding area width is less than 60"		
Boarding area running slope is greater than 2%	X	Remove and replace boarding area
Boarding area cross slope is greater than adjacent street grade		
Heaving/Sinking/Cracking present in the boarding area		
Ponding present in the boarding area		
Permanent obstruction (>0.25") in boarding area		
Temporary obstruction (>0.25") in boarding area		
Transition at connection to the curb is greater than 0.25"		
Boarding area is missing a connection to the street or sidewalk network		
Adjacent Sidewalk Network Issues	Issue Exists	Possible Solutions
Sidewalk network width is less than 48"		
Sidewalk network cross slope is greater than 2%		
Heaving/Sinking/Cracking present in the sidewalk network		
Ponding present in the sidewalk network		
Permanent obstruction (>0.25") in sidewalk network

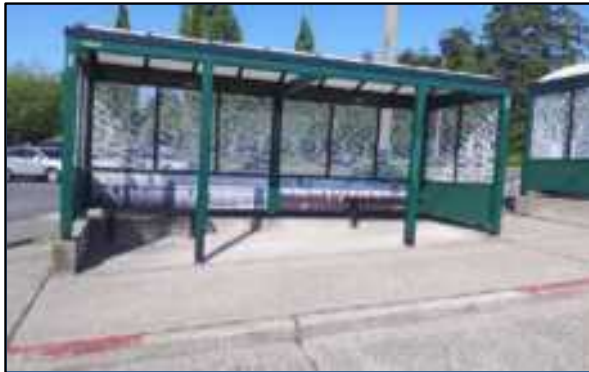
Shelter/Clear Space

No clear space under shelter		
Shelter clear space length is less than 48"		Remove and replace clear space
Shelter clear space width is less than 30"		
Shelter clear space running slope is greater than 2%	X	
Shelter opening clear width is less than 32"

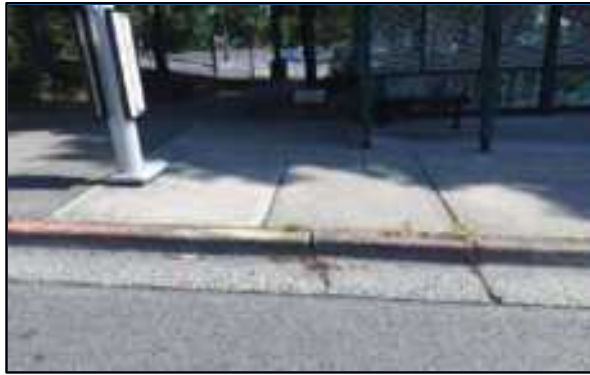
Boarding/Alighting Area

Boarding Area Issues	Issue Exists	Possible Solutions
Boarding area does not exist		
Boarding area length is less than 96"		
Boarding area width is less than 60"		
Boarding area running slope is greater than 2%	X	Remove and replace boarding area
Boarding area cross slope is greater than adjacent street grade		
Heaving/Sinking/Cracking present in the boarding area	X	
Ponding present in the boarding area		
Permanent obstruction (>0.25") in boarding area		
Temporary obstruction (>0.25") in boarding area		
Transition at connection to the curb is greater than 0.25"	X	Fix connection transition
Boarding area is missing a connection to the street or sidewalk network		
Adjacent Sidewalk Network Issues	Issue Exists	Possible Solutions
Sidewalk network width is less than 48"		
Sidewalk network cross slope is greater than 2%		
Heaving/Sinking/Cracking present in the sidewalk network		
Ponding present in the sidewalk network

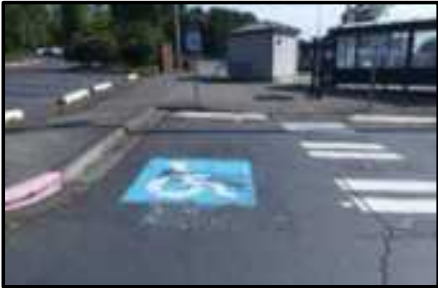
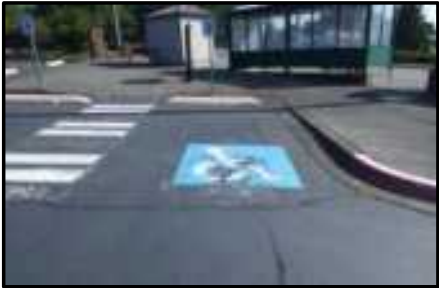
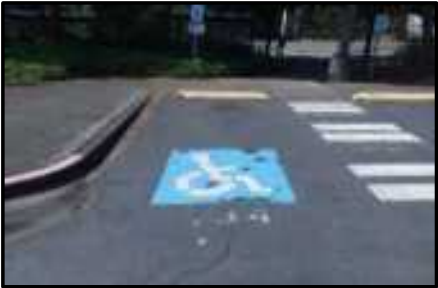
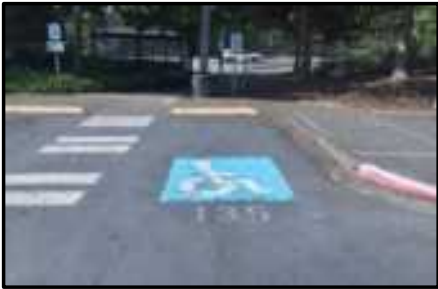
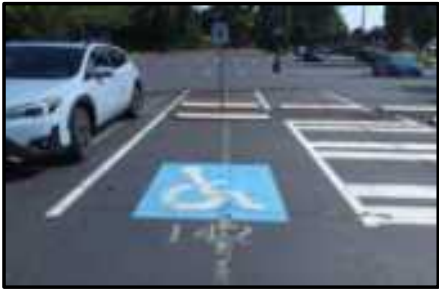
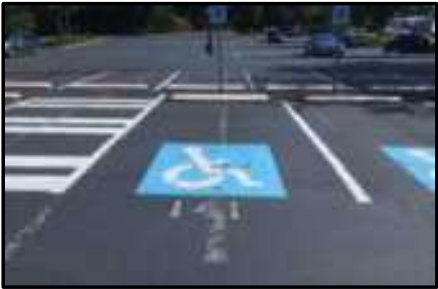
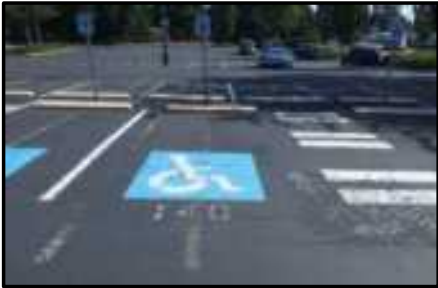
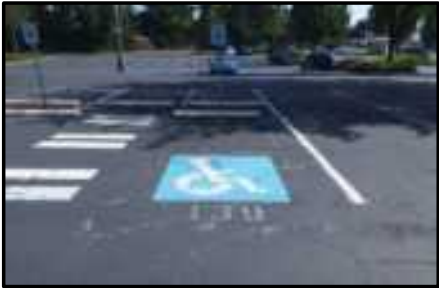
Parking Space Issue	Parking Space ID								Possible Solutions
	P1	P2	P3	P4	P5	P6	P7	P8	
Parking space not marked as accessible	x	x	x	x					
Parking space width is less than 96"									
Parking space does not have an adjacent access aisle									
Car parking space access aisle width is less than 60"	x		x				x		
Van parking space access aisle width is less than 96"									Remove and replace pavement markings
Access aisle does not extend the full length of the parking space it serves									Install access aisle hatch pavement markings
Access aisle is not marked to discourage parking in the aisle							x		
Access aisle overlaps the vehicular way									
Access aisle does not adjoin an accessible route									
Constrained width where the access aisle adjoins the accessible route is less than 48"									
Access aisle has change in level > 0.25"	x						x		
Access aisle has horizontal openings > 0.5"									Repave and restripe access aisle or relocate access aisle

Access aisle running slope is > 2%							x		
Access aisle cross slope is > 2%	x		x		x		x		
Parking space has change in level > 0.25"		x						x	
Parking space horizontal openings > 0.5"									
Parking space running slope is > 2%	x		x			x	x		Repave and restripe accessible parking space or relocate accessible parking space
Parking space cross slope is > 2%	x	x	x	x	x	x	x	x	
Parking space vertical clearance is < 98"									
Parking space identification sign is missing or incorrect	x								Install accessible parking sign

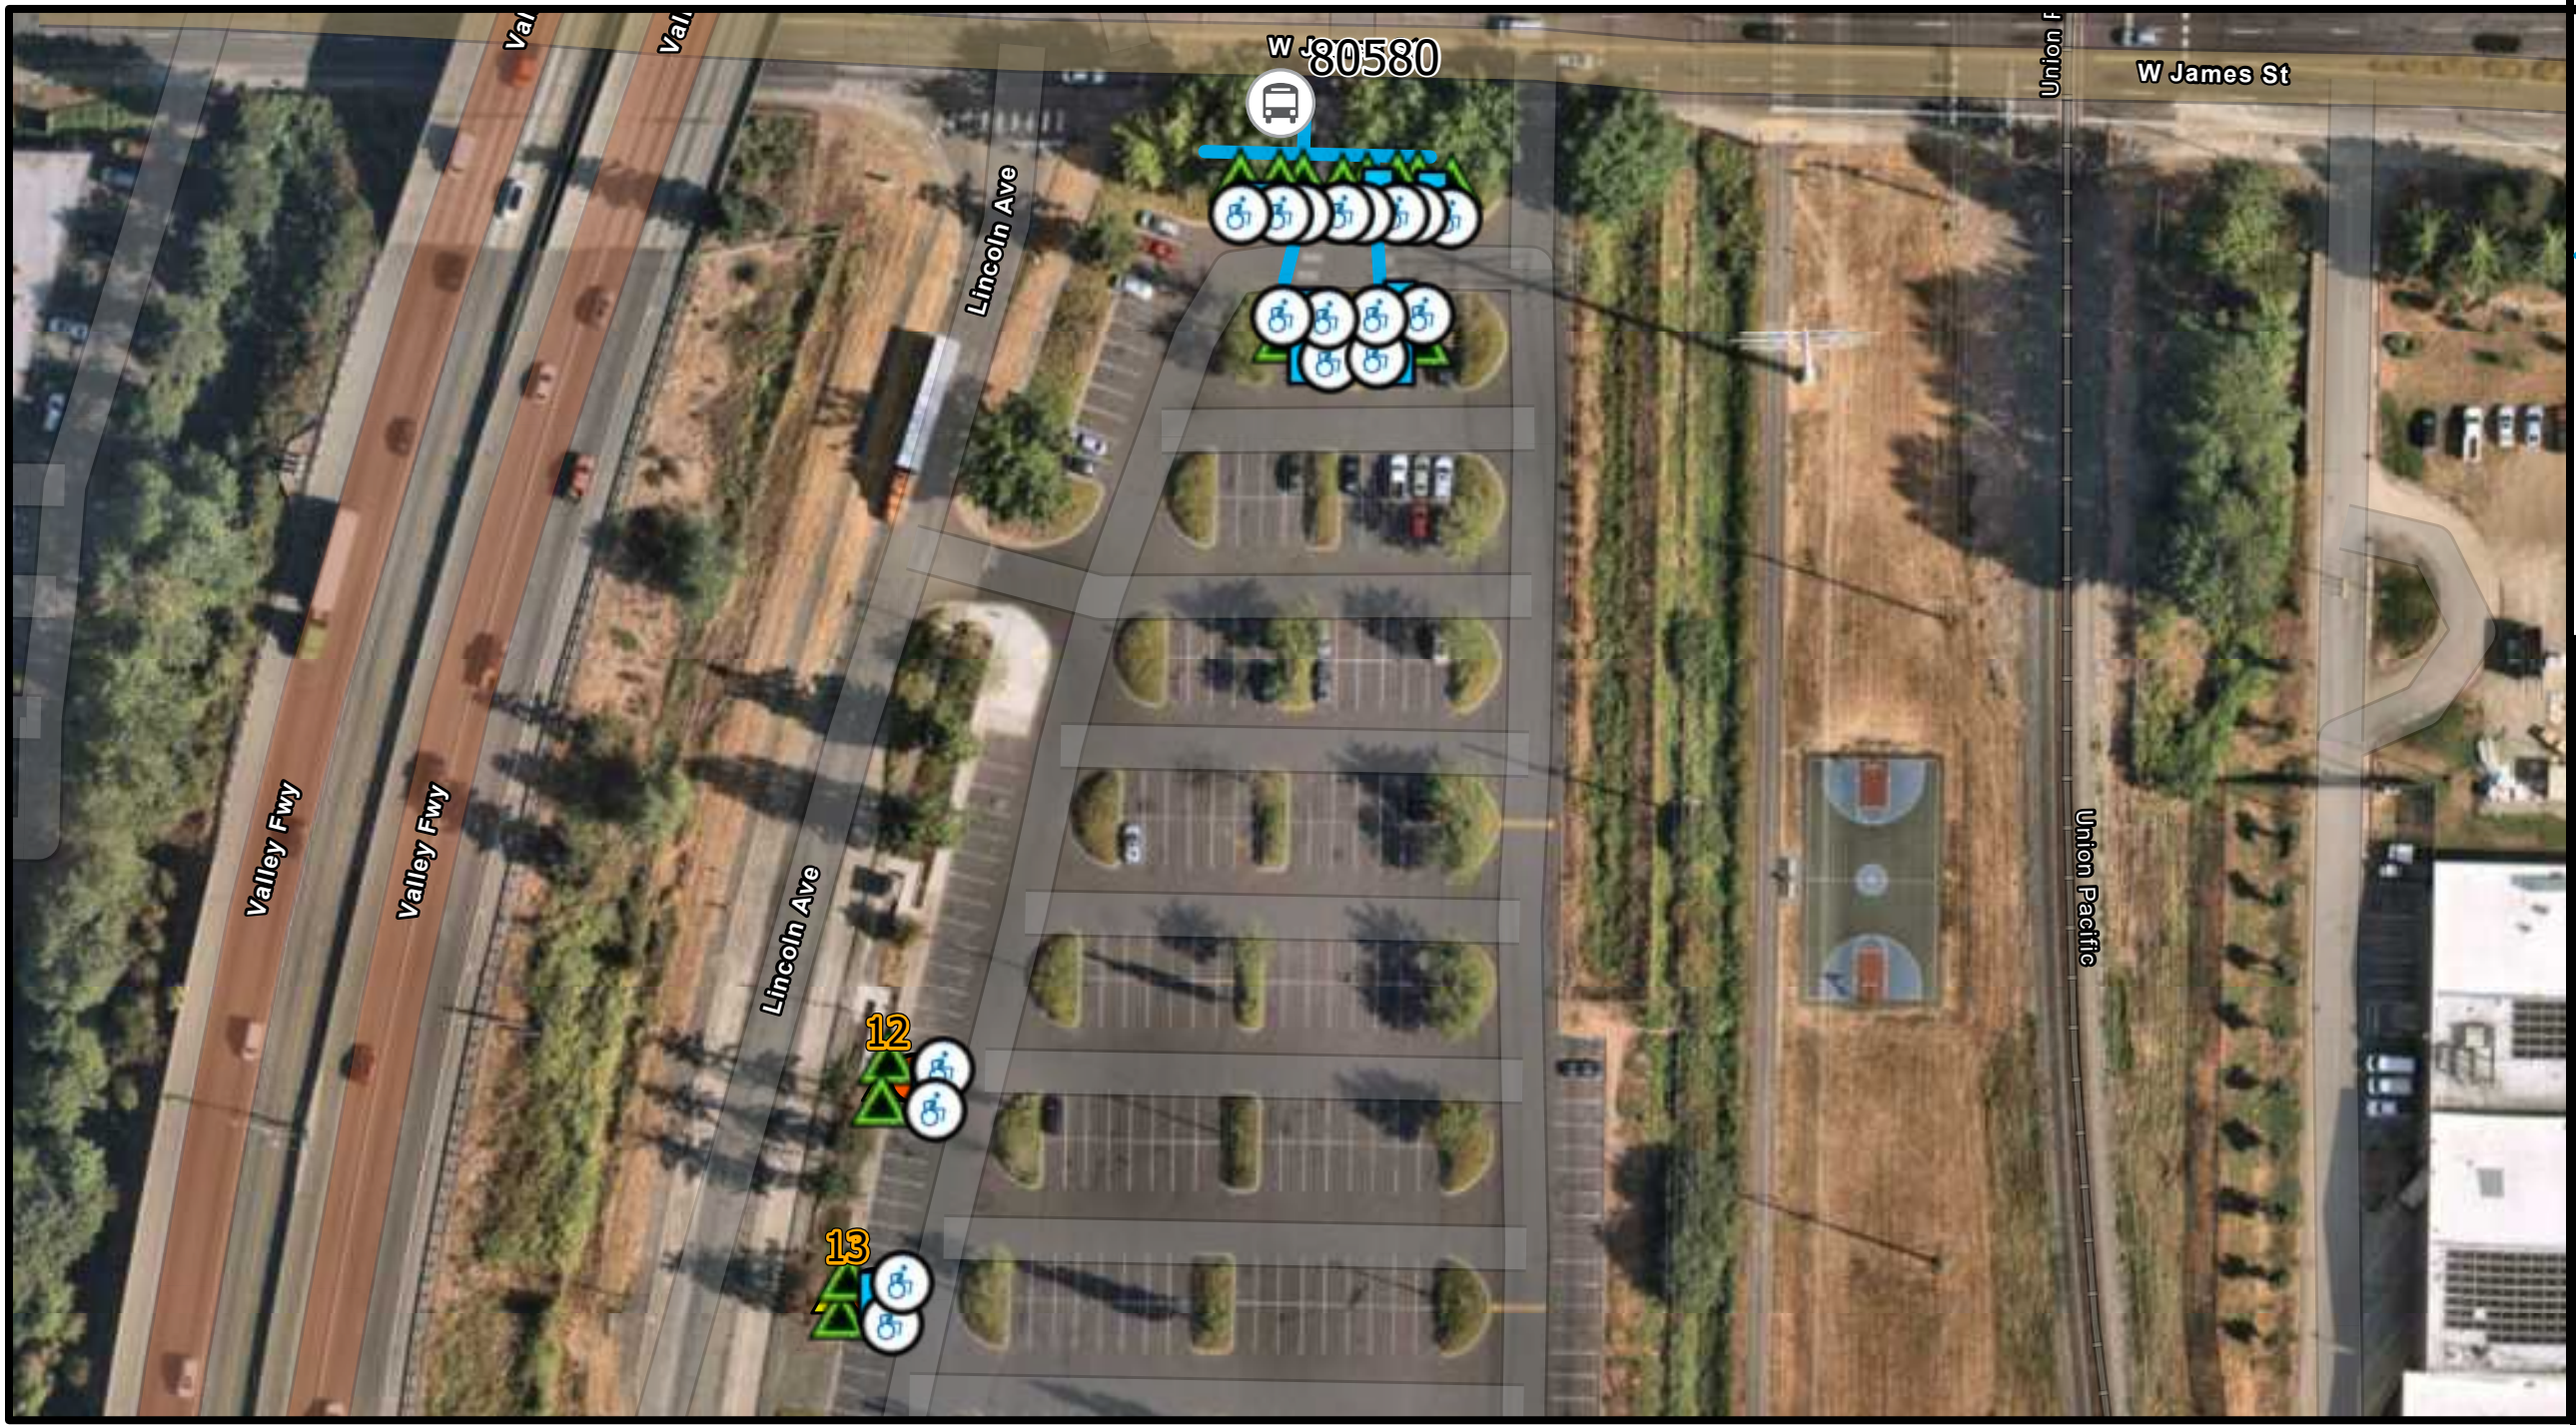
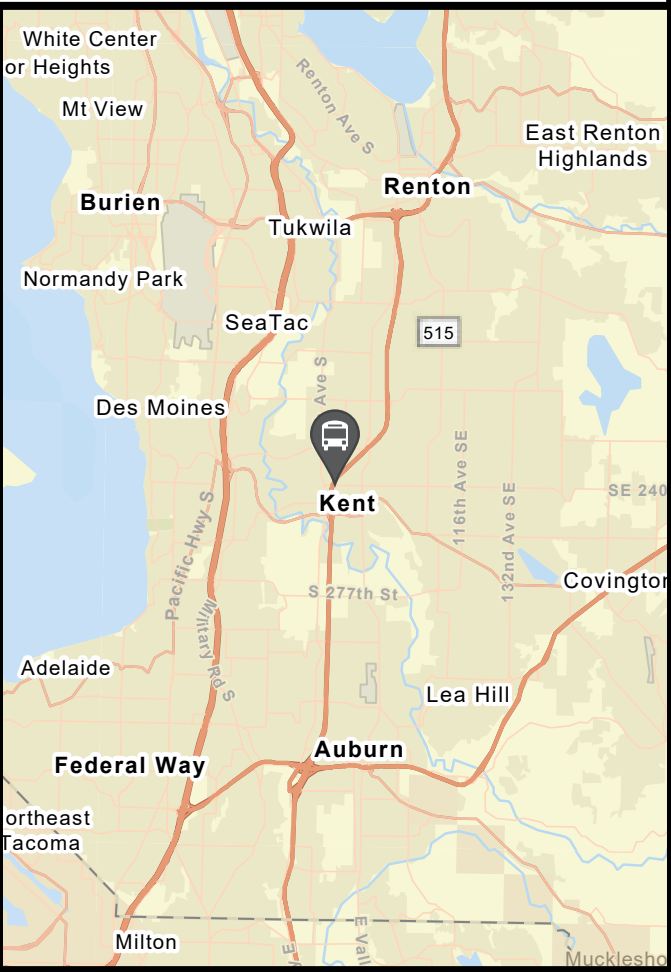
- Intersections and ID
- Curb Ramp
- Path of Travel
- Accessible Parking Sign
- Accessible Parking
- Access Aisle
- Transit Stop and ID
- Ramp
- Building

Facility Quantity Summary of Evaluated Elements	
	Feet
Path of Travel	211
	Quantity
Intersections with Curb Ramps	2
Ramps	0
Transit Stops	1
Accessible Parking Spaces	18

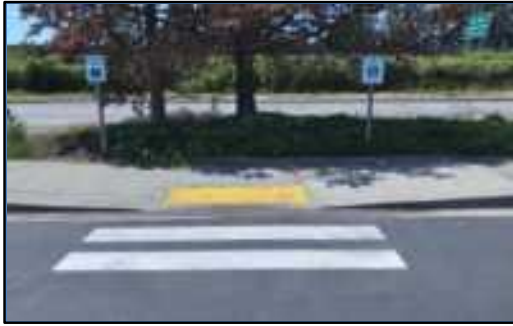
Ramp 1A

Issues	Point ID	Possible Solutions
	1A	
Curb ramp does not exist and is needed		
Curb ramp does not land in crosswalk		
No 4' x 4' clear space at base of curb ramp		
Curbed side is not 90° or has traversable adjacent surface		
Flare cross slope is greater than 10%		
Curb ramp running slope is greater than 8.3%		
Blended transition running slope is greater than 5%		
Cut-thru ramp running slope is greater than 5%		
Curb ramp cross slope is greater than 2%		
Cut-thru ramp cross slope is greater than 2%		
Curb ramp width is less than 48"		
Cut-thru ramp width is less than 60"		
Permanent obstruction (>0.25") in curb ramp/landing/flares		
Turning space does not exist and is needed		
Turning space length is less than 4' (or 5' when constrained)		
Turning space width is less than 4' (or 5' when constrained)		
Turning space running slope is greater than 2%		
Turning space cross slope greater than 2%		
Temporary obstruction (>0.25") in curb ramp/landing/flares

Non-compliant detectable warning surface (DWS)		
No detectable warning surface (DWS)		
Transition onto roadway is greater than 0.25"	X	Fix transition to roadway
Counter slope of the gutter or street at the foot of the curb ramp is greater than 5%		
Ponding occurs at base of curb ramp

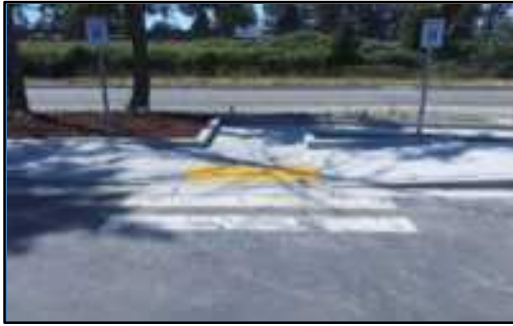
Ramp 1A

Issues	Point ID	Possible Solutions
	1A	
Curb ramp does not exist and is needed		
Curb ramp does not land in crosswalk		
No 4' x 4' clear space at base of curb ramp		
Curbed side is not 90° or has traversable adjacent surface		
Flare cross slope is greater than 10%		
Curb ramp running slope is greater than 8.3%		
Blended transition running slope is greater than 5%		
Cut-thru ramp running slope is greater than 5%		
Curb ramp cross slope is greater than 2%		
Cut-thru ramp cross slope is greater than 2%		
Curb ramp width is less than 48"		
Cut-thru ramp width is less than 60"		
Permanent obstruction (>0.25") in curb ramp/landing/flares		
Turning space does not exist and is needed		
Turning space length is less than 4' (or 5' when constrained)		
Turning space width is less than 4' (or 5' when constrained)		
Turning space running slope is greater than 2%		
Turning space cross slope greater than 2%		
Temporary obstruction (>0.25") in curb ramp/landing/flares

Non-compliant detectable warning surface (DWS)		
No detectable warning surface (DWS)		
Transition onto roadway is greater than 0.25"	X	Fix transition to roadway
Counter slope of the gutter or street at the foot of the curb ramp is greater than 5%		
Ponding occurs at base of curb ramp

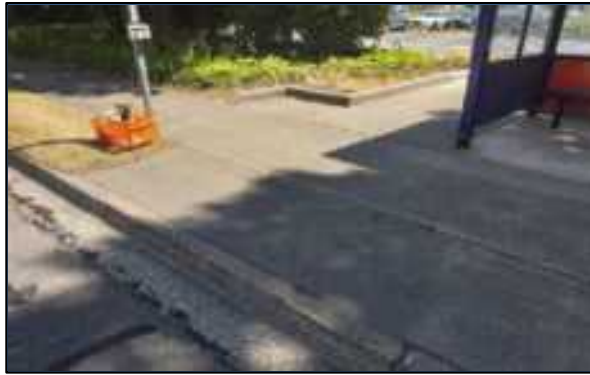
Boarding/Alighting Area

Boarding Area Issues	Issue Exists	Possible Solutions
Boarding area does not exist		
Boarding area length is less than 96"		
Boarding area width is less than 60"		
Boarding area running slope is greater than 2%	X	Remove and replace boarding area
Boarding area cross slope is greater than adjacent street grade		
Heaving/Sinking/Cracking present in the boarding area	X	
Ponding present in the boarding area		
Permanent obstruction (>0.25") in boarding area		
Temporary obstruction (>0.25") in boarding area		
Transition at connection to the curb is greater than 0.25"		
Boarding area is missing a connection to the street or sidewalk network		
Adjacent Sidewalk Network Issues	Issue Exists	Possible Solutions
Sidewalk network width is less than 48"		
Sidewalk network cross slope is greater than 2%		
Heaving/Sinking/Cracking present in the sidewalk network		
Ponding present in the sidewalk network		
Permanent obstruction (>0.25") in sidewalk network

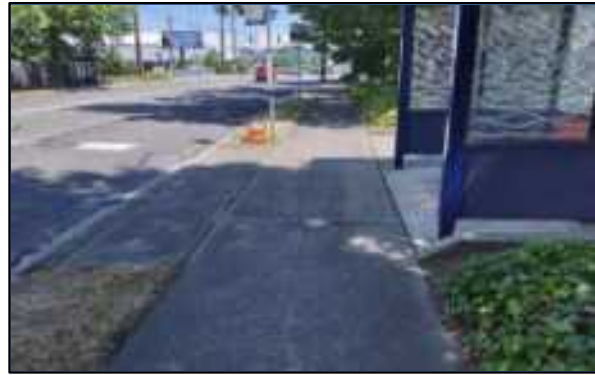
Adjacent Sidewalk Network

Temporary obstruction (>0.25") in sidewalk network		
Transition at connection to boarding area is greater than 0.25"		
Transit Stop Sidewalk Issues	Issue Exists	Possible Solutions
Transit stop sidewalk cross slope is greater than 2%		
Heaving/Sinking/Cracking present in the transit stop sidewalk		
Ponding present in the transit stop sidewalk		
Permanent obstruction (>0.25") in transit stop sidewalk		
Temporary obstruction (>0.25") in transit stop sidewalk		
Transition at connection to sidewalk network is greater than 0.25"		
Transit Stop Amenity Issues	Issue Exists	Possible Solutions
No transit stop signage		
Transit stop signage is non-compliant	X	Remove and replace transit stop signage
No clear space adjacent to stand-alone bench		
Stand-alone bench clear space length is less than 48"		
Stand-alone bench clear space width is less than 30"		
Stand-alone bench clear space running slope is greater than 2%

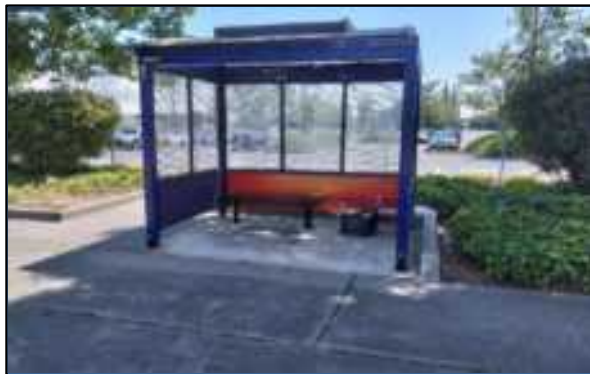
Shelter/Clear Space

No clear space under shelter		
Shelter clear space length is less than 48"		Remove and replace clear space
Shelter clear space width is less than 30"		
Shelter clear space running slope is greater than 2%	X	
Shelter opening clear width is less than 32"
